# Visual Site Inspection Report

<b>Project Name</b>	H-600 Pipeline Spread H	<b>AFE</b>	124300138	<b>Spread</b>	H-600 Pipeline Spread H
<b>Contractor</b>	Precision			<b>Report #</b>	26368
<b>Inspector</b>	Logan Box			<b>Date/Time</b>	7/26/2021 3:12 PM
<b>Permit #</b>	TBD	<b>Inspection Type</b>	VA SWPP	<b>Station Begin</b>	13525+99
<b>State</b>	VA	<b>Inspection Area</b>	Partial	<b>Station End</b>	13670+00
<b>County</b>	Franklin	<b>Ground</b>	Dry	<b>Temperature (°F)</b>	90.00
<b>Municipality</b>	N/A	<b>Weather</b>	Light Rain	<b>Rain Gauge (in)</b>	0.00
				<b>Rain Accumulation Time (days)</b>	0.00

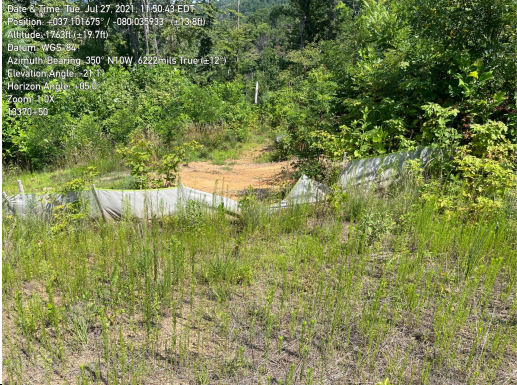
<b>GPS Location</b>	0	<b>GPS Location</b>	0		
<b>Field Station#</b>	13370+50	<b>Field Station#</b>	13371+50		
<b>Pic 7 Desc.</b>	P1 needs repaired - 72hr maintenance item	<b>Pic 8 Desc.</b>	ROW and ECDs in good condition, With Vegetation established, temporary stabilization of travel lane beginning to seed and turn

E&S BMPs	Compliance Level	Corrective Action	Corrective Time Frame	Date Repaired
Cleanwater Diversion Berm	Acceptable			
Cleanwater Diversion Pipe	Acceptable			
Compost Filter Sock	Acceptable			
Equipment Bridge	Acceptable			
Erosion Control Blanket	Acceptable			
Rock Construction Entrance	Acceptable			
Silt Fence (Reinforce Filter Fence)	Acceptable			
Silt Fence (Reinforced Filter Fabric Fence)	Communication	P1 needs repaired - 72hr item		7/28/2021
Sump Pit	Acceptable

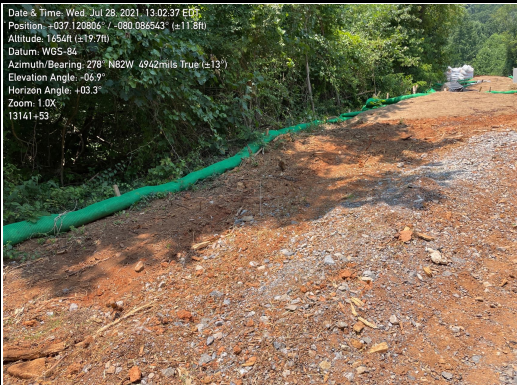
GPS Location				0		GPS Location				0			
Field Station#				13141+53		Field Station#				13141+53			
Pic 17 Desc.				E&S crew arrived and removed trash prior to completing inspection. Maintenance item was satisfactory prior to leaving area				Pic 18 Desc.				Blasting crew drilling charge holes to prepare to blast soon.	
<p>Date &amp; Time: Wed, Jul 28, 2021, 14:08:04 EDT Position: +037.121010° / -080.084309° (+15.6m) Altitude: 1575ft (+13.0m) Datum: WGS-84 Azimuth/Bearing: 277° N 83° W 4924mils True (+10.1) Elevation Angle: +06.1° Horizon Angle: +06.1° Zoom: 1.0X 13141+53</p>
