Visual Site Inspection Report

Project Name	H-600 Pipeline Spread H	AFE	124300138	Spread	H-600 Pipeline Spread H
Contractor	Precision			Report #	26667
Inspector	Bryan Cole			Date/Time	8/2/2021 5:12 PM
Permit #	TBD	Inspection Type	VA SWPP	Station Begin	13316+21
State	VA	Inspection Area	Partial	Station End	13422+00
County	Franklin	Ground	Dry	Temperature (°F)	78.00
Municipality	N/A	Weather	Sunny	Rain Gauge (in)	0.20
				Rain Accumulation Time (days)	0.00

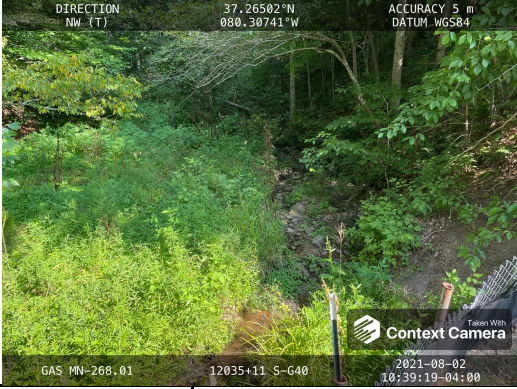
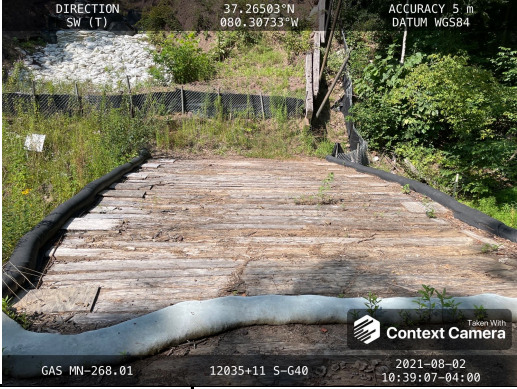
GPS Location	See photo		GPS Location	See photo	
Field Station#	12035+11		Field Station#	12035+11	
Pic 7 Desc.	Stream S-G40. No issues observed		Pic 8 Desc.	Equipment bridge over Stream S-G40.

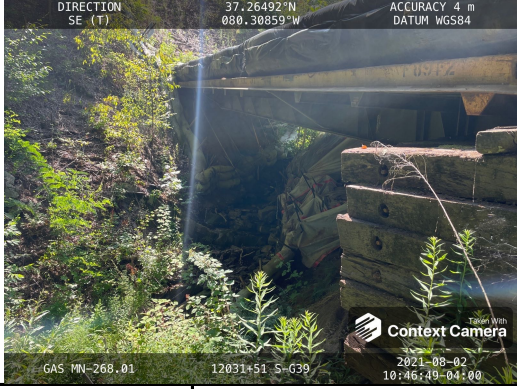
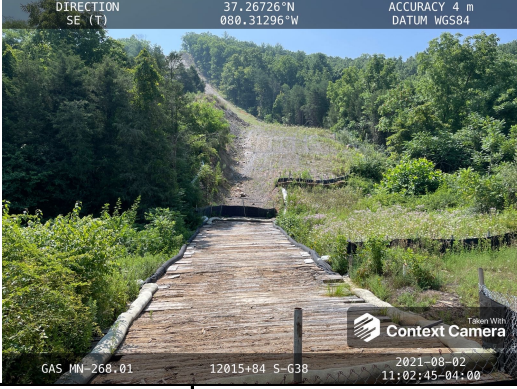
GPS Location	See photo		GPS Location	See photo	
Field Station#	12031+51		Field Station#	12015+84	
Pic 9 Desc.	Stream S-G39. No issues noted.		Pic 10 Desc.	Equipment bridge and buffer area at S-G38

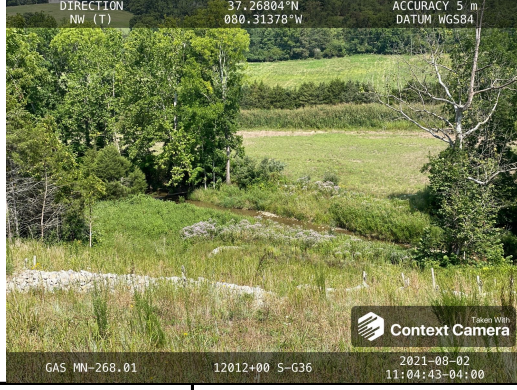
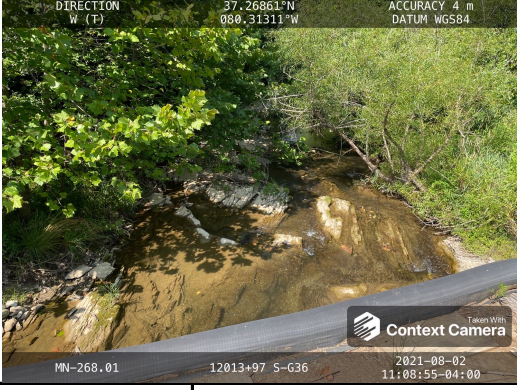
GPS Location	See photo		GPS Location	See photo	
Field Station#	12012+00		Field Station#	12013+97	
Pic 11 Desc.	Stream S-G36. No issues noted.		Pic 12 Desc.	Stream S-G36 on MN-268.01. No issues noted

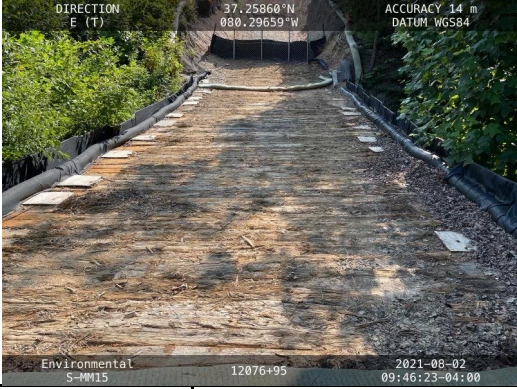
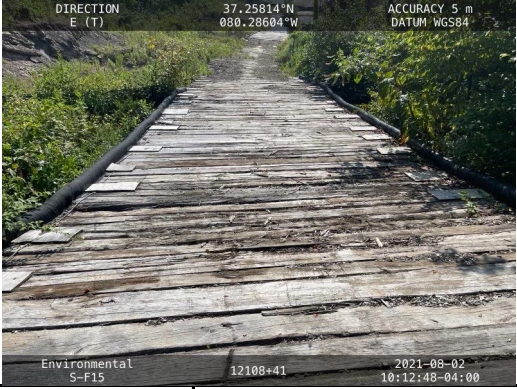
GPS Location	See photo		GPS Location	See photo	
Field Station#	12076+95		Field Station#	12108+41	
Pic 13 Desc.	Equipment bridge over Stream S-MM15		Pic 14 Desc.	Equipment bridge over Stream S-F15

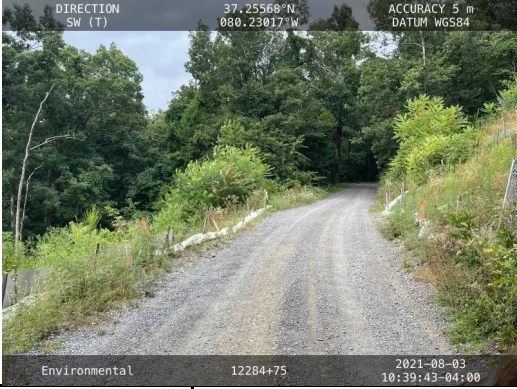
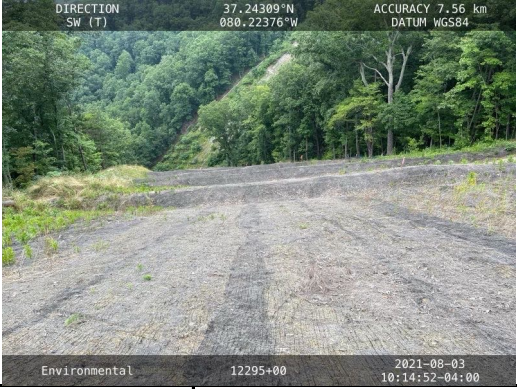
GPS Location	See photo		GPS Location	See photo	
Field Station#	12284+75		Field Station#	12295+00	
Pic 13 Desc.	Access Road MN-276.03 maintained		Pic 14 Desc.	Current ROW conditions. Waterbars functional.

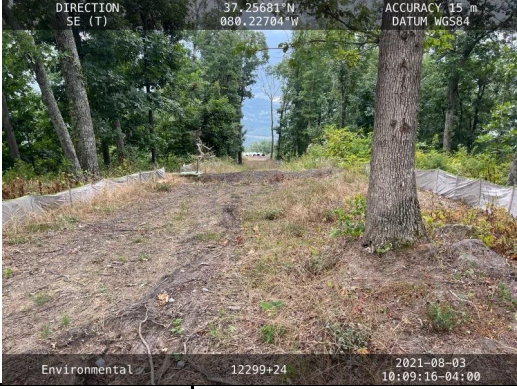
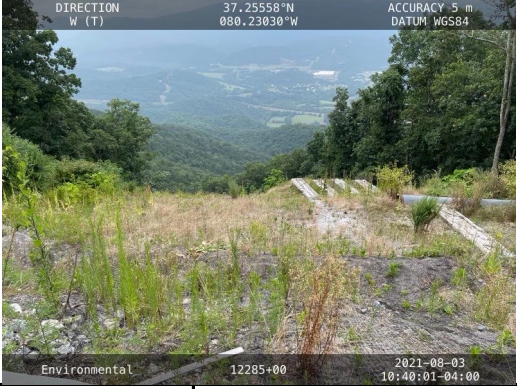
GPS Location	See photo		GPS Location	See photo	
Field Station#	12299+24		Field Station#	12285+00	
Pic 15 Desc.	Area stabilized. Perimeter controls maintained		Pic 16 Desc.	Current ROW conditions. ROW is stable

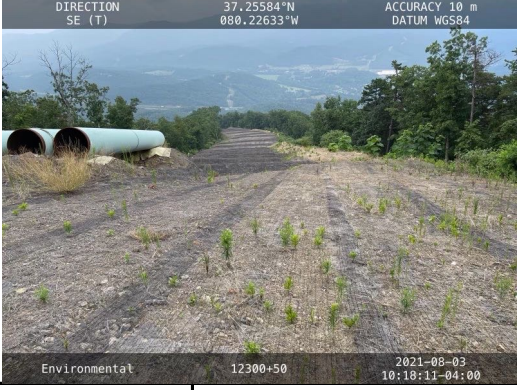
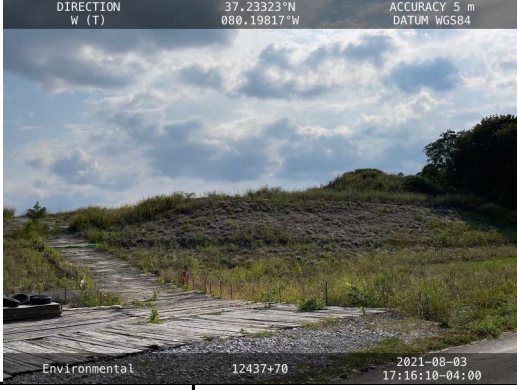
GPS Location	See photo		GPS Location	See photo	
Field Station#	12300+50		Field Station#	12437+70	
Pic 17 Desc.	Current ROW conditions. Area stable		Pic 18 Desc.	Current ROW conditions. Area stable

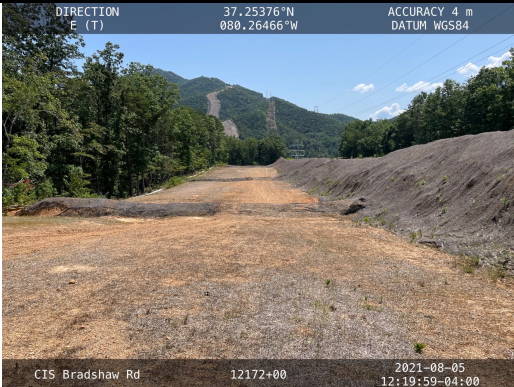
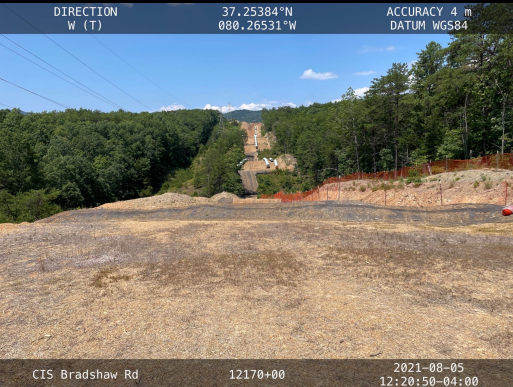
GPS Location	See photo		GPS Location	See photo	
Field Station#	12172+00		Field Station#	12170+00	
Pic 1 Desc.	Current ROW conditions. ROW is stable and waterbars are functional.		Pic 2 Desc.	Current ROW conditions. ROW is stable and waterbars are functional.

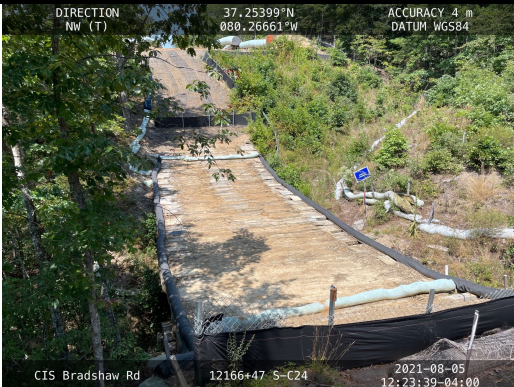
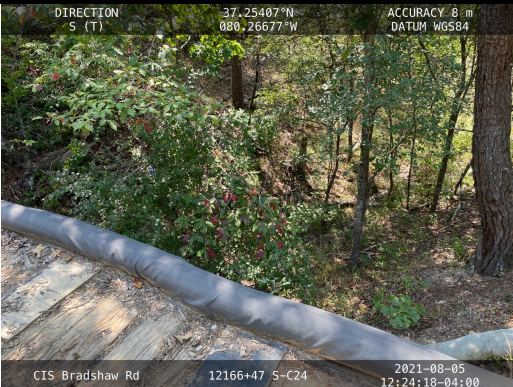
GPS Location	See photo		GPS Location	See photo	
Field Station#	12166+47		Field Station#	12166+47	
Pic 3 Desc.	Equipment Bridge over Stream S-C24		Pic 4 Desc.	Downstream photo of Stream S-C24

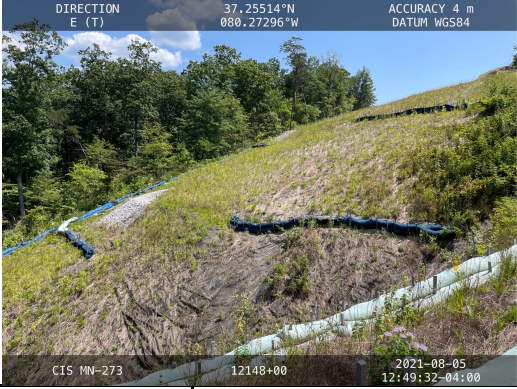
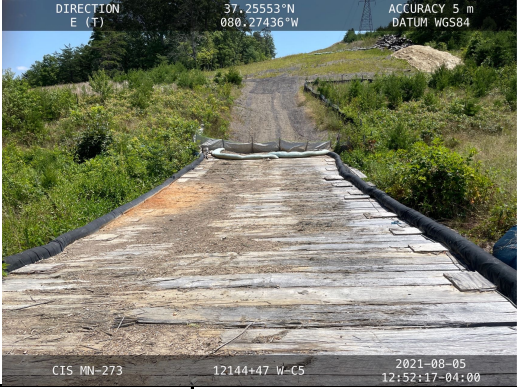
GPS Location	See photo		GPS Location	See photo	
Field Station#	12148+00		Field Station#	12144+47	
Pic 7 Desc.	Current ROW conditions. Permanent and temporary ECDs are functional.		Pic 8 Desc.	Equipment Bridge and ECDs over Wetland.

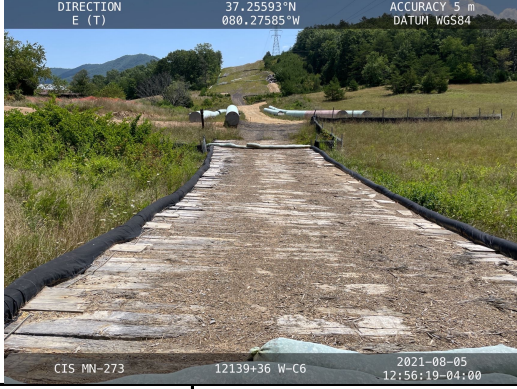
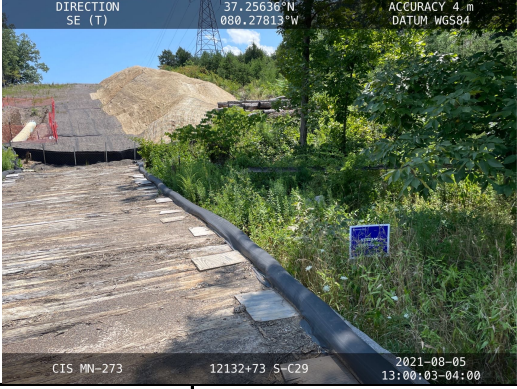
GPS Location	See photo		GPS Location	See photo	
Field Station#	12139+36		Field Station#	12132+73	
Pic 9 Desc.	Equipment Bridge and ECDs over Wetland.		Pic 10 Desc.	Equipment Bridge and ECDs at Stream S-C29

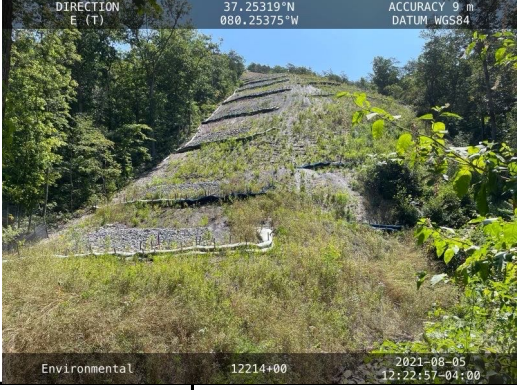
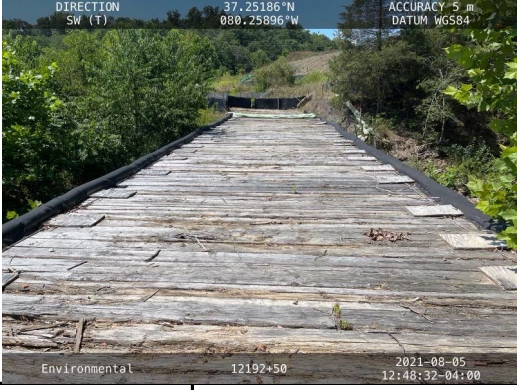
GPS Location	See photo		GPS Location	See photo	
Field Station#	12214+00		Field Station#	12192+50	
Pic 17 Desc.	Current ROW conditions. Permanent and temporary ECDs are functional. ROW is stable.		Pic 18 Desc.	Equipment Bridge over Stream S-C21.

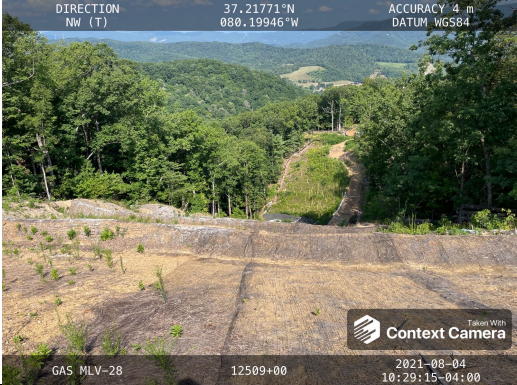
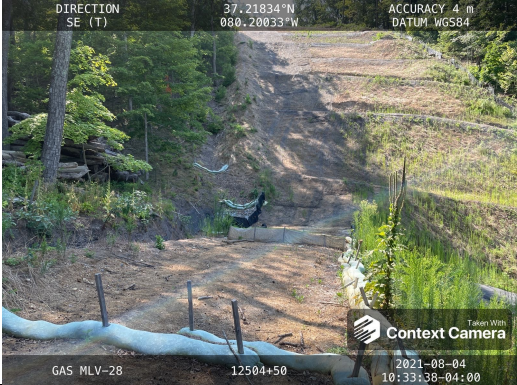
GPS Location	See photo		GPS Location	See photo	
Field Station#	12509+00		Field Station#	12504+50	
Pic 7 Desc.	Current ROW conditions. ROW is stable. Waterbars are functional		Pic 8 Desc.	Equipment Bridge over CWD pipe

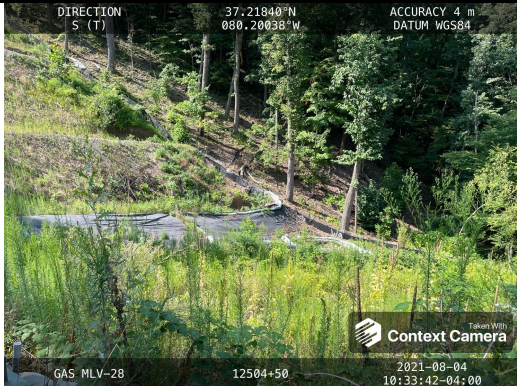
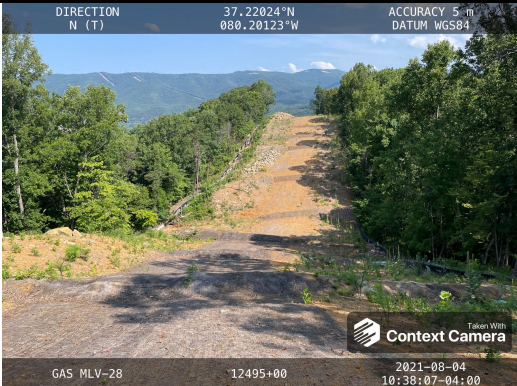
GPS Location	See photo		GPS Location	See photo	
Field Station#	12504+50		Field Station#	12495+00	
Pic 9 Desc.	CWD outlet. ROW is stable.		Pic 10 Desc.	Current ROW conditions. Waterbars are functional

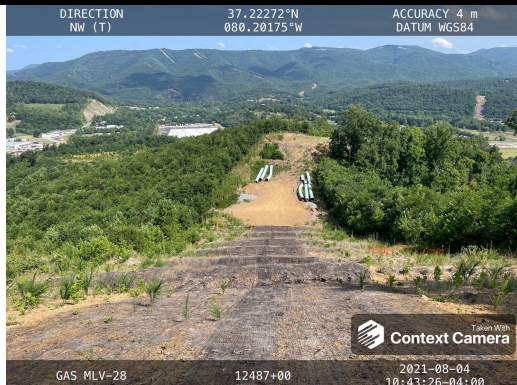
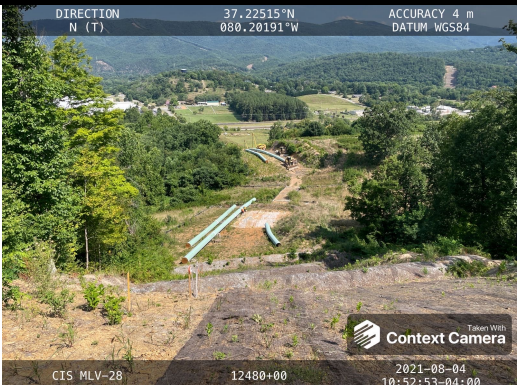
GPS Location	See photo		GPS Location	See photo	
Field Station#	12487+00		Field Station#	12480+00	
Pic 11 Desc.	Current ROW conditions. Waterbars are functional.		Pic 12 Desc.	Current ROW conditions. ROW is stable.

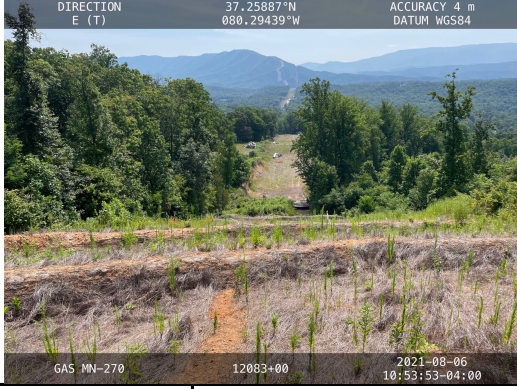
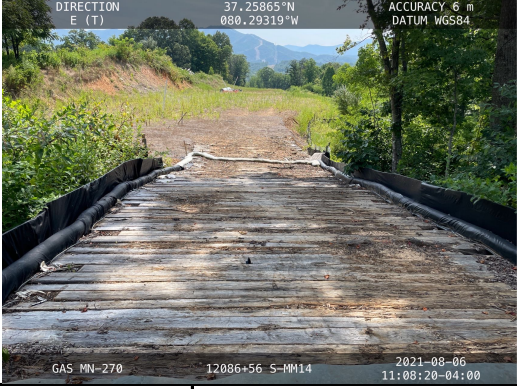
GPS Location	See photo		GPS Location	See photo	
Field Station#	12083+00		Field Station#	12086+56	
Pic 9 Desc.	Current ROW conditions. ROW is stable and waterbars are functional		Pic 10 Desc.	Equipment Bridge over Stream S-MM14

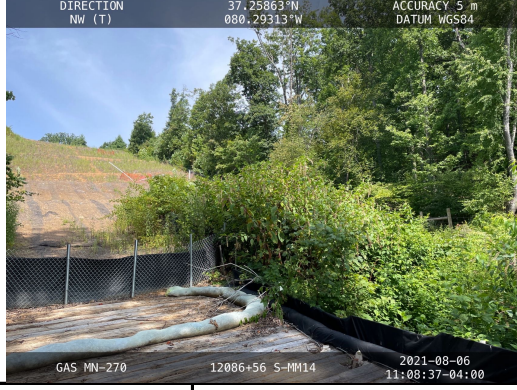
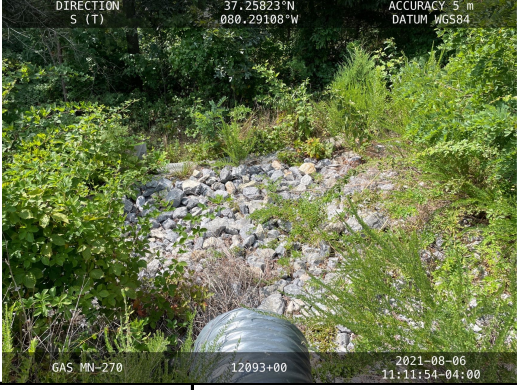
GPS Location	See photo		GPS Location	See photo	
Field Station#	12086+56		Field Station#	12093+00	
Pic 11 Desc.	Aquatic Buffer Space at Stream S-MM14		Pic 12 Desc.	CWD Outlet is functional

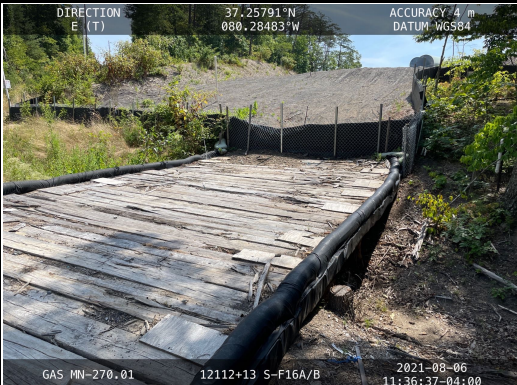
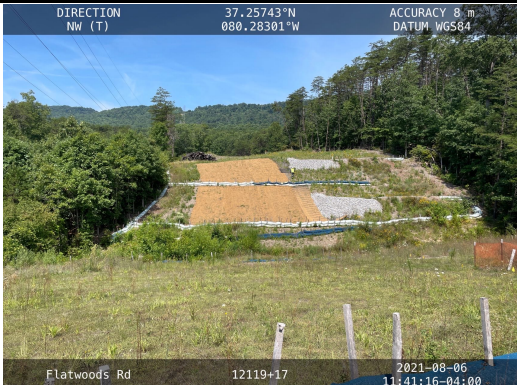
GPS Location	See photo		GPS Location	See photo	
Field Station#	12112+13		Field Station#	12119+17	
Pic 17 Desc.	Equipment BRidge over Stream S-F16A/B		Pic 18 Desc.	Current ROW conditions. Permanent and temporary ECDs are functional.

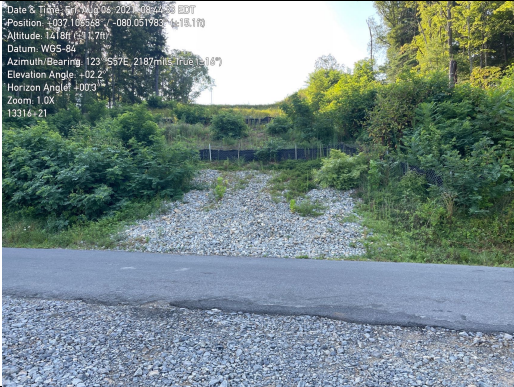
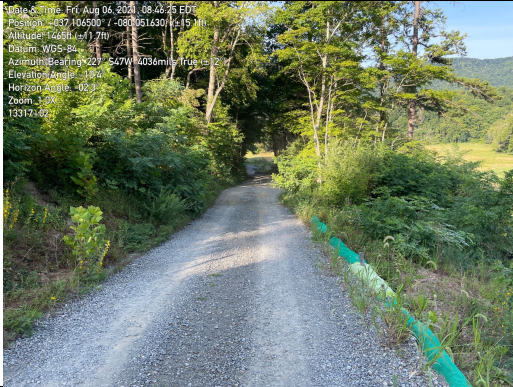
GPS Location	0	GPS Location	0		
Field Station#	13316+21	Field Station#	13317+02		
Pic 1 Desc.	Wades Gap Road Crossing and RCE in good condition		Pic 2 Desc.	Private Driveway in good condition

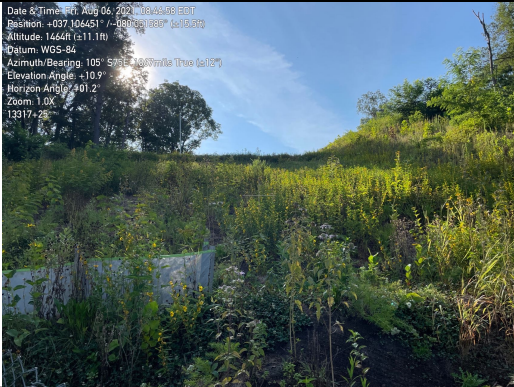
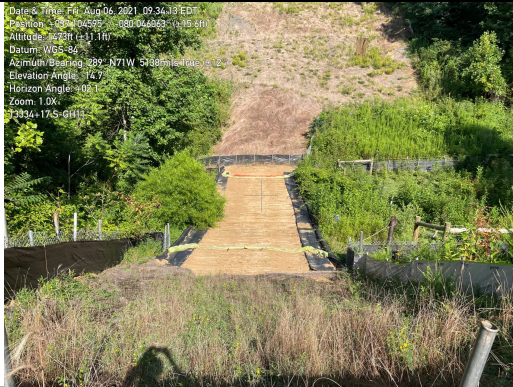
GPS Location	0	GPS Location	0		
Field Station#	13317+25	Field Station#	13334+17		
Pic 3 Desc.	ROW and ECDs in good condition, with vegetation established across ROW		Pic 4 Desc.	MVP-S-GH11 and Corresponding buffer zone in good condition

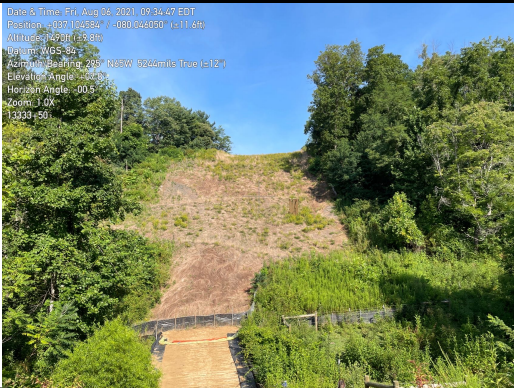
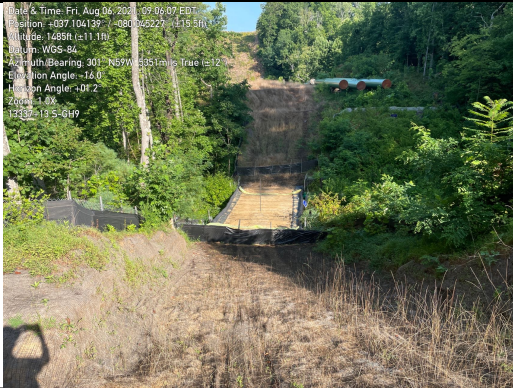
GPS Location	0	GPS Location	0		
Field Station#	13333+50	Field Station#	13337+13		
Pic 5 Desc.	ROW and ECDs in good condition, with vegetation established across ROW		Pic 6 Desc.	MVP-S-GH9 and Corresponding buffer zone in good condition
