Visual Site Inspection Report

Project Name	H-600 Pipeline Spread H	AFE	124300138	Spread	H-600 Pipeline Spread H
Contractor	Precision			Report #	26948
Inspector	Pat Davis			Date/Time	8/9/2021 5:30 PM
Permit #	TBD	Inspection Type	VA SWPP	Station Begin	+0
State	VA	Inspection Area	Partial	Station End	+0
County	Roanoke	Ground	Dry	Temperature (°F)	93.00
Municipality	N/A	Weather	Sunny	Rain Gauge (in)	0.00
				Rain Accumulation Time (days)	0.00

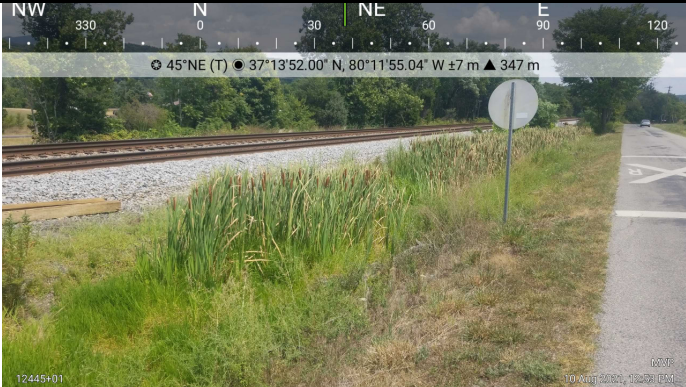
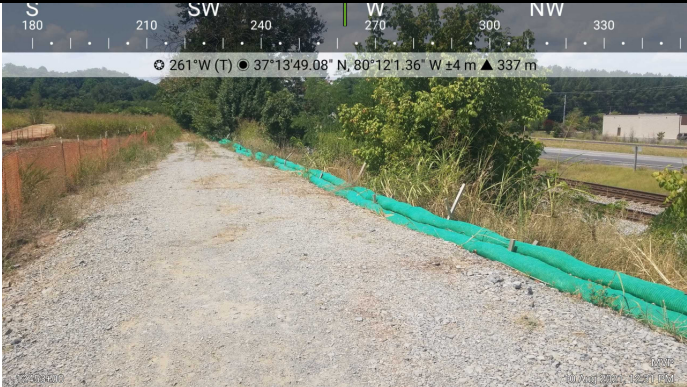
GPS Location	See Above	GPS Location	See Above		
Field Station#	12445+01	Field Station#	12453+00		
Pic 1 Desc.	Overview of Waterbody S-I1. ECDs are functional and ROW is stable.	Pic 2 Desc.	ROW Overview. ECDs are functional and ROW is stable.

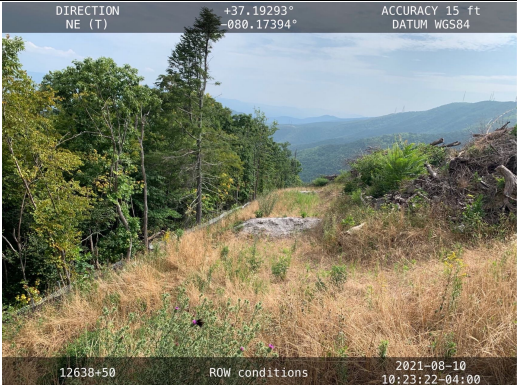
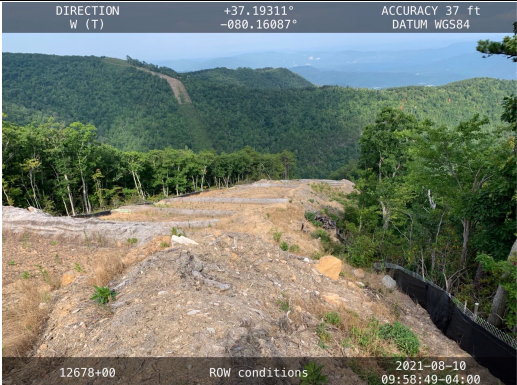
GPS Location	See photo		GPS Location	See photo	
Field Station#	12638+50		Field Station#	12678+00	
Pic 17 Desc.	Current ROW conditions on GAS RO-279.01		Pic 18 Desc.	Current ROW conditions on CIS Honeysuckle Road

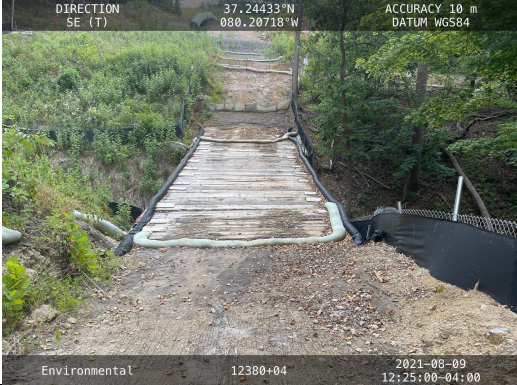
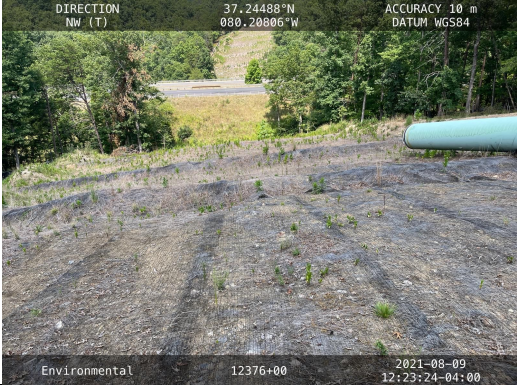
GPS Location	See photo		GPS Location	See photo	
Field Station#	12380+04		Field Station#	12376+00	
Pic 7 Desc.	Bridge and ECDs crossing S-NN19 in acceptable condition		Pic 8 Desc.	Stabilized ROW in acceptable condition

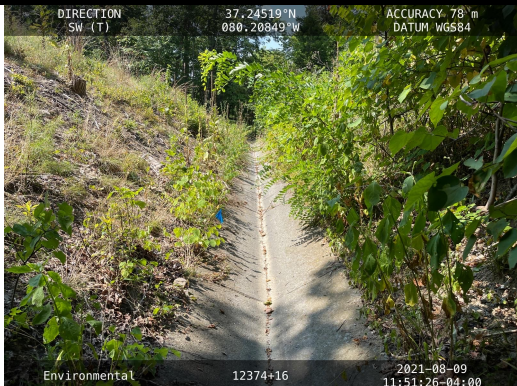
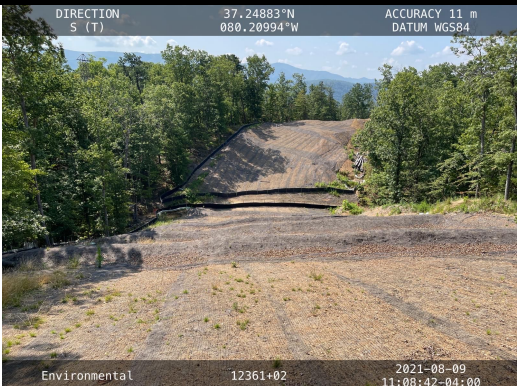
GPS Location	See photo		GPS Location	See photo	
Field Station#	12374+16		Field Station#	12361+02	
Pic 9 Desc.	Stream crossing S-OO16 in acceptable condition		Pic 10 Desc.	Stabilized ROW and land owner crossing in acceptable condition

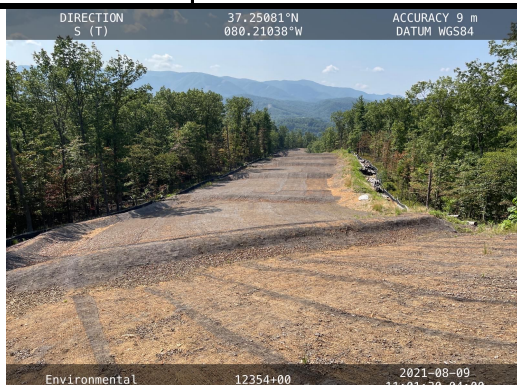
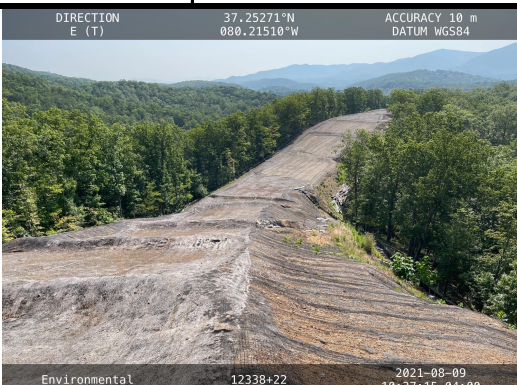
GPS Location	See photo		GPS Location	see photo	
Field Station#	12354+00		Field Station#	12338+22	
Pic 11 Desc.	Stabilized ROW in acceptable condition		Pic 12 Desc.	Stabilized ROW in acceptable condition

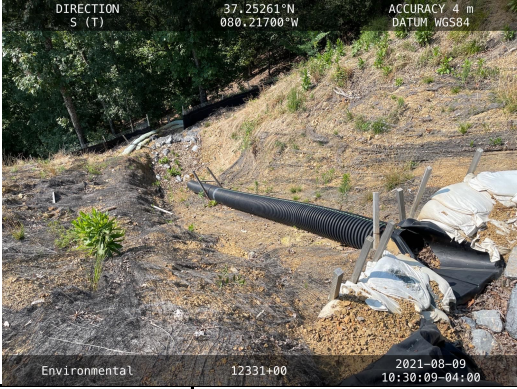
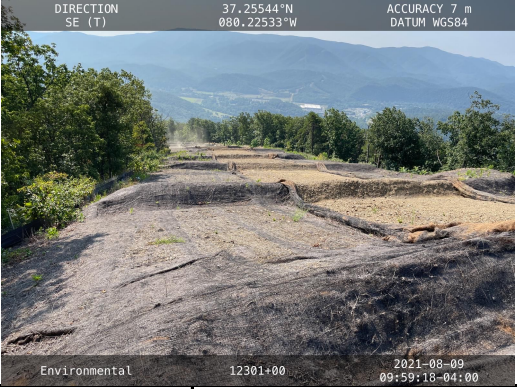
GPS Location	See photo		GPS Location	See photo	
Field Station#	12331+00		Field Station#	12301+00	
Pic 13 Desc.	Fill slope drain in acceptable condition		Pic 14 Desc.	Environmental crew rolling back the blanket to allow the dozer to knock out the travel lane

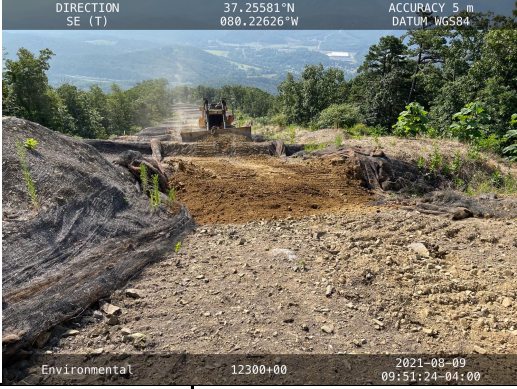
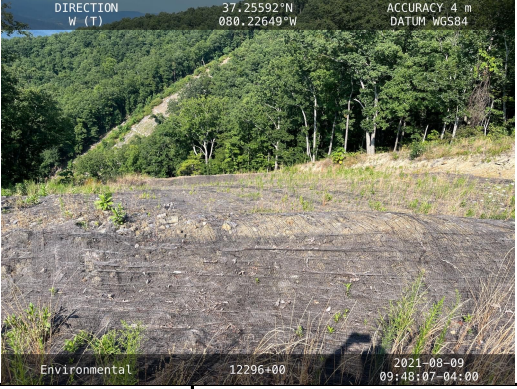
GPS Location	See photo		GPS Location	See photo	
Field Station#	12300+00		Field Station#	12296+00	
Pic 15 Desc.	Dozer taking out travel lane to allow vehicles to pass to perform maintenance work		Pic 16 Desc.	Stabilized slope in acceptable condition

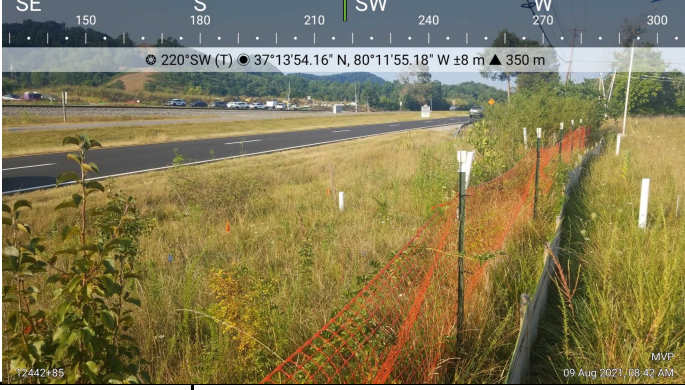
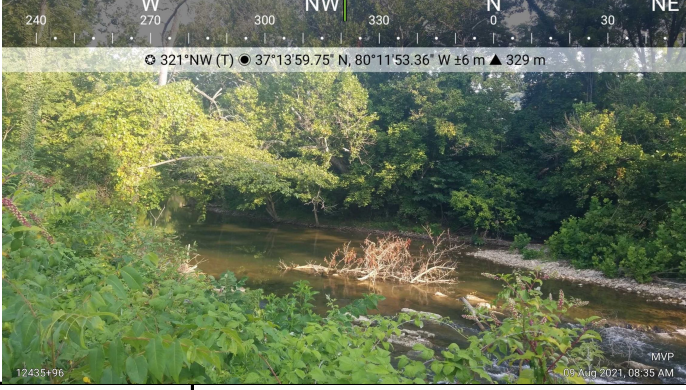
GPS Location	See photo		GPS Location	See photo	
Field Station#	12442+85		Field Station#	12435+96	
Pic 17 Desc.	P1 perimeter controls in acceptable condition		Pic 18 Desc.	Stream crossing S-NN16 in acceptable condition

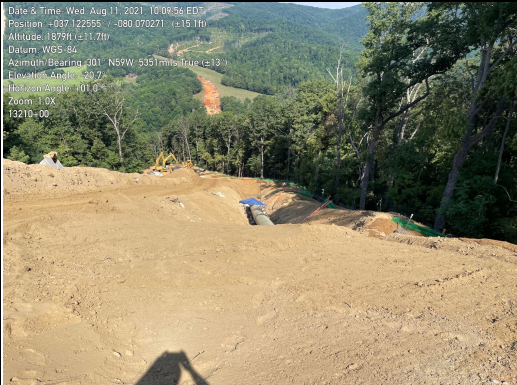
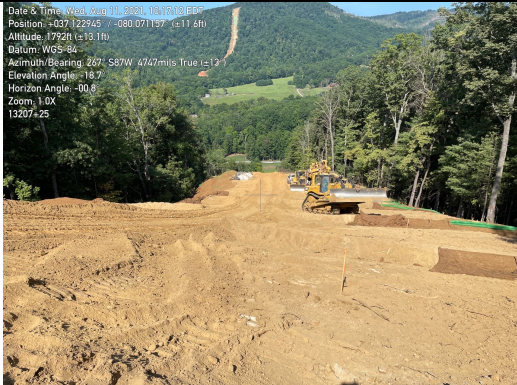
GPS Location			0			
Field Station#			13210+00			
Pic 7 Desc.			ROW and ECDs in good condition, ROW is stable			
GPS Location			0			
Field Station#			13207+25			
Pic 8 Desc.			ROW and ECDs in good condition			
<p>Date & Time: Wed, Aug 11, 2021, 10:39:37 EDT Position: +037.123091 / -080.071875 (+15.5ft) Altitude: 1722ft (+11.1ft) Datum: WGS-84 Azimuth/Bearing: 014° N14E 0249mils True (+13) Elevation Angle: -27.7 Horizon Angle: +04.6 Zoom: 1.0X 13205-00</p>

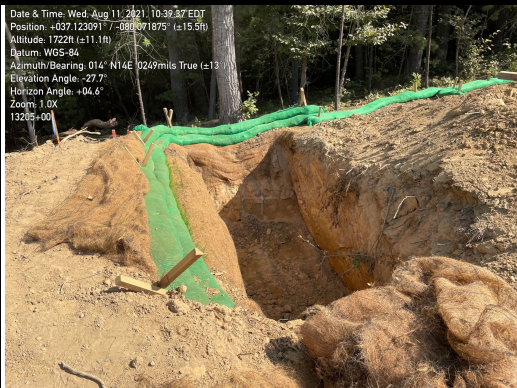
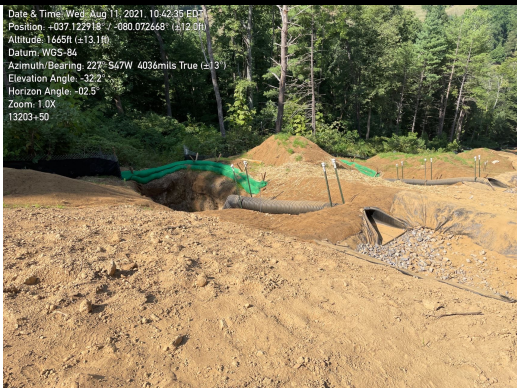
GPS Location			0			
Field Station#			13205+00			
Pic 9 Desc.			Sump pit and end treatment in good condition			
GPS Location			0			
Field Station#			13203+50			
Pic 10 Desc.			Slope drain pipe in good condition			
<p>Date & Time: Wed, Aug 11, 2021, 10:49:43 EDT Position: +037.122945 / -080.074288 (+15.8ft) Altitude: 1476ft (+11.0ft) Datum: WGS-84 Azimuth/Bearing: 285° N75W 5089mils True (+13) Elevation Angle: -21.4 Horizon Angle: +02.9 Zoom: 1.0X 13197-55</p>

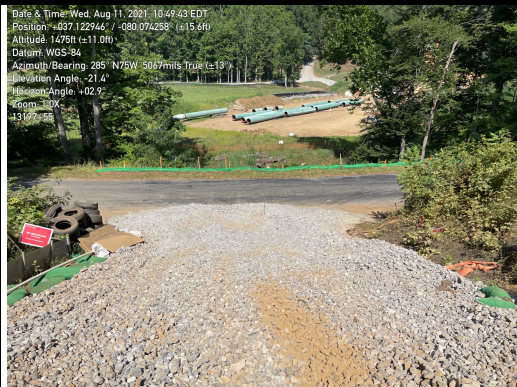
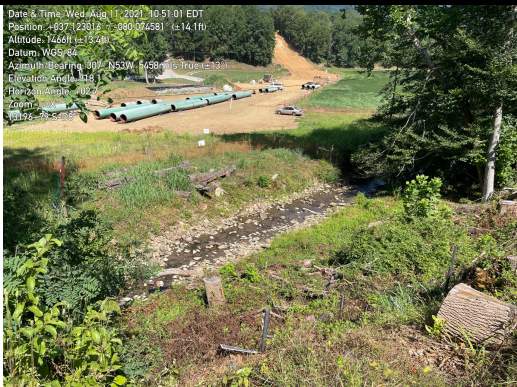
GPS Location			0			
Field Station#			13197+55			
Pic 11 Desc.			Dillons Mill Road Crossing in good condition and RCE in good condition and functioning properly			
GPS Location			0

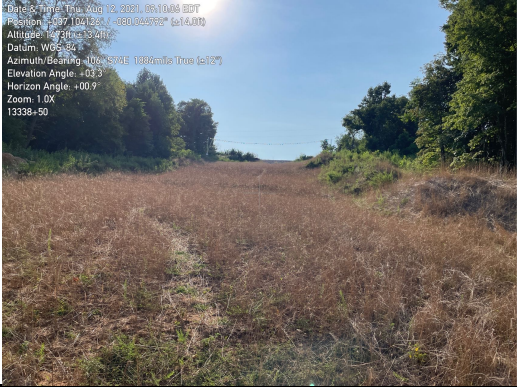
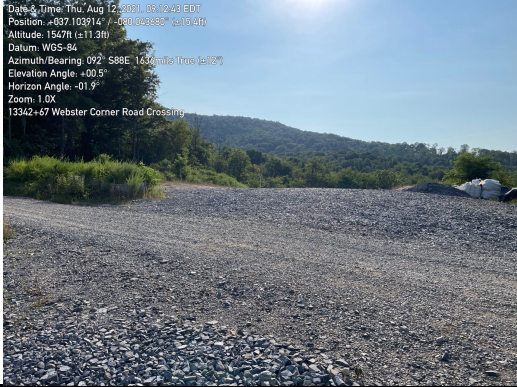
GPS Location	0	GPS Location	0		
Field Station#	13338+50	Field Station#	13342+67		
Pic 7 Desc.	ROW and ECDs in good condition, with vegetation established across ROW	Pic 8 Desc.	Webster Corner Road Crossing in good condition, RCE in good condition and functioning properly		
<p>Date & Time: Thu Aug 12, 2021, 09:16:28 EDT Position: +037.103789 / -80.045555° (±14.00) Altitude: 1550ft (±26.30ft) Datum: WGS-84 Azimuth/Bearing: 111° 549E 1973mils True (±12°) Elevation Angle: -14.1° Horizon Angle: -02.3° Zoom: 1.0X 13343+75</p>

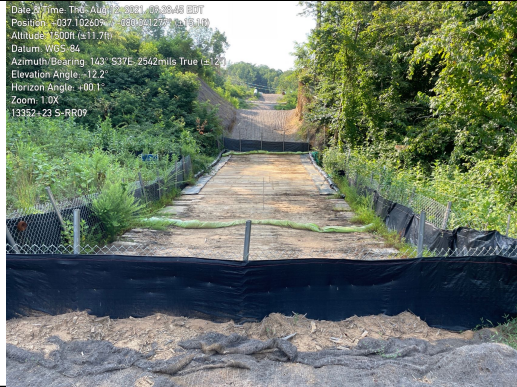
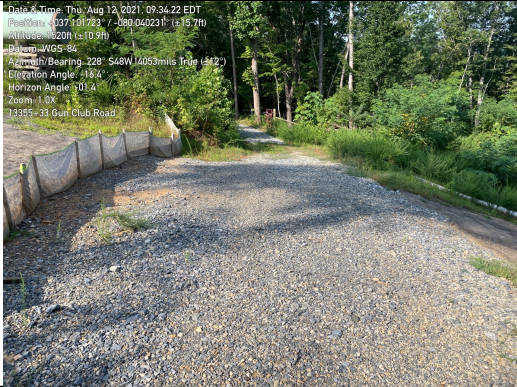
GPS Location	0	GPS Location	0		
Field Station#	13352+23	Field Station#	13355+33		
Pic 11 Desc.	MVP-S-RR09 and Corresponding buffer zone in good condition	Pic 12 Desc.	Private Road (Gun Club Road) in good condition

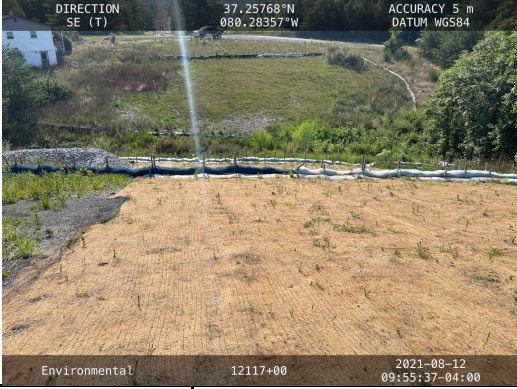
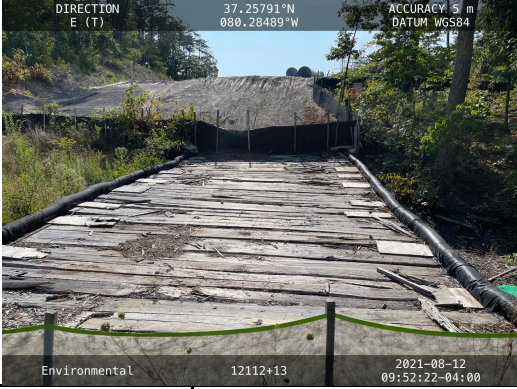
GPS Location	See photo		GPS Location	See photo	
Field Station#	12117+00		Field Station#	12112+13	
Pic 7 Desc.	Stabilized Row in acceptable condition		Pic 8 Desc.	Bridge and ECDs at stream crossing S-F16A/B in acceptable condition

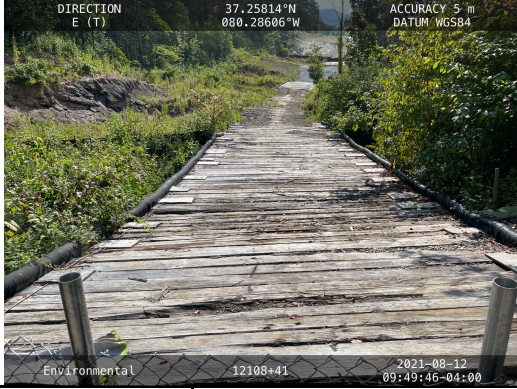
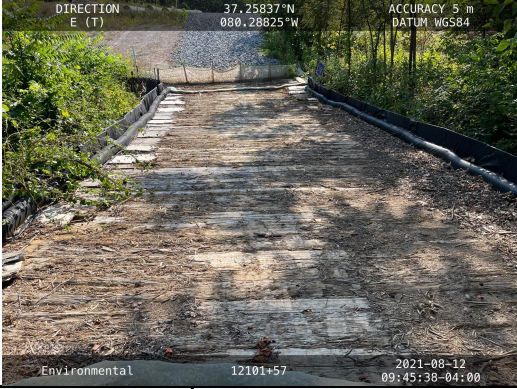
GPS Location	See photo		GPS Location	See photo	
Field Station#	12108+41		Field Station#	12101+57	
Pic 9 Desc.	Bridge and ECDs at stream crossing S-F15 in acceptable condition		Pic 10 Desc.	Bridge and ECDs crossing stream S-MM11 in acceptable condition

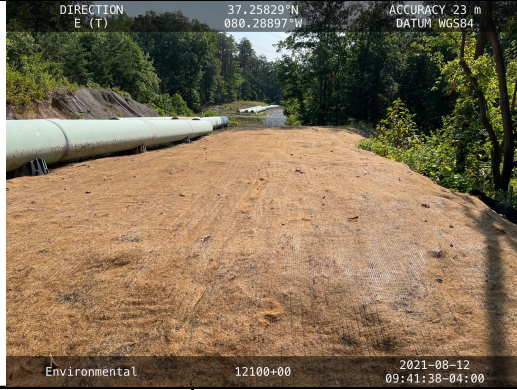
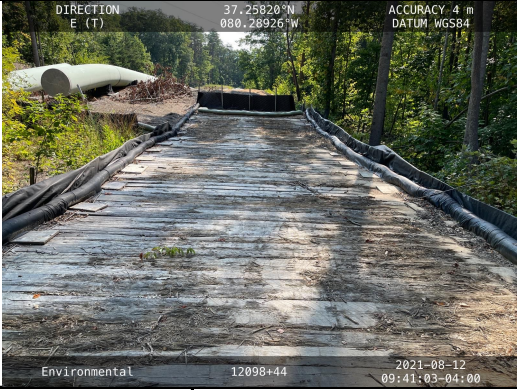
GPS Location	See photo		GPS Location	See photo	
Field Station#	12100+00		Field Station#	12098+44	
Pic 11 Desc.	Stabilized Row in acceptable condition		Pic 12 Desc.	Bridge and ECDs crossing stream S-MM13 in acceptable condition

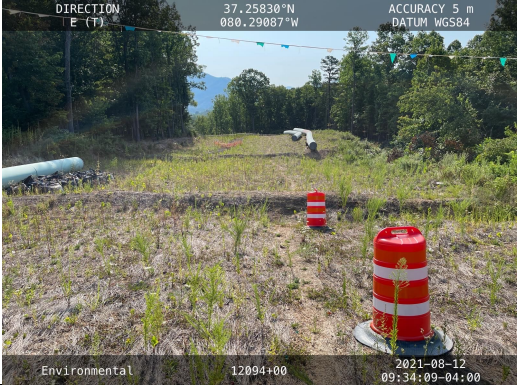
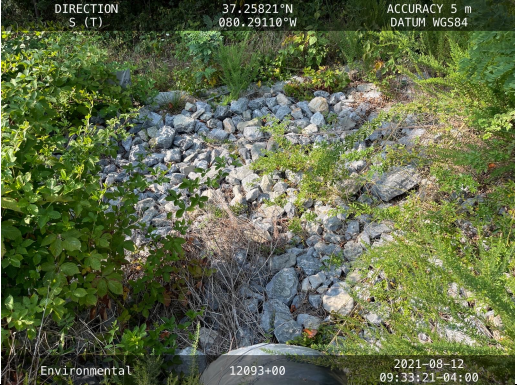
GPS Location	See photo		GPS Location	See photo	
Field Station#	12094+00		Field Station#	12093+00	
Pic 13 Desc.	Stabilized Row in acceptable condition		Pic 14 Desc.	Clean water crossing pipe outlet in acceptable condition

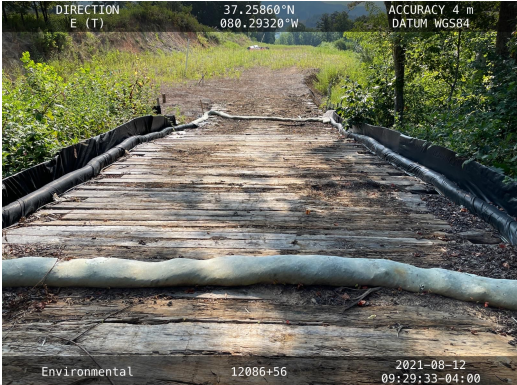
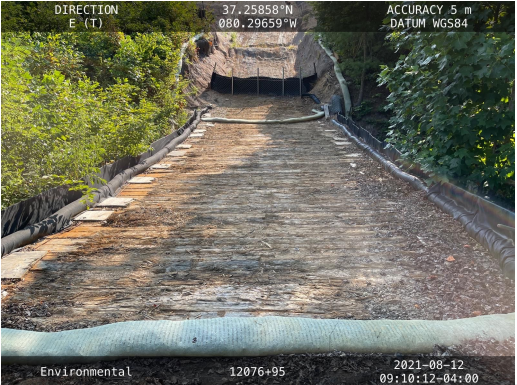
GPS Location	See photo		GPS Location	See photo	
Field Station#	12086+56		Field Station#	12076+95	
Pic 15 Desc.	Bridge and ECDs at stream crossing S-MM14 in acceptable condition		Pic 16 Desc.	Bridge and ECDs crossing stream S-MM15 in acceptable condition

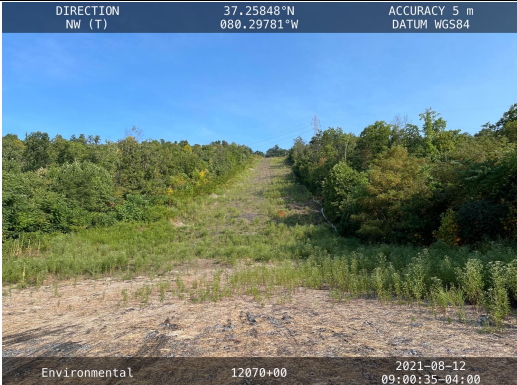
GPS Location	See photo		GPS Location	See photo	
Field Station#	12074+00		Field Station#	12070+00	
Pic 17 Desc.	Stabilized Row in acceptable condition		Pic 18 Desc.	Stabilized slope in acceptable condition

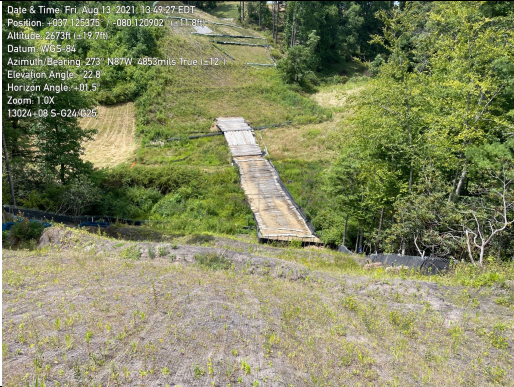
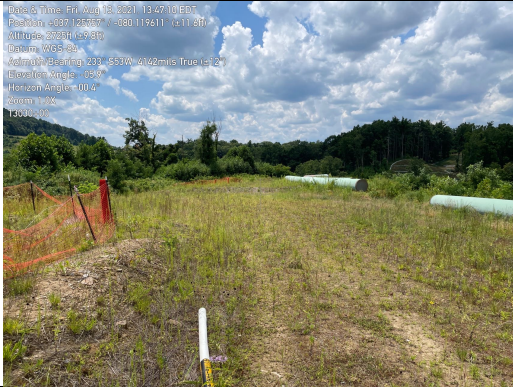
GPS Location	0	GPS Location	0		
Field Station#	13024+08	Field Station#	13030+00		
Pic 1 Desc.	MVP-S-G24/G25 and Corresponding buffer zone in good condition		Pic 2 Desc.	ROW and ECD in good condition, with vegetation established across ROW	
<p>Date & Time: Fri Aug 13, 2021 13:46:09 EDT Position: +037123350 / +080119641 (+11.6ft) Altitude: 2568ft (+11.0ft) Datum: WGS-84 Azimuth/Bearing: 051° N51E 350mils True (±12°) Elevation Angle: -24.8° Horizon Angle: -01.7° Zoom: 1.0x 13034+00</p>

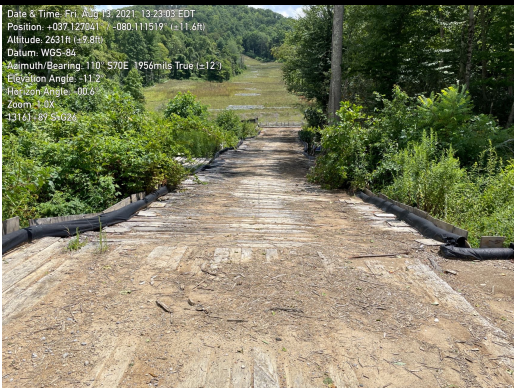
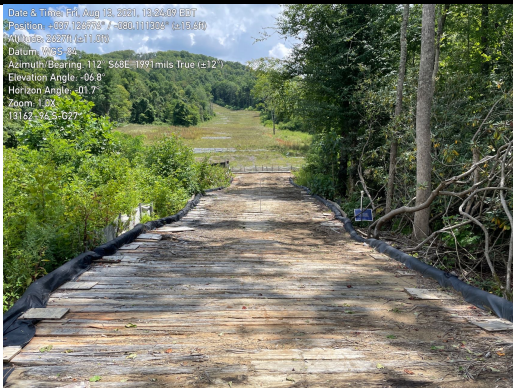
GPS Location	0	GPS Location	0		
Field Station#	13161+89	Field Station#	13162+96		
Pic 5 Desc.	MVP-S-G26 and Corresponding buffer zone in good condition		Pic 6 Desc.	MVP-S-G27 and Corresponding buffer zone in good condition

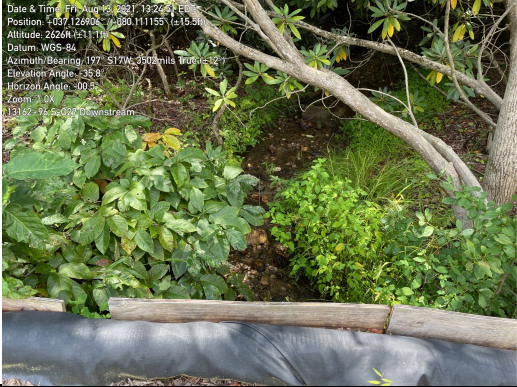
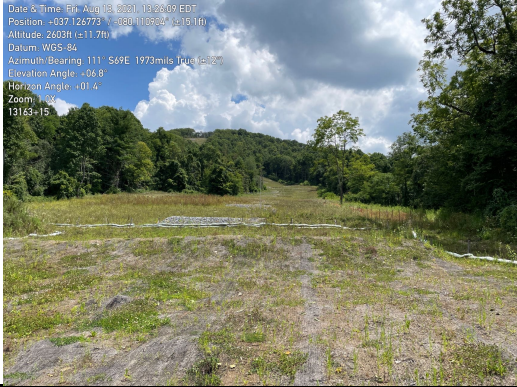
GPS Location 0		GPS Location 0	
Field Station# 13162+96		Field Station# 13163+15	
Pic 7 Desc. MVP-S-G27 Downstream and Corresponding buffer zone in good condition		Pic 8 Desc. ROW and ECD in good condition, with vegetation established across ROW	
<p>Date & Time: Fri Aug 13, 2021 13:22:22 EDT Position: +037.122976 / -080.111613 (+15.10) Altitude: 2626ft (+11.7m) Datum: WGS-84 Azimuth/Bearing: 315° N45W 5600mils True (+3.3°) Elevation Angle: +22.6° Horizon Angle: -01.8° Zoom: 1.0X 13161+00</p>

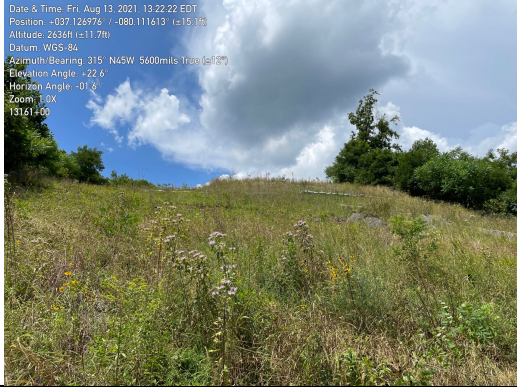
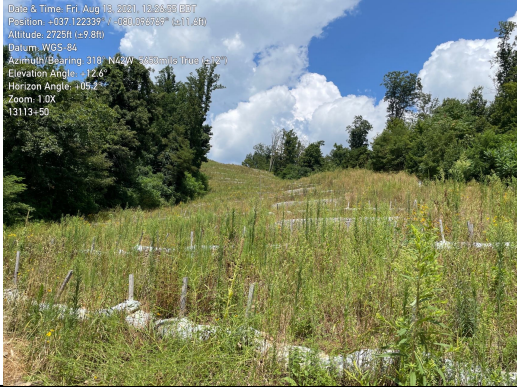
GPS Location 0		GPS Location 0	
Field Station# 13161+00		Field Station# 13113+50	
Pic 9 Desc. ROW and ECD in good condition, with vegetation established across ROW		Pic 10 Desc. ROW and ECD in good condition, with vegetation established across ROW	
<p>Date & Time: Fri Aug 13, 2021 10:44:25 EDT Position: +037.122244 / -080.092348 (+12.24.8m) Altitude: 2236ft (+210.0ft) Datum: WGS-84 Azimuth/Bearing: 090° S82E 1772mils True (+3.2°) Elevation Angle: +04.3° Horizon Angle: -01.7° Zoom: 1.0X 13125+00</p>
