# Visual Site Inspection Report

<b>Project Name</b>	H-600 Pipeline Spread H	<b>AFE</b>	124300138	<b>Spread</b>	H-600 Pipeline Spread H
<b>Contractor</b>	Precision			<b>Report #</b>	27308
<b>Inspector</b>	Norm Kitchen			<b>Date/Time</b>	8/16/2021 6:00 PM
<b>Permit #</b>	TBD	<b>Inspection Type</b>	VA SWPP	<b>Station Begin</b>	12443+75
<b>State</b>	VA	<b>Inspection Area</b>	Partial	<b>Station End</b>	12544+06
<b>County</b>	Montgomery	<b>Ground</b>	Wet	<b>Temperature (°F)</b>	80.00
<b>Municipality</b>	N/A	<b>Weather</b>	Light Rain	<b>Rain Gauge (in)</b>	0.90
				<b>Rain Accumulation Time (days)</b>	1.00

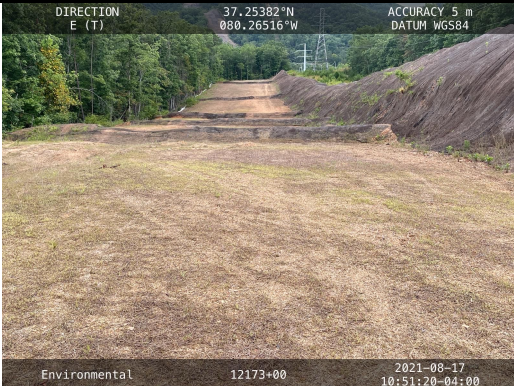
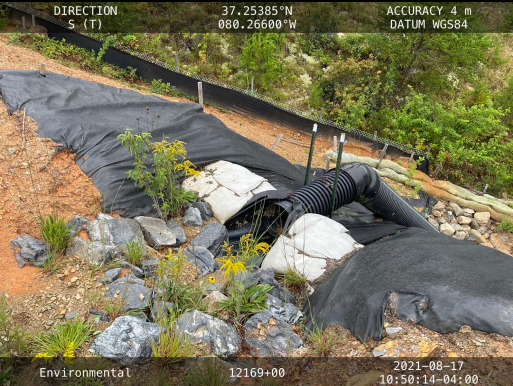
<b>GPS Location</b>	See photo		<b>GPS Location</b>	See photo	
<b>Field Station#</b>	12173+00		<b>Field Station#</b>	12169+00	
<b>Pic 5 Desc.</b>	Stabilized ROW in acceptable condition		<b>Pic 6 Desc.</b>	Fill slope drain pipe in acceptable condition

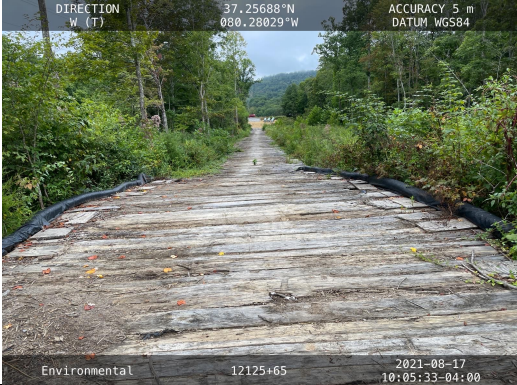
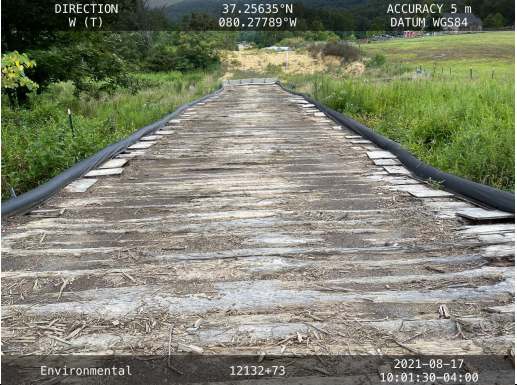
<b>GPS Location</b>	See photo		<b>GPS Location</b>	see photo	
<b>Field Station#</b>	12125+65		<b>Field Station#</b>	12132+73	
<b>Pic 13 Desc.</b>	Bridge and timber mat road in acceptable condition		<b>Pic 14 Desc.</b>	Bridge and ECDs crossing stream S-C29 in acceptable

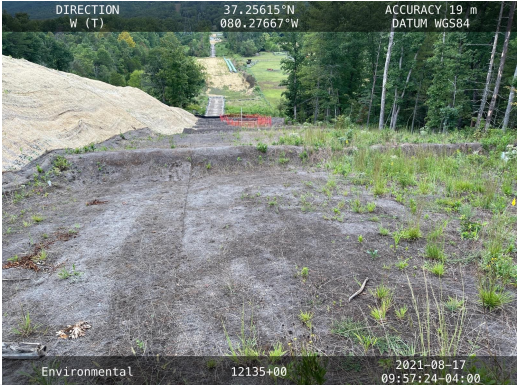
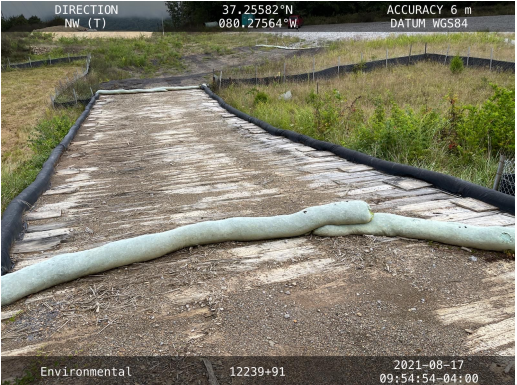
<b>GPS Location</b>	See photo		<b>GPS Location</b>	See photo	
<b>Field Station#</b>	12135+00		<b>Field Station#</b>	12239+91	
<b>Pic 15 Desc.</b>	Stabilized slope in acceptable condition		<b>Pic 16 Desc.</b>	Wetland W-C6 in acceptable condition

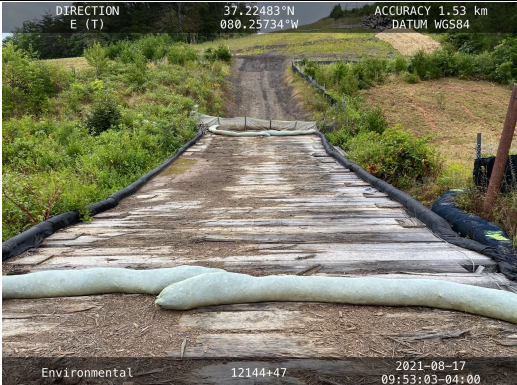
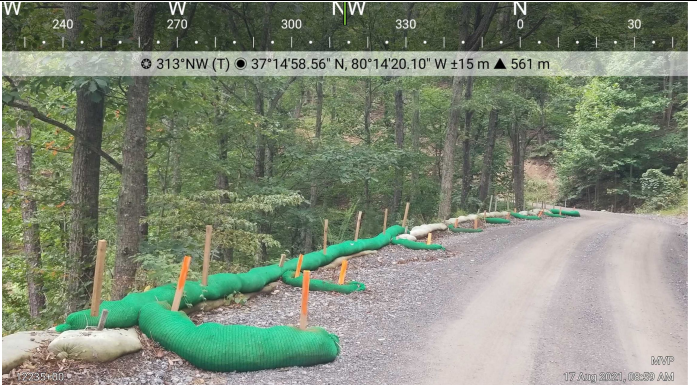
<b>GPS Location</b>	See photo		<b>GPS Location</b>	see photo	
<b>Field Station#</b>	12144+47		<b>Field Station#</b>	12234+50	
<b>Pic 17 Desc.</b>	Bridge and ECDs crossing wetland W-C5 in acceptable condition		<b>Pic 18 Desc.</b>	CFS checks along access Road MVP-MN-276.03 in acceptable condition

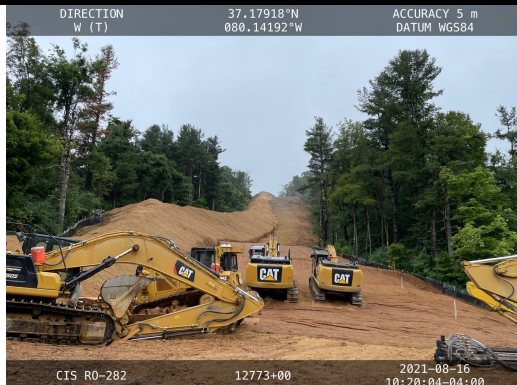
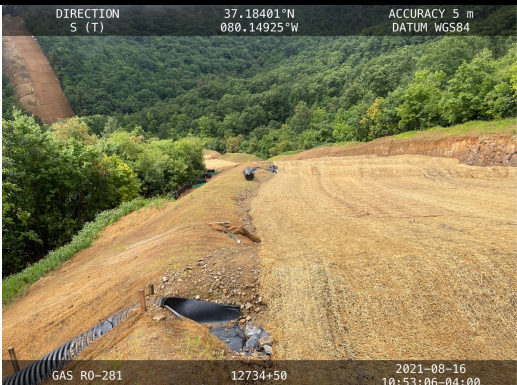
<b>GPS Location</b>	See photo		<b>GPS Location</b>	See photo	
<b>Field Station#</b>	12773+00		<b>Field Station#</b>	12734+50	
<b>Pic 11 Desc.</b>	Current ROW conditions. ROW is stable. Stockpiles are stabilized.		<b>Pic 12 Desc.</b>	Current ROW conditions. ROW is stable and slope drains are functional.

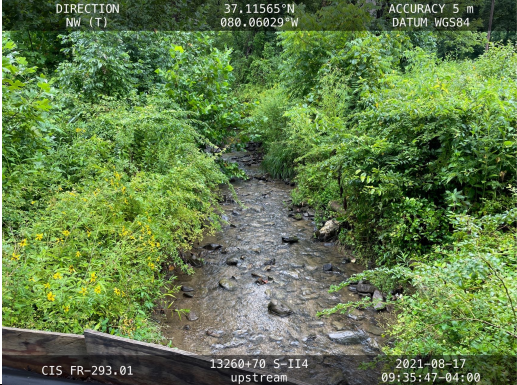
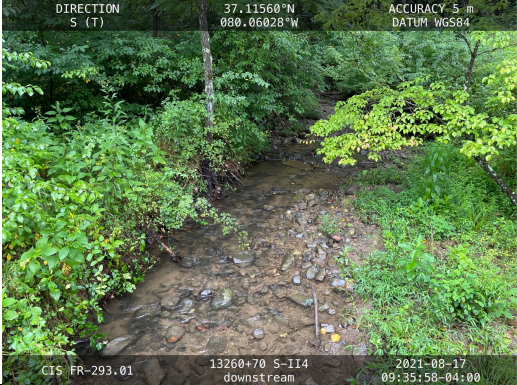
<b>GPS Location</b>	See photo		<b>GPS Location</b>	See photo	
<b>Field Station#</b>	13260+70		<b>Field Station#</b>	13260+70	
<b>Pic 7 Desc.</b>	Upstream of Stream S-II4		<b>Pic 8 Desc.</b>	Downstream of Stream S-II4

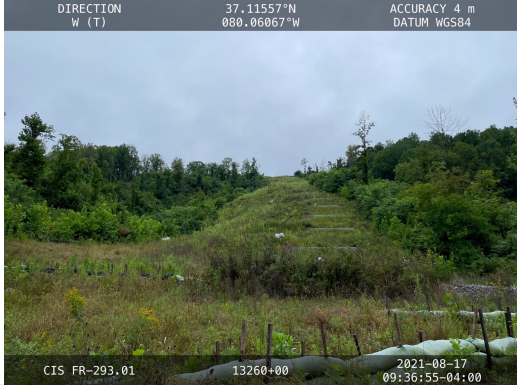
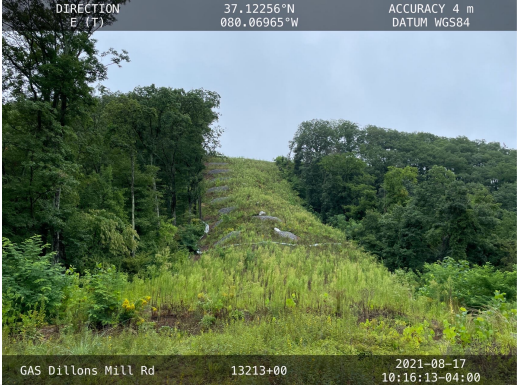
<b>GPS Location</b>	See photo		<b>GPS Location</b>	See photo	
<b>Field Station#</b>	13260+00		<b>Field Station#</b>	13213+00	
<b>Pic 9 Desc.</b>	Current ROW conditions. ROW is stable and permanent and temporary ECDs are functional		<b>Pic 10 Desc.</b>	Current ROW conditions. ROW is stable and permanent and temporary ECDs are functional

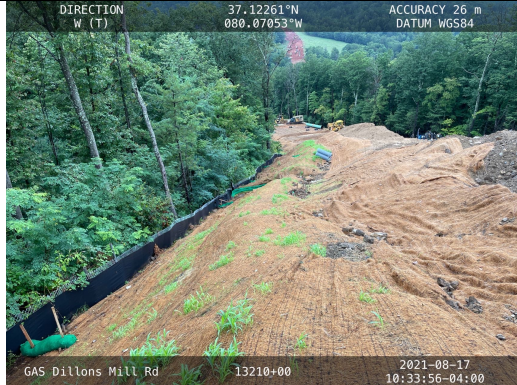
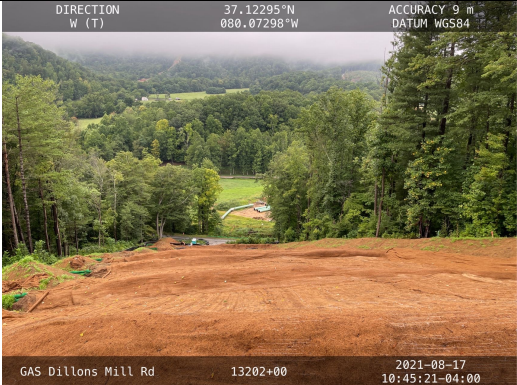
<b>GPS Location</b>	See photo		<b>GPS Location</b>	See photo	
<b>Field Station#</b>	13210+00		<b>Field Station#</b>	13202+00	
<b>Pic 11 Desc.</b>	Fill slope is stable. Perimeter controls are functional.		<b>Pic 12 Desc.</b>	Current ROW conditions. ROW stabilized with Curlex

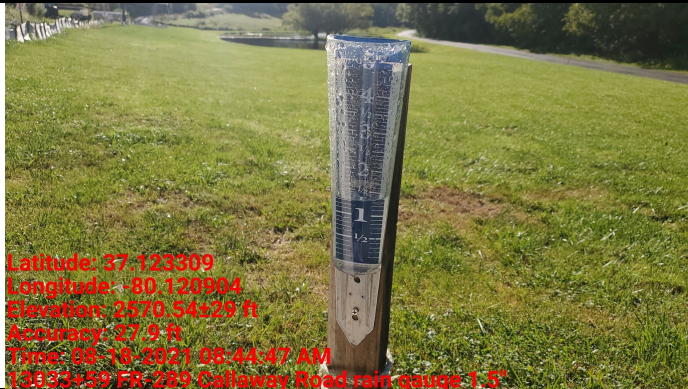
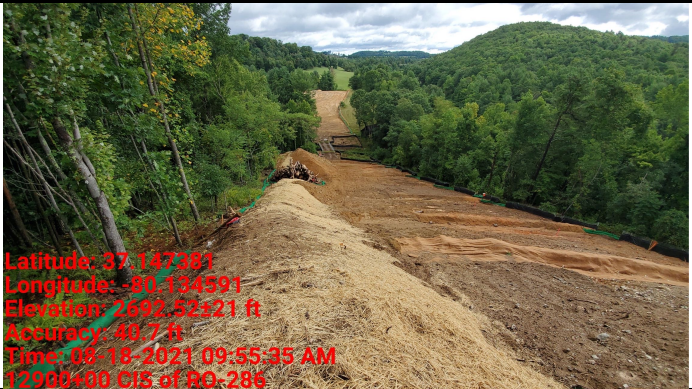
Latitude: 37.123309 Longitude: -80.120954 Elevation: 2570.54±25 ft Accuracy: 37.9 ft Time: 08-18-2021 08:44:47 AM 13033+59 FR-289 Callaway Road rain gauge 1.5"			Latitude: 37.147181 Longitude: -80.134591 Elevation: 2692.52±21 ft Accuracy: 40.7 ft Time: 08-18-2021 09:55:35 AM 12900+00 CIS of RO-286		
GPS Location	See pic for GPS location		GPS Location	See pic for GPS location	
Field Station#	13033+59		Field Station#	12900+00	
Pic 1 Desc.	Callaway Road rain gauge 1.5" total precipitation.		Pic 2 Desc.	Stream S-IJ12 from the GAS slope.

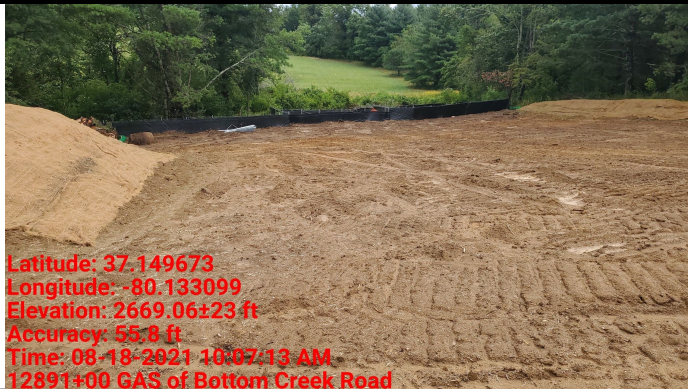
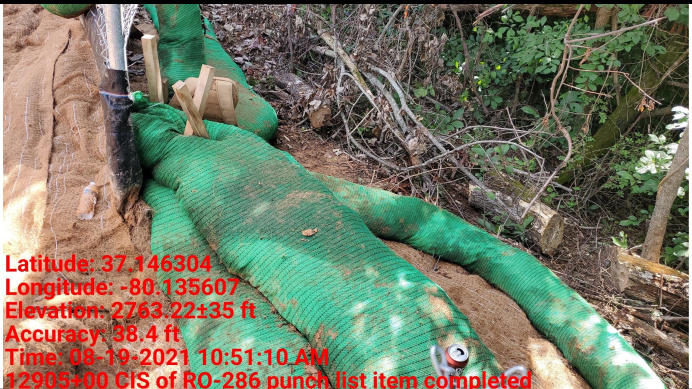
Latitude: 37.149673 Longitude: -80.133099 Elevation: 2669.06±23 ft Accuracy: 55.8 ft Time: 08-18-2021 10:07:13 AM 12891+00 GAS of Bottom Creek Road			Latitude: 37.146304 Longitude: -80.135607 Elevation: 2763.22±35 ft Accuracy: 38.4 ft Time: 08-19-2021 10:51:10 AM 12905+00 CIS of RO-286 punch list item completed

GPS Location	See pic for GPS location		GPS Location	See pic for GPS location	
Field Station#	12891+00		Field Station#	12918+00	
Pic 3 Desc.	Stream S-KL55 from the GAS.		Pic 4 Desc.	Sediment deposits on the back side of the ECD's. Issue added to the Punch List. No sediment found beyond the LOD. Completed

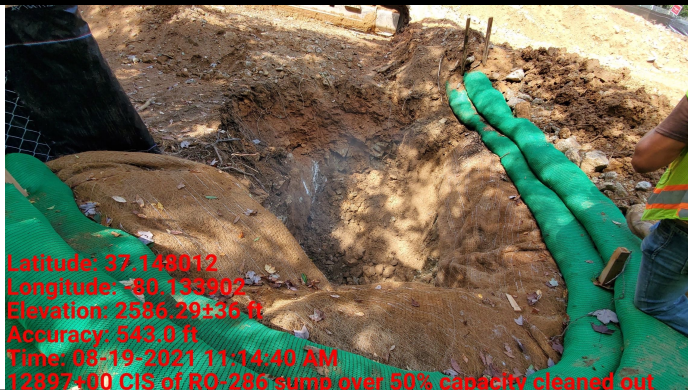
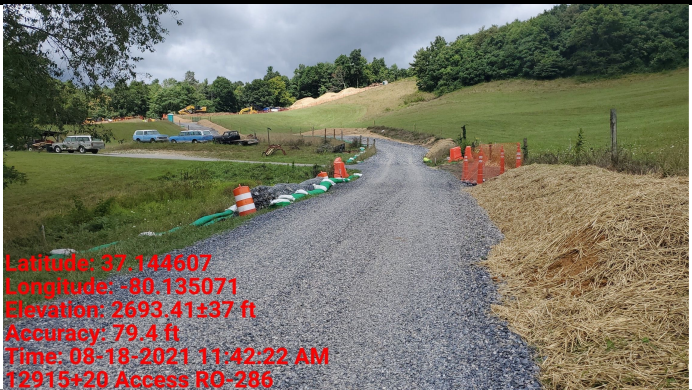
Latitude: 37.148012 Longitude: -80.133902 Elevation: 2586.29±36 ft Accuracy: 543.0 ft Time: 08-19-2021 11:14:40 AM 12897+00 CIS of RO-286 sump over 50% capacity cleaned out			Latitude: 37.144607 Longitude: -80.135071 Elevation: 2693.41±37 ft Accuracy: 79.4 ft Time: 08-18-2021 11:42:22 AM 12915+20 Access RO-286		
GPS Location	See pic for GPS location		GPS Location	See pic for GPS location	
Field Station#	12922+00		Field Station#	12915+20	
Pic 5 Desc.	Sumps over 50% capacity added to the Punch List to be cleaned out. Completed		Pic 6 Desc.	Clean water diversion cross over and level spreader.

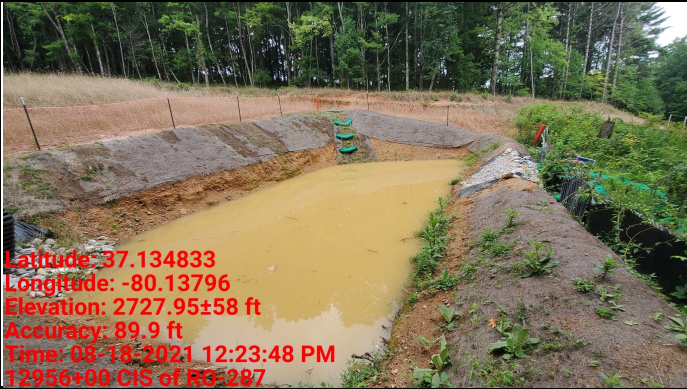
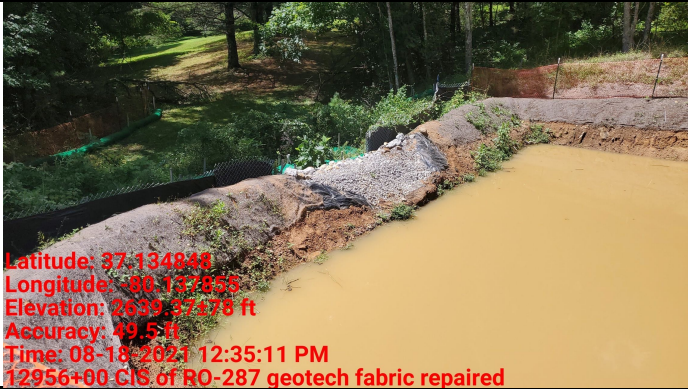
Latitude: 37.134833 Longitude: -80.13796 Elevation: 2727.95±58 ft Accuracy: 89.9 ft Time: 08-18-2021 12:23:48 PM 12956+00 CIS of RO-287			Latitude: 37.134844 Longitude: -80.137855 Elevation: 2639.37±78 ft Accuracy: 49.5 ft Time: 08-18-2021 12:35:11 PM 12956+00 CIS of RO-287 geotech fabric repaired		
GPS Location	See pic for GPS location		GPS Location	See pic for GPS location	
Field Station#	12956+00		Field Station#	12956+00	
Pic 7 Desc.	Sediment trap on the CIS of RO-287.		Pic 8 Desc.	Environmental crew performed maintenance to the geotech fabric of the outlet today.

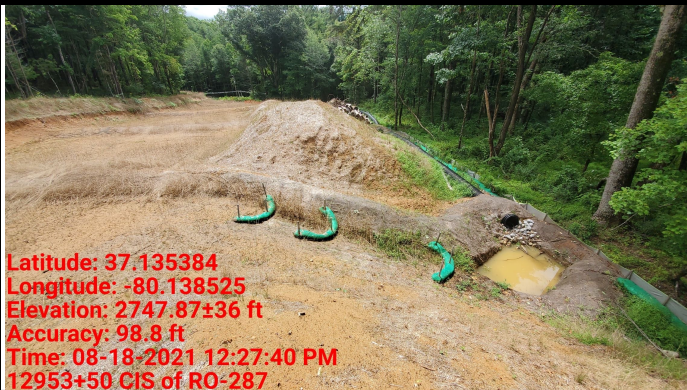
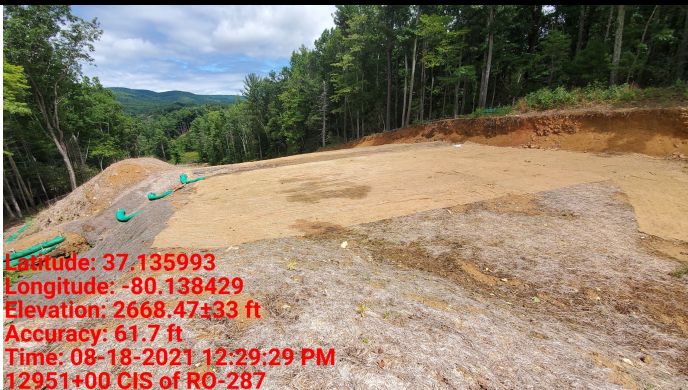
Latitude: 37.135384 Longitude: -80.138525 Elevation: 2747.87±36 ft Accuracy: 98.8 ft Time: 08-18-2021 12:27:40 PM 12953+50 CIS of RO-287			Latitude: 37.135993 Longitude: -80.138429 Elevation: 2668.47±33 ft Accuracy: 61.7 ft Time: 08-18-2021 12:29:29 PM 12951+00 CIS of RO-287

GPS Location	See pic for GPS location		GPS Location	See pic for GPS location	
Field Station#	12953+50		Field Station#	12951+00	
Pic 9 Desc.	Current ROW conditions on the CIS of RO-287 from the top of the slope.		Pic 10 Desc.	Current ROW conditions of the ROW at the top of the slope.

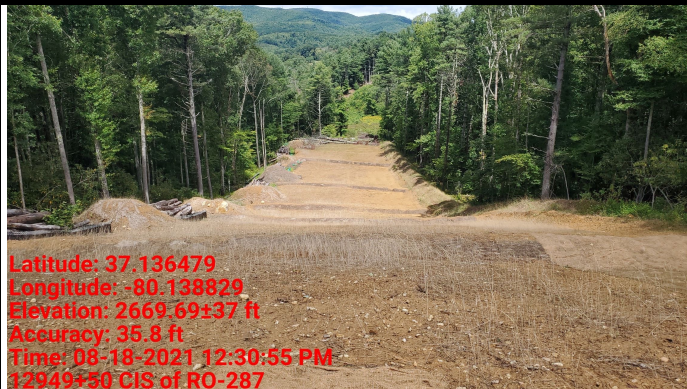
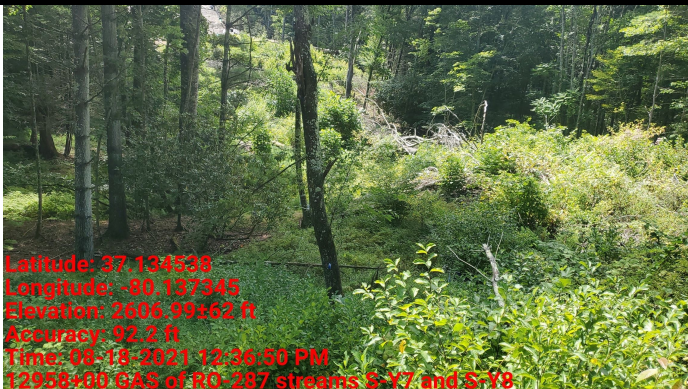
Latitude: 37.136479 Longitude: -80.138829 Elevation: 2669.69±37 ft Accuracy: 35.8 ft Time: 08-18-2021 12:30:55 PM 12949+50 CIS of RO-287			Latitude: 37.134538 Longitude: -80.137345 Elevation: 2606.99±62 ft Accuracy: 92.3 ft Time: 08-18-2021 12:30:50 PM 12958+00 GAS of RO-287 streams S-Y7 and S-Y8		
GPS Location	See pic for GPS location		GPS Location	See pic for GPS location	
Field Station#	12949+50		Field Station#	12958+00	
Pic 11 Desc.	GAS of stream S-IJ43 from the top of the slope on the CIS of RO-287.		Pic 12 Desc.	Streams S-Y7 and S-Y8 from the CIS of the streams.

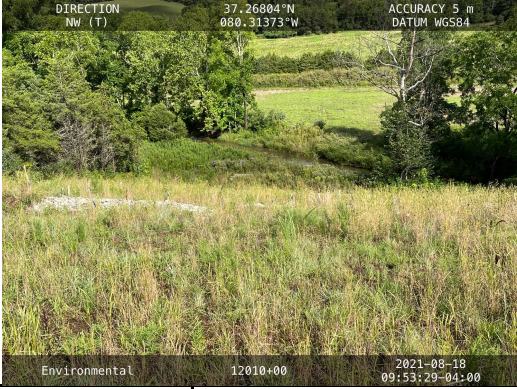
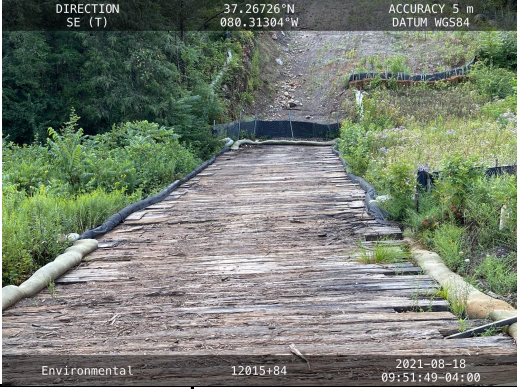
<b>GPS Location</b>	See photo		<b>GPS Location</b>	See photo	
<b>Field Station#</b>	12010+00		<b>Field Station#</b>	12015+85	
<b>Pic 7 Desc.</b>	Stabilized ROW in acceptable condition		<b>Pic 8 Desc.</b>	Bridge and ECDs crossing stream S-G38 in acceptable condition

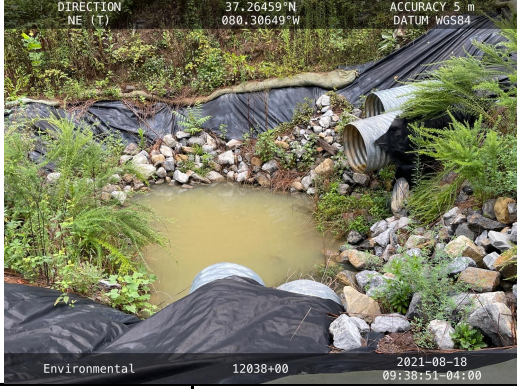
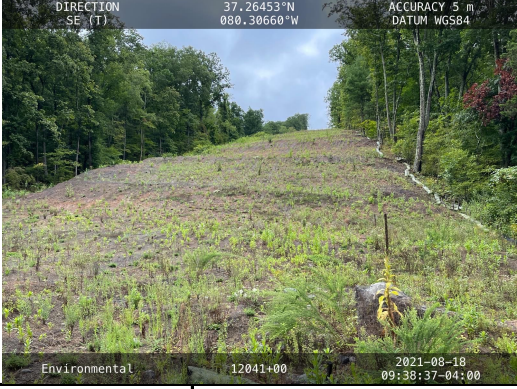
<b>GPS Location</b>	See photo		<b>GPS Location</b>	see photo	
<b>Field Station#</b>	12038+00		<b>Field Station#</b>	12041+00	
<b>Pic 9 Desc.</b>	Clean water crossing inlet in acceptable condition		<b>Pic 10 Desc.</b>	Stabilized slope in acceptable condition

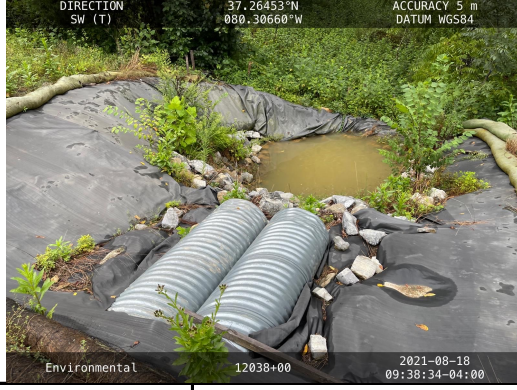
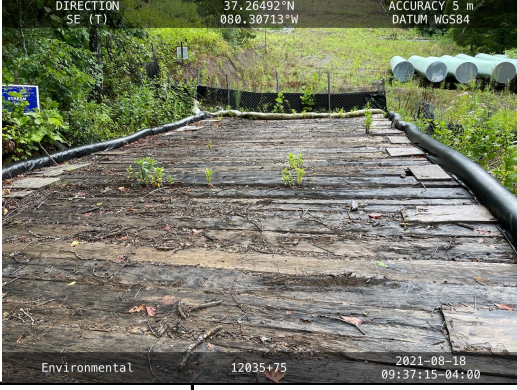
<b>GPS Location</b>	See photo		<b>GPS Location</b>	See photo	
<b>Field Station#</b>	12038+00		<b>Field Station#</b>	12035+75	
<b>Pic 11 Desc.</b>	Clean water crossing pipe outlet in acceptable condition		<b>Pic 12 Desc.</b>	Bridge and ECDs crossing stream S-PP23 in acceptable condition

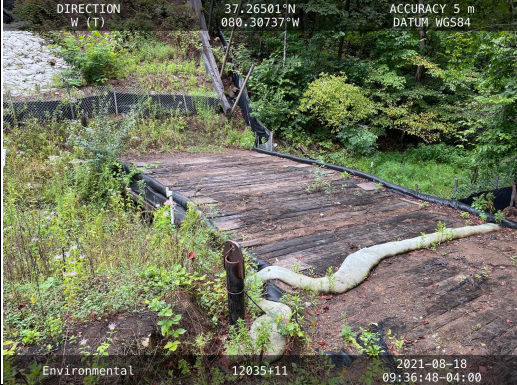
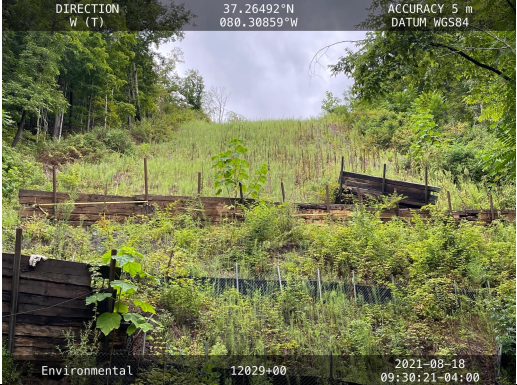
<b>GPS Location</b>	See photo		<b>GPS Location</b>	See photo	
<b>Field Station#</b>	12035+11		<b>Field Station#</b>	12029+00	
<b>Pic 13 Desc.</b>	Bridge and ECDs crossing stream S-G40 in acceptable condition		<b>Pic 14 Desc.</b>	Stabilized slope in acceptable condition

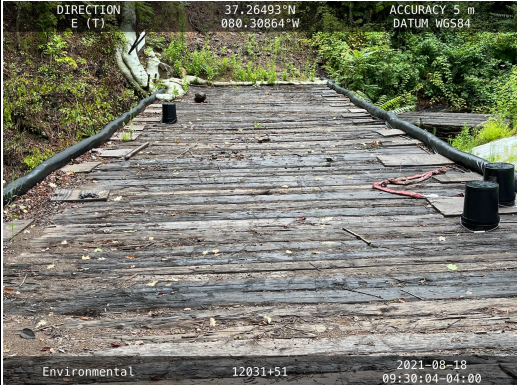
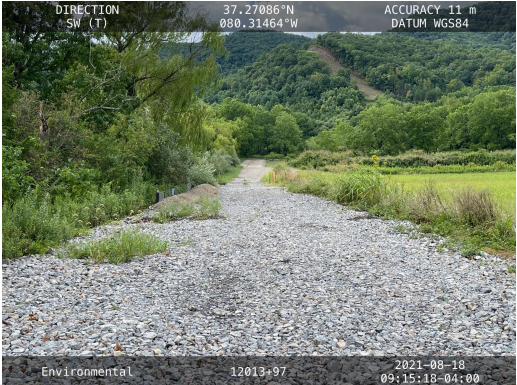
<b>GPS Location</b>	See photo		<b>GPS Location</b>	See photo	
<b>Field Station#</b>	12031+51		<b>Field Station#</b>	12013+97	
<b>Pic 15 Desc.</b>	Bridge and ECDs crossing stream S-G39 in acceptable condition		<b>Pic 16 Desc.</b>	Access Road MVP-MN-268.01 In Acceptable condition

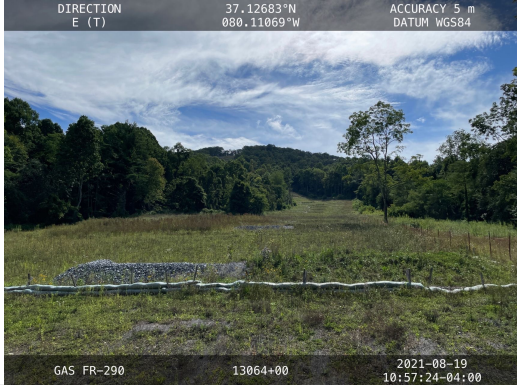
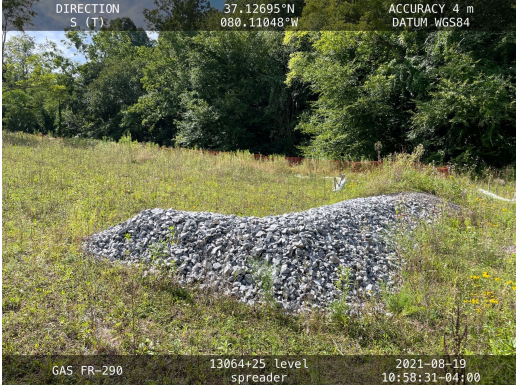
<b>GPS Location</b>	See photo		<b>GPS Location</b>	See photo	
<b>Field Station#</b>	13064+00		<b>Field Station#</b>	13064+25	
<b>Pic 9 Desc.</b>	Current ROW conditions. ROW is stable.		<b>Pic 10 Desc.</b>	Permanent Level Spreader is functional

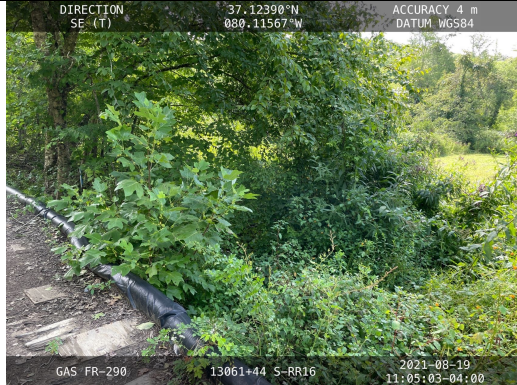
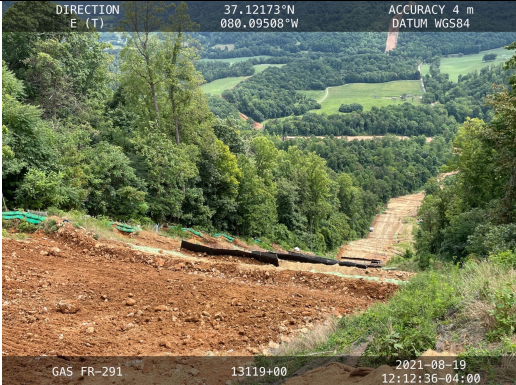
<b>GPS Location</b>	See photo		<b>GPS Location</b>	See photo	
<b>Field Station#</b>	13061+44		<b>Field Station#</b>	13119+00	
<b>Pic 11 Desc.</b>	Downstream photo of Stream S-RR16		<b>Pic 12 Desc.</b>	Current ROW conditions. ROW is stable.

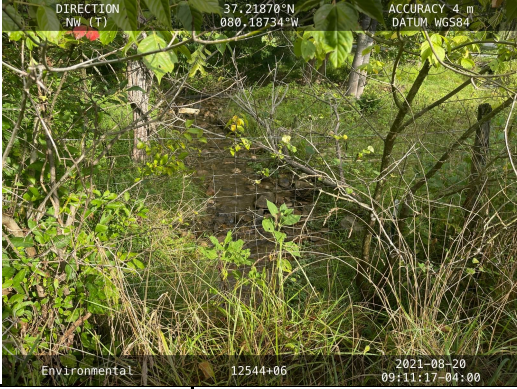
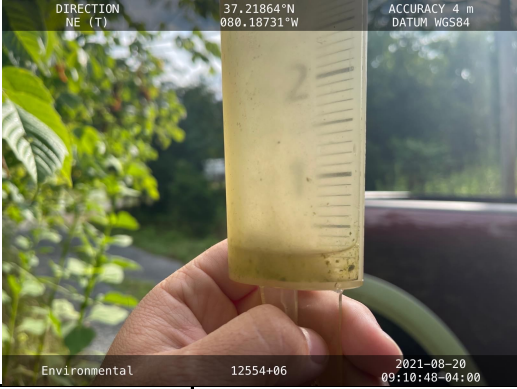
<b>GPS Location</b>	See photo		<b>GPS Location</b>	See photo	
<b>Field Station#</b>	12544+06		<b>Field Station#</b>	12544+06	
<b>Pic 7 Desc.</b>	Downstream of stream crossing S-KL32 in acceptable condition		<b>Pic 8 Desc.</b>	Yellow finch rain gauge (0.3")

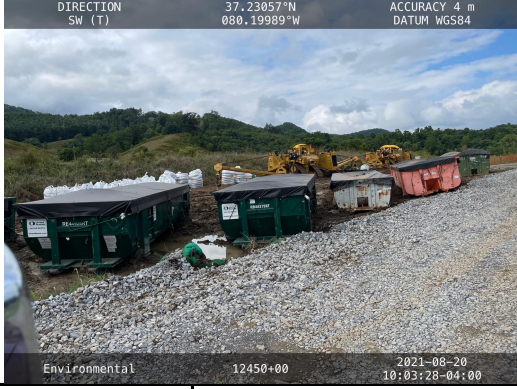
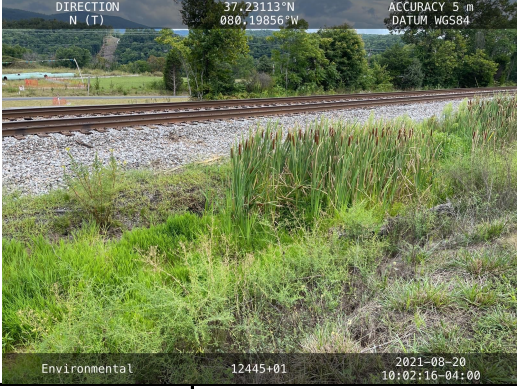
<b>GPS Location</b>	See photo		<b>GPS Location</b>	See photo	
<b>Field Station#</b>	12450+00		<b>Field Station#</b>	12445+01	
<b>Pic 9 Desc.</b>	Roll off containers for contaminated soils.		<b>Pic 10 Desc.</b>	Stream crossing S-I1 in acceptable condition

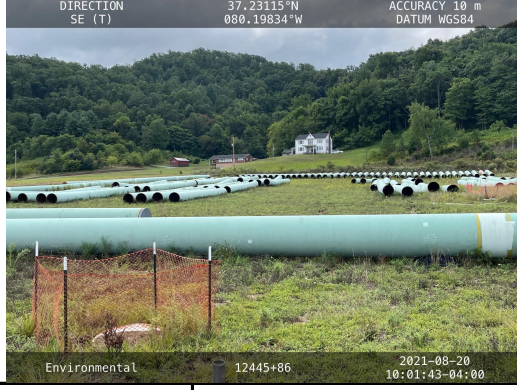
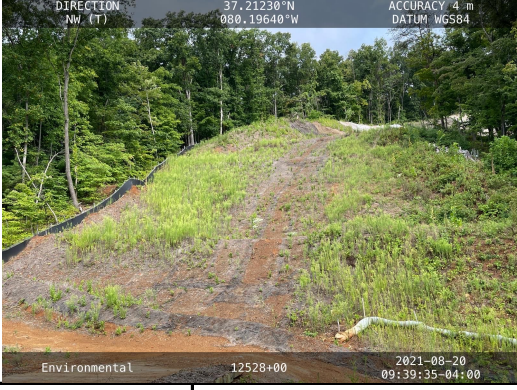
<b>GPS Location</b>	See photo		<b>GPS Location</b>	See photo	
<b>Field Station#</b>	12444+86		<b>Field Station#</b>	12528+00	
<b>Pic 11 Desc.</b>	Staged pipe in the stabilized ATWS		<b>Pic 12 Desc.</b>	Stabilized slope in acceptable condition

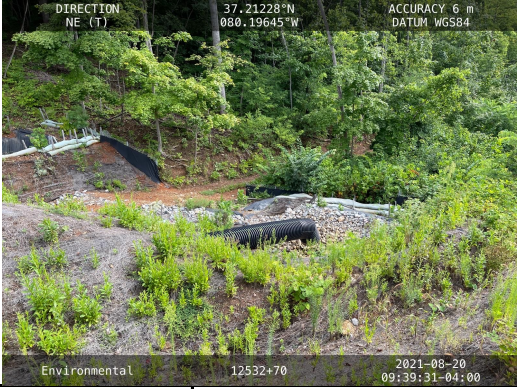
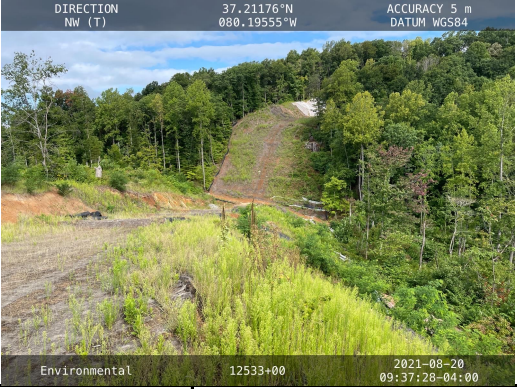
<b>GPS Location</b>	See photo		<b>GPS Location</b>	See photo	
<b>Field Station#</b>	12532+70		<b>Field Station#</b>	12533+00	
<b>Pic 13 Desc.</b>	Clean water crossing pipe outlet in acceptable condition		<b>Pic 14 Desc.</b>	Stabilized fill slope in acceptable condition

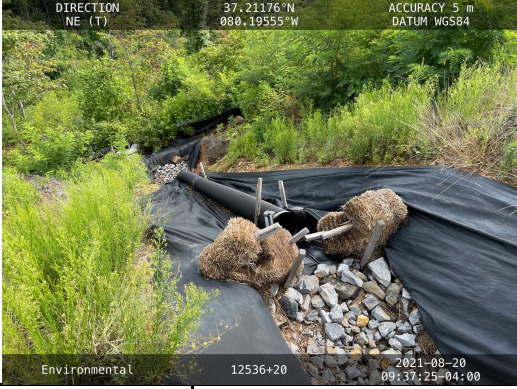
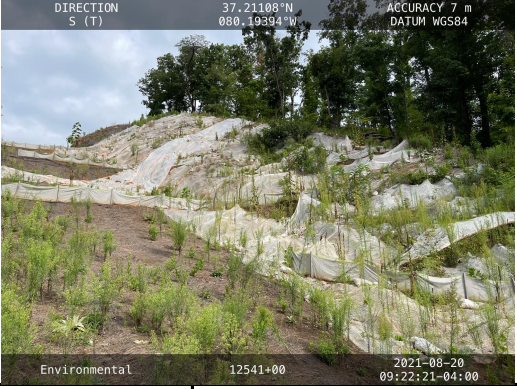
<b>GPS Location</b>	See photo		<b>GPS Location</b>	see photo	
<b>Field Station#</b>	12536+20		<b>Field Station#</b>	12541+00	
<b>Pic 15 Desc.</b>	Fill slope drain inlet in acceptable condition		<b>Pic 16 Desc.</b>	Plastic covered spoil pile in acceptable condition

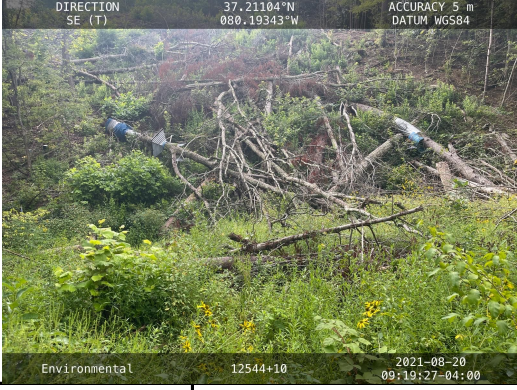
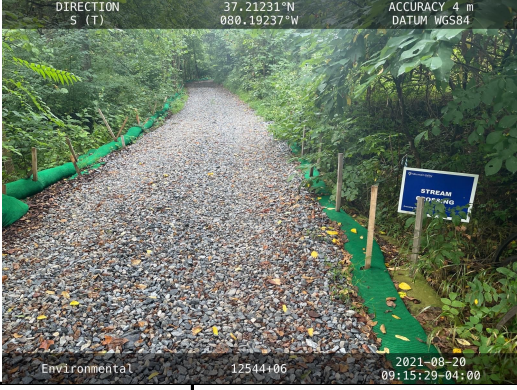
<b>GPS Location</b>	see photo		<b>GPS Location</b>	See photo	
<b>Field Station#</b>	12544+10		<b>Field Station#</b>	12544+06	
<b>Pic 17 Desc.</b>	Felled trees and ROW conditions.		<b>Pic 18 Desc.</b>	Stream crossing S-EF54 in acceptable condition
