Visual Site Inspection Report

Project Name	H-600 Pipeline Spread H	AFE	124300138	Spread	H-600 Pipeline Spread H
Contractor	Precision			Report #	27607
Inspector	Bryan Cole			Date/Time	8/23/2021 7:19 PM
Permit #	TBD	Inspection Type	VA SWPP	Station Begin	13141+65
State	VA	Inspection Area	Partial	Station End	13316+21
County	Franklin	Ground	Dry	Temperature (°F)	90.00
Municipality	N/A	Weather	Sunny	Rain Gauge (in)	0.00
				Rain Accumulation Time (days)	0.00

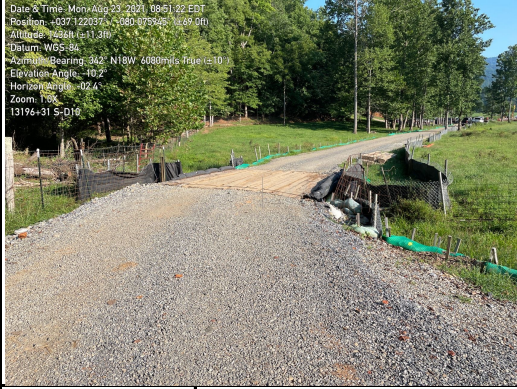
GPS Location 0		GPS Location 0			
Field Station# 13359+00		Field Station# 13196+31			
Pic 7 Desc. ROW and ECDs in good condition with vegetation established across ROW		Pic 8 Desc. MVP-S-D10 and Corresponding buffer zone in good condition			
<p>Date & Time: Mon Aug 23 2021 10:12:17 EDT Position: +037.122114 / -080.069666 (-15.7th) Altitude: 1652ft (-17.7th) Datum: WGS-84 Azimuth/Bearing: 009.114NE 1440mils True (-12.0) Elevation Angle: -07.7 Horizon Angle: -03.2 Zoom: 1.0X 13212+00</p>

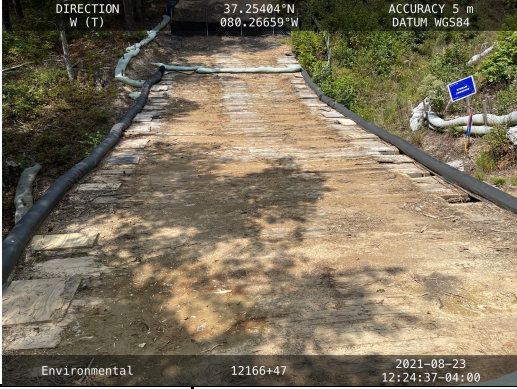
GPS Location	See photo		GPS Location	see photo	
Field Station#	12166+47		Field Station#	12168+00	
Pic 7 Desc.	Bridge and ECDs at stream crossing S-C24 in acceptable condition		Pic 8 Desc.	Fill slope drain in acceptable condition

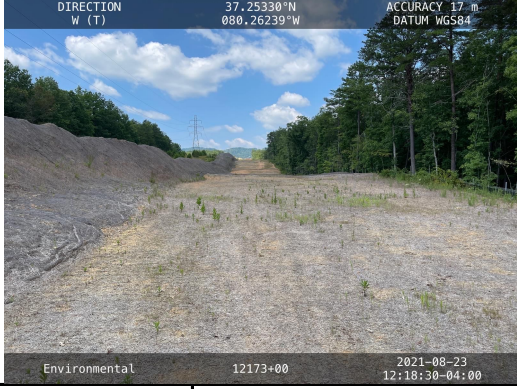
GPS Location	See photo		GPS Location	See photo	
Field Station#	12173+00		Field Station#	12192+50	
Pic 9 Desc.	Stabilized row in acceptable condition		Pic 10 Desc.	Bridge and ECDs at stream crossing S-C21 in acceptable condition

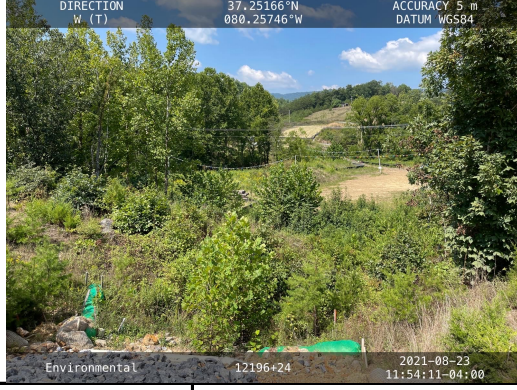
GPS Location	See photo		GPS Location	See photo	
Field Station#	12196+24		Field Station#	12197+46	
Pic 11 Desc.	Stream crossing S-0011 in acceptable condition		Pic 12 Desc.	New road replacing the rail road tracks.

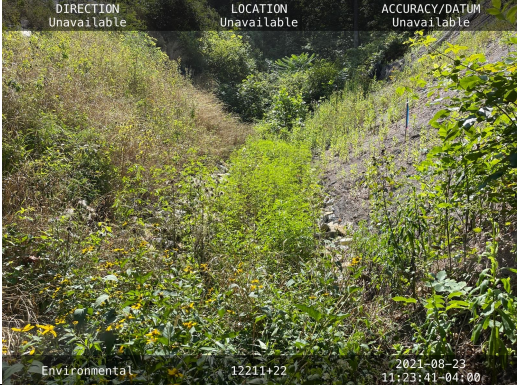
GPS Location	see photo		GPS Location	See photo	
Field Station#	12211+22		Field Station#	12210+00	
Pic 13 Desc.	Stabilized drainage feature in acceptable condition		Pic 14 Desc.	Stabilized slope in acceptable condition

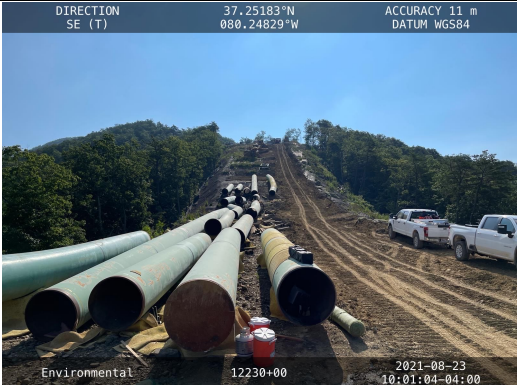
GPS Location	See photo		GPS Location	See photo	
Field Station#	12230+00		Field Station#	12236+00	
Pic 17 Desc.	ROW with travel lane knocked out for working purposes		Pic 18 Desc.	Stabilized ROW In Acceptable condition

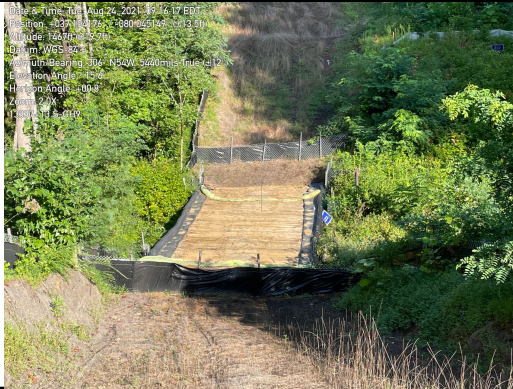
GPS Location	0	GPS Location	0		
Field Station#	13317+30	Field Station#	13337+13		
Pic 3 Desc.	ROW and ECDs in good condition with vegetation established across ROW		Pic 4 Desc.	MVP-S-GH9 and Corresponding buffer zone in good condition

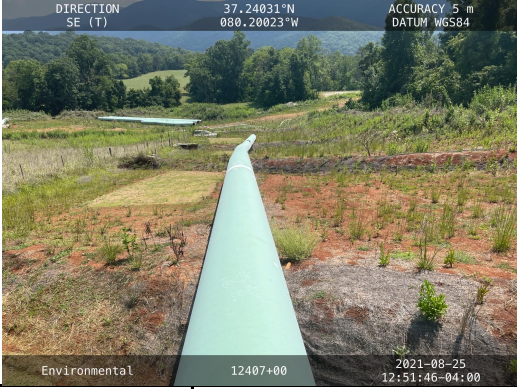
GPS Location	See photo		GPS Location	See photo	
Field Station#	12407+00		Field Station#	12421+00	
Pic 7 Desc.	Stabilized row in acceptable condition		Pic 8 Desc.	Clean water crossing pipe inlet in acceptable condition

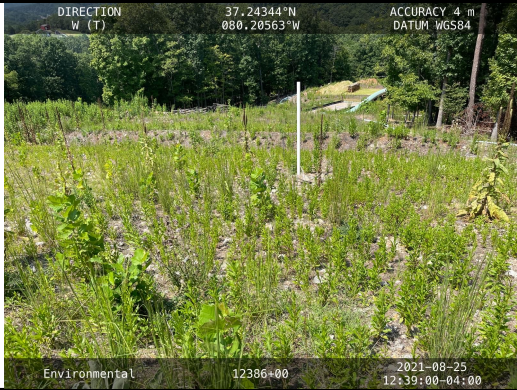
GPS Location	See photo		GPS Location	See photo	
Field Station#	12386+00		Field Station#	12383+93	
Pic 9 Desc.	Stabilized ROW in acceptable condition		Pic 10 Desc.	Clean water crossing in acceptable condition

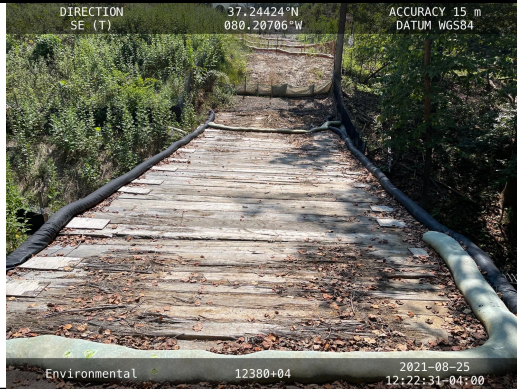
GPS Location	See photo		GPS Location	See photo	
Field Station#	12380+04		Field Station#	12375+00	
Pic 11 Desc.	Bridge and ECDs crossing stream S-NN19 in acceptable condition		Pic 12 Desc.	Stabilized slope in acceptable condition

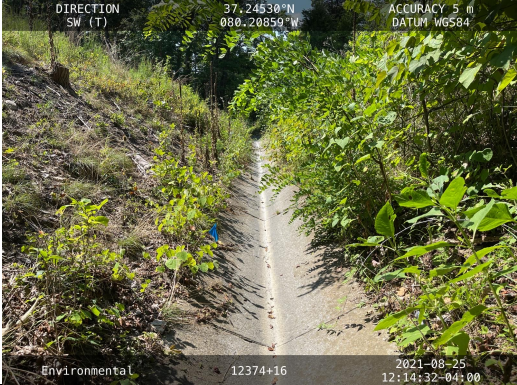
GPS Location	See photo		GPS Location	See photo	
Field Station#	12374+16		Field Station#	12331+00	
Pic 13 Desc.	Stream crossing S-0016 In Acceptable condition		Pic 14 Desc.	Fill slope drain in acceptable condition

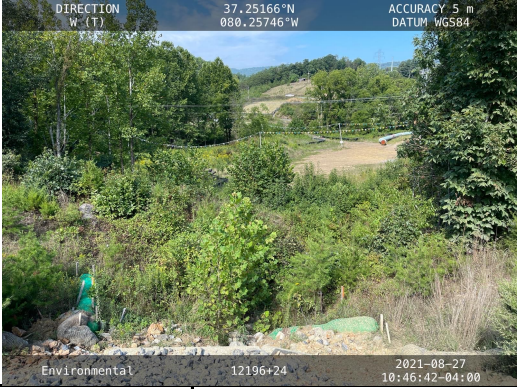
GPS Location	See photo		GPS Location	See photo	
Field Station#	12196+24		Field Station#	12198+64	
Pic 13 Desc.	Stream crossing S-OO11 on west side of the previous railroad crossing		Pic 14 Desc.	Stream crossing of S-OO11 on the east side of the previous railroad crossing
