Visual Site Inspection Report

Project Name	H-600 Pipeline Spread H	AFE	124300138	Spread	H-600 Pipeline Spread H
Contractor	Precision			Report #	27870
Inspector	Jonathan Altizer			Date/Time	8/30/2021 3:48 PM
Permit #	TBD	Inspection Type	VA SWPP	Station Begin	12868+00
State	VA	Inspection Area	Partial	Station End	13024+00
County	Roanoke	Ground	Damp	Temperature (°F)	84.00
Municipality	N/A	Weather	Sunny	Rain Gauge (in)	0.10
				Rain Accumulation Time (days)	2.00

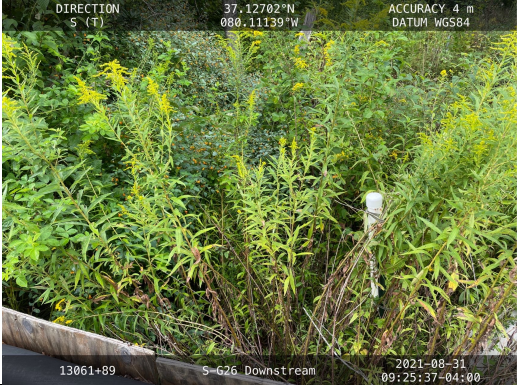
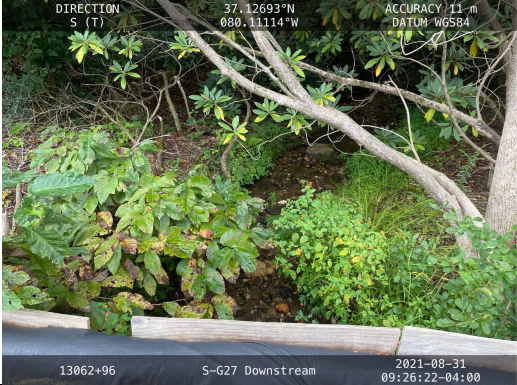
GPS Location	See photo		GPS Location	See photo	
Field Station#	13061+89		Field Station#	13062+96	
Pic 7 Desc.	Downstream photo of Stream S-G26		Pic 8 Desc.	Downstream photo of Stream S-G27

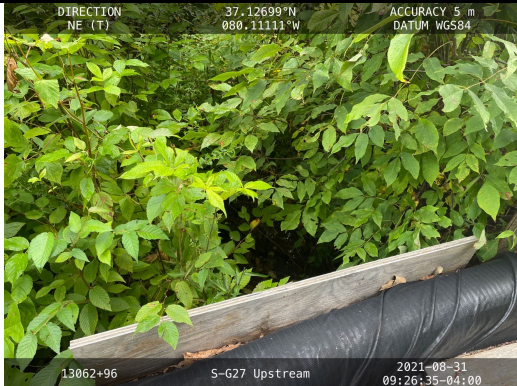
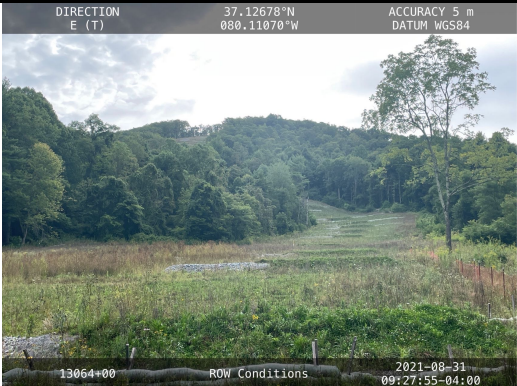
GPS Location	See photo		GPS Location	See photo	
Field Station#	13062+96		Field Station#	13064+00	
Pic 9 Desc.	Upstream photo of Stream S-G27		Pic 10 Desc.	Current ROW conditions. ROW is stable.

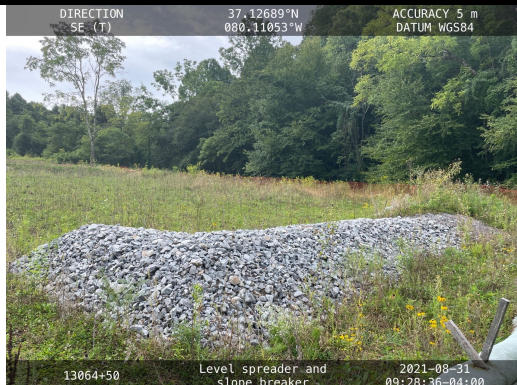
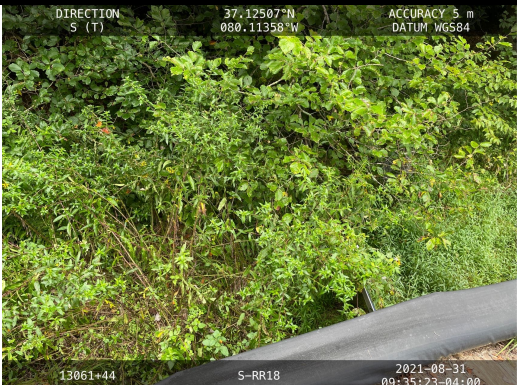
GPS Location	See photo		GPS Location	See photo	
Field Station#	13064+50		Field Station#	13061+44	
Pic 11 Desc.	Level Spreader and Slope Breaker is functional		Pic 12 Desc.	Downstream photo of Stream S-RR18

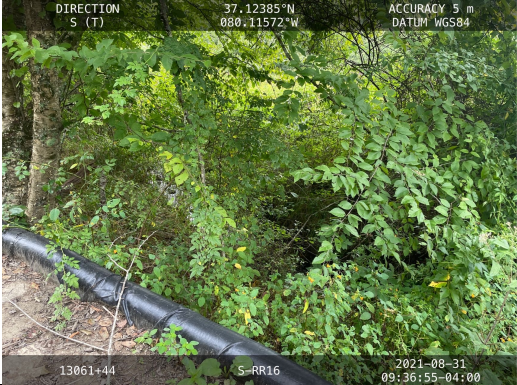
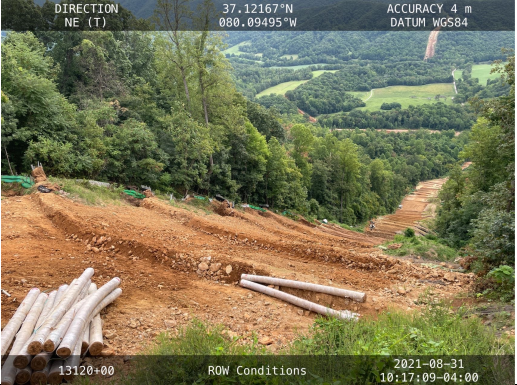
GPS Location	See photo		GPS Location	See photo	
Field Station#	13061+44		Field Station#	13120+00	
Pic 13 Desc.	Downstream photo of Stream S-RR16		Pic 14 Desc.	Current ROW conditions. Waterbars have been reworked

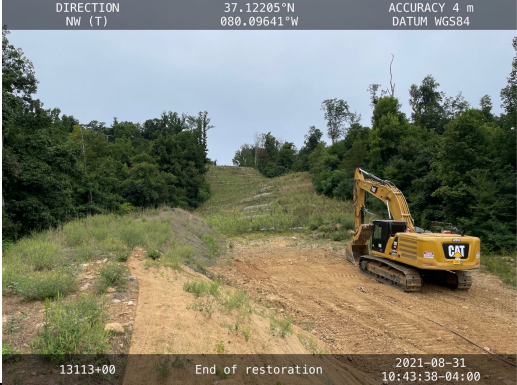
GPS Location	See photo		GPS Location	See photo	
Field Station#	13113+00		Field Station#	13137+00	
Pic 15 Desc.	End of restoration. ROW is stable.		Pic 16 Desc.	Current ROW conditions. Crew actively installing curlex on slope.

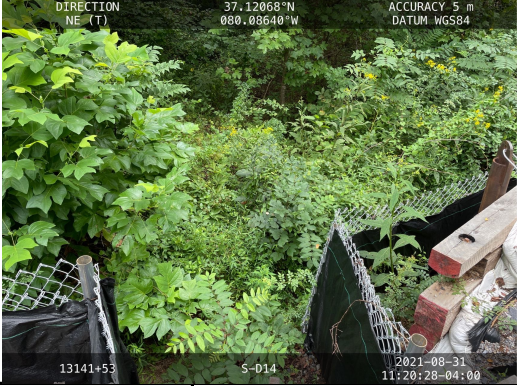
GPS Location	See photo		GPS Location	See photo	
Field Station#	13137+33		Field Station#	13141+53	
Pic 17 Desc.	Downstream photo of Stream S-D17		Pic 18 Desc.	Downstream photo of Stream S-D14

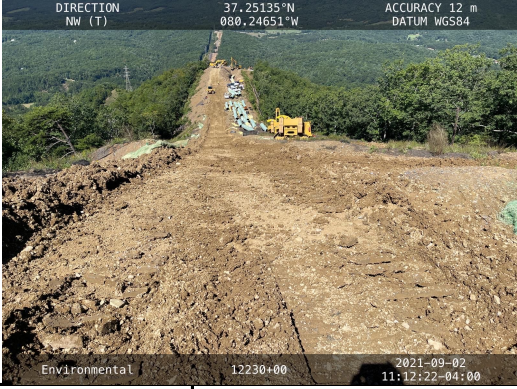
GPS Location	See photo		GPS Location	see photo	
Field Station#	12230+00		Field Station#	12216+00	
Pic 15 Desc.	ROW conditions with travel lane knocked out.		Pic 16 Desc.	Excavator padding and backfilling open ditch

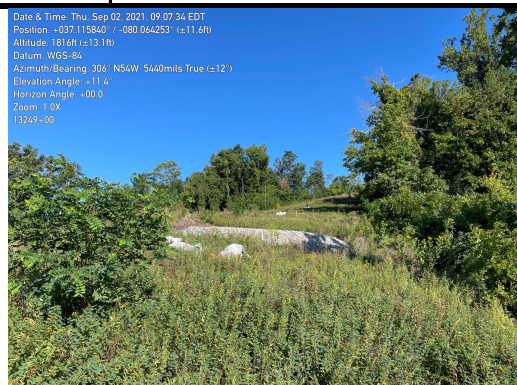
GPS Location				0				GPS Location				0			
Field Station#				13253+00				Field Station#				13249+00			
Pic 5 Desc.				Slip observed to be stable, no notable changes, vegetation established				Pic 6 Desc.				ROW and ECDs in good condition and vegetation established across ROW
