Visual Site Inspection Report

| Project Name | H-600 Pipeline Spread H | AFE | 124300138 | Spread | H-600 Pipeline Spread H |
| Permit # | TBD | Inspection Type | VA SWPP | Station Begin | +0 |

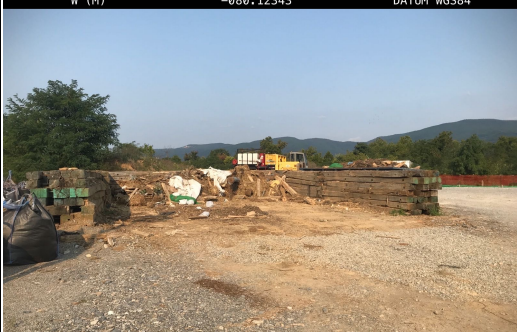
| Pic 15 Desc. | | Condition of temporary trash transfer pit. Debris is inside the boundary of the pit. Looking W. | | | |

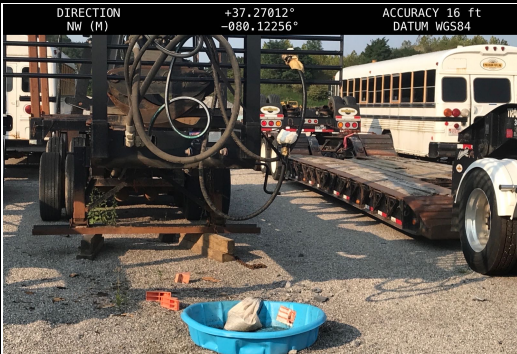
| Pic 17 Desc. | | Condition of containment under stored trailer. Looking NW. | | | |

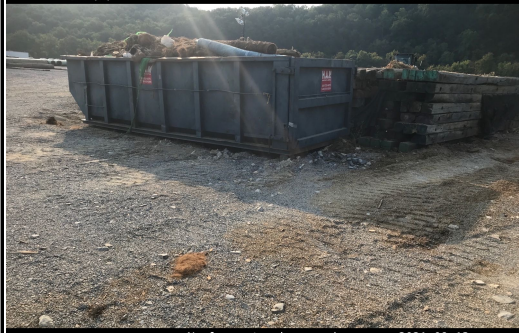
| Pic 14 Desc. | | No loose trash around north dumpster or in the yard. Looking SE. | | | |

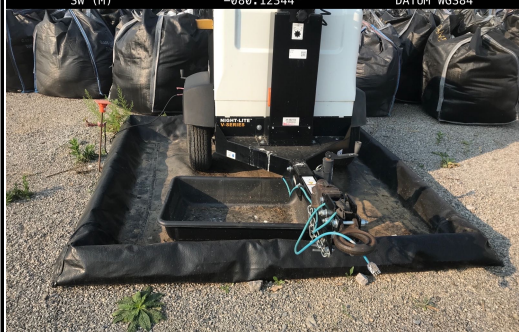
| Pic 16 Desc. | | Condition of containment under light plant. Free of stormwater. Looking SW. | | | |

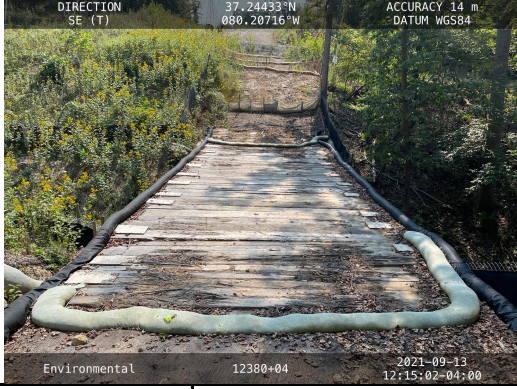
| Pic 9 Desc. | Bridge and ECDs crossing stream S-NN19 in acceptable condition | | Pic 10 Desc. | Stabilized Row in acceptable condition | |

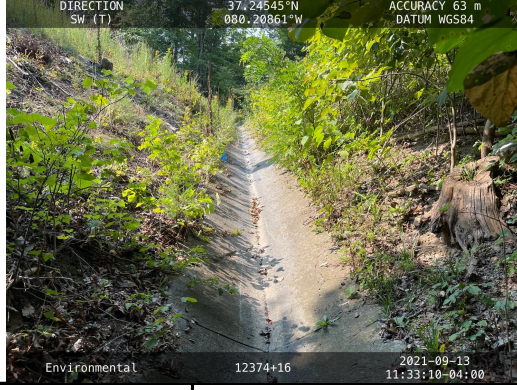
| Pic 11 Desc. | Stream crossing S-0016 in acceptable condition | | Pic 12 Desc. | Stabilized Row in acceptable condition | |

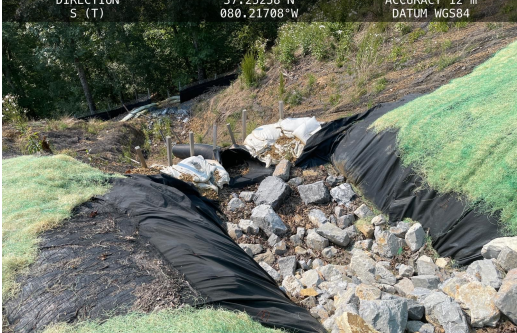
| Field Station# | 12331+50 | | Field Station# | 12308+00 | |

| Pic 15 Desc. | Fill slope drain in acceptable condition | | Pic 16 Desc. | Stabilized Row in acceptable condition | |

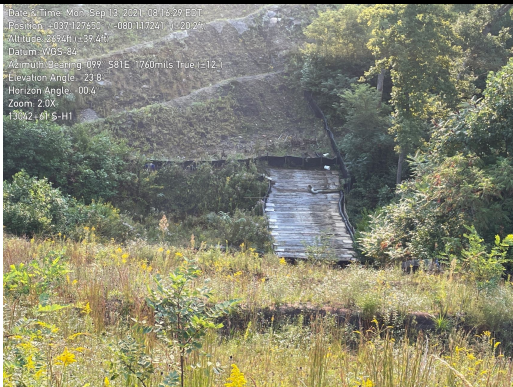
| AFE | | 124300138 | | Date/Time | | 9/13/2021 6:23 PM | | Report # | | | |
|---|--|---|--|---|--|---|--|---|--|---|--|
| Pic 3 Desc. | | | | MVP-S-H1 and Corresponding buffer zone in good condition | | Pic 4 Desc. | | | | RCE in good condition and functioning properly | |

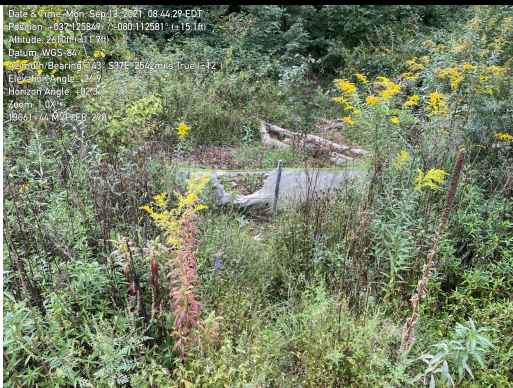
| AFE | | 124300138 | | Date/Time | | 9/13/2021 6:23 PM | | Report # | | | |
|---|--|---|--|---|--|---|--|---|--|---|--|
| Pic 5 Desc. | | | | P1 along access road 290 needs replaced - 72hr maintenance item | | Pic 6 Desc. | | | | MVP-S-G26 and Corresponding buffer zone in good condition | |

| E&S BMPs | Compliance Level | Corrective Action | Corrective Time Frame | Date Repaired |
|---|---|---|---|---|
| Silt Fence (Reinforce Filter Fence) | Communication | Repair/Replace P1 - 72hr item | | 9/13/2021 |

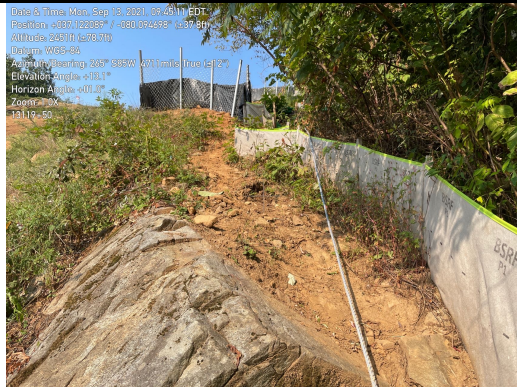
| AFE | 124300138 | Date/Time | 9/13/2021 6:23 PM | Report # | |
|---|---|---|---|---|--|
| Pic 11 Desc. Add Curlex to walking path, 72hr maintenance item | | Pic 12 Desc. Repair P1, 72hr maintenance item | | | |

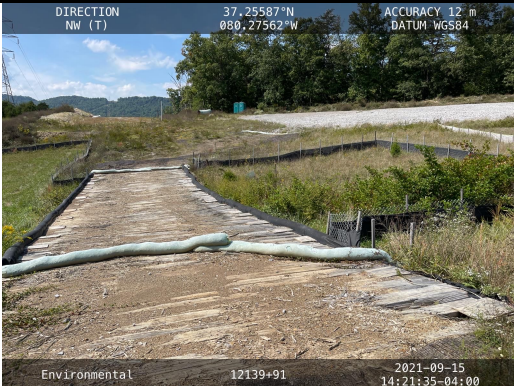
| Pic 3 Desc. | Berm around inlet needs to be built higher than the inlet and compacted. | | Pic 4 Desc. | Bridge and ECDs crossing stream S-C29 in acceptable condition | |

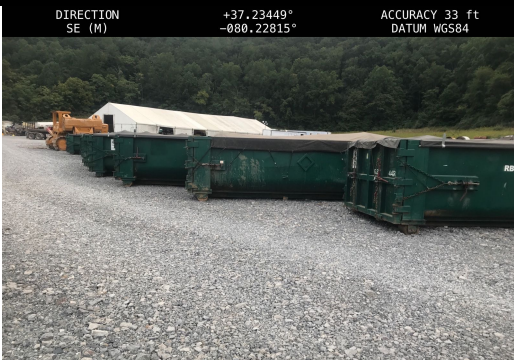
| Pic 3 Desc. | No fluids or deposits around hazardous waste dumpsters stored in the yard. Looking SE. | | Pic 4 Desc. | Condition of containment under hazardous waste dumpsters. Free of fluids. Looking SE. | |

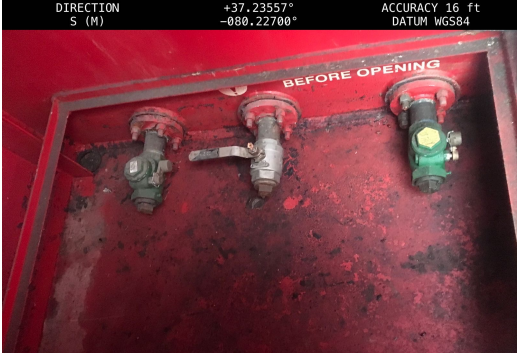
| Pic 15 Desc. | Off Road Fuel unit condition of internal drip pan. Free of fluids. Looking SW. | | Pic 16 Desc. | Off Road Fuel unit no leaky internal fittings. Looking SW. | |

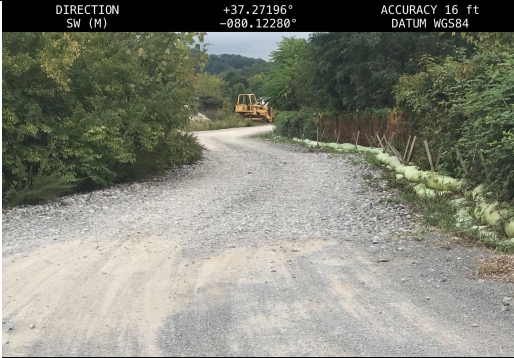
| Pic 1 Desc. | Condition of north rock entrance. No sediment on stone. Looking SW. | | Pic 2 Desc. | Landowner soil disturbance along triple stack compost filter sock. Area not stabilized. Looking S. | |
