# Visual Site Inspection Report

<b>Project Name</b>	H-600 Pipeline Spread H	<b>AFE</b>	124300138	<b>Spread</b>	H-600 Pipeline Spread H
<b>Contractor</b>	Precision			<b>Report #</b>	28156
<b>Inspector</b>	Pat Davis			<b>Date/Time</b>	9/7/2021 6:30 PM
<b>Permit #</b>	TBD	<b>Inspection Type</b>	VA SWPP	<b>Station Begin</b>	+0
<b>State</b>	VA	<b>Inspection Area</b>	Partial	<b>Station End</b>	+0
<b>County</b>	Montgomery	<b>Ground</b>	Dry	<b>Temperature (°F)</b>	65.00
<b>Municipality</b>	N/A	<b>Weather</b>	Sunny	<b>Rain Gauge (in)</b>	0.00
				<b>Rain Accumulation Time (days)</b>	0.00

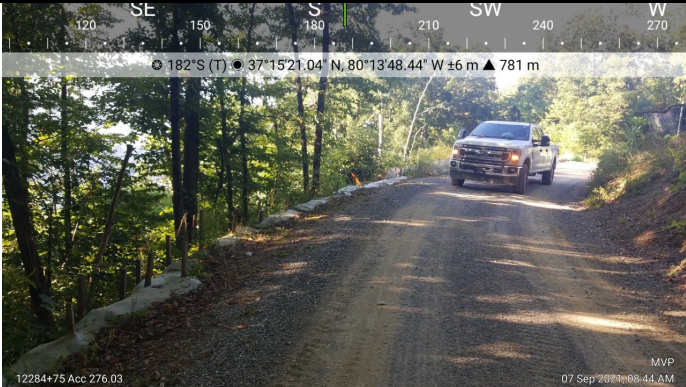
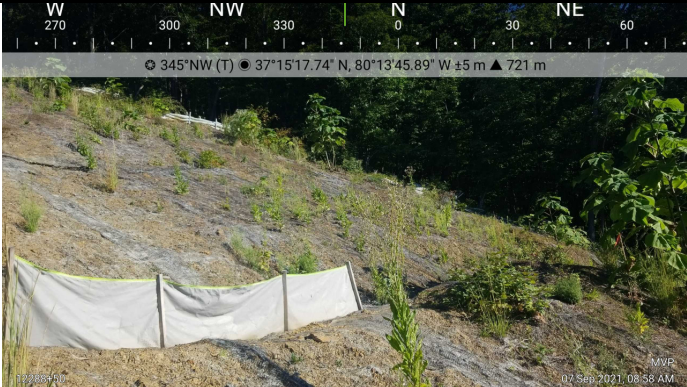
<b>GPS Location</b>	See Above	<b>GPS Location</b>	See Above		
<b>Field Station#</b>	12284+75	<b>Field Station#</b>	12288+50		
<b>Pic 1 Desc.</b>	ROW Overview. Acc 276.03. ECDs are functional and area is stable.	<b>Pic 2 Desc.</b>	ROW Overview. ECDs are functional and ROW is stable.

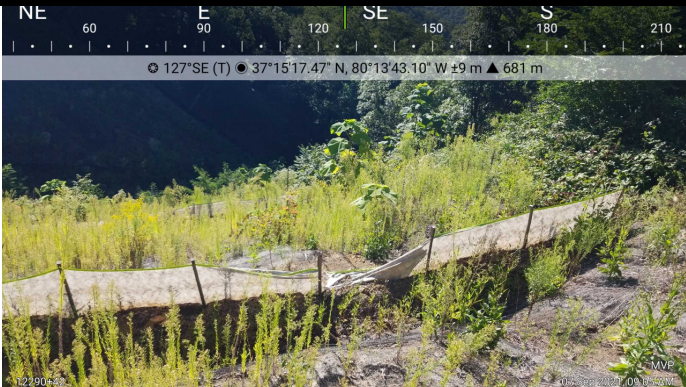
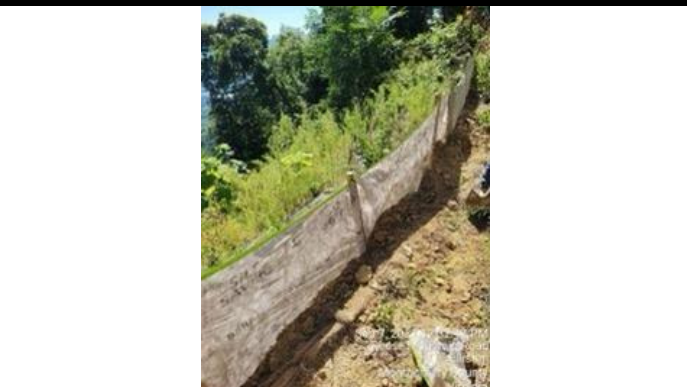
<b>GPS Location</b>	See Above	<b>GPS Location</b>	See Above		
<b>Field Station#</b>	12290+42	<b>Field Station#</b>	12290+42		
<b>Pic 3 Desc.</b>	Punchlist Item: Repair P1 Silt Fence.	<b>Pic 4 Desc.</b>	Punchlist Item: P1 Silt Fence repaired.

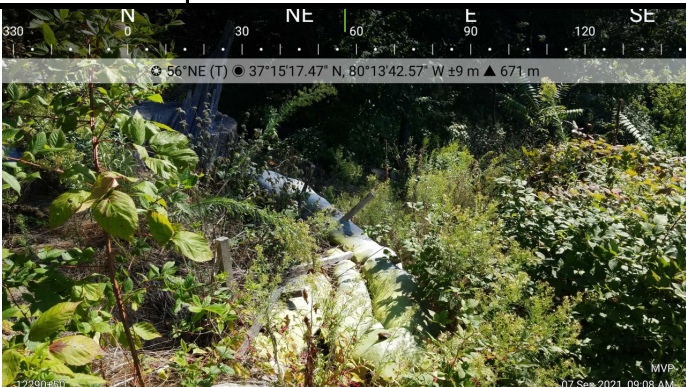
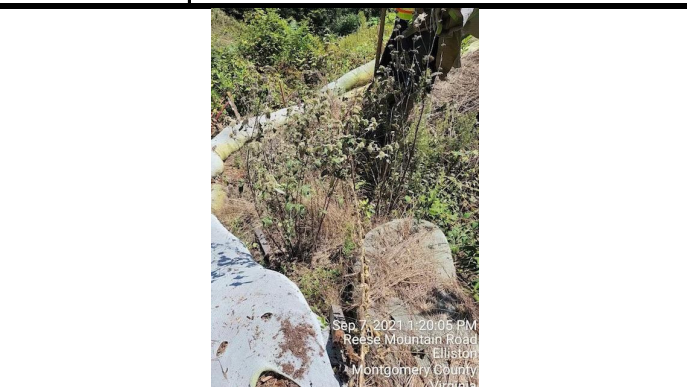
<b>GPS Location</b>	See Above	<b>GPS Location</b>	See Above		
<b>Field Station#</b>	12290+50	<b>Field Station#</b>	12290+50		
<b>Pic 5 Desc.</b>	Punchlist Item: repair triple stack compost filter sock.	<b>Pic 6 Desc.</b>	Punchlist Item: triple stack compost filter sock repaired.

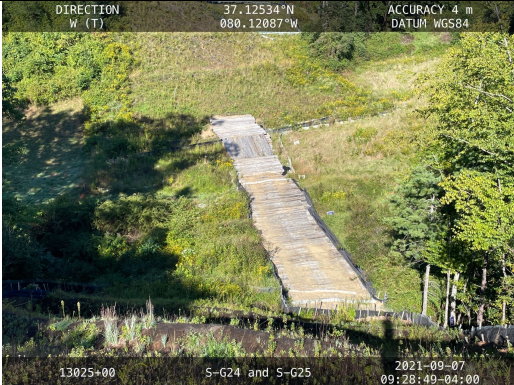
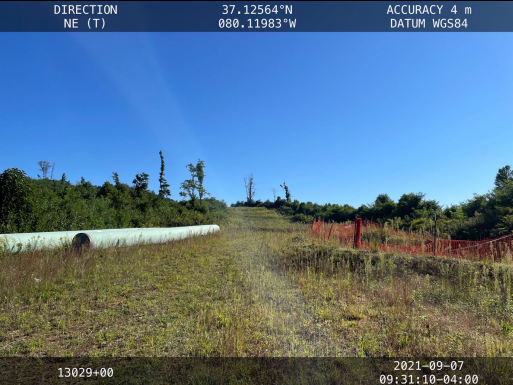
<b>GPS Location</b>	See photo		<b>GPS Location</b>	See photo	
<b>Field Station#</b>	13025+00		<b>Field Station#</b>	13029+00	
<b>Pic 1 Desc.</b>	Overview of Streams S-G24 and S-G25		<b>Pic 2 Desc.</b>	Current ROW conditions. ROW is stable.

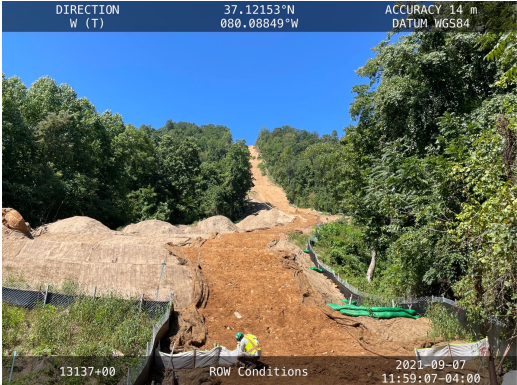
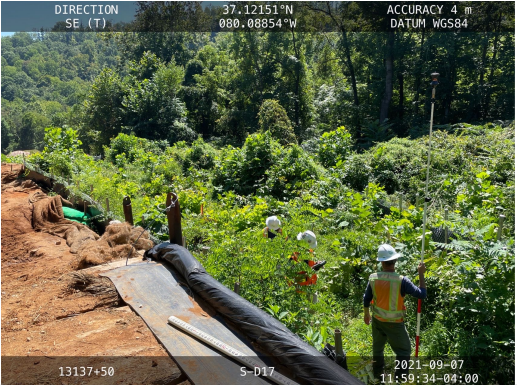
<b>GPS Location</b>	See photo		<b>GPS Location</b>	See photo	
<b>Field Station#</b>	13137+00		<b>Field Station#</b>	13137+50	
<b>Pic 15 Desc.</b>	Contractor removing curlex and ECDs from travel lane.		<b>Pic 16 Desc.</b>	Downstream photo of Stream S-D17

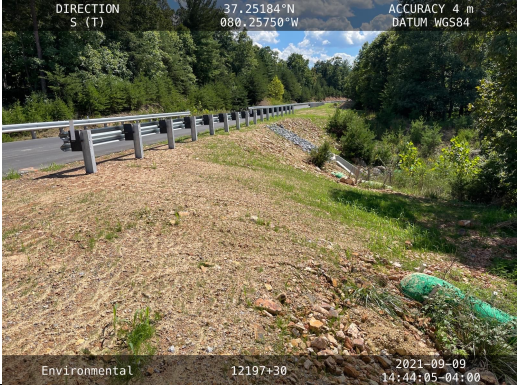
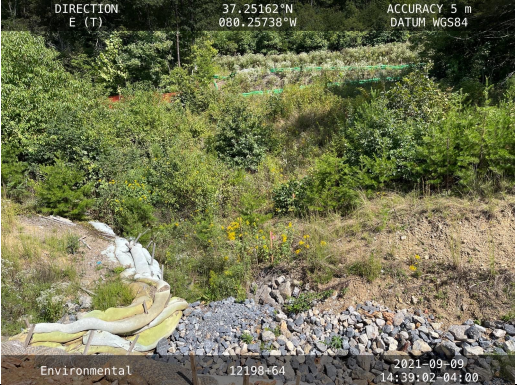
<b>GPS Location</b>	See photo		<b>GPS Location</b>	See photo	
<b>Field Station#</b>	12197+30		<b>Field Station#</b>	12198+64	
<b>Pic 13 Desc.</b>	Stabilized road bank on newly built road		<b>Pic 14 Desc.</b>	Stream crossing S-0011 on the East side of the railroad crossing

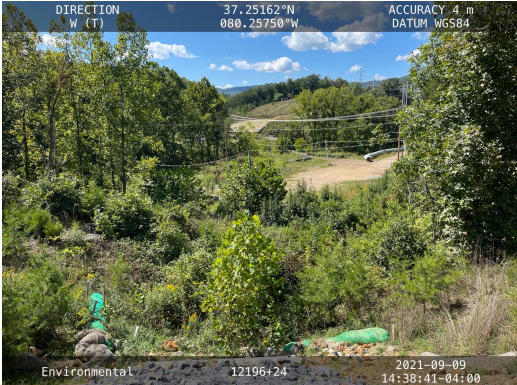
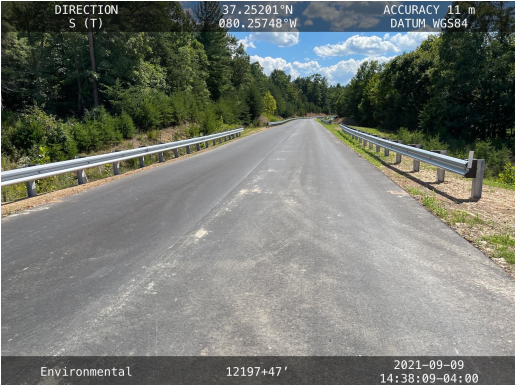
<b>GPS Location</b>	see photo		<b>GPS Location</b>	See photo	
<b>Field Station#</b>	12196+24		<b>Field Station#</b>	12197+47	
<b>Pic 15 Desc.</b>	Stream crossing S-0011 in acceptable condition		<b>Pic 16 Desc.</b>	Newly built road replacing the previous railroad tracks

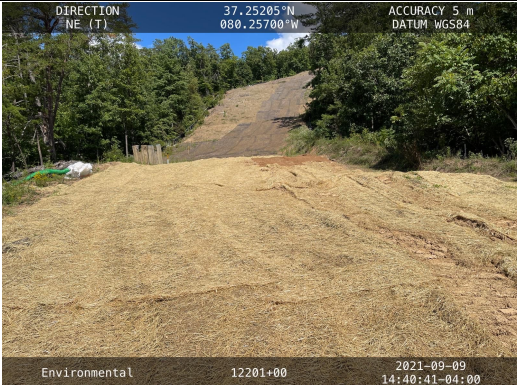
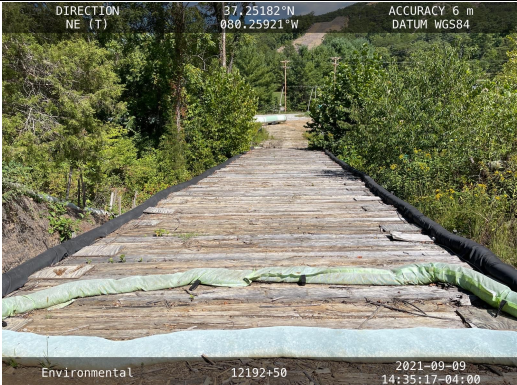
<b>GPS Location</b>	see photo		<b>GPS Location</b>	See photo	
<b>Field Station#</b>	12201+00		<b>Field Station#</b>	12192+50	
<b>Pic 17 Desc.</b>	Stabilized ROW in acceptable condition		<b>Pic 18 Desc.</b>	Bridge and ECDs crossing stream S-C21 in acceptable condition

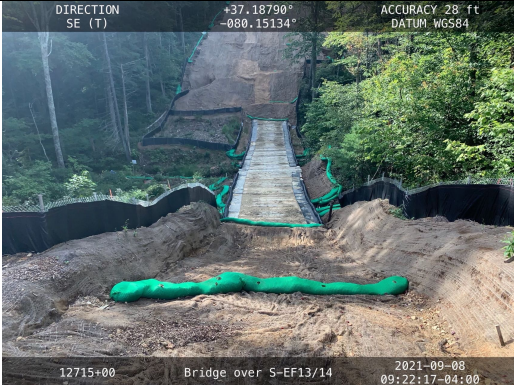
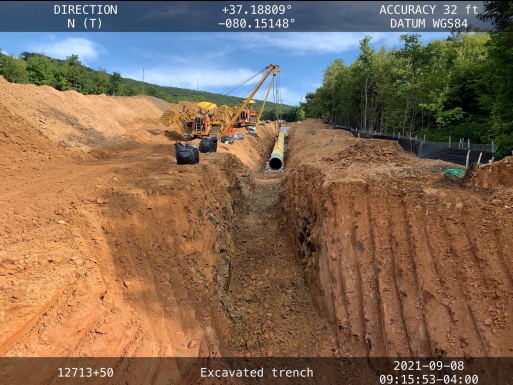
<b>GPS Location</b>	See photo	<b>GPS Location</b>	See photo		
<b>Field Station#</b>	12715+00	<b>Field Station#</b>	12713+50		
<b>Pic 1 Desc.</b>	Overview of Streams S-Y13 and S-Y14. ECDs maintained.	<b>Pic 2 Desc.</b>	Excavated trench. Contractor lowering in pipe.

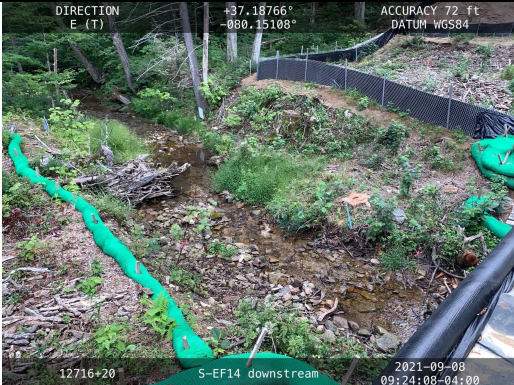
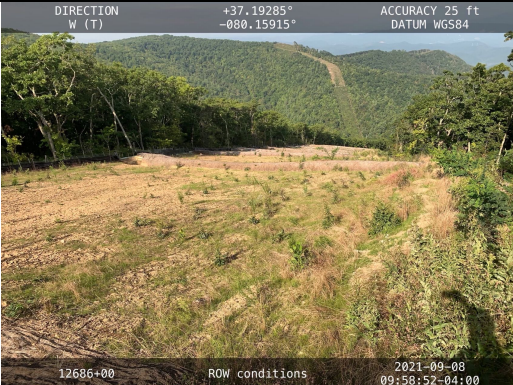
<b>GPS Location</b>	See photo	<b>GPS Location</b>	See photo		
<b>Field Station#</b>	12716+20	<b>Field Station#</b>	12686+00		
<b>Pic 3 Desc.</b>	Downstream photo of S-Y14	<b>Pic 4 Desc.</b>	Current ROW conditions. ROW is stable.

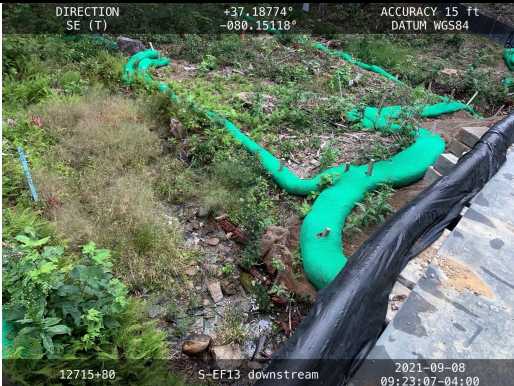
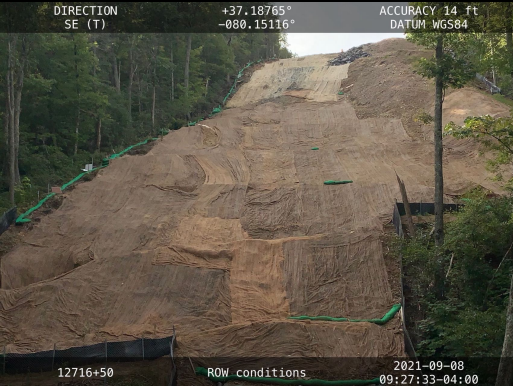
<b>GPS Location</b>	See photo	<b>GPS Location</b>	See photo		
<b>Field Station#</b>	12715+80	<b>Field Station#</b>	12716+50		
<b>Pic 5 Desc.</b>	Downstream photo of Stream S-Y13	<b>Pic 6 Desc.</b>	Steep slope area adjacent to S-Y13 and S-Y14 stabilized with curlex

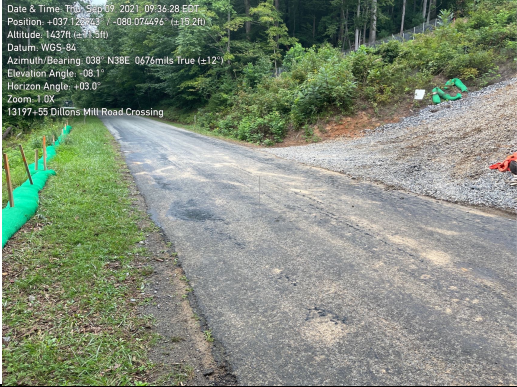
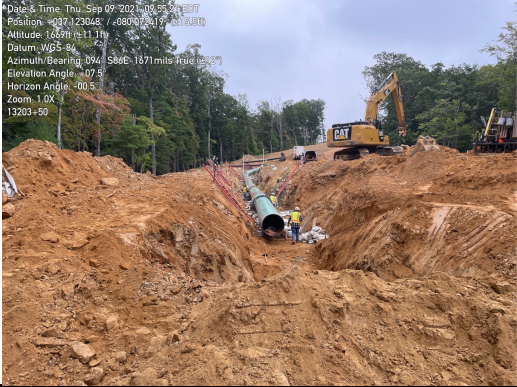
<b>GPS Location</b>	0	<b>GPS Location</b>	0		
<b>Field Station#</b>	13197+55	<b>Field Station#</b>	13203+50		
<b>Pic 7 Desc.</b>	Dillion's Mill Road Crossing in good condition		<b>Pic 8 Desc.</b>	ROW and ECDs in good condition, temporary waterbar pipes in good condition

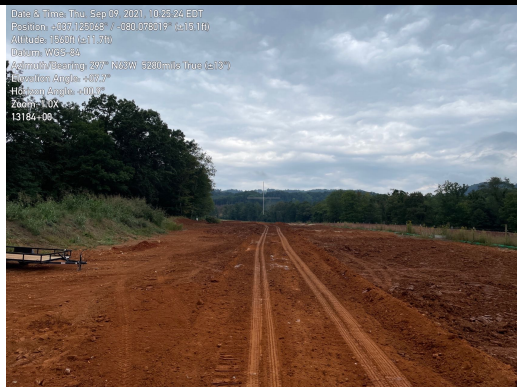
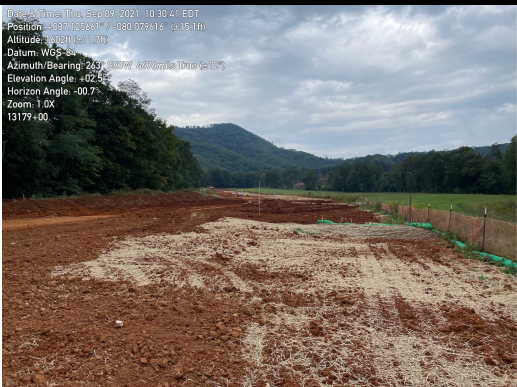
<b>GPS Location</b>	0	<b>GPS Location</b>	0		
<b>Field Station#</b>	13184+00	<b>Field Station#</b>	13179+00		
<b>Pic 11 Desc.</b>	ROW and ECDs in good condition and stable		<b>Pic 12 Desc.</b>	ROW and ECDs in good condition and stable

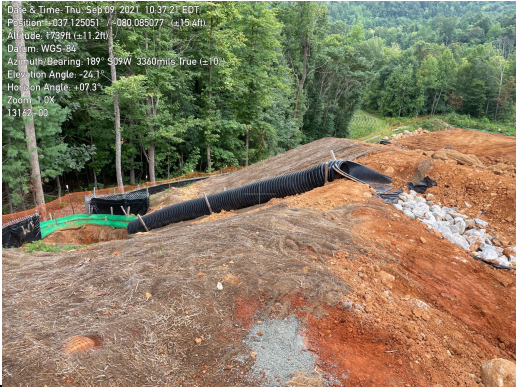
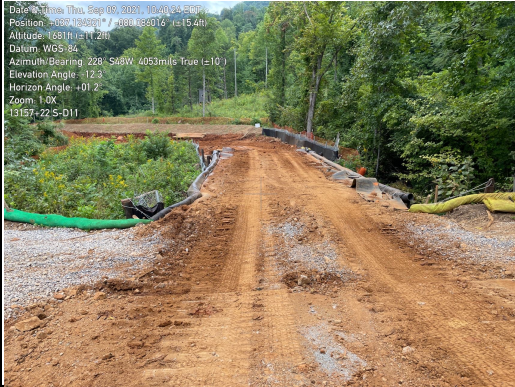
<b>GPS Location</b> 0		<b>GPS Location</b> 0			
<b>Field Station#</b> 13162+00		<b>Field Station#</b> 13157+22			
<b>Pic 15 Desc.</b> Slope drain pipe in good condition		<b>Pic 16 Desc.</b> MVP-S-D11 and Corresponding buffer zone in good condition			
<p>Date &amp; Time: Thu, Sep 09, 2021, 10:42:05 EDT  Position: +037.121409° / -080.035336° (±15.1m)  Altitude: 13146 (±11.7m)  Datum: WGS-84  Azimuth/Bearing: 239° S39W 362mils True (±12°)  Elevation Angle: +35.3°  Horizon Angle: +00.3°  Zoom: 1.0X  13144+39 S-D12/D13</p>

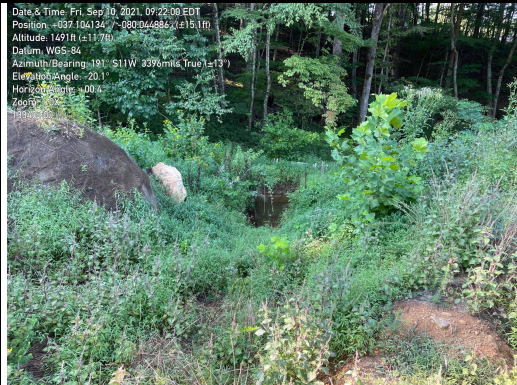
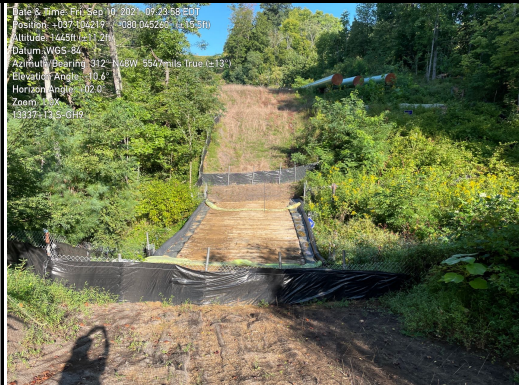
</div>					
GPS Location		0		GPS Location		0	
Field Station#		13340+00		Field Station#		13337+13	
Pic 11 Desc.		Sump and end treatment in good condition		Pic 12 Desc.		MVP-S-GH9 and Corresponding buffer zone in good condition

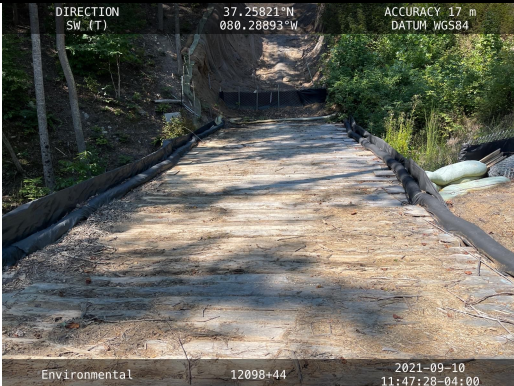
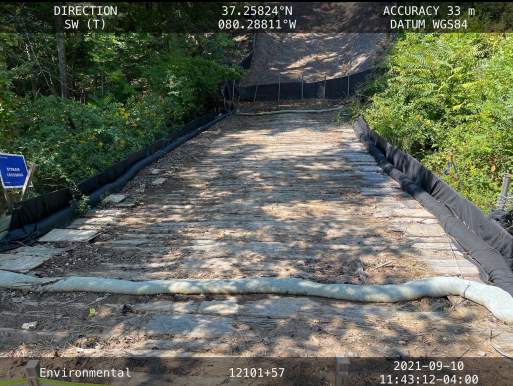
<b>GPS Location</b>	See photo		<b>GPS Location</b>	See photo	
<b>Field Station#</b>	12098+44		<b>Field Station#</b>	12101+57	
<b>Pic 5 Desc.</b>	Bridge and ECDs at crossing S-MM13 in acceptable condition		<b>Pic 6 Desc.</b>	Bridge and ECDs crossing stream S-Mm11 in acceptable condition

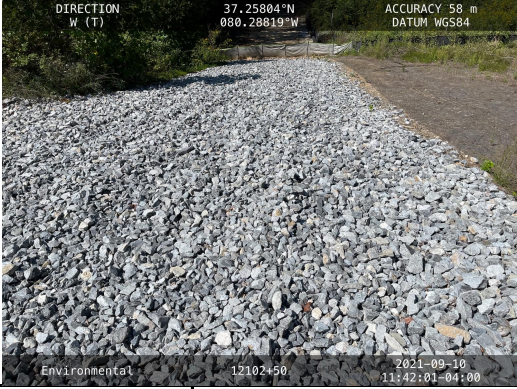
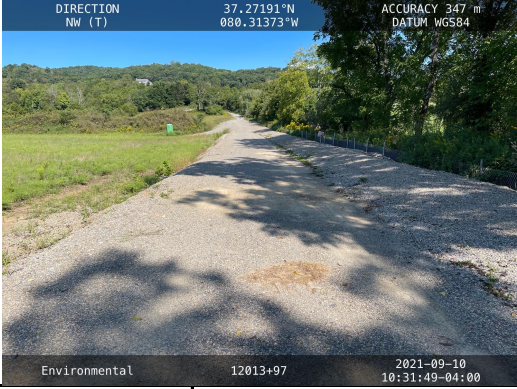
<b>GPS Location</b>	see photo		<b>GPS Location</b>	See photo	
<b>Field Station#</b>	12102+59		<b>Field Station#</b>	12013+97	
<b>Pic 7 Desc.</b>	RCE on the CIS of Half Acre of Rock road in acceptable condition		<b>Pic 8 Desc.</b>	Access Road MVP-MN-268.01 In Acceptable condition
