# Visual Site Inspection Report

<b>Project Name</b>	H-600 Pipeline Spread I	<b>AFE</b>	124300139	<b>Spread</b>	H-600 Pipeline Spread I
<b>Contractor</b>	Precision			<b>Report #</b>	25989
<b>Inspector</b>	Ben Davenport			<b>Date/Time</b>	7/19/2021 11:34 AM
<b>Permit #</b>	TBD	<b>Inspection Type</b>	VA SWPP	<b>Station Begin</b>	14694+77
<b>State</b>	VA	<b>Inspection Area</b>	Partial	<b>Station End</b>	14802+19
<b>County</b>	Franklin	<b>Ground</b>	Damp	<b>Temperature (°F)</b>	82.00
<b>Municipality</b>	N/A	<b>Weather</b>	Light Rain	<b>Rain Gauge (in)</b>	0.10
				<b>Rain Accumulation Time (days)</b>	1.00

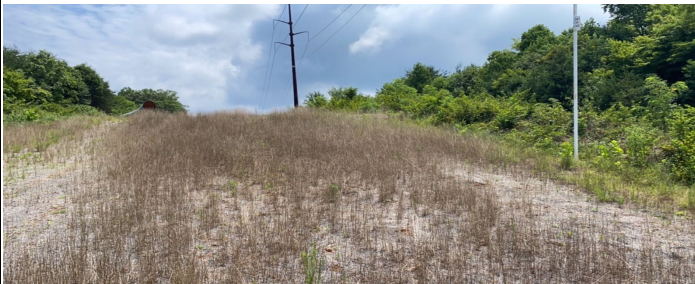
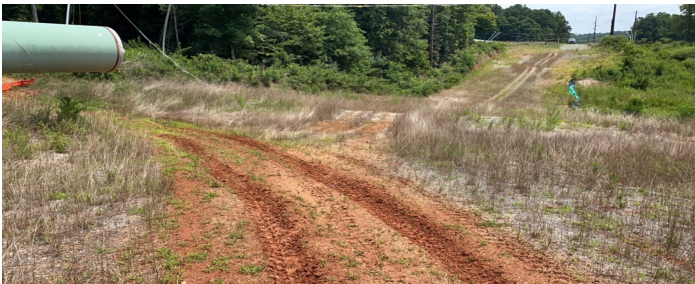
36°59'17" N 79°42'26" W 127°SE COURSE 0° GPS 07.19.2021 12:54:59 Accur +/-215.9 Ft			36°59'17" N 79°42'21" W 93°E COURSE 81° GPS 07.19.2021 12:56:59 Sorry no results found Accur +/-26.8 Ft ALT 930 Ft		
<b>GPS Location</b>	1		<b>GPS Location</b>	2	
<b>Field Station#</b>	14703+00		<b>Field Station#</b>	14708+00	
<b>Pic 1 Desc.</b>	View of dying vegetation in temporary area along ROW		<b>Pic 2 Desc.</b>	Landowner causing rutting in travel lane at ROW crossing. Will monitor area

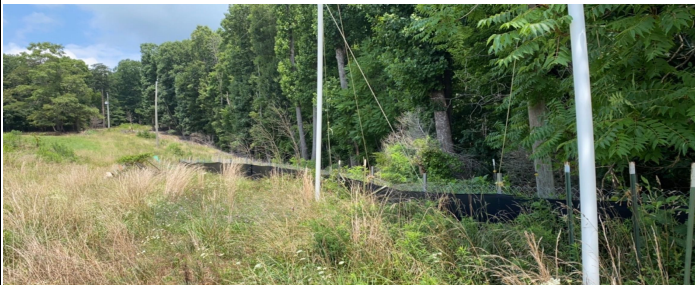
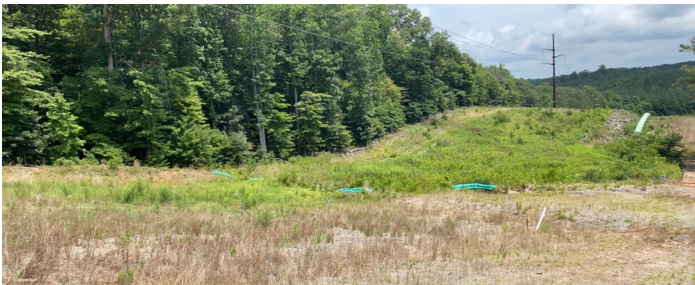
<b>Pic 3 Desc.</b>	Perimeter SSF in place and functional		<b>Pic 4 Desc.</b>	CFS triple stack in good condition at resource buffer

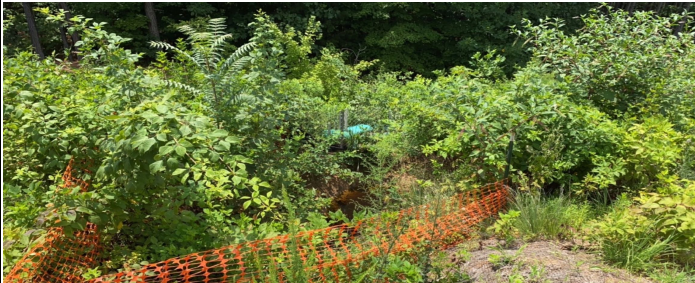
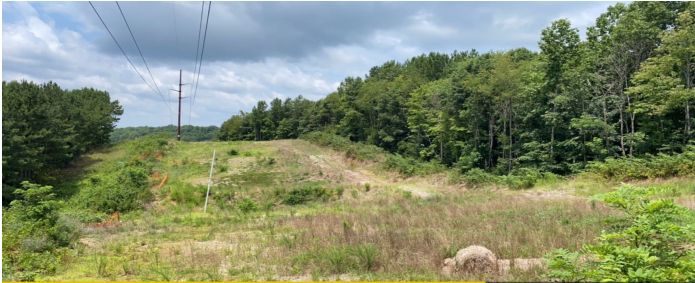
36°59'9" N 79°41'39" W 172°S COURSE 217° GPS Union Hall, VA 24176, United States 07.19.2021 13:25:14 Accur +/-26.7 Ft ALT 945 Ft			36°59'9" N 79°41'39" W 295°NW COURSE 227° GPS Union Hall, VA 24176, United States 07.19.2021 13:25:09 Accur +/-59.5 Ft ALT 938 Ft		
<b>GPS Location</b>	5		<b>GPS Location</b>	6	
<b>Field Station#</b>	14750+00		<b>Field Station#</b>	14741+00	
<b>Pic 5 Desc.</b>	Safety fence around sump pit and CFS end treatment which are in good condition		<b>Pic 6 Desc.</b>	View of temporary stabilization and vegetation along ROW

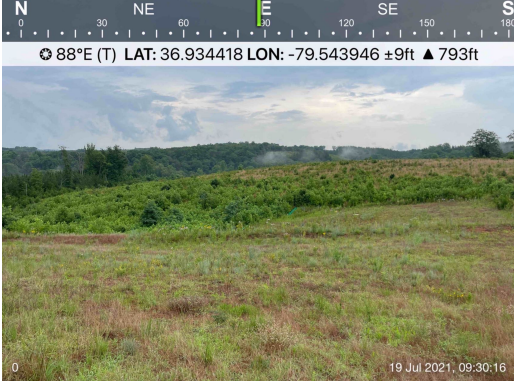
<b>GPS Location</b>	See photo		<b>GPS Location</b>	See photo	
<b>Field Station#</b>	15260+00		<b>Field Station#</b>	15230+00	
<b>Pic 1 Desc.</b>	Vegetation continues to fill in throughout this section of ROW.		<b>Pic 2 Desc.</b>	Vegetation continues to fill in throughout this section of ROW.

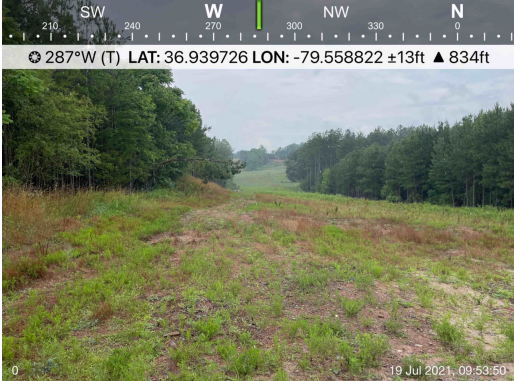
<b>GPS Location</b>	See photo		<b>GPS Location</b>	See photo	
<b>Field Station#</b>	15209+00		<b>Field Station#</b>	15195+00	
<b>Pic 3 Desc.</b>	Vegetation continues to fill in throughout this section of ROW.		<b>Pic 4 Desc.</b>	Drainage ECDs are in good condition and functioning.

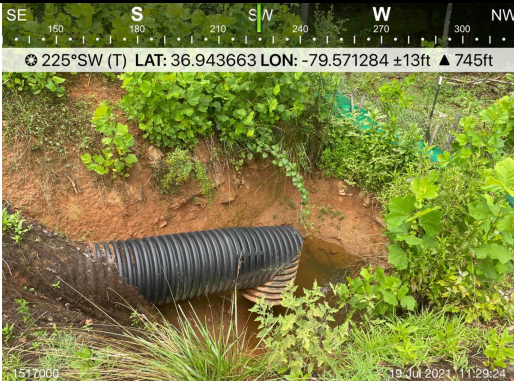
<b>GPS Location</b>	See photo		<b>GPS Location</b>	See photo	
<b>Field Station#</b>	15170+00		<b>Field Station#</b>	15170+00	
<b>Pic 5 Desc.</b>	Slope drain functioning as intended.		<b>Pic 6 Desc.</b>	Waterbars are in good condition throughout this section.

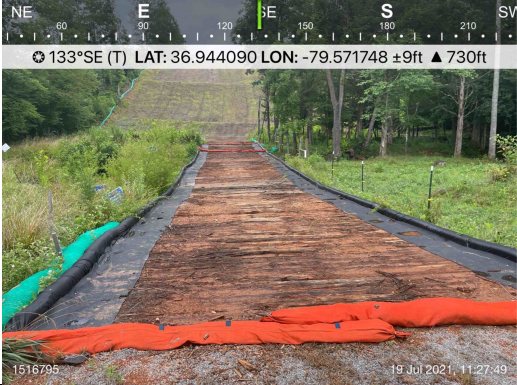
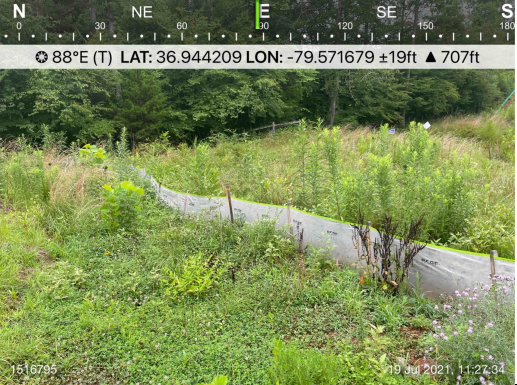
<b>GPS Location</b>	See photo		<b>GPS Location</b>	See photo	
<b>Field Station#</b>	15167+95		<b>Field Station#</b>	15167+95	
<b>Pic 7 Desc.</b>	Equipment bridge ECDs are in place and functioning.		<b>Pic 8 Desc.</b>	P1 is in good condition at all stream and wetland buffers.

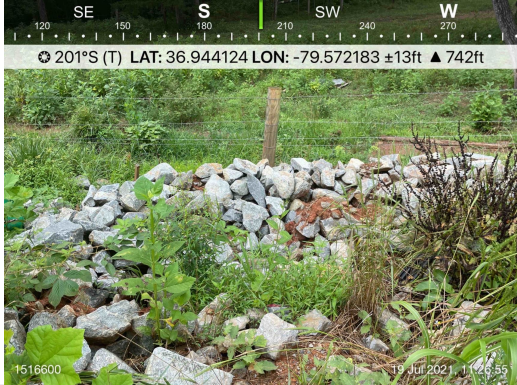
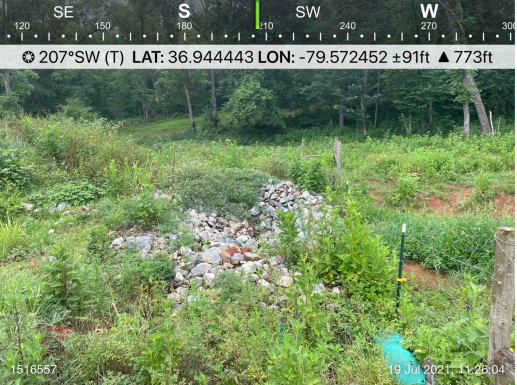
<b>GPS Location</b>	See photo		<b>GPS Location</b>	See photo	
<b>Field Station#</b>	15166+00		<b>Field Station#</b>	15165+57	
<b>Pic 9 Desc.</b>	Rock outlet is in good condition.		<b>Pic 10 Desc.</b>	Rock inlet is in good condition.

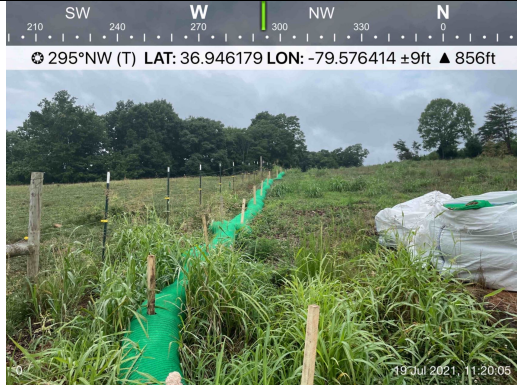
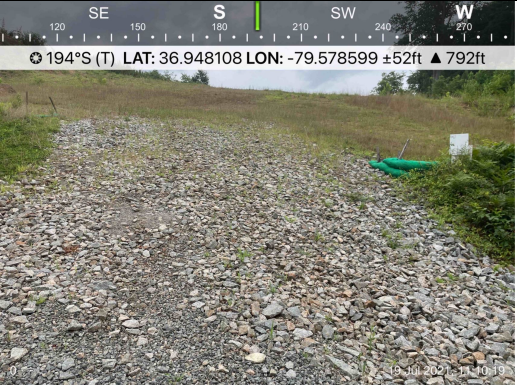
<b>GPS Location</b>	See photo		<b>GPS Location</b>	See photo	
<b>Field Station#</b>	15152+84		<b>Field Station#</b>	15142+66	
<b>Pic 11 Desc.</b>	Perimeter CFS is in good condition throughout this section.		<b>Pic 12 Desc.</b>	RCE is in good condition at Rockcreek Rd.

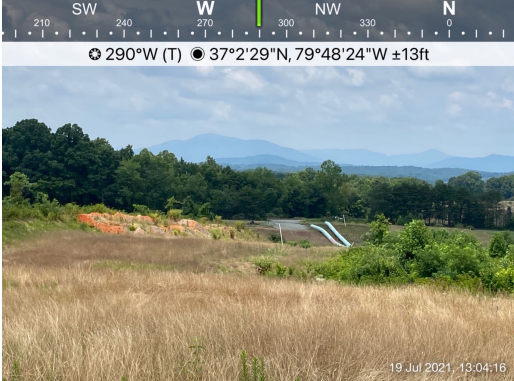
<b>GPS Location</b>	0	<b>GPS Location</b>	0		
<b>Field Station#</b>	14320+00	<b>Field Station#</b>	14333+00		
<b>Pic 1 Desc.</b>	Approximately 14320+00. Overview of ROW.	<b>Pic 2 Desc.</b>	Approximately 14333+00. Overview of road crossing and RCEs.

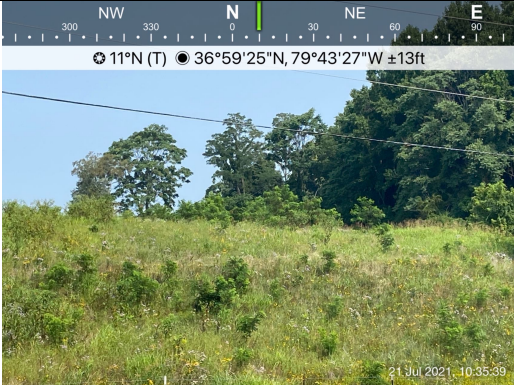
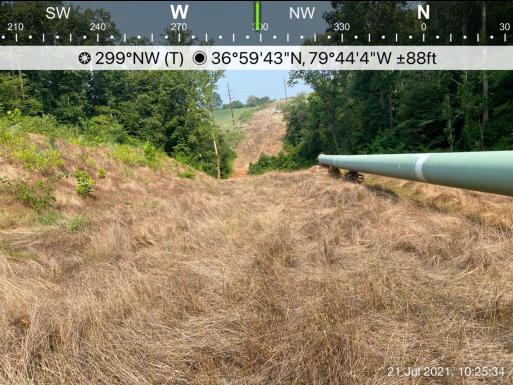
<b>GPS Location</b>	0	<b>GPS Location</b>	0		
<b>Field Station#</b>	14647+50	<b>Field Station#</b>	14615+00		
<b>Pic 1 Desc.</b>	Approximately 14647+50. Overview of ROW.		<b>Pic 2 Desc.</b>	Approximately 14615+00. Overview of ROW.

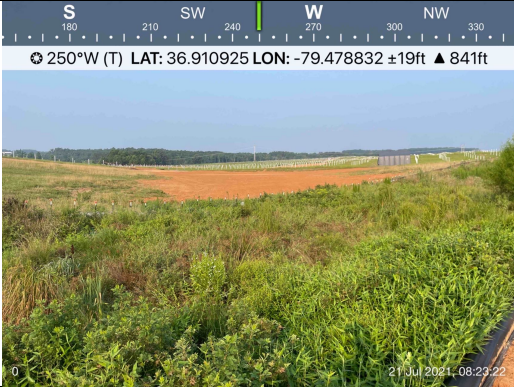
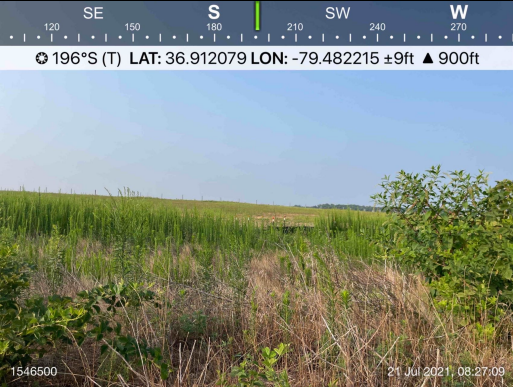
<b>GPS Location</b>	See photo	<b>GPS Location</b>	See photo		
<b>Field Station#</b>	15475+00	<b>Field Station#</b>	15465+00		
<b>Pic 1 Desc.</b>	3rd party rock outlet is in good condition along this drainage.	<b>Pic 2 Desc.</b>	No evidence of sedimentation from 3rd party rock outlet.

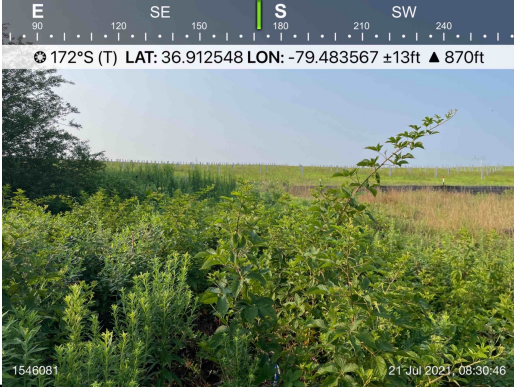
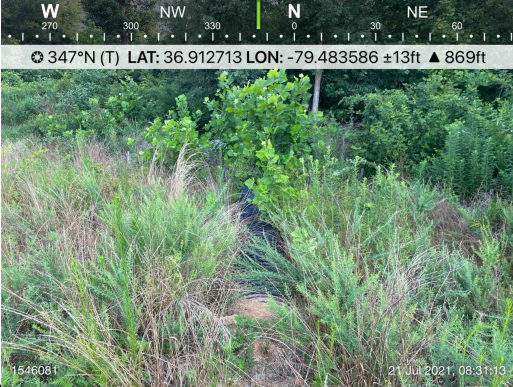
<b>GPS Location</b>	See photo	<b>GPS Location</b>	See photo		
<b>Field Station#</b>	15460+81	<b>Field Station#</b>	15460+81		
<b>Pic 3 Desc.</b>	No evidence of sedimentation from 3rd party disturbance into CWD inlet.	<b>Pic 4 Desc.</b>	CWD remains in good condition.

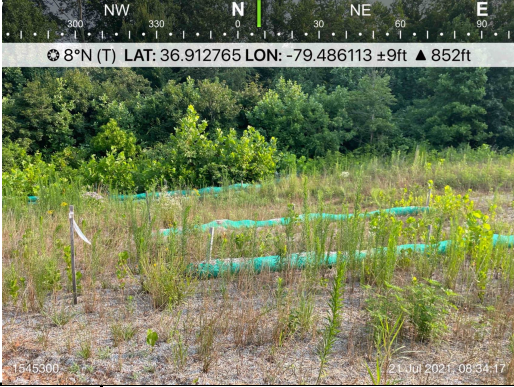
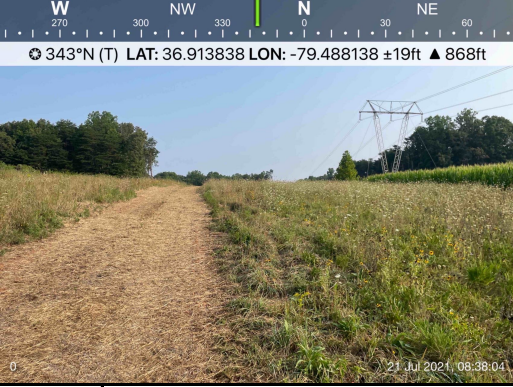
<b>GPS Location</b>	See photo	<b>GPS Location</b>	See photo		
<b>Field Station#</b>	15453+00	<b>Field Station#</b>	15445+00		
<b>Pic 5 Desc.</b>	No evidence of sedimentation from 3rd party disturbance.	<b>Pic 6 Desc.</b>	Vegetation continues to fill in throughout this section of ROW.

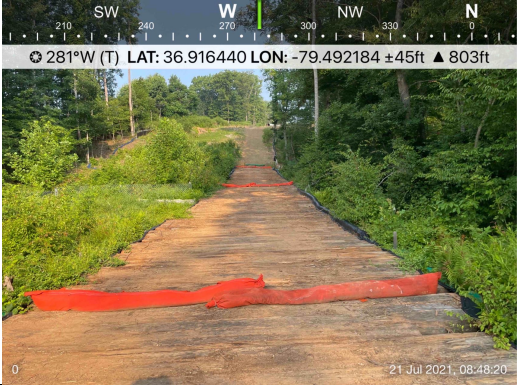
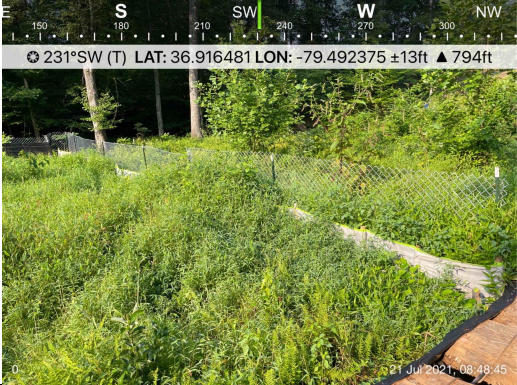
<b>GPS Location</b>	See photo		<b>GPS Location</b>	See photo	
<b>Field Station#</b>	15427+00		<b>Field Station#</b>	15427+00	
<b>Pic 7 Desc.</b>	Equipment bridge ECDs are in place and functioning.		<b>Pic 8 Desc.</b>	P1 is in good condition at all stream and wetland buffers.

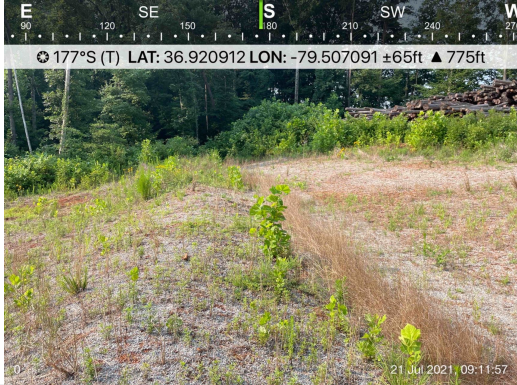
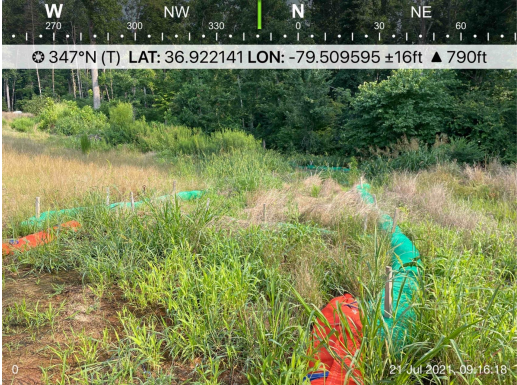
<b>GPS Location</b>	See photo		<b>GPS Location</b>	See photo	
<b>Field Station#</b>	15380+00		<b>Field Station#</b>	15375+00	
<b>Pic 9 Desc.</b>	Waterbars are in good condition throughout this section.		<b>Pic 10 Desc.</b>	Drainage ECDs are in good condition and functioning.	
Insert image here			Insert image here		
<b>GPS Location</b>			<b>GPS Location</b>		
<b>Field Station#</b>			<b>Field Station#</b>		
<b>Pic 11 Desc.</b>			<b>Pic 12 Desc.</b>

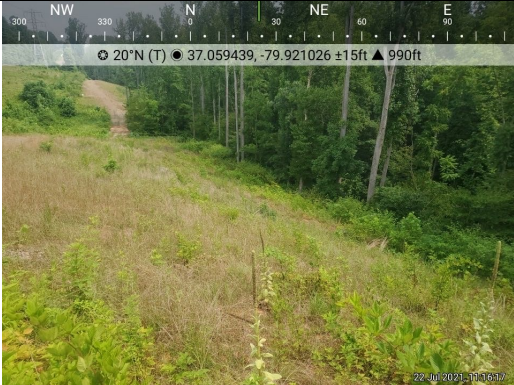
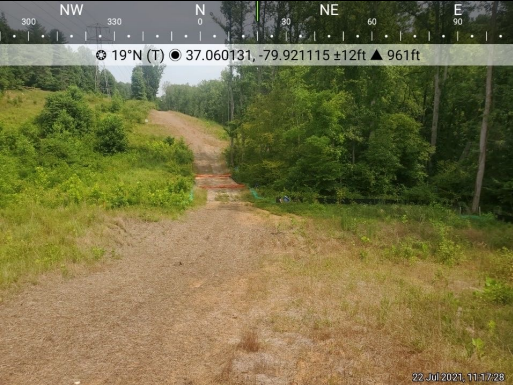
<b>GPS Location</b>	0	<b>GPS Location</b>	0		
<b>Field Station#</b>	13850+00	<b>Field Station#</b>	13848+00		
<b>Pic 1 Desc.</b>	Sideslope stabilization	<b>Pic 2 Desc.</b>	GAS S-C16 Temporary vegetation

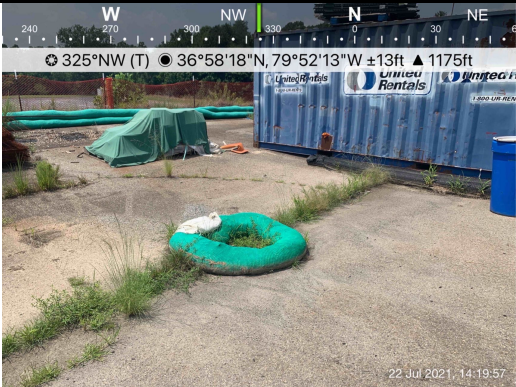
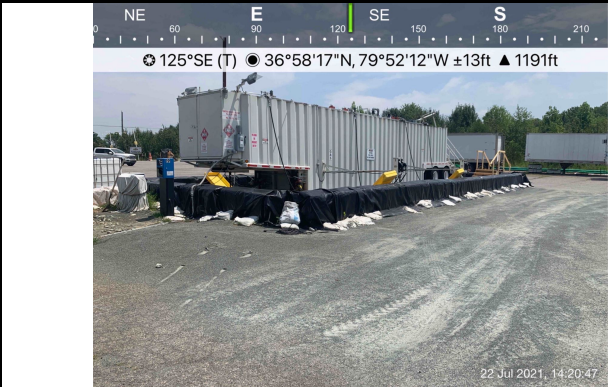
GPS Location	000000000000		GPS Location	000000000000	
Field Station#	0000+00		Field Station#	0000+00	
Pic 1 Desc.	Inlet protection and perimeter ECD's on west side of LY-046 in good condition.		Pic 2 Desc.	Secondary containment structure for fuel cell at LY-046 in good condition.

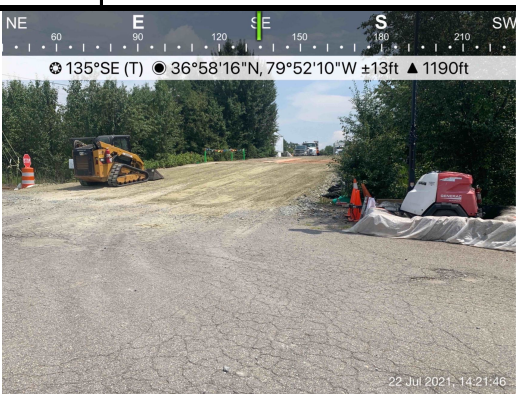
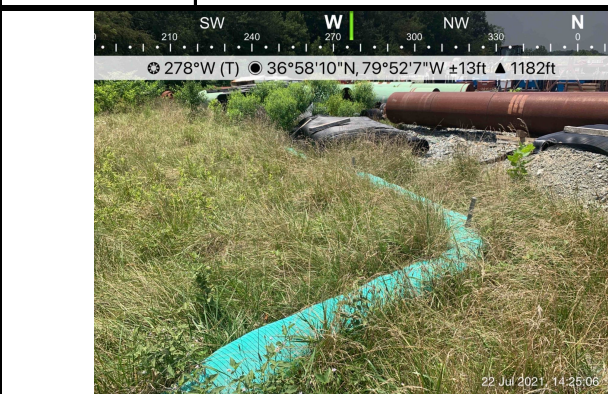
GPS Location	000000000000		GPS Location	000000000000	
Field Station#	0000+00		Field Station#	0000+00	
Pic 3 Desc.	Reinstallation of new air bridge mats between LY-045 and LY-046 no issue observed.		Pic 4 Desc.	Perimeter ECD's on west side of LY-045 in good condition

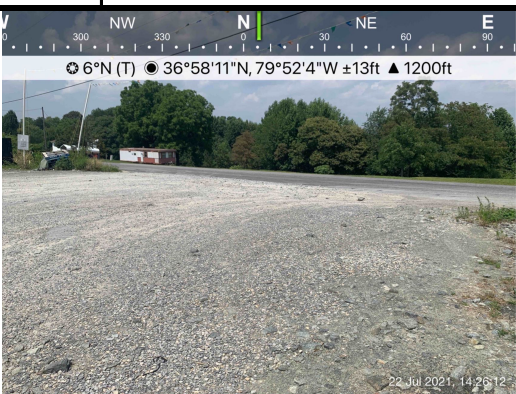
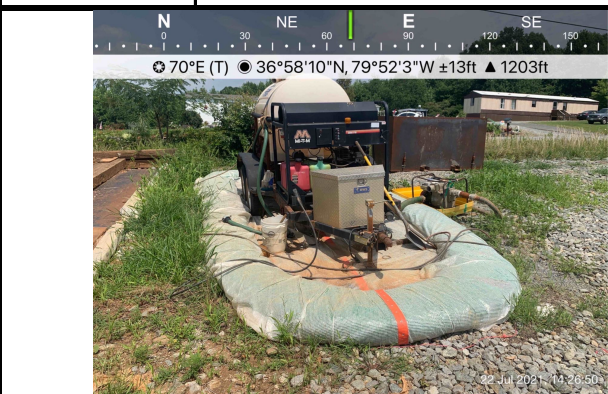
GPS Location	000000000000		GPS Location	000000000000	
Field Station#	0000+00		Field Station#	0000+00	
Pic 5 Desc.	RCE at zLY-045 in good condition.		Pic 6 Desc.	Secondary containment structure for wash station at LY-045 in good condition

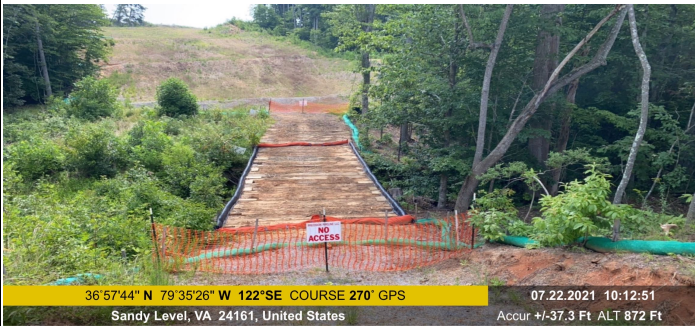
GPS Location	1	GPS Location	2		
Field Station#	15072+86	Field Station#	15072+86		
Pic 1 Desc.	Equipment bridge and surrounding ECDs in place and functional at stream crossing and resource buffer		Pic 2 Desc.	Downstream view of S-G11 at ROW crossing

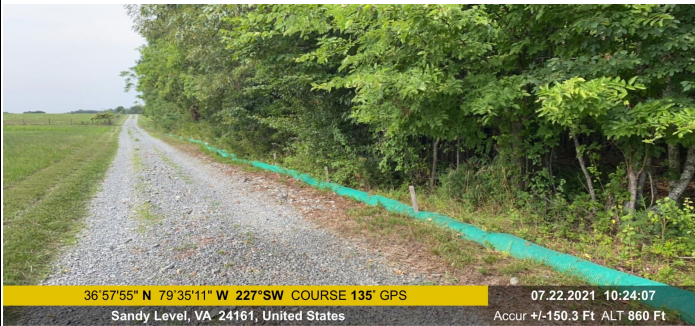
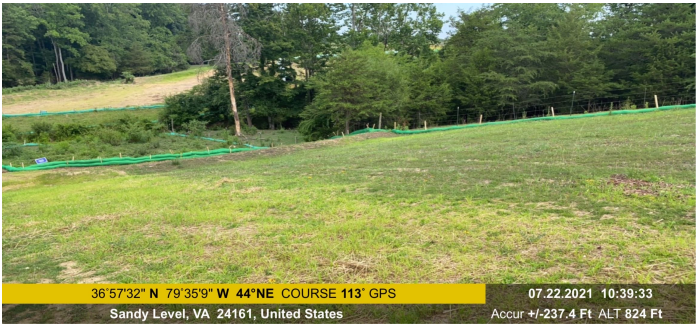
GPS Location	5	GPS Location	6		
Field Station#	15080+64	Field Station#	15095+00		
Pic 5 Desc.	Perimeter CFS along access road in good condition		Pic 6 Desc.	New vegetation growing in final cleanup area where recent environmental maintenance was completed

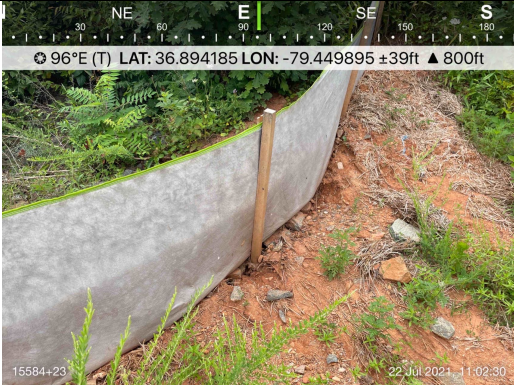
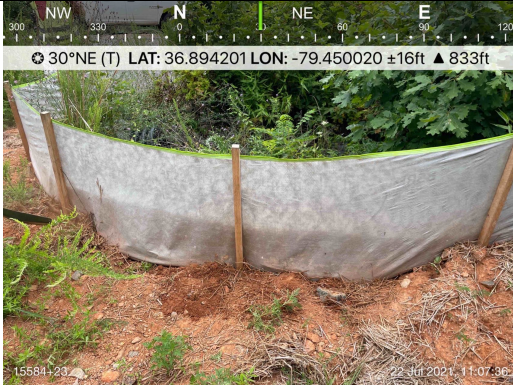
<b>GPS Location</b>	See photo		<b>GPS Location</b>	See photo	
<b>Field Station#</b>	15584+23		<b>Field Station#</b>	15584+23	
<b>Pic 1 Desc.</b>	P1 is undermined and needs to be keyed in.		<b>Pic 2 Desc.</b>	Environmental crew has corrected this issue.

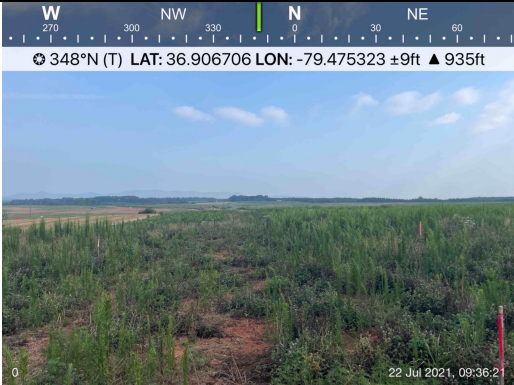
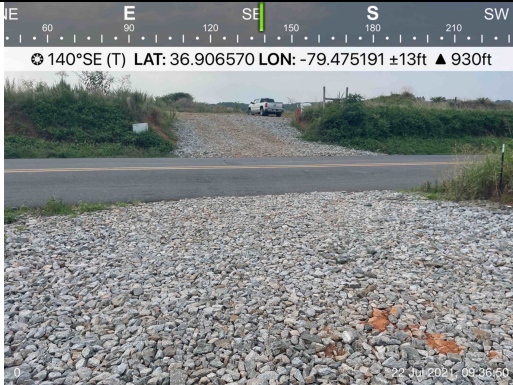
<b>GPS Location</b>	See photo		<b>GPS Location</b>	See photo	
<b>Field Station#</b>	15495+00		<b>Field Station#</b>	15496+70	
<b>Pic 3 Desc.</b>	Vegetation continues to fill in throughout this section of ROW.		<b>Pic 4 Desc.</b>	RCEs are in good condition at all road crossings.

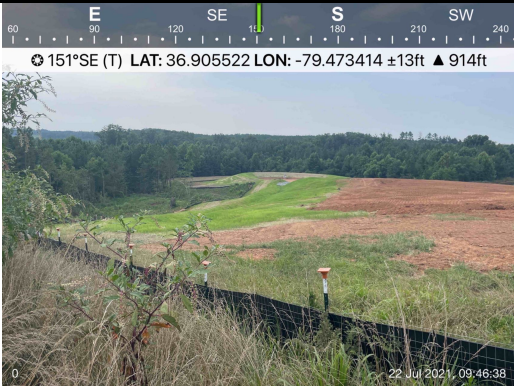
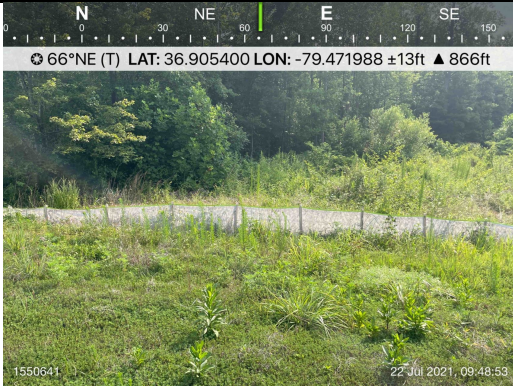
<b>GPS Location</b>	See photo		<b>GPS Location</b>	See photo	
<b>Field Station#</b>	15500+00		<b>Field Station#</b>	15506+41	
<b>Pic 5 Desc.</b>	No evidence of sedimentation from 3rd party disturbance.		<b>Pic 6 Desc.</b>	P1 is in good condition at all stream and wetland buffers.

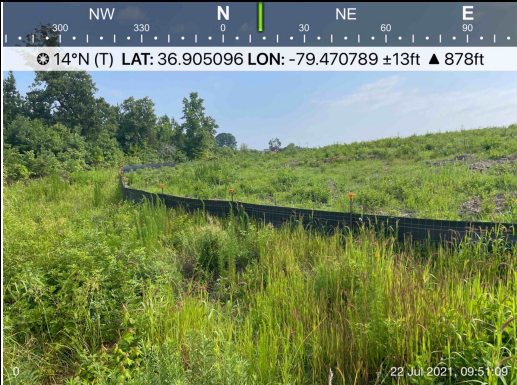
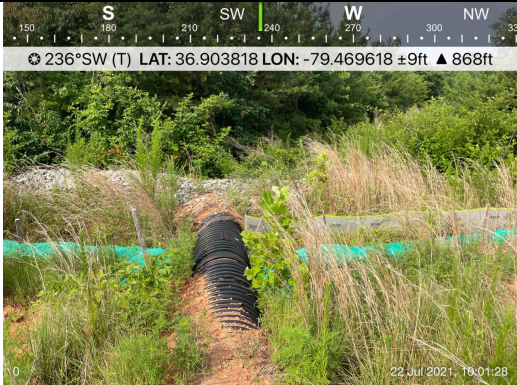
GPS Location	See photo		GPS Location	See photo	
Field Station#	15510+00		Field Station#	15515+00	
Pic 7 Desc.	3rd party ECDs appear to be in good condition.		Pic 8 Desc.	CWDs are functioning throughout this section.

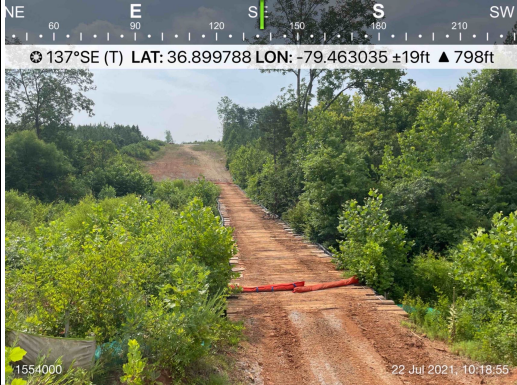
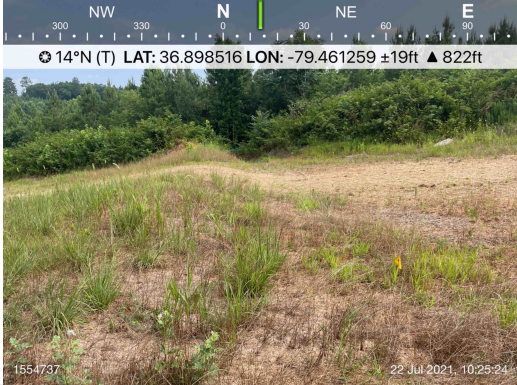
GPS Location	See photo		GPS Location	See photo	
Field Station#	15540+00		Field Station#	15547+37	
Pic 9 Desc.	Equipment bridge ECDs are in good condition and functioning.		Pic 10 Desc.	Warerbars are in good condition.

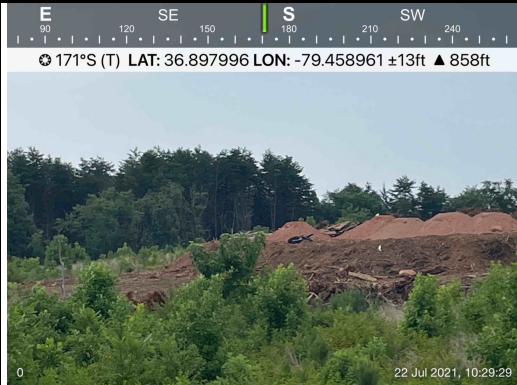
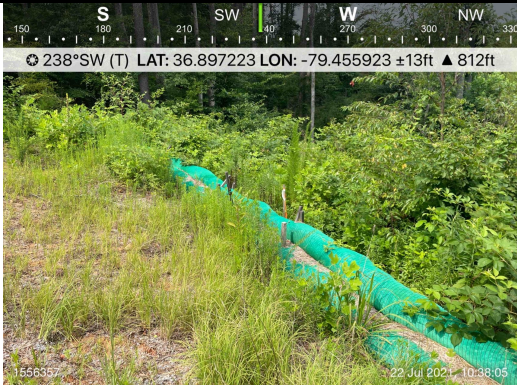
GPS Location	See photo		GPS Location	See photo	
Field Station#	15556+83		Field Station#	15563+57	
Pic 11 Desc.	No evidence of sedimentation from 3rd party disturbance disturbance. EI will continue to monitor this area.		Pic 12 Desc.	CFS is in good condition.

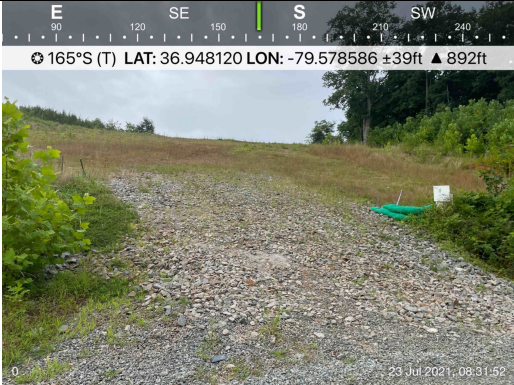
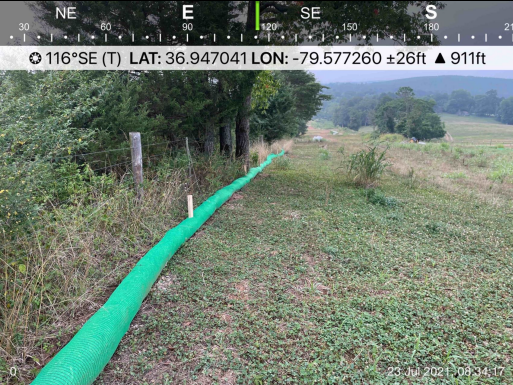
<b>GPS Location</b>	See photo		<b>GPS Location</b>	See photo	
<b>Field Station#</b>	15142+66		<b>Field Station#</b>	15150+00	
<b>Pic 1 Desc.</b>	RCEs are in good condition at all road crossings.		<b>Pic 2 Desc.</b>	Perimeter CFS is in good condition throughout this section.

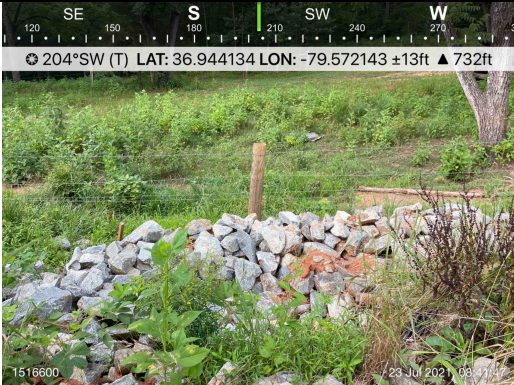
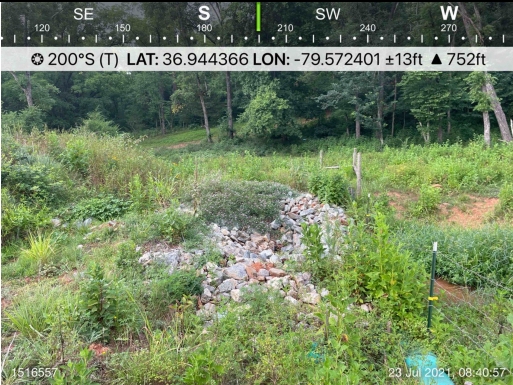
<b>GPS Location</b>	See photo		<b>GPS Location</b>	See photo	
<b>Field Station#</b>	15166+00		<b>Field Station#</b>	15165+57	
<b>Pic 3 Desc.</b>	Rock outlet is in good condition.		<b>Pic 4 Desc.</b>	Rock inlet remains in good condition.

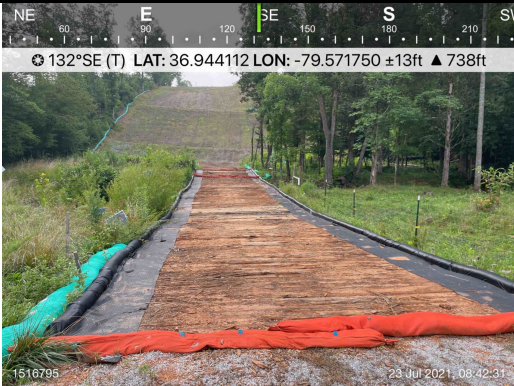
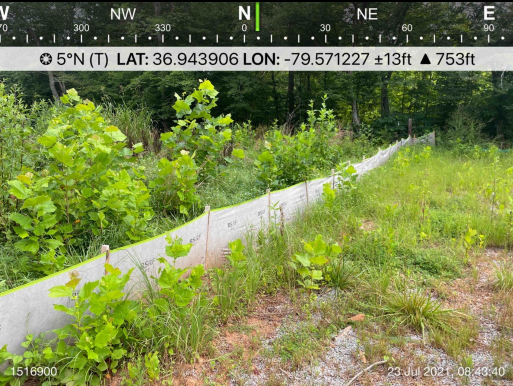
<b>GPS Location</b>	See photo		<b>GPS Location</b>	See photo	
<b>Field Station#</b>	15167+95		<b>Field Station#</b>	15169+00	
<b>Pic 5 Desc.</b>	Equipment bridge ECDs are in place and functioning.		<b>Pic 6 Desc.</b>	P1 is in good condition at this stream buffer.

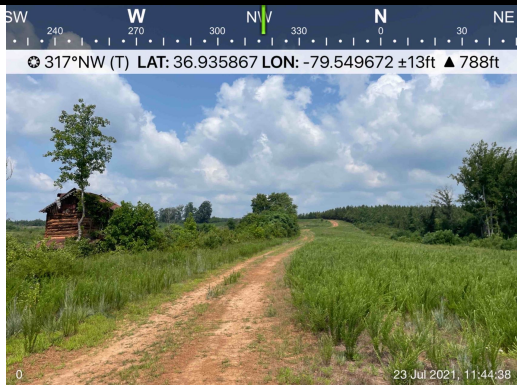
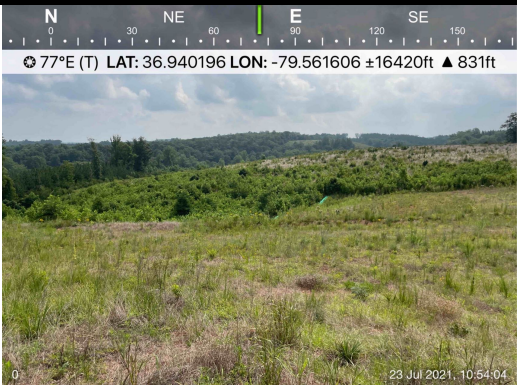
<b>GPS Location</b>	See photo		<b>GPS Location</b>	See photo	
<b>Field Station#</b>	15130+00		<b>Field Station#</b>	15260+00	
<b>Pic 11 Desc.</b>	Vegetation continues to fill in throughout this section.		<b>Pic 12 Desc.</b>	Vegetation continues to fill in throughout this section.

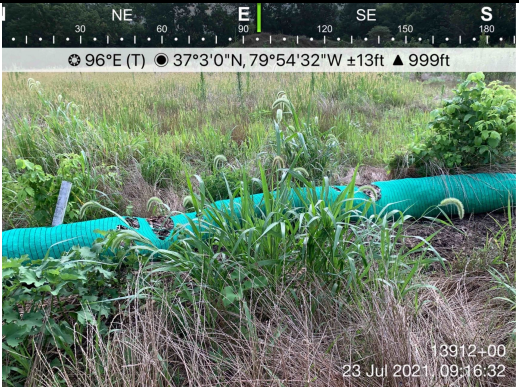
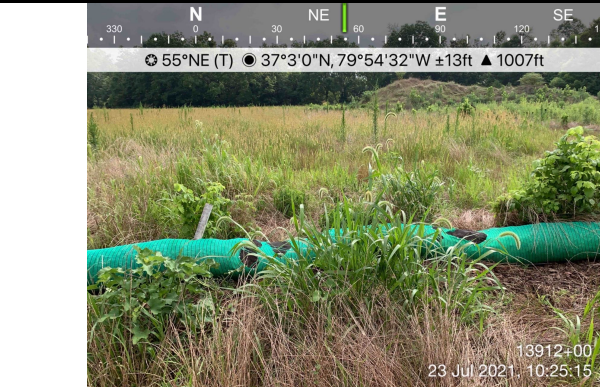
<p>55°NE (T) 37°3'0"N, 79°54'32"W ±13ft ▲ 1007ft</p> <p>13912+00 23 Jul 2021, 10:25:15</p>	
GPS Location	0		GPS Location	0	
Field Station#	13912+00		Field Station#	13912+00	
Pic 1 Desc.	Perimeter CFS damaged by third party traffic, contractor patched holes immediately		Pic 2 Desc.	Perimeter CFS after maintenance by the contractor

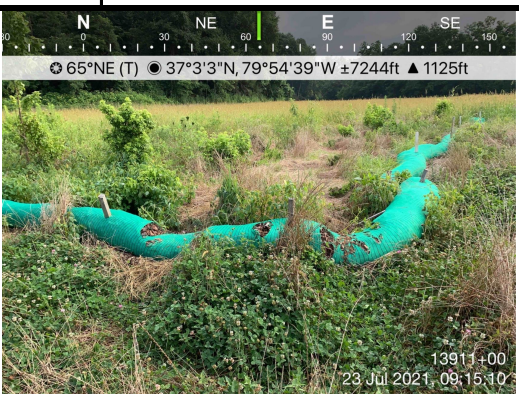
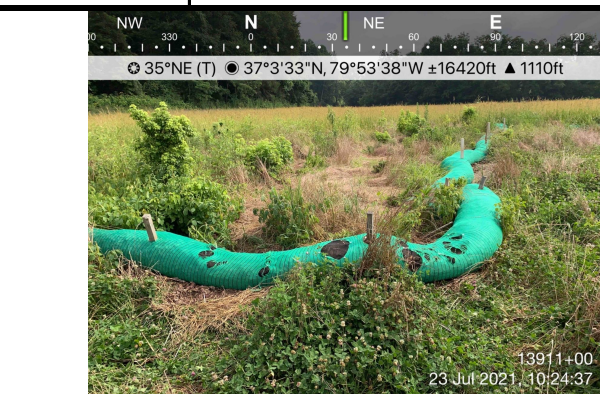
<p>35°NE (T) 37°3'33"N, 79°53'38"W ±16420ft ▲ 1110ft</p> <p>13911+00 23 Jul 2021, 10:24:37</p>	
GPS Location	0		GPS Location	0	
Field Station#	13911+00		Field Station#	13911+00	
Pic 3 Desc.	Perimeter CFS damaged by third party traffic, contractor patched holes immediately		Pic 4 Desc.	Perimeter CFS after maintenance by the contractor

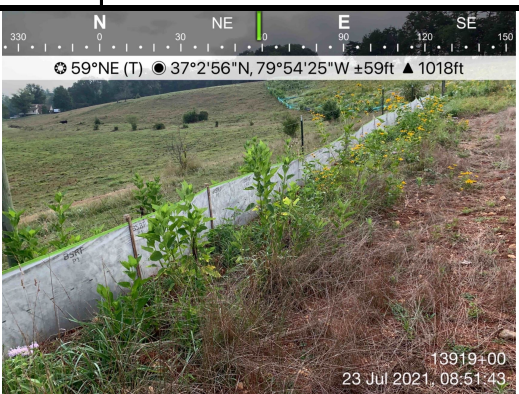
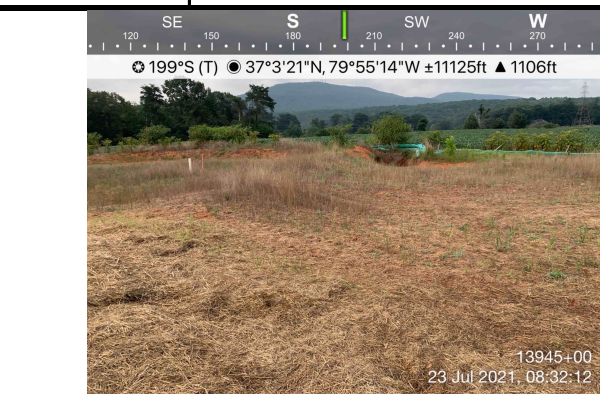
<p>199°S (T) 37°3'21"N, 79°55'14"W ±11125ft ▲ 1106ft</p> <p>13945+00 23 Jul 2021, 08:32:12</p>	
GPS Location	0		GPS Location	0	
Field Station#	13919+00		Field Station#	13945+00	
Pic 5 Desc.	P1 silt fence in acceptable condition		Pic 6 Desc.	Waterbar in acceptable condition

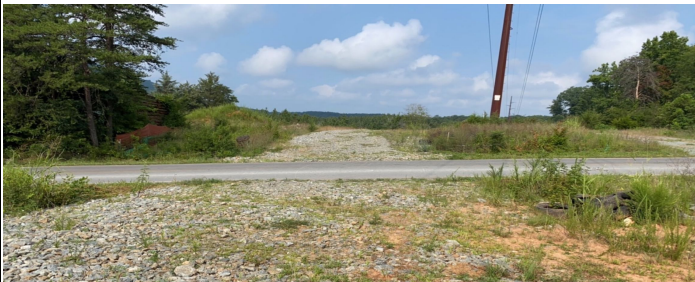
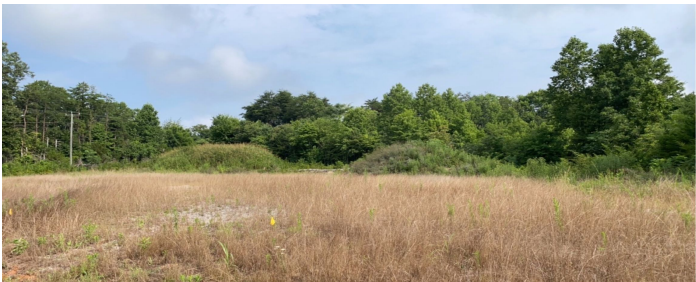
36°59'17" N 79°42'36" W 173°S COURSE 6' GPS 1558-2498 Jacks Creek Rd, Union Hall, VA 24176, United States 07.23.2021 10:04:33 Accur +/-15.4 Ft ALT 962 Ft			36°59'17" N 79°42'33" W 324°NW COURSE 289' GPS Sorry no results found 07.23.2021 10:06:46 Accur +/-15.4 Ft ALT 945 Ft		
GPS Location	1		GPS Location	2	
Field Station#	14694+77		Field Station#	14696+00	
Pic 1 Desc.	RCE at Jacks Creek Rd in good condition.		Pic 2 Desc.	Extra workspace GAS Jacks Creek Rd. Spoil piles stabilized and vegetated.

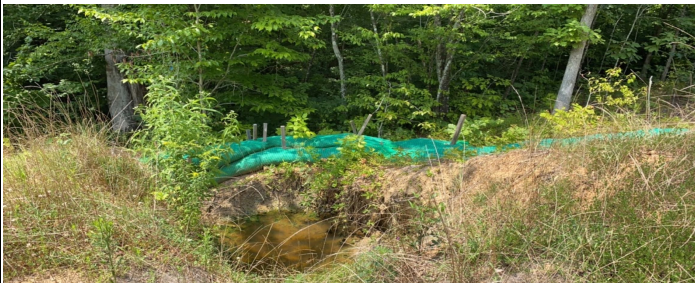
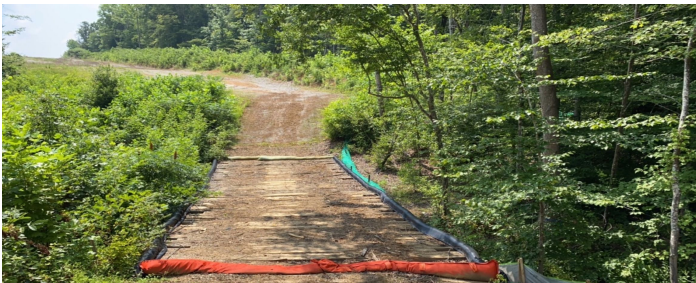
36°58'41" N 79°40'51" W 186°S COURSE 0' GPS 07.23.2021 11:58:46 Accur +/-91.9 Ft ALT 0 Ft			36°58'41" N 79°40'51" W 156°SE COURSE 155' GPS 07.23.2021 11:58:59 Accur +/-37.7 Ft ALT 887 Ft		
GPS Location	3		GPS Location	4	
Field Station#	14791+00		Field Station#	14794+24	
Pic 3 Desc.	Sump pit and CFS end treatment in good condition.		Pic 4 Desc.	Equipment bridge and surrounding ECDs in place and functional at stream crossing and resource buffer.

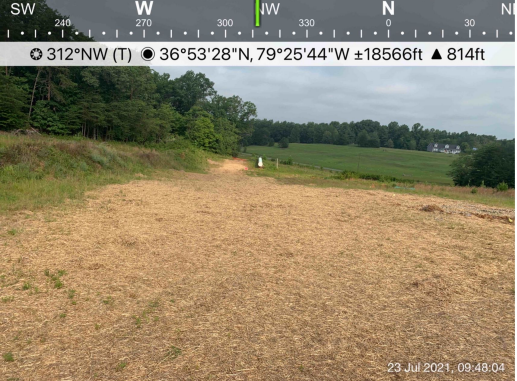
GPS Location	O	GPS Location	O		
Field Station#	15640+00	Field Station#	15616+00		
Pic 1 Desc.	Observing temporary stabilization, sump and end treatment		Pic 2 Desc.	Observing temporary stabilization and water bars
