Visual Site Inspection Report

Project Name	H-600 Pipeline Spread I	AFE	124300139	Spread	H-600 Pipeline Spread I
Contractor	Precision			Report #	26291
Inspector	Ben Davenport			Date/Time	7/26/2021 1:59 PM
Permit #	TBD	Inspection Type	VA SWPP	Station Begin	14802+19
State	VA	Inspection Area	Partial	Station End	14928+52
County	Franklin	Ground	Dry	Temperature (°F)	88.00
Municipality	N/A	Weather	Sunny	Rain Gauge (in)	0.00
				Rain Accumulation Time (days)	0.00

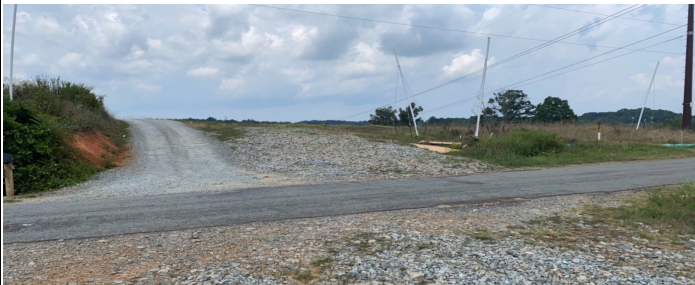
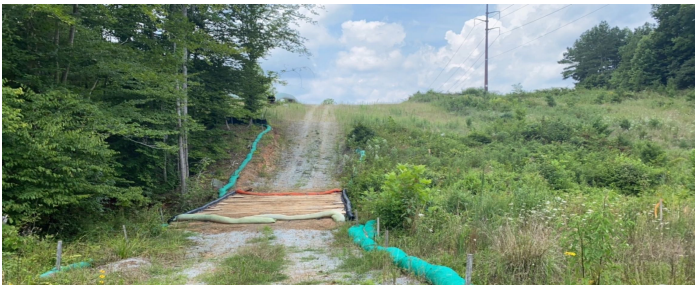
Pic 3 Desc.	RCE at Ramsey Memorial Rd in good condition		Pic 4 Desc.	Equipment bridge and surrounding ECDs in place and functional at stream crossing and resource buffer

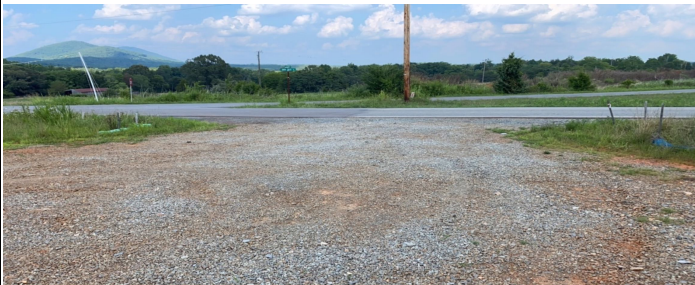
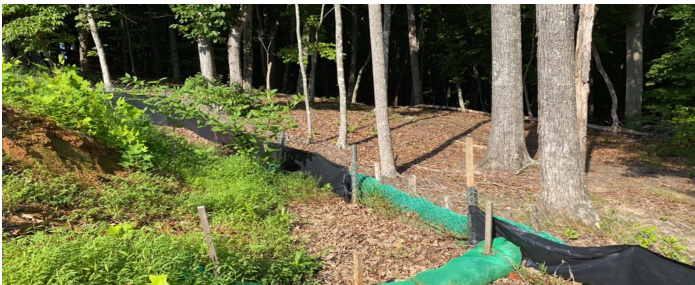
Pic 3 Desc.	Approach at Snow Creek Rd extra workspace in good condition		Pic 4 Desc.	Perimeter SSF and CFS J Hook in good condition

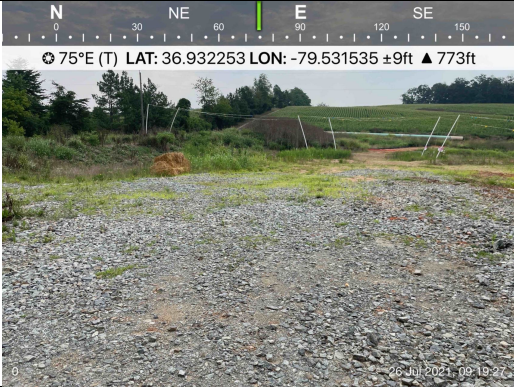
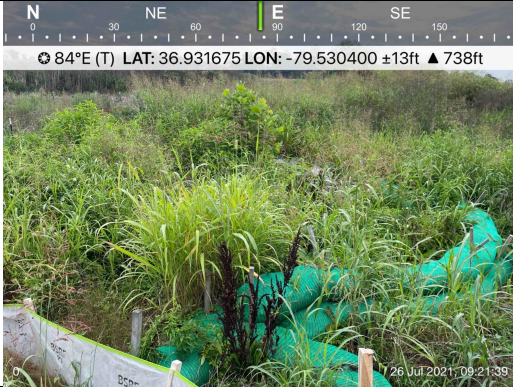
GPS Location	See photo		GPS Location	See photo	
Field Station#	15296+00		Field Station#	15299+00	
Pic 1 Desc.	RCEs are in good condition at all road crossings.		Pic 2 Desc.	CWD is in good condition.

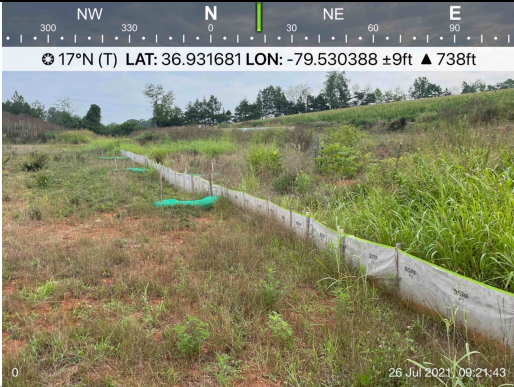
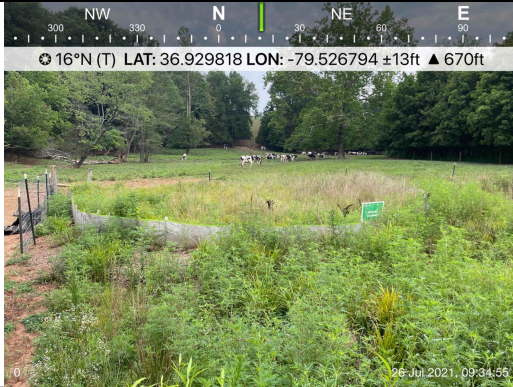
GPS Location	See photo		GPS Location	See photo	
Field Station#	15299+00		Field Station#	15311+87	
Pic 3 Desc.	P1 is in good condition along this drainage.		Pic 4 Desc.	Wetland buffer P1 is in good condition.

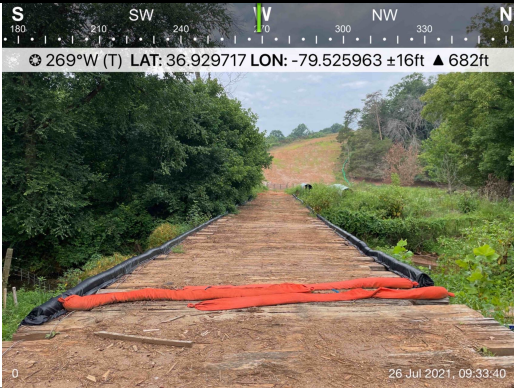
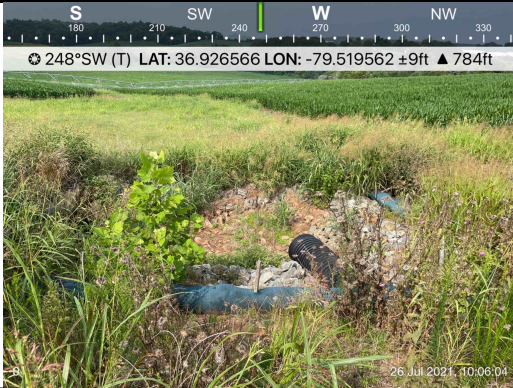
GPS Location	See photo		GPS Location	See photo	
Field Station#	15314+19		Field Station#	15338+00	
Pic 5 Desc.	Equipment bridge ECDs are in good condition and functioning.		Pic 6 Desc.	CWD is functioning as intended.

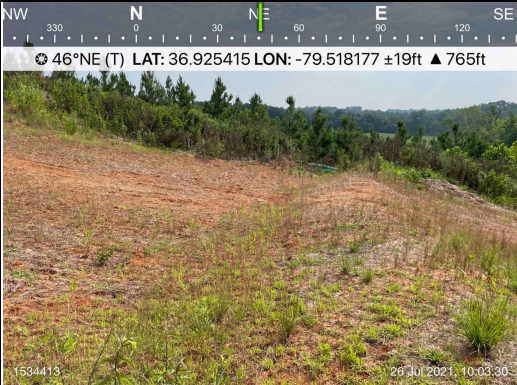
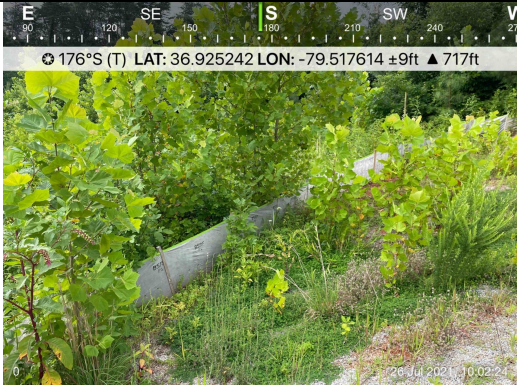
GPS Location	See photo		GPS Location	See photo	
Field Station#	15344+13		Field Station#	15346+20	
Pic 7 Desc.	Waterbars are in good condition throughout this section.		Pic 8 Desc.	P1 is in good condition at all stream and wetland buffers.

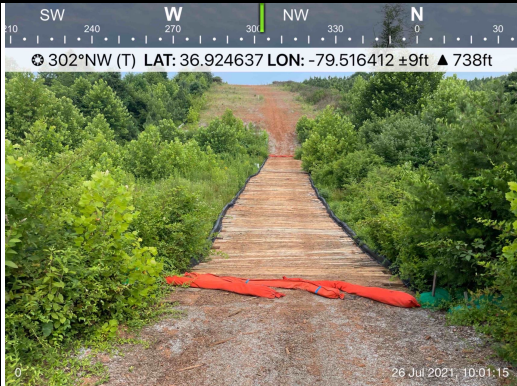
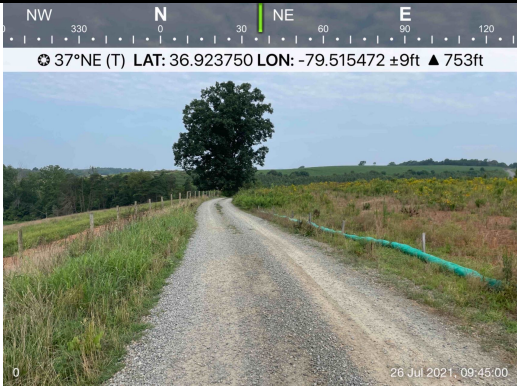
GPS Location	See photo		GPS Location	See photo	
Field Station#	15347+00		Field Station#	15350+00	
Pic 9 Desc.	Equipment bridge ECDs are in good condition.		Pic 10 Desc.	MVP-PI-332 is in good condition with controls in place.

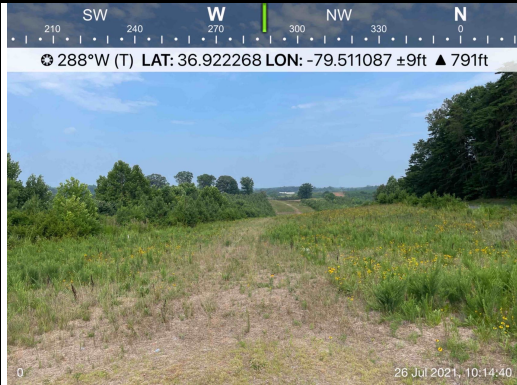
<div>Insert image here</div>			
GPS Location	See photo		GPS Location		
Field Station#	15370+00		Field Station#		
Pic 11 Desc.	Vegetation continues to fill in throughout this section.		Pic 12 Desc.

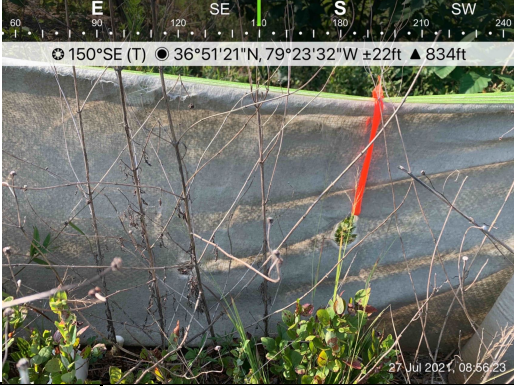
GPS Location	O	GPS Location	O		
Field Station#	15827+00	Field Station#	15858+00		
Pic 1 Desc.	Observing P1 that requires maintenance	Pic 2 Desc.	Observing temporary stabilization, water bar and CFS checks.

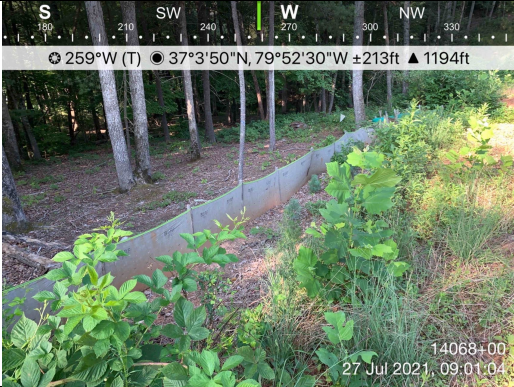
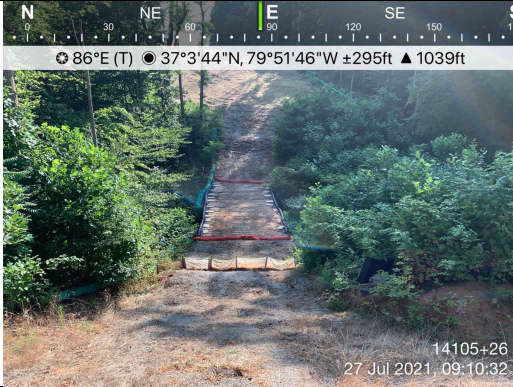
GPS Location	0	GPS Location	0		
Field Station#	14068+00	Field Station#	14105+26		
Pic 1 Desc.	P1 silt fence in acceptable condition	Pic 2 Desc.	P1 silt fence and equipment bridge in acceptable conditions

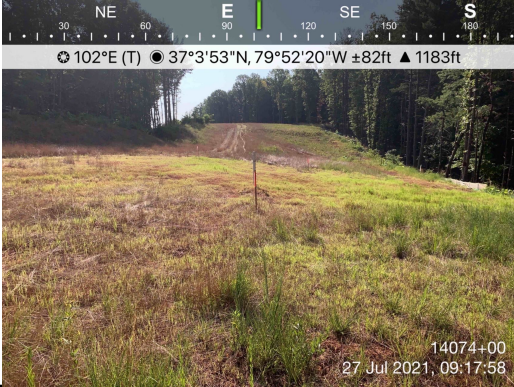
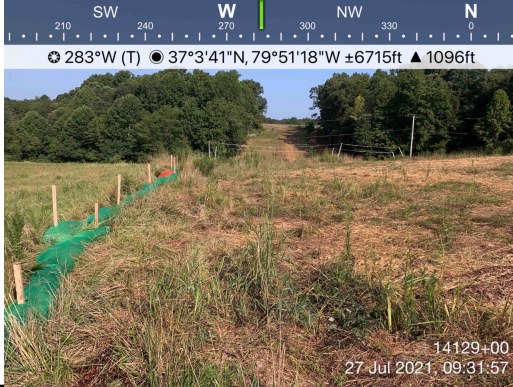
GPS Location	0	GPS Location	0		
Field Station#	14074+00	Field Station#	14129+00		
Pic 3 Desc.	Temporary vegetative stabilization in acceptable condition	Pic 4 Desc.	Perimeter CFS and temporary vegetative stabilization in acceptable condition

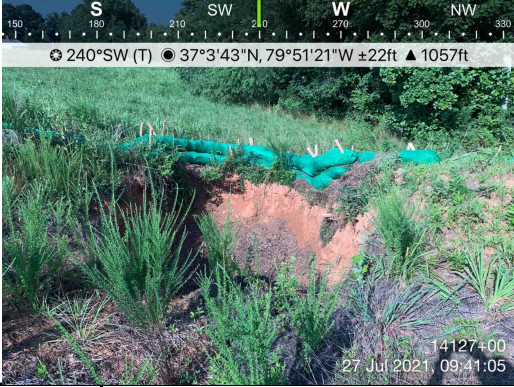
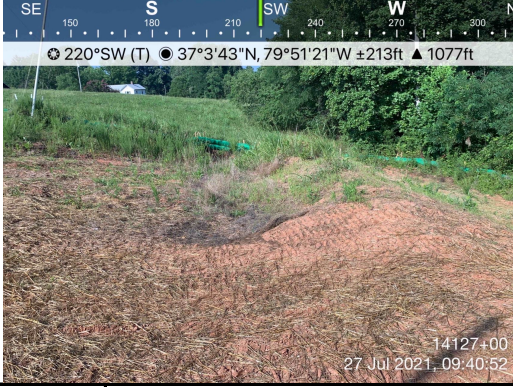
GPS Location	0	GPS Location	0		
Field Station#	14127+00	Field Station#	14127+00		
Pic 5 Desc.	Waterbar end treatment in acceptable condition	Pic 6 Desc.	Waterbar in acceptable condition

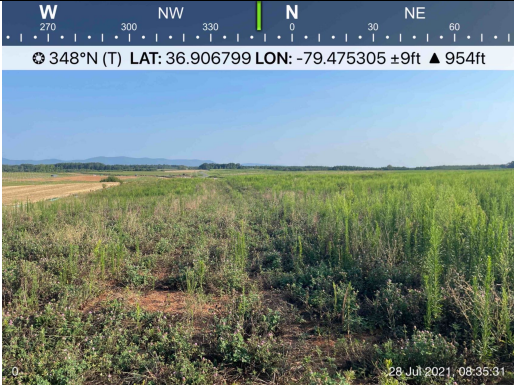
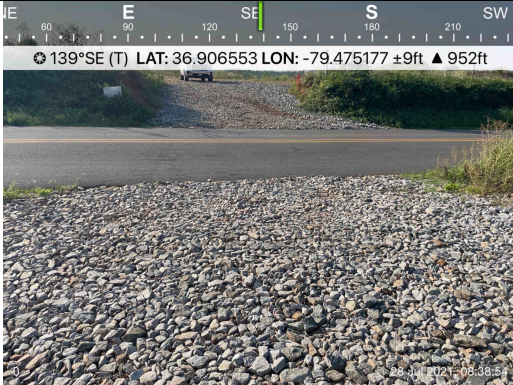
GPS Location	See photo		GPS Location	See photo	
Field Station#	15495+00		Field Station#	15496+70	
Pic 1 Desc.	Vegetation continues to fill in throughout this section of ROW.		Pic 2 Desc.	RCEs are in good condition at all road crossings.

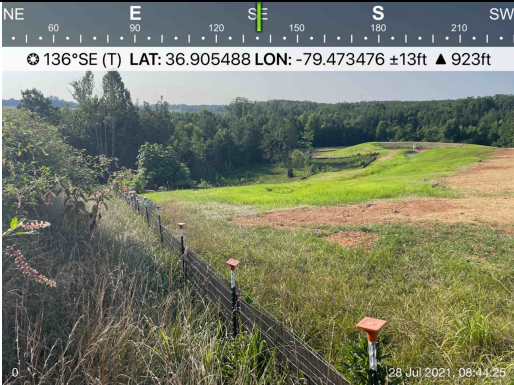
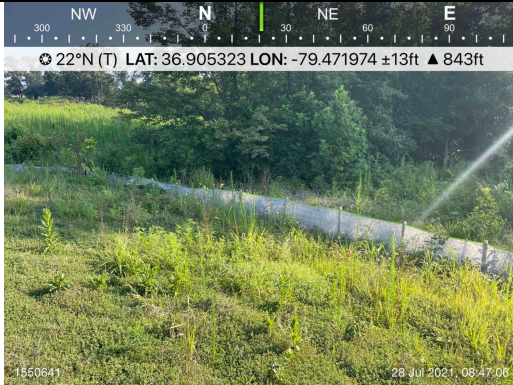
GPS Location	See photo		GPS Location	See photo	
Field Station#	15502+00		Field Station#	15506+41	
Pic 3 Desc.	No evidence of sedimentation from 3rd party disturbance.		Pic 4 Desc.	P1 is in good condition at all stream and wetland crossings.

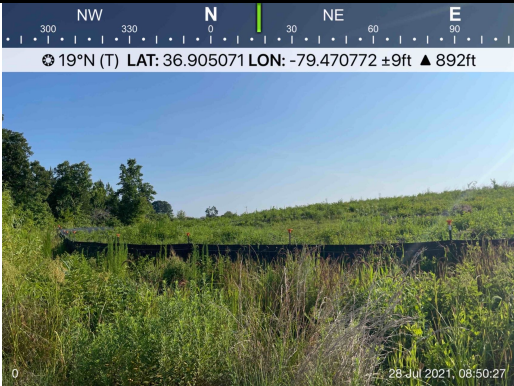
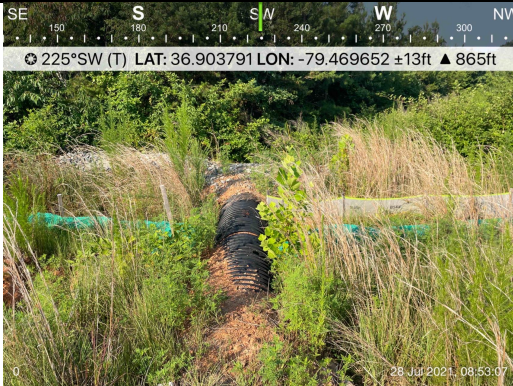
GPS Location	See photo		GPS Location	See photo	
Field Station#	15510+00		Field Station#	15515+00	
Pic 5 Desc.	3rd party ECDs appear to be in good condition with no evidence of sedimentation.		Pic 6 Desc.	CWDs are functioning as intended throughout this section.

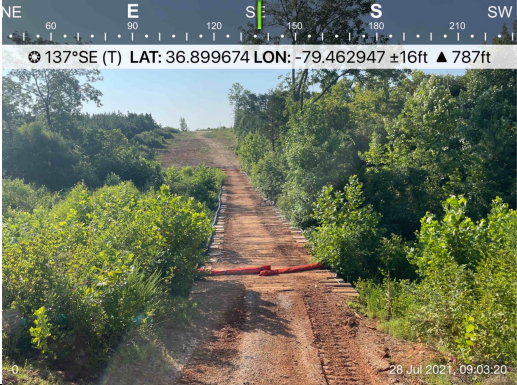
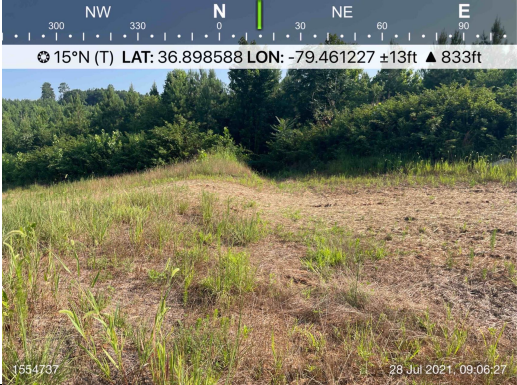
GPS Location	See photo		GPS Location	See photo	
Field Station#	15540+00		Field Station#	15547+37	
Pic 7 Desc.	Equipment bridge ECDs are in place and functioning.		Pic 8 Desc.	Waterbars are in good condition and functioning.

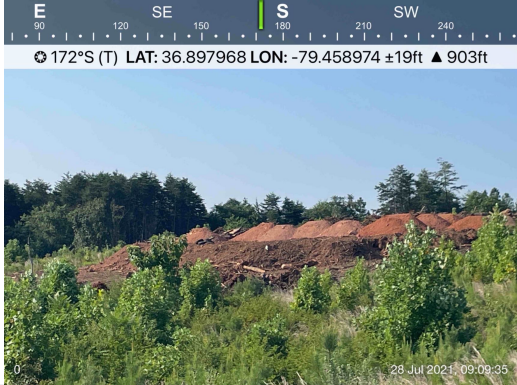
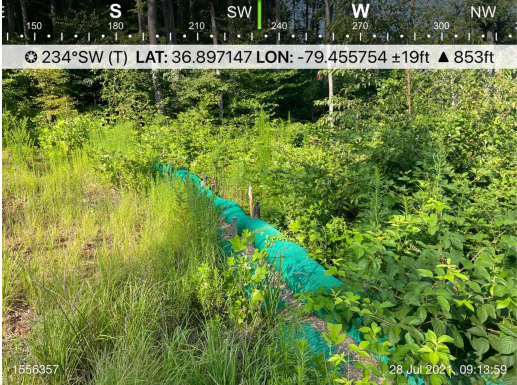
GPS Location	See photo		GPS Location	See photo	
Field Station#	15556+83		Field Station#	15563+57	
Pic 9 Desc.	No evidence of sedimentation from 3rd party disturbance into S-CC9. EI will continue to monitor this area.		Pic 10 Desc.	CFS is in good condition.

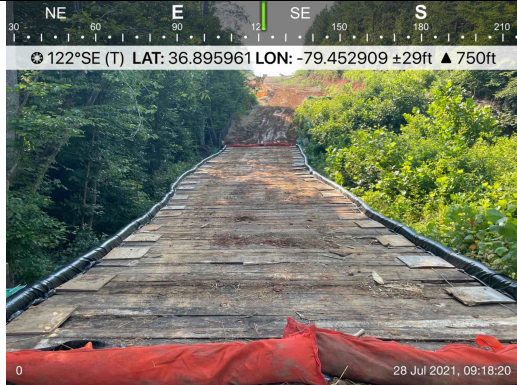
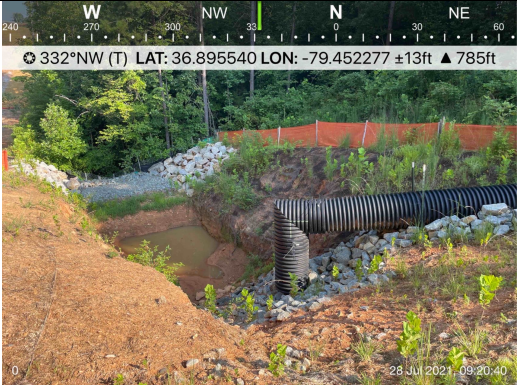
GPS Location	See photo		GPS Location	See photo	
Field Station#	15573+54		Field Station#	15574+87	
Pic 11 Desc.	Recently repaired equipment bridge is in good condition.		Pic 12 Desc.	Slope drain remains in good condition and functioning.

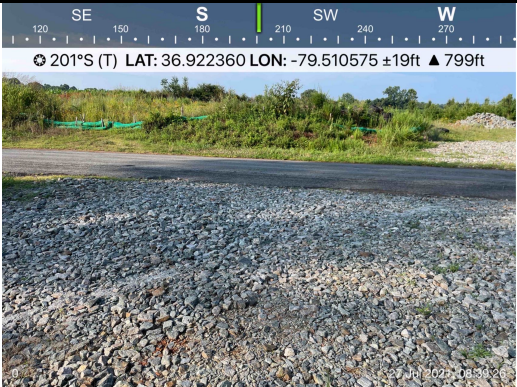
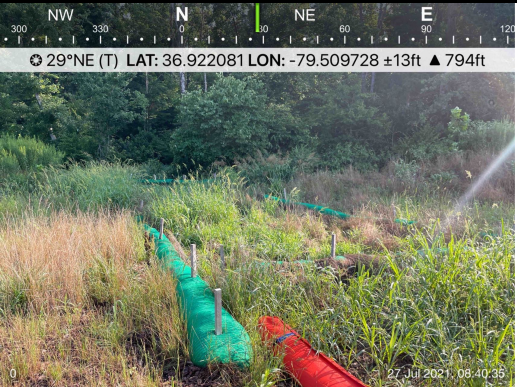
GPS Location	See photo		GPS Location	See photo	
Field Station#	15370+62		Field Station#	15375+00	
Pic 1 Desc.	RCEs are in good condition at all road crossings.		Pic 2 Desc.	Drainage ECDs are in place and functioning.

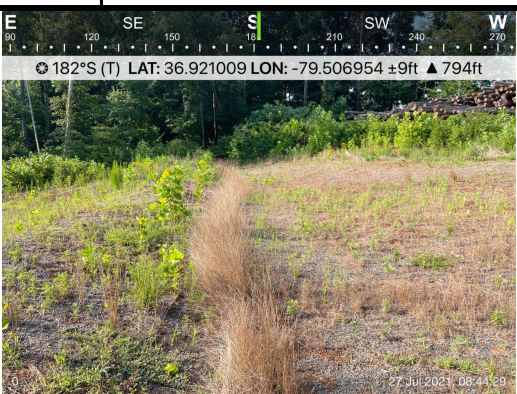
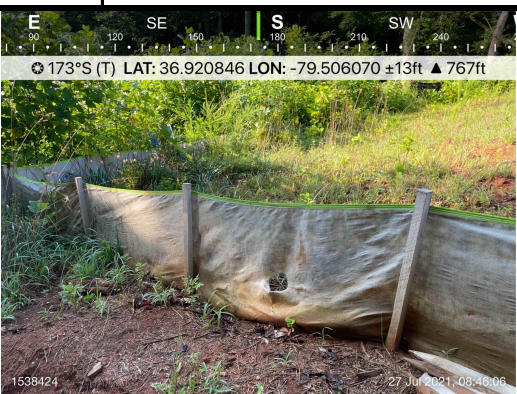
GPS Location	See photo		GPS Location	See photo	
Field Station#	15380+00		Field Station#	15384+24	
Pic 3 Desc.	Waterbars are in good condition and functioning throughout this section.		Pic 4 Desc.	P1 has been damaged and needs to be replaced at this stream buffer.

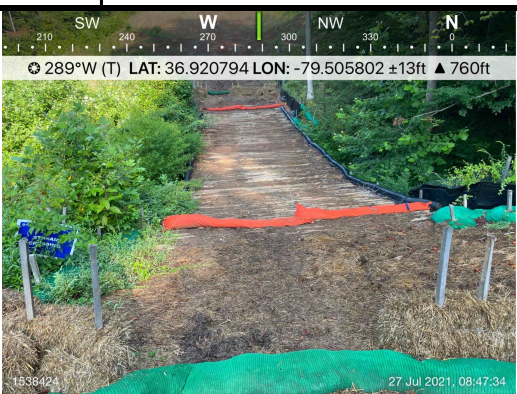
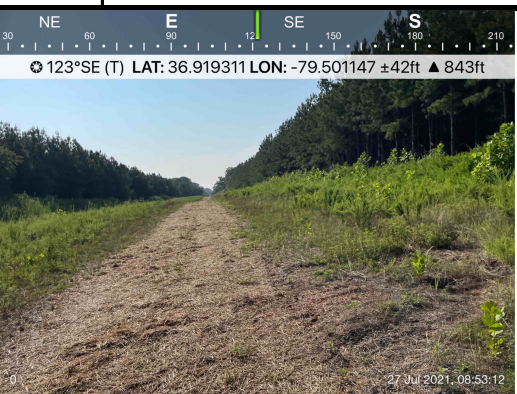
GPS Location	See photo		GPS Location	See photo	
Field Station#	15384+74		Field Station#	15400+00	
Pic 5 Desc.	Equipment bridge ECDs are in good condition and functioning.		Pic 6 Desc.	Vegetation continues to fill in throughout this section of ROW.

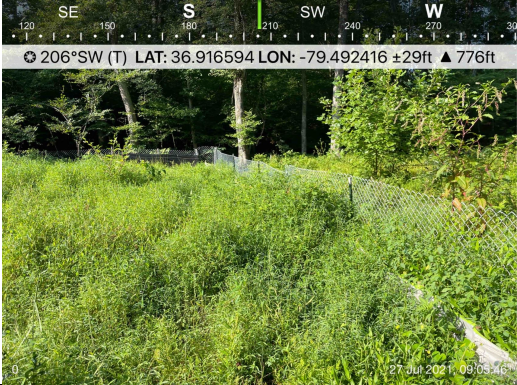
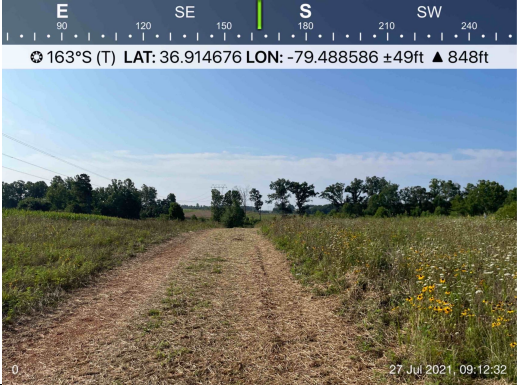
GPS Location	See photo		GPS Location	See photo	
Field Station#	15427+00		Field Station#	15440+00	
Pic 7 Desc.	Reinforced P1 remains in good condition.		Pic 8 Desc.	Vegetation continues to fill in throughout this section of ROW.

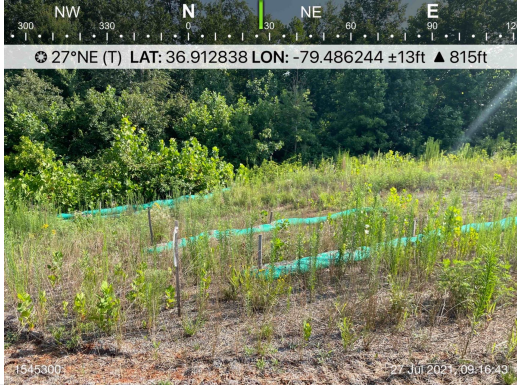
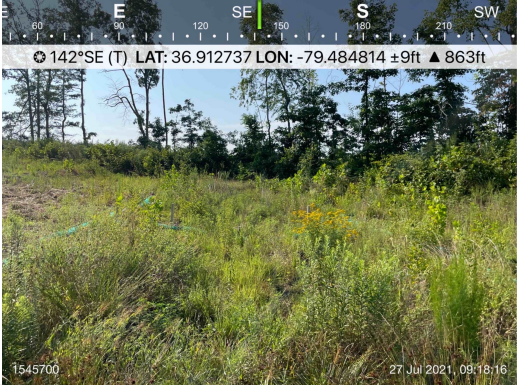
GPS Location	See photo		GPS Location	See photo	
Field Station#	15453+00		Field Station#	15457+00	
Pic 9 Desc.	CWD is in good condition with no evidence of sedimentation from 3rd party disturbance.		Pic 10 Desc.	Drainage ECDs are in place and functioning with no evidence of sedimentation from 3rd party disturbance.

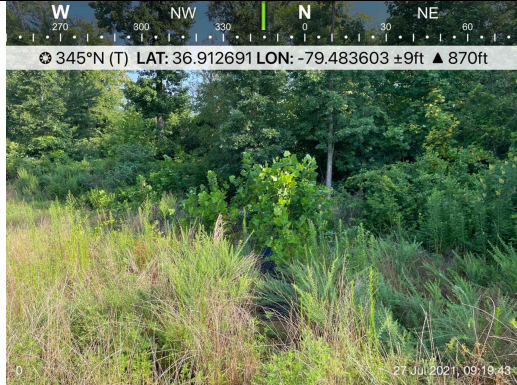
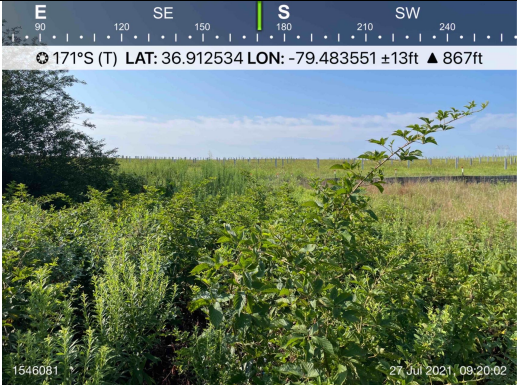
GPS Location	See photo		GPS Location	See photo	
Field Station#	15460+81		Field Station#	15460+81	
Pic 11 Desc.	CWD is in good condition with no evidence of sedimentation from 3rd party disturbance.		Pic 12 Desc.	CWD inlet remains in good condition with no evidence of sedimentation from 3rd party disturbance.

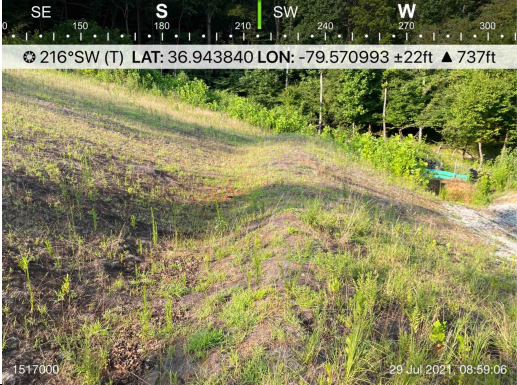
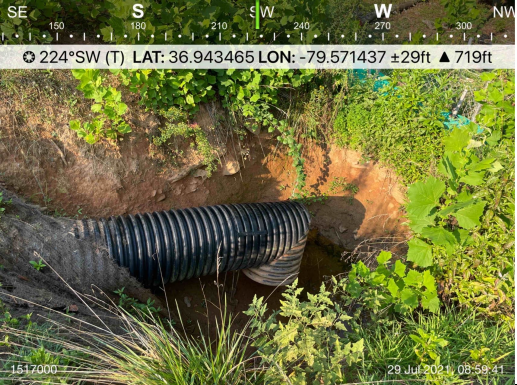
GPS Location	See photo		GPS Location	See photo	
Field Station#	15170+00		Field Station#	15170+00	
Pic 7 Desc.	Waterbars are in good condition.		Pic 8 Desc.	Slope drain is functioning as intended.

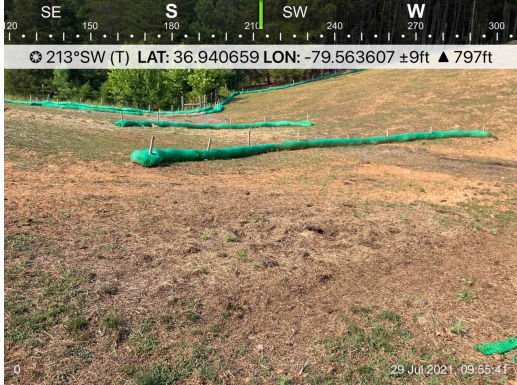
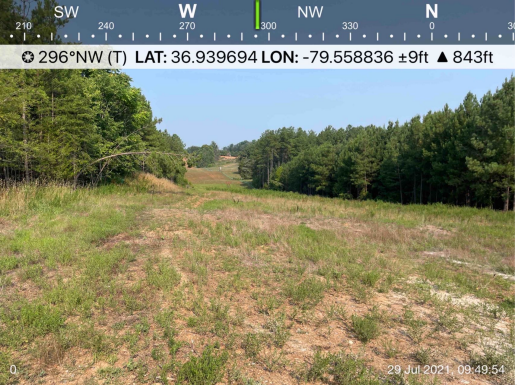
GPS Location	See photo		GPS Location	See photo	
Field Station#	15195+00		Field Station#	15209+00	
Pic 9 Desc.	Drainage ECDs are in place and functioning.		Pic 10 Desc.	Vegetation continues to fill in throughout this section of ROW.

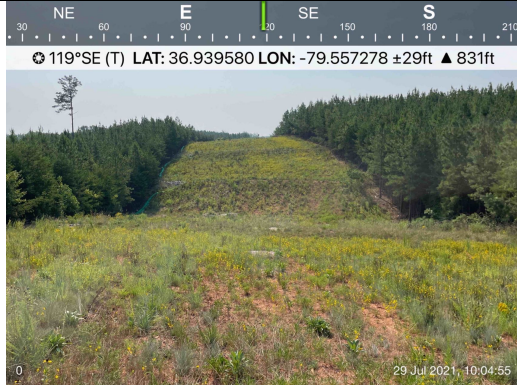
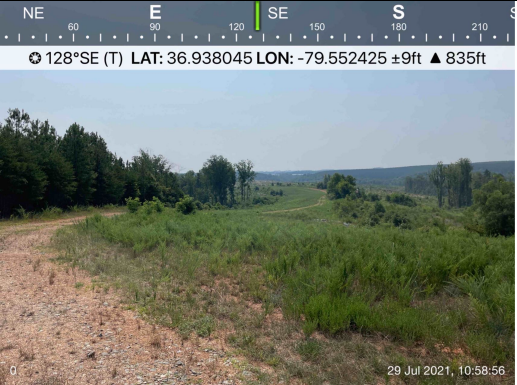
GPS Location	See photo		GPS Location	See photo	
Field Station#	15215+00		Field Station#	15230+00	
Pic 11 Desc.	Drainage features and permanent waterbars are in good condition throughout restored sections of ROW.		Pic 12 Desc.	Vegetation continues to fill in throughout this section.

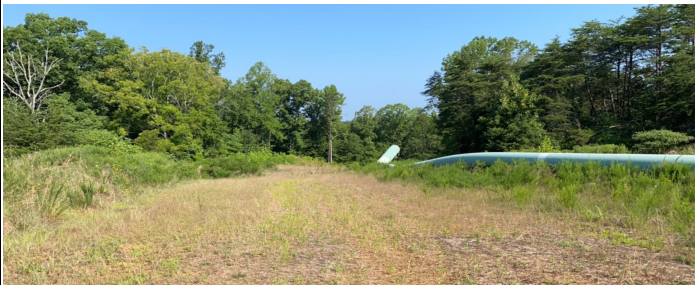
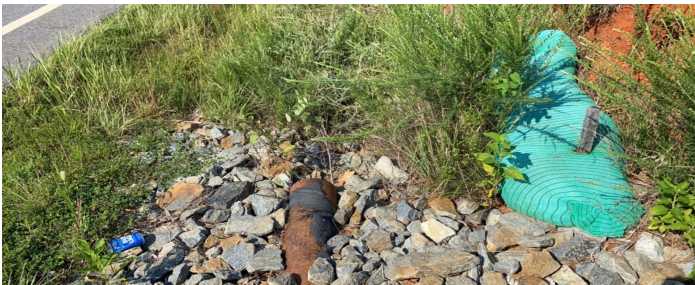
Field Station#	15107+75	Field Station#	15113+00		
Pic 3 Desc.	ROW stabilized and vegetated in temporary area		Pic 4 Desc.	Culvert at road crossing in good condition

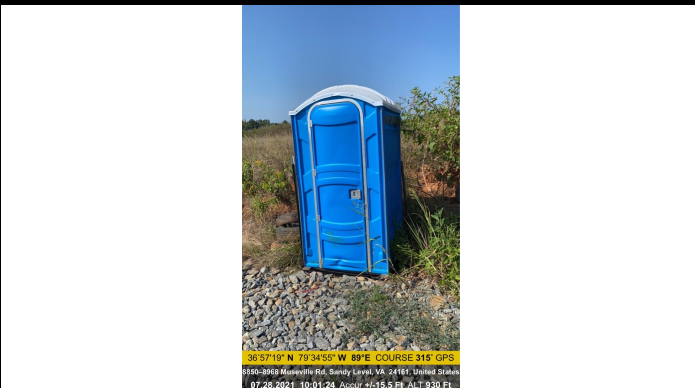
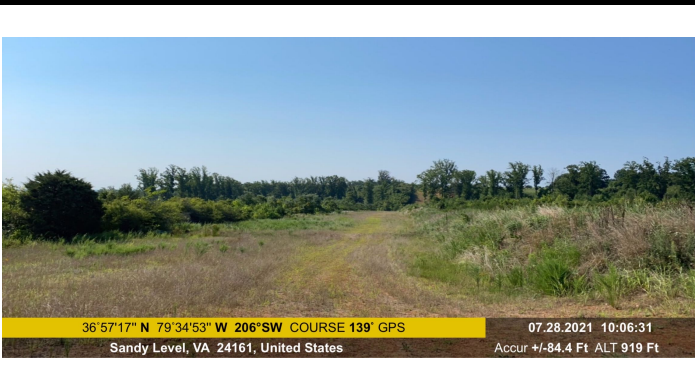
36°57'19" N 79°34'55" W 89°E COURSE 315' GPS 8890-8969 Museville Rd, Sandy Level, VA 24161, United States 07.28.2021 10:01:24 Accur +/-15.5 Ft ALT 930 Ft			36°57'17" N 79°34'53" W 206°SW COURSE 139' GPS Sandy Level, VA 24161, United States 07.28.2021 10:06:31 Accur +/-84.4 Ft ALT 919 Ft		
GPS Location	5	GPS Location	6		
Field Station#	15113+00	Field Station#	15121+00		
Pic 5 Desc.	Portajon has necessary containment underneath to protect from spills		Pic 6 Desc.	ROW stabilized and vegetated in temporary area

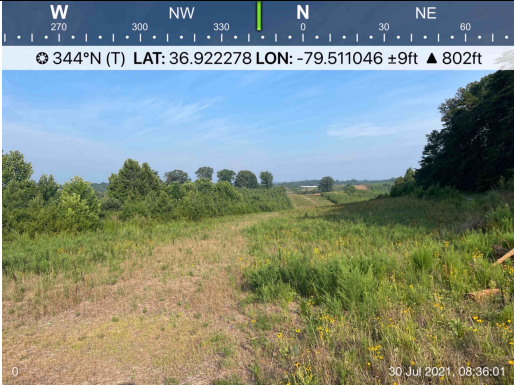
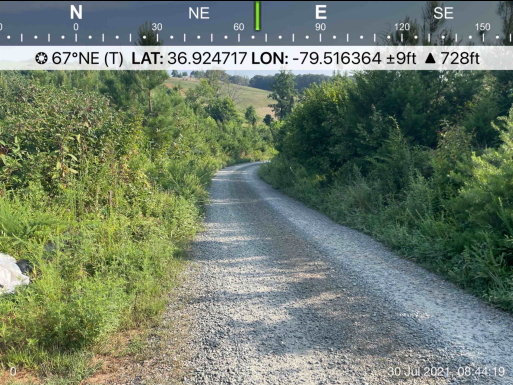
GPS Location	See photo		GPS Location	See photo	
Field Station#	15370+00		Field Station#	15350+00	
Pic 1 Desc.	Vegetation continues to fill in throughout this section of ROW.		Pic 2 Desc.	MVP-PI-332 remains in good condition with controls in place.

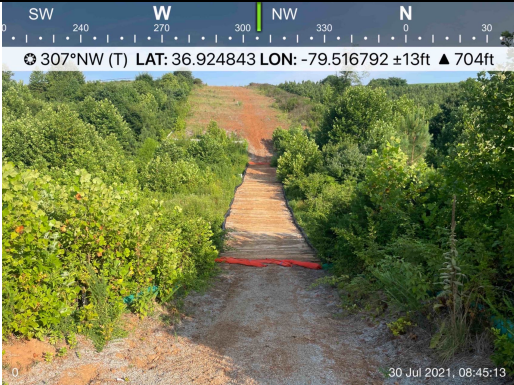
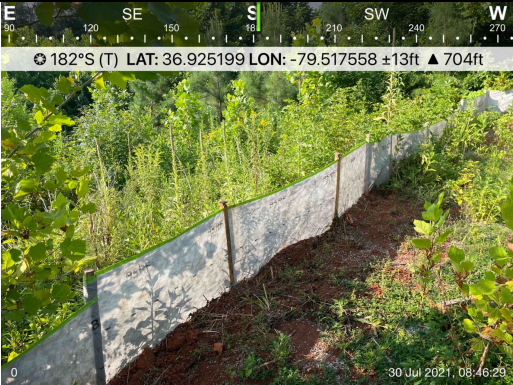
GPS Location	See photo		GPS Location	See photo	
Field Station#	15346+90		Field Station#	15346+20	
Pic 3 Desc.	Equipment bridge ECDs are in place and functioning as intended.		Pic 4 Desc.	P1 is in good condition at all stream and wetland buffers.

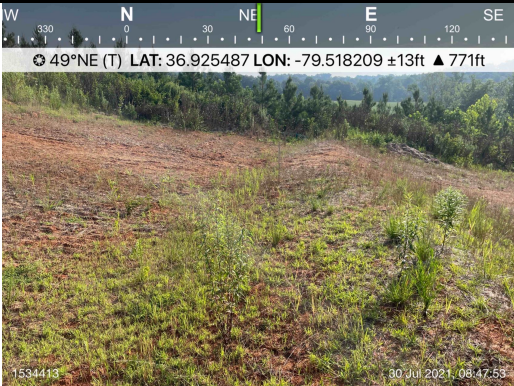
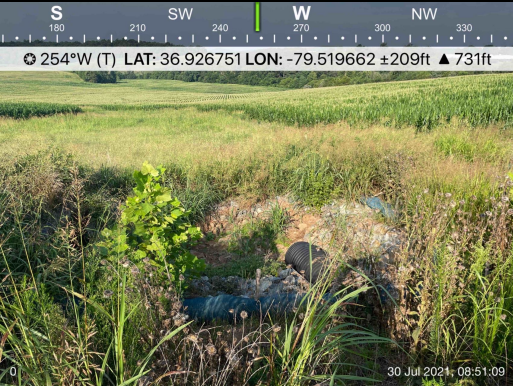
GPS Location	See photo		GPS Location	See photo	
Field Station#	15344+13		Field Station#	15338+00	
Pic 5 Desc.	Waterbars are functioning as intended.		Pic 6 Desc.	CWDs are in good condition and functioning.

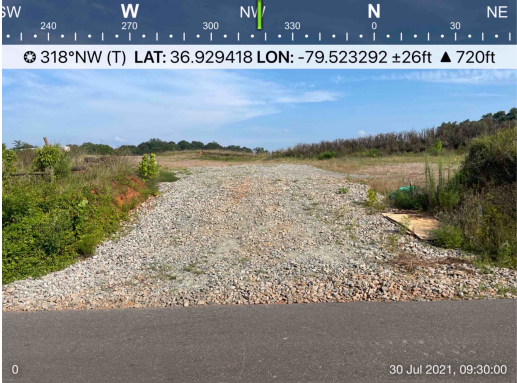
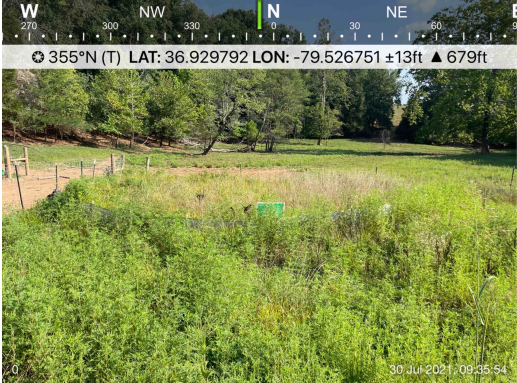
GPS Location	See photo		GPS Location	See photo	
Field Station#	15323+24		Field Station#	15311+87	
Pic 7 Desc.	RCEs are in good condition at all road crossings.		Pic 8 Desc.	Wetland buffer P1 is in good condition.

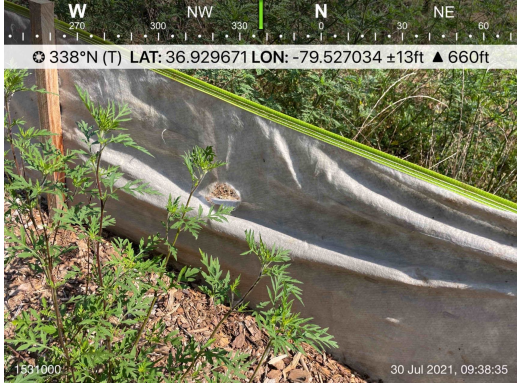
GPS Location	See photo		GPS Location	See photo	
Field Station#	15310+00		Field Station#	15310+00	
Pic 9 Desc.	P1 has been damaged and needs to be replaced.		Pic 10 Desc.	Environmental crew has corrected this issue.

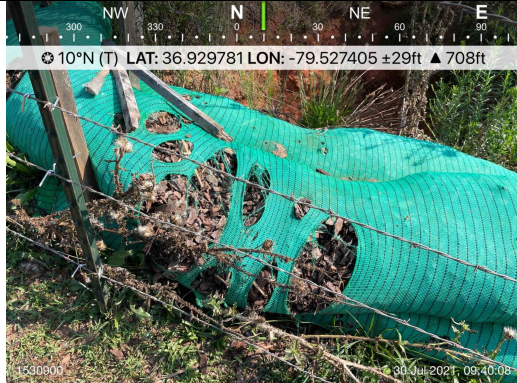
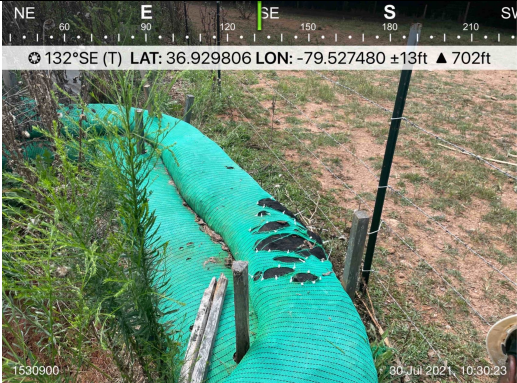
GPS Location	See photo		GPS Location	See photo	
Field Station#	15309+00		Field Station#	15309+00	
Pic 11 Desc.	CFS has been damaged and needs to be repaired.		Pic 12 Desc.	Environmental crew has corrected this issue.

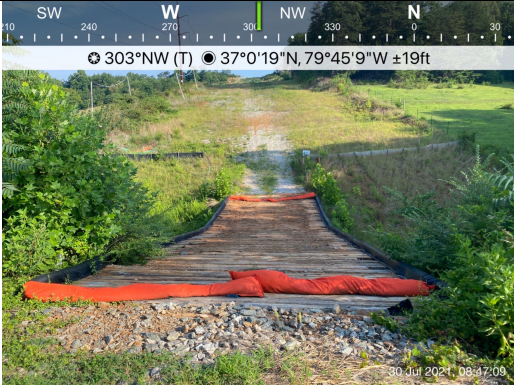
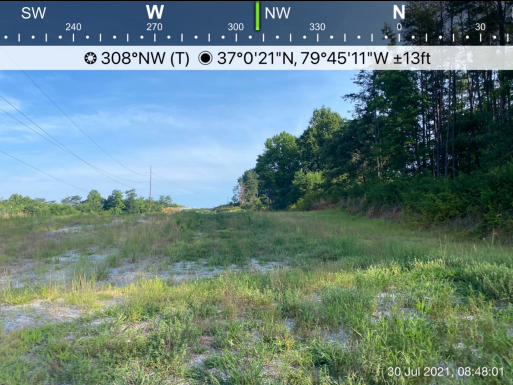
GPS Location	0	GPS Location	0		
Field Station#	14546+33	Field Station#	14536+90		
Pic 1 Desc.	Approximately 14546+33. Overview of stream crossing, equipment bridge and ECDs at stream S-G17.		Pic 2 Desc.	Approximately 14536+90. Overview of ROW.
