Visual Site Inspection Report

| Project Name | H-600 Pipeline Spread I | AFE | 124300139 | Spread | H-600 Pipeline Spread I |

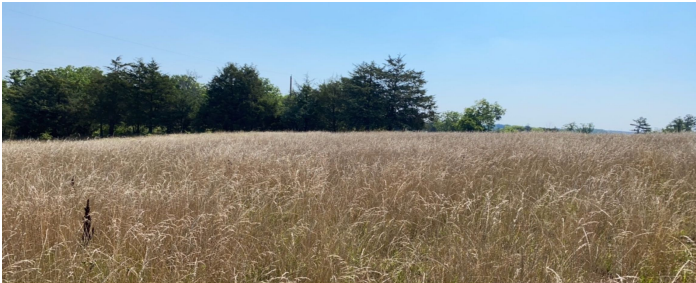
| Pic 1 Desc. | Contractor replaced P1 silt fence per punch list item. | | Pic 2 Desc. | ROW stabilized and vegetated in final cleanup area. Noticeable use of travel lane. | |

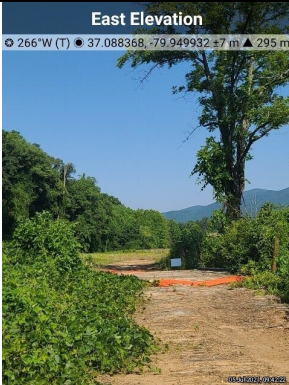
| Pic 1 Desc. | Stream observation photo facing upstream during routine inspection today. No issues observed at the time of inspection. | | Pic 2 Desc. | Monitored stabilization on spoil piles. Good coverage noted, no environmental issues observed at the time of inspection. | |

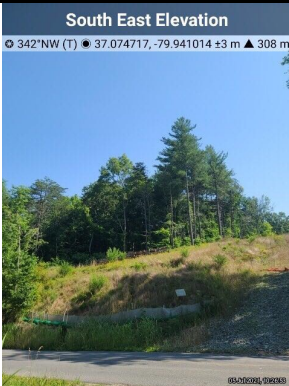
| Pic 3 Desc. | Monitored equipment bridge and protection. Ecds in place . Good vegetation noted. No environmental issues observed at the time of inspection. | | Pic 4 Desc. | Monitored Erosion control blanket on stream bank S-E28 where equipment mats were previously removed during maintenance | |

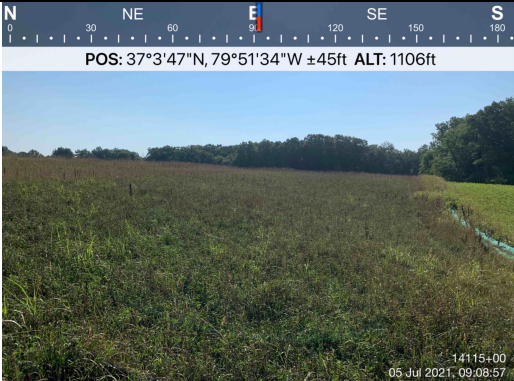
| Pic 1 Desc. | P1 silt fence in acceptable condition | Pic 2 Desc. | Perimeter CFS in acceptable condition | | |

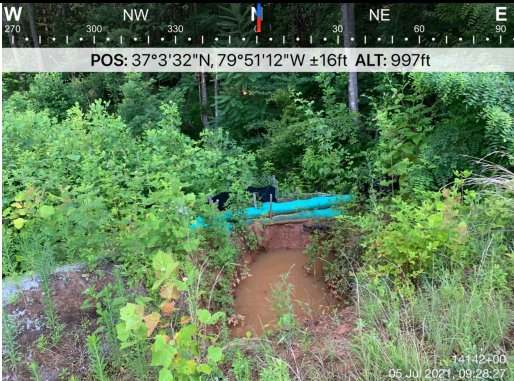
| Pic 3 Desc. | Permanent vegetative stabilization in acceptable condition | Pic 4 Desc. | Waterbar in acceptable condition | | |

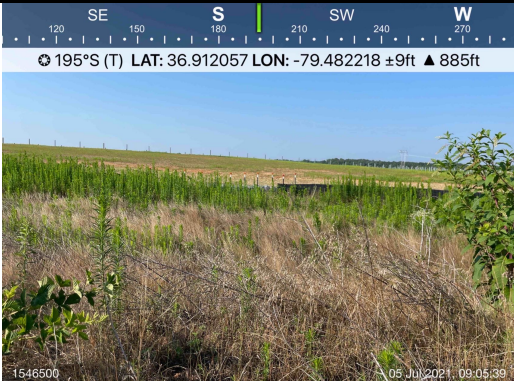
| Pic 3 Desc. | RCEs are in good condition at all road crossings. | | Pic 4 Desc. | 3rd party rock outlet appears to be in good condition. | |

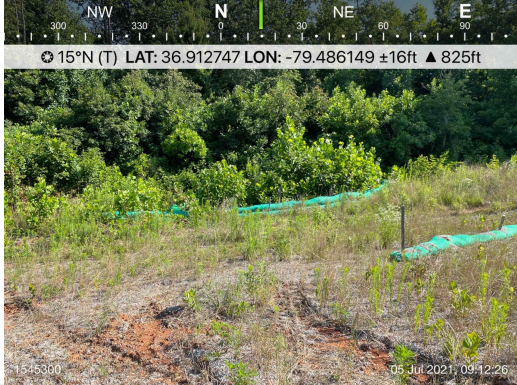
| Pic 7 Desc. | CWD is functioning as intended. | | Pic 8 Desc. | Drainage ECDs are in good condition with no evidence of sedimentation from 3rd party disturbance. | |

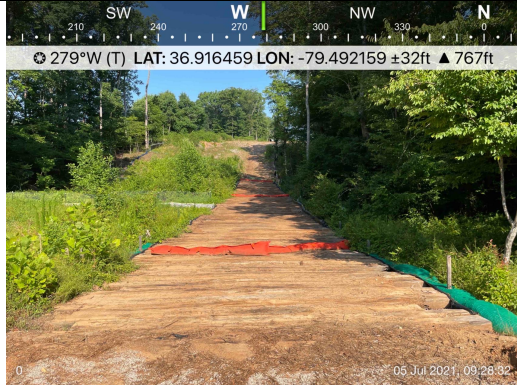
| Pic 9 Desc. | CWD is in good condition. | | Pic 10 Desc. | Vegetation continues to fill in throughout this section. | |

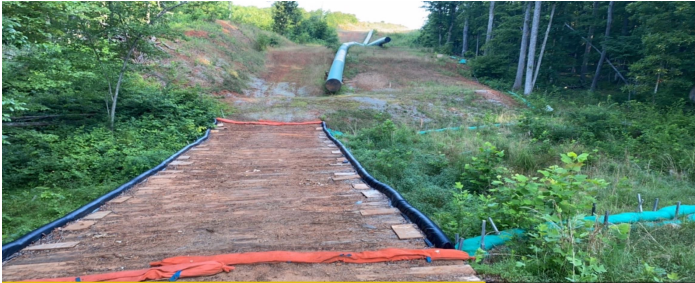
| Pic 3 Desc. | ROW seeded and stabilized and perimeter CFS replaced per punch list items | | Pic 4 Desc. | ROW seeded and stabilized and perimeter CFS replaced per punch list items | |

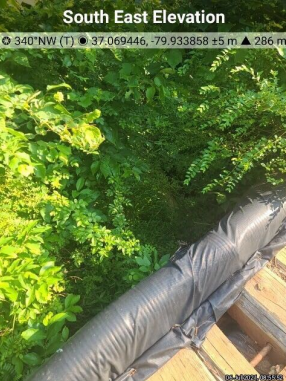
| Pic 1 Desc. | Stream observation photo facing downstream during routine inspection today. No issues observed at the time of inspection. | | Pic 2 Desc. | Stream observation photo facing upstream during routine inspection today. No issues observed at the time of inspection. | |

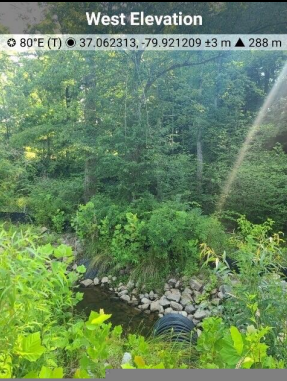
| Pic 3 Desc. | Stream observation photo facing upstream.during routine inspection today. No issues observed at the time of inspection. | | Pic 4 Desc. | Stream observation photo facing downstream during routine inspection today. No issues observed at the time of inspection. | |

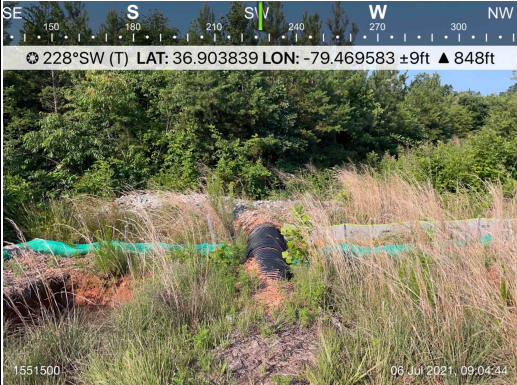
| Pic 13 Desc. | P1 is in good condition at all stream and wetland buffers. | | Pic 14 Desc. | 3rd party ECDs appear to be in good condition. | |

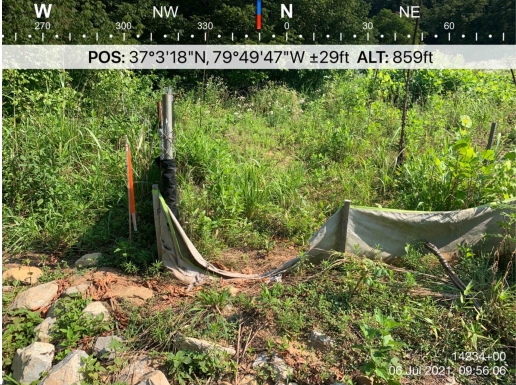
| Pic 1 Desc. | P1 silt fence damaged by livestock (2 panels between 14193+00 and 14193+50), contractor repaired immediately | | Pic 2 Desc. | P1 silt fence after repair | |

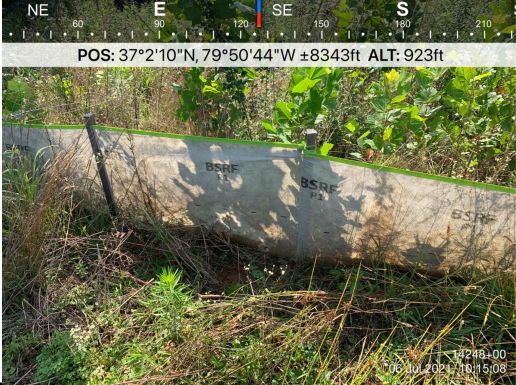
| Pic 3 Desc. | P1 silt fence damaged by wildlife, contractor repaired immediately | | Pic 4 Desc. | P1 silt fence after repair | |

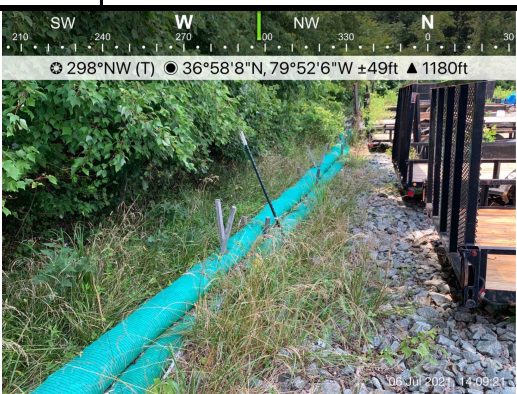
| Pic 3 Desc. | General Construction permits and contact information posted at entrance of LY-046 | | Pic 4 Desc. | Perimeter ECD's on south end of LY-045 in good condition. | |

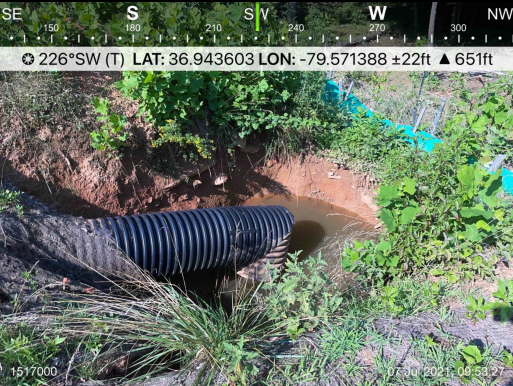
| Pic 3 Desc. | Vegetation continues to fill in throughout this section. | | Pic 4 Desc. | Drainage ECDs are in good condition and functioning. | |

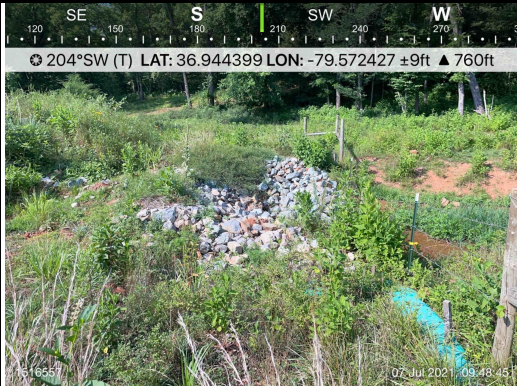
| Pic 7 Desc. | Equipment bridge ECDs are in place and functioning. | Pic 8 Desc. | Rock outlet remains in good condition. | | |

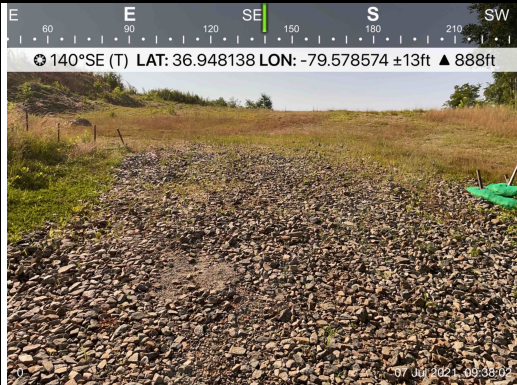
| Pic 9 Desc. | Rock inlet remains in good condition. | Pic 10 Desc. | Perimeter CFS is in good condition throughout this section. | | |

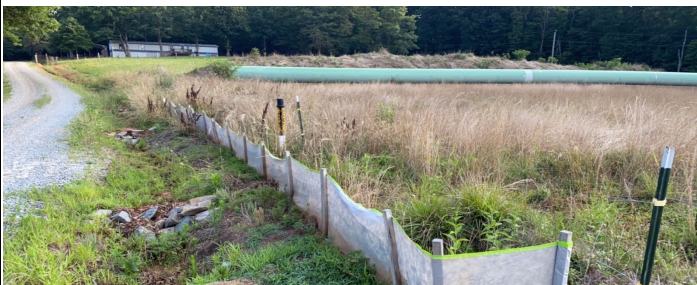
| Pic 1 Desc. | ROW stabilized in temporary area. Temporary vegetation beginning to die out. | | Pic 2 Desc. | Perimeter SSF and CFS triple stacks in good condition. Temporary vegetation beginning to die out along ROW. | |

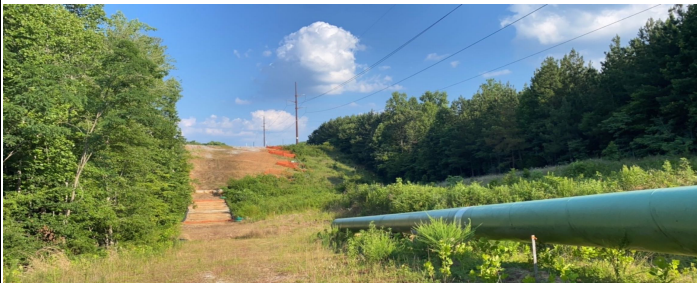
| Pic 3 Desc. | Perimeter P1 silt fence in place and functional. RCE and culvert along access road in good condition. | | Pic 4 Desc. | Spoil pile stabilized and vegetated. P1 silt fence at base in good condition. | |

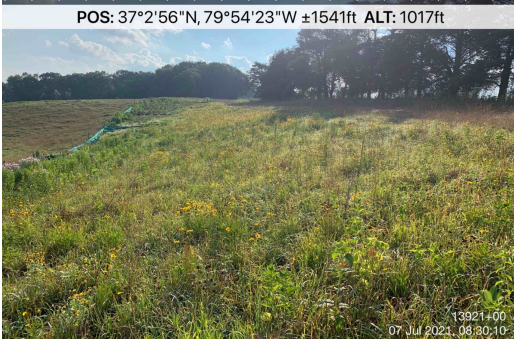
| Pic 3 Desc. Permanent vegetative stabilization in acceptable condition | | Pic 4 Desc. Equipment bridge in acceptable condition | | Field Station# 13888+50 | |

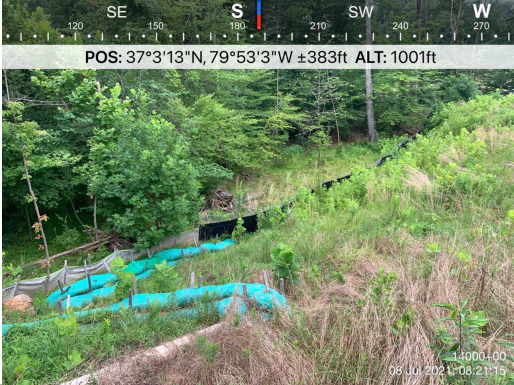
| Pic 1 Desc. | P1 silt fence damaged by a fallen tree, contractor addressed it immediately | | Pic 2 Desc. | P1 silt fence after repair | |

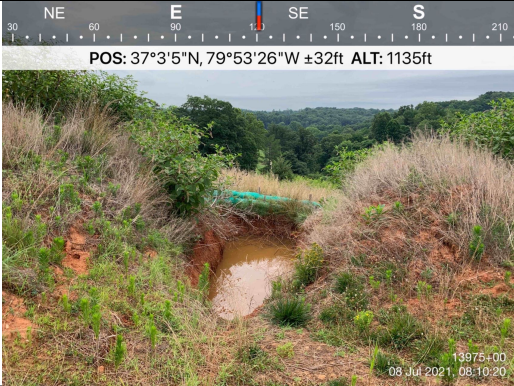
| Pic 3 Desc. | CFS and super silt in acceptable condition | | Pic 4 Desc. | Permanent vegetative stabilization in acceptable condition | |

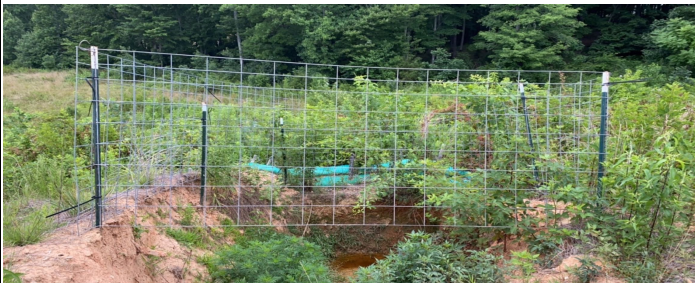
| Pic 1 Desc. | CWD pipe into plunge pool performing intended function. No issues observed. | | Pic 2 Desc. | Temporary diversion berm stabilized and vegetated. Perimeter SSF in place and functional. | |

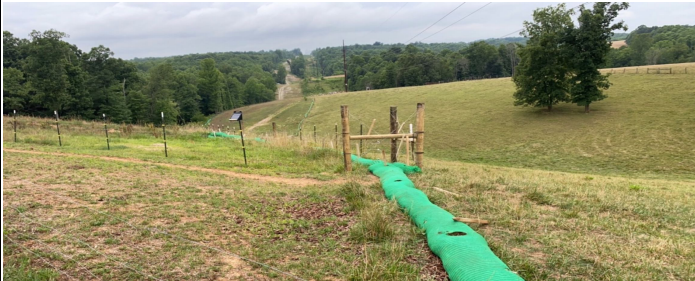
| Pic 3 Desc. | Sump pit and CFS end treatment in good condition. | | Pic 4 Desc. | Perimeter P1 silt fence performing intended function and in good condition. | |

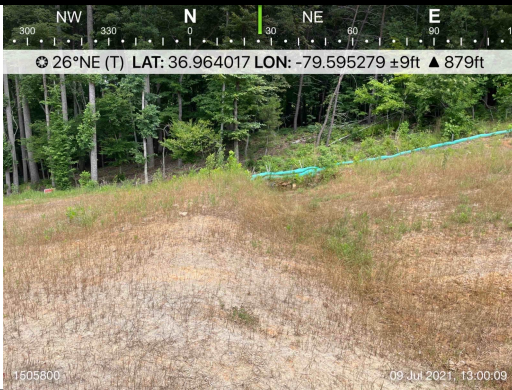
| Pic 3 Desc. | ROW around valve section is stabilized. Perimeter CFS in place and functional | | Pic 4 Desc. | Perimeter P1 silt fence at resource buffer in good condition | |

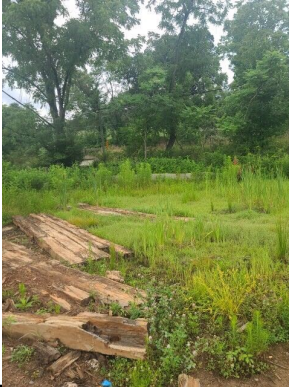
| Pic 1 Desc. | Vegetation observation photo facing up row from stream crossing showing good coverage. | | Pic 2 Desc. | Stream observation photo after recent rain events. No environmental issues observed at the time of inspection. | |

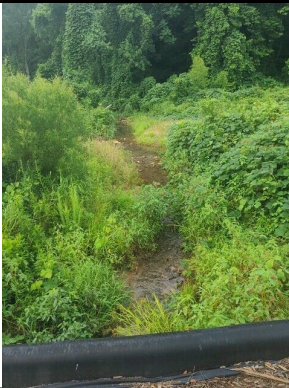
| Pic 3 Desc. | Monitored P1 on LOD . No environmental issues observed at the time of inspection. | | Pic 4 Desc. | Stream observation photo after recent rain events downstream . No issues observed at the time of inspection. | |

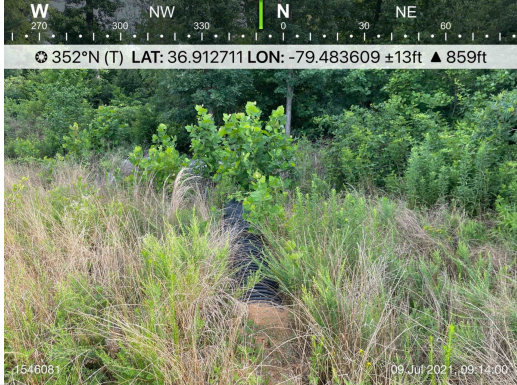
| Pic 7 Desc. | CWD is in good condition with no evidence of sedimentation from 3rd party disturbance. | | Pic 8 Desc. | Drainage is in good condition with no evidence of sedimentation. | |

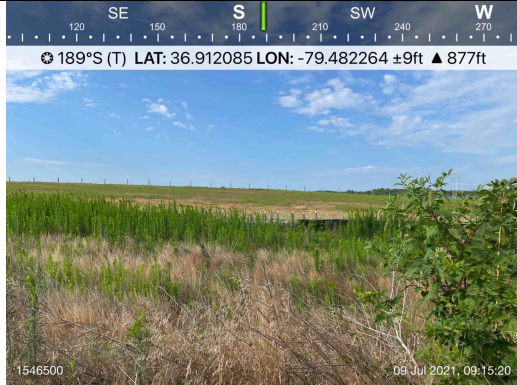
| Pic 9 Desc. | CWD is in good condition with no evidence of sedimentation from 3rd party disturbance. | | Pic 10 Desc. | CWD is in good condition with no evidence of sedimentation from 3rd party rock outlet. | |
