Visual Site Inspection Report

Project Name	H-600 Pipeline Spread I	AFE	124300139	Spread	H-600 Pipeline Spread I
Contractor	Precision			Report #	26665
Inspector	John White			Date/Time	8/2/2021 10:44 AM
Permit #	TBD	Inspection Type	VA SWPP	Station Begin	15772+27
State	VA	Inspection Area	Full	Station End	15947+64
County	Pittsylvania	Ground	Dry	Temperature (°F)	75.00
Municipality	Chatham	Weather	Sunny	Rain Gauge (in)	0.20
				Rain Accumulation Time (days)	6.00

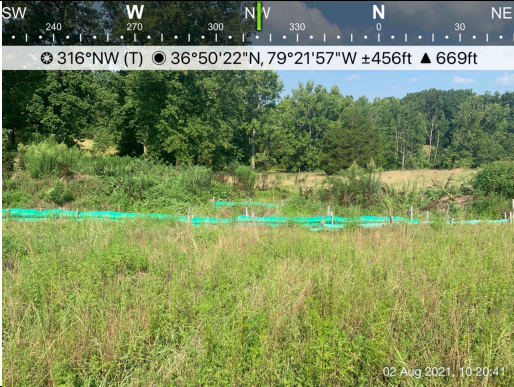
GPS Location	O	GPS Location	O		
Field Station#	15930+00	Field Station#	15934+00		
Pic 1 Desc.	Observing temporary stabilization and ECD's	Pic 2 Desc.	Observing temporary stabilization, CWD outlet and ECD's

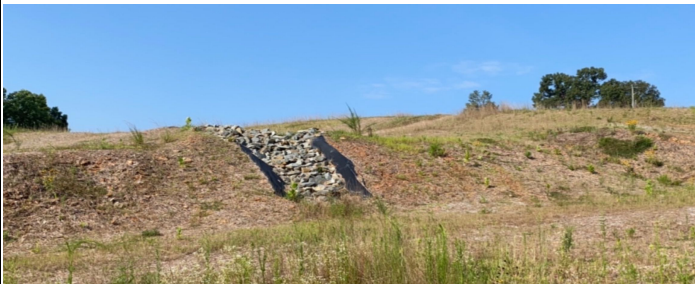
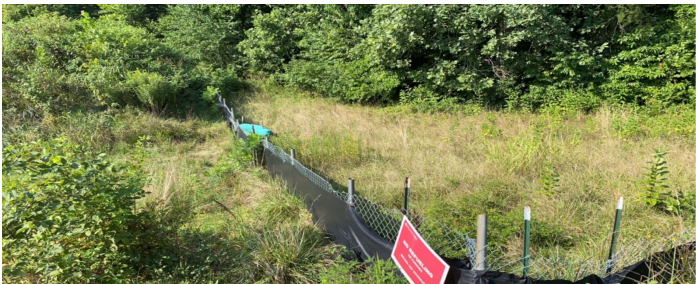
36°58'4" N 79°38'14" W 222°SW COURSE 227° GPS 2082 Ramsey Memorial Rd, Penhook, VA 24137, United States 08.02.2021 09:40:23 Accur +/-35.0 Ft ALT 849 Ft			36°58'2" N 79°38'10" W 177°S COURSE 21° GPS 2082 Ramsey Memorial Rd, Penhook, VA 24137, United States 08.02.2021 09:44:21 Accur +/-35.0 Ft ALT 821 Ft		
GPS Location	1		GPS Location	2	
Field Station#	14931+00		Field Station#	14934+46	
Pic 1 Desc.	Rock-lined channel on slope in good condition		Pic 2 Desc.	Perimeter SSF and CFS triple stack performing intended functions

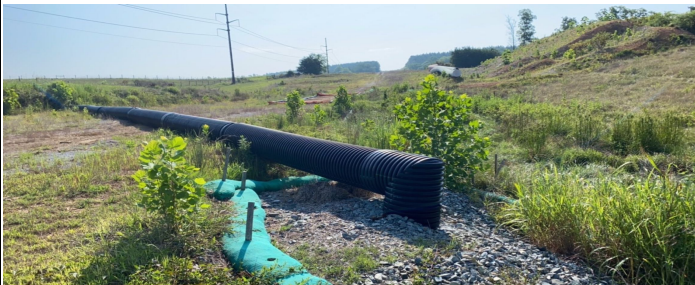
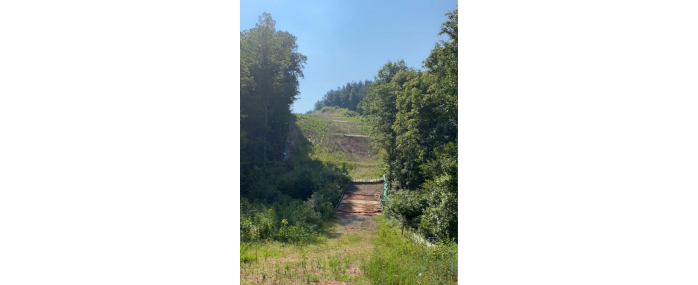
Pic 3 Desc.	CWD pipe in place and functional		Pic 4 Desc.	Equipment bridge and surrounding ECDs in place and functional at stream crossing

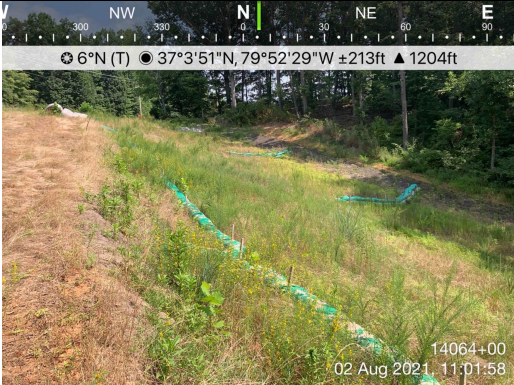
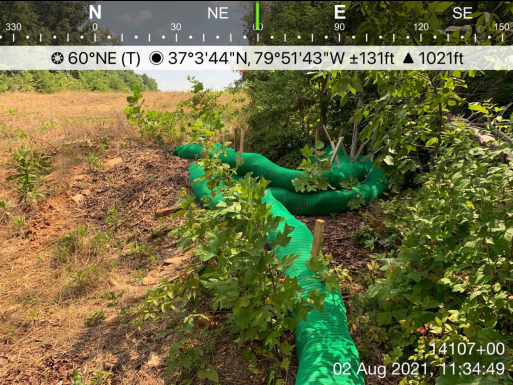
GPS Location	0	GPS Location	0		
Field Station#	14064+00	Field Station#	14107+00		
Pic 1 Desc.	CFS and temporary vegetative stabilization in acceptable condition	Pic 2 Desc.	Perimeter CFS and waterbar end treatment in acceptable condition

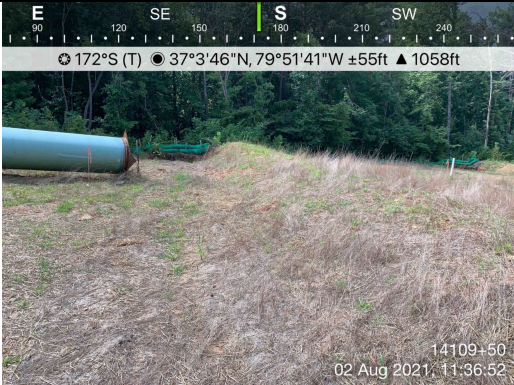
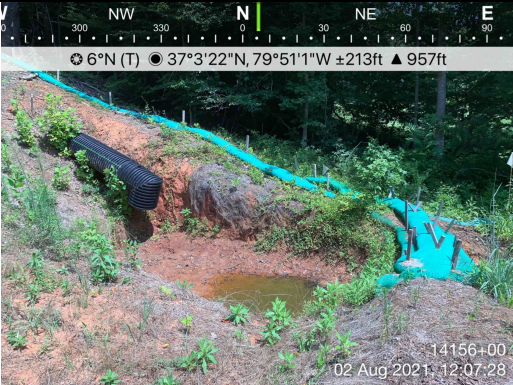
GPS Location	0	GPS Location	0		
Field Station#	14109+00	Field Station#	14156+00		
Pic 3 Desc.	Waterbar in acceptable condition	Pic 4 Desc.	Slope drain, sump pit and CFS in acceptable condition

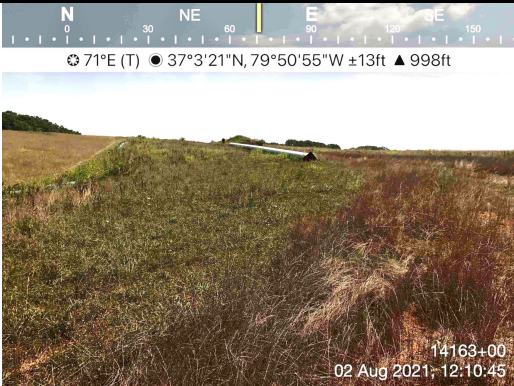
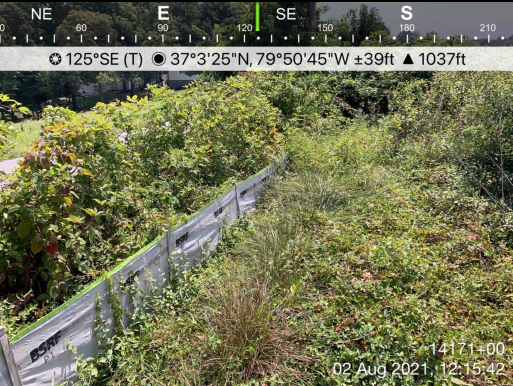
GPS Location	0	GPS Location	0		
Field Station#	14163+00	Field Station#	14171+00		
Pic 5 Desc.	Permanent vegetative stabilization in acceptable condition	Pic 6 Desc.	P1 silt fence in acceptable condition

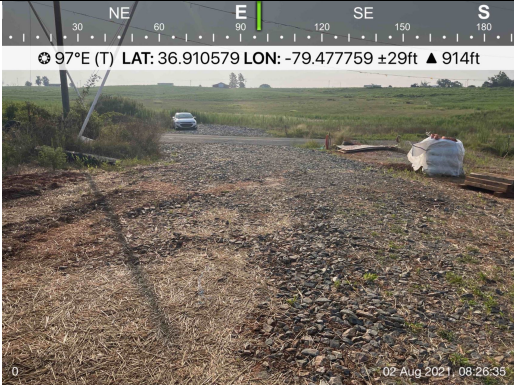
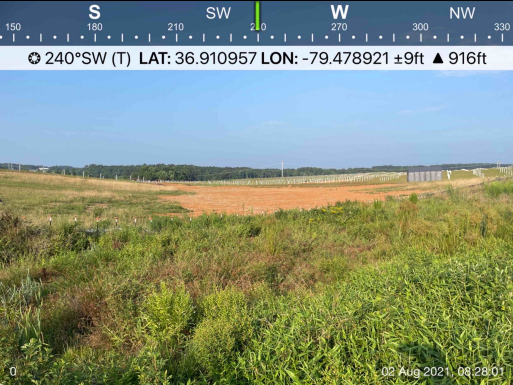
GPS Location	See photo		GPS Location	See photo	
Field Station#	15370+62		Field Station#	15475+00	
Pic 1 Desc.	RCEs are in good condition at all road crossings.		Pic 2 Desc.	3rd party rock outlet appears to be in good condition.

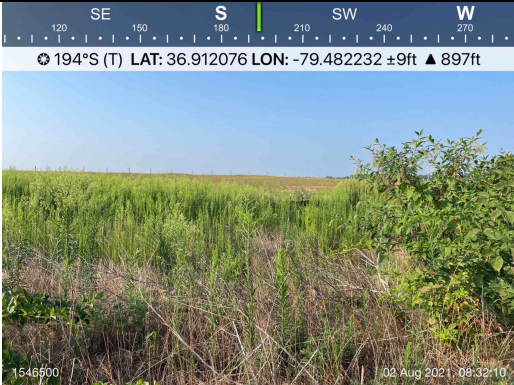
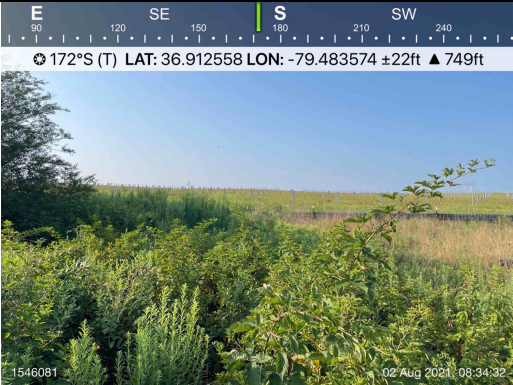
GPS Location	See photo		GPS Location	See photo	
Field Station#	15465+00		Field Station#	15460+81	
Pic 3 Desc.	No evidence of sedimentation from 3rd party rock outlet.		Pic 4 Desc.	No evidence of sedimentation from 3rd party rock outlet into CWD inlet.

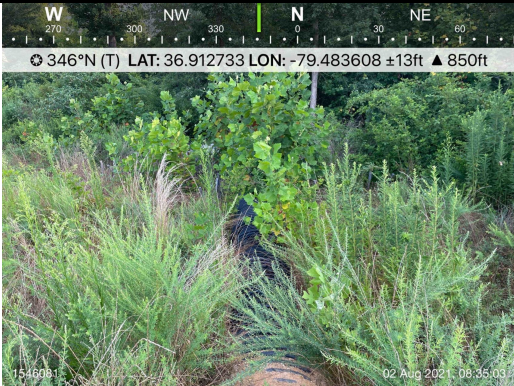
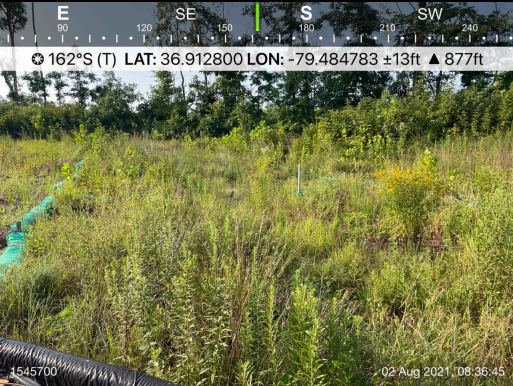
GPS Location	See photo		GPS Location	See photo	
Field Station#	15460+81		Field Station#	15457+00	
Pic 5 Desc.	CWD in good condition and functioning.		Pic 6 Desc.	Drainage ECDs are in place and functioning.

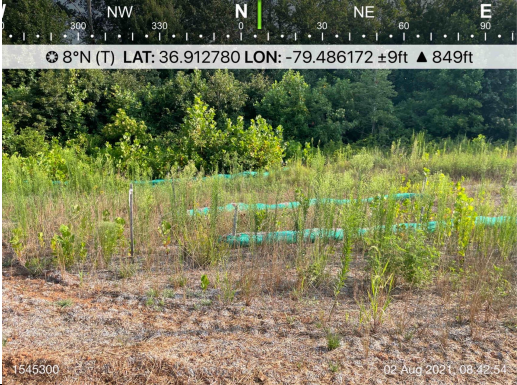
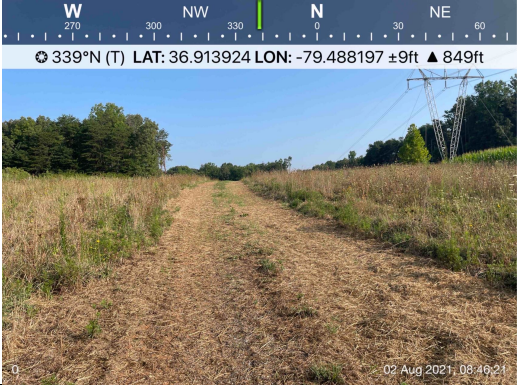
GPS Location	See photo		GPS Location	See photo	
Field Station#	15453+00		Field Station#	15443+00	
Pic 7 Desc.	No evidence of sedimentation from 3rd party disturbance into CWD.		Pic 8 Desc.	Vegetation continues to fill in throughout this section.

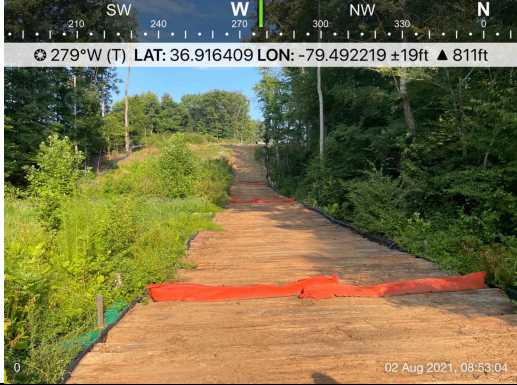
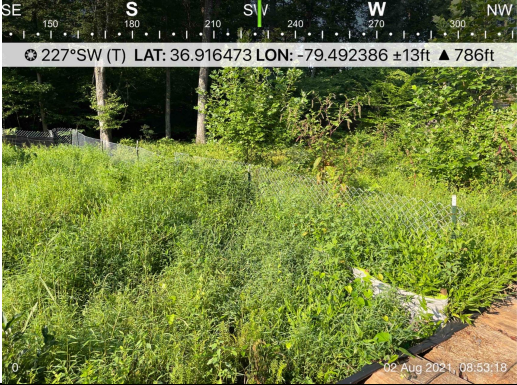
GPS Location	See photo		GPS Location	See photo	
Field Station#	15427+30		Field Station#	15427+30	
Pic 9 Desc.	Equipment bridge ECDs are in good condition and functioning.		Pic 10 Desc.	P1 is in good condition at all stream and wetland crossings.

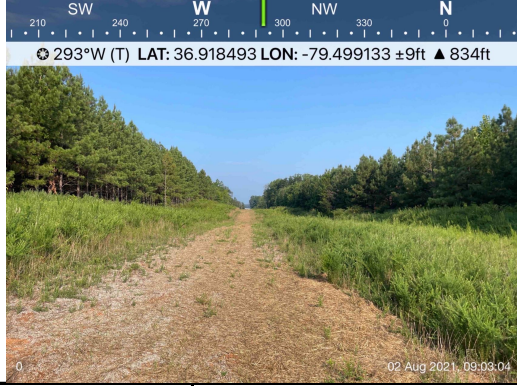
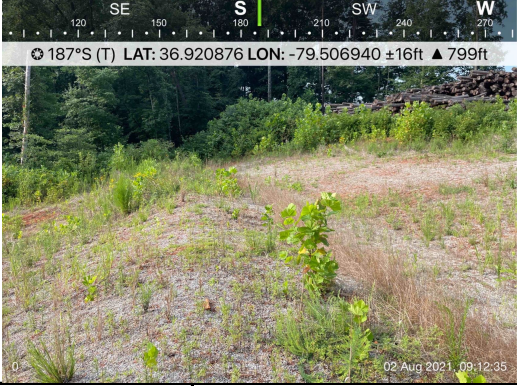
GPS Location	See photo		GPS Location	See photo	
Field Station#	15405+00		Field Station#	15380+00	
Pic 11 Desc.	Vegetation continues to fill in throughout this section.		Pic 12 Desc.	Waterbars are functioning as intended.

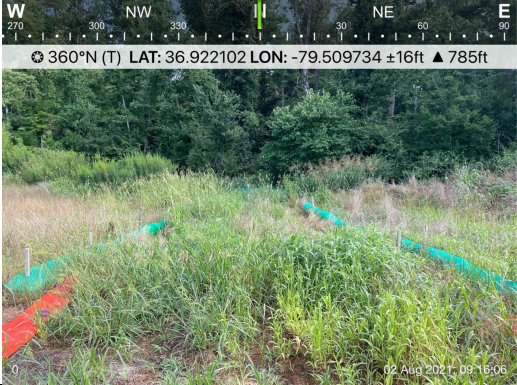
GPS Location	See photo	GPS Location			
Field Station#	15375+00	Field Station#			
Pic 13 Desc.	Drainage ECDs are in good condition and functioning.	Pic 14 Desc.			
Insert image here		Insert image here			
GPS Location		GPS Location			
Field Station#		Field Station#			
Pic 15 Desc.		Pic 16 Desc.			
Insert image here		Insert image here			
GPS Location		GPS Location			
Field Station#		Field Station#			
Pic 17 Desc.		Pic 18 Desc.

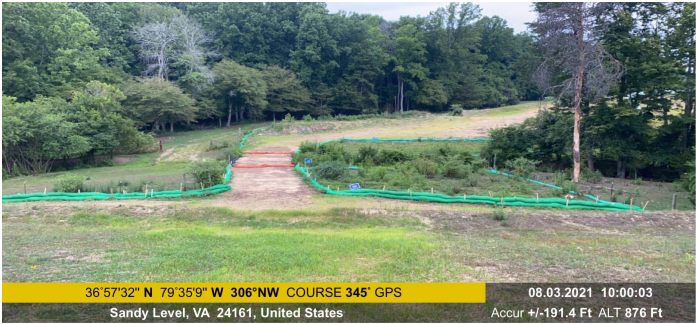
GPS Location	1	GPS Location	2		
Field Station#	15072+86	Field Station#	15092+95		
Pic 1 Desc.	Equipment bridge and surrounding ECDs in place and functional at stream crossing.	Pic 2 Desc.	Equipment bridge and surrounding ECDs in place and functional at stream crossing.

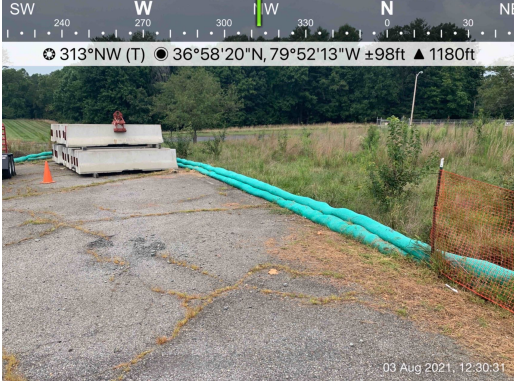
GPS Location	000000000000	GPS Location	000000000000		
Field Station#	0000+00	Field Station#	0000+00		
Pic 1 Desc.	Perimeter ECD's on north end of LY-46 in good condition	Pic 2 Desc.	Inlet protection for catch basin on north end of LY-046 in good condition.

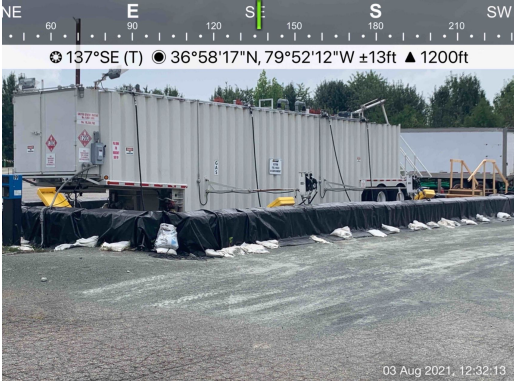
GPS Location	000000000000	GPS Location	000000000000		
Field Station#	0000+00	Field Station#	0000+00		
Pic 3 Desc.	Secondary containment structure for fuel cell in good condition.	Pic 4 Desc.	Perimeter ECD's on northwest corner of LY-045 in good condition

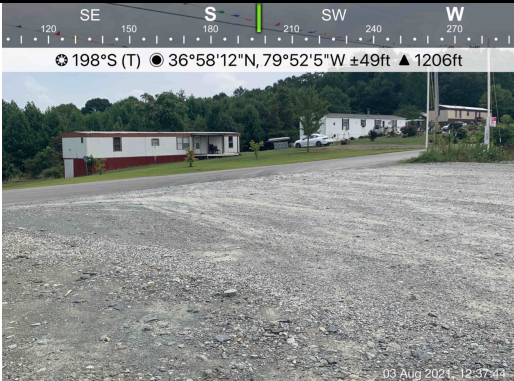
Insert image here			
GPS Location	000000000000	GPS Location			
Field Station#	0000+00	Field Station#			
Pic 5 Desc.	RCE at LY-045 in good condition.	Pic 6 Desc.

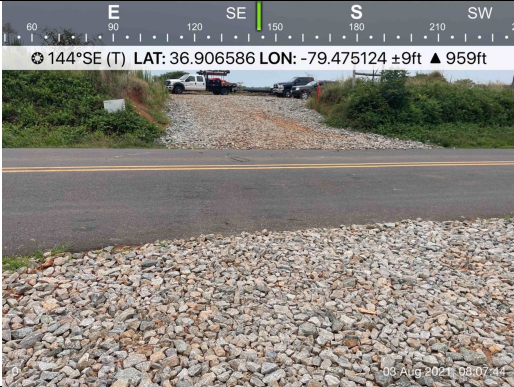
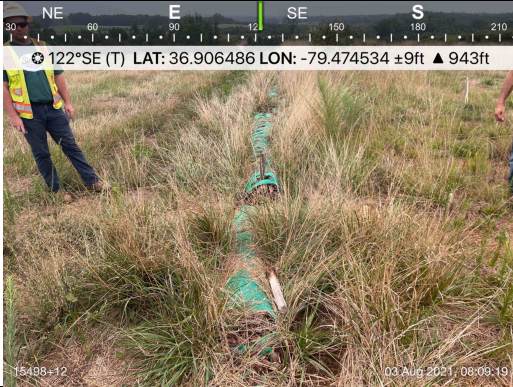
GPS Location	See photo	GPS Location	See photo		
Field Station#	15496+70	Field Station#	15498+12		
Pic 1 Desc.	RCEs are in good condition at all road crossings.	Pic 2 Desc.	CFS has been damaged and needs to be replaced.

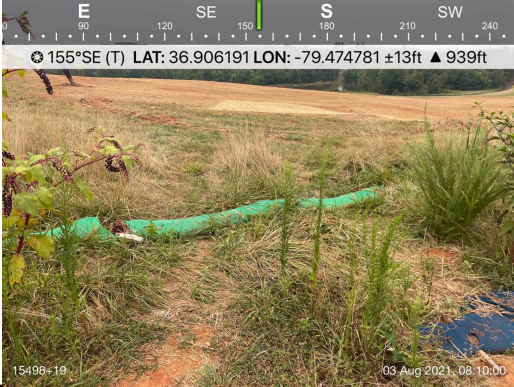
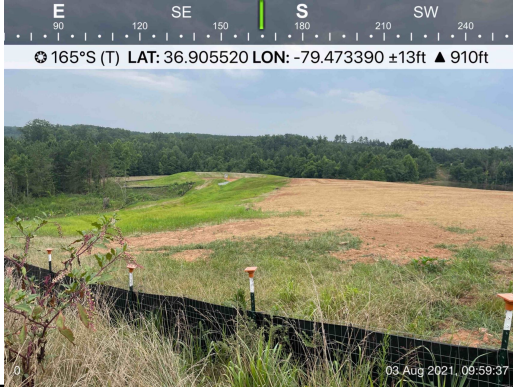
GPS Location	See photo	GPS Location	See photo		
Field Station#	15498+19	Field Station#	15503+00		
Pic 3 Desc.	CFS has been damaged and needs to be replaced.	Pic 4 Desc.	No evidence of sedimentation from 3rd party disturbance.

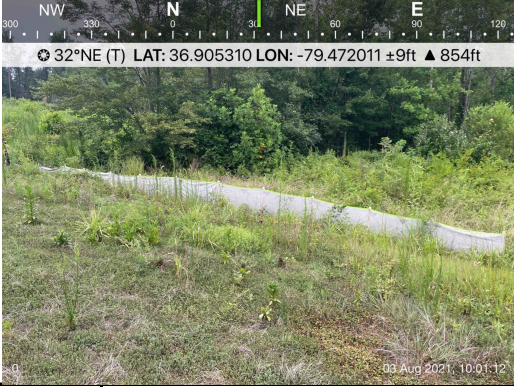
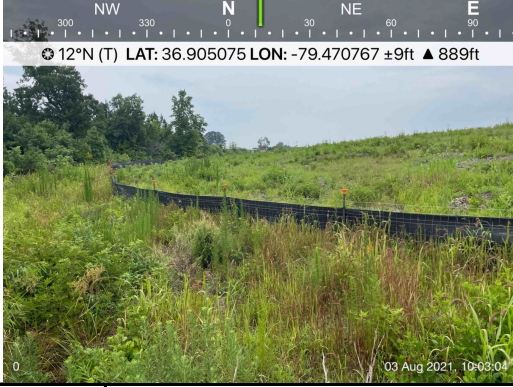
GPS Location	See photo	GPS Location	See photo		
Field Station#	15506+41	Field Station#	15510+00		
Pic 5 Desc.	P1 is in good condition at all stream and wetland crossings.	Pic 6 Desc.	3rd party ECDs appear to be in good condition.

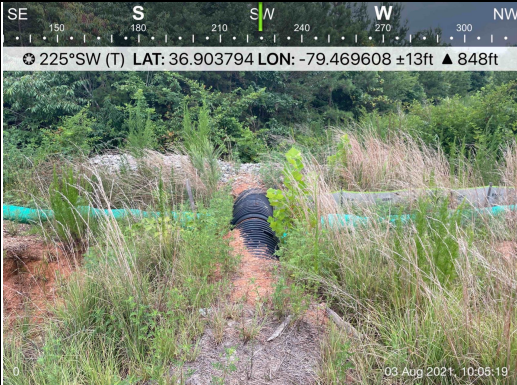
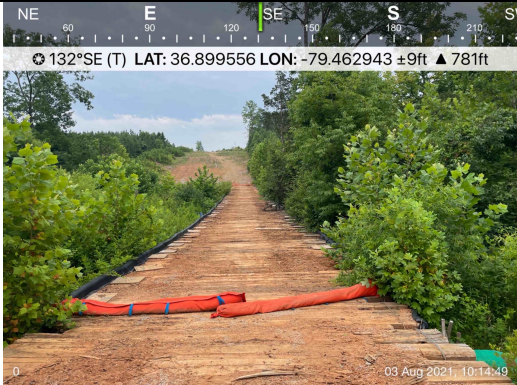
GPS Location	See photo		GPS Location	See photo	
Field Station#	15515+00		Field Station#	15540+00	
Pic 7 Desc.	CWD is functioning as intended.		Pic 8 Desc.	Equipment bridge ECDs are in place and functioning.

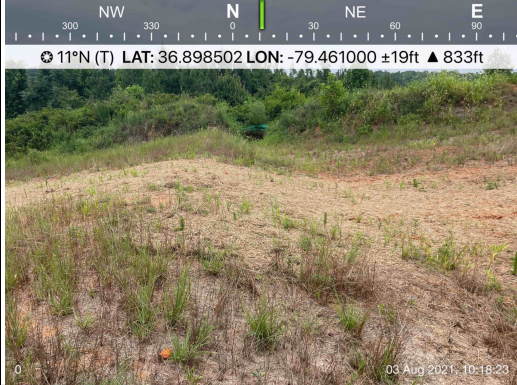
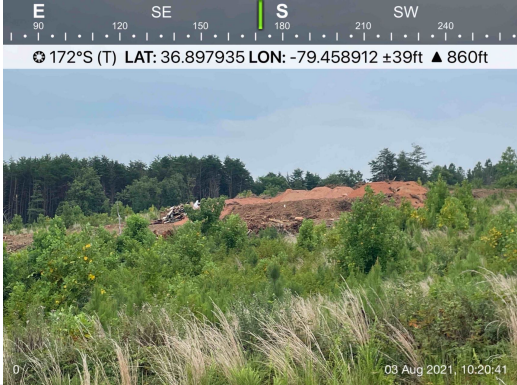
GPS Location	See photo		GPS Location	See photo	
Field Station#	15547+37		Field Station#	15556+83	
Pic 9 Desc.	Waterbars are in good condition and functioning.		Pic 10 Desc.	No evidence of sedimentation from 3rd party disturbance above S-CC9

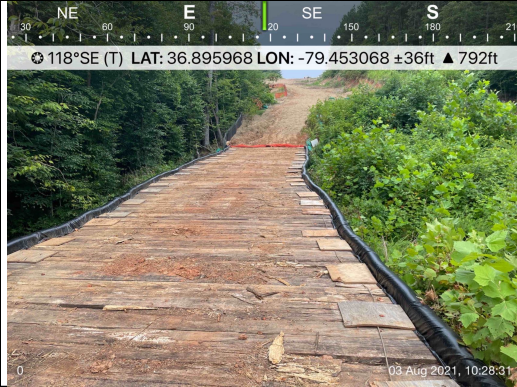
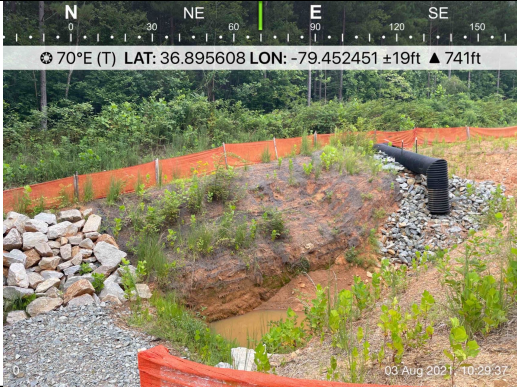
GPS Location	See photo		GPS Location	See photo	
Field Station#	15573+22		Field Station#	15574+87	
Pic 11 Desc.	Previously repaired equipment bridge remains in good condition.		Pic 12 Desc.	Slope drain is in good condition and functioning.

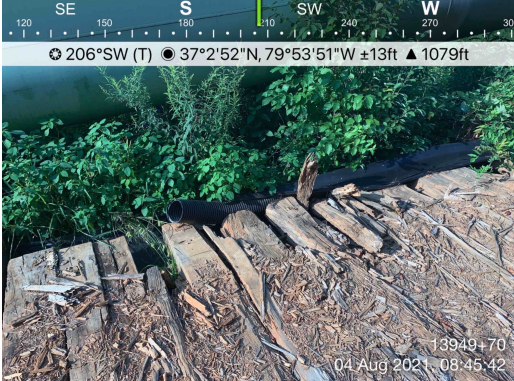
GPS Location	0	GPS Location	0		
Field Station#	13949+70	Field Station#	13945+00		
Pic 1 Desc.	Geotech fabric and sideboard are detached from equipment bridge		Pic 2 Desc.	Temporary vegetative stabilization in acceptable condition

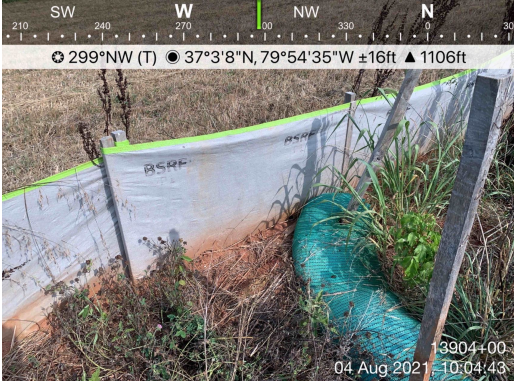
GPS Location	0	GPS Location	0		
Field Station#	13904+00	Field Station#	13891+00		
Pic 3 Desc.	Hole in P1 silt fence at ground line, damaged by wildlife		Pic 4 Desc.	P1 silt fence has a broken stake, damaged by wildlife

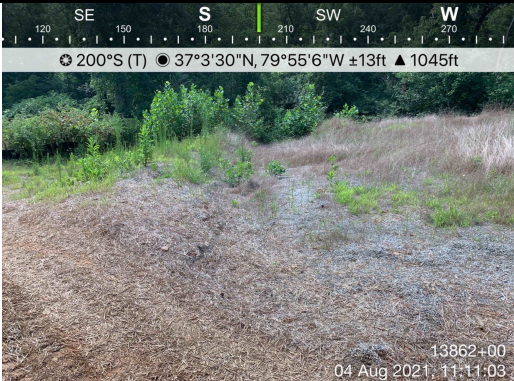
GPS Location	0	GPS Location	0		
Field Station#	13862+00	Field Station#	13862+00		
Pic 5 Desc.	Waterbar in acceptable condition		Pic 6 Desc.	Waterbar end treatment and super silt fence in acceptable conditions

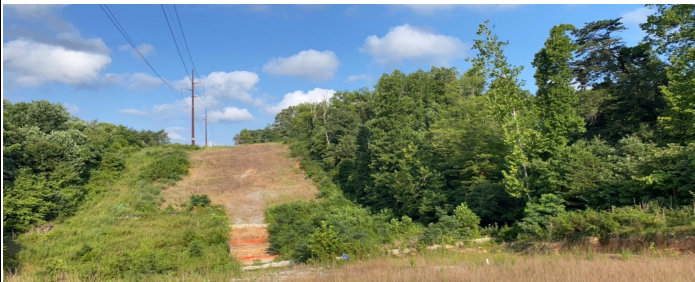
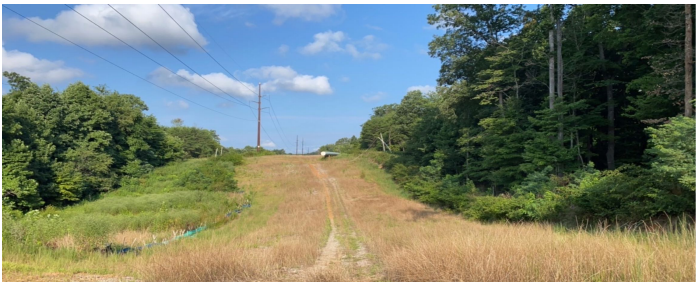
36°59'17" N 79°42'26" W 290°W COURSE 329° GPS 496 Holliday Ln, Union Hall, VA 24176, United States 08.04.2021 09:02:49 Accur +/-139.9 Ft ALT 822 Ft			36°59'17" N 79°42'17" W 276°W COURSE 329° GPS Sorry no results found 08.04.2021 08:59:12 Accur +/-100.5 Ft ALT 822 Ft		
GPS Location	1		GPS Location	2	
Field Station#	14700+70		Field Station#	14709+00	
Pic 1 Desc.	Equipment bridge and surrounding ECDs in place and functional at stream crossing and resource buffer.		Pic 2 Desc.	Temporary stabilization and vegetation along ROW. Perimeter controls in place and functional.

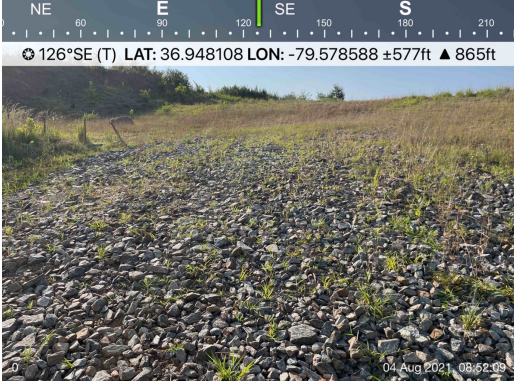
GPS Location	See photo	GPS Location	See photo		
Field Station#	15142+66	Field Station#	15150+00		
Pic 1 Desc.	RCE is in good condition at Rockcreek Rd.	Pic 2 Desc.	Perimeter CFS is in good condition throughout this section of ROW.

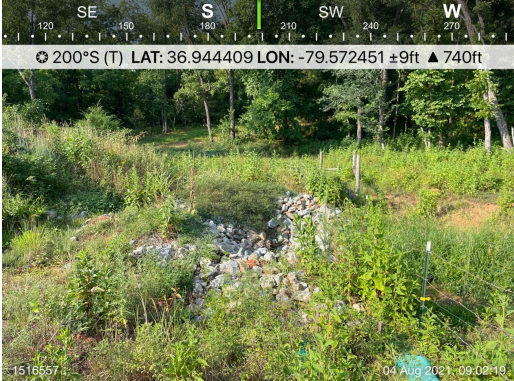
GPS Location	See photo	GPS Location	See photo		
Field Station#	15165+57	Field Station#	15166+00		
Pic 3 Desc.	Rock inlet remains in good condition.	Pic 4 Desc.	Rock outlet remains in good condition.

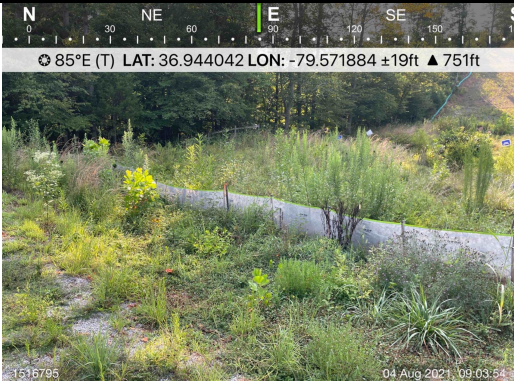
GPS Location	See photo	GPS Location	See photo		
Field Station#	15167+95	Field Station#	15167+95		
Pic 5 Desc.	P1 is in good condition at stream buffer.	Pic 6 Desc.	Equipment bridge ECDs are in place and functioning.

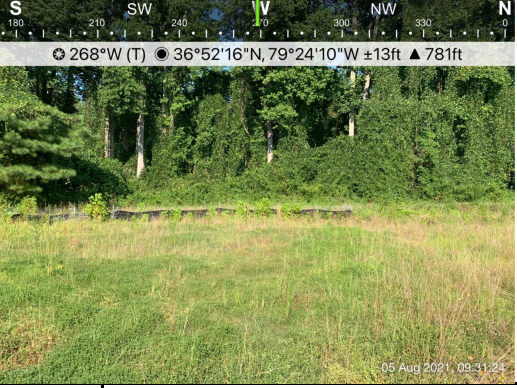
GPS Location	O	GPS Location	O		
Field Station#	15772+27	Field Station#	15762+00		
Pic 1 Desc.	Observing access road and RCE's	Pic 2 Desc.	Observing temporary stabilization and ECD's

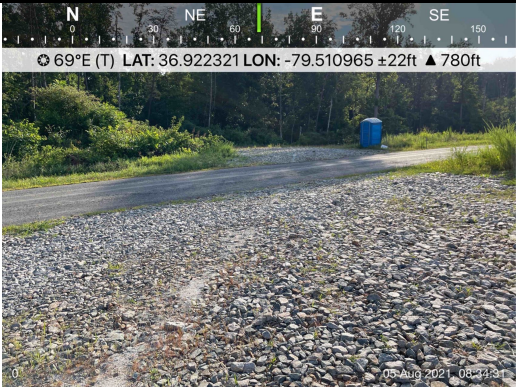
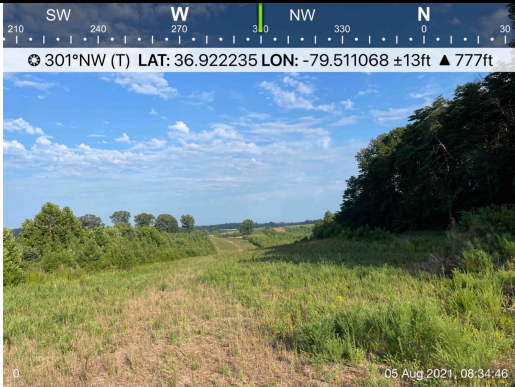
GPS Location	See photo		GPS Location	See photo	
Field Station#	15370+62		Field Station#	15370+00	
Pic 1 Desc.	RCEs are in good condition at all road crossings.		Pic 2 Desc.	Vegetation continues to fill in throughout this section of ROW.

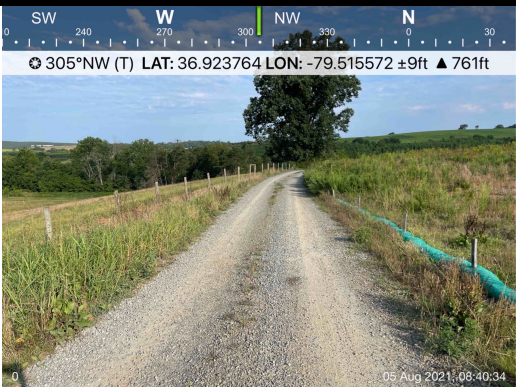
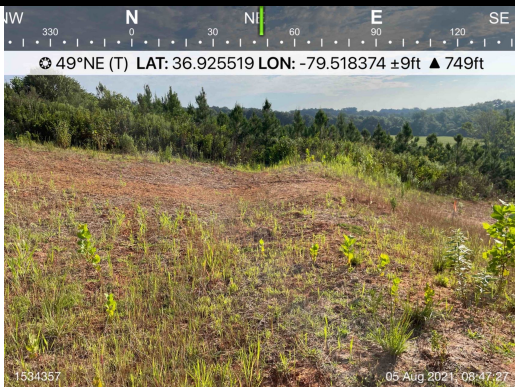
GPS Location	See photo		GPS Location	See photo	
Field Station#	15350+00		Field Station#	15343+57	
Pic 3 Desc.	MVP-PI-332 remains in good condition with controls in place.		Pic 4 Desc.	Waterbars are in good condition.

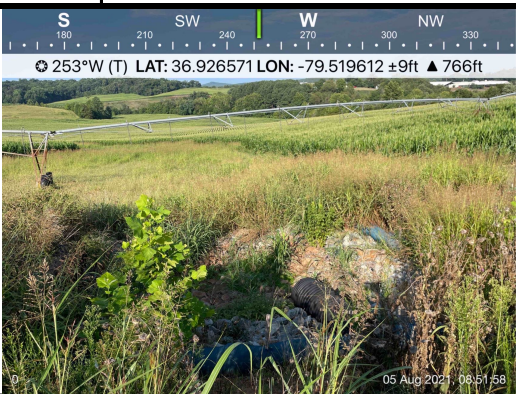
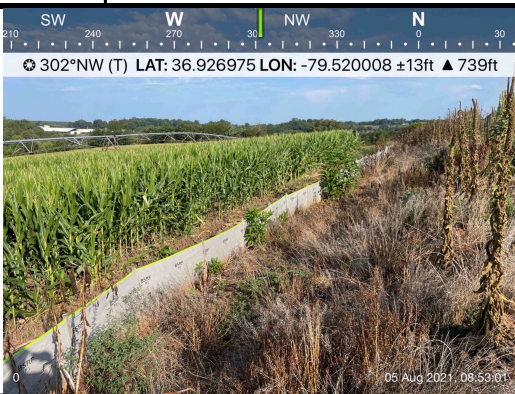
GPS Location	See photo		GPS Location	See photo	
Field Station#	15338+00		Field Station#	15335+00	
Pic 5 Desc.	CWD is functioning as intended.		Pic 6 Desc.	Perimeter P1 is in good condition throughout this section.

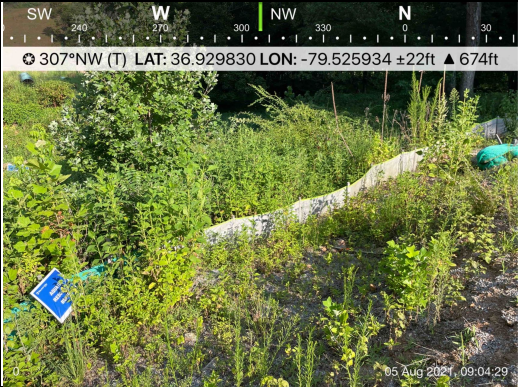
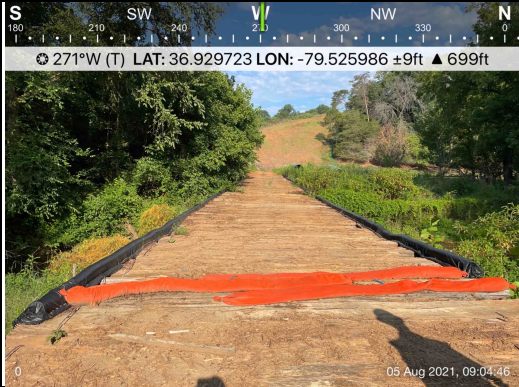
<p>S SW NW N 271°W (T) LAT: 36.929723 LON: -79.525986 ±9ft ▲ 699ft 05 Aug 2021, 09:04:45</p>	
GPS Location	See photo		GPS Location	See photo	
Field Station#	15314+50		Field Station#	15314+19	
Pic 7 Desc.	P1 is in good condition at all stream and wetland buffers.		Pic 8 Desc.	Equipment bridge ECDs are in place and functioning.

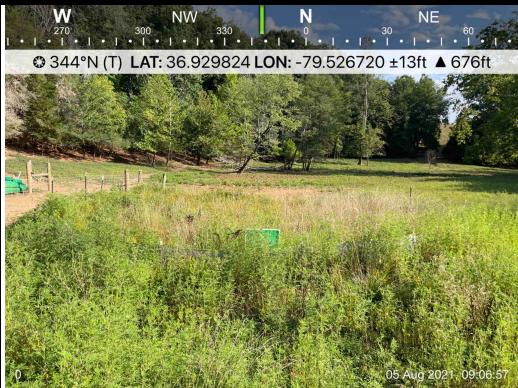
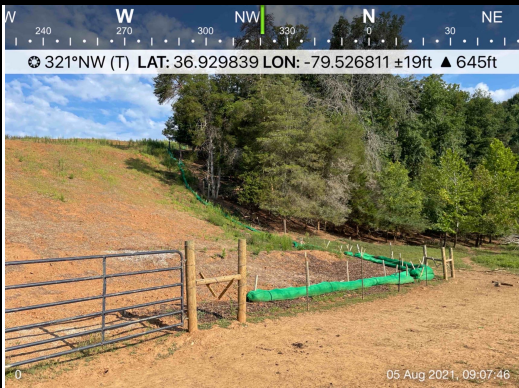
<p>W NW N NE 321°NW (T) LAT: 36.929839 LON: -79.526811 ±19ft ▲ 645ft 05 Aug 2021, 09:07:46</p>	
GPS Location	See photo		GPS Location	See photo	
Field Station#	15311+78		Field Station#	15310+00	
Pic 9 Desc.	Wetland buffer P1 remains in good condition.		Pic 10 Desc.	Perimeter CFS is in good condition.

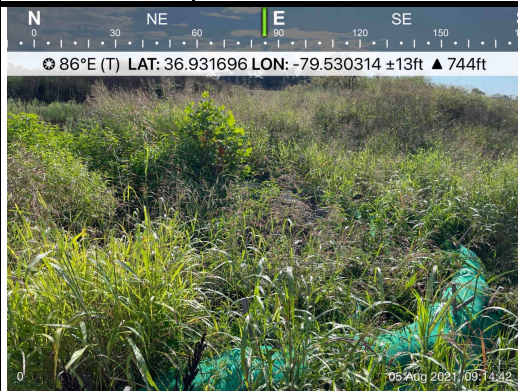
<p>N NE E SE 86°E (T) LAT: 36.931696 LON: -79.530314 ±13ft ▲ 744ft 05 Aug 2021, 09:14:42</p>				<p>Insert image here</p>	
GPS Location	See photo		GPS Location		
Field Station#	15299+00		Field Station#		
Pic 11 Desc.	CWD is functioning as intended.		Pic 12 Desc.

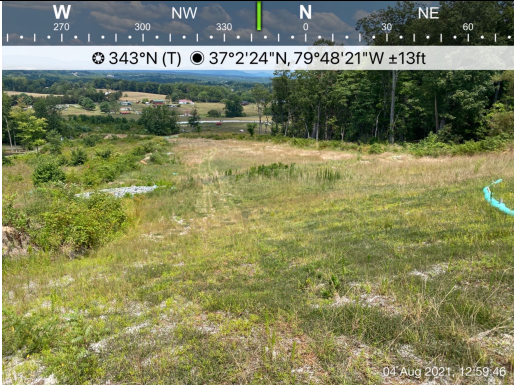
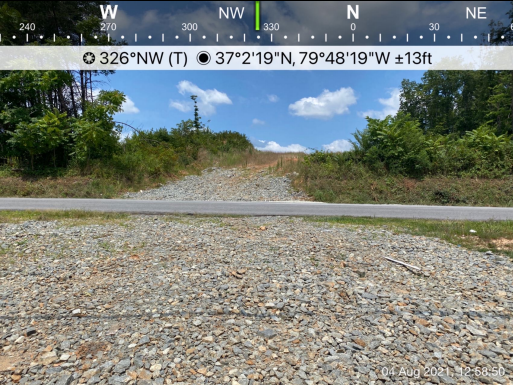
GPS Location	0	GPS Location	0		
Field Station#	14325+00	Field Station#	14333+50		
Pic 1 Desc.	Approximately 14325+00. Overview of ROW.		Pic 2 Desc.	Approximately 14333+50. Overview of road crossing and RCEs.

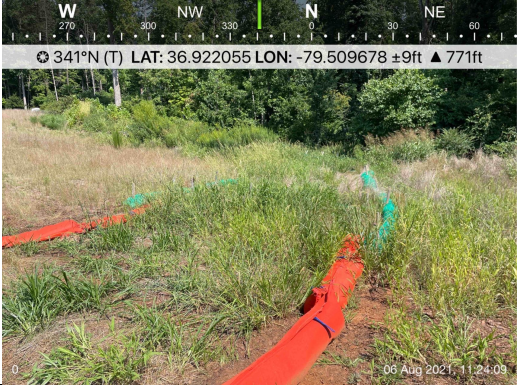
GPS Location	See photo	GPS Location			
Field Station#	15375+00	Field Station#			
Pic 13 Desc.	Drainage feature ECDs are in good condition.	Pic 14 Desc.			
Insert image here		Insert image here			
GPS Location		GPS Location			
Field Station#		Field Station#			
Pic 15 Desc.		Pic 16 Desc.			
Insert image here		Insert image here			
GPS Location		GPS Location			
Field Station#		Field Station#			
Pic 17 Desc.		Pic 18 Desc.

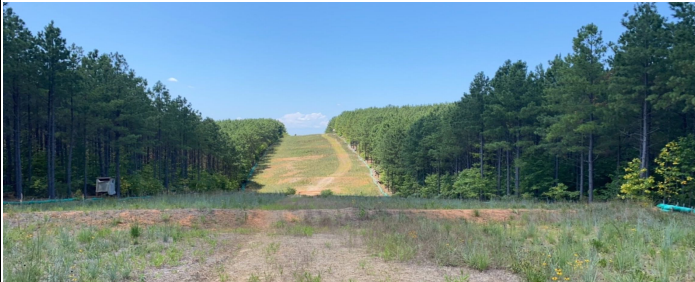
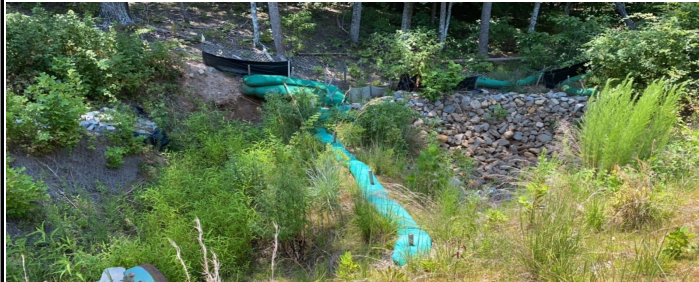
36°57'58" N 79°37'26" W 293°W COURSE 300° GPS Penhook, VA 24137, United States 08.05.2021 13:16:27 Accur +/-43.0 Ft ALT 925 Ft			36°57'57" N 79°37'22" W 229°SW COURSE 237° GPS Penhook, VA 24137, United States 08.05.2021 13:14:44 Accur +/-65.0 Ft ALT 925 Ft		
GPS Location	1		GPS Location	2	
Field Station#	14970+00		Field Station#	14976+00	
Pic 1 Desc.	View of vegetation/stabilization in final cleanup area along ROW		Pic 2 Desc.	Various ECDs and perimeter controls performing intended functions

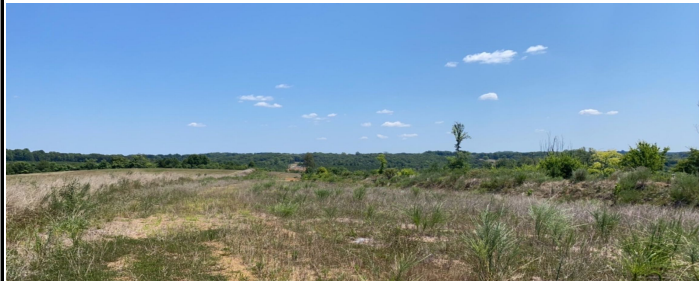
36°57'52" N 79°36'52" W 157°SE COURSE 195° GPS Penhook, VA 24137, United States 08.05.2021 12:56:30 Accur +/-27.6 Ft ALT 919 Ft			36°57'55" N 79°36'41" W 222°SW COURSE 322° GPS Penhook, VA 24137, United States 08.05.2021 13:01:12 Accur +/-45.7 Ft ALT 923 Ft		
GPS Location	5		GPS Location	6	
Field Station#	15002+00		Field Station#	15009+00	
Pic 5 Desc.	Perimeter CFS and SSF in good condition		Pic 6 Desc.	Temporary stabilization and vegetation along ROW
