# Visual Site Inspection Report

<b>Project Name</b>	H-600 Pipeline Spread I	<b>AFE</b>	124300139	<b>Spread</b>	H-600 Pipeline Spread I
<b>Contractor</b>	Precision			<b>Report #</b>	26955
<b>Inspector</b>	John White			<b>Date/Time</b>	8/9/2021 10:39 AM
<b>Permit #</b>	TBD	<b>Inspection Type</b>	VA SWPP	<b>Station Begin</b>	15947+64
<b>State</b>	VA	<b>Inspection Area</b>	Full	<b>Station End</b>	16027+46
<b>County</b>	Pittsylvania	<b>Ground</b>	Dry	<b>Temperature (°F)</b>	80.00
<b>Municipality</b>	Chatham	<b>Weather</b>	Sunny	<b>Rain Gauge (in)</b>	0.60
				<b>Rain Accumulation Time (days)</b>	6.00

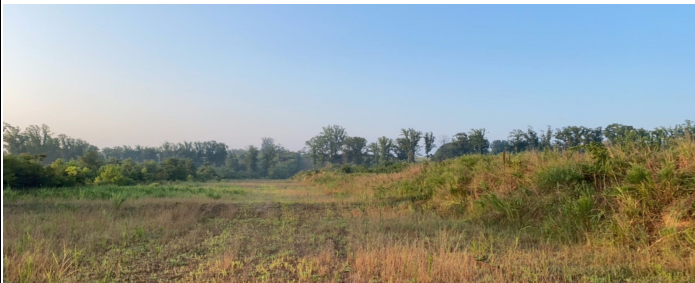
36°57'43" N 79°35'25" W 117°SE COURSE 160' GPS Sandy Level, VA 24161, United States 08.09.2021 07:36:32 Accur +/-39.7 Ft ALT 859 Ft			36°57'44" N 79°35'24" W 314°NW COURSE 40' GPS Sandy Level, VA 24161, United States 08.09.2021 07:37:01 Accur +/-59.2 Ft ALT 859 Ft		
<b>GPS Location</b>	1	<b>GPS Location</b>	2		
<b>Field Station#</b>	15073+50	<b>Field Station#</b>	15073+00		
<b>Pic 1 Desc.</b>	Slope drain tile and rock outlet in good condition		<b>Pic 2 Desc.</b>	Sump pit in good condition. CFS end treatment and triple stack at resource buffer in place and functional.

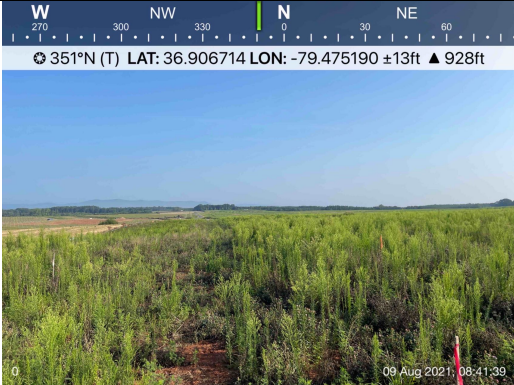
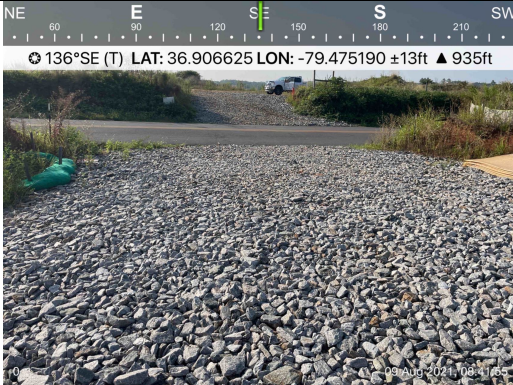
<b>GPS Location</b>	See photo		<b>GPS Location</b>	See photo	
<b>Field Station#</b>	15495+00		<b>Field Station#</b>	15496+00	
<b>Pic 1 Desc.</b>	Vegetation continues to fill in throughout this section of ROW.		<b>Pic 2 Desc.</b>	RCEs are in good condition at all road crossings.

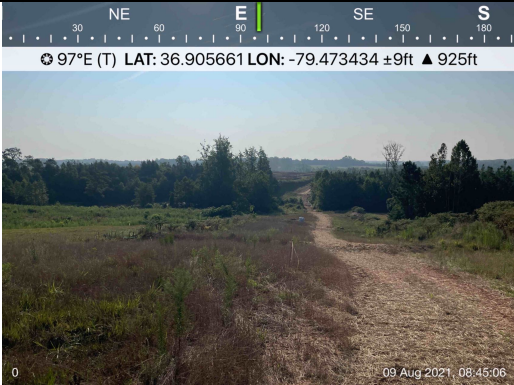
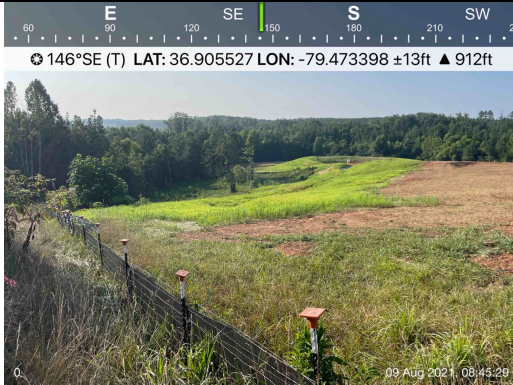
<b>GPS Location</b>	See photo		<b>GPS Location</b>	See photo	
<b>Field Station#</b>	15500+00		<b>Field Station#</b>	15503+00	
<b>Pic 3 Desc.</b>	Vegetation continues to fill in throughout this section of ROW.		<b>Pic 4 Desc.</b>	No evidence of sedimentation from 3rd party disturbance.

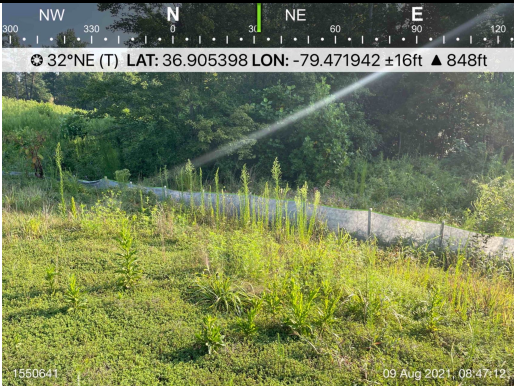
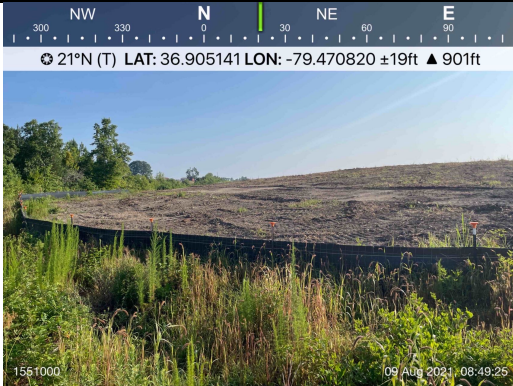
<b>GPS Location</b>	See photo		<b>GPS Location</b>	See photo	
<b>Field Station#</b>	15506+41		<b>Field Station#</b>	15510+00	
<b>Pic 5 Desc.</b>	P1 is in good condition at all stream and wetland buffers.		<b>Pic 6 Desc.</b>	3rd party ECDs appear to be in good condition.

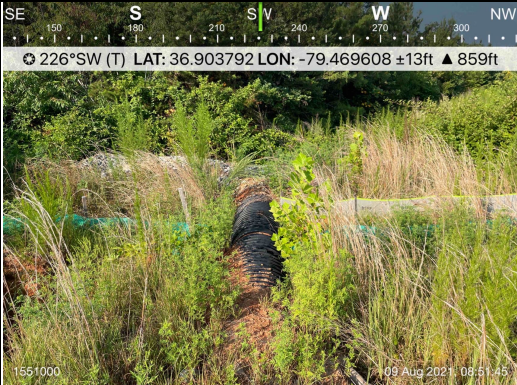
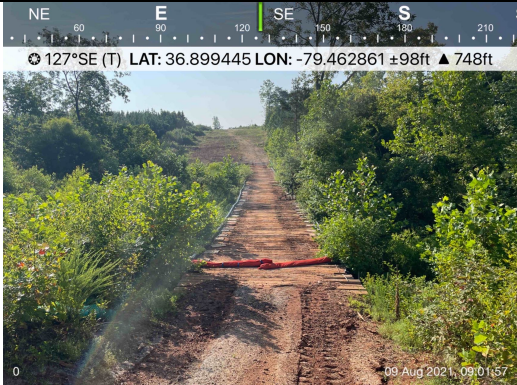
<b>GPS Location</b>	See photo		<b>GPS Location</b>	See photo	
<b>Field Station#</b>	15515+00		<b>Field Station#</b>	15540+00	
<b>Pic 7 Desc.</b>	CWDs are in good condition and functioning.		<b>Pic 8 Desc.</b>	Equipment bridge ECDs are in place and functioning.

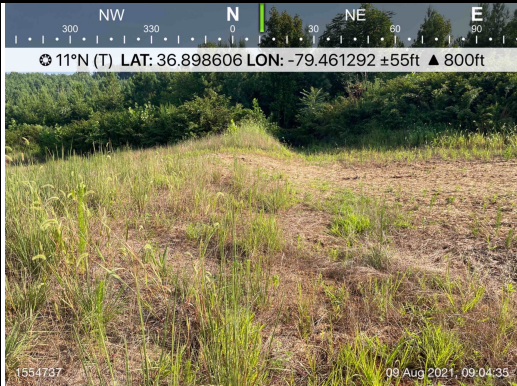
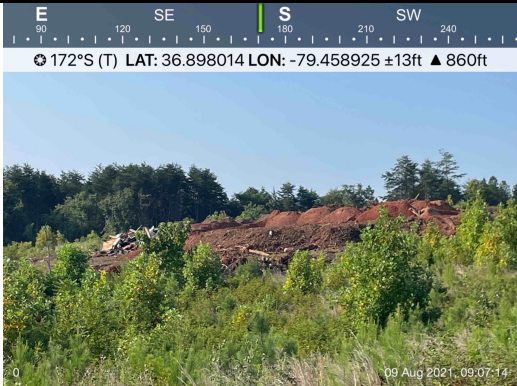
<b>GPS Location</b>	See photo		<b>GPS Location</b>	See photo	
<b>Field Station#</b>	15547+37		<b>Field Station#</b>	15556+83	
<b>Pic 9 Desc.</b>	Waterbars are functioning as intended.		<b>Pic 10 Desc.</b>	No evidence of sedimentation from 3rd party disturbance.

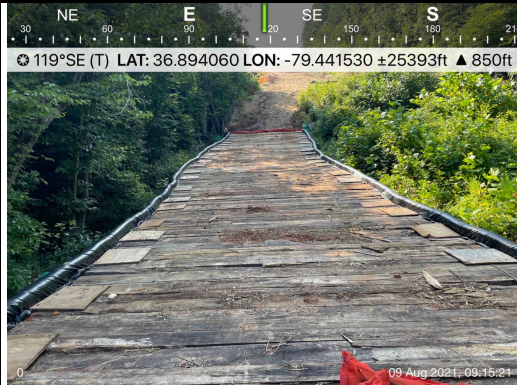
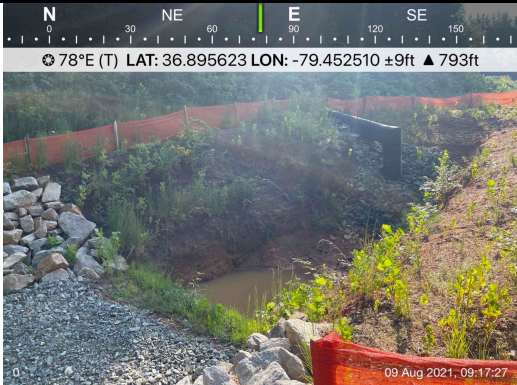
<b>GPS Location</b>	See photo		<b>GPS Location</b>	See photo	
<b>Field Station#</b>	15573+39		<b>Field Station#</b>	15574+87	
<b>Pic 11 Desc.</b>	Recently repaired equipment bridge remains in good condition.		<b>Pic 12 Desc.</b>	Slope drain is functioning as intended.

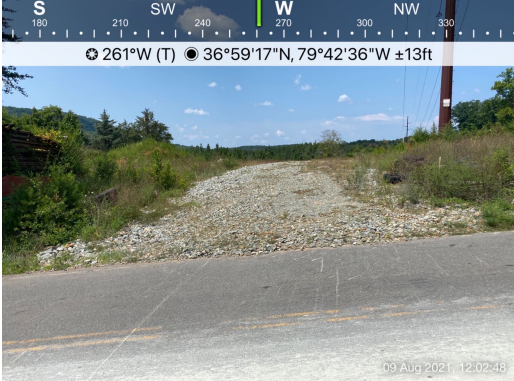
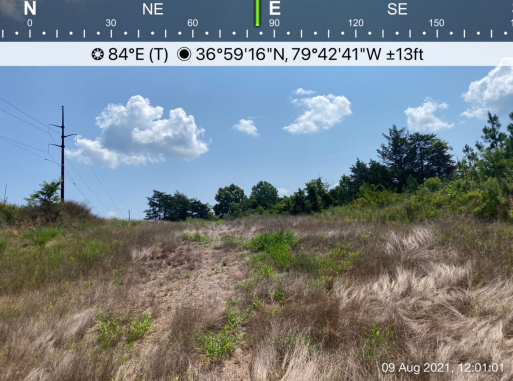
<b>GPS Location</b>	0	<b>GPS Location</b>	0		
<b>Field Station#</b>	14694+50	<b>Field Station#</b>	14691+00		
<b>Pic 1 Desc.</b>	Approximately 14694+50. Overview of road crossing and RCE.	<b>Pic 2 Desc.</b>	Approximately 14691+00. Overview of ROW.

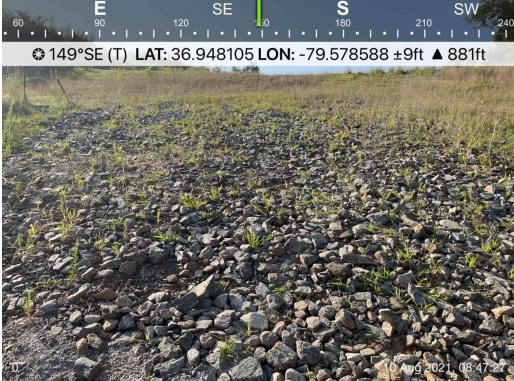
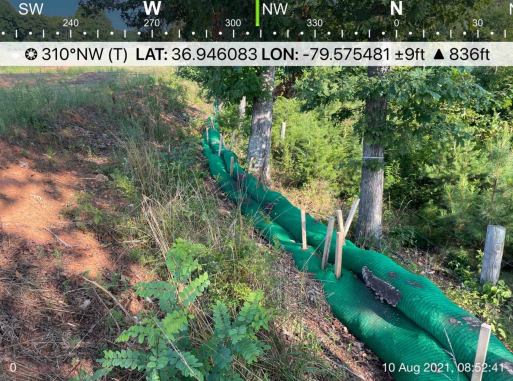
<b>GPS Location</b>	See photo		<b>GPS Location</b>	See photo	
<b>Field Station#</b>	15142+66		<b>Field Station#</b>	15155+00	
<b>Pic 1 Desc.</b>	RCE is in good condition at Rockcreek Rd.		<b>Pic 2 Desc.</b>	Perimeter CFS is in good condition throughout this section.

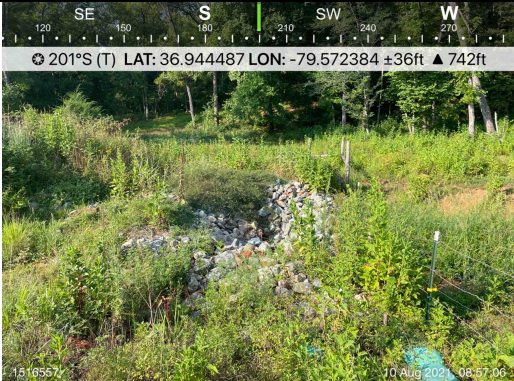
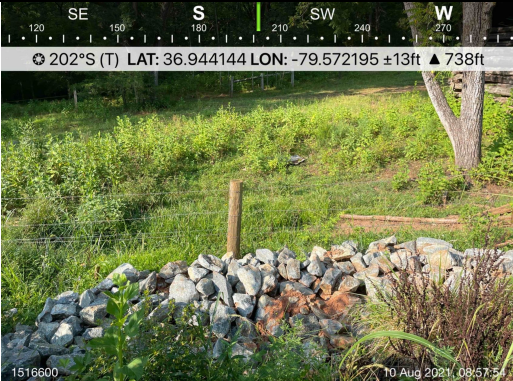
<b>GPS Location</b>	See photo		<b>GPS Location</b>	See photo	
<b>Field Station#</b>	15165+57		<b>Field Station#</b>	15166+00	
<b>Pic 3 Desc.</b>	Rock inlet remains in good condition.		<b>Pic 4 Desc.</b>	Rock outlet remains in good condition.

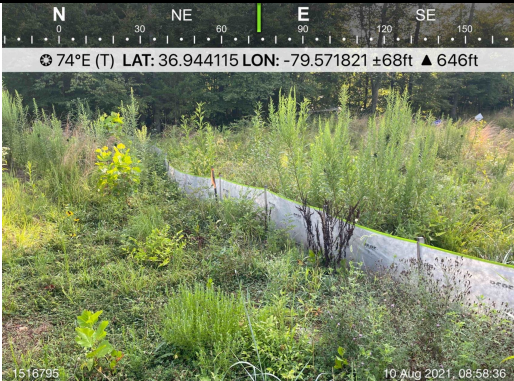
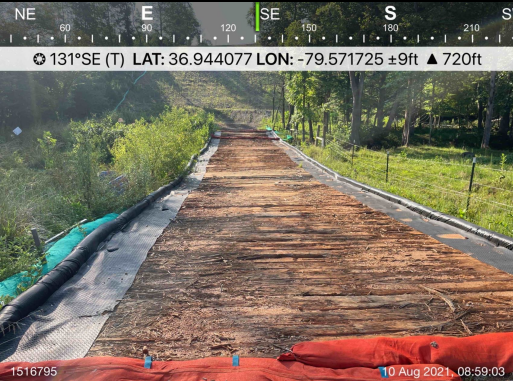
<b>GPS Location</b>	See photo		<b>GPS Location</b>	See photo	
<b>Field Station#</b>	15167+95		<b>Field Station#</b>	15167+95	
<b>Pic 5 Desc.</b>	P1 is in good condition at this stream buffer.		<b>Pic 6 Desc.</b>	Equipment bridge ECDs are in place and functioning.

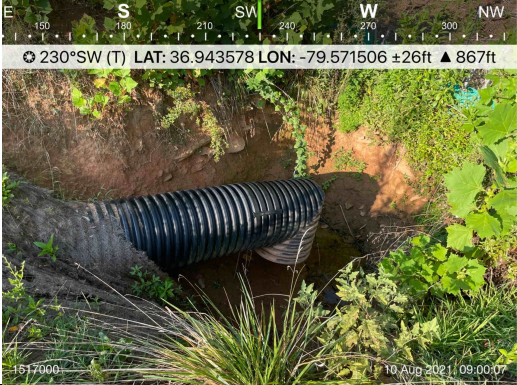
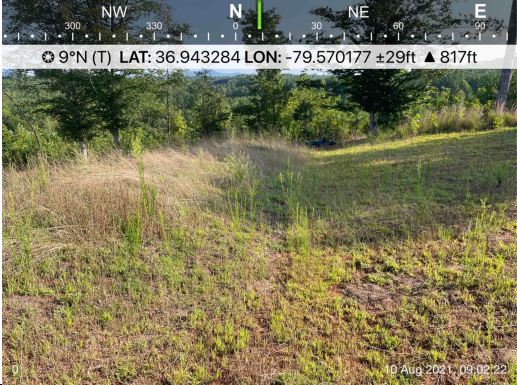
<b>GPS Location</b>	See photo		<b>GPS Location</b>	See photo	
<b>Field Station#</b>	15170+00		<b>Field Station#</b>	15173+00	
<b>Pic 7 Desc.</b>	Slope drain is in good condition and functioning as intended.		<b>Pic 8 Desc.</b>	Waterbars are in good condition throughout this section.

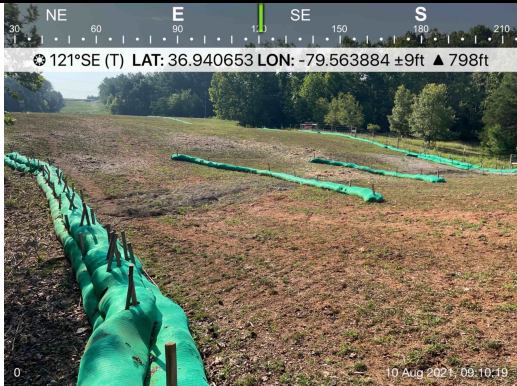
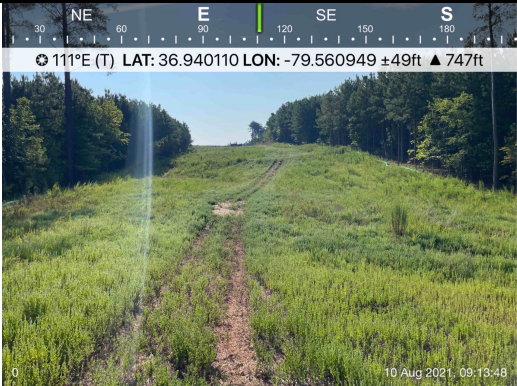
<b>GPS Location</b>	See photo		<b>GPS Location</b>	See photo	
<b>Field Station#</b>	15195+00		<b>Field Station#</b>	15205+00	
<b>Pic 9 Desc.</b>	Drainage ECDs are in place and functioning.		<b>Pic 10 Desc.</b>	Vegetation continues to fill in throughout this section of ROW

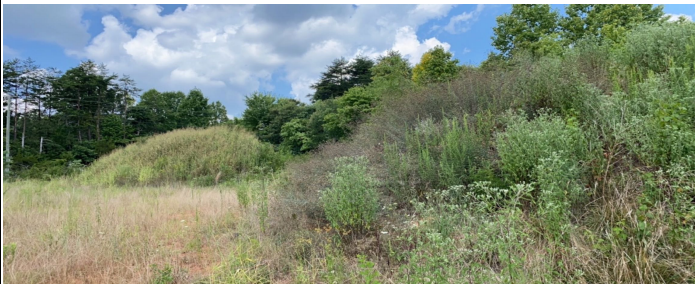
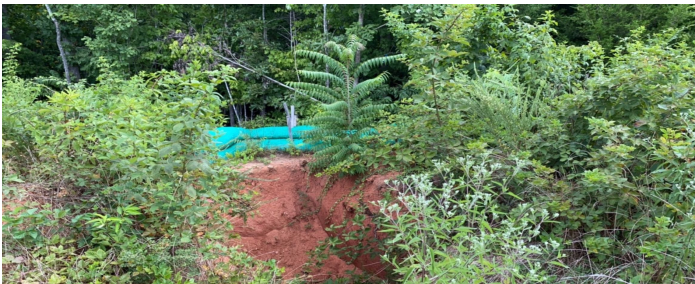
36°59'18" N 79°42'34" W 10°N COURSE 353° GPS 1558-2498 Jacks Creek Rd, Union Hall, VA 24176, United States 08.10.2021 12:21:19 Accur +/-25.7 Ft ALT 947 Ft			36°59'18" N 79°42'33" W 149°SE COURSE 22° GPS 1558-2498 Jacks Creek Rd, Union Hall, VA 24176, United States 08.10.2021 12:21:27 Accur +/-15.6 Ft ALT 945 Ft		
GPS Location	1		GPS Location	2	
Field Station#	14697+50		Field Station#	14699+00	
Pic 1 Desc.	Spoil piles stabilized and vegetated in extra workspace		Pic 2 Desc.	Sump pit and CFS end treatment in good condition

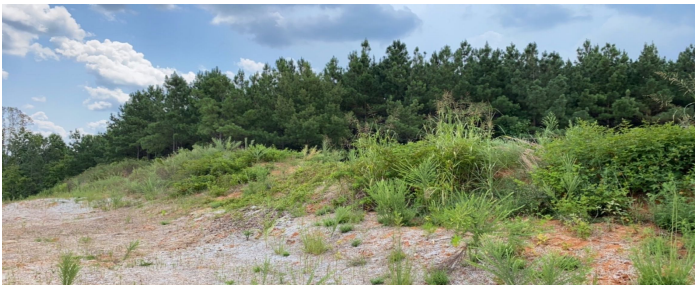
Pic 3 Desc.	Equipment bridge and surrounding ECDs in place and functional at stream crossing and resource buffer		Pic 4 Desc.	Temporary diversion berm stabilized and vegetated and performing intended function

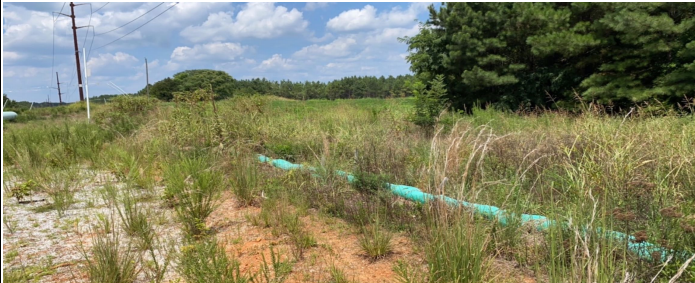
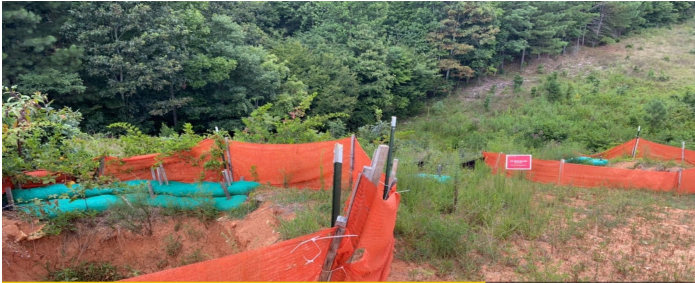
36°58'59" N 79°41'19" W 74°E COURSE 351° GPS Union Hall, VA 24176, United States 08.10.2021 12:48:37 Accur +/-48.8 Ft ALT 960 Ft			36°58'57" N 79°41'17" W 149°SE COURSE 134° GPS Sorry no results found 08.10.2021 12:36:23 Accur +/-56.6 Ft ALT 959 Ft		
GPS Location	5		GPS Location	6	
Field Station#	14773+00		Field Station#	14765+00	
Pic 5 Desc.	Perimeter CFS in place and functional		Pic 6 Desc.	Sump pits, CFS end treatments, and perimeter SSF in place and functional

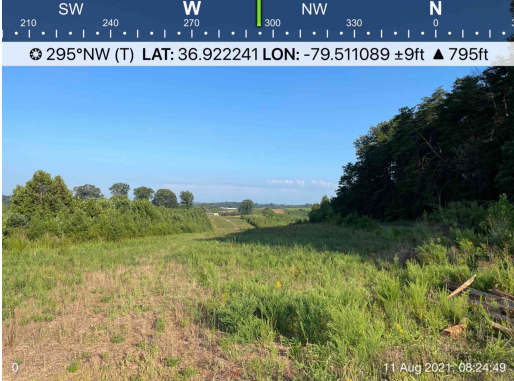
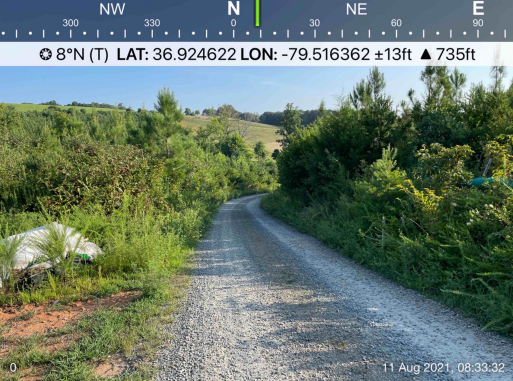
<b>GPS Location</b>	See photo		<b>GPS Location</b>	See photo	
<b>Field Station#</b>	15370+00		<b>Field Station#</b>	15350+00	
<b>Pic 1 Desc.</b>	Vegetation continues to fill in throughout this section of ROW.		<b>Pic 2 Desc.</b>	MVP-PI-332 remains in good condition with controls in place.

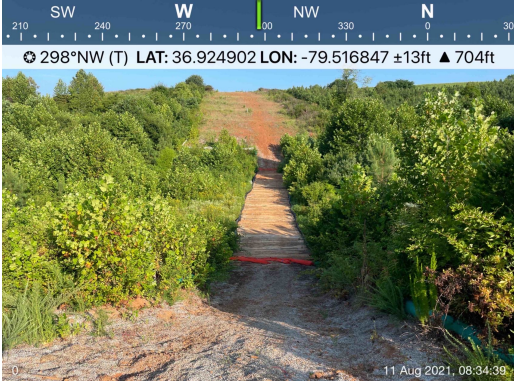
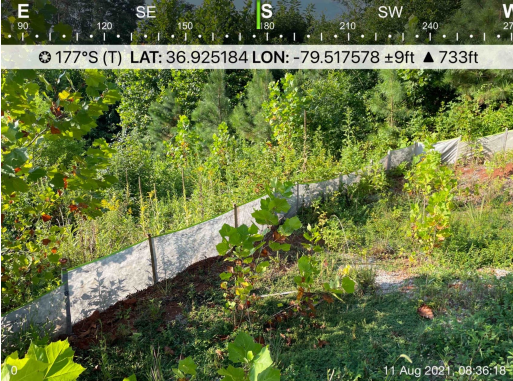
<b>GPS Location</b>	See photo		<b>GPS Location</b>	See photo	
<b>Field Station#</b>	15346+87		<b>Field Station#</b>	15346+00	
<b>Pic 3 Desc.</b>	Equipment bridge ECDs are in place and functioning.		<b>Pic 4 Desc.</b>	P1 in good condition at this stream buffer.

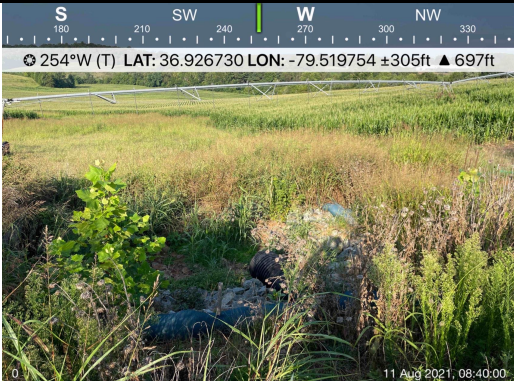
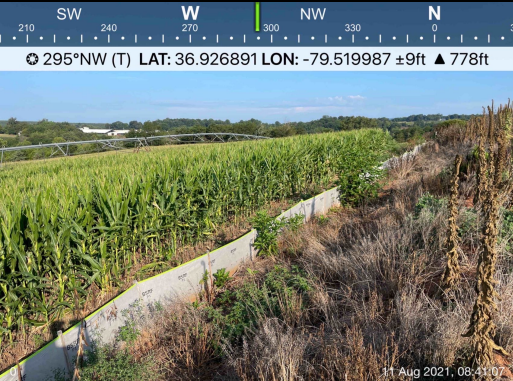
<b>GPS Location</b>	See photo		<b>GPS Location</b>	See photo	
<b>Field Station#</b>	15338+00		<b>Field Station#</b>	15335+00	
<b>Pic 5 Desc.</b>	CWD is in good condition and functioning as intended.		<b>Pic 6 Desc.</b>	Perimeter P1 is in good condition.

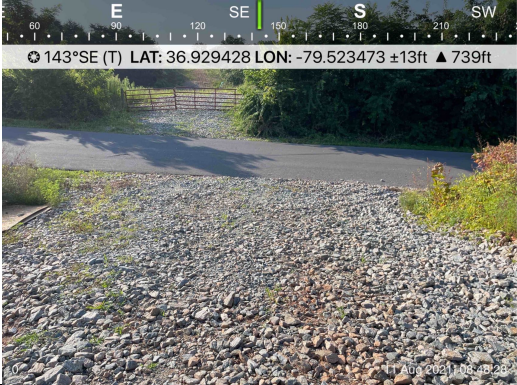
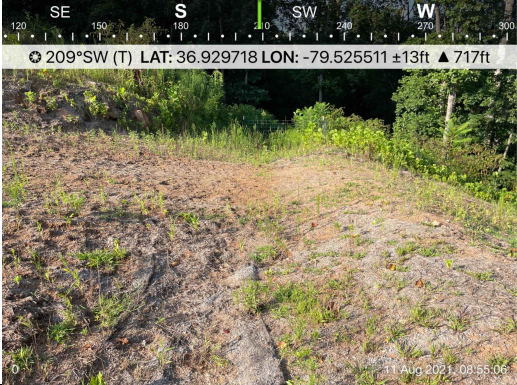
<b>GPS Location</b>	See photo		<b>GPS Location</b>	See photo	
<b>Field Station#</b>	15323+24		<b>Field Station#</b>	15315+00	
<b>Pic 7 Desc.</b>	RCEs are in good condition at all road crossings.		<b>Pic 8 Desc.</b>	Waterbars are functioning as intended.

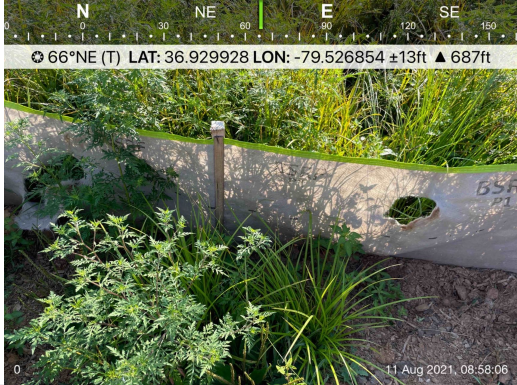
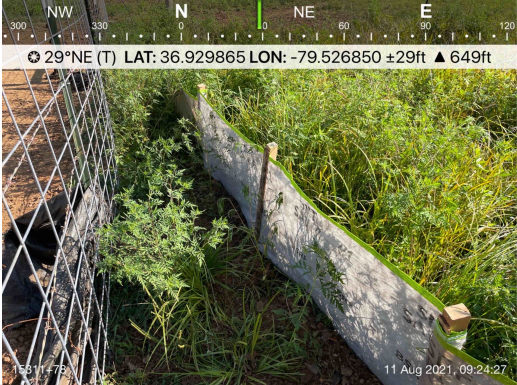
<b>GPS Location</b>	See photo		<b>GPS Location</b>	See photo	
<b>Field Station#</b>	15311+87		<b>Field Station#</b>	15311+87	
<b>Pic 9 Desc.</b>	P1 has been damaged by livestock at this wetland buffer and needs to be replaced.		<b>Pic 10 Desc.</b>	Environmental crew has corrected this issue.

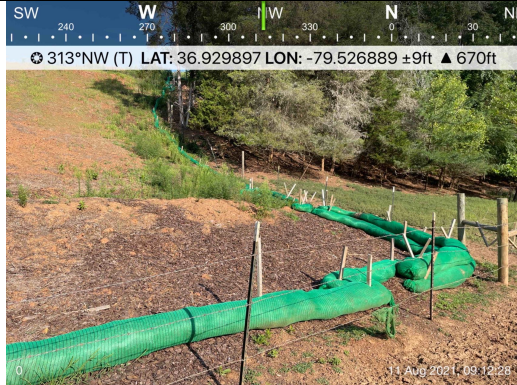
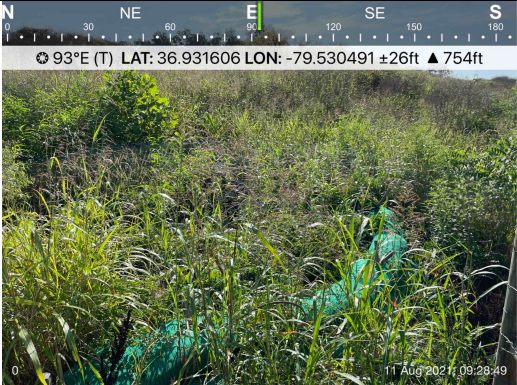
<b>GPS Location</b>	See photo		<b>GPS Location</b>	See photo	
<b>Field Station#</b>	15310+00		<b>Field Station#</b>	15299+00	
<b>Pic 11 Desc.</b>	Perimeter CFS is in good condition.		<b>Pic 12 Desc.</b>	CWD is functioning as intended.

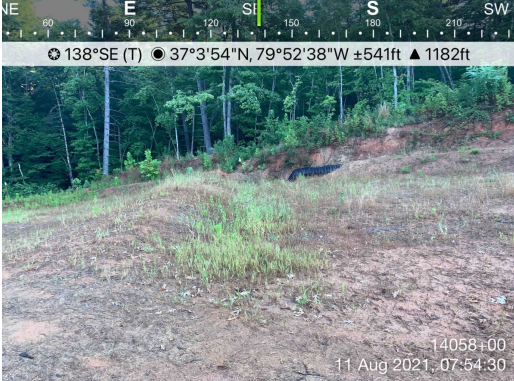
<b>GPS Location</b>	0	<b>GPS Location</b>	0		
<b>Field Station#</b>	14058+00	<b>Field Station#</b>	14058+00		
<b>Pic 1 Desc.</b>	Waterbar end treatment in acceptable condition	<b>Pic 2 Desc.</b>	Sump pit and slope drain pipe in acceptable conditions

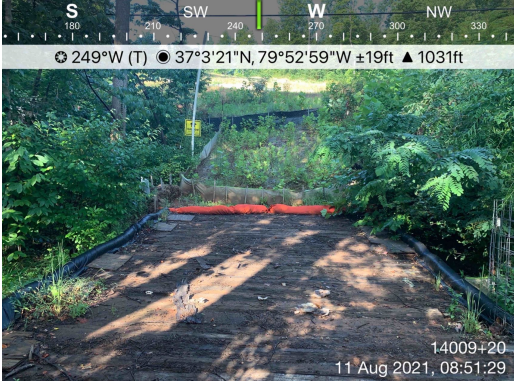
<b>GPS Location</b>	0	<b>GPS Location</b>	0		
<b>Field Station#</b>	14009+20	<b>Field Station#</b>	14001+00		
<b>Pic 3 Desc.</b>	P1 silt fence and equipment bridge in acceptable condition	<b>Pic 4 Desc.</b>	Temporary vegetative stabilization in acceptable condition

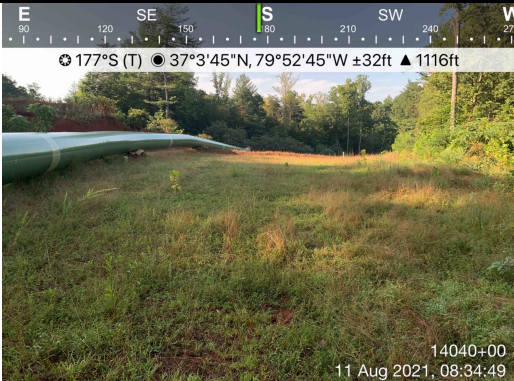
<b>GPS Location</b>	0	<b>GPS Location</b>	0		
<b>Field Station#</b>	14040+00	<b>Field Station#</b>	13964+00		
<b>Pic 5 Desc.</b>	Temporary vegetative stabilization in acceptable condition	<b>Pic 6 Desc.</b>	Clean water diversion berm and CFS in acceptable conditions

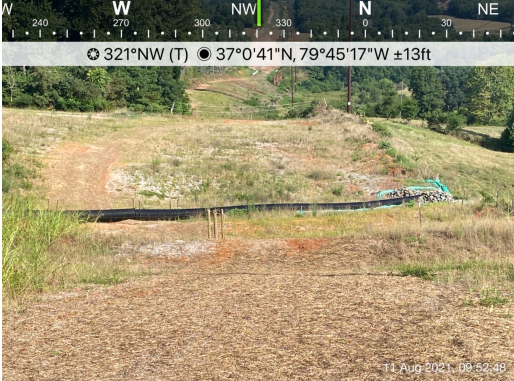
<b>GPS Location</b>	0	<b>GPS Location</b>	0		
<b>Field Station#</b>	14518+00	<b>Field Station#</b>	14524+50		
<b>Pic 1 Desc.</b>	Approximately 14518+00. Overview of ROW.	<b>Pic 2 Desc.</b>	Approximately 14524+50. Overview of road crossing and RCEs.

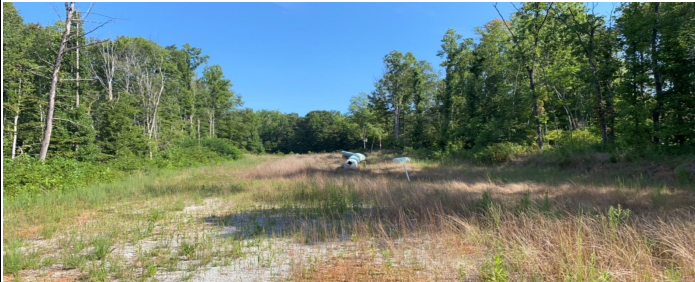
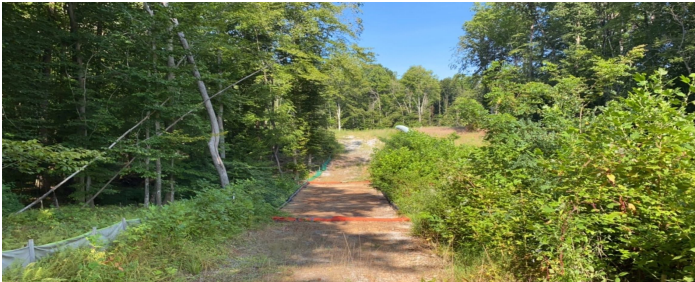
36°58'24" N 79°40'25" W 51°NE COURSE 27' GPS 08.11.2021 10:07:08 Accur +/-37.7 Ft ALT 882 Ft			36°58'23" N 79°40'10" W 314°NW COURSE 261' GPS 08.11.2021 10:05:25 1120 Listening Hill Rd, Penhook, VA 24137, United States Accur +/-269.1 Ft ALT 947 Ft		
GPS Location	1	GPS Location	2		
Field Station#	14818+00	Field Station#	14823+54		
Pic 1 Desc.	Picture of temporary stabilization and vegetation along ROW		Pic 2 Desc.	Equipment bridge and surrounding ECDs in place and functional at stream crossing and resource buffer

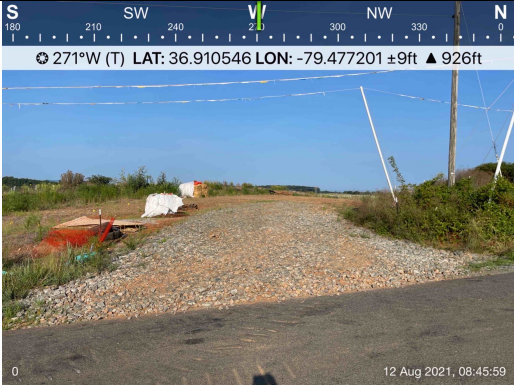
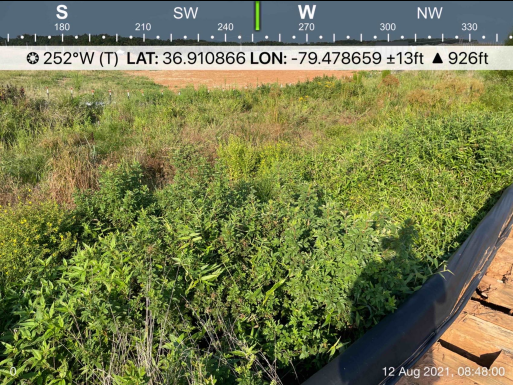
<b>GPS Location</b>	See photo		<b>GPS Location</b>	See photo	
<b>Field Station#</b>	15480+67		<b>Field Station#</b>	15475+00	
<b>Pic 1 Desc.</b>	RCEs are in good condition at all road crossings.		<b>Pic 2 Desc.</b>	3rd party rock outlet appears to be in good condition along this drainage.

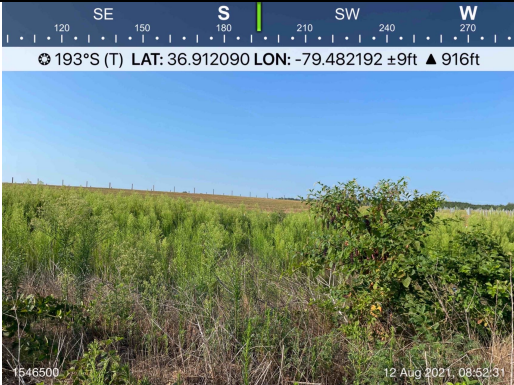
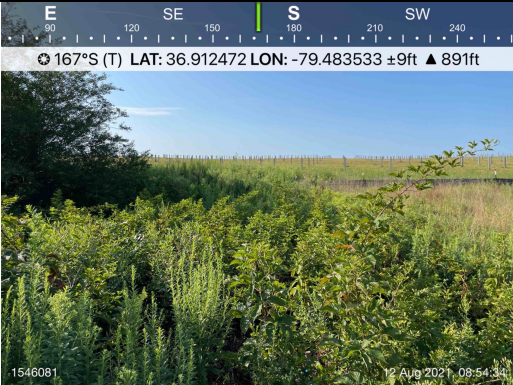
<b>GPS Location</b>	See photo		<b>GPS Location</b>	See photo	
<b>Field Station#</b>	15465+00		<b>Field Station#</b>	15460+81	
<b>Pic 3 Desc.</b>	No evidence of sedimentation from 3rd party rock outlet.		<b>Pic 4 Desc.</b>	No evidence of sedimentation from 3rd party rock outlet into CWD inlet.

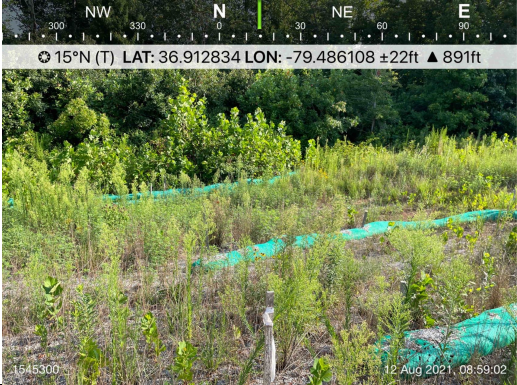
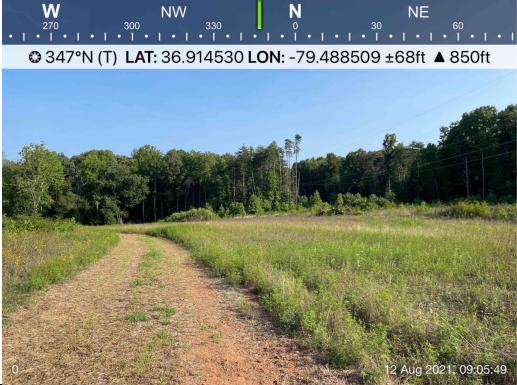
<b>GPS Location</b>	See photo		<b>GPS Location</b>	See photo	
<b>Field Station#</b>	15453+00		<b>Field Station#</b>	15442+00	
<b>Pic 7 Desc.</b>	CWD in good condition with no evidence of sedimentation from 3rd party disturbance.		<b>Pic 8 Desc.</b>	Vegetation continues to fill in throughout this section.

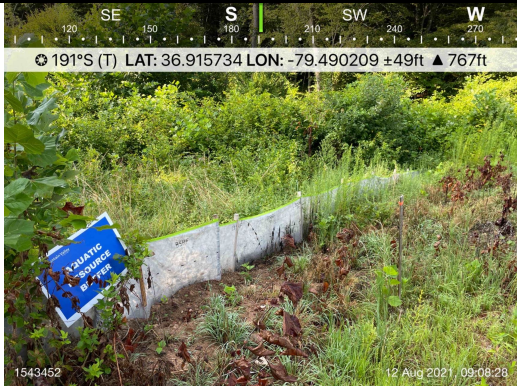
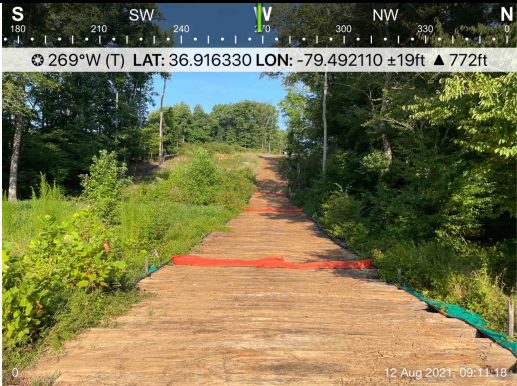
<b>GPS Location</b>	See photo		<b>GPS Location</b>	See photo	
<b>Field Station#</b>	15434+52		<b>Field Station#</b>	15427+43	
<b>Pic 9 Desc.</b>	P1 is in good condition at all stream and wetland buffers.		<b>Pic 10 Desc.</b>	Equipment bridge ECDs are in place and functioning.

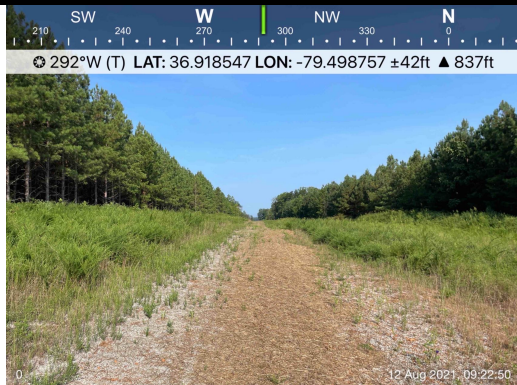
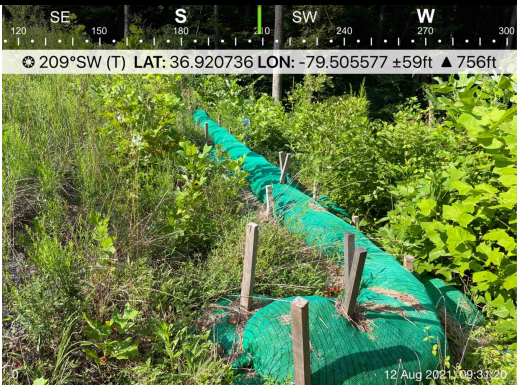
<b>GPS Location</b>	See photo		<b>GPS Location</b>	See photo	
<b>Field Station#</b>	15415+00		<b>Field Station#</b>	15385+00	
<b>Pic 11 Desc.</b>	Vegetation continues to fill in throughout this section.		<b>Pic 12 Desc.</b>	CFS is in good condition throughout this section.

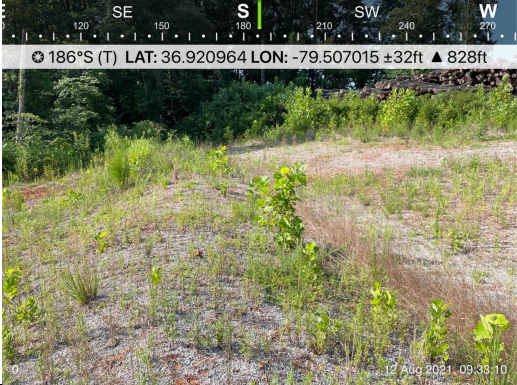
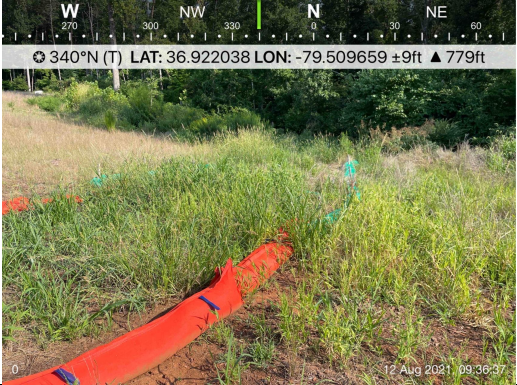
<b>GPS Location</b>	See photo	<b>GPS Location</b>	See photo		
<b>Field Station#</b>	15380+00	<b>Field Station#</b>	15375+00		
<b>Pic 13 Desc.</b>	Waterbars are in good condition.	<b>Pic 14 Desc.</b>	Drainage feature ECDs are in good condition.		
Insert image here		Insert image here			
<b>GPS Location</b>		<b>GPS Location</b>			
<b>Field Station#</b>		<b>Field Station#</b>			
<b>Pic 15 Desc.</b>		<b>Pic 16 Desc.</b>			
Insert image here		Insert image here			
<b>GPS Location</b>		<b>GPS Location</b>			
<b>Field Station#</b>		<b>Field Station#</b>			
<b>Pic 17 Desc.</b>		<b>Pic 18 Desc.</b>

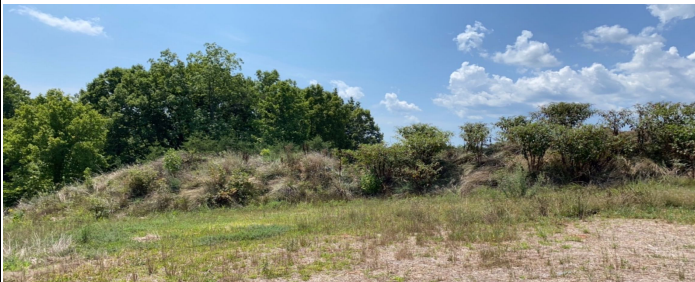
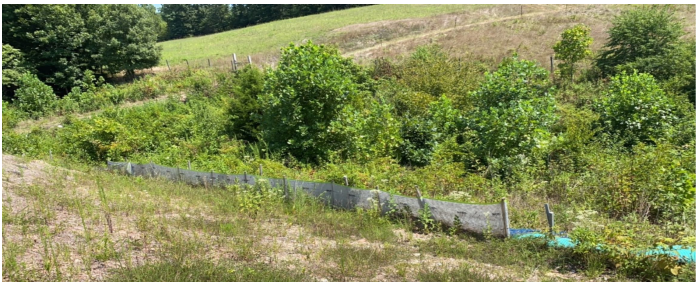
36°58'3" N 79°38'15" W 163°S COURSE 32° GPS 2082 Ramsey Memorial Rd, Penhook, VA 24137, United States 08.12.2021 12:23:09 Accur +/-36.9 Ft ALT 873 Ft			36°58'3" N 79°38'15" W 84°E COURSE 59° GPS 2082 Ramsey Memorial Rd, Penhook, VA 24137, United States 08.12.2021 12:24:30 Accur +/-216.6 Ft ALT 871 Ft		
GPS Location	1		GPS Location	2	
Field Station#	14930+00		Field Station#	14932+39	
Pic 1 Desc.	Temporary diversion berm stabilized and vegetated		Pic 2 Desc.	P1 silt fence in good condition at resource buffer

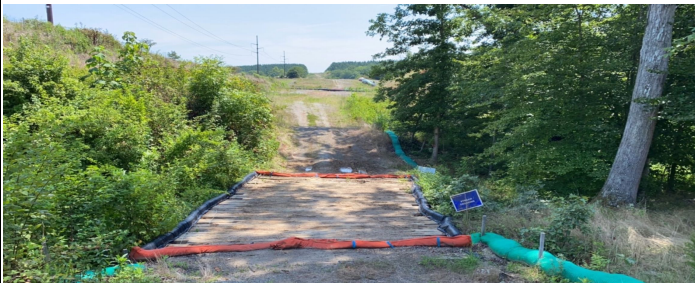
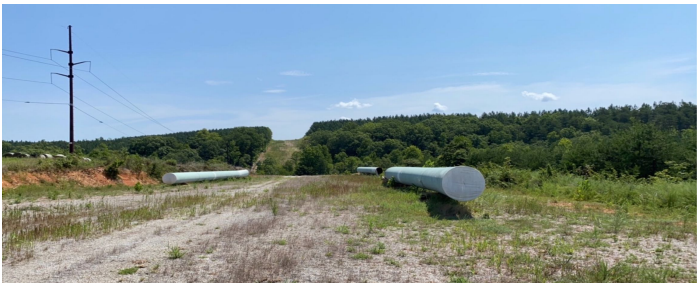
Field Station#	14932+89		Field Station#	14945+00	
Pic 3 Desc.	Equipment bridge and surrounding ECDs in place and functional at stream crossing and resource buffer		Pic 4 Desc.	Temporary stabilization and vegetation along ROW

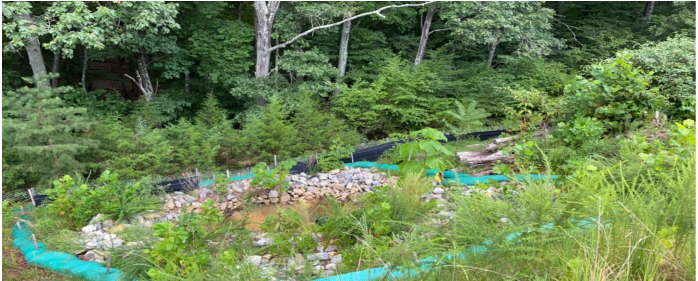
36°57'55" N 79°35'53" W 273°W COURSE 209° GPS Penhook, VA 24137, United States 08.12.2021 14:48:39 Accur +/-62.8 Ft ALT 828 Ft			36°57'52" N 79°35'46" W 292°W COURSE 226° GPS Penhook, VA 24137, United States 08.12.2021 14:46:19 Accur +/-85.9 Ft ALT 0 Ft		
GPS Location	5		GPS Location	6	
Field Station#	15045+50		Field Station#	15053+00	
Pic 5 Desc.	ECDs down slope are in good condition		Pic 6 Desc.	Plunge pool performing intended function

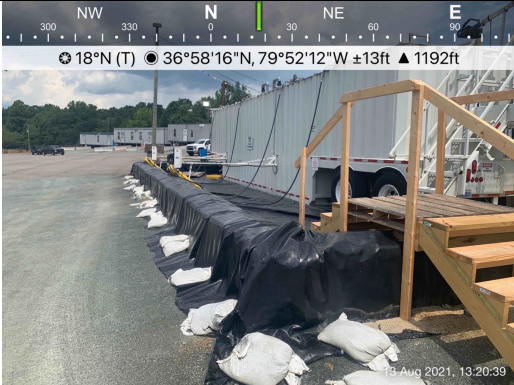
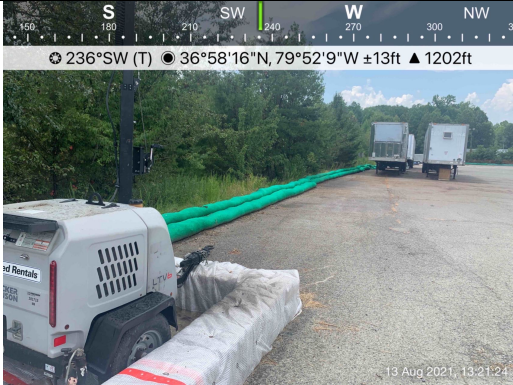
<b>GPS Location</b>	000000000000	<b>GPS Location</b>	000000000000		
<b>Field Station#</b>	0000+00	<b>Field Station#</b>	0000+00		
<b>Pic 1 Desc.</b>	Secondary containment structure for fuel cell at LY-046 in good condition.	<b>Pic 2 Desc.</b>	Perimeter ECD's and secondary containment structure for light plant on south end of LY-046 in good condition

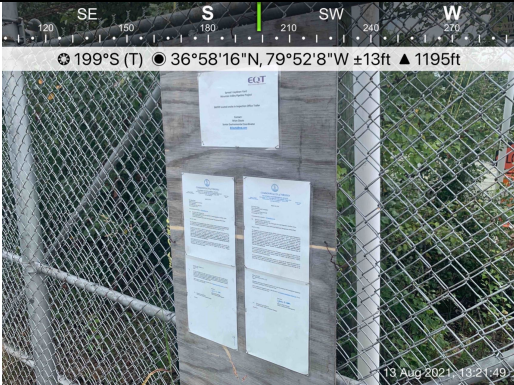
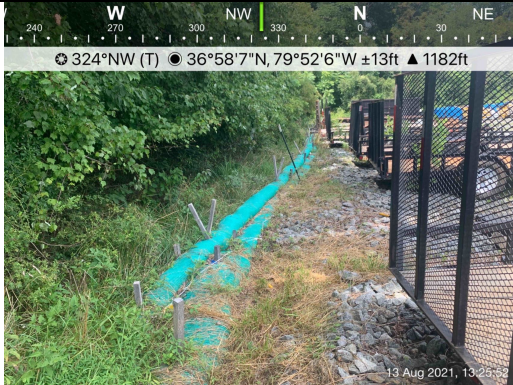
<b>GPS Location</b>	000000000000	<b>GPS Location</b>	000000000000		
<b>Field Station#</b>	0000+00	<b>Field Station#</b>	0000+00		
<b>Pic 3 Desc.</b>	Construction permits and contact information are posted at the main entrance of LY-046 as required.	<b>Pic 4 Desc.</b>	Perimeter ECD's on west side of LY-045 near employee parking area in good condition.
