Visual Site Inspection Report

Project Name	H-600 Pipeline Spread I		AFE	124300139	Spread	H-600 Pipeline Spread I	
Contractor	Precision				Report #	27186	
Inspector	Ben Davenport				Date/Time	8/16/2021 9:06 AM	
Permit #	TBD	Inspection Type	VA SWPP		Station Begin	14694+77	
State	VA	Inspection Area	Partial		Station End	14802+19	
County	Franklin	Ground	Muddy		Temperature (°F)	81.00	
Municipality	N/A	Weather	Cloudy		Rain Gauge (in)	1.30	
					Rain Accumulation Time (days)	1.00

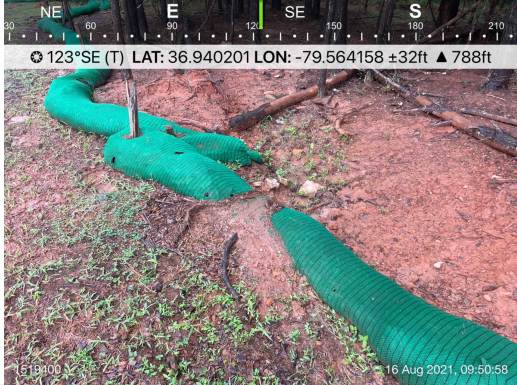
GPS Location	See photo		GPS Location	See photo	
Field Station#	15194+00		Field Station#	15194+00	
Pic 9 Desc.	CFS needs to be cleared of sediment and restaked.		Pic 10 Desc.	Environmental crew has corrected this issue.

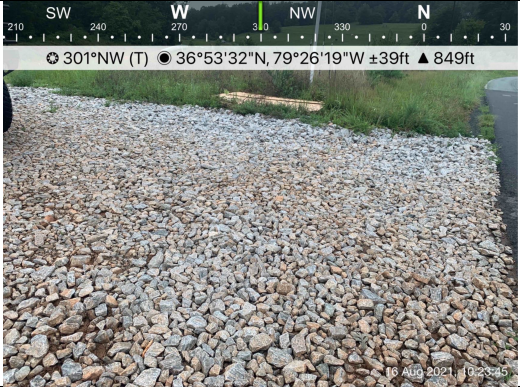
GPS Location	O	GPS Location	O		
Field Station#	15619+48	Field Station#	15619+48		
Pic 1 Desc.	Observing trash that needs to be removed from the RCE (3rd party damage)	Pic 2 Desc.	Observing clean RCE

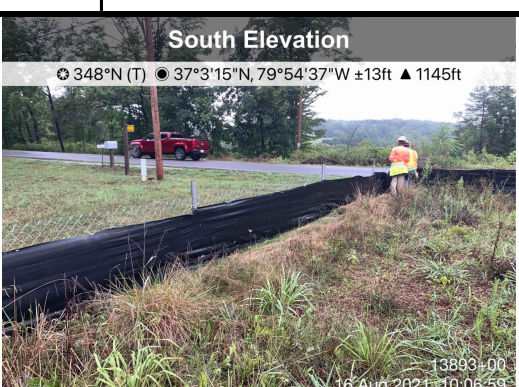
GPS Location	0		GPS Location	0	
Field Station#	13893+00		Field Station#	13890+00	
Pic 5 Desc.	Super silt fence after maintenance		Pic 6 Desc.	Sump pit and slope drain pipe in acceptable conditions

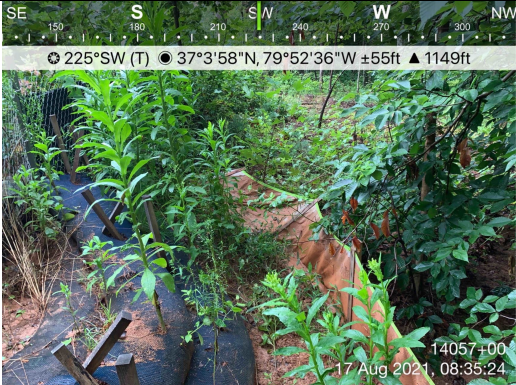
GPS Location	0	GPS Location	0		
Field Station#	14057+00	Field Station#	14046+00		
Pic 1 Desc.	P1 silt fence has broken stakes	Pic 2 Desc.	P1 silt fence has a broken stake

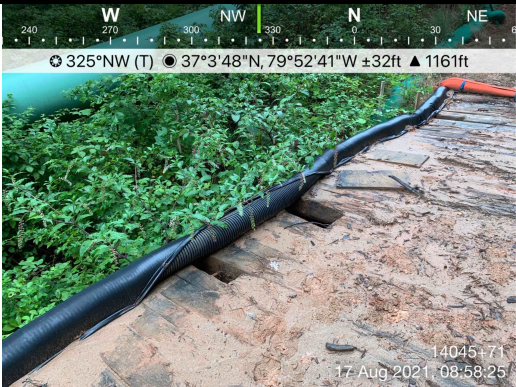
GPS Location	0	GPS Location	0		
Field Station#	14045+71	Field Station#	14042+80		
Pic 3 Desc.	Geotech fabric is detached from the equipment bridge	Pic 4 Desc.	Hole in P1 silt fence, appears to be damaged by wildlife

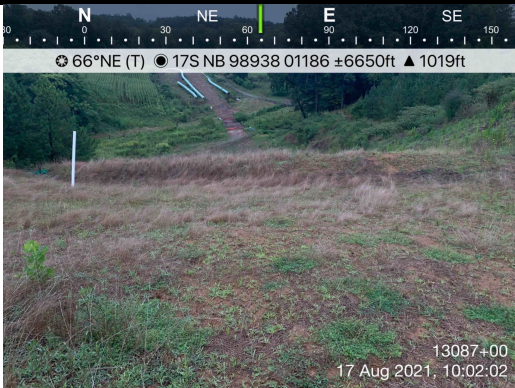
GPS Location	0	GPS Location	0		
Field Station#	14043+00	Field Station#	13087+00		
Pic 5 Desc.	P1 silt fence has broken stakes	Pic 6 Desc.	Waterbar and temporary vegetative stabilization in acceptable conditions

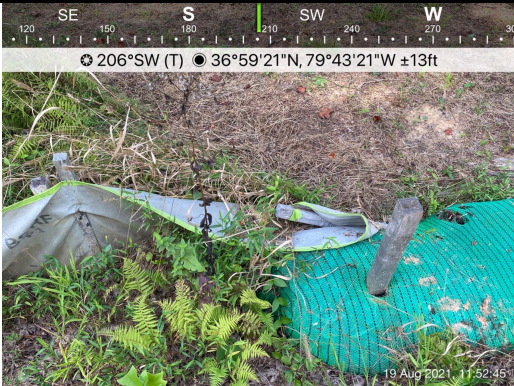
GPS Location	0	GPS Location	0		
Field Station#	14656+50	Field Station#	14673+25		
Pic 5 Desc.	Approximately 14656+50. P-1 requires maintenance. Stake broken due to third party atv activities.		Pic 6 Desc.	Approximately 14673+25. Sediment build up on waddle.

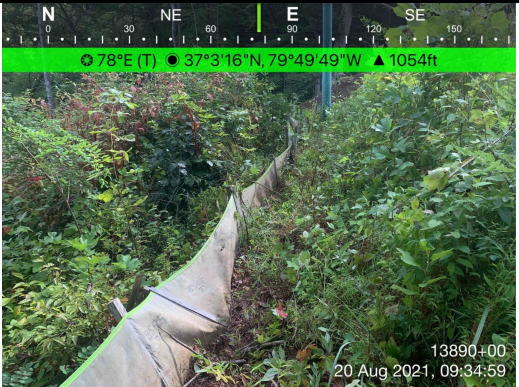
GPS Location		0			
Field Station#		13890+00			
Pic 1 Desc.		P1 silt fence is damaged and deteriorated requiring replacement

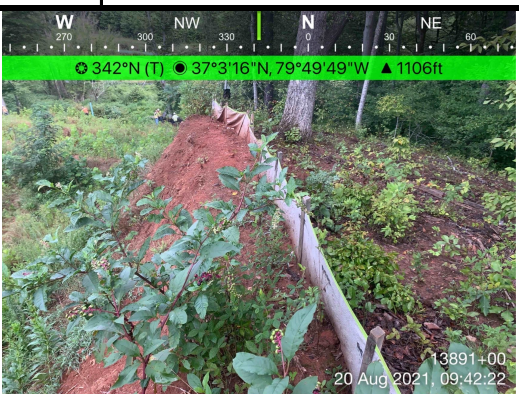
GPS Location		0			
Field Station#		13891+00			
Pic 3 Desc.		P1 silt fence is deteriorated from 13891+00 to 13891+75, to be removed temporarily per DEQ approval

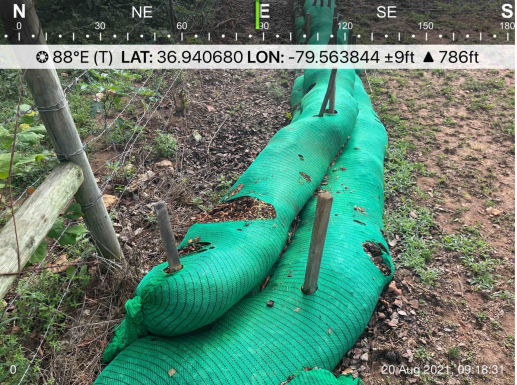
GPS Location	See photo		GPS Location	See photo	
Field Station#	15187+00		Field Station#	15195+00	
Pic 9 Desc.	Vegetation continues to fill in throughout this section.		Pic 10 Desc.	CFS along drainage has been damaged by livestock and needs to be repaired and restaked.
