Visual Site Inspection Report

Project Name	H-600 Pipeline Spread I	AFE	124300139	Spread	H-600 Pipeline Spread I
Contractor	Precision			Report #	27600
Inspector	John White			Date/Time	8/23/2021 10:49 AM
Permit #	TBD	Inspection Type	VA SWPP	Station Begin	15647+03
State	VA	Inspection Area	Full	Station End	15772+27
County	Pittsylvania	Ground	Dry	Temperature (°F)	85.00
Municipality	Chatham	Weather	Sunny	Rain Gauge (in)	0.50
				Rain Accumulation Time (days)	6.00

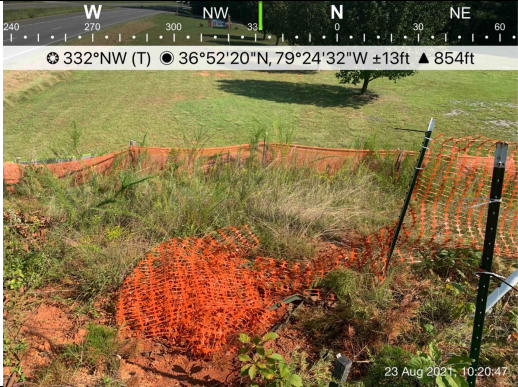
GPS Location	O	GPS Location	O		
Field Station#	15744+30	Field Station#	15744+50		
Pic 1 Desc.	Observing CFS that requires maintenance	Pic 2 Desc.	Observing safety fence that requires maintenance (3rd party damage)

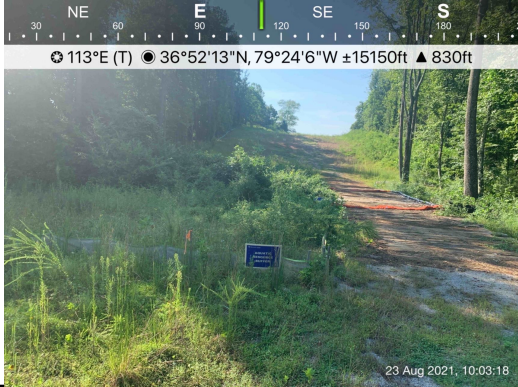
GPS Location	O	GPS Location	O		
Field Station#	15744+50	Field Station#	15763+80		
Pic 3 Desc.	Observing CFS that requires maintenance	Pic 4 Desc.	Observing temporary stabilization, signage, buffer, equipment crossing and ECD's

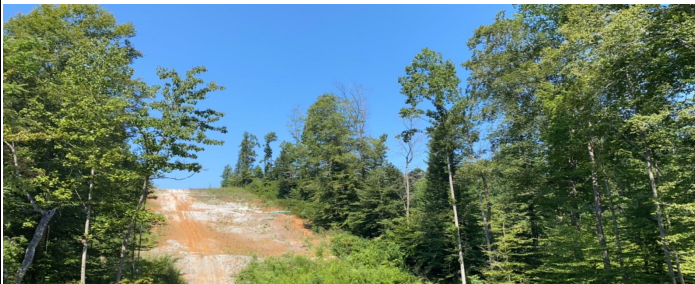
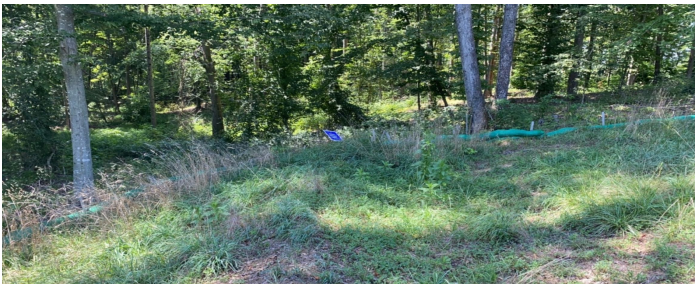
36°58'14" N 79°39'25" W 300°NW COURSE 326° GPS 08.23.2021 11:30:05 Sorry no results found Accur +/-61.6 Ft ALT 816 Ft			36°58'29" N 79°40'28" W 259°W COURSE 266° GPS 08.23.2021 12:01:00 1120 Listening Hill Rd, Penhook, VA 24137, United States Accur +/-92.7 Ft ALT 947 Ft		
GPS Location	1	GPS Location	2		
Field Station#	14868+00	Field Station#	14814+00		
Pic 1 Desc.	Picture of temporary stabilization on slope. Limited to no vegetation observed on slope.		Pic 2 Desc.	Water bar and perimeter CFS in good condition in final cleanup area

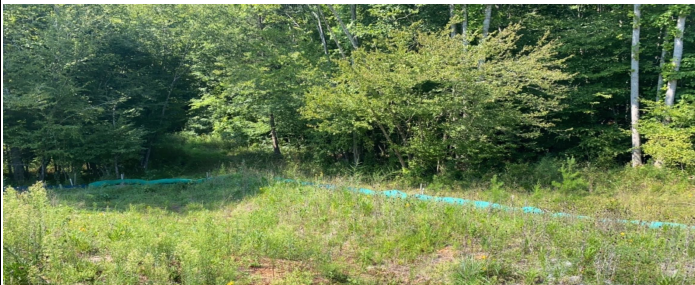
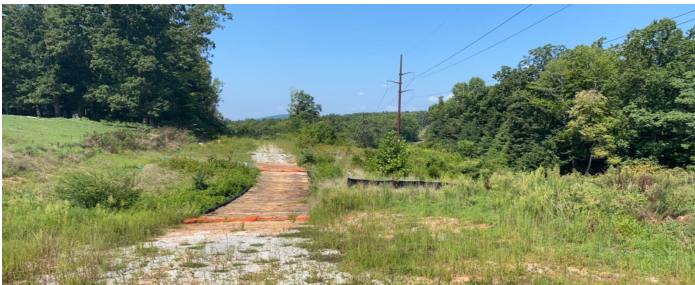
Field Station#	14909+00	Field Station#	14833+02		
Pic 3 Desc.	Perimeter CFS in good condition in temporary area		Pic 4 Desc.	Equipment bridge and surrounding ECDs in place and functional at stream crossing and resource buffer

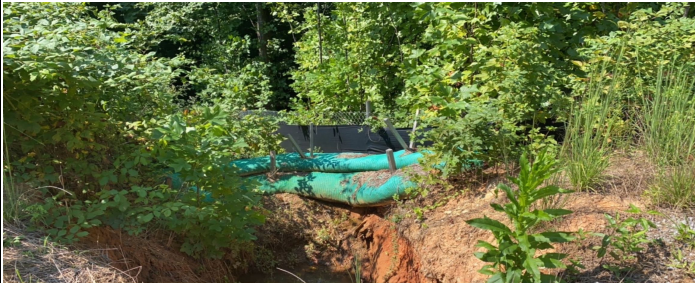
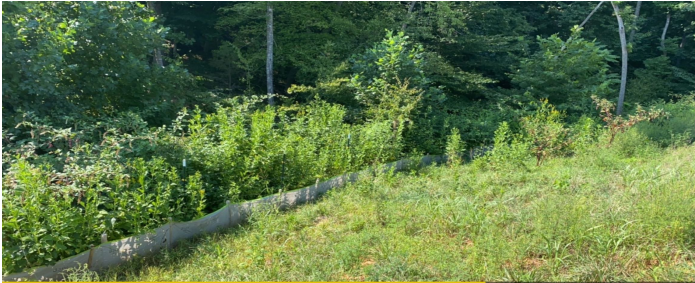
36°58'8" N 79°38'46" W 234°SW COURSE 326° GPS 08.23.2021 11:24:42 Sorry no results found Accur +/-285.2 Ft ALT 816 Ft			36°58'5" N 79°38'24" W 246°SW COURSE 0° GPS 08.23.2021 11:04:12 Sorry no results found Accur +/-118.2 Ft ALT 0 Ft		
GPS Location	5	GPS Location	6		
Field Station#	14889+00	Field Station#	14922+50		
Pic 5 Desc.	Sump pit, CFS end treatment, and perimeter SSF in place and functional		Pic 6 Desc.	P1 silt fence along ROW in good condition

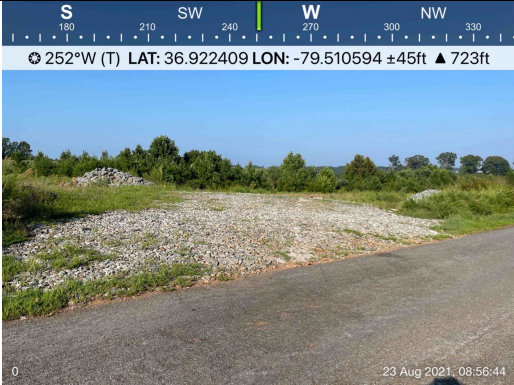
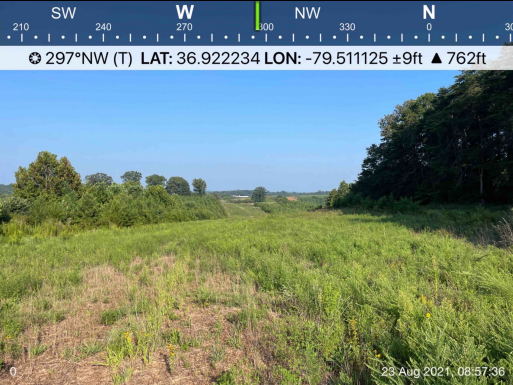
GPS Location	See photo		GPS Location	See photo	
Field Station#	15370+62		Field Station#	15370+00	
Pic 1 Desc.	RCEs are in good condition at all road crossings.		Pic 2 Desc.	Vegetation continues to fill in throughout this section of ROW.

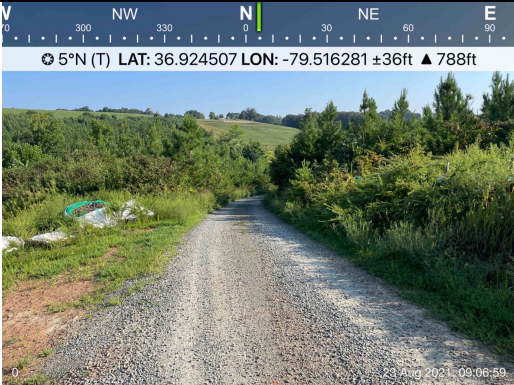
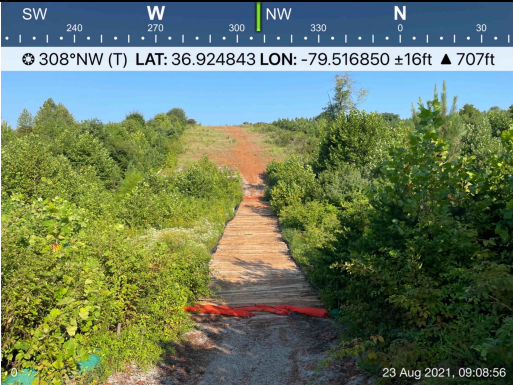
GPS Location	See photo		GPS Location	See photo	
Field Station#	15350+00		Field Station#	15346+90	
Pic 3 Desc.	MVP-PI-332 is in good condition with controls in place.		Pic 4 Desc.	Equipment bridge ECDs are in place and functioning.

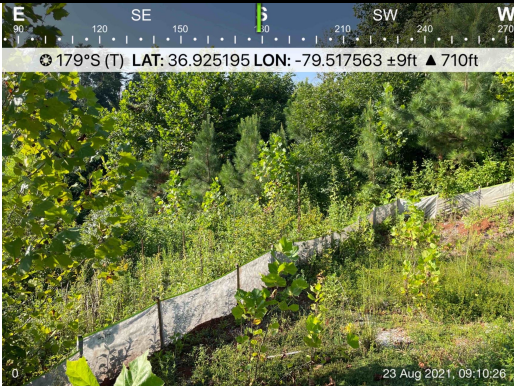
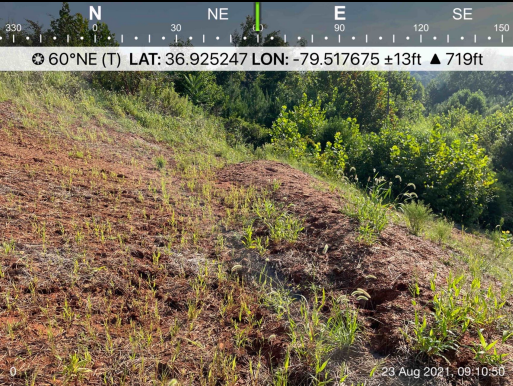
GPS Location	See photo		GPS Location	See photo	
Field Station#	15346+00		Field Station#	15345+00	
Pic 5 Desc.	P1 is in good condition at all stream and wetland buffers.		Pic 6 Desc.	Waterbars are in good condition and functioning.

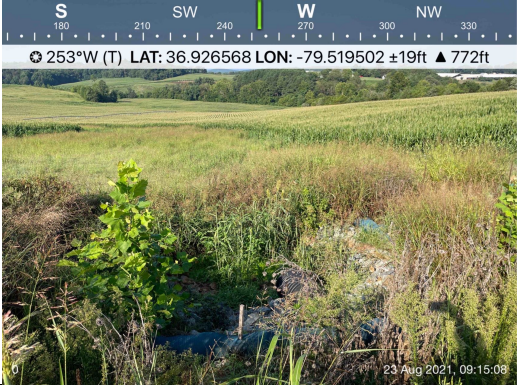
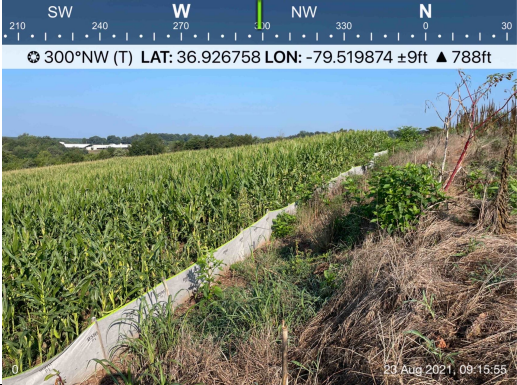
GPS Location	See photo	GPS Location	See photo		
Field Station#	15338+00	Field Station#	15336+00		
Pic 7 Desc.	CWD is functioning as intended.	Pic 8 Desc.	Perimeter P1 is in good condition throughout this section.

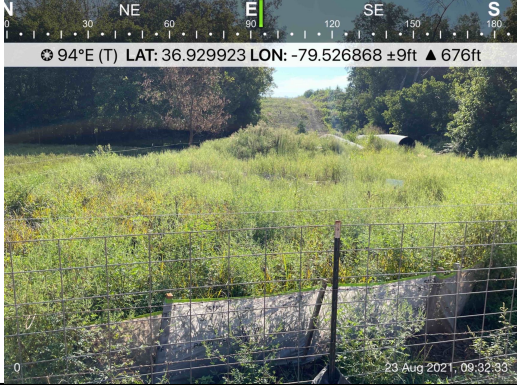
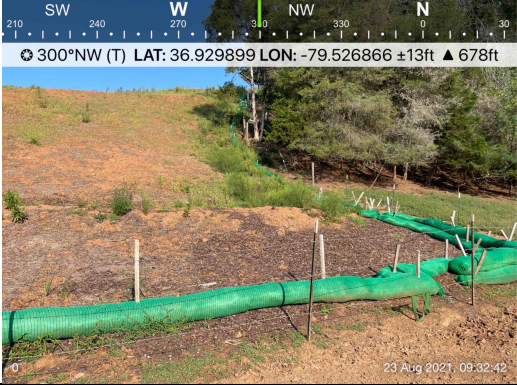
GPS Location	See photo	GPS Location	See photo		
Field Station#	15311+78	Field Station#	15310+00		
Pic 9 Desc.	Wetland buffer P1 remains in good condition.	Pic 10 Desc.	CFS is in good condition throughout this section.

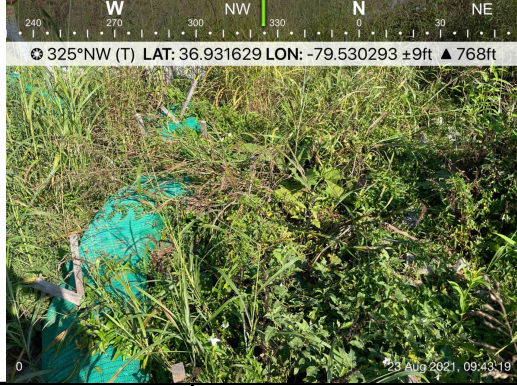
Insert image here			
GPS Location	See photo	GPS Location			
Field Station#	15299+00	Field Station#			
Pic 11 Desc.	CWD is functioning as intended.	Pic 12 Desc.

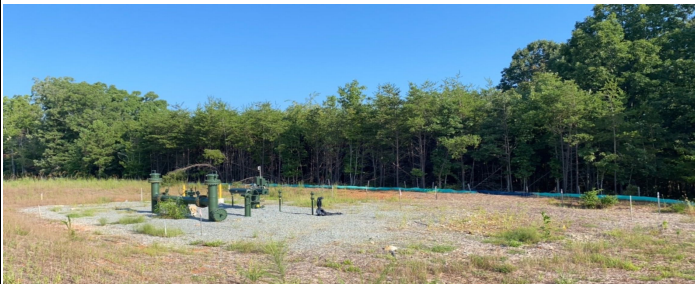
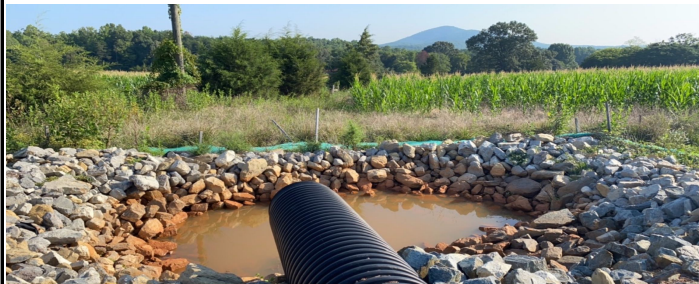
36°57'56" N 79°37'14" W 66°NE COURSE 317' GPS 19101-19383 Snow Creek Rd, Penhook, VA 24137, United States 08.24.2021 09:08:55 Accur +/-15.4 Ft ALT 955 Ft			36°57'55" N 79°37'10" W 299°NW COURSE 26' GPS 19101-19383 Snow Creek Rd, Penhook, VA 24137, United States 08.24.2021 09:07:37 Accur +/-15.4 Ft ALT 952 Ft		
GPS Location	1		GPS Location	2	
Field Station#	14979+85		Field Station#	14983+00	
Pic 1 Desc.	Picture of valve section CIS Snow Creek Rd. Perimeter CFS in good condition.		Pic 2 Desc.	Plunge pool performing intended function.

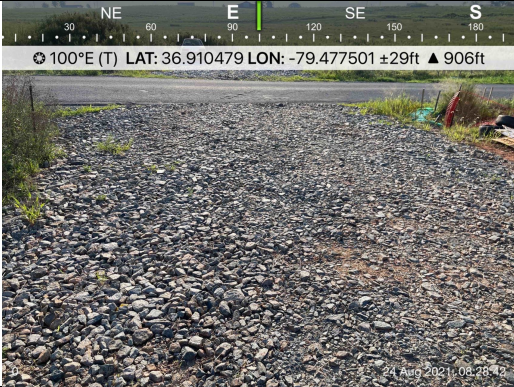
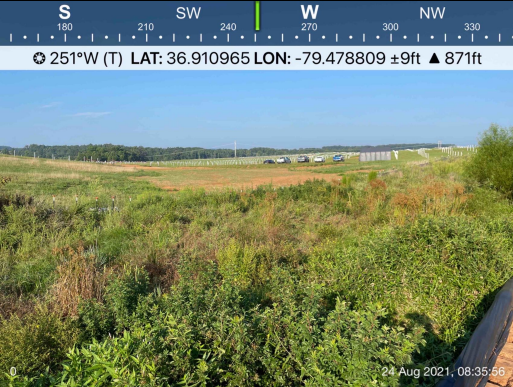
GPS Location	See photo	GPS Location	See photo		
Field Station#	15480+67	Field Station#	15475+00		
Pic 1 Desc.	RCEs are in good condition at all road crossings.	Pic 2 Desc.	3rd party rock outlet appears to be in good condition along this drainage.

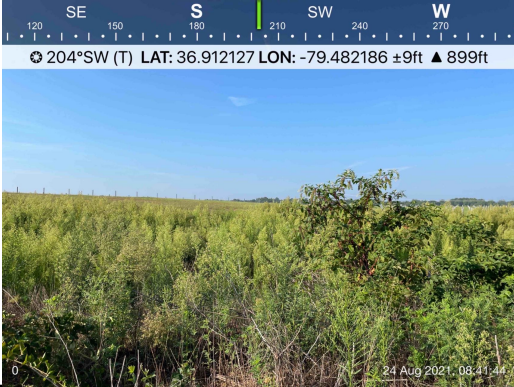
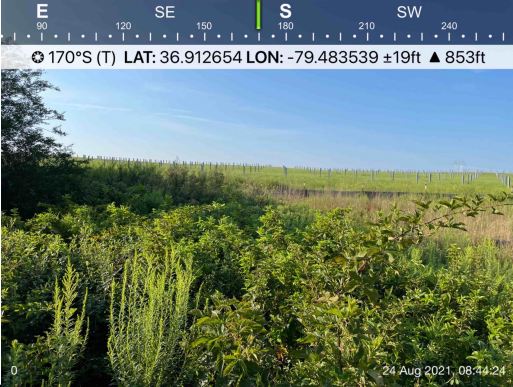
GPS Location	See photo	GPS Location	See photo		
Field Station#	15465+00	Field Station#	15460+81		
Pic 3 Desc.	No evidence of sedimentation from 3rd party disturbance.	Pic 4 Desc.	No evidence of sedimentation from 3rd party disturbance into CWD inlet.

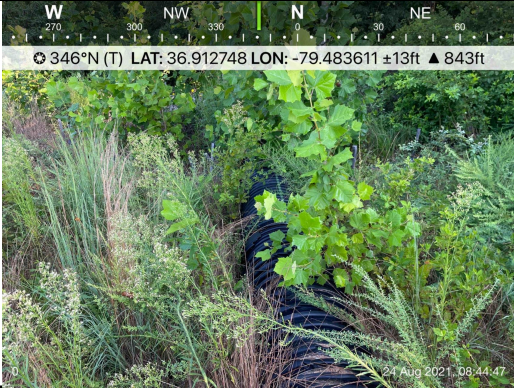
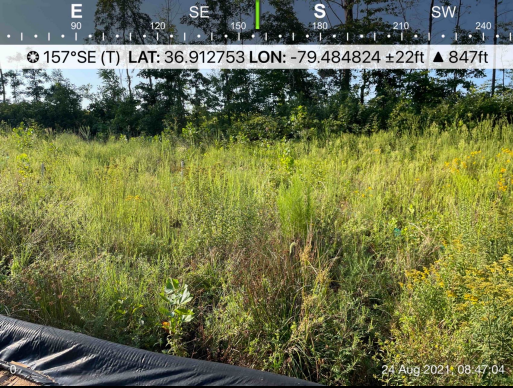
GPS Location	See photo	GPS Location	See photo		
Field Station#	15460+81	Field Station#	15457+00		
Pic 5 Desc.	CWDs are in good condition throughout this section.	Pic 6 Desc.	No evidence of sedimentation from 3rd party disturbance into drainage feature.

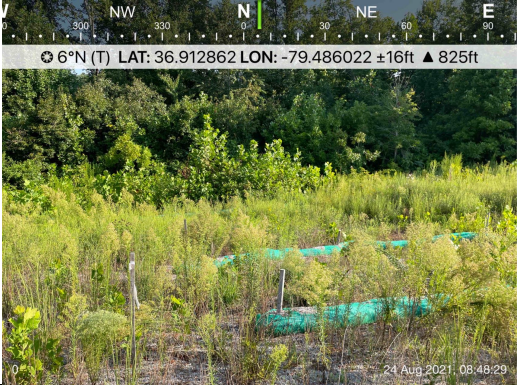
GPS Location	See photo		GPS Location	See photo	
Field Station#	15453+00		Field Station#	15445+00	
Pic 7 Desc.	No evidence of sedimentation into CWD at this location.		Pic 8 Desc.	Vegetation continues to fill in throughout this section.

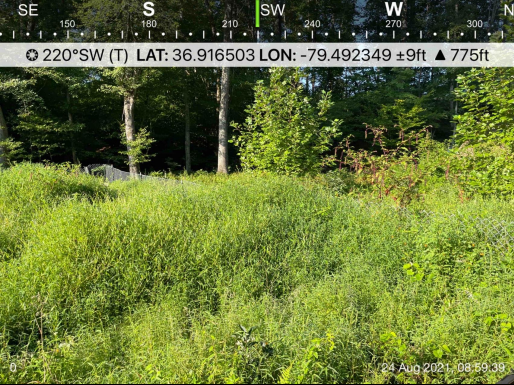
GPS Location	See photo		GPS Location	See photo	
Field Station#	15427+00		Field Station#	15427+00	
Pic 9 Desc.	Equipment bridge ECDs are in good condition and functioning.		Pic 10 Desc.	Buffer ECDs are in place and functioning at all stream and wetland buffers.

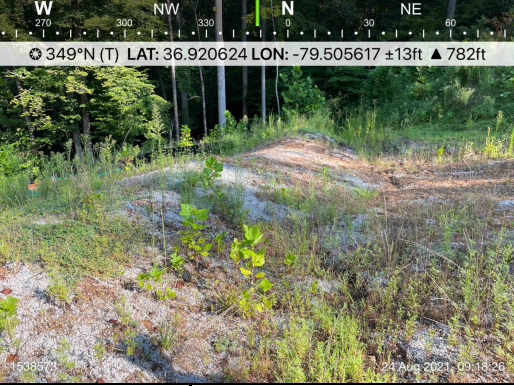
GPS Location	See photo		GPS Location	See photo	
Field Station#	15400+00		Field Station#	15385+73	
Pic 11 Desc.	Vegetation continues to fill in throughout this section.		Pic 12 Desc.	Waterbars are functioning as intended.

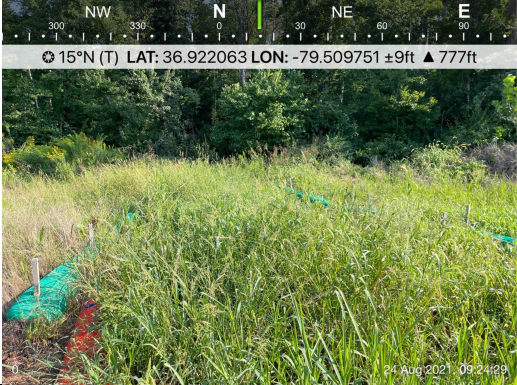
GPS Location	See photo	GPS Location			
Field Station#	15375+00	Field Station#			
Pic 13 Desc.	Drainage ECDs are in good condition and functioning.	Pic 14 Desc.			
Insert image here		Insert image here			
GPS Location		GPS Location			
Field Station#		Field Station#			
Pic 15 Desc.		Pic 16 Desc.			
Insert image here		Insert image here			
GPS Location		GPS Location			
Field Station#		Field Station#			
Pic 17 Desc.		Pic 18 Desc.

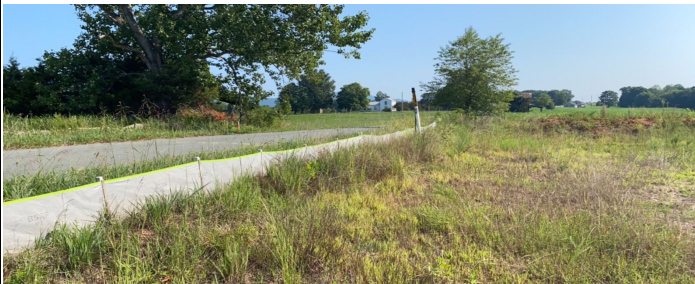
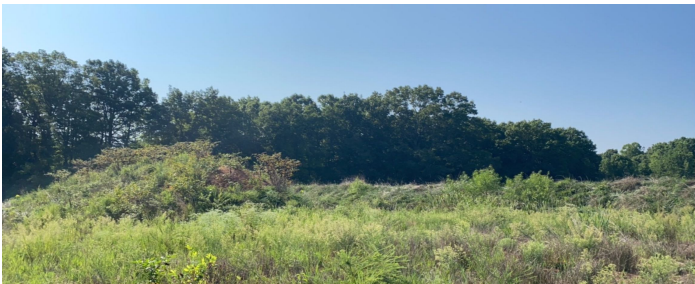
36°57'47" N 79°35'36" W 88°E COURSE 305° GPS Sandy Level, VA 24161, United States 08.25.2021 10:10:38 Accur +/-19.3 Ft ALT 923 Ft			36°57'45" N 79°35'33" W 120°SE COURSE 137° GPS 1918-2164 Armstrong Rd, Penhook, VA 24137, United States 08.25.2021 10:04:32 Accur +/-31.7 Ft ALT 917 Ft		
GPS Location	1	GPS Location	2		
Field Station#	15064+00	Field Station#	15068+00		
Pic 1 Desc.	Perimeter P1 silt fence in place and functional at road crossing		Pic 2 Desc.	Spoil pile and temporary diversion berm stabilized and vegetated

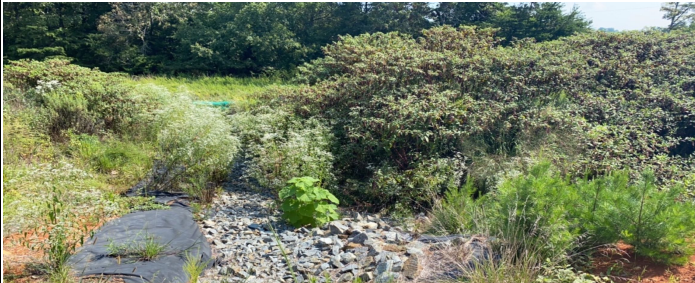
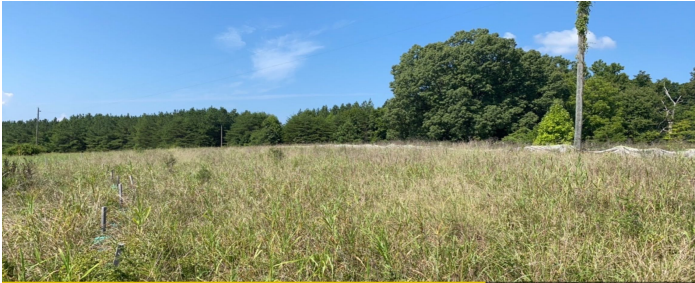
36°57'22" N 79°34'55" W 347°N COURSE 308° GPS 8850-8968 Museville Rd, Sandy Level, VA 24161, United States 08.25.2021 11:10:47 Accur +/-221.5 Ft ALT 937 Ft			36°57'18" N 79°34'55" W 246°SW COURSE 312° GPS 8851-8969 Museville Rd, Sandy Level, VA 24161, United States 08.25.2021 11:17:31 Accur +/-33.5 Ft ALT 924 Ft		
GPS Location	5	GPS Location	6		
Field Station#	15110+00	Field Station#	15114+00		
Pic 5 Desc.	Rock lined channel in good condition		Pic 6 Desc.	Extra workspace stabilized and vegetated

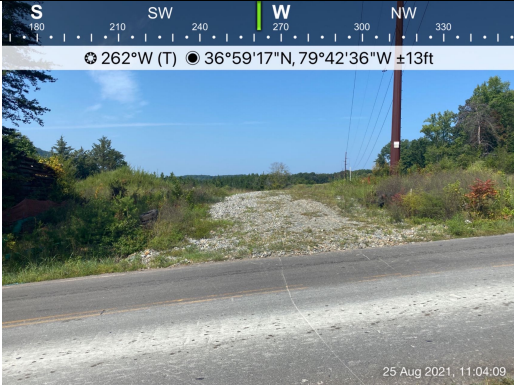
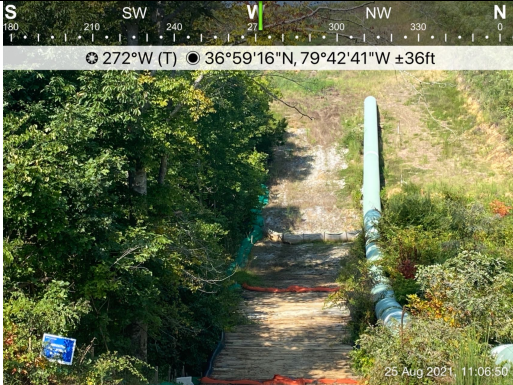
GPS Location	0	GPS Location	0		
Field Station#	14694+70	Field Station#	14689+36		
Pic 1 Desc.	Approximately 14594+70. Overview of road crossing and RCE.		Pic 2 Desc.	Approximately 14689+36. Overview of stream crossing, equipment bridge and ECDs at stream S-H34.

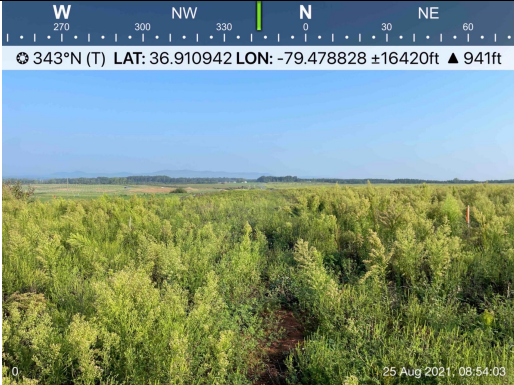
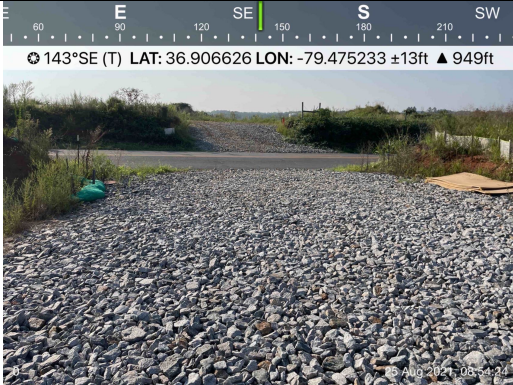
GPS Location	See photo	GPS Location	See photo		
Field Station#	15495+00	Field Station#	15496+70		
Pic 1 Desc.	Vegetation continues to fill in throughout this section	Pic 2 Desc.	RCEs are in good condition at all road crossings.

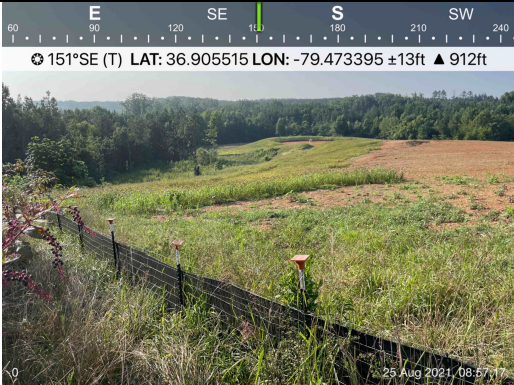
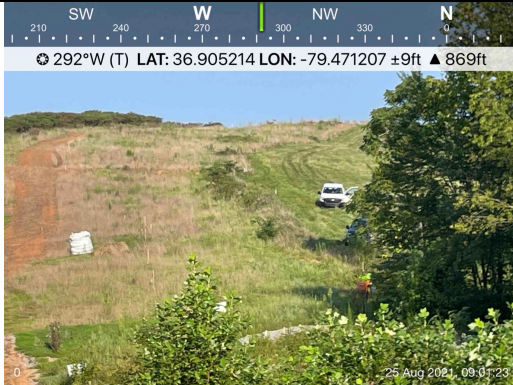
GPS Location	See photo	GPS Location	See photo		
Field Station#	15500+00	Field Station#	15506+41		
Pic 3 Desc.	No evidence of sedimentation from 3rd party disturbance.	Pic 4 Desc.	Survey crew on site with Wood. No vehicles used on ROW.

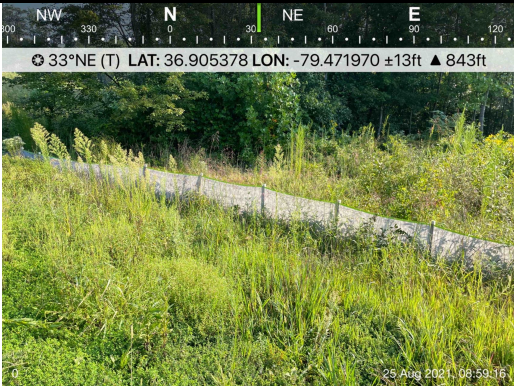
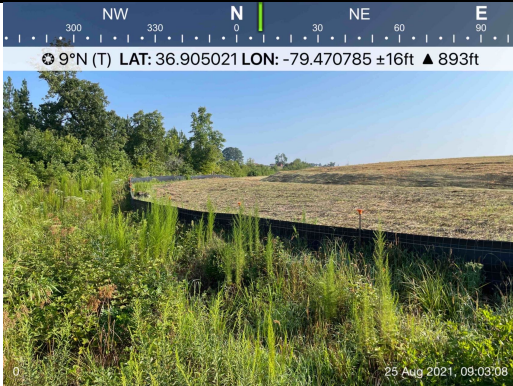
GPS Location	See photo	GPS Location	See photo		
Field Station#	15507+00	Field Station#	15510+00		
Pic 5 Desc.	P1 is in good condition at all stream and wetland buffers.	Pic 6 Desc.	3rd party ECDs appear to be in good condition.

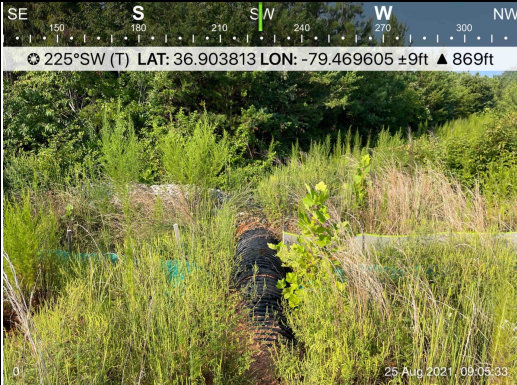
GPS Location	See photo		GPS Location	See photo	
Field Station#	15515+00		Field Station#	15540+74	
Pic 7 Desc.	CWDs are functioning as intended.		Pic 8 Desc.	P1 needs to be restaked.

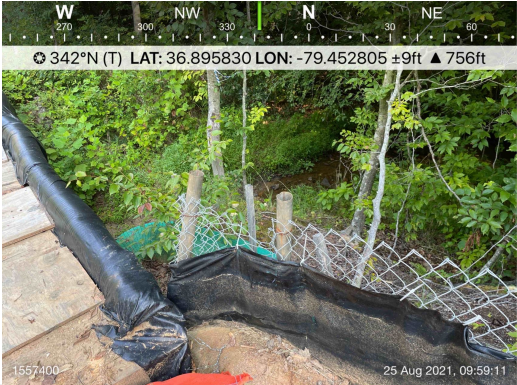
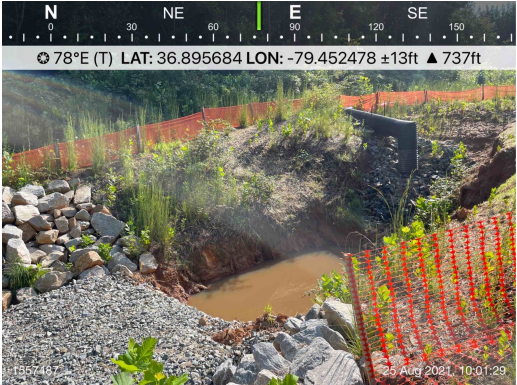
GPS Location	See photo	GPS Location	See photo		
Field Station#	15574+00	Field Station#	15574+87		
Pic 15 Desc.	Environmental crew has corrected this issue.	Pic 16 Desc.	Slope drain remains in good condition.		
Insert image here		Insert image here			
GPS Location		GPS Location			
Field Station#		Field Station#			
Pic 17 Desc.		Pic 18 Desc.

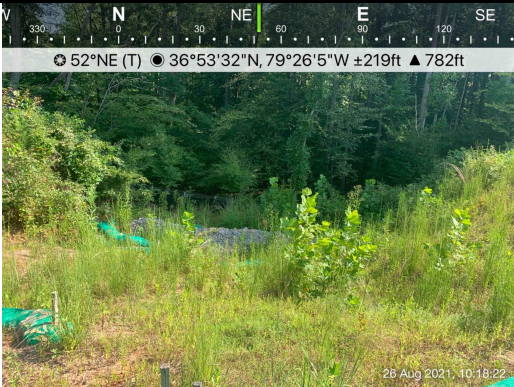
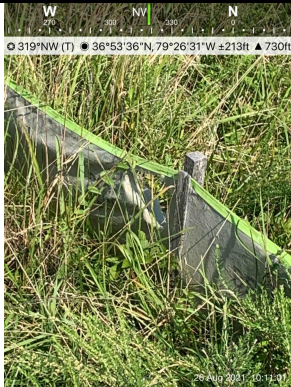
GPS Location	O	GPS Location	O		
Field Station#	15632+00	Field Station#	15608+00		
Pic 1 Desc.	Observing temporary stabilization,CWD outlet and ECD's	Pic 2 Desc.	Observing p1 that requires maintenance

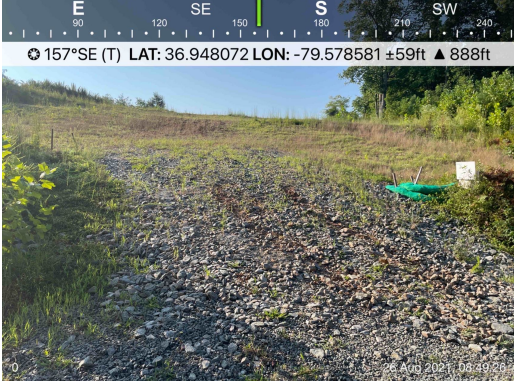
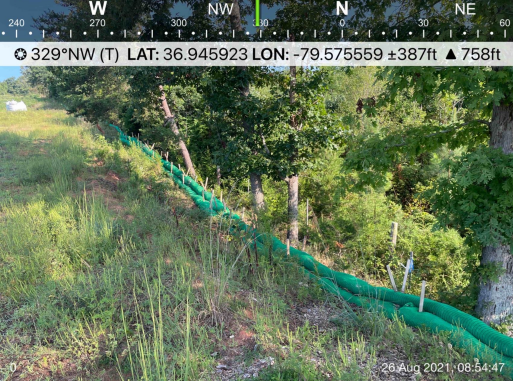
GPS Location	See photo		GPS Location	See photo	
Field Station#	15142+66		Field Station#	15155+00	
Pic 1 Desc.	RCE is in good condition at Rockcreek Rd.		Pic 2 Desc.	Perimeter CFS is in good condition throughout this section.

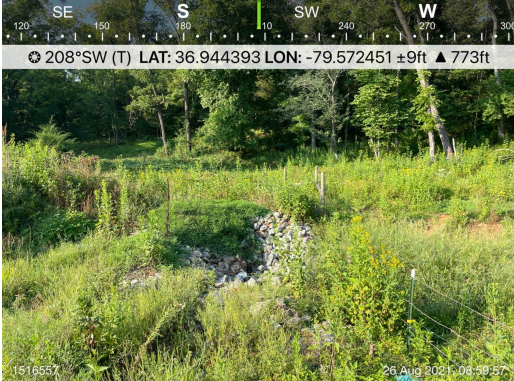
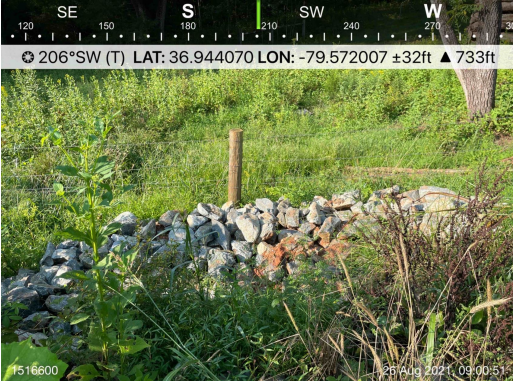
GPS Location	See photo		GPS Location	See photo	
Field Station#	15165+57		Field Station#	15166+00	
Pic 3 Desc.	Rock inlet remains in good condition.		Pic 4 Desc.	Rock outlet remains in good condition.

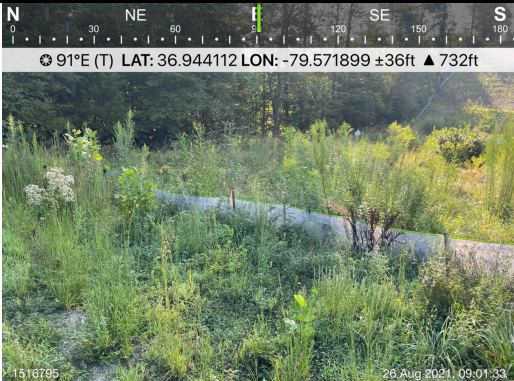
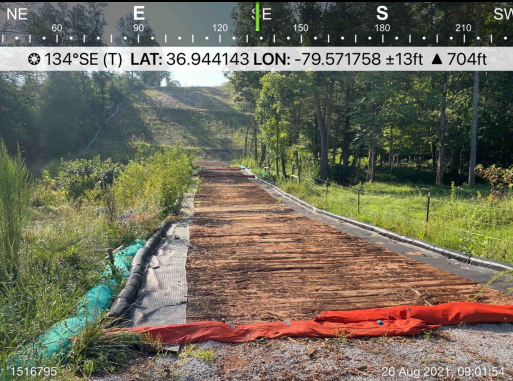
GPS Location	See photo		GPS Location	See photo	
Field Station#	15167+95		Field Station#	15167+95	
Pic 5 Desc.	P1 is in good condition at stream buffer.		Pic 6 Desc.	Equipment bridge ECDs are in good condition and functioning.

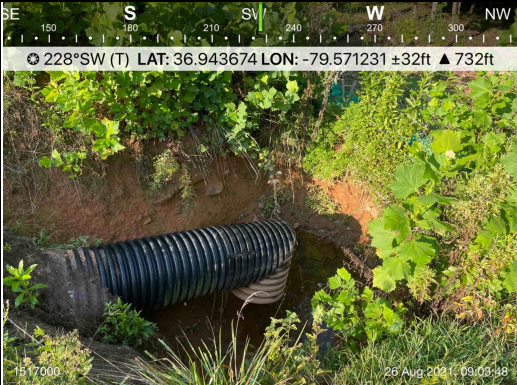
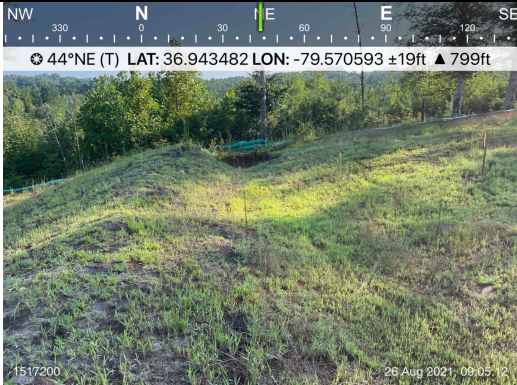
GPS Location	See photo		GPS Location	See photo	
Field Station#	15170+00		Field Station#	15172+00	
Pic 7 Desc.	Slope drain is in good condition and functioning.		Pic 8 Desc.	Waterbars are in good condition.

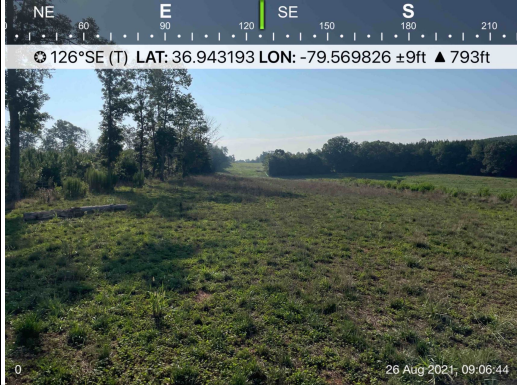
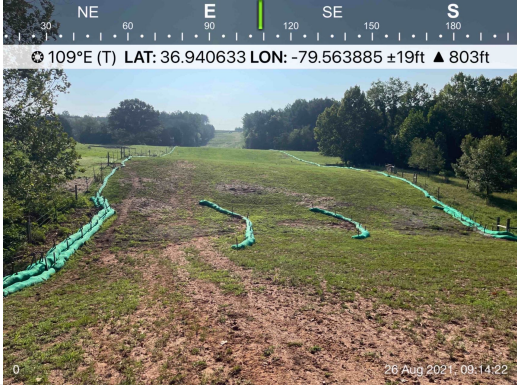
GPS Location	See photo		GPS Location	See photo	
Field Station#	15175+00		Field Station#	15195+00	
Pic 9 Desc.	Vegetation continues to fill in throughout this section.		Pic 10 Desc.	Drainage ECDs are in good condition and functioning.

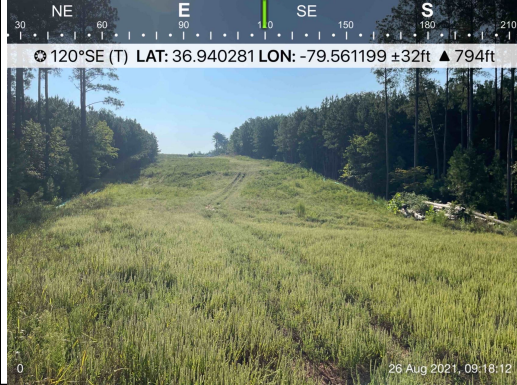
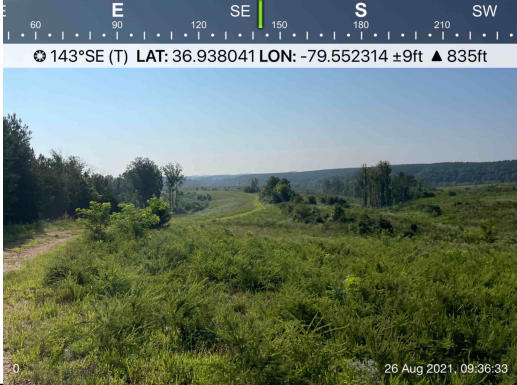
GPS Location	See photo		GPS Location	See photo	
Field Station#	15201+00		Field Station#	15230+00	
Pic 11 Desc.	Vegetation continues to fill in throughout this section.		Pic 12 Desc.	Vegetation continues to fill in throughout this section.
