# Visual Site Inspection Report

<b>Project Name</b>	H-600 Pipeline Spread I	<b>AFE</b>	124300139	<b>Spread</b>	H-600 Pipeline Spread I
<b>Contractor</b>	Precision	<b>Report #</b>	27866		
<b>Inspector</b>	Ben Farmer	<b>Date/Time</b>	8/30/2021 2:51 PM		
<b>Permit #</b>	TBD	<b>Inspection Type</b>	VA SWPP	<b>Station Begin</b>	15370+62
<b>State</b>	VA	<b>Inspection Area</b>	Partial	<b>Station End</b>	15480+67
<b>County</b>	Pittsylvania	<b>Ground</b>	Damp	<b>Temperature (°F)</b>	79.00
<b>Municipality</b>	Chatham	<b>Weather</b>	Sunny	<b>Rain Gauge (in)</b>	0.40
				<b>Rain Accumulation Time (days)</b>	0.00

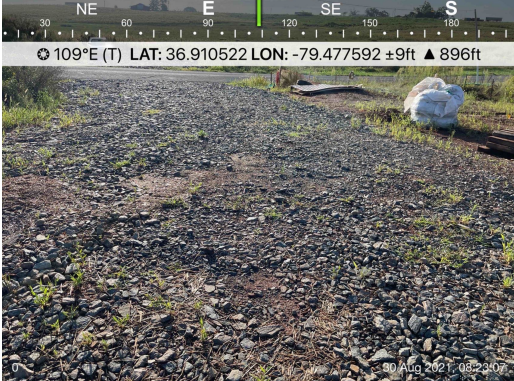
<b>GPS Location</b>	See photo		<b>GPS Location</b>	See photo	
<b>Field Station#</b>	15480+67		<b>Field Station#</b>	15475+00	
<b>Pic 1 Desc.</b>	RCEs are in good condition at all road crossings.		<b>Pic 2 Desc.</b>	3rd party rock outlet appears to be in good condition.

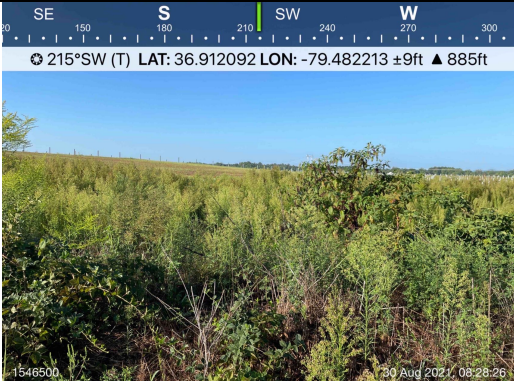
<b>GPS Location</b>	See photo		<b>GPS Location</b>	See photo	
<b>Field Station#</b>	15465+00		<b>Field Station#</b>	15460+81	
<b>Pic 3 Desc.</b>	No evidence of sedimentation from 3rd party rock outlet.		<b>Pic 4 Desc.</b>	No evidence of sedimentation from 3rd party rock outlet into CWD inlet.

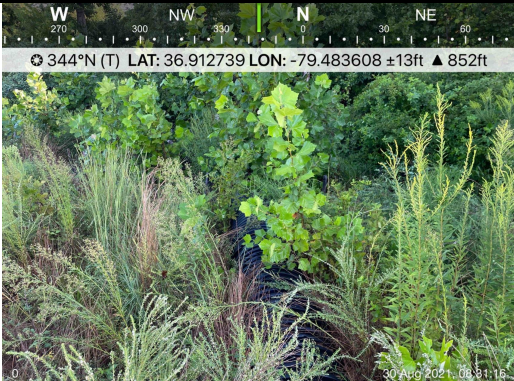
<b>GPS Location</b>	See photo		<b>GPS Location</b>	See photo	
<b>Field Station#</b>	15460+81		<b>Field Station#</b>	15457+00	
<b>Pic 5 Desc.</b>	CWD remains in good condition.		<b>Pic 6 Desc.</b>	No evidence of sedimentation from 3rd party disturbance.

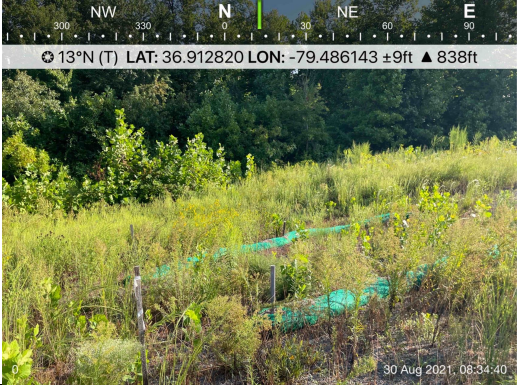
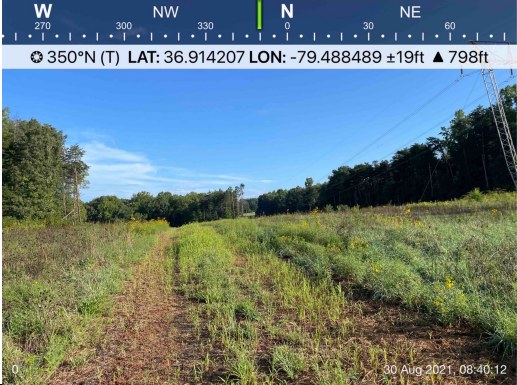
<b>GPS Location</b>	See photo		<b>GPS Location</b>	See photo	
<b>Field Station#</b>	15453+00		<b>Field Station#</b>	15445+00	
<b>Pic 7 Desc.</b>	CWD is in good condition with no evidence of sedimentation from 3rd party disturbance.		<b>Pic 8 Desc.</b>	Vegetation continues to fill in throughout this section.

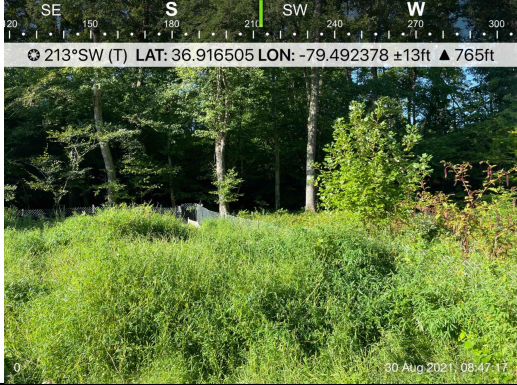
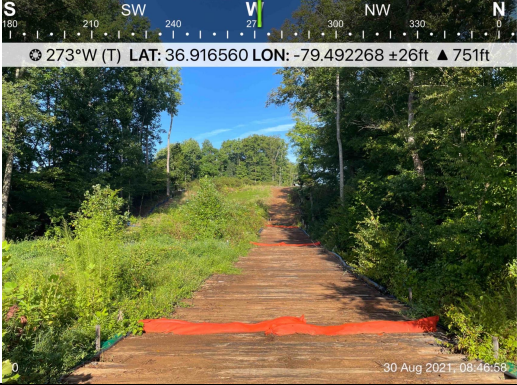
<b>GPS Location</b>	See photo		<b>GPS Location</b>	See photo	
<b>Field Station#</b>	15427+00		<b>Field Station#</b>	15427+00	
<b>Pic 9 Desc.</b>	Stream buffer vegetation and ECDs are in good condition.		<b>Pic 10 Desc.</b>	Equipment bridge ECDs are in place and functioning.

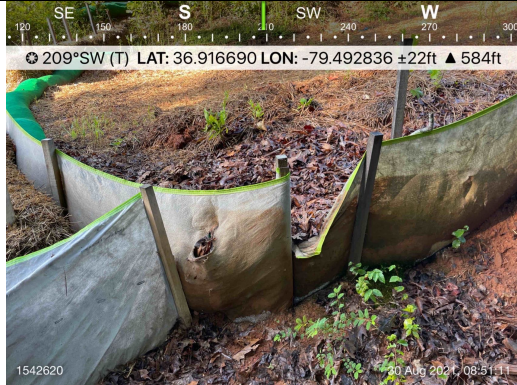
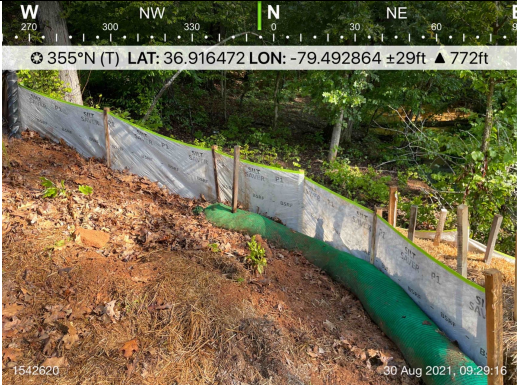
<b>GPS Location</b>	See photo		<b>GPS Location</b>	See photo	
<b>Field Station#</b>	15426+20		<b>Field Station#</b>	15426+20	
<b>Pic 11 Desc.</b>	P1 has been damaged and needs to be replaced.		<b>Pic 12 Desc.</b>	Environmental crew has corrected this issue.

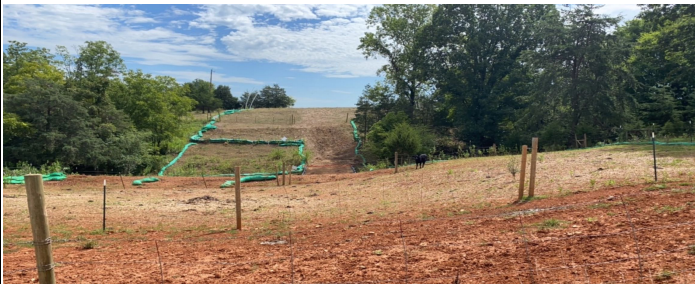
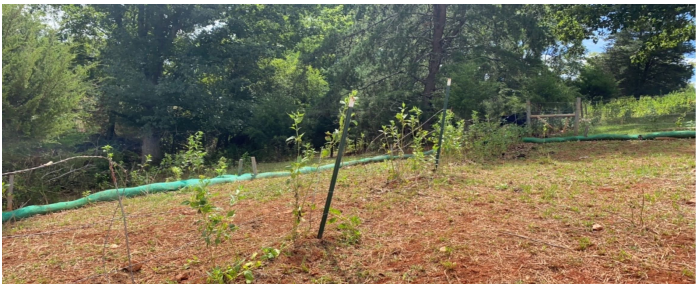
36°57'53" N 79°37'3" W 107°E COURSE 78' GPS 121-175 Ashworth Rd, Penhook, VA 24137, United States 08.30.2021 11:51:37 Accur +/-49.8 Ft ALT 0 Ft			36°57'52" N 79°37'2" W 147°SE COURSE 176' GPS 121-175 Ashworth Rd, Penhook, VA 24137, United States 08.30.2021 11:52:27 Accur +/-52.4 Ft ALT 926 Ft		
GPS Location	1	GPS Location	2		
Field Station#	14990+00	Field Station#	14990+00		
Pic 1 Desc.	Routine maintenance. Seed and stabilize denuded area of ROW from cattle damage.		Pic 2 Desc.	Routine maintenance. Damage to cattle fence from cattle damage.

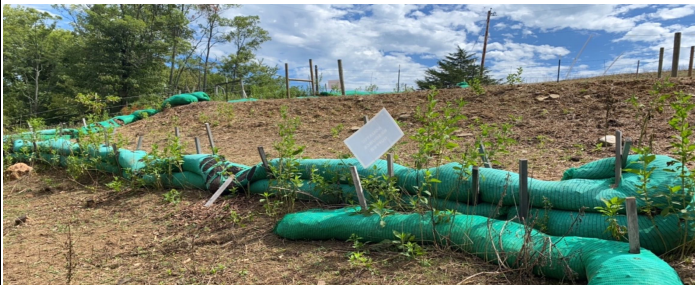
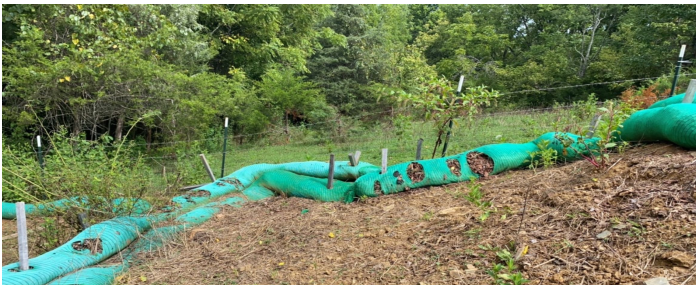
GPS Location	3	GPS Location	4		
Field Station#	14992+00	Field Station#	14993+00		
Pic 3 Desc.	Routine maintenance. Repair/replace damaged CFS triple stack from cattle damage.		Pic 4 Desc.	Routine maintenance. Repair/replace damaged CFS triple stack from cattle damage.

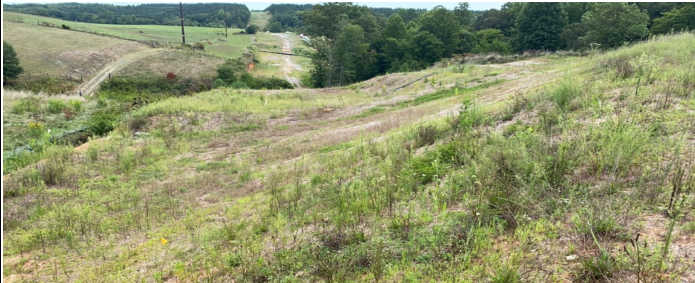
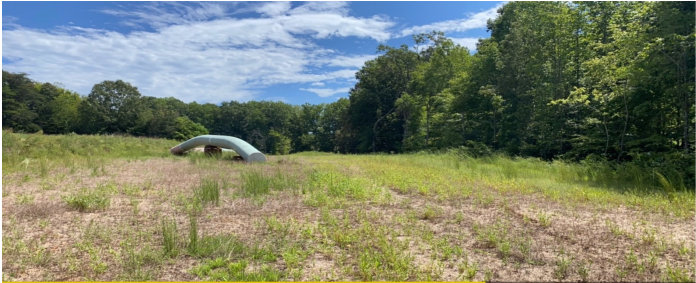
36°58'4" N 79°38'16" W 115°SE COURSE 113' GPS 2082 Ramsey Memorial Rd, Penhook, VA 24137, United States 08.30.2021 12:16:24 Accur +/-36.9 Ft ALT 874 Ft			36°57'54" N 79°35'52" W 137°SE COURSE 121' GPS Sorry no results found 08.30.2021 13:09:13 Accur +/-147.5 Ft ALT 812 Ft		
GPS Location	5	GPS Location	6		
Field Station#	14930+00	Field Station#	15051+00		
Pic 5 Desc.	Temporary stabilization and vegetation along ROW in two tone area. No issues observed.		Pic 6 Desc.	Picture of temporary stabilization and vegetation along ROW.

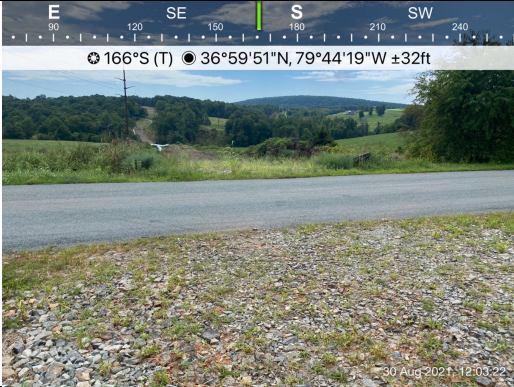
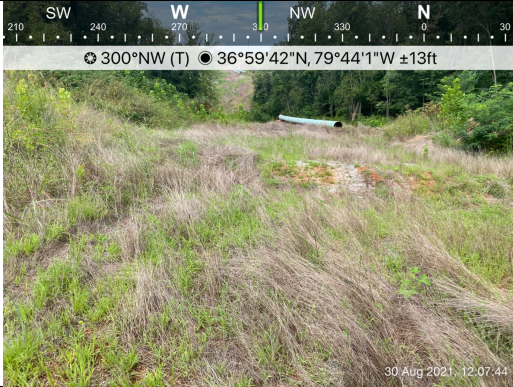
<b>GPS Location</b>	0	<b>GPS Location</b>	0		
<b>Field Station#</b>	14599+00	<b>Field Station#</b>	14615+00		
<b>Pic 1 Desc.</b>	Approximately 14599+00. Overview of road crossing and RCEs.		<b>Pic 2 Desc.</b>	Approximately 14615+00. Overview of ROW.

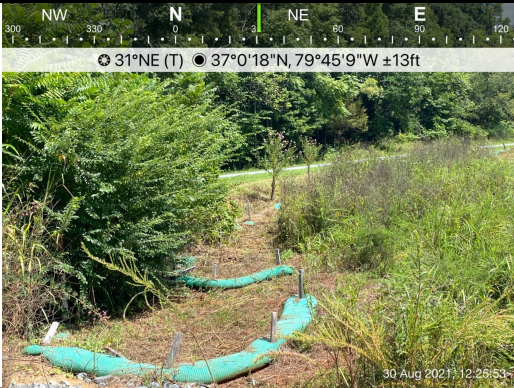
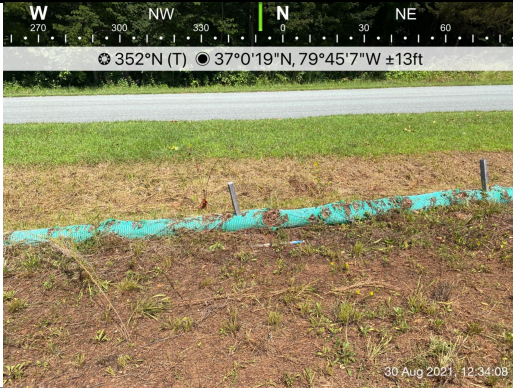
<b>GPS Location</b>	0	<b>GPS Location</b>	0		
<b>Field Station#</b>	14547+00	<b>Field Station#</b>	14546+95		
<b>Pic 5 Desc.</b>	Approximately 14547+00. Third party has mowed and sprayed area of ROW.		<b>Pic 6 Desc.</b>	Approximately 14546+95. CFS along MVP-ATWS-362 has deteriorated and been damaged. Replace CFS.

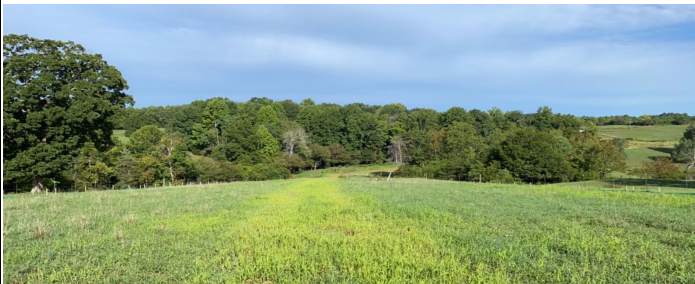
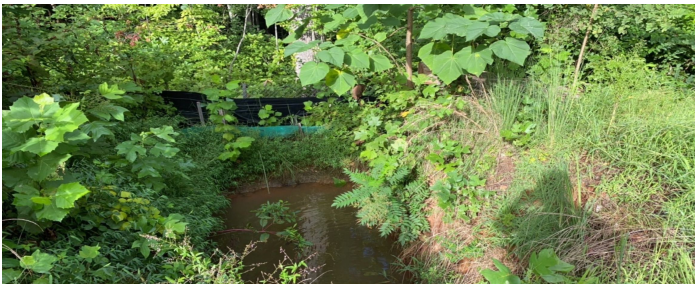
36°57'31" N 79°35'5" W 340°N COURSE 351° GPS Sandy Level, VA 24161, United States 08.31.2021 09:35:49 Accur +/-70.6 Ft ALT 935 Ft			36°56'53" N 79°34'43" W 298°NW COURSE 0° GPS 337-521 Rockcreek Rd, Sandy Level, VA 24161, United States 08.31.2021 09:16:33 Accur +/-70.8 Ft ALT 0 Ft		
GPS Location	1		GPS Location	2	
Field Station#	15096+00		Field Station#	15141+50	
Pic 1 Desc.	Picture of stabilization and vegetation in final cleanup area		Pic 2 Desc.	Sump pit and CFS end treatment in place and functional

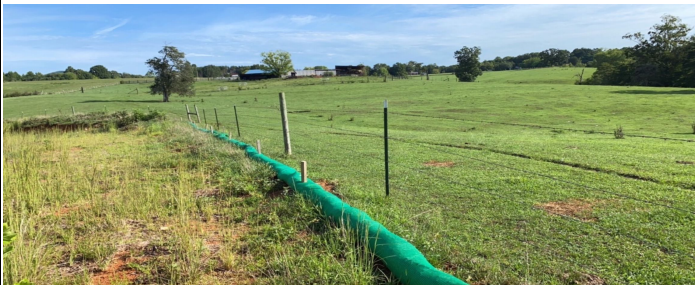
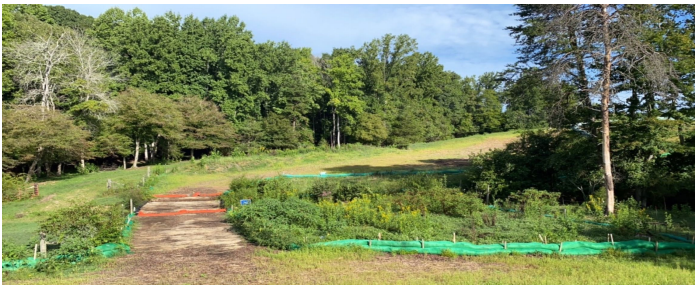
Pic 3 Desc.	Perimeter CFS in good condition		Pic 4 Desc.	Equipment bridge and surrounding ECDs in place and functional at stream crossing and resource buffer

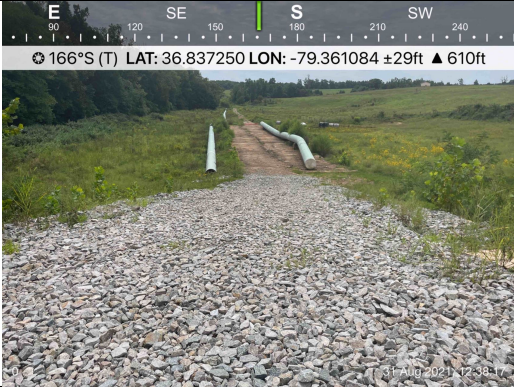
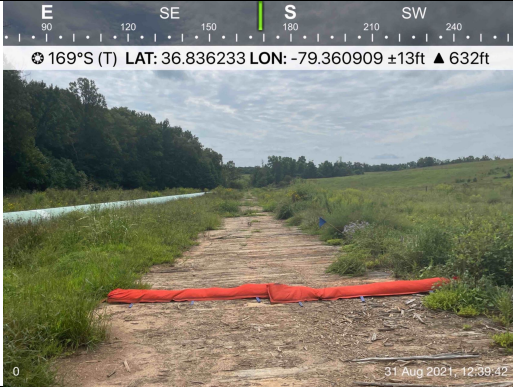
<b>GPS Location</b>	See photo		<b>GPS Location</b>	See photo	
<b>Field Station#</b>	15947+64		<b>Field Station#</b>	15953+00	
<b>Pic 1 Desc.</b>	RCE is in good condition at Chalk Level Rd.		<b>Pic 2 Desc.</b>	ECDs are in good condition and functioning at wetland W-H2 boundary.

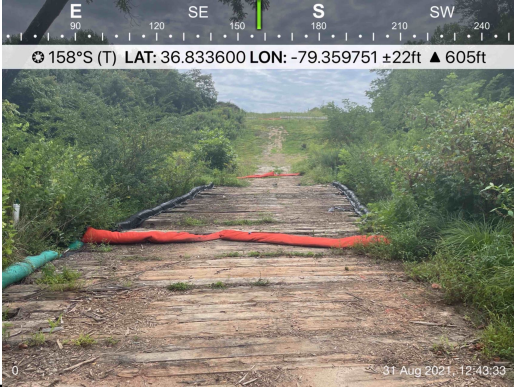
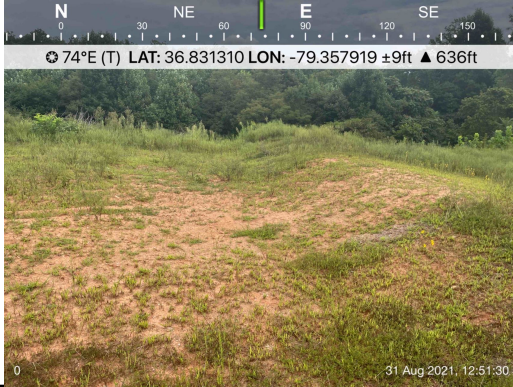
<b>GPS Location</b>	See photo		<b>GPS Location</b>	See photo	
<b>Field Station#</b>	15962+32		<b>Field Station#</b>	15970+00	
<b>Pic 3 Desc.</b>	Equipment bridge ECDs are in good condition and functioning at all stream and wetland crossings.		<b>Pic 4 Desc.</b>	Waterbars are functioning as intended.

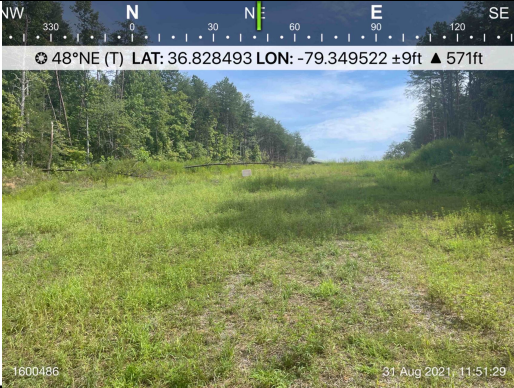
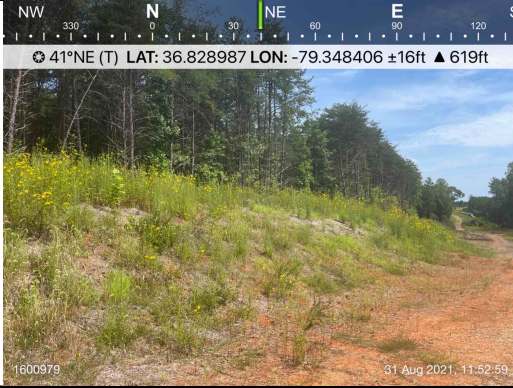
<b>GPS Location</b>	See photo		<b>GPS Location</b>	See photo	
<b>Field Station#</b>	16004+86		<b>Field Station#</b>	16009+79	
<b>Pic 5 Desc.</b>	Vegetation continues to fill in throughout this section.		<b>Pic 6 Desc.</b>	Stockpiles remain stabilized.

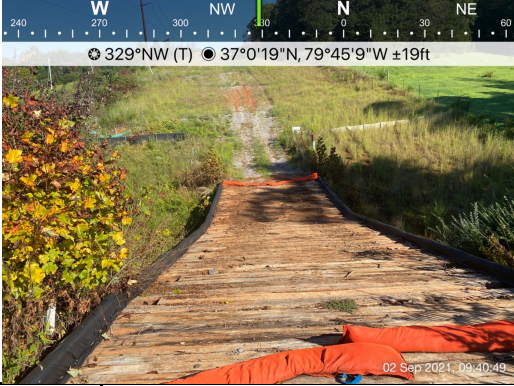
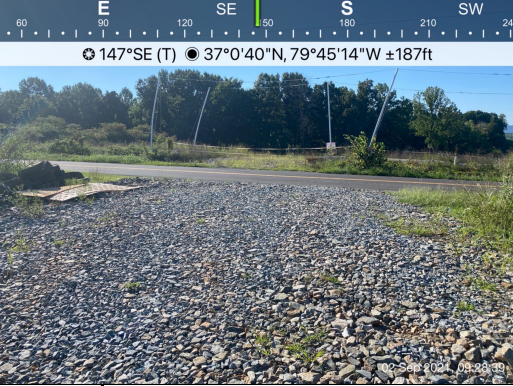
<b>GPS Location</b>	0	<b>GPS Location</b>	0		
<b>Field Station#</b>	14546+33	<b>Field Station#</b>	14524+50		
<b>Pic 1 Desc.</b>	Approximately 14546+33. Overview of stream crossing, equipment bridge and ECDs at stream S-G17.		<b>Pic 2 Desc.</b>	Approximately 14524+50. Overview of road crossing and RCEs.

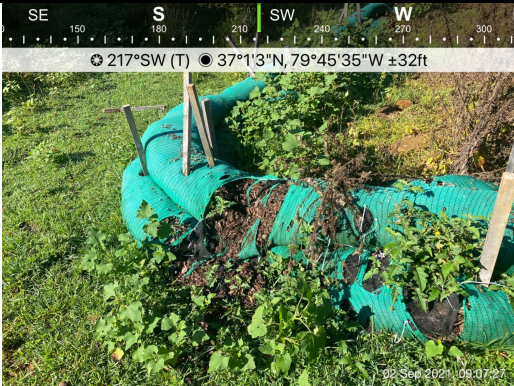
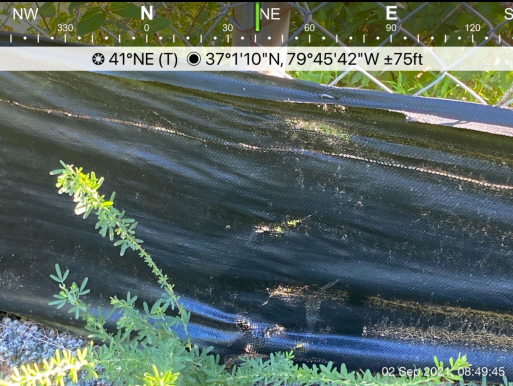
<b>GPS Location</b>	0	<b>GPS Location</b>	0		
<b>Field Station#</b>	14495+00	<b>Field Station#</b>	14486+75		
<b>Pic 5 Desc.</b>	Approximately 14495+00-14496+50. CFS weathered and damaged by livestock. Replace CFS as needed.		<b>Pic 6 Desc.</b>	Approximately 14486+75-14487+50. SSF requires maintenance. Fence deteriorating and has been damaged by wildlife. Replace damaged section.
