Visual Site Inspection Report

Project Name	H-600 Pipeline Spread I	AFE	124300139	Spread	H-600 Pipeline Spread I
Contractor	Precision			Report #	28411
Inspector	John White			Date/Time	9/13/2021 10:31 AM
Permit #	TBD	Inspection Type	VA SWPP	Station Begin	15584+23
State	VA	Inspection Area	Full	Station End	15647+03
County	Pittsylvania	Ground	Dry	Temperature (°F)	83.00
Municipality	Chatham	Weather	Sunny	Rain Gauge (in)	0.00
				Rain Accumulation Time (days)	6.00

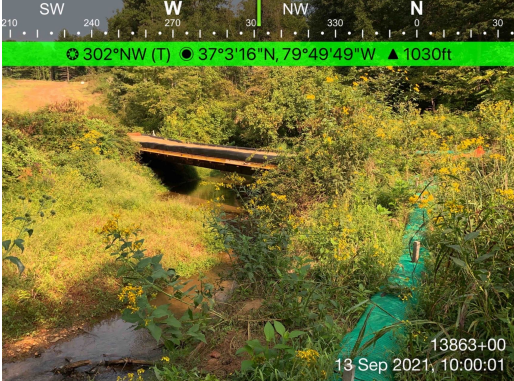
GPS Location	0	GPS Location	0		
Field Station#	13863+00	Field Station#	13887+00		
Pic 1 Desc.	CFS and equipment bridge in acceptable conditions	Pic 2 Desc.	P1 silt fence in acceptable condition

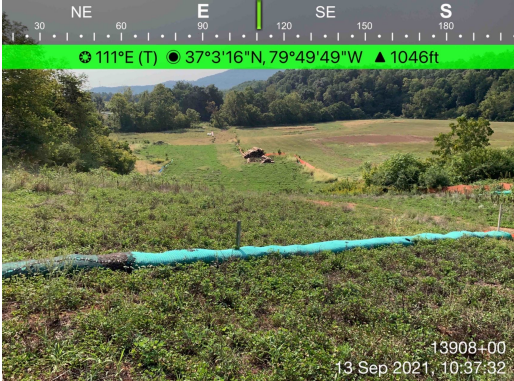
GPS Location	0	GPS Location	0		
Field Station#	13908+00	Field Station#	13946+00		
Pic 3 Desc.	CFS and Permanent vegetative stabilization in acceptable conditions	Pic 4 Desc.	Waterbar in acceptable condition

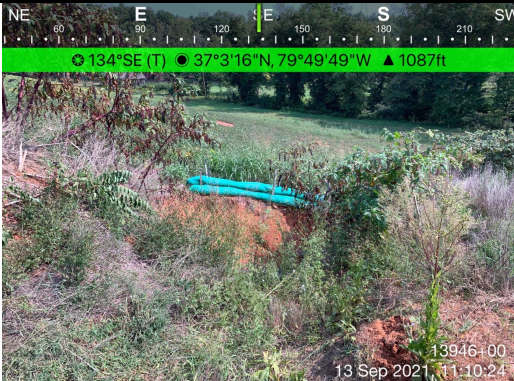
GPS Location	0	GPS Location	0		
Field Station#	13946+00	Field Station#	13995+00		
Pic 5 Desc.	Waterbar end treatment in acceptable condition	Pic 6 Desc.	Sump pit, slope drain pipe and P1 silt fence in acceptable conditions

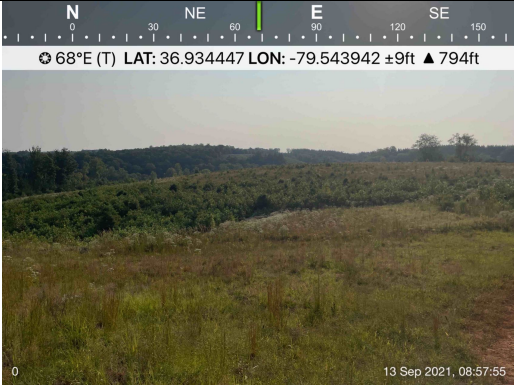
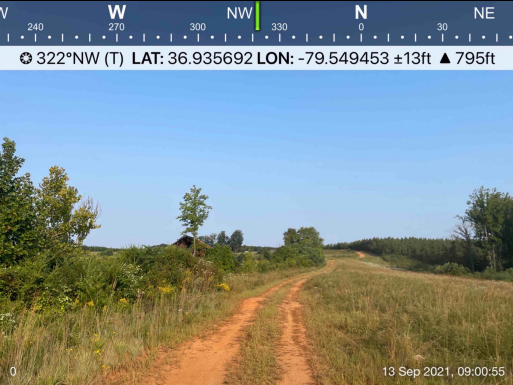
GPS Location	See photo		GPS Location	See photo	
Field Station#	15260+00		Field Station#	15232+00	
Pic 1 Desc.	Vegetation continues to fill in throughout this section of ROW.		Pic 2 Desc.	Vegetation continues to fill in throughout this section of ROW.

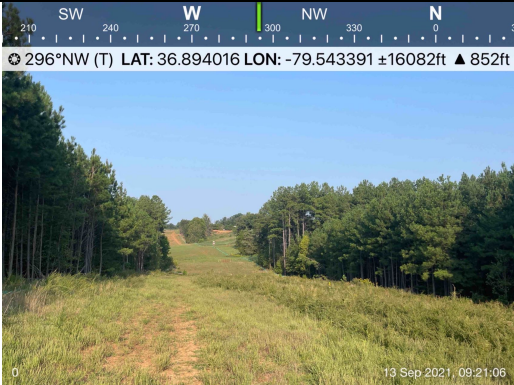
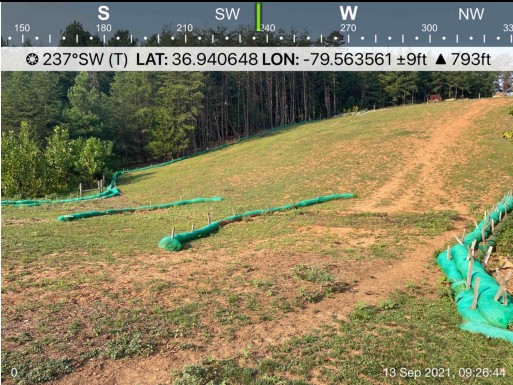
GPS Location	See photo		GPS Location	See photo	
Field Station#	15207+00		Field Station#	15195+00	
Pic 3 Desc.	Vegetation continues to fill in throughout this section of ROW.		Pic 4 Desc.	Drainage ECDs are in good condition along this drainage.

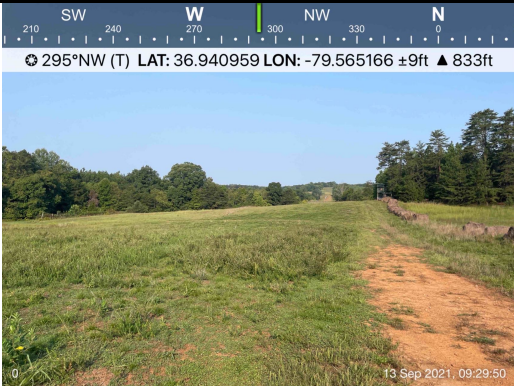
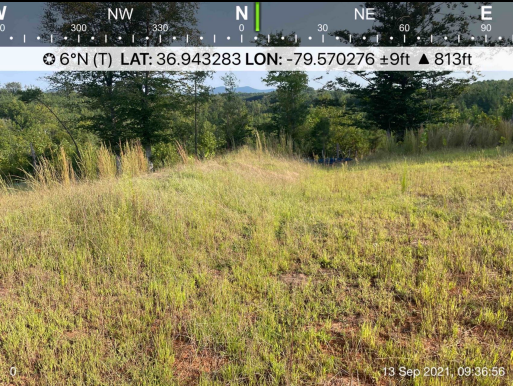
GPS Location	See photo		GPS Location	See photo	
Field Station#	15182+00		Field Station#	15172+00	
Pic 5 Desc.	Vegetation continues to fill in throughout this section of ROW.		Pic 6 Desc.	Waterbars are in good condition and functioning.

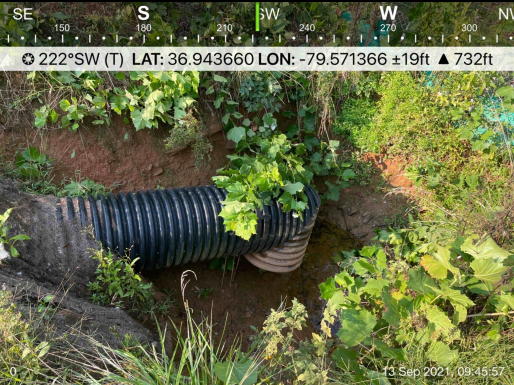
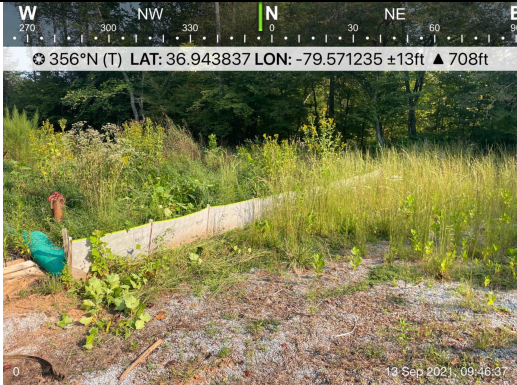
GPS Location	See photo		GPS Location	See photo	
Field Station#	15170+00		Field Station#	15169+58	
Pic 7 Desc.	Slope drain is functioning as intended.		Pic 8 Desc.	P1 is in good condition at stream buffer.

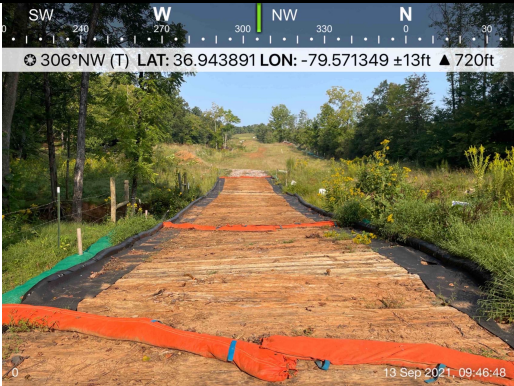
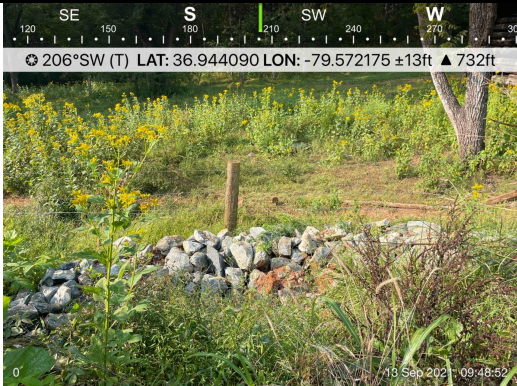
GPS Location	See photo		GPS Location	See photo	
Field Station#	15169+58		Field Station#	15166+00	
Pic 9 Desc.	Equipment bridge ECDs are in place and functioning.		Pic 10 Desc.	Rock outlet remains in good condition.

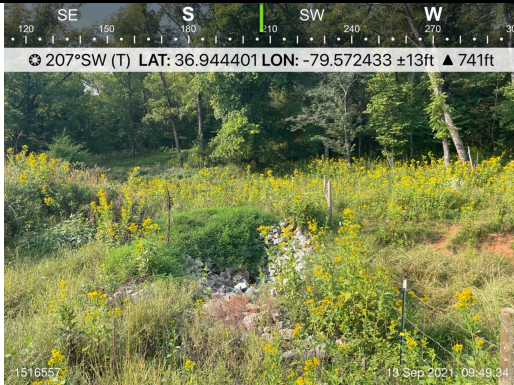
Insert image here			
GPS Location	See photo		GPS Location		
Field Station#	15165+57		Field Station#		
Pic 11 Desc.	Rock inlet remains in good condition.		Pic 12 Desc.

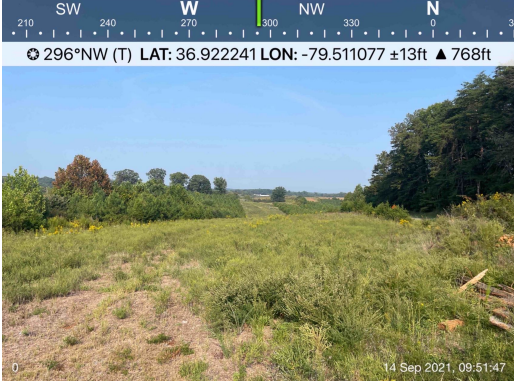
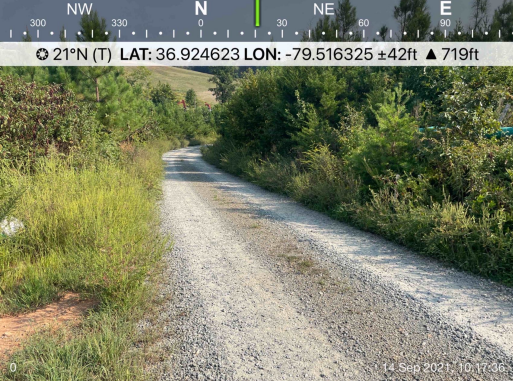
GPS Location	See photo		GPS Location	See photo	
Field Station#	15370+00		Field Station#	15350+00	
Pic 1 Desc.	Vegetation continues to fill in throughout this section.		Pic 2 Desc.	MVP-PI-332 remains in good condition with controls in place.

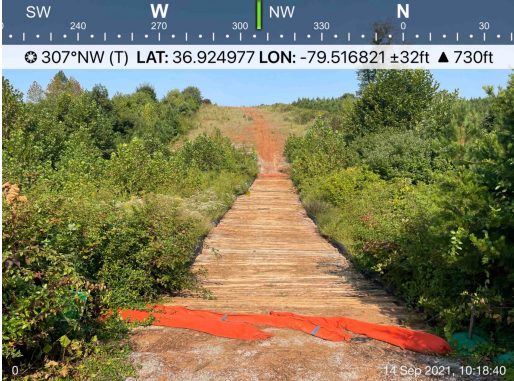
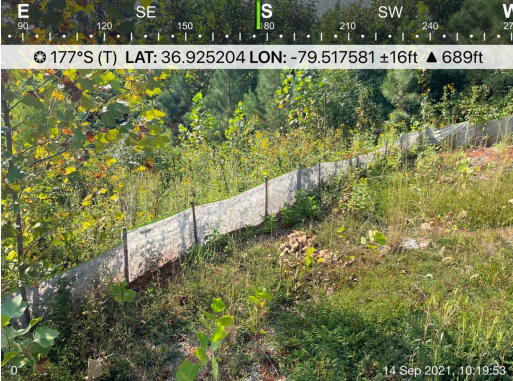
GPS Location	See photo		GPS Location	See photo	
Field Station#	15346+80		Field Station#	15346+00	
Pic 3 Desc.	Equipment bridge ECDs are in place and functioning.		Pic 4 Desc.	P1 is in good condition at all stream and wetland buffers.

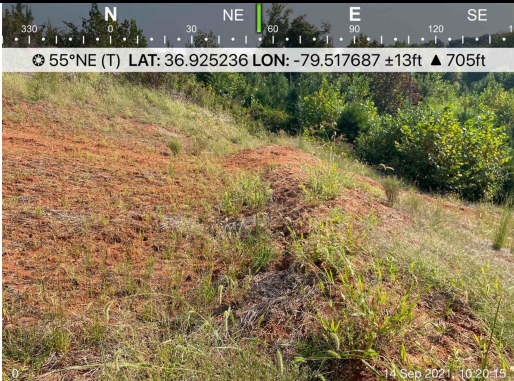
GPS Location	See photo		GPS Location	See photo	
Field Station#	15345+00		Field Station#	15338+00	
Pic 5 Desc.	Waterbars are in good condition and functioning.		Pic 6 Desc.	CWDs are functioning as intended.

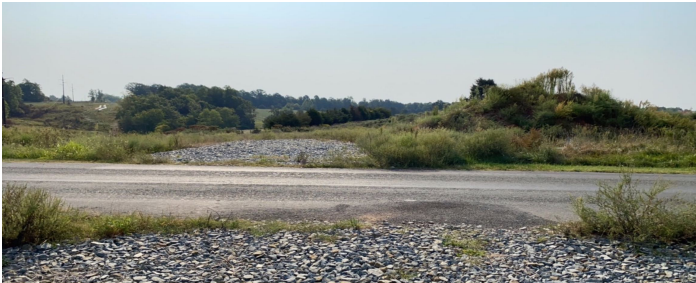
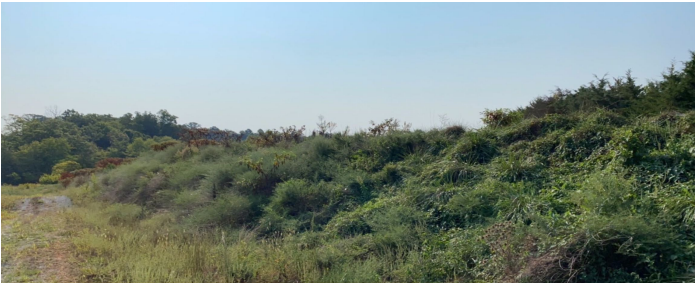
GPS Location	3		GPS Location	4	
Field Station#	14845+68		Field Station#	14850+00	
Pic 3 Desc.	RCE at Listening Hill Rd in good condition		Pic 4 Desc.	Temporary diversion berm stabilized and vegetated

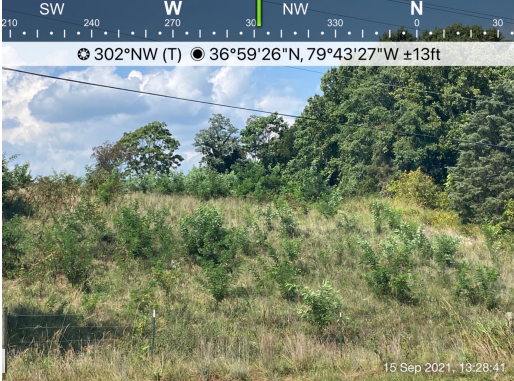
GPS Location	0	GPS Location	0		
Field Station#	14647+00	Field Station#	14615+00		
Pic 1 Desc.	Approximately 14647+00. Overview of ROW.		Pic 2 Desc.	Approximately 14615+00. Overview of ROW.

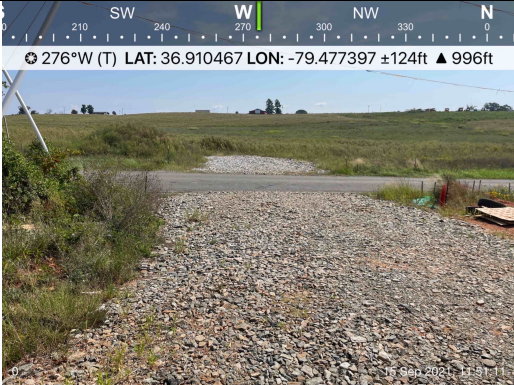
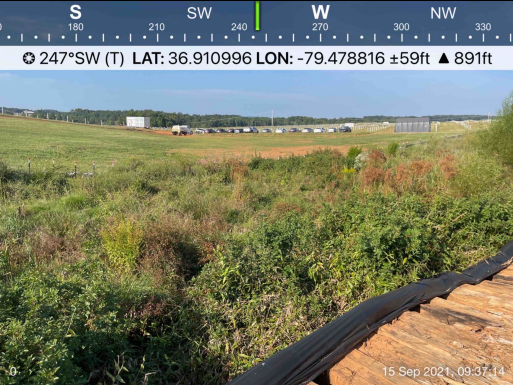
GPS Location	See photo		GPS Location	See photo	
Field Station#	15480+67		Field Station#	15475+00	
Pic 1 Desc.	RCEs are in good condition at all road crossings.		Pic 2 Desc.	Rock outlet appears to be in good condition along this drainage.

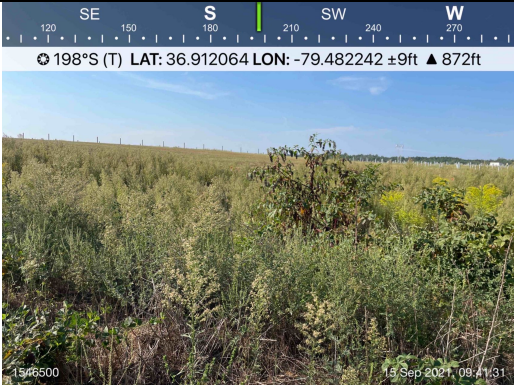
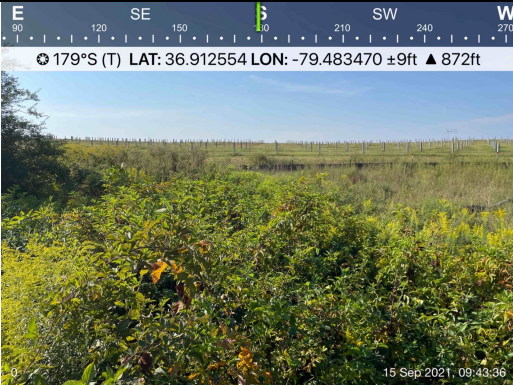
GPS Location	See photo		GPS Location	See photo	
Field Station#	15465+00		Field Station#	15460+81	
Pic 3 Desc.	No evidence of sedimentation from 3rd party disturbance.		Pic 4 Desc.	No evidence of sedimentation from 3rd party disturbance into CWD inlet.

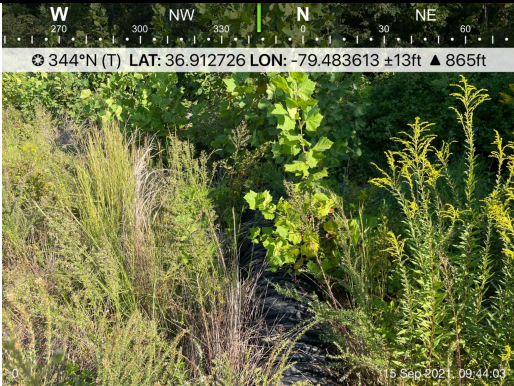
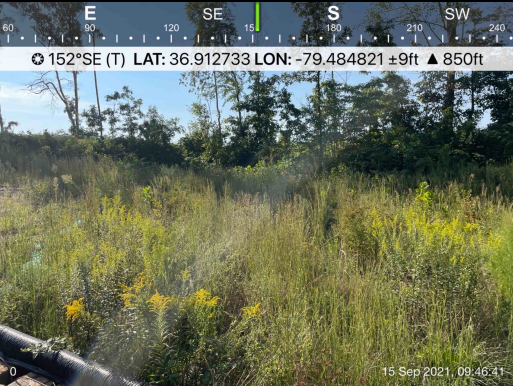
GPS Location	See photo		GPS Location	See photo	
Field Station#	15460+81		Field Station#	15457+00	
Pic 5 Desc.	CWD remains in good condition.		Pic 6 Desc.	No evidence of sedimentation within drainage.

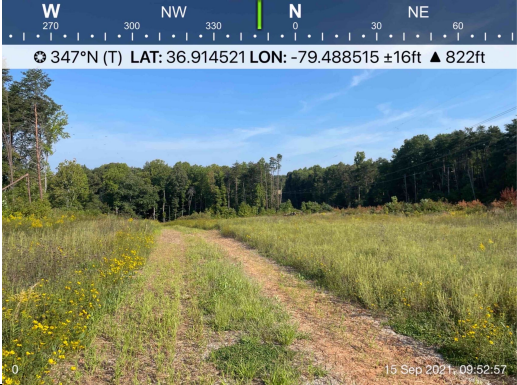
GPS Location	See photo		GPS Location	See photo	
Field Station#	15453+00		Field Station#	15440+00	
Pic 7 Desc.	No evidence of sedimentation from 3rd party disturbance.		Pic 8 Desc.	Vegetation continues to fill in throughout this section.

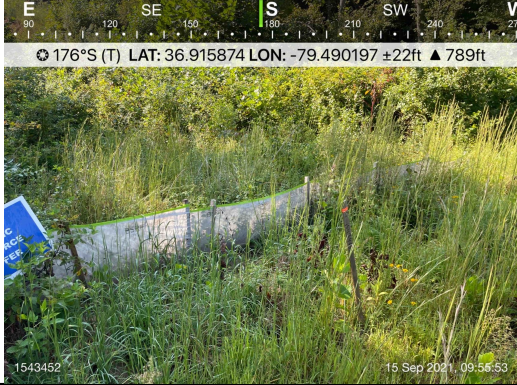
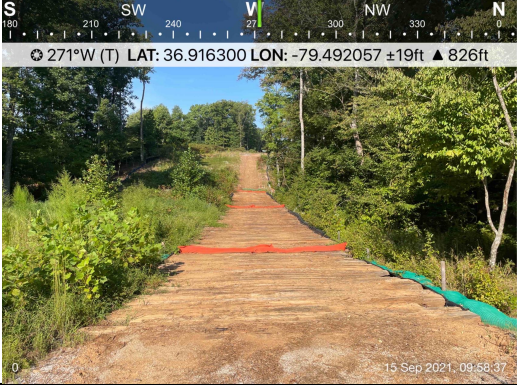
GPS Location	See photo		GPS Location	See photo	
Field Station#	15434+52		Field Station#	15426+70	
Pic 9 Desc.	P1 is in good condition at all stream and wetland buffers.		Pic 10 Desc.	Equipment bridge ECDs are in good condition and functioning.

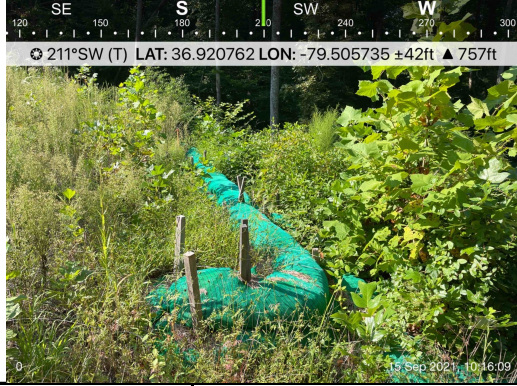
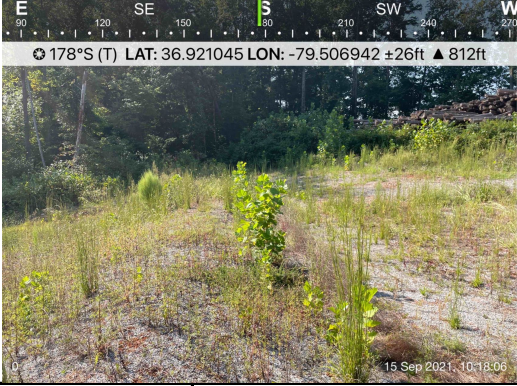
GPS Location	See photo		GPS Location	See photo	
Field Station#	15385+00		Field Station#	15380+00	
Pic 11 Desc.	Perimeter CFS is in good condition throughout this section.		Pic 12 Desc.	Waterbars are functioning as intended.

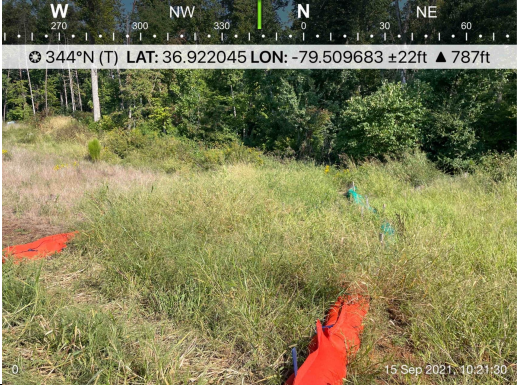
Insert image here			
GPS Location	See photo	GPS Location			
Field Station#	15375+00	Field Station#			
Pic 13 Desc.	Drainage ECDs are in place and functioning.	Pic 14 Desc.			
Insert image here		Insert image here			
GPS Location		GPS Location			
Field Station#		Field Station#			
Pic 15 Desc.		Pic 16 Desc.			
Insert image here		Insert image here			
GPS Location		GPS Location			
Field Station#		Field Station#			
Pic 17 Desc.		Pic 18 Desc.

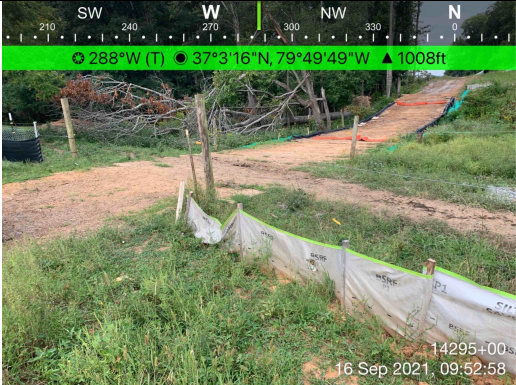
GPS Location	0	GPS Location	0		
Field Station#	14295+00	Field Station#	14294+00		
Pic 1 Desc.	P1 silt fence damaged by livestock	Pic 2 Desc.	P1 silt fence damaged by livestock

4. E&S BMPs (List BMPs and note if installed and maintained as per the plan. If corrective action is needed, a picture is required.)					
E&S BMPs	Compliance Level	Corrective Action	Corrective Time Frame	Date Repaired	
3rd Party Damages	Communication	Repair P-1 damaged by livestock			
Cleanwater Diversion Pipe	Acceptable				
Compost Filter Sock	Acceptable				
Equipment Bridge	Acceptable				
Rock Construction Entrance	Acceptable				
Sensitive Resource Buffer	Acceptable				
Sensitive Resource Signage	Acceptable				
Silt Fence (Filter Fabric Fence)	Communication	Repair livestock damage			
Silt Fence (Reinforce Filter Fence)	Acceptable

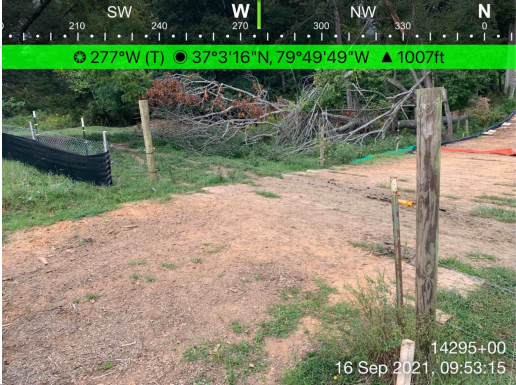
GPS Location	0	GPS Location	0		
Field Station#	14295+00	Field Station#	14279+00		
Pic 3 Desc.	Electric fence damaged by livestock	Pic 4 Desc.	Equipment bridge in acceptable condition

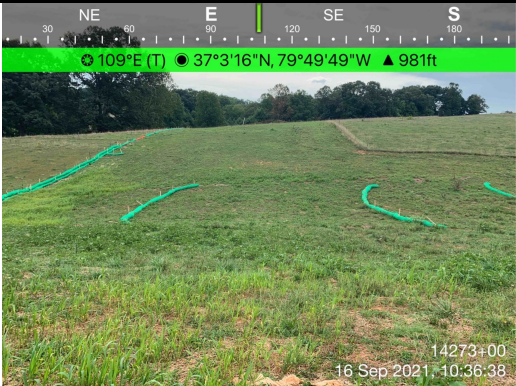
GPS Location	0	GPS Location	0		
Field Station#	14273+00	Field Station#	14296+00		
Pic 5 Desc.	Permanent vegetative stabilization and CFS in acceptable conditions	Pic 6 Desc.	Waterbar in acceptable condition

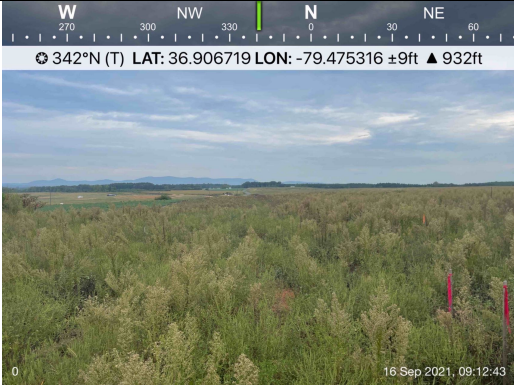
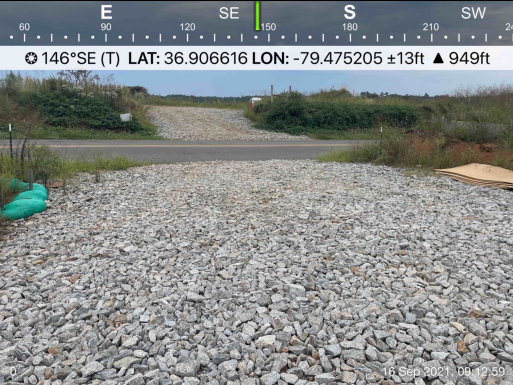
GPS Location	See photo		GPS Location	See photo	
Field Station#	15495+00		Field Station#	15496+70	
Pic 1 Desc.	Vegetation continues to fill in throughout this section.		Pic 2 Desc.	RCEs are in good condition at all road crossings.

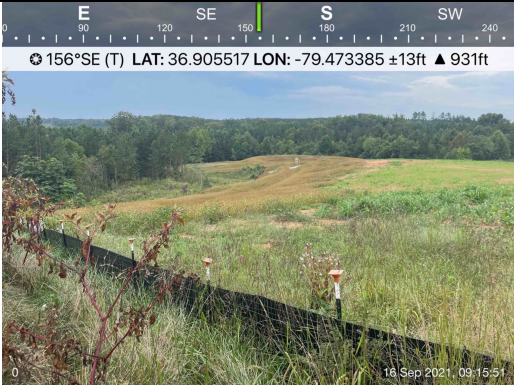
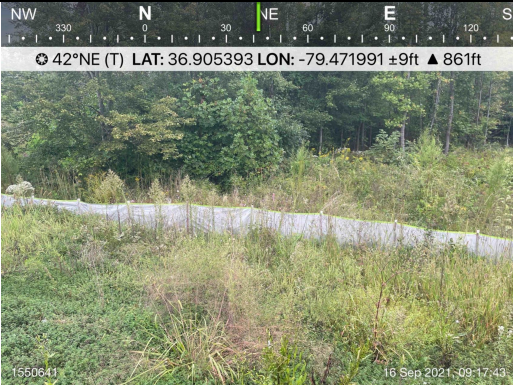
GPS Location	See photo		GPS Location	See photo	
Field Station#	15505+00		Field Station#	15506+41	
Pic 3 Desc.	No evidence of sedimentation from 3rd party disturbance.		Pic 4 Desc.	P1 is in good condition at all stream and wetland crossings.

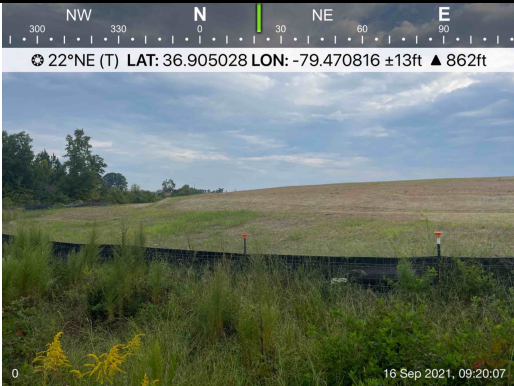
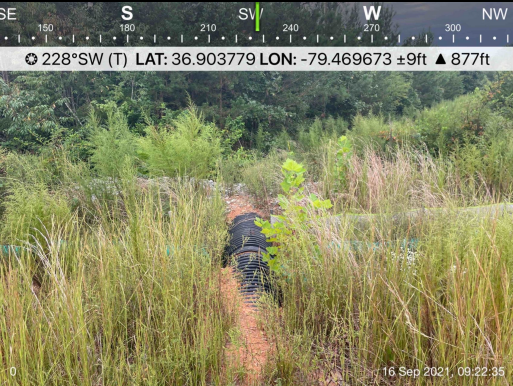
GPS Location	See photo		GPS Location	See photo	
Field Station#	15505+00		Field Station#	15510+00	
Pic 5 Desc.	3rd party ECDs appear to be in good condition.		Pic 6 Desc.	CWDs are functioning as intended.

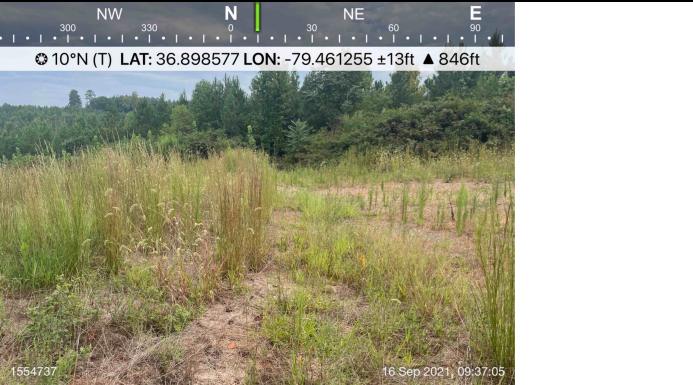
GPS Location	See photo		GPS Location	See photo	
Field Station#	15540+00		Field Station#	15547+37	
Pic 7 Desc.	Equipment bridge ECDs are in place and functioning.		Pic 8 Desc.	Waverbars are in good condition throughout this section.

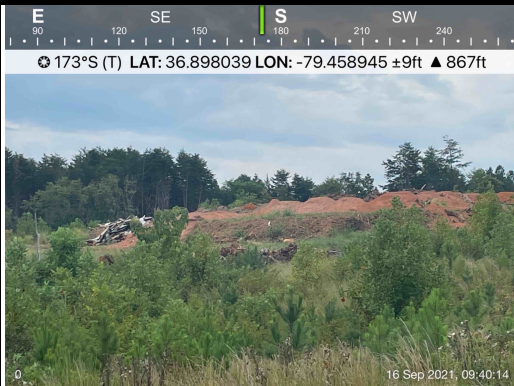
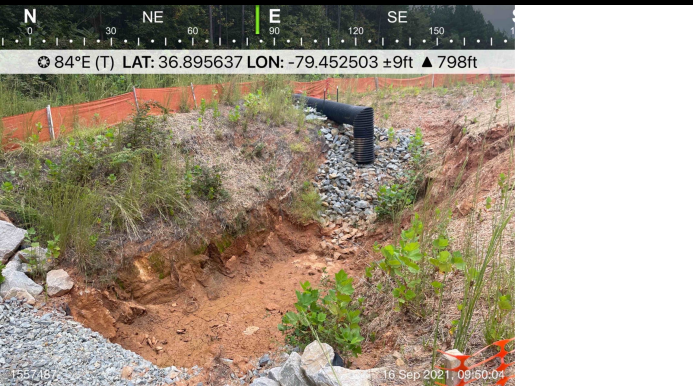
GPS Location	See photo		GPS Location	See photo	
Field Station#	15556+00		Field Station#	15574+87	
Pic 9 Desc.	No evidence of sedimentation from 3rd party disturbance.		Pic 10 Desc.	Slope drain is functioning as intended.

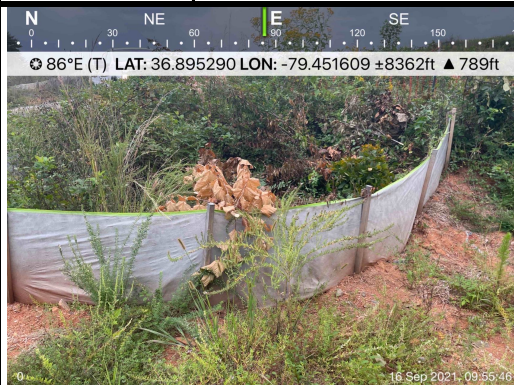
<p>Insert image here</p>	
GPS Location	See photo		GPS Location		
Field Station#	15584+20		Field Station#		
Pic 11 Desc.	Road pipe outlet P1 is in good condition.		Pic 12 Desc.

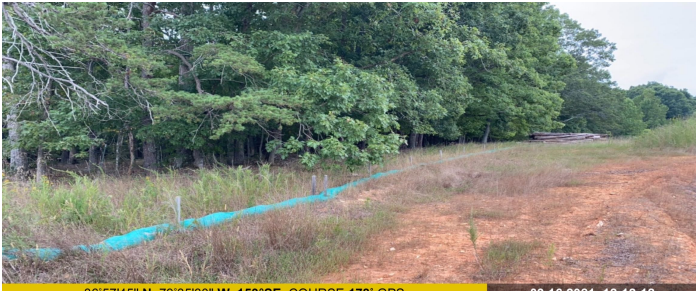
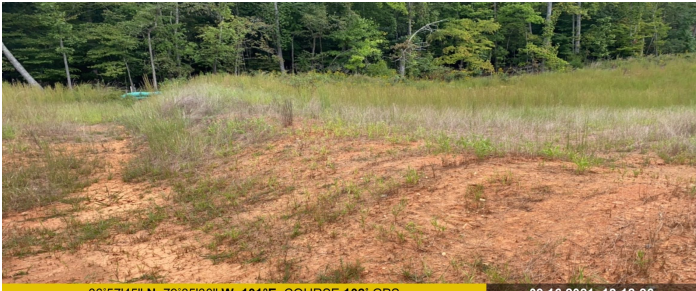
GPS Location	3		GPS Location	4	
Field Station#	15069+00		Field Station#	15070+00	
Pic 3 Desc.	Perimeter CFS in place and functional		Pic 4 Desc.	Water bar and CFS end treatment in good condition

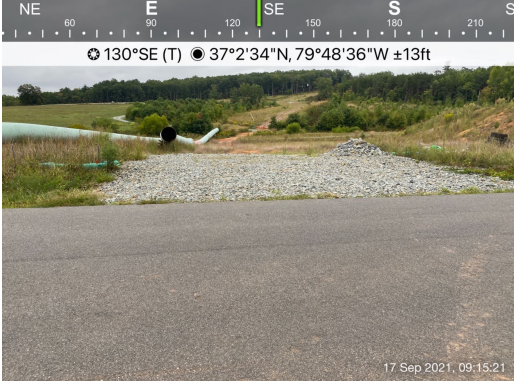
GPS Location	0	GPS Location	0		
Field Station#	14312+00	Field Station#	14326+00		
Pic 1 Desc.	Approximately 14312+00. Overview of road crossing and RCE.		Pic 2 Desc.	Approximately 14326+00. Overview of ROW.
