# Visual Site Inspection Report

<b>Project Name</b>	H-600 Pipeline Spread I	<b>AFE</b>	124300139	<b>Spread</b>	H-600 Pipeline Spread I
<b>Contractor</b>	Precision			<b>Report #</b>	28123
<b>Inspector</b>	Ben Farmer			<b>Date/Time</b>	9/6/2021 3:28 PM
<b>Permit #</b>	TBD	<b>Inspection Type</b>	VA SWPP	<b>Station Begin</b>	15480+67
<b>State</b>	VA	<b>Inspection Area</b>	Partial	<b>Station End</b>	15584+23
<b>County</b>	Pittsylvania	<b>Ground</b>	Damp	<b>Temperature (°F)</b>	76.00
<b>Municipality</b>	Chatham	<b>Weather</b>	Sunny	<b>Rain Gauge (in)</b>	0.00
				<b>Rain Accumulation Time (days)</b>	0.00

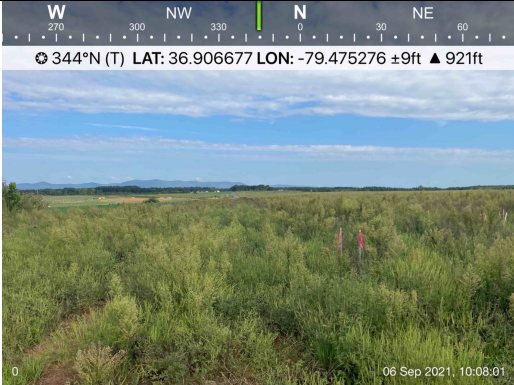
<b>GPS Location</b>	See photo		<b>GPS Location</b>	See photo	
<b>Field Station#</b>	15495+00		<b>Field Station#</b>	15496+70	
<b>Pic 1 Desc.</b>	Vegetation continues to fill in throughout this section.		<b>Pic 2 Desc.</b>	RCEs are in good condition at all road crossings.

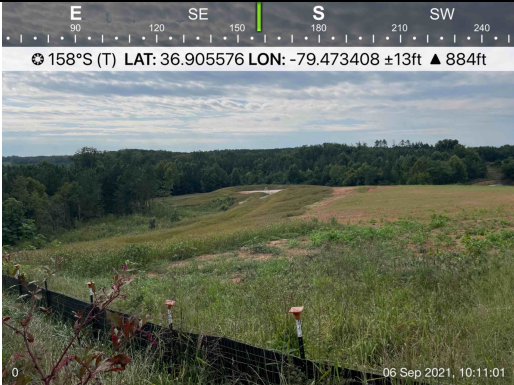
<b>GPS Location</b>	See photo		<b>GPS Location</b>	See photo	
<b>Field Station#</b>	15505+00		<b>Field Station#</b>	15506+41	
<b>Pic 3 Desc.</b>	No evidence of sedimentation from 3rd party disturbance.		<b>Pic 4 Desc.</b>	P1 is in good condition at all stream and wetland buffers.

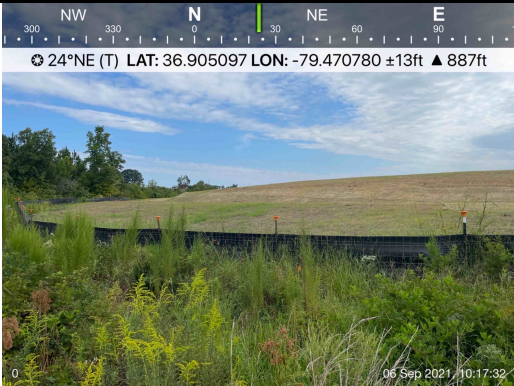
<b>GPS Location</b>	See photo		<b>GPS Location</b>	See photo	
<b>Field Station#</b>	15510+00		<b>Field Station#</b>	15515+00	
<b>Pic 5 Desc.</b>	3rd party ECDs appear to be in good condition.		<b>Pic 6 Desc.</b>	CWDs are functioning as intended.

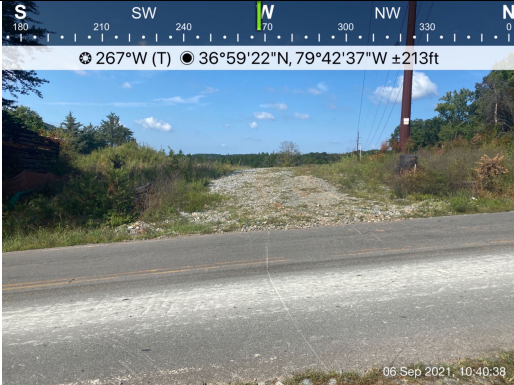
<b>GPS Location</b>	0	<b>GPS Location</b>	0		
<b>Field Station#</b>	14694+50	<b>Field Station#</b>	14685+00		
<b>Pic 1 Desc.</b>	Approximately 14694+50. Overview of road crossing and RCE.		<b>Pic 2 Desc.</b>	Approximately 14685+00. Overview of ROW.

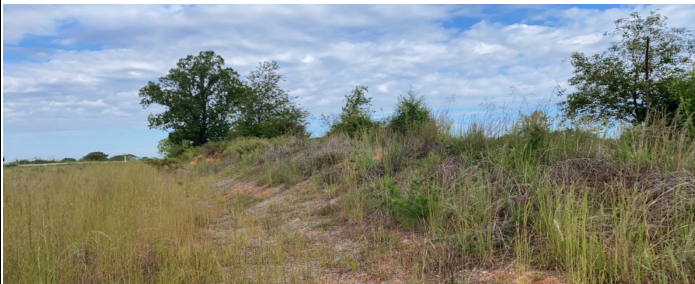
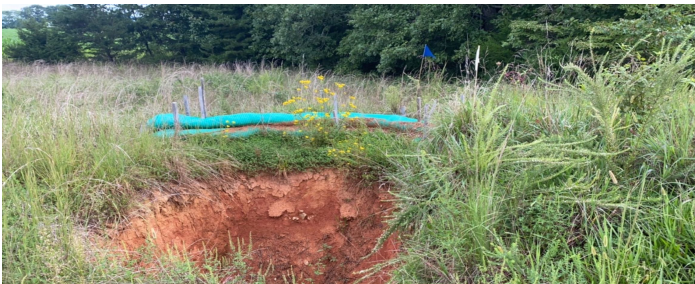
36°57'47" N 79°35'32" W 29°NE COURSE 228' GPS 1918-2164 Armstrong Rd, Penhook, VA 24137, United States 09.06.2021 09:35:34 Accur +/-33.4 Ft ALT 918 Ft			36°57'46" N 79°35'30" W 82°E COURSE 105' GPS 1918-2164 Armstrong Rd, Penhook, VA 24137, United States 09.06.2021 09:36:38 Accur +/-15.3 Ft ALT 900 Ft		
GPS Location	1	GPS Location	2		
Field Station#	15066+00	Field Station#	15068+00		
Pic 1 Desc.	Temporary diversion berm stabilized and vegetated	Pic 2 Desc.	Sump pit and CFS end treatment in good condition

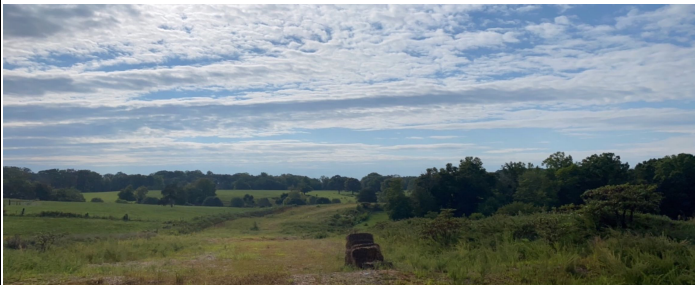
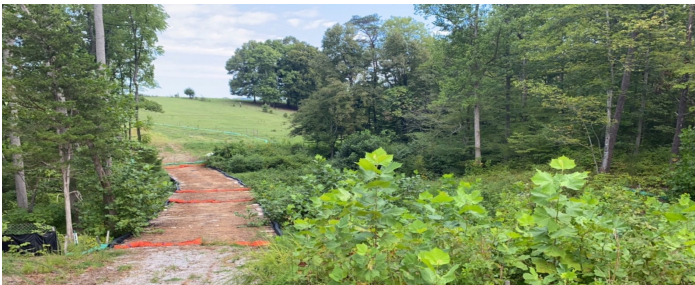
Pic 3 Desc.	Picture of temporary stabilization and vegetation along ROW; no issues observed	Pic 4 Desc.	Equipment bridge and surrounding ECDs in place and functional at stream crossing

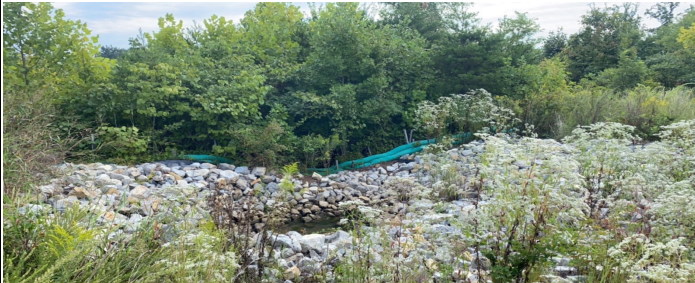
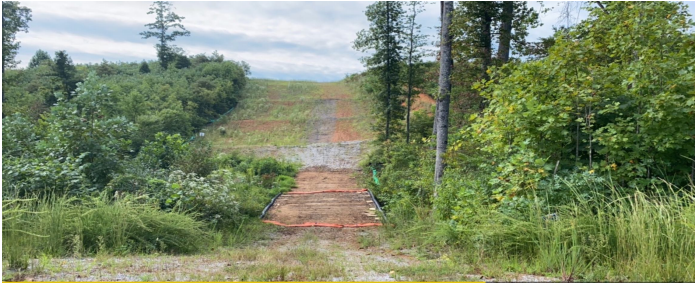
36°57'15" N 79°34'51" W 143°SE COURSE 197' GPS Sandy Level, VA 24161, United States 09.06.2021 10:04:38 Accur +/-296.3 Ft ALT 872 Ft			36°57'9" N 79°34'50" W 230°SW COURSE 179' GPS Sandy Level, VA 24161, United States 09.06.2021 10:07:07 Accur +/-15.2 Ft ALT 873 Ft		
GPS Location	5	GPS Location	6		
Field Station#	15121+00	Field Station#	15126+40		
Pic 5 Desc.	Plunge pool performing intended function	Pic 6 Desc.	Equipment bridge and surrounding ECDs in place and functional at stream crossing

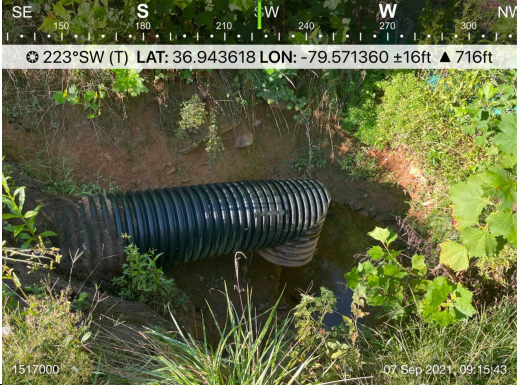
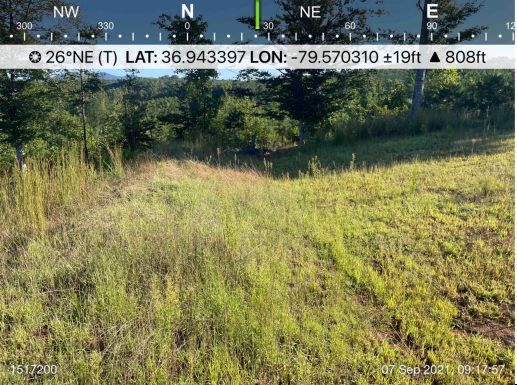
<b>GPS Location</b>	See photo		<b>GPS Location</b>	See photo	
<b>Field Station#</b>	15170+00		<b>Field Station#</b>	15172+00	
<b>Pic 7 Desc.</b>	Slope drain is functioning as intended.		<b>Pic 8 Desc.</b>	Waterbars are in good condition throughout this section.

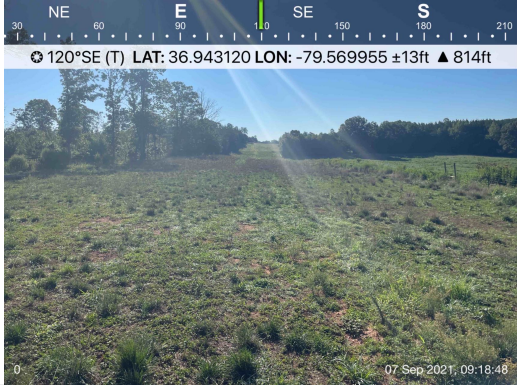
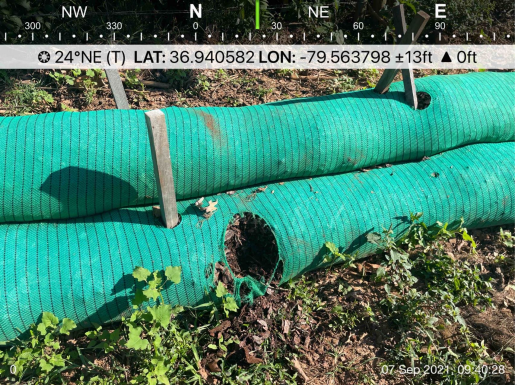
<b>GPS Location</b>	See photo		<b>GPS Location</b>	See photo	
<b>Field Station#</b>	15174+00		<b>Field Station#</b>	15195+00	
<b>Pic 9 Desc.</b>	Vegetation continues to fill in throughout this area.		<b>Pic 10 Desc.</b>	CFS has been damaged by livestock and needs to be repaired.

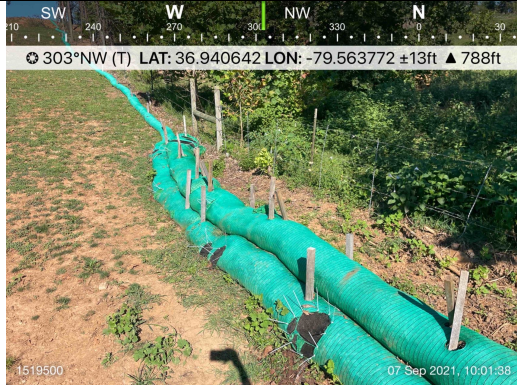
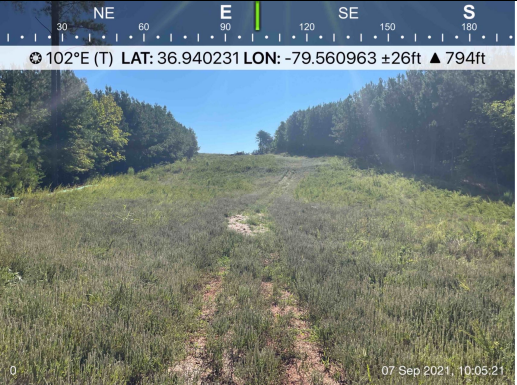
<b>GPS Location</b>	See photo		<b>GPS Location</b>	See photo	
<b>Field Station#</b>	15195+00		<b>Field Station#</b>	15200+00	
<b>Pic 11 Desc.</b>	Environmental crew has corrected this issue.		<b>Pic 12 Desc.</b>	Vegetation continues to fill in throughout this section.

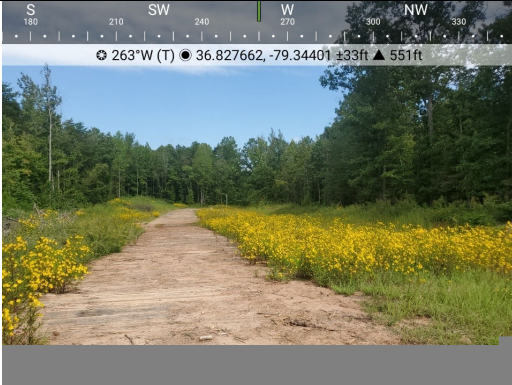
<b>GPS Location</b>	0	<b>GPS Location</b>	0		
<b>Field Station#</b>	7+35	<b>Field Station#</b>	10+00		
<b>Pic 1 Desc.</b>	Temporary vegetation and mat road		<b>Pic 2 Desc.</b>	Perimeter CFS

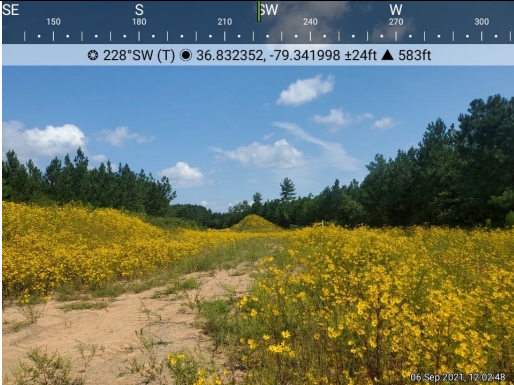
<b>GPS Location</b>	0	<b>GPS Location</b>	0		
<b>Field Station#</b>	2+50	<b>Field Station#</b>	5+00		
<b>Pic 1 Desc.</b>	Temporary vegetation	<b>Pic 2 Desc.</b>	Perimeter CFS

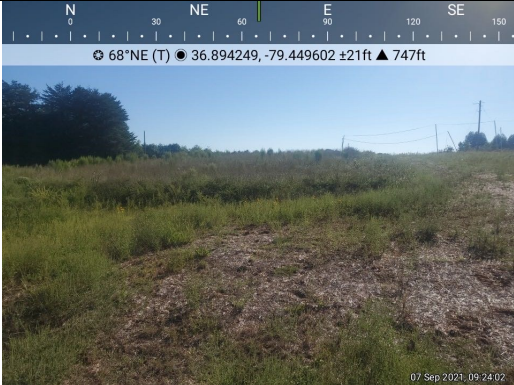
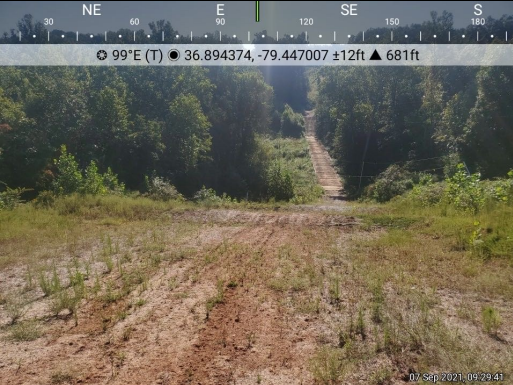
<b>GPS Location</b>	0	<b>GPS Location</b>	0		
<b>Field Station#</b>	15586+00	<b>Field Station#</b>	15590+00		
<b>Pic 1 Desc.</b>	GAS Anderson Mill Rd #1 Vegetation	<b>Pic 2 Desc.</b>	Vegetation

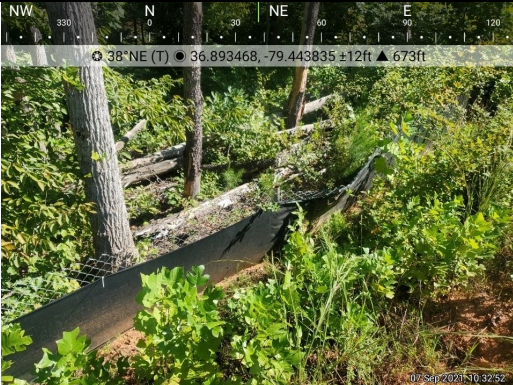
<b>GPS Location</b>	0	<b>GPS Location</b>	0		
<b>Field Station#</b>	15603+00	<b>Field Station#</b>	15603+00		
<b>Pic 3 Desc.</b>	SSF needing repairs	<b>Pic 4 Desc.</b>	SSF repairs completed

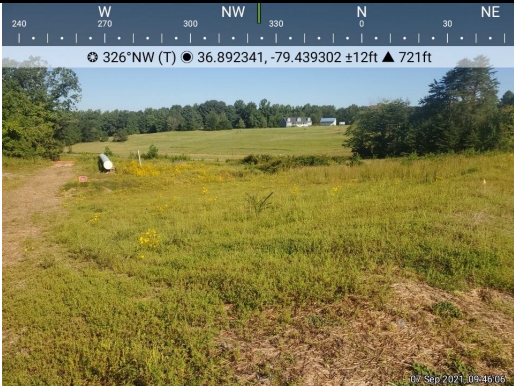
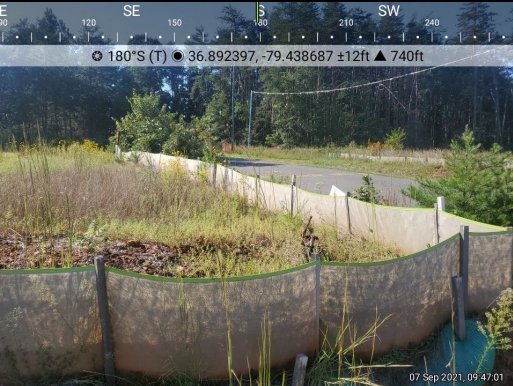
<b>GPS Location</b>	0	<b>GPS Location</b>	0		
<b>Field Station#</b>	15618+00	<b>Field Station#</b>	15620+00		
<b>Pic 5 Desc.</b>	Temporary vegetation	<b>Pic 6 Desc.</b>	GAS Anderson Mill #2 Perimeter silt fence

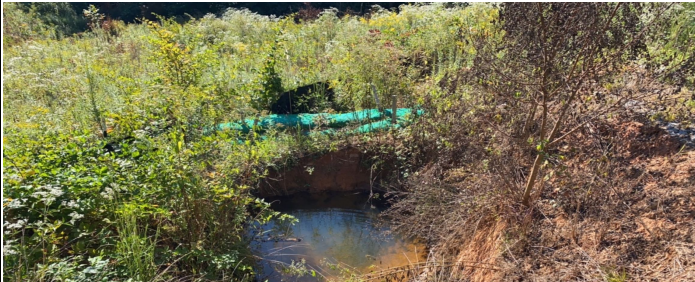
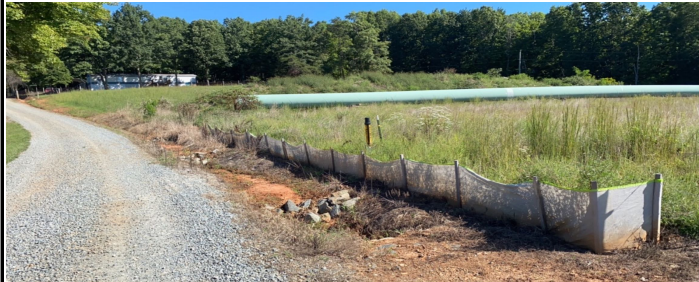
36°59'17" N 79°42'30" W 138°SE COURSE 145' GPS Sorry no results found 09.07.2021 10:16:42 Accur +/-48.5 Ft ALT 896 Ft			36°59'17" N 79°42'15" W 64°NE COURSE 159' GPS Sorry no results found 09.07.2021 10:22:18 Accur +/-36.8 Ft ALT 935 Ft		
GPS Location	1		GPS Location	2	
Field Station#	14708+00		Field Station#	14712+33	
Pic 1 Desc.	Sump pit and CFS end treatment in good condition		Pic 2 Desc.	Access road and perimeter controls in place and functional

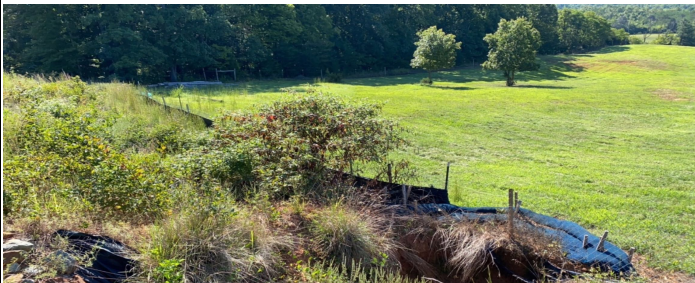
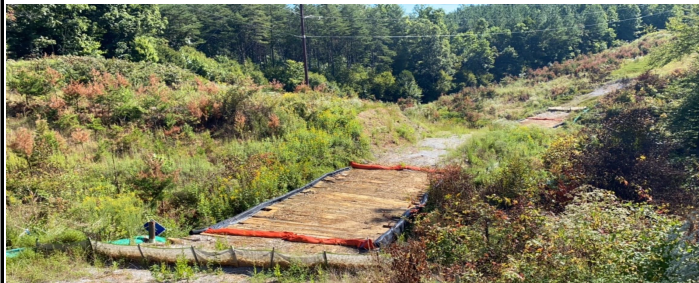
36°59'17" N 79°42'13" W 101°E COURSE 90' GPS Sorry no results found 09.07.2021 10:23:16 Accur +/-69.3 Ft ALT 935 Ft			36°59'17" N 79°42'13" W 83°E COURSE 3' GPS Sorry no results found 09.07.2021 10:30:23 Accur +/-367.2 Ft ALT 934 Ft		
GPS Location	3		GPS Location	4	
Field Station#	14714+99		Field Station#	14727+62	
Pic 3 Desc.	Perimeter controls in place and functional along ROW; no issues observed		Pic 4 Desc.	Equipment bridge and surrounding ECDs in place and functional

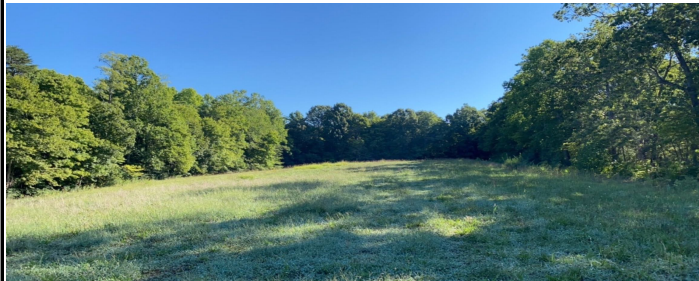
36°59'5" N 79°41'31" W 145°SE COURSE 3' GPS Sorry no results found 09.07.2021 10:41:19 Accur +/-106.7 Ft ALT 934 Ft			36°58'38" N 79°40'40" W 341°N COURSE 277' GPS Union Hall, VA 24176, United States 09.07.2021 09:52:48 Accur +/-49.3 Ft ALT 955 Ft		
GPS Location	5		GPS Location	6	
Field Station#	14751+50		Field Station#	14801+00	
Pic 5 Desc.	Equipment bridge and surrounding ECDs in place and functional; ROW stabilized in temporary area		Pic 6 Desc.	Extra workspace stabilized and vegetated

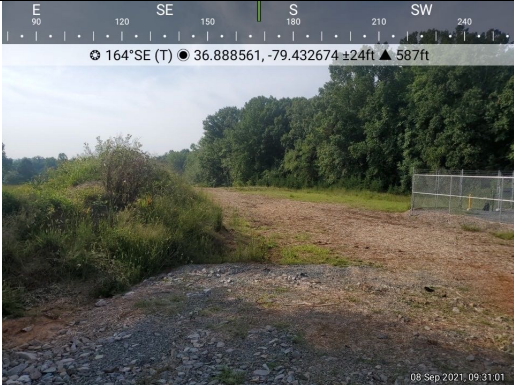
<b>GPS Location</b>	0	<b>GPS Location</b>	0		
<b>Field Station#</b>	15647+50	<b>Field Station#</b>	15655+00		
<b>Pic 1 Desc.</b>	GAS Anderson Mill #3 Vegetation	<b>Pic 2 Desc.</b>	Sump pit

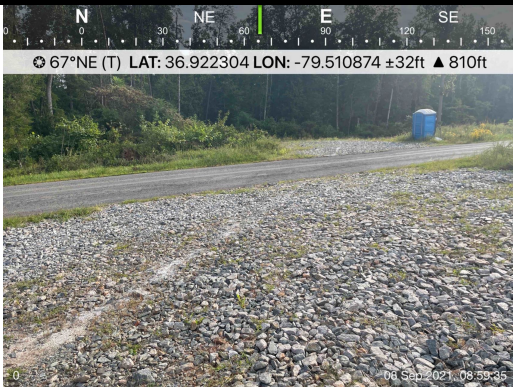
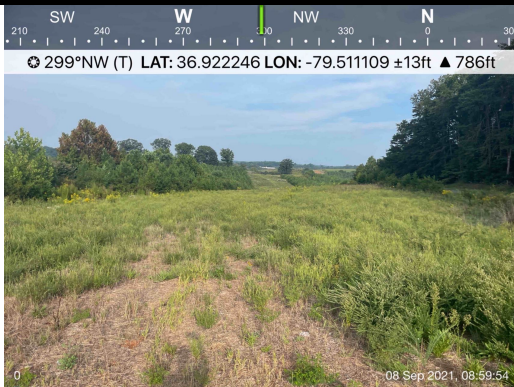
GPS Location	See photo		GPS Location	See photo	
Field Station#	15370+62		Field Station#	15370+00	
Pic 1 Desc.	RCEs are in good condition at all road crossings.		Pic 2 Desc.	Vegetation continues to fill in throughout this section.

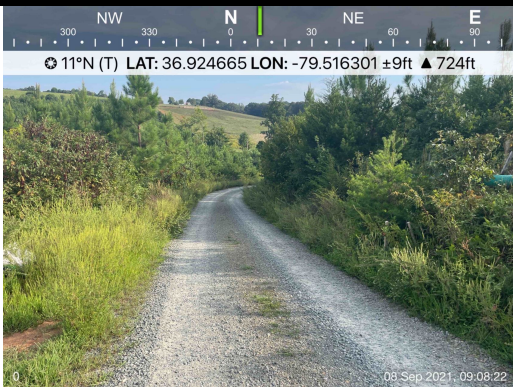
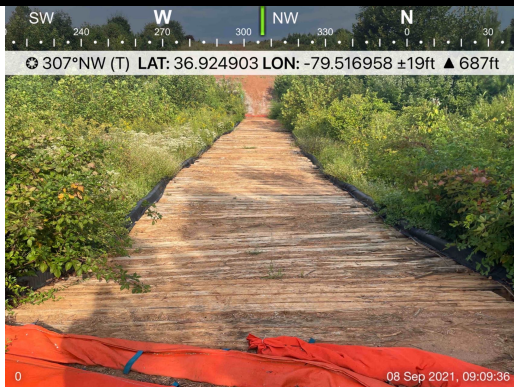
GPS Location	See photo		GPS Location	See photo	
Field Station#	15350+00		Field Station#	15346+80	
Pic 3 Desc.	MVP-PI-332 is in good condition with controls in place.		Pic 4 Desc.	Equipment bridge ECDs are in good condition.

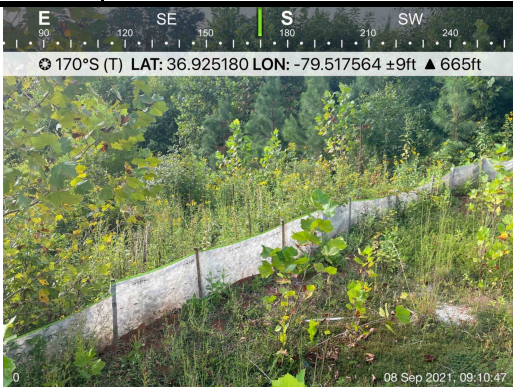
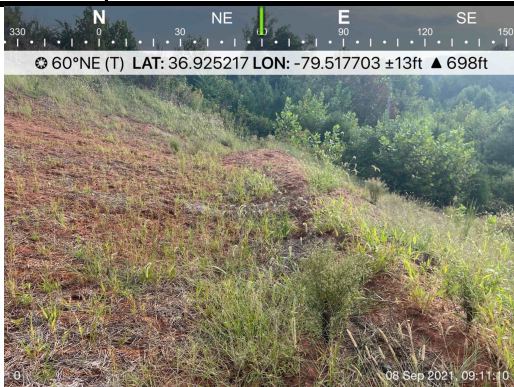
GPS Location	See photo		GPS Location	See photo	
Field Station#	15346+00		Field Station#	15345+00	
Pic 5 Desc.	P1 is in good condition at all stream and wetland buffers.		Pic 6 Desc.	Waterbars are functioning as intended.

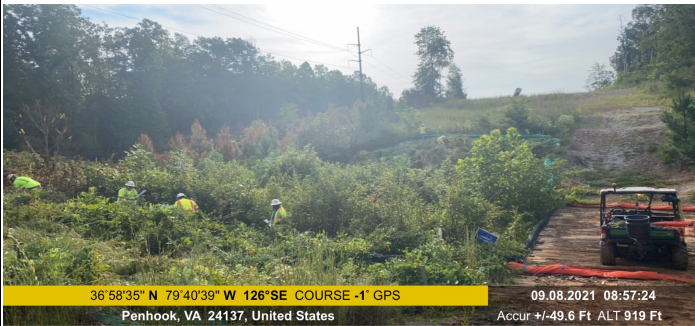
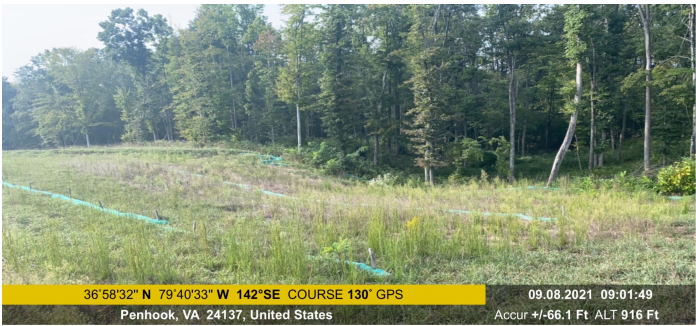
<b>GPS Location</b>	1	<b>GPS Location</b>	2		
<b>Field Station#</b>	14804+99	<b>Field Station#</b>	14813+00		
<b>Pic 1 Desc.</b>	Contractor trimming vegetation in resource buffer		<b>Pic 2 Desc.</b>	CFS check dams in final cleanup area performing intended function

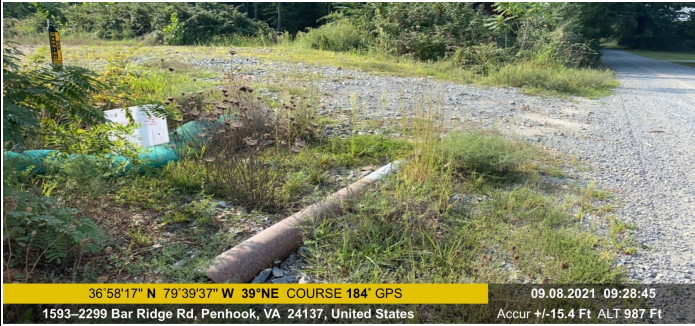
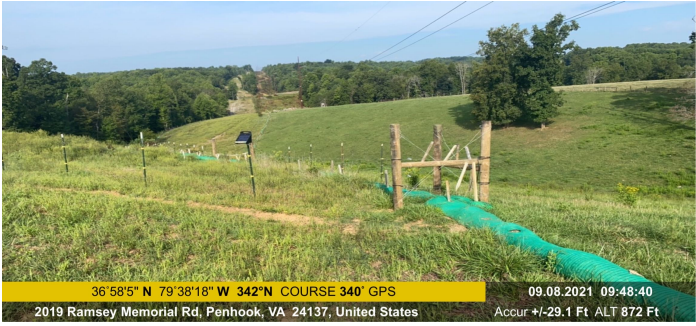
<b>GPS Location</b>	5	<b>GPS Location</b>	6		
<b>Field Station#</b>	14861+31	<b>Field Station#</b>	14924+00		
<b>Pic 5 Desc.</b>	Culvert at road crossing and RCE in good condition		<b>Pic 6 Desc.</b>	Perimeter CFS in place and functional

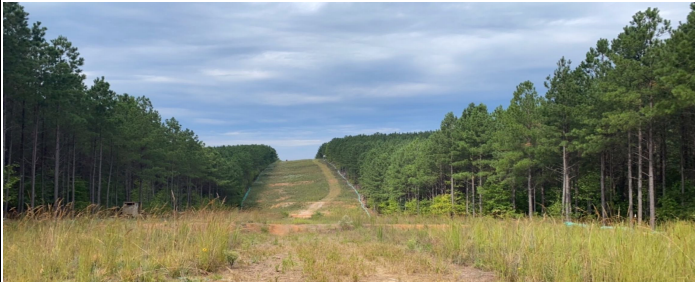
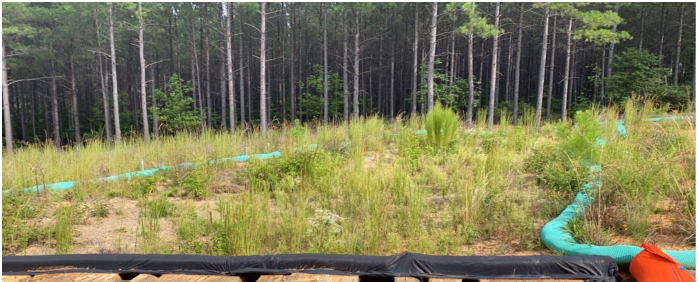
36°57'58" N 79°37'26" W 338°NW COURSE 319' GPS Penhook, VA 24137, United States 09.09.2021 10:56:59 Accur +/-36.5 Ft ALT 929 Ft			36°57'58" N 79°37'26" W 322°NW COURSE 285' GPS Penhook, VA 24137, United States 09.09.2021 10:56:52 Accur +/-58.1 Ft ALT 933 Ft		
<b>GPS Location</b>	1	<b>GPS Location</b>	2		
<b>Field Station#</b>	14962+00	<b>Field Station#</b>	14970+00		
<b>Pic 1 Desc.</b>	ROW stabilized and vegetated in final cleanup area	<b>Pic 2 Desc.</b>	ECDs surrounding natural drainage area in good condition

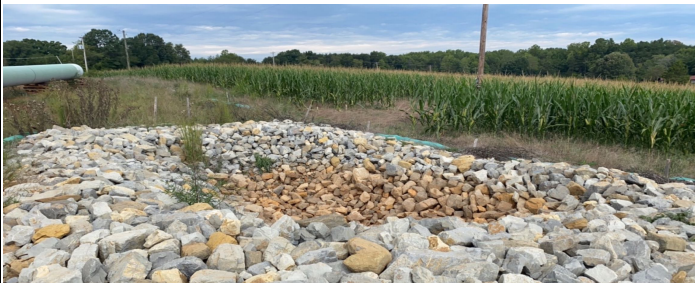
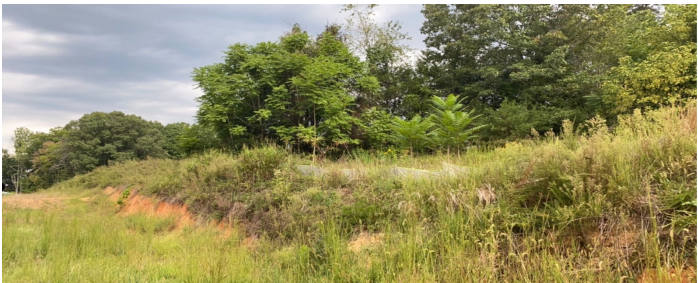
<b>Field Station#</b>	14988+00	<b>Field Station#</b>	15053+00		
<b>Pic 3 Desc.</b>	Plunge pool and perimeter CFS in place and functional	<b>Pic 4 Desc.</b>	Temporary diversion berm stabilized and vegetated; perimeter P1 silt fence in good condition

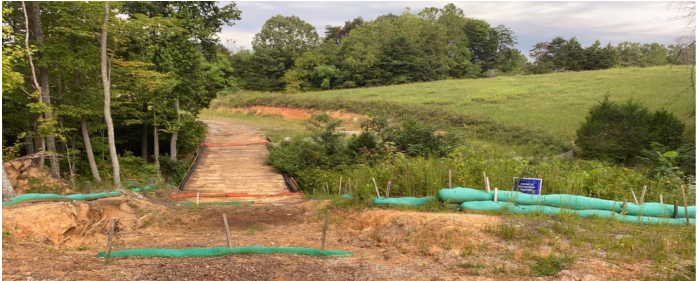
36°57'54" N 79°35'52" W 177°S COURSE 109' GPS Penhook, VA 24137, United States 09.09.2021 09:20:42 Accur +/-15.4 Ft ALT 857 Ft			36°57'51" N 79°35'44" W 334°NW COURSE 20' GPS Penhook, VA 24137, United States 09.09.2021 09:16:17 Accur +/-15.3 Ft ALT 901 Ft		
<b>GPS Location</b>	5	<b>GPS Location</b>	6		
<b>Field Station#</b>	15049+00	<b>Field Station#</b>	15055+88		
<b>Pic 5 Desc.</b>	Sump pit and CFS end treatment performing intended functions; perimeter SSF in good condition	<b>Pic 6 Desc.</b>	Equipment bridge and surrounding ECDs in place and functional at stream crossing and resource buffer

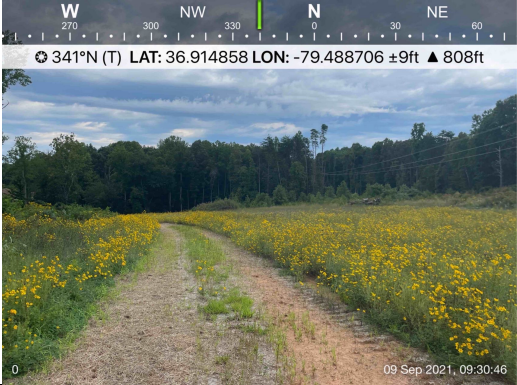
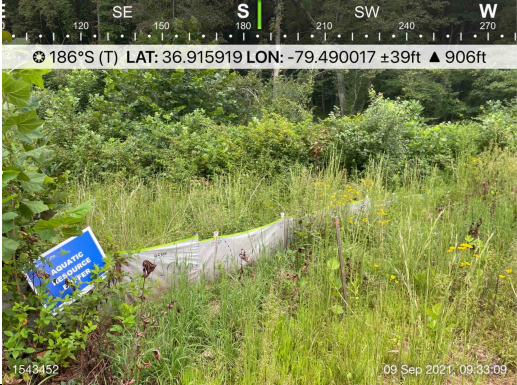
<b>GPS Location</b>	See photo		<b>GPS Location</b>	See photo	
<b>Field Station#</b>	15440+00		<b>Field Station#</b>	15434+52	
<b>Pic 7 Desc.</b>	Vegetation continues to fill in throughout this section.		<b>Pic 8 Desc.</b>	P1 is in good condition at all stream and wetland buffers.

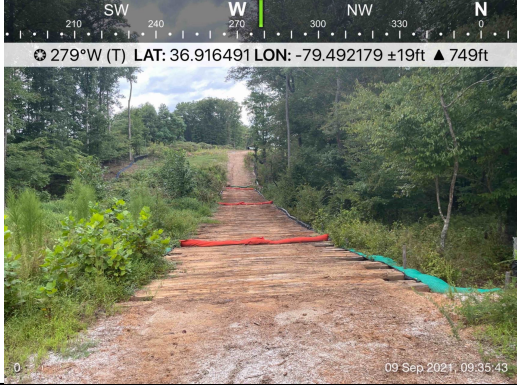
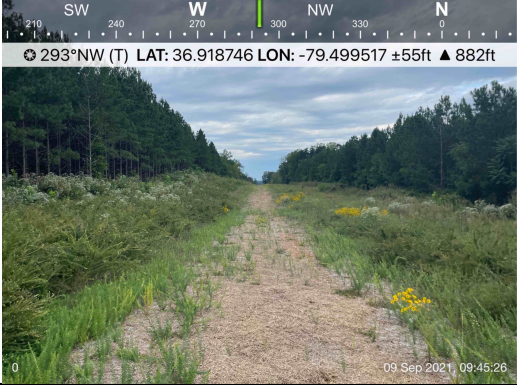
<b>GPS Location</b>	See photo		<b>GPS Location</b>	See photo	
<b>Field Station#</b>	15426+70		<b>Field Station#</b>	15415+00	
<b>Pic 9 Desc.</b>	Equipment bridge ECDs are in place and functioning.		<b>Pic 10 Desc.</b>	Vegetation continues to fill in throughout this section.

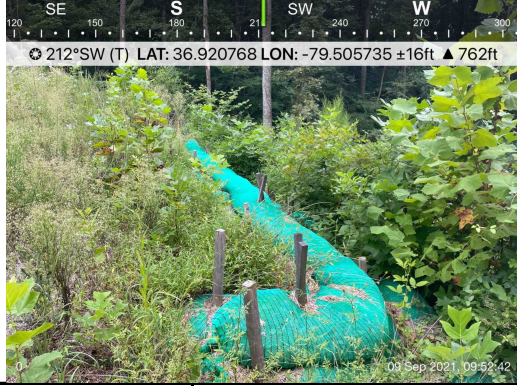
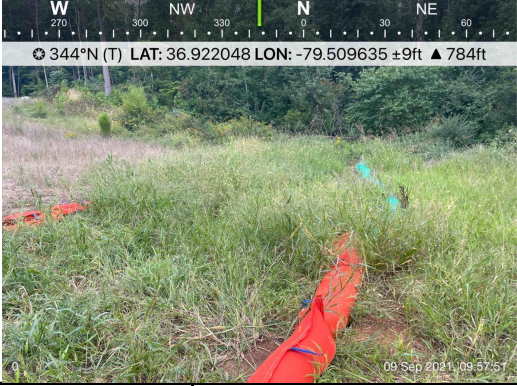
<b>GPS Location</b>	See photo		<b>GPS Location</b>	See photo	
<b>Field Station#</b>	15385+00		<b>Field Station#</b>	15380+50	
<b>Pic 11 Desc.</b>	CFS remains in good condition.		<b>Pic 12 Desc.</b>	Drainage ECDs are in place and functioning.

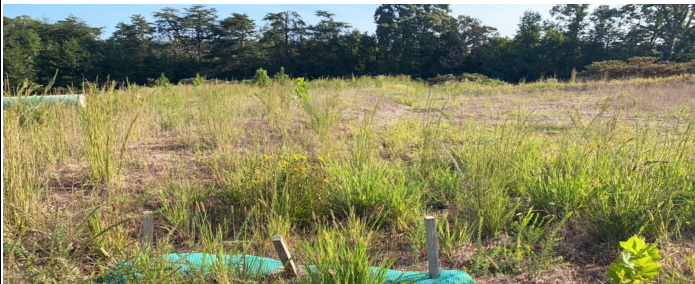
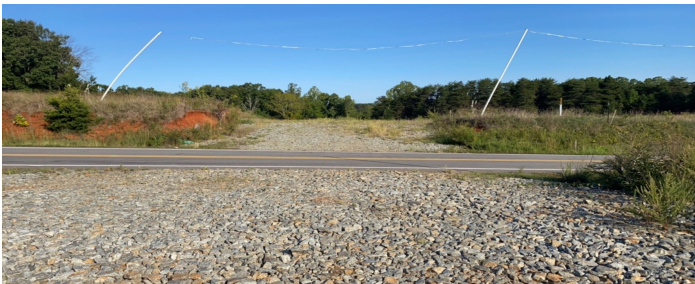
36°57'22" N 79°34'56" W 127°SE COURSE 18° GPS Sandy Level, VA 24161, United States 09.10.2021 09:12:42 Accur +/-33.8 Ft ALT 927 Ft			36°57'20" N 79°34'55" W 31°NE COURSE 323° GPS Sandy Level, VA 24161, United States 09.10.2021 09:11:22 Accur +/-38.9 Ft ALT 932 Ft		
<b>GPS Location</b>	1	<b>GPS Location</b>	2		
<b>Field Station#</b>	15111+00	<b>Field Station#</b>	15113+00		
<b>Pic 1 Desc.</b>	CFS check dams performing intended function	<b>Pic 2 Desc.</b>	RCE at Museville Rd in good condition

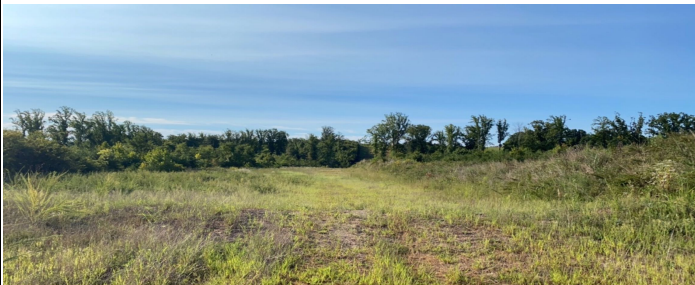
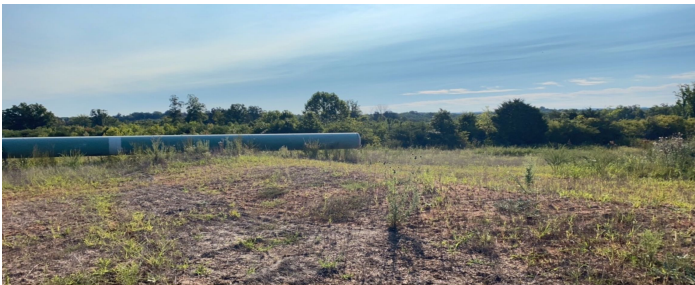
<b>GPS Location</b>	3	<b>GPS Location</b>	4		
<b>Field Station#</b>	15122+00	<b>Field Station#</b>	15116+00		
<b>Pic 3 Desc.</b>	ROW stabilized and vegetated in temporary area	<b>Pic 4 Desc.</b>	Water bar performing intended function

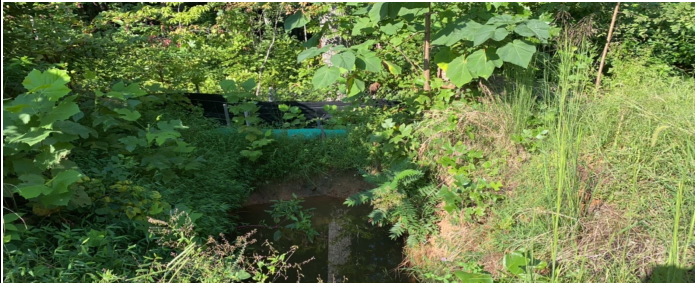
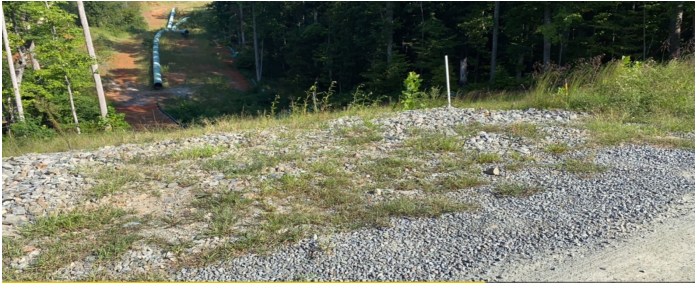
36°56'53" N 79°34'43" W 302°NW COURSE 226° GPS 336-520 Rockcreek Rd, Sandy Level, VA 24161, United States 09.10.2021 09:54:28 Accur +/-19.5 Ft ALT 867 Ft			36°56'53" N 79°34'42" W 178°S COURSE 47° GPS 336-520 Rockcreek Rd, Sandy Level, VA 24161, United States 09.10.2021 09:53:38 Accur +/-15.3 Ft ALT 890 Ft		
<b>GPS Location</b>	5	<b>GPS Location</b>	6		
<b>Field Station#</b>	15138+00	<b>Field Station#</b>	15142+66		
<b>Pic 5 Desc.</b>	Sump pit and CFS end treatment in place and functional	<b>Pic 6 Desc.</b>	RCE at Rock Creek Rd in good condition

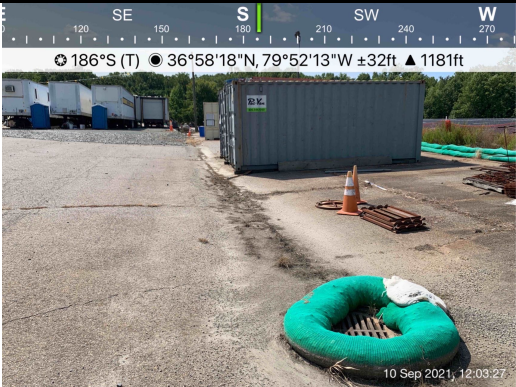
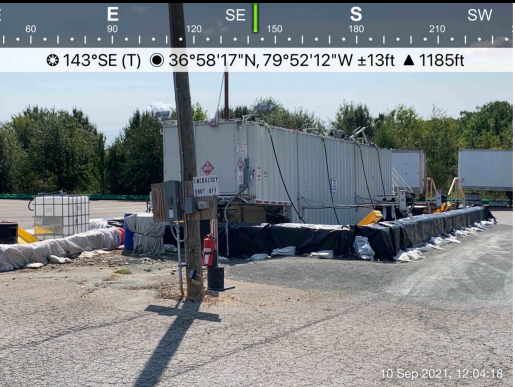
GPS Location	000000000000		GPS Location	000000000000	
Field Station#	0000+00		Field Station#	0000+00	
Pic 1 Desc.	Inlet protection for catch basin on north end of LY-046 in good condition.		Pic 2 Desc.	Secondary containment structure for fuel cell at LY-046 in good condition.

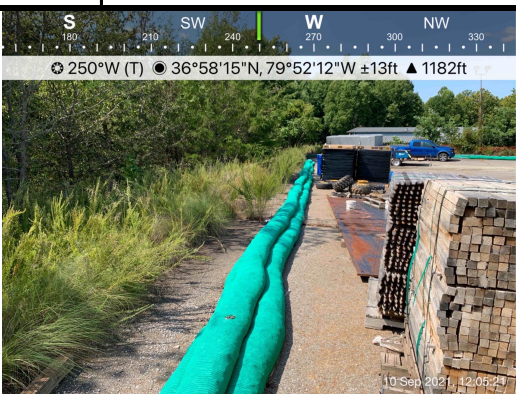
GPS Location	000000000000		GPS Location	000000000000	
Field Station#	0000+00		Field Station#	0000+00	
Pic 3 Desc.	Perimeter ECD's on south end of LY-046 in good condition.		Pic 4 Desc.	Secondary containment structure for wash station at LY-045 in good condition.

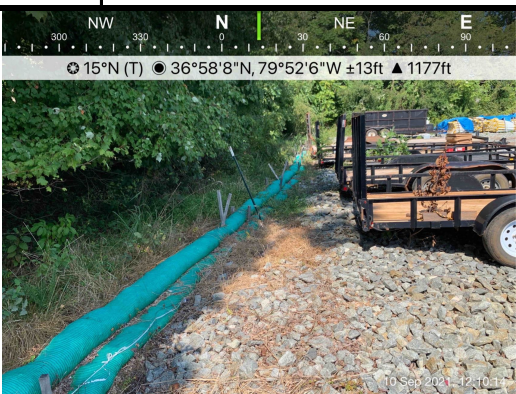
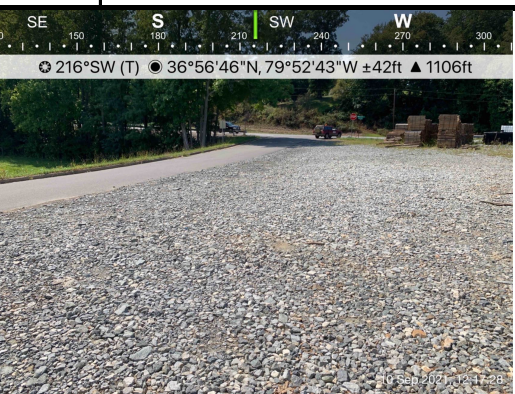
GPS Location	000000000000		GPS Location	000000000000	
Field Station#	0000+00		Field Station#	0000+00	
Pic 5 Desc.	Perimeter ECD's on west side of LY-045 near employee parking area in good condition.		Pic 6 Desc.	RCE at LY-033 in good condition.

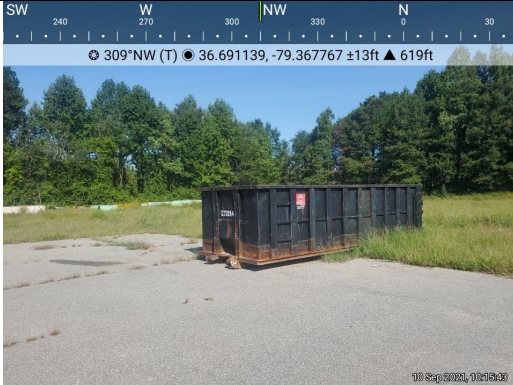
<b>GPS Location</b>	0	<b>GPS Location</b>	0		
<b>Field Station#</b>	0+00	<b>Field Station#</b>	0+00		
<b>Pic 1 Desc.</b>	LY-048 Housekeeping		<b>Pic 2 Desc.</b>	LY-048 Bulk dumpster

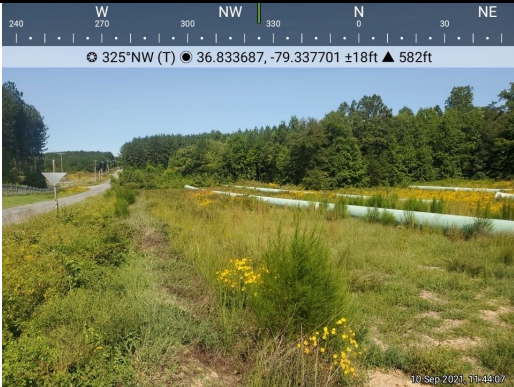
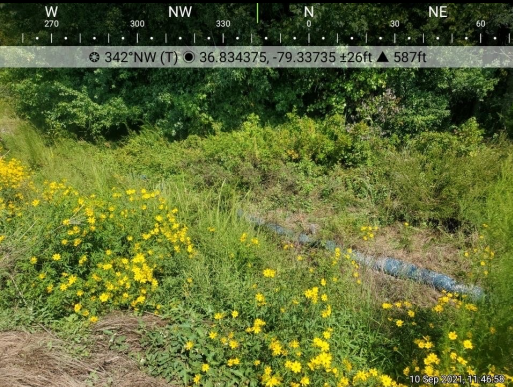
<b>GPS Location</b>	0	<b>GPS Location</b>	0		
<b>Field Station#</b>	24+00	<b>Field Station#</b>	23+75		
<b>Pic 1 Desc.</b>	Temporary vegetation	<b>Pic 2 Desc.</b>	East perimeter ATWS CFS
