Visual Site Inspection Report

Project Name	H-600 Pipeline Spread G	AFE	124300137	Spread	H-600 Pipeline Spread G
Contractor	Precision			Report #	29615
Inspector	Patrick Shields			Date/Time	10/11/2021 5:53 PM
Permit #	TBD	Inspection Type	VA SWPP	Station Begin	10655+00
State	VA	Inspection Area	Full	Station End	10859+34
County	Giles	Ground	Wet	Temperature (°F)	67.00
Municipality	N/A	Weather	Cloudy	Rain Gauge (in)	0.10
				Rain Accumulation Time (days)	1.00

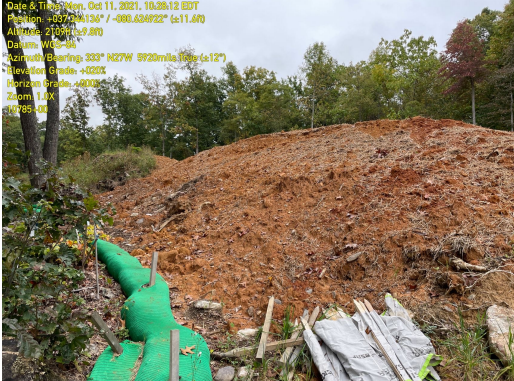
GPS Location	See photo	GPS Location	See photo		
Field Station#	10785+00	Field Station#	10685+00		
Pic 1 Desc.	Stabilize spoil pile	Pic 2 Desc.	CFS perimeter control in place

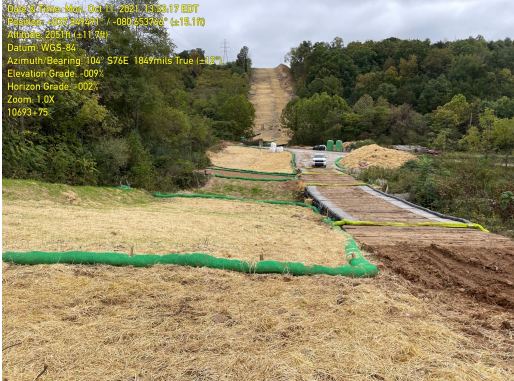
GPS Location	See photo	GPS Location	See photo		
Field Station#	10693+75	Field Station#	10701+00		
Pic 3 Desc.	Cleanwater drainage feature in place	Pic 4 Desc.	End treatments in place

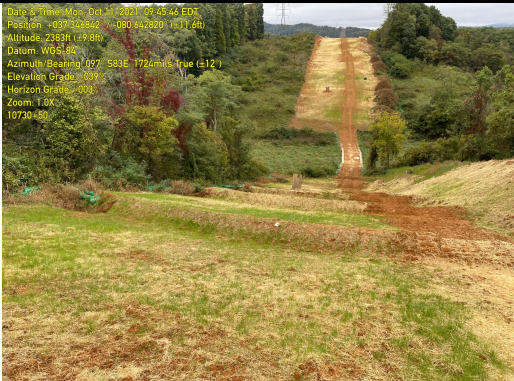
GPS Location	See photo	GPS Location	See photo		
Field Station#	10730+50	Field Station#	10750+00		
Pic 5 Desc.	Waterbars in place	Pic 6 Desc.	RCE in place

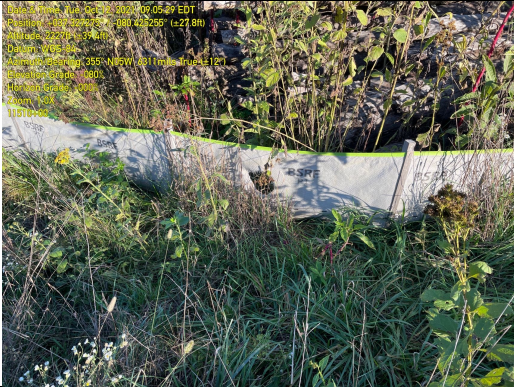
GPS Location	See photo	GPS Location	See photo		
Field Station#	11510+00	Field Station#	11512+50		
Pic 1 Desc.	Hole in P1 silt fence	Pic 2 Desc.	Geotextile fabric needs repaired

E&S BMPs	Compliance Level	Corrective Action	Corrective Time Frame	Date Repaired
Equipment Bridge	Communication			
Silt Fence (Filter Fabric Fence)	Communication			
Cleanwater Diversion Berm	Acceptable			
Compost Filter Sock	Acceptable			
Culvert	Acceptable			
Erosion Control Blanket	Acceptable			
Plunge Pool	Acceptable			
Sensitive Resource Buffer	Acceptable			
Silt Fence (Reinforce Filter Fence)	Acceptable

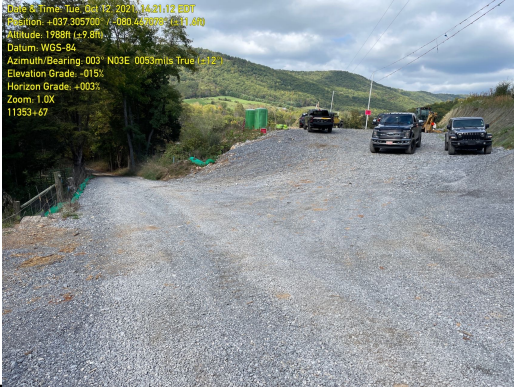
GPS Location	See photo	GPS Location	See photo		
Field Station#	11353+67	Field Station#	11293+00		
Pic 3 Desc.	RCE in place	Pic 4 Desc.	Stream buffer in place

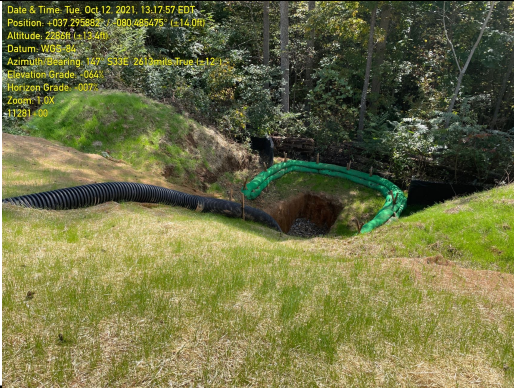
GPS Location	See photo	GPS Location	See photo		
Field Station#	11281+00	Field Station#	11363+00		
Pic 5 Desc.	End treatment in place	Pic 6 Desc.	End treatments in place

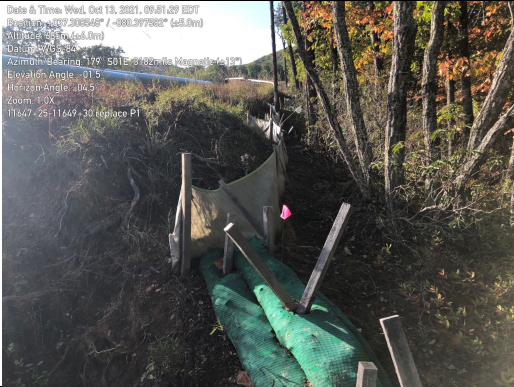
GPS Location	On photo	GPS Location	On photo		
Field Station#	11647+25	Field Station#	11664+00		
Pic 1 Desc.	Communication. Replace worn P1 silt fence along perimeter.	Pic 2 Desc.	Perimeter ECDs checked for maintenance needs.

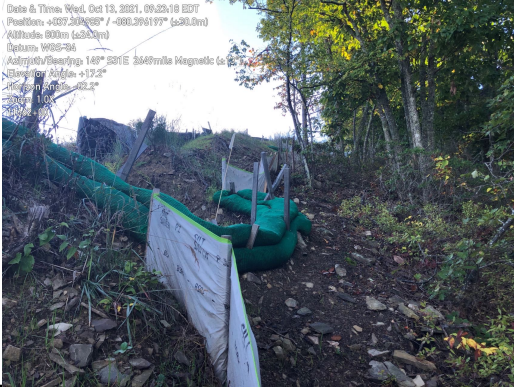
GPS Location	On photo	GPS Location	On photo		
Field Station#	11662+00	Field Station#	11655+00		
Pic 3 Desc.	Perimeter ECDs checked for functionality	Pic 4 Desc.	Slope breakers functioning as designed.

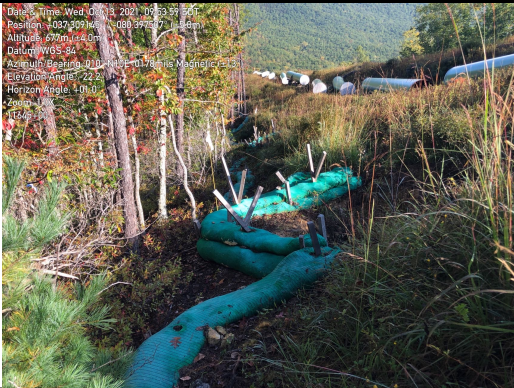
GPS Location	On photo	GPS Location	On photo		
Field Station#	11645+00	Field Station#	1128+50		
Pic 5 Desc.	ROW stable. No sediment movement.	Pic 6 Desc.	Silt fence recently replaced

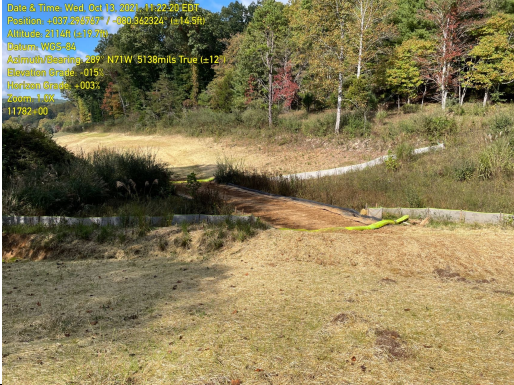
GPS Location	See photo	GPS Location	See photo		
Field Station#	11782+00	Field Station#	11765+75		
Pic 1 Desc.	Cleanwater drainage feature in place	Pic 2 Desc.	RCE in place

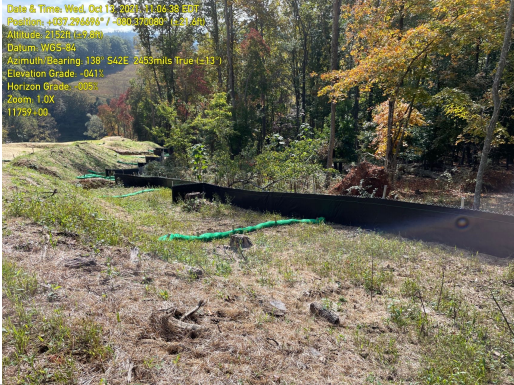
GPS Location	See photo	GPS Location	See photo		
Field Station#	11759+00	Field Station#	11749+00		
Pic 3 Desc.	Supersilt fence perimeter control in place	Pic 4 Desc.	Waterbars in place

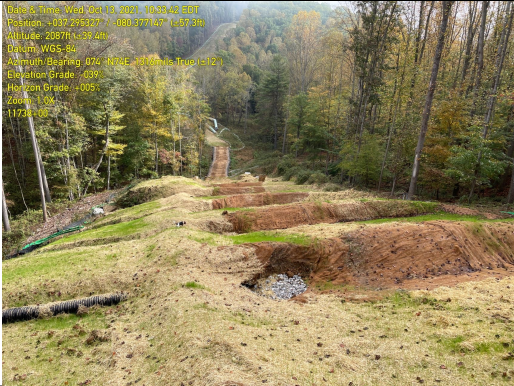
GPS Location	See photo	GPS Location	See photo		
Field Station#	11738+00	Field Station#	11719+00		
Pic 5 Desc.	Stone inlet protection in place	Pic 6 Desc.	CFS perimeter control in place

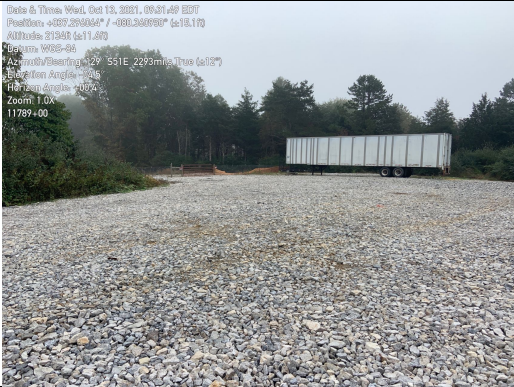
GPS Location	See photo	GPS Location	See photo		
Field Station#	11789+00	Field Station#	11788+85		
Pic 1 Desc.	RCE at MT Tabor Rd is acceptable	Pic 2 Desc.	Secondary containment in place

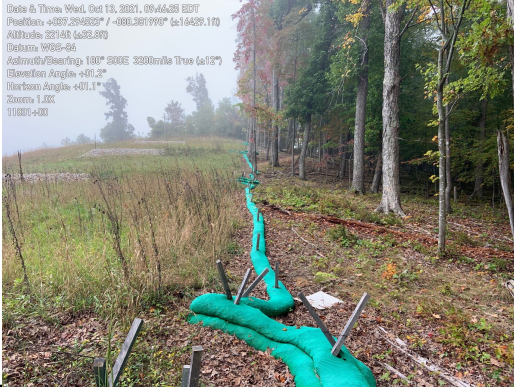
GPS Location	See photo	GPS Location	See photo		
Field Station#	11831+00	Field Station#	11854+16		
Pic 3 Desc.	Perimeter controls are in acceptable condition	Pic 4 Desc.	Damaged P1

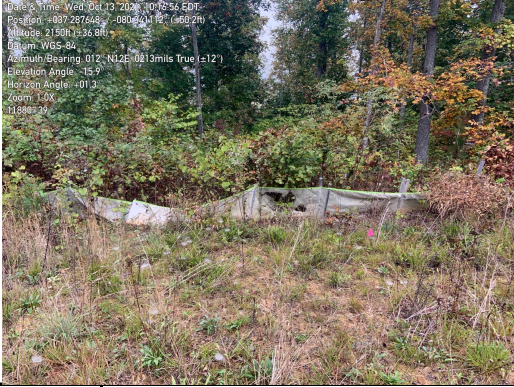
GPS Location	See photo	GPS Location	See photo		
Field Station#	11880+39	Field Station#	11899+99		
Pic 5 Desc.	Damaged P1	Pic 6 Desc.	Broad based dips and P1 along AR266.03 are acceptable
