Visual Site Inspection Report

Project Name	H-600 Pipeline Spread G	AFE	124300137	Spread	H-600 Pipeline Spread G
Contractor	Precision			Report #	29913
Inspector	Patrick Shields			Date/Time	10/18/2021 5:13 PM
Permit #	TBD	Inspection Type	VA SWPP	Station Begin	11254+99
State	VA	Inspection Area	Full	Station End	11524+16
County	Giles	Ground	Dry	Temperature (°F)	63.00
Municipality	N/A	Weather	Sunny	Rain Gauge (in)	0.10
				Rain Accumulation Time (days)	1.00

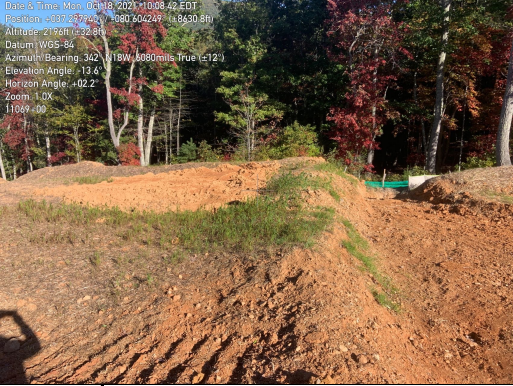
<p>Date & Time: Mon, Oct 18, 2021, 10:08:42 EDT Position: +037.312973 / -080.533724 / 11093+35 Altitude: 1944ft (+36.6ft) Datum: WGS-84 Azimuth/Bearing: 142° 53SE 330mils True (+12°) Elevation Angle: -02.2° Horizon Angle: +01.2° Zoom: 1.0X 11093+35</p>			
GPS Location		See photo		GPS Location	
Field Station#		11093+35		Field Station#	
Pic 1 Desc.		Hydro seeding of restored Row		Pic 2 Desc.

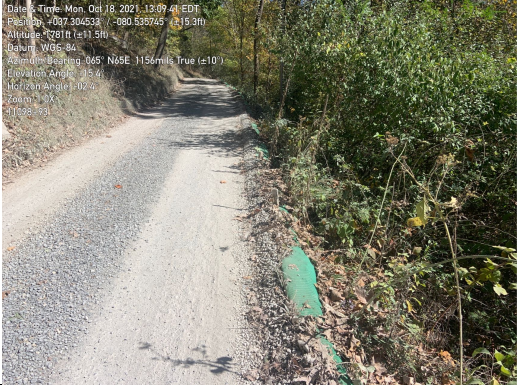
GPS Location	See photo	GPS Location			
Field Station#	11098+93	Field Station#			
Pic 13 Desc.	Stone is migrating over CFS along AR245.02 and needs pulled back onto road	Pic 14 Desc.			
Insert image here		Insert image here			
GPS Location		GPS Location			
Field Station#		Field Station#			
Pic 15 Desc.		Pic 16 Desc.			
Insert image here		Insert image here			
GPS Location		GPS Location			
Field Station#		Field Station#			
Pic 17 Desc.		Pic 18 Desc.

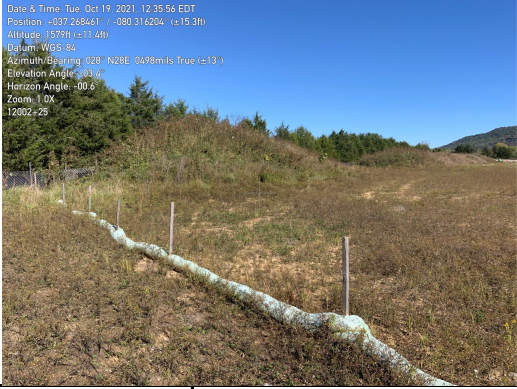
Insert image here	
GPS Location	See photo	GPS Location			
Field Station#	12002+25	Field Station#			
Pic 13 Desc.	Temporary CFS water bar in place	Pic 14 Desc.			
Insert image here		Insert image here			
GPS Location		GPS Location			
Field Station#		Field Station#			
Pic 15 Desc.		Pic 16 Desc.			
Insert image here		Insert image here			
GPS Location		GPS Location			
Field Station#		Field Station#			
Pic 17 Desc.		Pic 18 Desc.

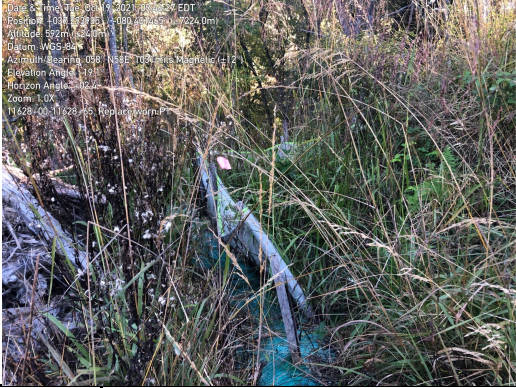
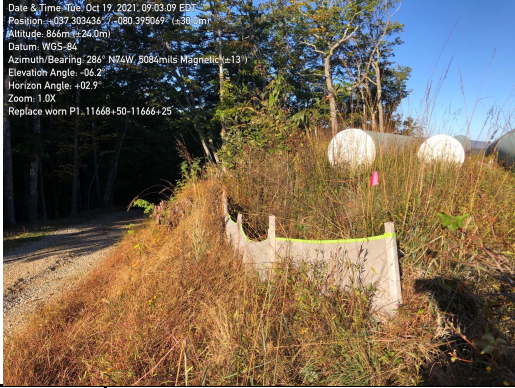
<p>Date & Time: Tue, Oct 19, 2021 09:03:09 EDT Position: 43°37'30.2436"N 72°40'39.5049"W (a30m) Altitude: 846m (2776ft) Datum: WGS-84 Azimuth/Bearing: 08° N24W 208mils Magnetic (-13°) Elevation Angle: -06.2° Horizon Angle: +02.9° Zoom: 1.0x Replace worn P1: 11628+00</p>

<p>Date & Time: Tue, Oct 19, 2021 09:03:09 EDT Position: 43°37'30.2436"N 72°40'39.5049"W (a30m) Altitude: 846m (2776ft) Datum: WGS-84 Azimuth/Bearing: 08° N24W 208mils Magnetic (-13°) Elevation Angle: -06.2° Horizon Angle: +02.9° Zoom: 1.0x Replace worn P1: 11668+50-11666+25</p>			
GPS Location	On photo	GPS Location	On photo		
Field Station#	11628+00	Field Station#	11668+50		
Pic 1 Desc.	Communication; Worn silt fence to be replaced.	Pic 2 Desc.	Communication; Worn silt fence to be replaced.

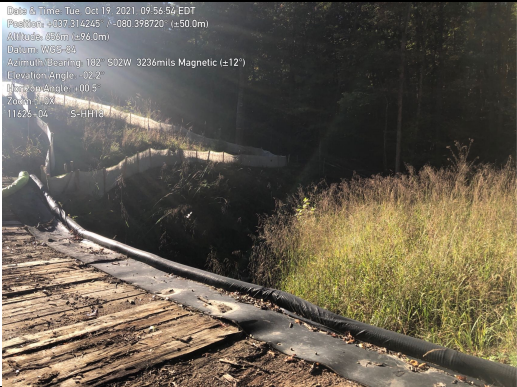
GPS Location	On photo	GPS Location	On photo		
Field Station#	11626+04	Field Station#	11614+20		
Pic 7 Desc.	The S-HH18 crossing is stable	Pic 8 Desc.	The S-RR14 crossing is stable

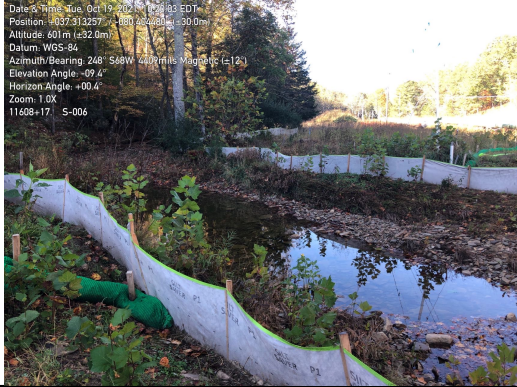
<p style="text-align: center;">Insert image here</p>			
GPS Location	On photo	GPS Location			
Field Station#	11608+17	Field Station#			
Pic 9 Desc.	The S-006 crossing is stable	Pic 10 Desc.			
<p style="text-align: center;">Insert image here</p>		<p style="text-align: center;">Insert image here</p>			
GPS Location		GPS Location			
Field Station#		Field Station#			
Pic 11 Desc.		Pic 12 Desc.

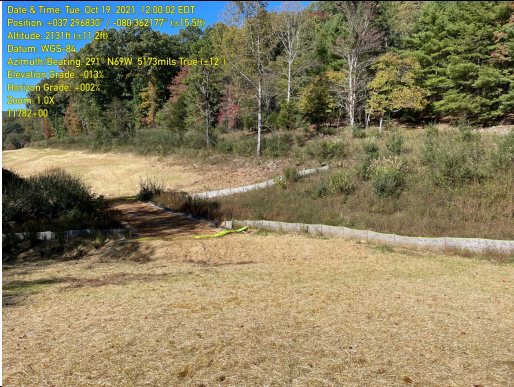
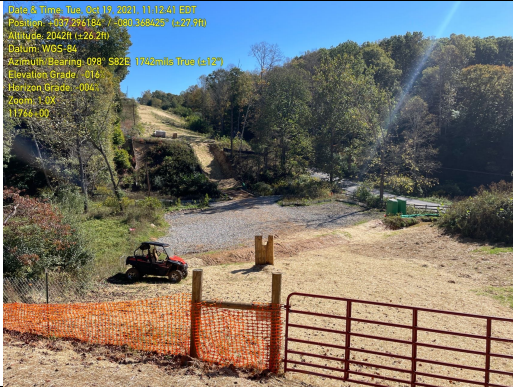
GPS Location		See photo		GPS Location	
Field Station#		11782+00		Field Station#	
Pic 1 Desc.		Cleanwater drainage feature in place		Pic 2 Desc.	
				RCE in place

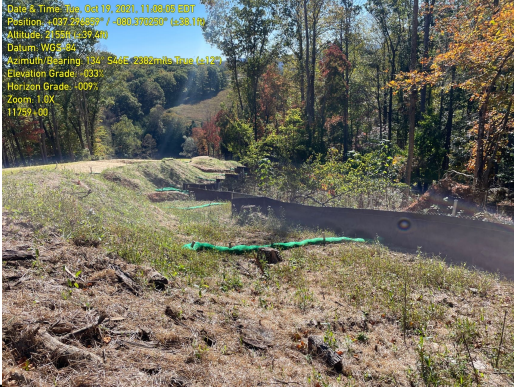
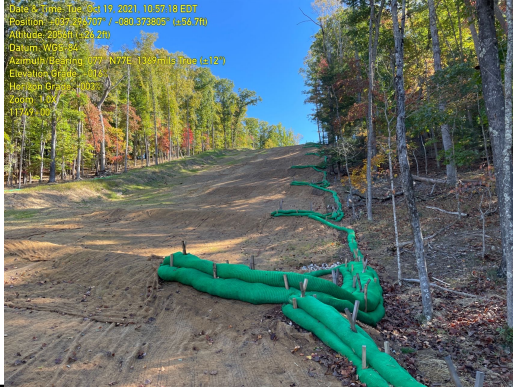
GPS Location		See photo		GPS Location	
Field Station#		11759+00		Field Station#	
Pic 3 Desc.		Supersilt fence perimeter control in place		Pic 4 Desc.	
				End treatments in place

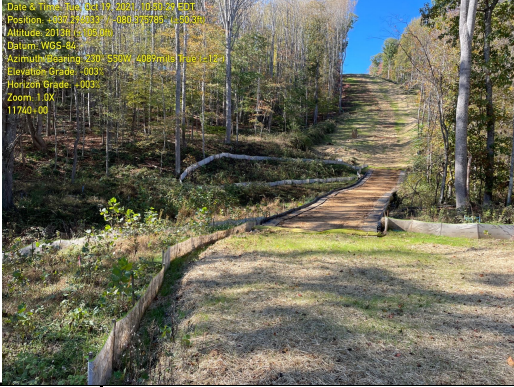
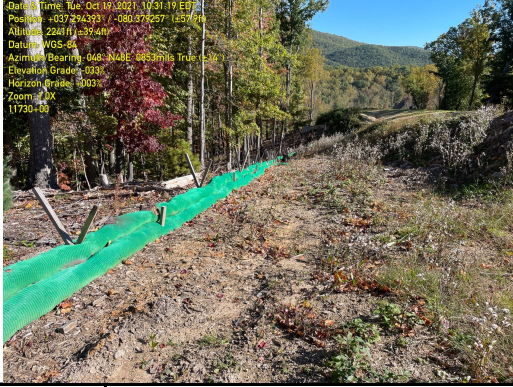
GPS Location		See photo		GPS Location	
Field Station#		11740+00		Field Station#	
Pic 5 Desc.		Stream buffer in place		Pic 6 Desc.	
				CFS triple stack perimeter control in place

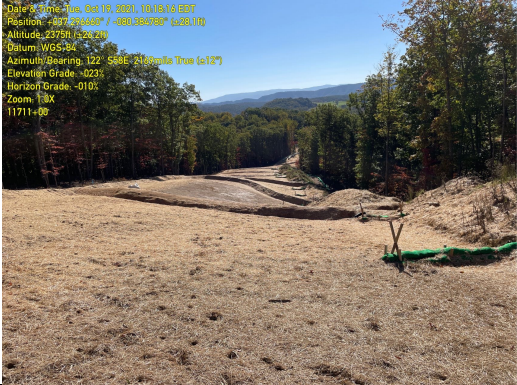
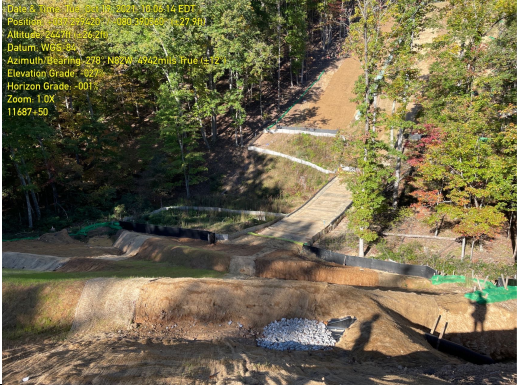
GPS Location	See photo	GPS Location	See photo		
Field Station#	11711+00	Field Station#	11687+50		
Pic 7 Desc.	Waterbars in place	Pic 8 Desc.	Stone inlet protection in place

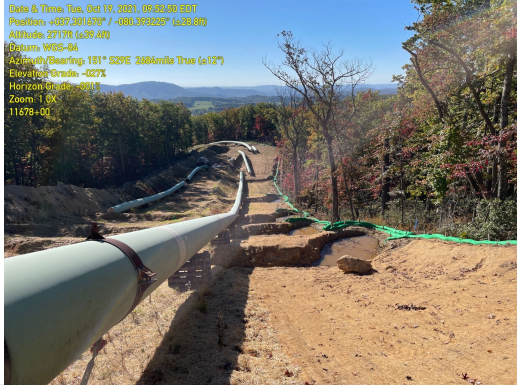
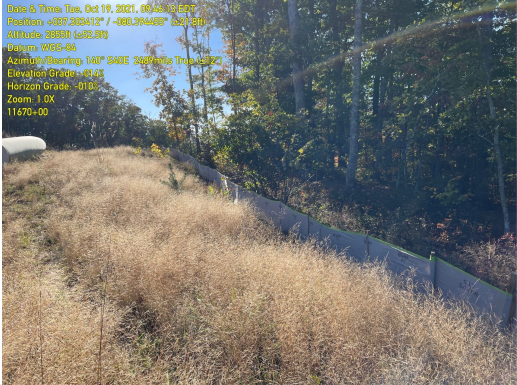
GPS Location	See photo	GPS Location	See photo		
Field Station#	11678+00	Field Station#	11670+00		
Pic 9 Desc.	End treatments in place	Pic 10 Desc.	P1 silt fence perimeter control in place

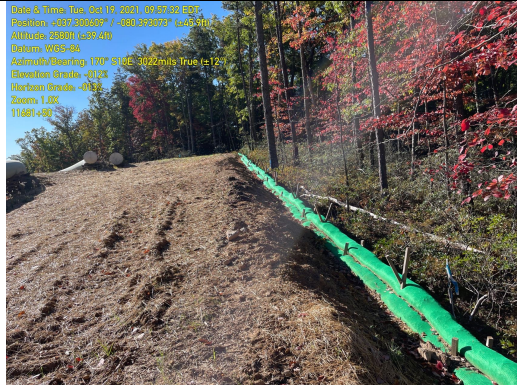
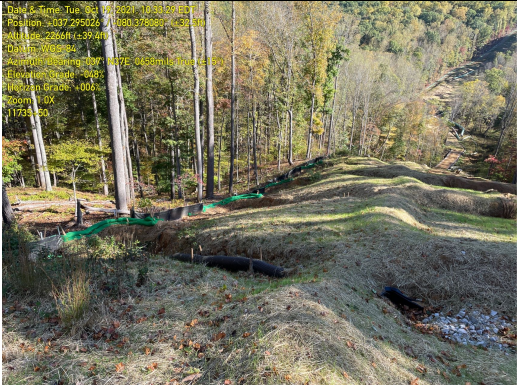
GPS Location	See photo	GPS Location	See photo		
Field Station#	11681+50	Field Station#	11735+50		
Pic 11 Desc.	CFS triple stack perimeter control in place	Pic 12 Desc.	Slope drain pipe in place
