Visual Site Inspection Report

Project Name	H-600 Pipeline Spread G	AFE	124300137	Spread	H-600 Pipeline Spread G
Contractor	Precision			Report #	30229
Inspector	Clint Sears			Date/Time	10/25/2021 12:49 PM
Permit #	TBD	Inspection Type	VA SWPP	Station Begin	11788+52
State	VA	Inspection Area	Full	Station End	12005+00
County	Montgomery	Ground	Dry	Temperature (°F)	73.00
Municipality	N/A	Weather	Sunny	Rain Gauge (in)	0.00
				Rain Accumulation Time (days)	1.00

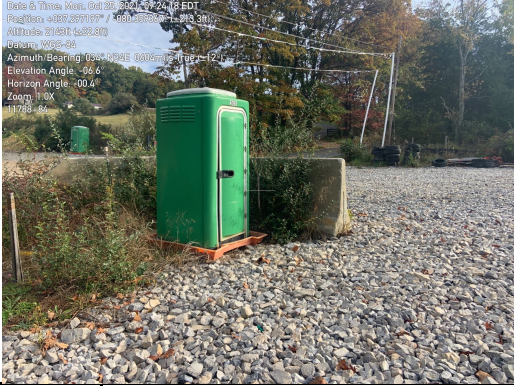
GPS Location		See photo		GPS Location	
Field Station#		11788+84		Field Station#	
Pic 1 Desc.		Secondary containment in place		Pic 2 Desc.

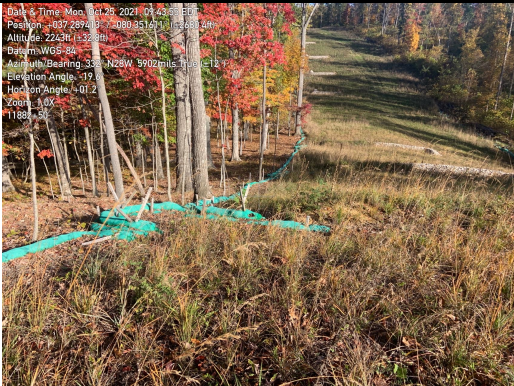
GPS Location		See photo		GPS Location	
Field Station#		11882+50		Field Station#	
Pic 5 Desc.		CFS water bar end treatments and perimeter controls functional		Pic 6 Desc.	
				AR266.03 is in acceptable condition

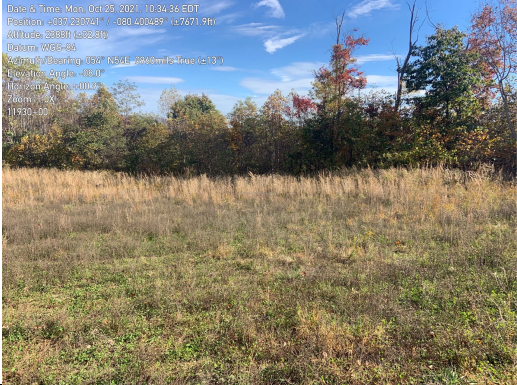
GPS Location	See photo	GPS Location	See photo		
Field Station#	11930+00	Field Station#	11943+00		
Pic 7 Desc.	Adequate vegetation	Pic 8 Desc.	Triple stacked CFS perimeter controls and SSF are in acceptable condition		
<p>Date & Time: Mon, Oct 25, 2021, 10:58:58 EDT Position: +037.267726° / -080.323033° / 1543.7ft Altitude: 1700ft (+20.0ft) Datum: WGS-84 Azimuth/Bearing: 334° N26W 593mils True (+13°) Elevation Angle: -04.5° Horizon Angle: -03.1° Zoom: 1.0X 11978+86</p>

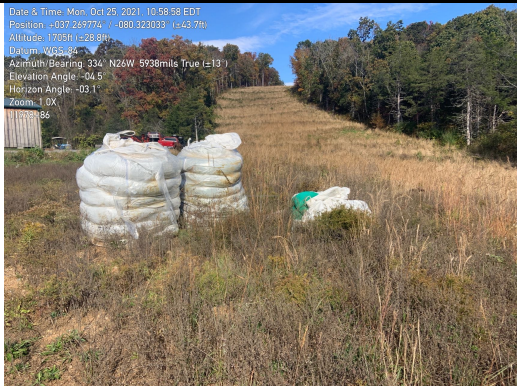
GPS Location	See photo	GPS Location	See photo		
Field Station#	11978+86	Field Station#	11978+58		
Pic 9 Desc.	Construction materials staged on ROW for later use	Pic 10 Desc.	P1 silt fence, triple stacked CFS and SSF are acceptable		
<p>Date & Time: Mon, Oct 25, 2021, 11:02:54 EDT Position: +037.263165° / -080.364323° / 7757.6ft Altitude: 1079ft (+53.3ft) Datum: WGS-84 Azimuth/Bearing: 277° N83W 492mils True (+13°) Elevation Angle: -14.0° Horizon Angle: -00.2° Zoom: 1.0X 11984+91</p>

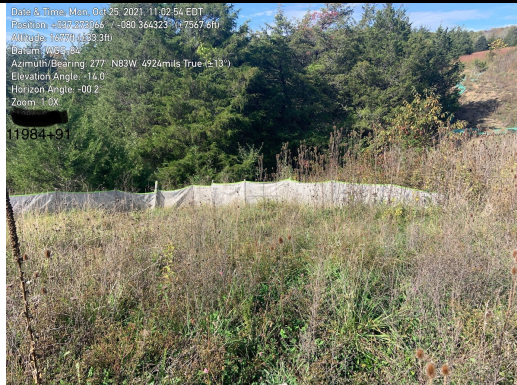
GPS Location	See photo	GPS Location	See photo		
Field Station#	11984+90	Field Station#	12002+00		
Pic 11 Desc.	P1 silt fence is in acceptable condition	Pic 12 Desc.	No refueling signage is acceptable

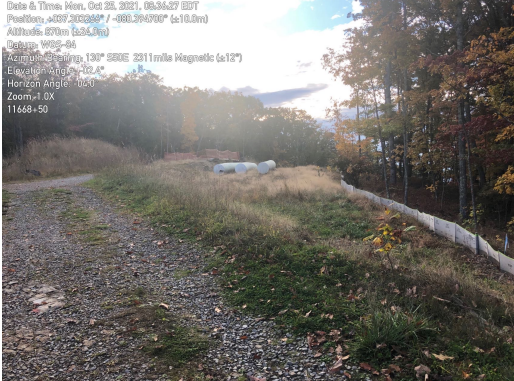
GPS Location		On photo		GPS Location	
Field Station#		11668+50		Field Station#	
Pic 1 Desc.		The top of Brush Mountain is stable with no environmental concerns apparent.		Pic 2 Desc.	
				Perimeter ECDs are in place.

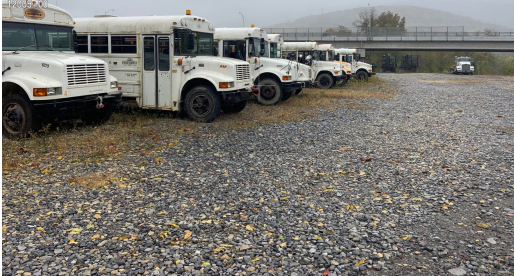
GPS Location	See photo	GPS Location	See photo		
Field Station#	12005+00	Field Station#	12005+00		
Pic 1 Desc.	Inspected parked vehicles for any visible leaks or spills	Pic 2 Desc.	RCE of western yard is maintained and in acceptable condition

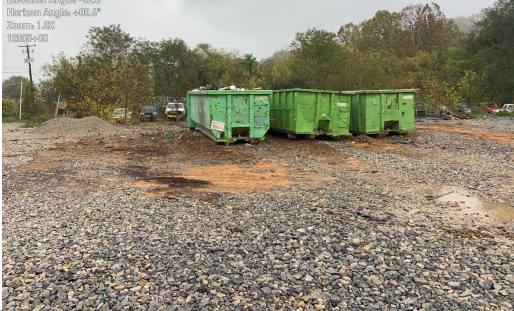
GPS Location	See photo	GPS Location	See photo		
Field Station#	12005+00	Field Station#	12005+00		
Pic 3 Desc.	Dumpsters in place	Pic 4 Desc.	RCE of eastern yard is in acceptable condition

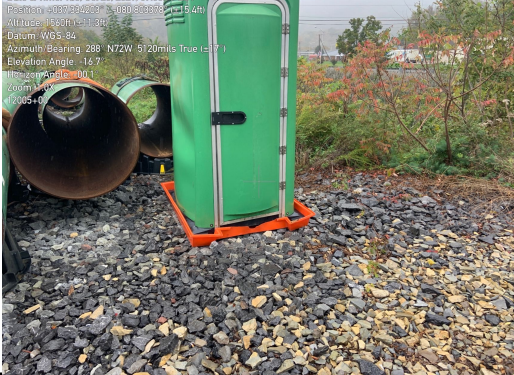
GPS Location	See photo	GPS Location	See photo		
Field Station#	12005+00	Field Station#	12005+00		
Pic 5 Desc.	Secondary containment in place	Pic 6 Desc.	CFS perimeter controls in place and functional

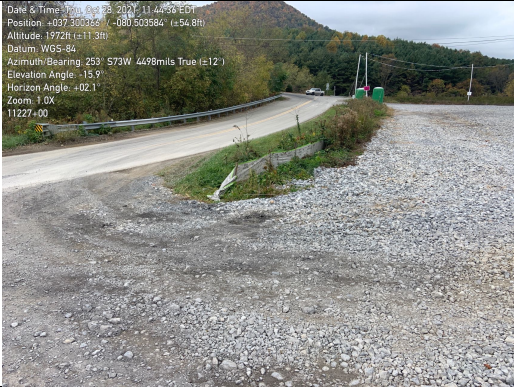
GPS Location	See photo	GPS Location	See photo		
Field Station#	11227+00	Field Station#	11227+00		
Pic 1 Desc.	Damaged P1 silt fence at Winding Way RCE	Pic 2 Desc.	Damaged CFS at Winding Way RCE

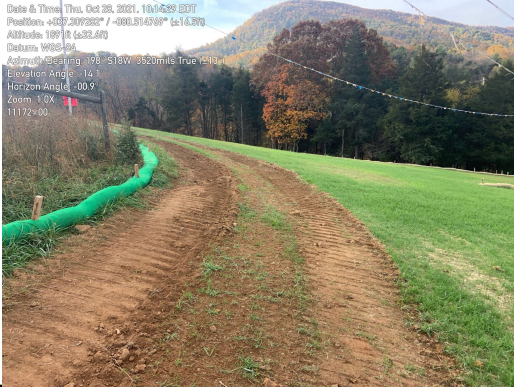
GPS Location	See photo	GPS Location	See photo		
Field Station#	11172+00	Field Station#	11167+70		
Pic 3 Desc.	Travel lane being utilized by contractor was seeded and straw is being staged for stabilization	Pic 4 Desc.	Clean water diversion pipe and level spreader functional

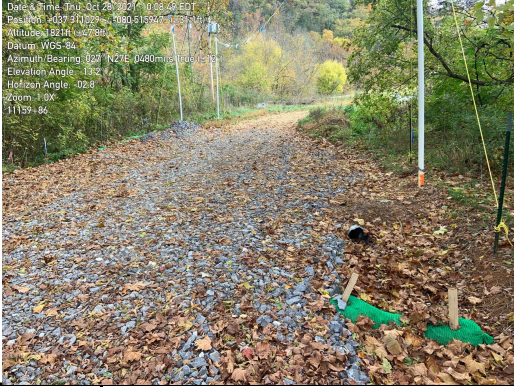
GPS Location	See photo	GPS Location	See photo		
Field Station#	11159+86	Field Station#	11146+18		
Pic 5 Desc.	AR249.03 is in acceptable condition	Pic 6 Desc.	Clean water diversion pipe inlet is in acceptable condition

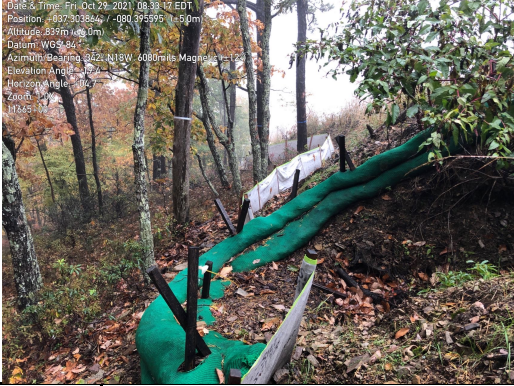
GPS Location	On photo	GPS Location	On photo		
Field Station#	11665+00	Field Station#	11660+00		
Pic 1 Desc.	Perimeter ECDs are in good condition.	Pic 2 Desc.	Perimeter ECDs are in place.

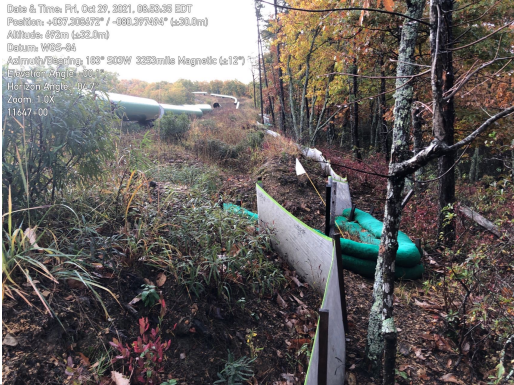
GPS Location	On photo	GPS Location	On photo		
Field Station#	11647+00	Field Station#	11633+00		
Pic 3 Desc.	Perimeter ECDs are in good condition.	Pic 4 Desc.	The ROW is stable with functional slope breakers in place.

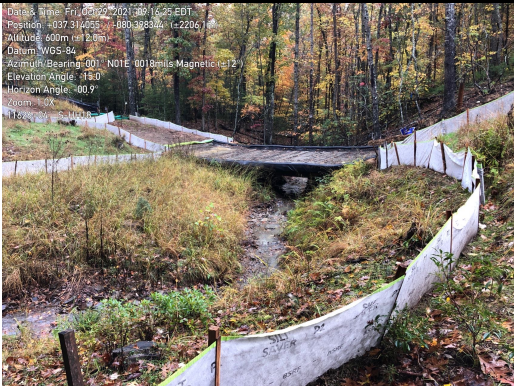
GPS Location	On photo	GPS Location	On photo		
Field Station#	11626+04	Field Station#	11614+20		
Pic 5 Desc.	The S-HH18 crossing is currently stable.	Pic 6 Desc.	The S-RR14 crossing is currently stable.

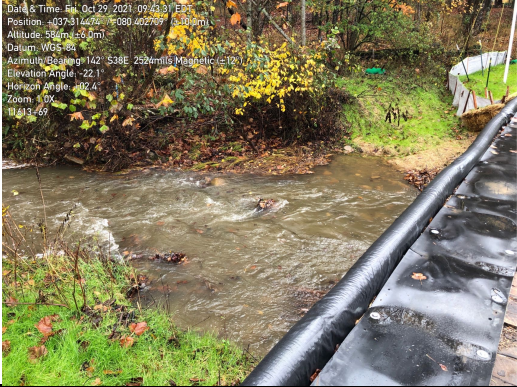
GPS Location	On photo	GPS Location	On photo		
Field Station#	11613+69	Field Station#	11608+17		
Pic 7 Desc.	The S-RR13 crossing at access road MN-258.04 is in good condition.	Pic 8 Desc.	The S-006 crossing is stable.

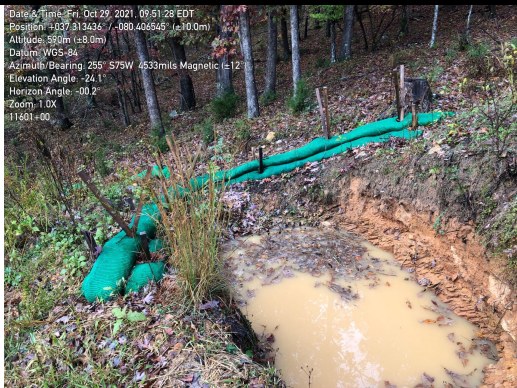
<p style="text-align: center;">Insert image here</p>			
GPS Location	On photo	GPS Location			
Field Station#	11601+00	Field Station#			
Pic 9 Desc.	Sumps and end treatments functional.	Pic 10 Desc.			
<p style="text-align: center;">Insert image here</p>		<p style="text-align: center;">Insert image here</p>			
GPS Location		GPS Location			
Field Station#		Field Station#			
Pic 11 Desc.		Pic 12 Desc.
