# Visual Site Inspection Report

<b>Project Name</b>	H-600 Pipeline Spread G	<b>AFE</b>	124300137	<b>Spread</b>	H-600 Pipeline Spread G
<b>Contractor</b>	Precision			<b>Report #</b>	29321
<b>Inspector</b>	Patrick Shields			<b>Date/Time</b>	10/4/2021 4:44 PM
<b>Permit #</b>	TBD	<b>Inspection Type</b>	VA SWPP	<b>Station Begin</b>	11524+16
<b>State</b>	VA	<b>Inspection Area</b>	Full	<b>Station End</b>	11600+01
<b>County</b>	Craig	<b>Ground</b>	Wet	<b>Temperature (°F)</b>	68.00
<b>Municipality</b>	N/A	<b>Weather</b>	Cloudy	<b>Rain Gauge (in)</b>	0.65
				<b>Rain Accumulation Time (days)</b>	1.00

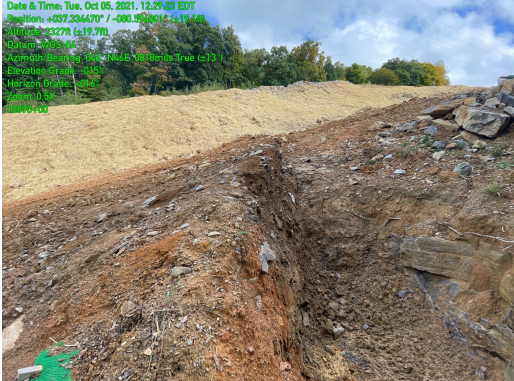
<b>GPS Location</b>	See Photo	<b>GPS Location</b>	See Photo		
<b>Field Station#</b>	10890+00	<b>Field Station#</b>	10890+60		
<b>Pic 1 Desc.</b>	Water bar exceeds the 5% requirements	<b>Pic 2 Desc.</b>	Sediment build up on CFS end treatment.

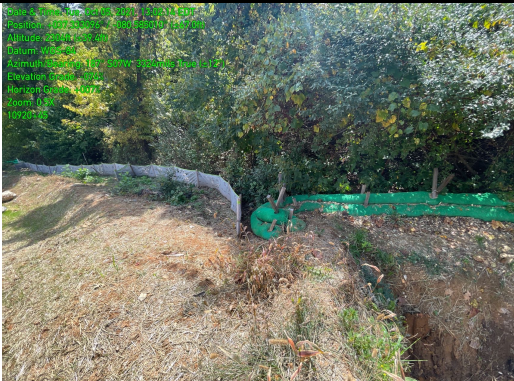
<b>GPS Location</b>	See Photo	<b>GPS Location</b>	See Photo		
<b>Field Station#</b>	10920+45	<b>Field Station#</b>	10907+00		
<b>Pic 5 Desc.</b>	View of gap between P1 and CFS end treatment.	<b>Pic 6 Desc.</b>	View of temporary stabilization of row and current conditions.

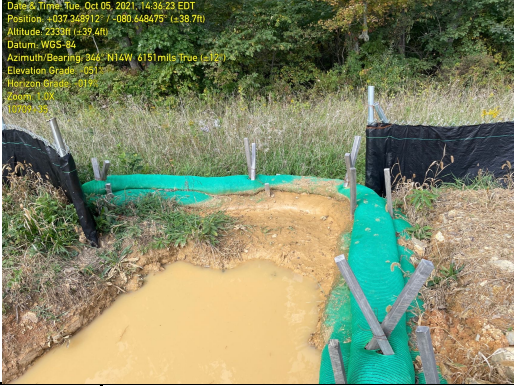
<b>GPS Location</b>	See photo	<b>GPS Location</b>	See photo		
<b>Field Station#</b>	10709+35	<b>Field Station#</b>	10790+40		
<b>Pic 1 Desc.</b>	End treatment needs sediment cleaned off	<b>Pic 2 Desc.</b>	Cleanwater diversion pipe needs adjusted and collars secured better

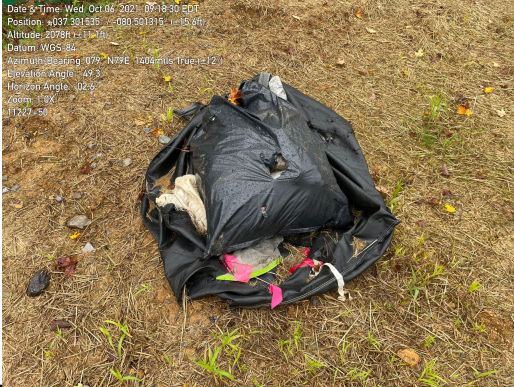
<b>GPS Location</b>	See photo	<b>GPS Location</b>	See photo		
<b>Field Station#</b>	11227+50	<b>Field Station#</b>	11167+90		
<b>Pic 3 Desc.</b>	Housekeeping trash needs removed	<b>Pic 4 Desc.</b>	P1 needs replaced		
<p>Date &amp; Time: Wed, Oct 06, 2021 08:04:14 EDT  Position: +037.297122 / -080.454377 (+13.07h)  Altitude: 2128ft (+13.07h)  Datum: WGS 84  Azimuth/Bearing: 120 S40E 2133mils true (+12.1h)  Elevation Angle: -13.7  Horizon Angle: -02.1  Zoom: 1.0x  11248+50</p>

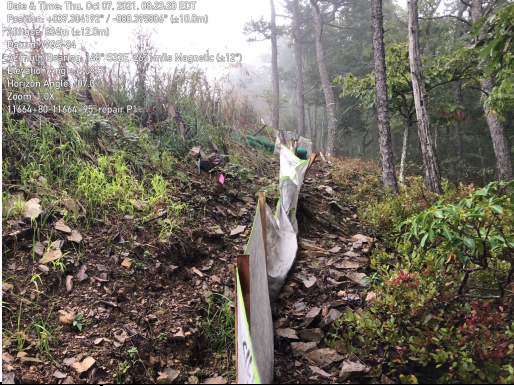
<b>GPS Location</b>		On photo		<b>GPS Location</b>	
<b>Field Station#</b>		11664+80		<b>Field Station#</b>	
<b>Pic 1 Desc.</b>		Communication. Install P1 properly		<b>Pic 2 Desc.</b>

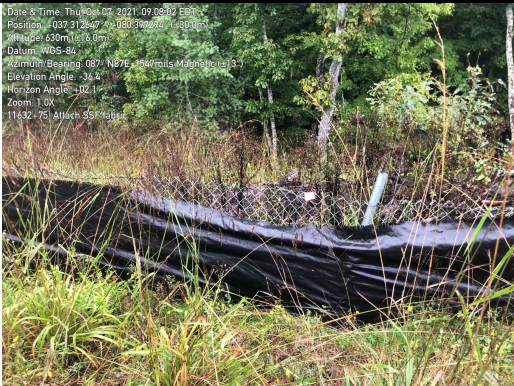
<b>GPS Location</b>		On photo		<b>GPS Location</b>	
<b>Field Station#</b>		11632+75		<b>Field Station#</b>	
<b>Pic 5 Desc.</b>		Communication. Re-attach SSF fabric		<b>Pic 6 Desc.</b>	
				Communication. Attach SSF fabric to chain link and eliminate stake
