Visual Site Inspection Report

Project Name	H-600 Pipeline Spread G	AFE	124300137	Spread	H-600 Pipeline Spread G
Contractor	Precision			Report #	31452
Inspector	David Schoolcraft			Date/Time	11/22/2021 12:21 PM
Permit #	TBD	Inspection Type	VA SWPP	Station Begin	11254+99
State	VA	Inspection Area	Full	Station End	11353+67
County	Giles	Ground	Damp	Temperature (°F)	45.00
Municipality	N/A	Weather	Sunny	Rain Gauge (in)	0.00
				Rain Accumulation Time (days)	1.00

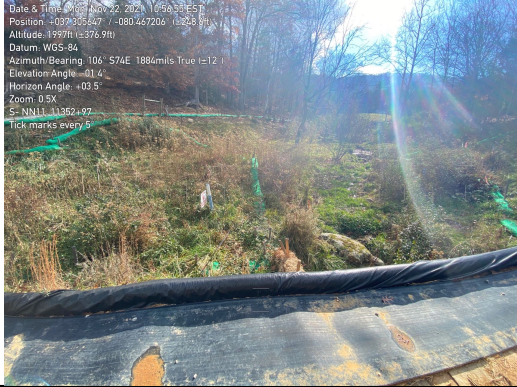
GPS Location	See Photo	GPS Location	See photo		
Field Station#	11352+97	Field Station#	11353+67		
Pic 9 Desc.	S-NN11	Pic 10 Desc.	RCE Old Furnace Road		
Insert image here		Insert image here			
GPS Location		GPS Location			
Field Station#		Field Station#			
Pic 11 Desc.		Pic 12 Desc.

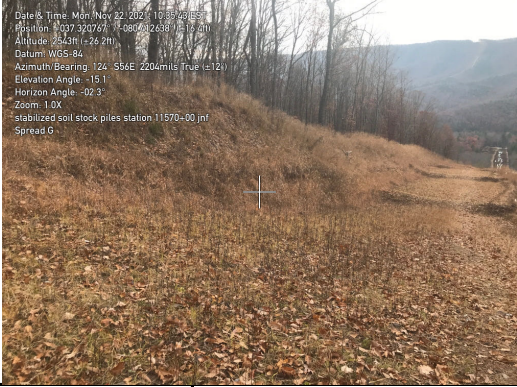
GPS Location	see photo		GPS Location	see photo	
Field Station#	11570+00		Field Station#	11575+00	
Pic 15 Desc.	Stabilized soil stock pile		Pic 16 Desc.	Slope drain	
<p>Date & Time: Mon, Nov 22, 2021, 11:05:54 EST Position: +037.3158917 / -080.4095927 (E=16.4ft) Altitude: 2851ft (+19.1ft) Datum: WGS-84 Azimuth/Bearing: 145 S35E 2578mils True (±12°) Elevation Angle: -19.4° Horizon Angle: +02.0° Zoom: 1.0X Stabilized ROW station 11593+00 .jnt Spread G</p>

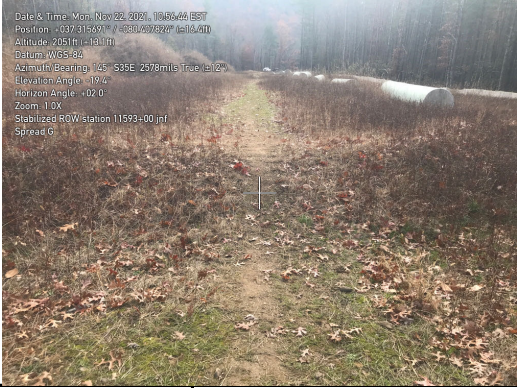
GPS Location	See photo		GPS Location	see photo	
Field Station#	11593+00		Field Station#	11600+01	
Pic 17 Desc.	Stabilized ROW		Pic 18 Desc.	Craig Creek RCE

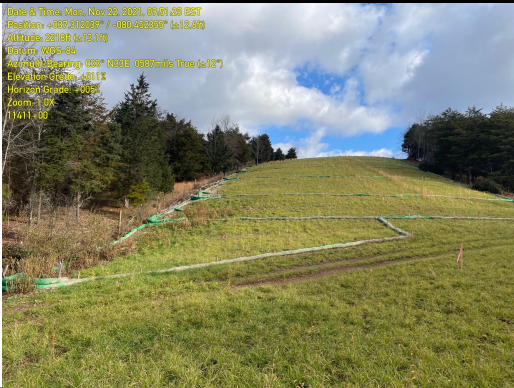
GPS Location	See photo	GPS Location	See photo		
Field Station#	11411+00	Field Station#	11396+00		
Pic 5 Desc.	CFS temporary waterbars in place	Pic 6 Desc.	Level spreader in place

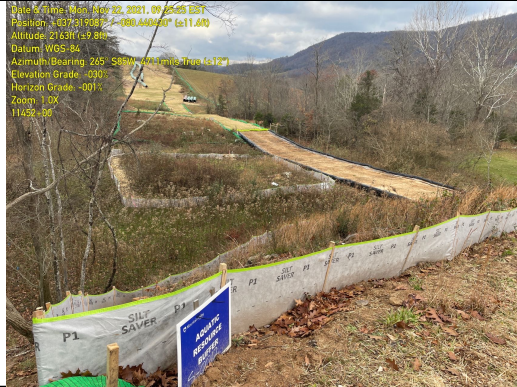
GPS Location	See photo	GPS Location	See photo		
Field Station#	11452+00	Field Station#	11380+00		
Pic 11 Desc.	Sensitive resource signage in place	Pic 12 Desc.	Remove tree from CFS perimeter control and repair damaged cattle fence

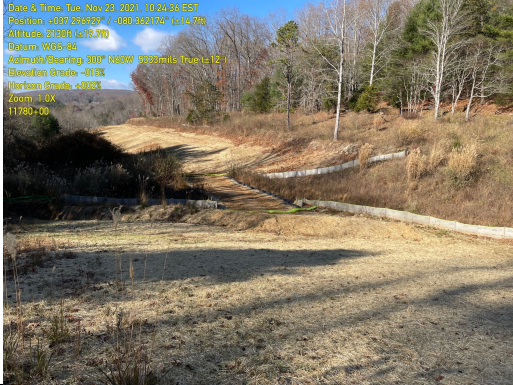
GPS Location				See photo				GPS Location				See photo			
Field Station#				11780+00				Field Station#				11766+37			
Pic 1 Desc.				Cleanwater drainage feature in place				Pic 2 Desc.				RCE in place

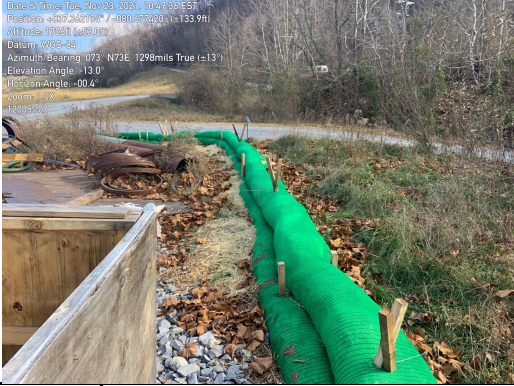
GPS Location	See photo	GPS Location	See photo		
Field Station#	12005+00	Field Station#	12005+00		
Pic 1 Desc.	Triple stacked CFS perimeter controls in place	Pic 2 Desc.	Culvert in place and acceptable

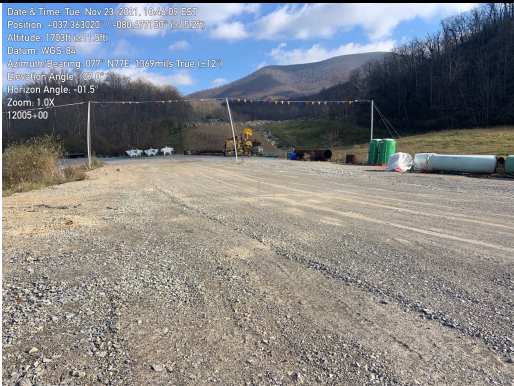
GPS Location	See photo	GPS Location	See photo		
Field Station#	12005+00	Field Station#	12005+00		
Pic 5 Desc.	Rock surface of the yard is maintained in acceptable condition	Pic 6 Desc.	Triple stacked CFS perimeter controls in place

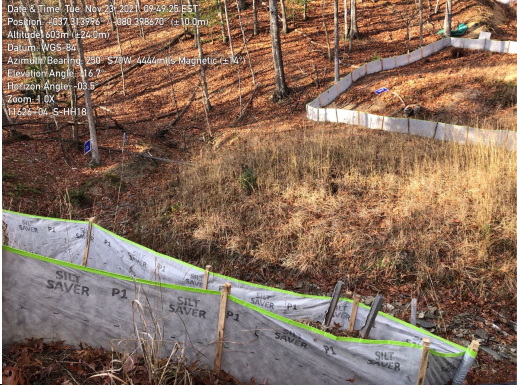
GPS Location	On photo	GPS Location	On photo		
Field Station#	11626+04	Field Station#	11614+20		
Pic 7 Desc.	The S-HH18 crossing is stable.	Pic 8 Desc.	The S-RR14 crossing is stable.		
Insert image here		Insert image here			
GPS Location		GPS Location			
Field Station#		Field Station#			
Pic 9 Desc.		Pic 10 Desc.			
Insert image here		Insert image here			
GPS Location		GPS Location			
Field Station#		Field Station#			
Pic 11 Desc.		Pic 12 Desc.

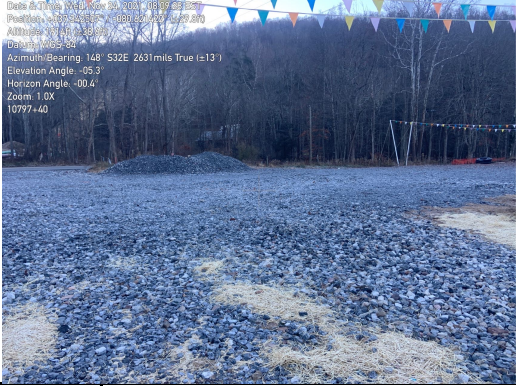
GPS Location	See photo	GPS Location	See photo		
Field Station#	10797+40	Field Station#	10793+00		
Pic 1 Desc.	RCE is maintained and in acceptable condition	Pic 2 Desc.	Temporary stabilization and vegetation acceptable

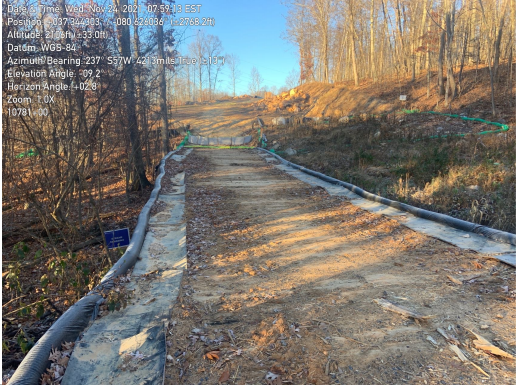
GPS Location	See photo	GPS Location	See photo		
Field Station#	10781+00	Field Station#	10777+00		
Pic 3 Desc.	Equipment bridge is maintained in acceptable condition	Pic 4 Desc.	Slope drain pipe and sump pit are in acceptable condition

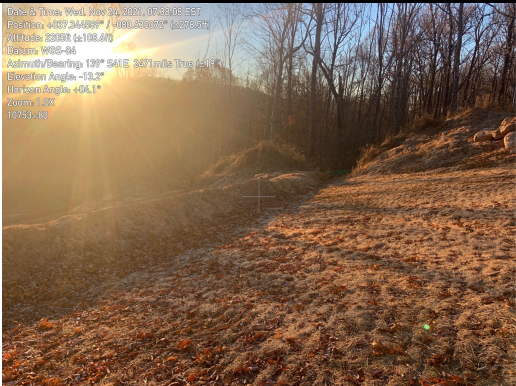
GPS Location	See photo	GPS Location	See photo		
Field Station#	10753+80	Field Station#	10772+00		
Pic 5 Desc.	Water bars are in acceptable condition	Pic 6 Desc.	Clean water diversion pipe and level spreader are in acceptable condition

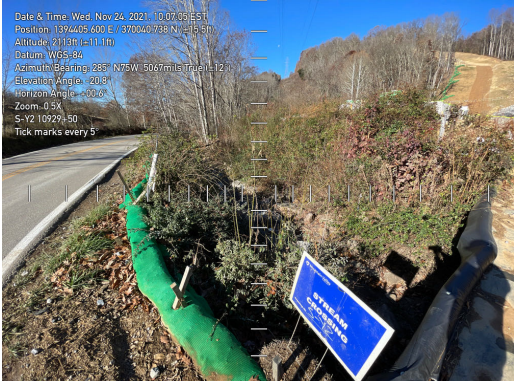
GPS Location	3	GPS Location	4		
Field Station#	10929+50	Field Station#	10899+00		
Pic 3 Desc.	S-Y2 and controls.	Pic 4 Desc.	Section of RoW showing conditions and controls.

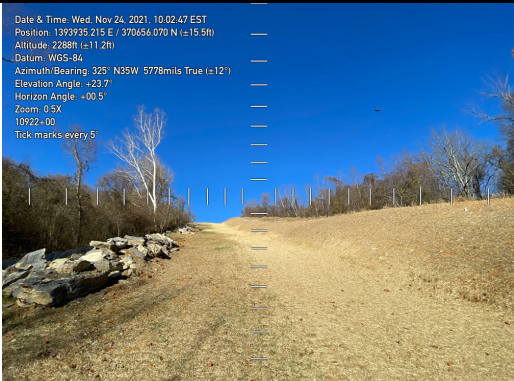
GPS Location	5	GPS Location	6		
Field Station#	10922+00	Field Station#	10887+75		
Pic 5 Desc.	Section of RoW showing conditions and controls.	Pic 6 Desc.	Plunge pool functional.
