Visual Site Inspection Report

Project Name	H-600 Pipeline Spread G	AFE	124300137	Spread	H-600 Pipeline Spread G
Contractor	Precision			Report #	31681
Inspector	Patrick Shields			Date/Time	11/29/2021 10:32 AM
Permit #	TBD	Inspection Type	VA SWPP	Station Begin	11670+00
State	VA	Inspection Area	Full	Station End	11788+52
County	Montgomery	Ground	Frozen	Temperature (°F)	34.00
Municipality	N/A	Weather	Cloudy	Rain Gauge (in)	0.00
				Rain Accumulation Time (days)	1.00

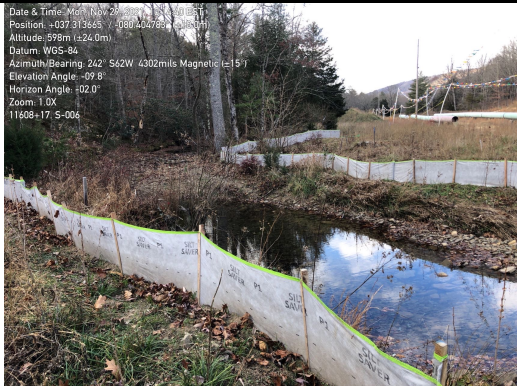
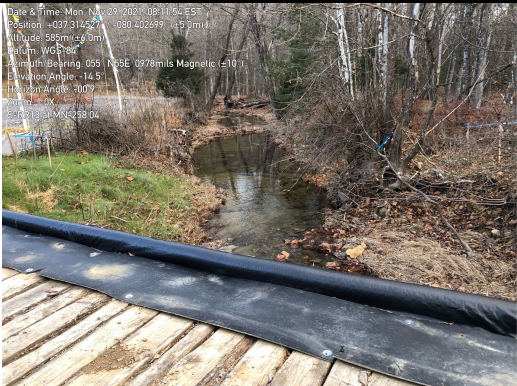
GPS Location	On photo	GPS Location	On photo		
Field Station#	11608+17	Field Station#	11613+69		
Pic 9 Desc.	The S-006 crossing is stable.	Pic 10 Desc.	The S-RR13 crossing on access road MN-258.04 is stable.		
<p>Insert image here</p>		<p>Insert image here</p>			
GPS Location		GPS Location			
Field Station#		Field Station#			
Pic 11 Desc.		Pic 12 Desc.

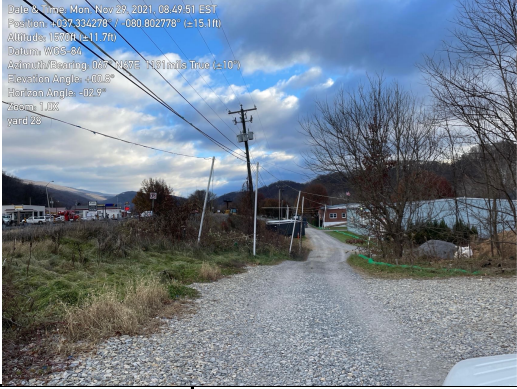
GPS Location	See photo	GPS Location			
Field Station#	12005+00	Field Station#			
Pic 7 Desc.	RCE functional	Pic 8 Desc.			
Insert image here		Insert image here			
GPS Location		GPS Location			
Field Station#		Field Station#			
Pic 9 Desc.		Pic 10 Desc.			
Insert image here		Insert image here			
GPS Location		GPS Location			
Field Station#		Field Station#			
Pic 11 Desc.		Pic 12 Desc.

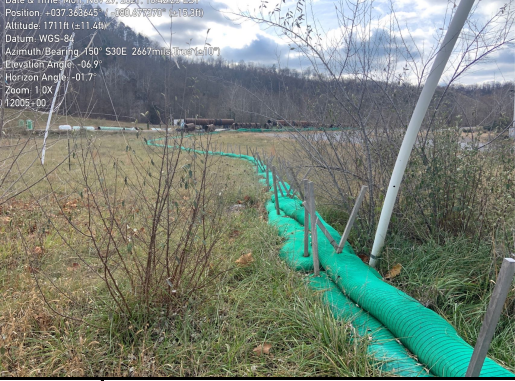
GPS Location	See photo	GPS Location	See photo		
Field Station#	12005+00	Field Station#	12005+00		
Pic 5 Desc.	Rock surface of the RCE is maintained in acceptable condition	Pic 6 Desc.	Triple stacked CFS perimeter controls in place

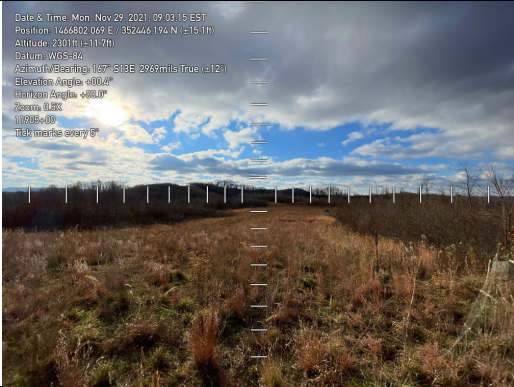
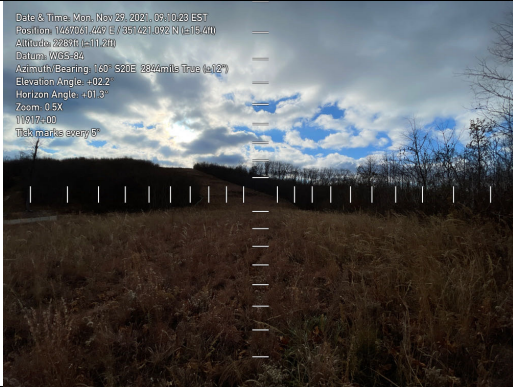
GPS Location 1		GPS Location 2			
Field Station# 11905+00		Field Station# 11917+00			
Pic 1 Desc. Section of RoW showing conditions and controls.		Pic 2 Desc. Section of RoW showing conditions and controls.			
<p>Date & Time: Mon, Nov 29, 2021, 09:19:30 EST Position: 1627285.439 E / 351909.609 N (=15.14°) Altitude: 2325ft (=11.2m) Datum: WGS-84 Azimuth/Bearing: 318° N42W 5653mils True (=12°) Elevation Angle: -35.0° Horizon Angle: +01.4° Zoom: 0.5X 11922+00 Tick marks every 5'</p>

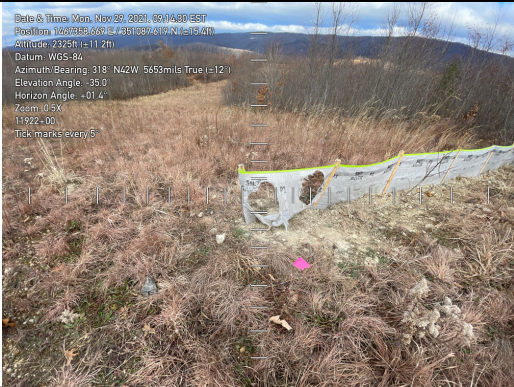
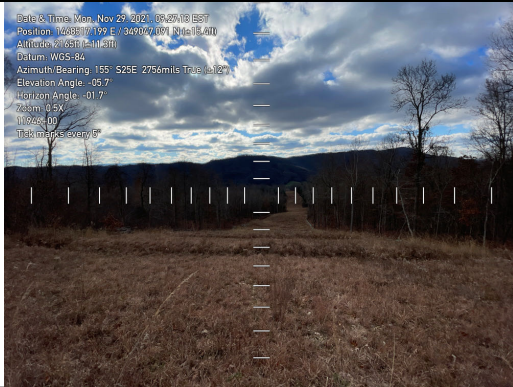
GPS Location 3		GPS Location 4			
Field Station# 11922+00		Field Station# 11946+00			
Pic 3 Desc. Damaged P-1.		Pic 4 Desc. Section of RoW showing conditions and controls.			
<p>Date & Time: Mon, Nov 29, 2021, 09:48:50 EST Position: 1627641.877 E / 345803.332 N (=15.41°) Altitude: 1894ft (=11.2m) Datum: WGS-84 Azimuth/Bearing: 058° S58E 3444mils True (=12°) Elevation Angle: -10.8° Horizon Angle: -02.4° Zoom: 0.5X 11978+85 Tick marks every 5'</p>

E&S BMPs	Compliance Level	Corrective Action	Corrective Time Frame	Date Repaired
Housekeeping	Acceptable			
Rock Construction Entrance	Acceptable			
Silt Fence (Filter Fabric Fence)	Communication	See punch list	Addressed	11/29/2021
Silt Fence (Reinforce Filter Fence)	Acceptable			
Vegetative Stabilization (Permanent)	Acceptable			
Vegetative Stabilization (Temporary)	Acceptable			
Waterbar	Acceptable			
Waterbar End Treatment	Acceptable

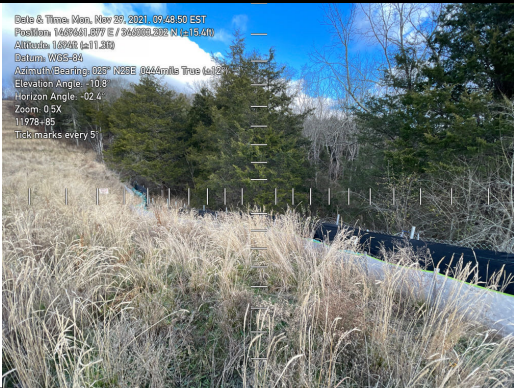
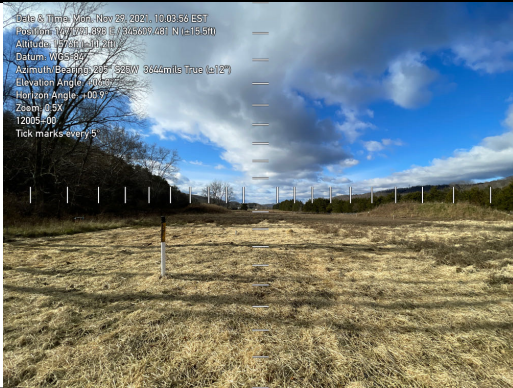
GPS Location 5		GPS Location 6			
Field Station# 11978+85		Field Station# 12005+00			
Pic 5 Desc. Karst feature protection functional.		Pic 6 Desc. Section of RoW showing conditions and controls.

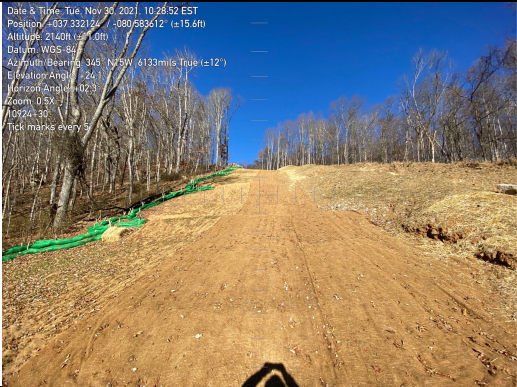
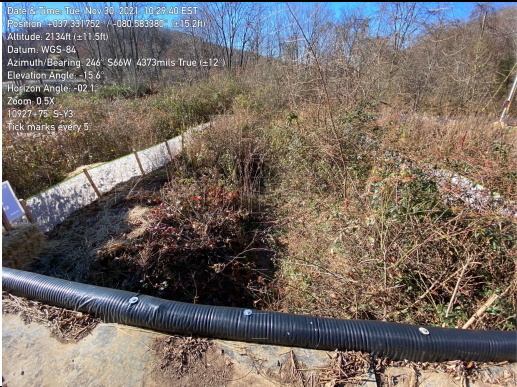
GPS Location	See Photo	GPS Location	See Photo		
Field Station#	10924+30	Field Station#	10927+75		
Pic 7 Desc.	Erosion control blanket	Pic 8 Desc.	S-Y3

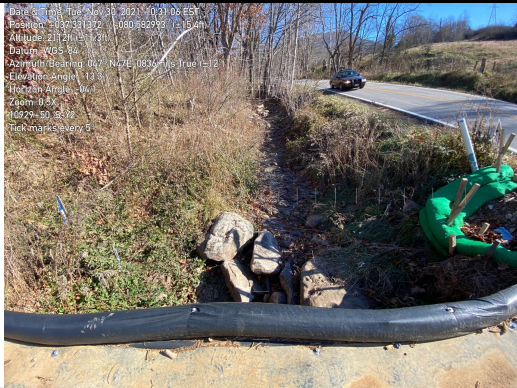
Insert image here	
GPS Location	See Photo	GPS Location			
Field Station#	10929+50	Field Station#			
Pic 9 Desc.	S-Y2	Pic 10 Desc.			
Insert image here		Insert image here			
GPS Location		GPS Location			
Field Station#		Field Station#			
Pic 11 Desc.		Pic 12 Desc.

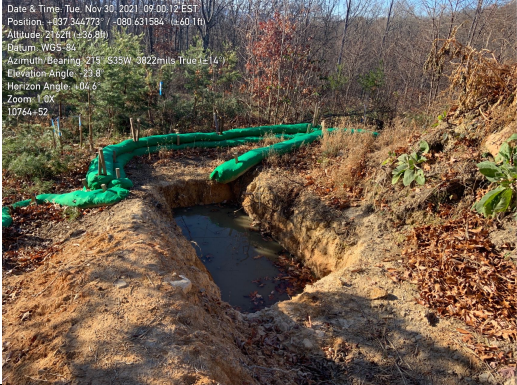
GPS Location	See photo	GPS Location			
Field Station#	10764+52	Field Station#			
Pic 7 Desc.	Sum pit and perimeter controls are in acceptable condition	Pic 8 Desc.			
Insert image here		Insert image here			
GPS Location		GPS Location			
Field Station#		Field Station#			
Pic 9 Desc.		Pic 10 Desc.			
Insert image here		Insert image here			
GPS Location		GPS Location			
Field Station#		Field Station#			
Pic 11 Desc.		Pic 12 Desc.

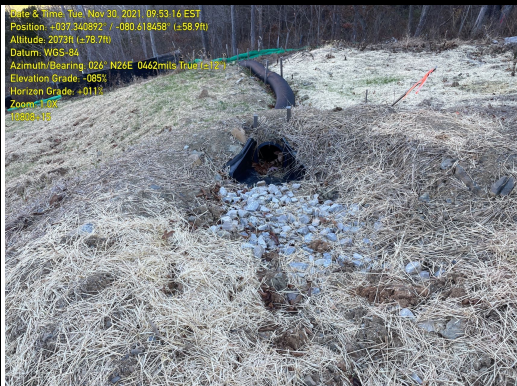
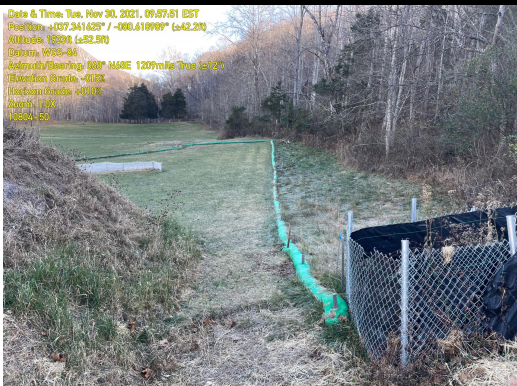
GPS Location	See photo	GPS Location	See photo		
Field Station#	10808+15	Field Station#	10804+50		
Pic 9 Desc.	Stone inlet protection in place	Pic 10 Desc.	CFS perimeter control in place

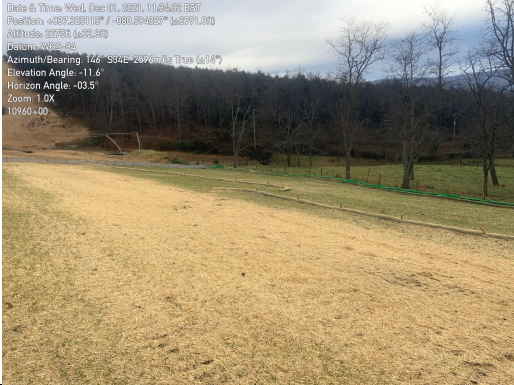
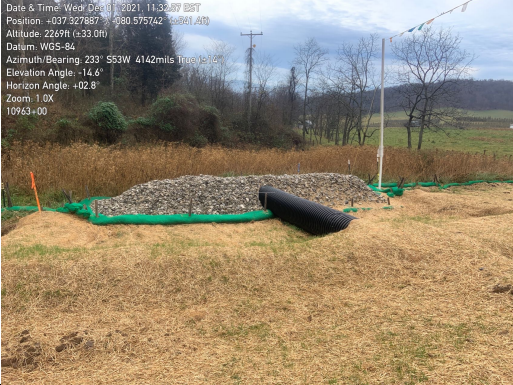
GPS Location	See photo	GPS Location	See photo		
Field Station#	10960+00	Field Station#	10963+00		
Pic 1 Desc.	Restored Row is in acceptable condition	Pic 2 Desc.	Clean water diversion pipe and level spreader are in acceptable condition

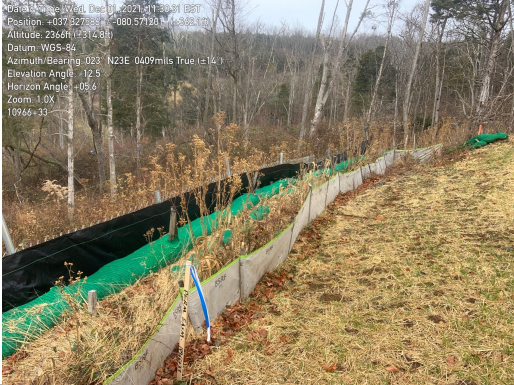
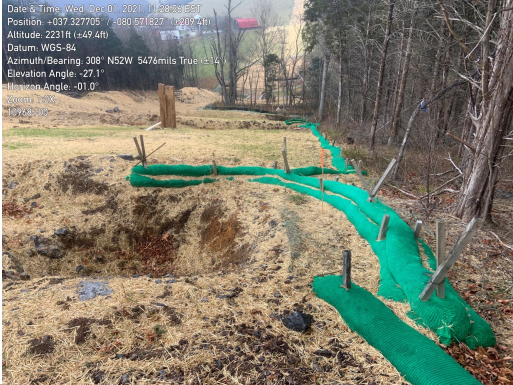
GPS Location	See photo	GPS Location	See photo		
Field Station#	10966+33	Field Station#	10968+00		
Pic 3 Desc.	Karst ECD's are in place	Pic 4 Desc.	Sump pits and CFS perimeter controls are in acceptable condition

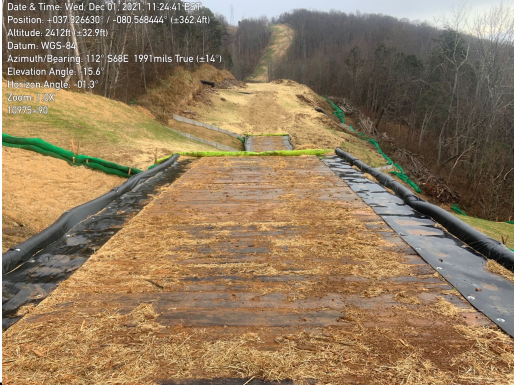
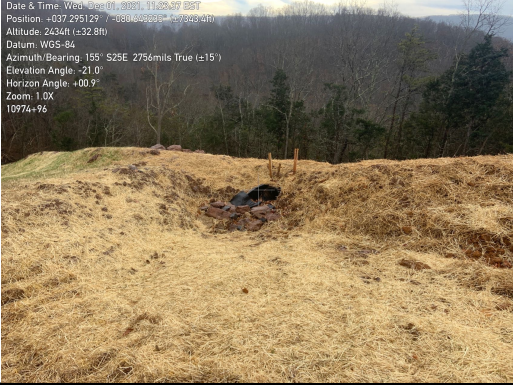
GPS Location	See photo	GPS Location	See photo		
Field Station#	10975+90	Field Station#	10974+96		
Pic 5 Desc.	Equipment bridge is in acceptable condition	Pic 6 Desc.	Stone inlet protection is in acceptable condition

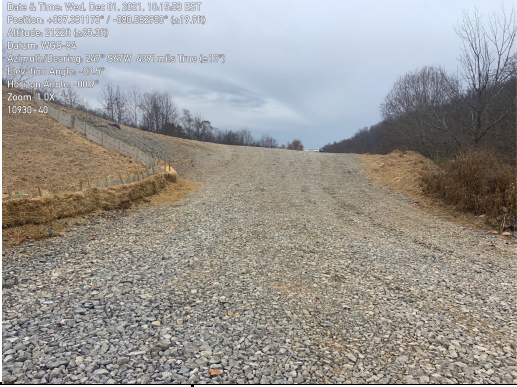
Insert image here			
GPS Location	See photo	GPS Location			
Field Station#	10930+40	Field Station#			
Pic 7 Desc.	RCE at Doe creek is maintained in acceptable condition	Pic 8 Desc.			
Insert image here		Insert image here			
GPS Location		GPS Location			
Field Station#		Field Station#			
Pic 9 Desc.		Pic 10 Desc.			
Insert image here		Insert image here			
GPS Location		GPS Location			
Field Station#		Field Station#			
Pic 11 Desc.		Pic 12 Desc.

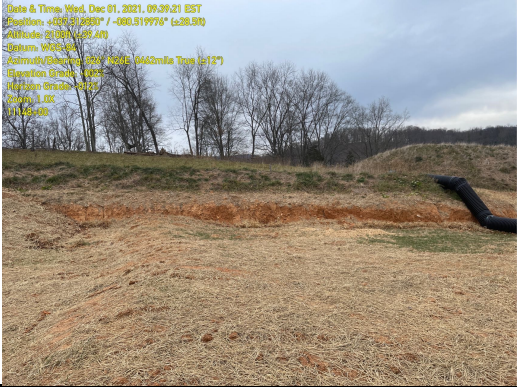
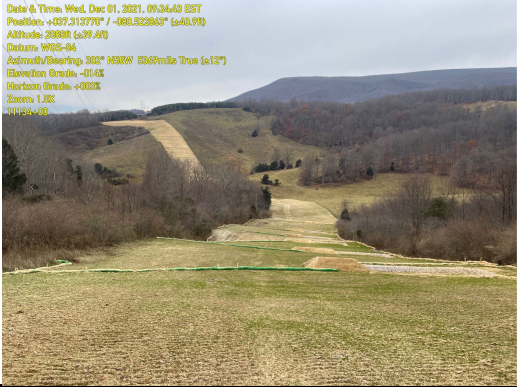
GPS Location	See photo	GPS Location	See photo		
Field Station#	11148+00	Field Station#	11134+00		
Pic 7 Desc.	Cleanwater diversion berm in place	Pic 8 Desc.	Permanent waterbars in place		
<p><small>Date & Time: Wed, Dec 01, 2021, 09:34:49 EST Position: +43°31'28.91" / -080.520646" (±28.59) Altitude: 1900ft (±39.40) Datum: WGS-84 Azimuth/Bearing: 302° MAGN 336° True (±12°) Elevation Grade: -014X Horizon Grade: +002X Zoom: 1.0X 11120+00</small></p>

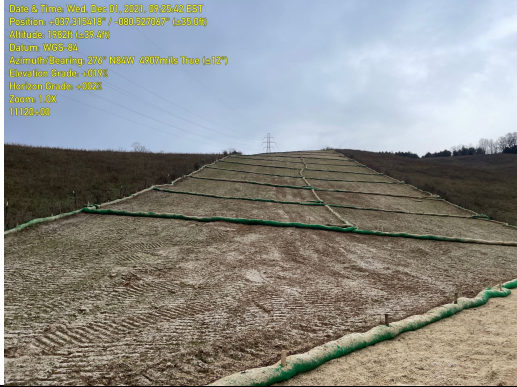
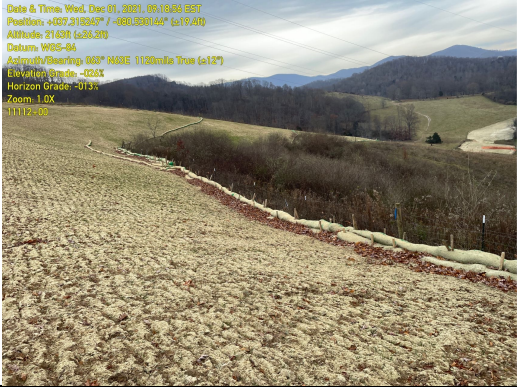
GPS Location	See photo	GPS Location	See photo		
Field Station#	11120+00	Field Station#	11112+00		
Pic 9 Desc.	CFS temporary waterbars in place	Pic 10 Desc.	CFS triple stack perimeter control in place		
<p><small>Date & Time: Wed, Dec 01, 2021, 09:17:30 EST Position: +43°31'47.49" / -080.530704" (±15.40) Altitude: 2110ft (±11.30) Datum: WGS-84 Azimuth/Bearing: 220° MAGN 329° True (±12°) Elevation Grade: -012X Horizon Grade: +005X Zoom: 1.0X 11109+00</small></p>

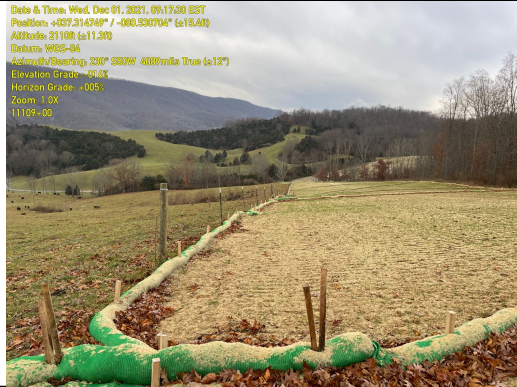
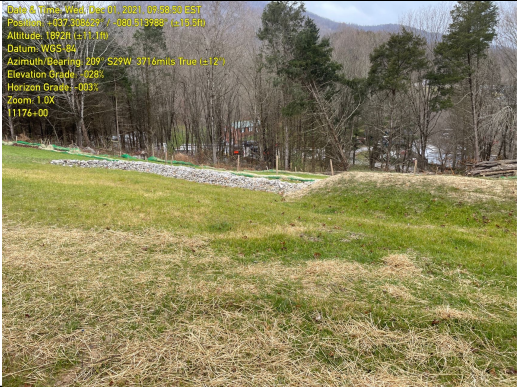
GPS Location	See photo	GPS Location	See photo		
Field Station#	11109+00	Field Station#	11176+00		
Pic 11 Desc.	CFS perimeter control in place	Pic 12 Desc.	Level spreader in place

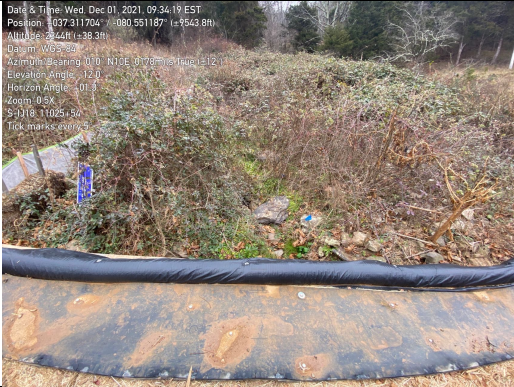
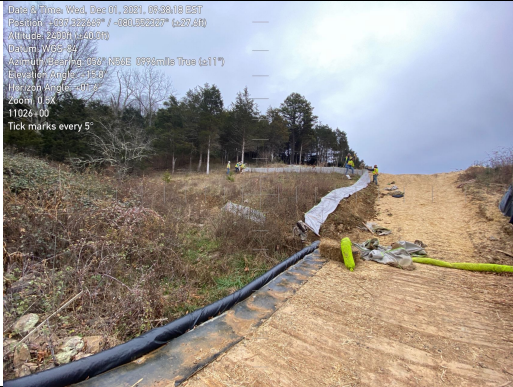
GPS Location	See Photo	GPS Location	See Photo		
Field Station#	11025+54	Field Station#	11026+00		
Pic 1 Desc.	S-IJ18	Pic 2 Desc.	Crews replacing Buffer ECDs

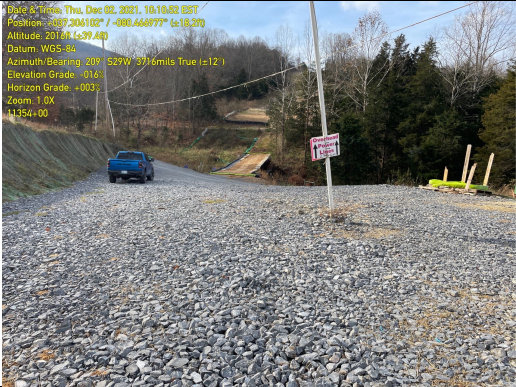
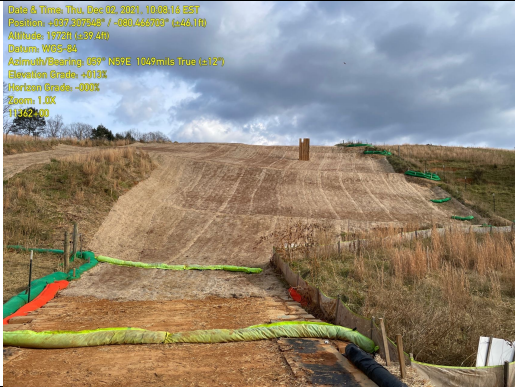
GPS Location	See photo	GPS Location	See photo		
Field Station#	11354+00	Field Station#	11362+00		
Pic 1 Desc.	RCE in place	Pic 2 Desc.	Erosion control blanket in place

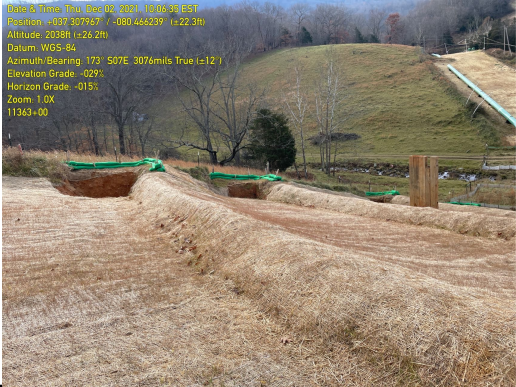
GPS Location	See photo	GPS Location	See photo		
Field Station#	11363+00	Field Station#	11370+00		
Pic 3 Desc.	End treatments in place	Pic 4 Desc.	Proper signage in place

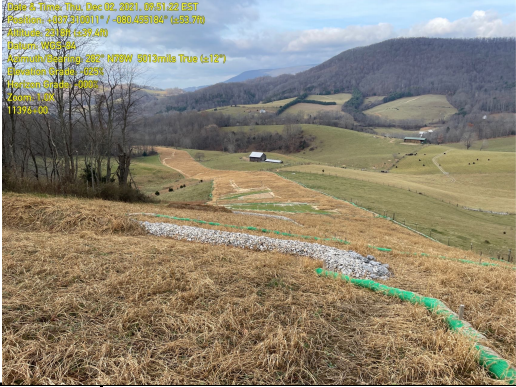
GPS Location	See photo	GPS Location	See photo		
Field Station#	11396+00	Field Station#	11412+00		
Pic 5 Desc.	Level spreader in place	Pic 6 Desc.	CFS waterbars in place

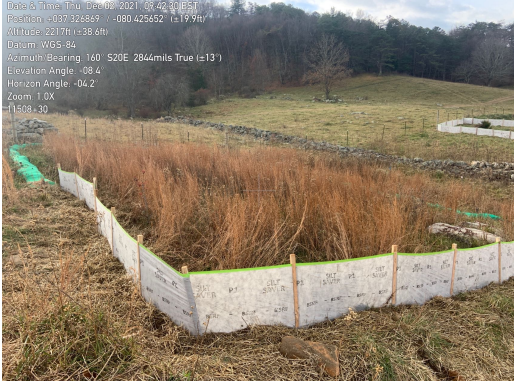
GPS Location	See photo	GPS Location	See photo		
Field Station#	11508+30	Field Station#	11508+00		
Pic 1 Desc.	Buffer zones are in acceptable condition	Pic 2 Desc.	Equipment bridge is maintained in acceptable condition

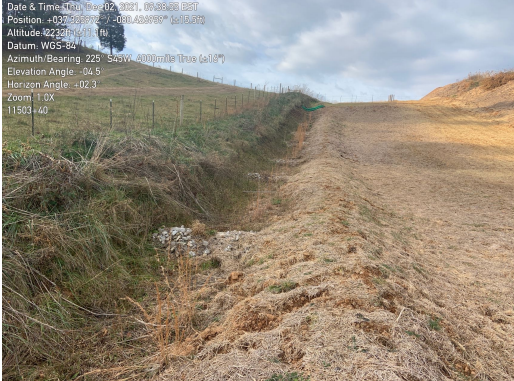
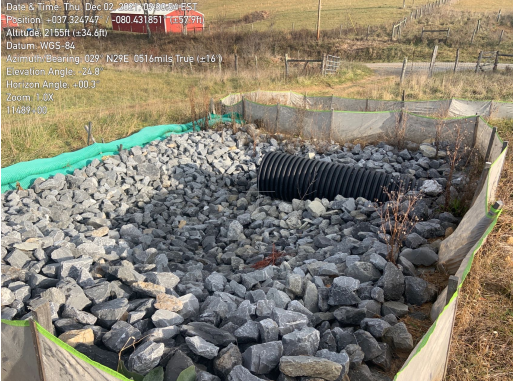
GPS Location	See photo	GPS Location	See photo		
Field Station#	11503+00	Field Station#	11489+00		
Pic 3 Desc.	Rock check dams in place	Pic 4 Desc.	Plunge pool is in acceptable condition

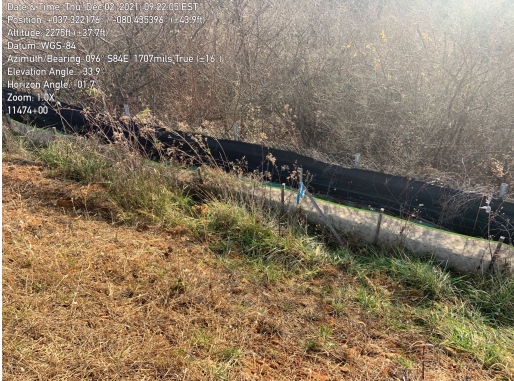
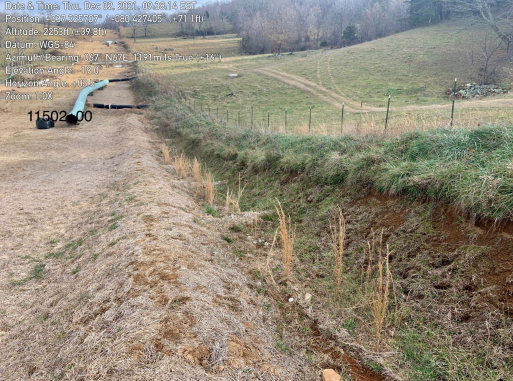
GPS Location	See photo	GPS Location	See photo		
Field Station#	11474+00	Field Station#	11502+00		
Pic 5 Desc.	Karst ECD's are in place	Pic 6 Desc.	Clean water diversion berm in place

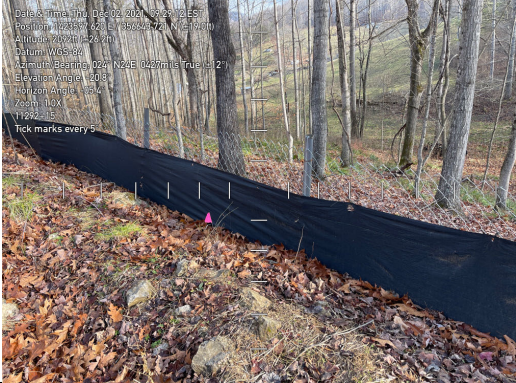
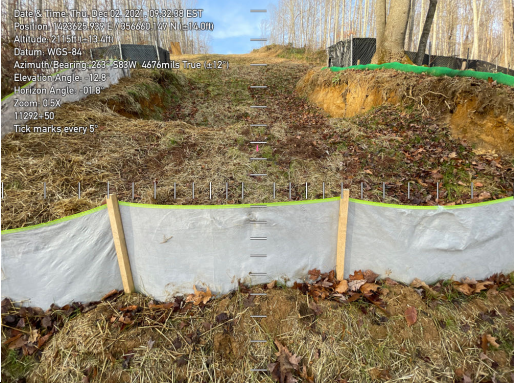
<p>Date & Time Thu Dec 02, 2021, 05:37:29 EST Position 11292+50 N 11292+50 W 11292+50 Altitude 742.41 ft (226.10 m) Datum WGS 84 Azimuth Bearing 124° 58' 43" 203mils True (12) Elevation Angle -12.3° Horizon Angle -13.5° Zoom 0.5X 11292+50 Tick marks every 5'</p>			
GPS Location	1	GPS Location	2		
Field Station#	11276+00	Field Station#	11292+50		
Pic 1 Desc.	Super silt fence needing replacement.	Pic 2 Desc.	P-1 needing repairs.
