Visual Site Inspection Report

Project Name	H-600 Pipeline Spread G	AFE	124300137	Spread	H-600 Pipeline Spread G
Contractor	Precision			Report #	30913
Inspector	Patrick Shields			Date/Time	11/8/2021 2:16 PM
Permit #	TBD	Inspection Type	VA SWPP	Station Begin	10798+92
State	VA	Inspection Area	Full	Station End	10859+46
County	Giles	Ground	Dry	Temperature (°F)	64.00
Municipality	N/A	Weather	Sunny	Rain Gauge (in)	0.00
				Rain Accumulation Time (days)	1.00

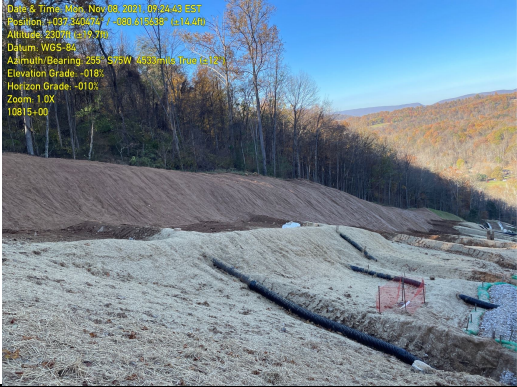
<p>Date & Time: Nov 08, 2021, 09:50:37 EST Location: 407.520283° / -90.01899° (-90.019°) Altitude: 2300ft (-90.019°) Datum: WGS-84 Azimuth/Bearing: 250° S58W 553mm True (±12°) Elevation Grade: -01% Horizon Grade: -01% Zoom: 1.0X 10815+00</p>			
GPS Location	See photo	GPS Location	See photo		
Field Station#	10812+00	Field Station#	10815+00		
Pic 7 Desc.	Cleanwater diversion outlet protection in place	Pic 8 Desc.	Spoil pile stabilized with erosion control blanket

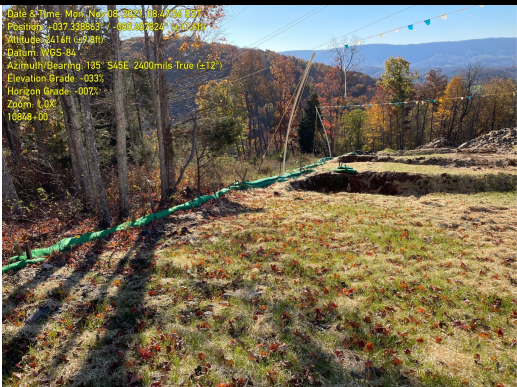
<p>Date & Time: Nov 08, 2021, 09:50:37 EST Location: 407.520283° / -90.01899° (-90.019°) Altitude: 2416ft (-90.019°) Datum: WGS-84 Azimuth/Bearing: 185° S45E 2400mm True (±12°) Elevation Grade: -03% Horizon Grade: -002% Zoom: 1.0X 10848+00</p>			
GPS Location	See photo	GPS Location	See photo		
Field Station#	10857+75	Field Station#	10848+00		
Pic 11 Desc.	End treatments in place	Pic 12 Desc.	CFS perimeter control in place

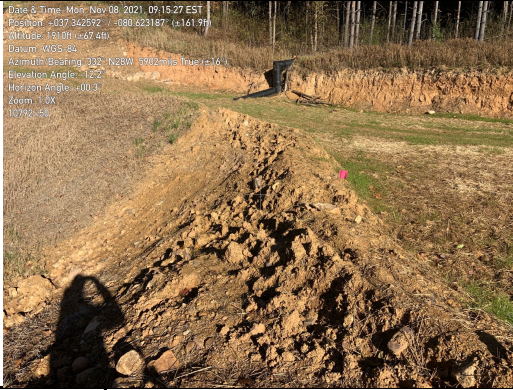
<p>Date & Time: Mon Nov 08 2021 09:15:27 EST Position: -837.342592, -880.623187, (+16.1M) Altitude: 1510ft (+46.6m) Datum: WGS 84 Azimuth/Bearing: 032° N28W 1002mils True (+16°) Elevation Angle: +1.2° Horizon Angle: +00.1° Zoom: 1.0X 10792+50</p>			
GPS Location	See photo	GPS Location	See photo		
Field Station#	10795+00	Field Station#	10792+50		
Pic 1 Desc.	Denuded soil needs seeded and stabilized	Pic 2 Desc.	Denuded soil needs seeded and stabilized

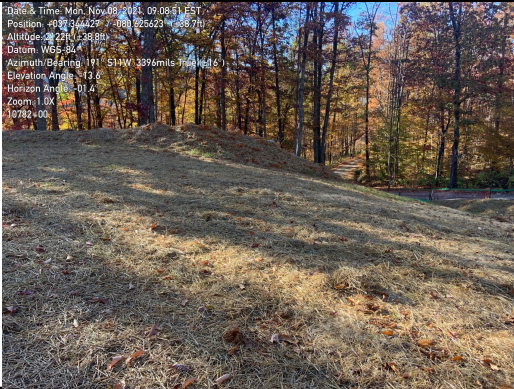
GPS Location	See photo	GPS Location	See photo		
Field Station#	10782+00	Field Station#	10779+80		
Pic 3 Desc.	Denuded soil from previous punch list is seeded and stabilized in acceptable condition	Pic 4 Desc.	Slope drain pipe sump pit and perimeter controls acceptable

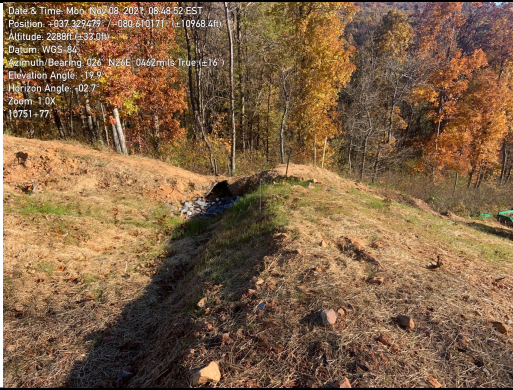
<p>Date & Time: Mon Nov 08 2021 08:48:52 EST Position: -837.329599, -880.610171, (+109.8M) Altitude: 2288ft (+69.7m) Datum: WGS 84 Azimuth/Bearing: 026° N26E 0460mils True (+16°) Elevation Angle: +19.9° Horizon Angle: +02.7° Zoom: 1.0X 10751+77</p>			
GPS Location	See photo	GPS Location	See photo		
Field Station#	10765+00	Field Station#	10751+77		
Pic 5 Desc.	Aquatic resource buffer zone is in acceptable condition	Pic 6 Desc.	Water bar and stone inlet protection functional

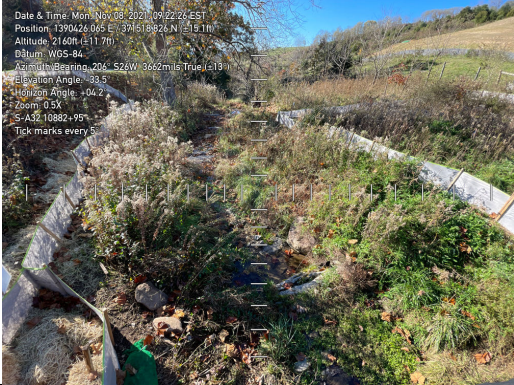
GPS Location	1	GPS Location	2		
Field Station#	10882+95	Field Station#	10927+71		
Pic 1 Desc.	S-A32 and controls.	Pic 2 Desc.	S-Y3 and controls.

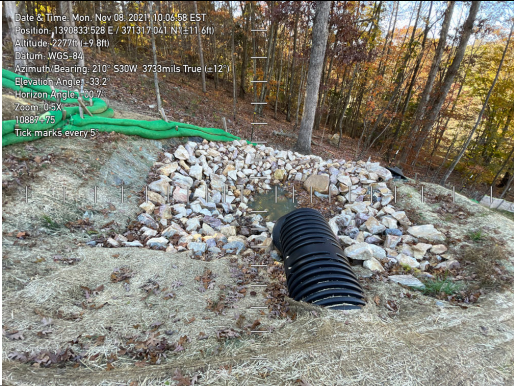
GPS Location	5	GPS Location	6		
Field Station#	10887+75	Field Station#	10907+00		
Pic 5 Desc.	Plunge pool functional.	Pic 6 Desc.	Section of RoW showing conditions and controls.

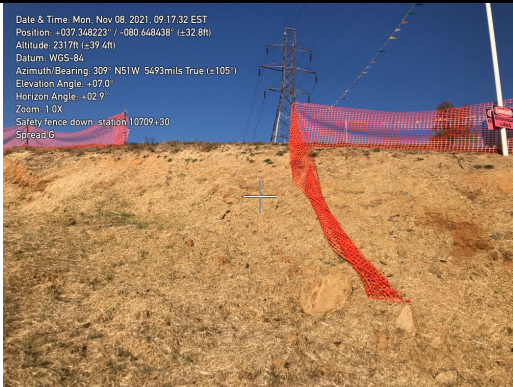
<p>Date & Time: Mon, Nov 08, 2021, 09:17:32 EST Position: +037.348223° / -080.648438° (±32.8ft) Altitude: 2317ft (±39.4ft) Datum: WGS-84 Azimuth/Bearing: 309° N51W 5493mils True (±105°) Elevation Angle: -07.0° Horizon Angle: -02.9° Zoom: 1.0X Safety fence down station 10709+30 Spread G</p>  								
GPS Location			See photo			GPS Location			see photo		
Field Station#			10709+30			Field Station#			10678+82		
Pic 1 Desc.			Fence needs repaired			Pic 2 Desc.			Sock on PL		
<p>Date & Time: Mon, Nov 08, 2021, 09:50:26 EST Position: +037.346358° / -080.640130° (±38.4ft) Altitude: 2337ft (±52.5ft) Datum: WGS-84 Azimuth/Bearing: 280° N80W 4978mils True (±107°) Elevation Angle: -26.1° Horizon Angle: -00.6° Zoom: 1.0X ROW - station 10735+00 Spread G</p>  			<p>Date & Time: Mon, Nov 08, 2021, 08:59:52 EST Position: +037.344685° / -080.641951° (±15.4ft) Altitude: 2294ft (±26.2ft) Datum: WGS-84 Azimuth/Bearing: 087° N87E 1547mils True (±63°) Elevation Angle: -18.5° Horizon Angle: -02.0° Zoom: 1.0X equipment bridge - station 10732+16 Spread G</p>

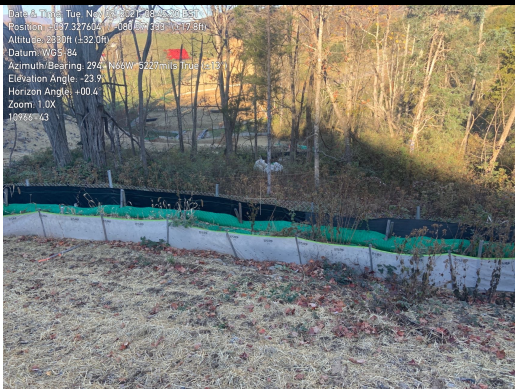
<p>Date & Time: Tue, Nov 09, 2021 08:50:03 EST Position: +037.223679, -080.553006, +10966+43 Altitude: 2330ft (+32.9ft) Datum: WGS 84 Azimuth/Bearing: 294.606W 5227mils True (+16) Elevation Angle: -23.9 Horizon Angle: +00.4 Zoom: 1.0X 10966+43</p>	
GPS Location	See photo		GPS Location	See photo	
Field Station#	11023+80		Field Station#	10966+43	
Pic 1 Desc.	AR244 is maintained in acceptable condition		Pic 2 Desc.	Karst ECD's are in acceptable condition

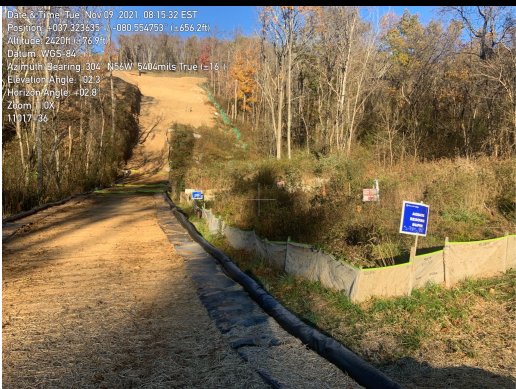
GPS Location	See photo		GPS Location	See photo	
Field Station#	11017+36		Field Station#	11006+20	
Pic 3 Desc.	Sensitive resource buffer, signage and equipment bridge are in acceptable condition		Pic 4 Desc.	Water bar is in acceptable condition

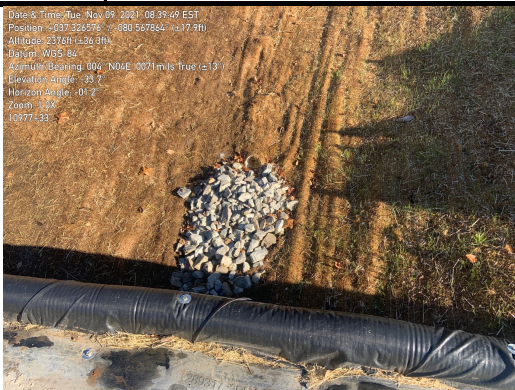
<p>Date & Time: Tue, Nov 09, 2021 08:39:49 EST Position: +037.223679, -080.557644, +10977+33 Altitude: 2376ft (+32.9ft) Datum: WGS 84 Azimuth/Bearing: 006.7N06E 0071mils True (+16) Elevation Angle: -33.7 Horizon Angle: +01.2 Zoom: 1.0X 10977+33</p>	
GPS Location	see photo		GPS Location	See photo	
Field Station#	11003+85		Field Station#	10977+33	
Pic 5 Desc.	Clean water diversion pipe and level spreader are in acceptable condition		Pic 6 Desc.	Daylight drain with outlet protection is in acceptable condition

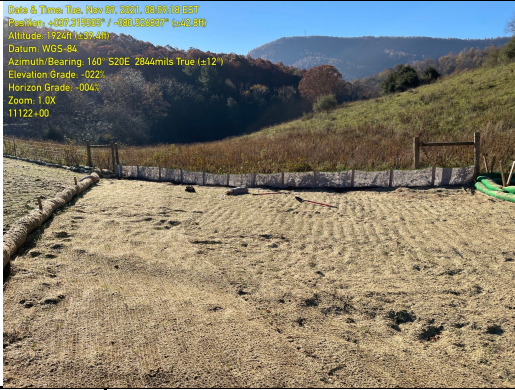
<p>Date & Time Tue, Nov 09, 2021, 09:40:18 EST Position: +037 315897 / -080 534597 (s46.84) Altitude: 5122ft (s45.87) Datum: WGS-84 Azimuth/Bearing: 160 S20E 2844mits True (s12°) Elevation Grade: -022° Horizon Grade: -004° Zoom: 1.0X 11122+00</p>			
GPS Location	See photo	GPS Location	See photo		
Field Station#	11184+85	Field Station#	11122+00		
Pic 1 Desc.	Rock check dams require maintenance	Pic 2 Desc.	Silt fence installed per punch list item

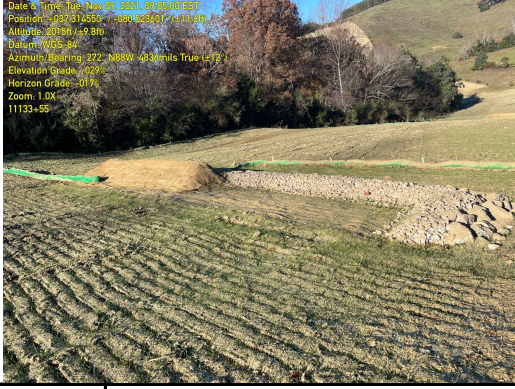
<p>Date & Time Tue, Nov 09, 2021, 09:40:05 EST Position: +037 315897 / -080 534597 (s46.84) Altitude: 5122ft (s45.87) Datum: WGS-84 Azimuth/Bearing: 222 N88W 404mits True (s7°) Elevation Grade: -029° Horizon Grade: -014° Zoom: 1.0X 11133+55</p>			
GPS Location	See photo	GPS Location	See photo		
Field Station#	11120+00	Field Station#	11133+55		
Pic 5 Desc.	Temporary CFS waterbars in place	Pic 6 Desc.	Level spreader in place

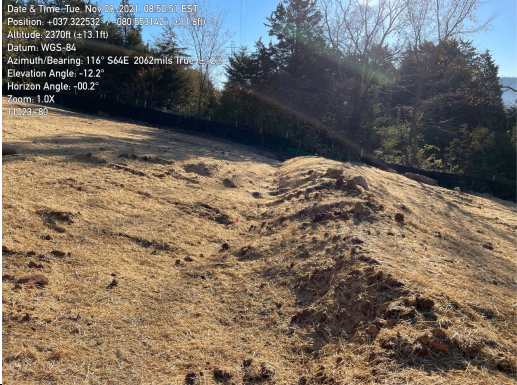
GPS Location	See photo	GPS Location	See photo		
Field Station#	11023+80	Field Station#	11023+80		
Pic 13 Desc.	Water bars needs built to spec & re-stabilization	Pic 14 Desc.	Water bars needs built to spec & re-stabilized.

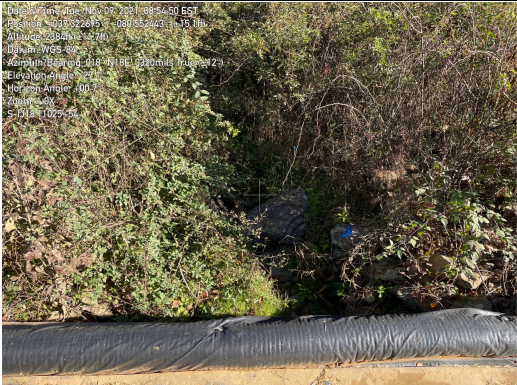
<p>Insert image here</p>			
GPS Location	See photo	GPS Location			
Field Station#	11025+54	Field Station#			
Pic 17 Desc.	S-IJ18 in good condition	Pic 18 Desc.

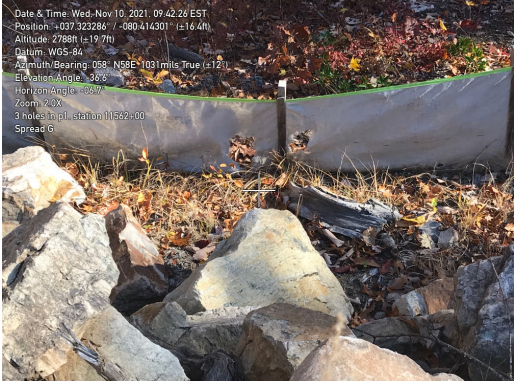
GPS Location	See photo		GPS Location	see photo	
Field Station#	11562+00		Field Station#	11562+00	
Pic 1 Desc.	Holes in P1. On PL		Pic 2 Desc.	P 1 down. On PL

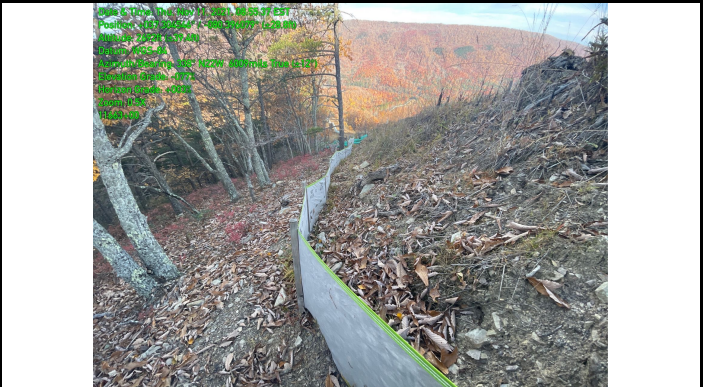
<p>Date & Time: Thu, Nov 11, 2021, 09:03:03 EST Position: +037.306302° / -080.397329° (±15.7m) Altitude: 2461ft (±10.9ft) Datum: WGS-84 Geoid Height: 328' NAD83 5531mils True (±12') Magnetic Declination: -10.1° Horizontal Accuracy: ±10.1m Vertical Accuracy: ±10.1m</p>	
GPS Location	See Photo		GPS Location	See Photo	
Field Station#	11165+00		Field Station#	11663+00	
Pic 1 Desc.	View of sump pit conditions		Pic 2 Desc.	View of P1 silt fence conditions

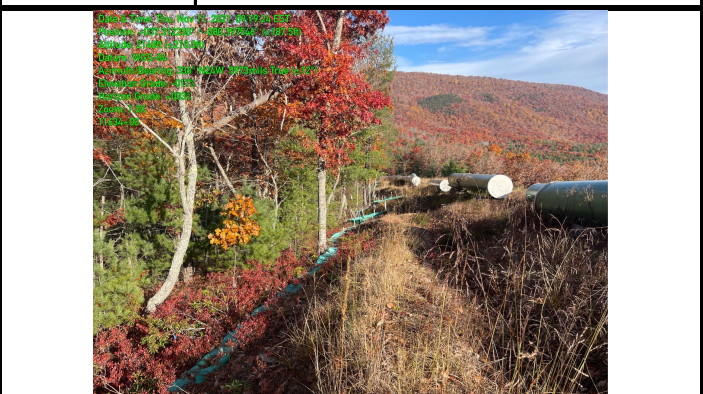
<p>Date & Time: Thu, Nov 11, 2021, 09:03:03 EST Position: +037.306302° / -080.397329° (±15.7m) Altitude: 2461ft (±10.9ft) Datum: WGS-84 Geoid Height: 328' NAD83 5531mils True (±12') Magnetic Declination: -10.1° Horizontal Accuracy: ±10.1m Vertical Accuracy: ±10.1m</p>	
GPS Location	See Photo		GPS Location	See Photo	
Field Station#	11646+00		Field Station#	11634+00	
Pic 5 Desc.	View of slope drain pipe inlet.		Pic 6 Desc.	View of perimeter ECDs functioning to design.

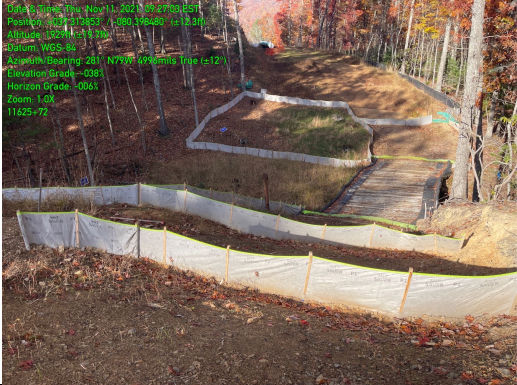
GPS Location	See Photo	GPS Location	See Photo		
Field Station#	11629+00	Field Station#	11625+72		
Pic 7 Desc.	View of row conditions	Pic 8 Desc.	View of EVDs in place and functioning

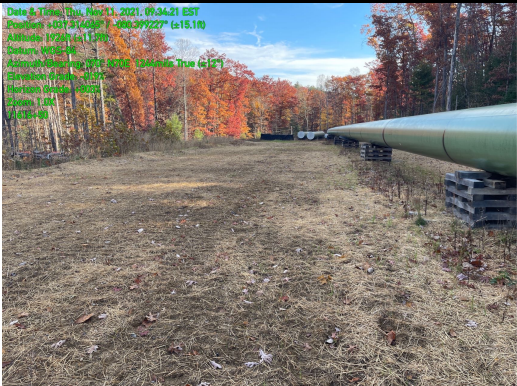
GPS Location	See Photo	GPS Location	See Photo		
Field Station#	11624+63	Field Station#	11616+50		
Pic 9 Desc.	View of row conditions	Pic 10 Desc.	View of row conditions

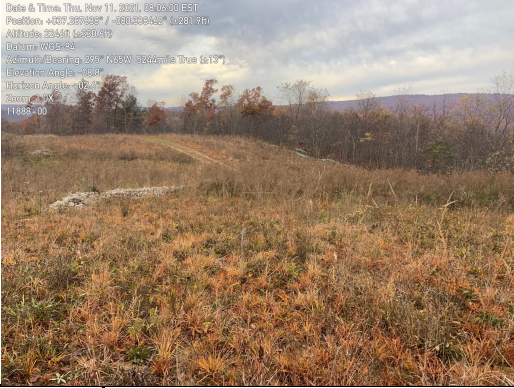
GPS Location	See photo		GPS Location	See photo	
Field Station#	11895+00		Field Station#	11888+00	
Pic 1 Desc.	CFS perimeter controls in place		Pic 2 Desc.	Water bars and level spreader in place

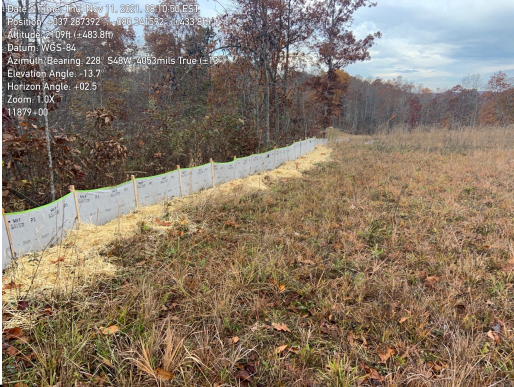
GPS Location	see photo		GPS Location	See photo	
Field Station#	11881+50		Field Station#	11879+00	
Pic 3 Desc.	New P1 silt fence installed and in acceptable condition		Pic 4 Desc.	Temporary stabilization of disturbed soils after P1 was installed

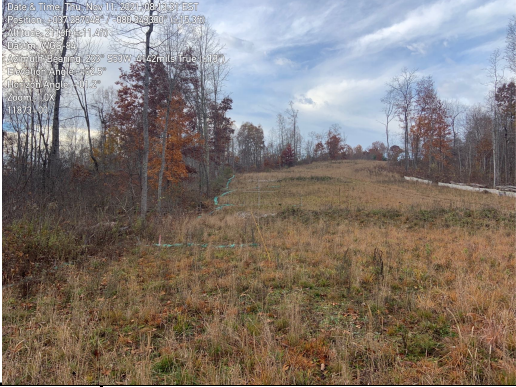
GPS Location	See photo		GPS Location	see photo	
Field Station#	11873+00		Field Station#	11841+00	
Pic 5 Desc.	CFS water bars and perimeter controls are in place		Pic 6 Desc.	Triple stacked CFS perimeter controls in place

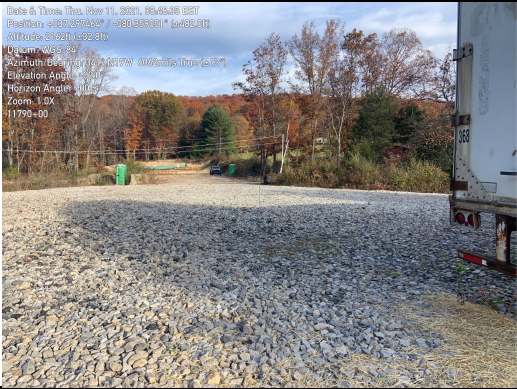
Insert image here	
GPS Location	See photo	GPS Location			
Field Station#	11790+00	Field Station#			
Pic 7 Desc.	RCE is maintained and in acceptable condition	Pic 8 Desc.			
Insert image here		Insert image here			
GPS Location		GPS Location			
Field Station#		Field Station#			
Pic 9 Desc.		Pic 10 Desc.			
Insert image here		Insert image here			
GPS Location		GPS Location			
Field Station#		Field Station#			
Pic 11 Desc.		Pic 12 Desc.

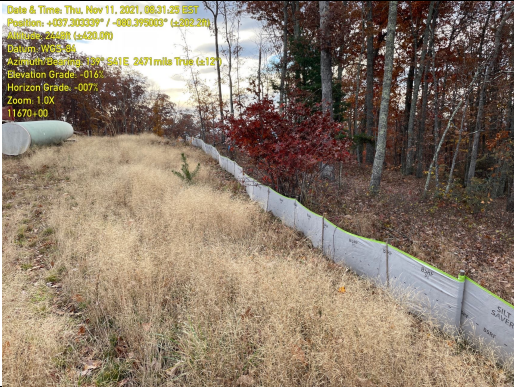
GPS Location	See photo	GPS Location	See photo		
Field Station#	11670+00	Field Station#	11678+00		
Pic 1 Desc.	P1 silt fence perimeter control in place	Pic 2 Desc.	End treatments in place
