Visual Site Inspection Report

Project Name	H-600 Pipeline Spread G	AFE	124300137	Spread	H-600 Pipeline Spread G
Contractor	Precision			Report #	28706
Inspector	Patrick Shields			Date/Time	9/20/2021 6:48 PM
Permit #	TBD	Inspection Type	VA SWPP	Station Begin	11254+99
State	VA	Inspection Area	Full	Station End	11524+16
County	Giles	Ground	Damp	Temperature (°F)	75.00
Municipality	N/A	Weather	Cloudy	Rain Gauge (in)	0.20
				Rain Accumulation Time (days)	1.00

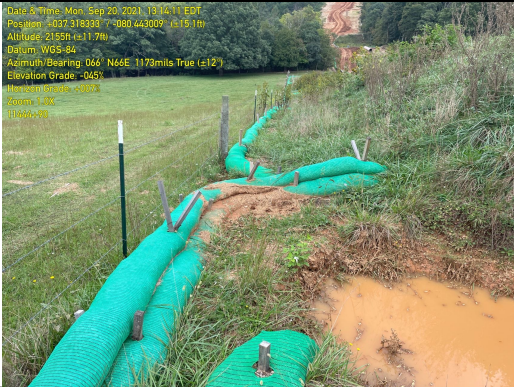
GPS Location		See photo		GPS Location	
Field Station#		11444+90		Field Station#	
Pic 3 Desc.		End treatment needs cleaned off		Pic 4 Desc.	
				Rilling needs repaired and stabilized	
<p>Date & Time: Mon, Sep 20, 2021, 13:09:53 EDT Position: +037.314481° / -080.448649° (+22.7m) Altitude: 2220ft (+26.2m) Datum: WGS-84 Azimuth Bearing: 044° N44E 0818mils True (+12°) Elevation Grade: -032% Horizon Grade: +011% Zoom: 1.0x 11423+75</p>

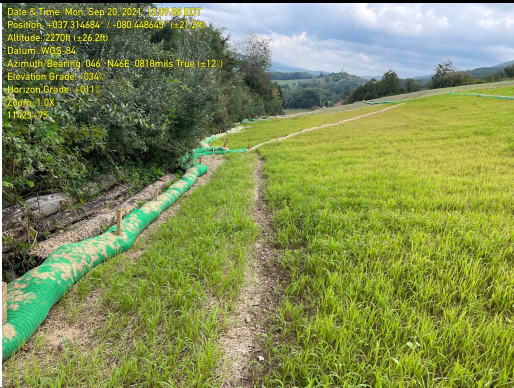
GPS Location		See photo		GPS Location	
Field Station#		11423+75		Field Station#	
Pic 5 Desc.		Backfill for erosion control blanket needs stabilized		Pic 6 Desc.	
				Sump needs cleaned out

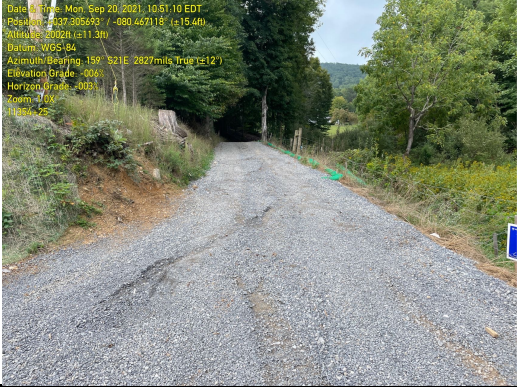
GPS Location	See photo	GPS Location	See photo		
Field Station#	11354+25	Field Station#	11329+42		
Pic 7 Desc.	Rilling on Access road	Pic 8 Desc.	CFS checks need cleaned off or replaced		
<p>Date & Time: Mon, Sep 20, 2021, 09:51:34 EDT Position: +037.300180° / -080.473895° (±14.1ft) Altitude: 2216ft (±26.2ft) Datum: WGS-84 Azimuth/Bearing: 152° S28E 2702mils True (±12°) Elevation Angle: -12.0° Horizon Angle: -05.8° Zoom: 1.0X 11324+80</p>

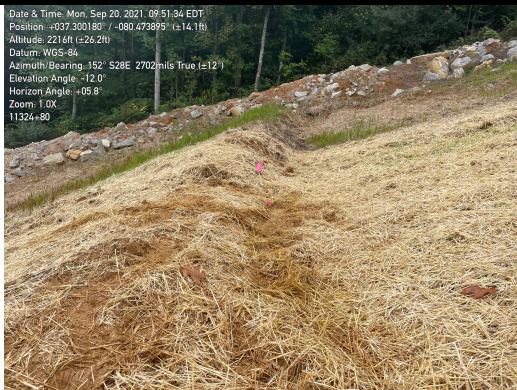
GPS Location	See photo	GPS Location	See photo		
Field Station#	11324+80	Field Station#	11362+00		
Pic 9 Desc.	Waterbar in travel lane needs maintenance	Pic 10 Desc.	Throat of waterbar needs cleaned out		
<p>Date & Time: Mon, Sep 20, 2021, 13:44:45 EDT Position: +037.322817° / -080.434930° (±11.6ft) Altitude: 2333ft (±8.8ft) Datum: WGS-84 Azimuth/Bearing: 064° N34E 1499mils True (±12°) Elevation Grade: -009° Horizon Angle: -009° Zoom: 1.0X 11477+00</p>

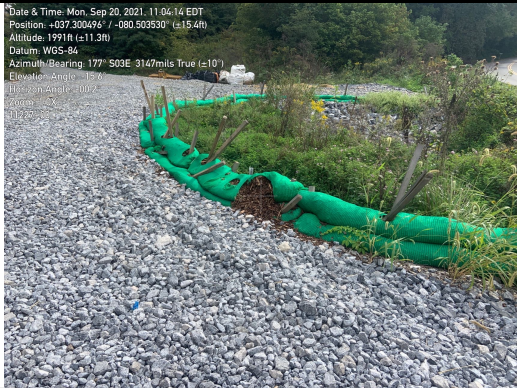
GPS Location	See photo	GPS Location	see photo		
Field Station#	11227+00	Field Station#	11185+00		
Pic 9 Desc.	Damaged CFS	Pic 10 Desc.	AR249.02 needs maintenance		
<p>Date & Time: Mon, Sep 20, 2021, 14:17:21 EDT Position: +037.311420° / -080.518721° (±656.2ft) Altitude: 1870ft (±184.7ft) Datum: WGS-84 Azimuth/Bearing: 139° S49E 2451mils True (±13°) Elevation Angle: -34.4° Horizon Angle: -07.8° Zoom: 1.0X 11150+00</p>

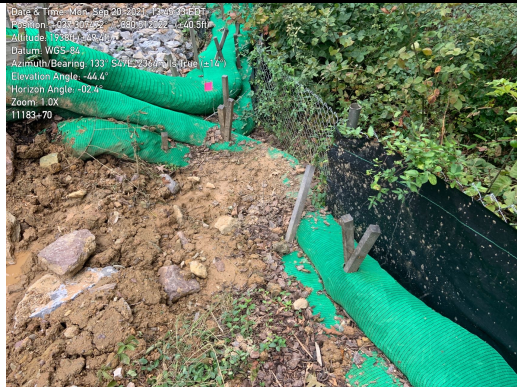
GPS Location	See photo	GPS Location	See photo		
Field Station#	11183+70	Field Station#	11150+00		
Pic 11 Desc.	Sediment needs removed from CFS	Pic 12 Desc.	P1 added to punch list for maintenance

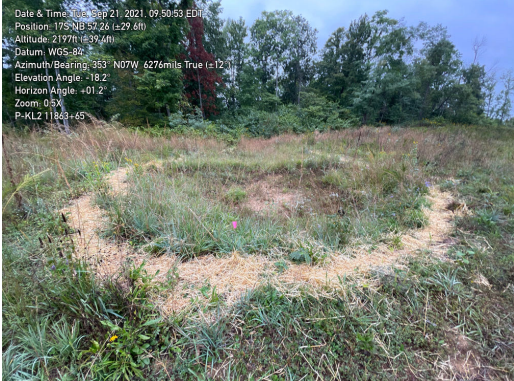
GPS Location	1	GPS Location	2		
Field Station#	11863+65	Field Station#	11880+00		
Pic 1 Desc.	Install P-1 protection on P-KL2.	Pic 2 Desc.	Representational photo of damaged P-1.

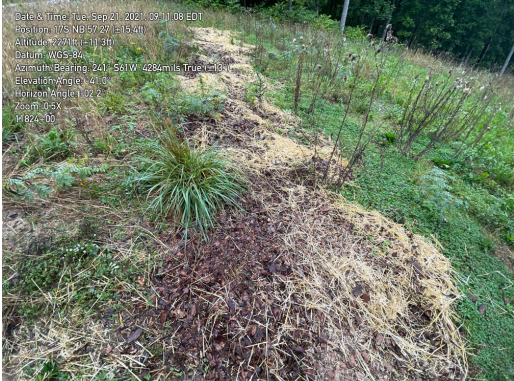
GPS Location	3	GPS Location	4		
Field Station#	11824+00	Field Station#	11788+52		
Pic 3 Desc.	Representational photo of wood chips needing spread to allow growth and proper amendments applied.	Pic 4 Desc.	RCE on the South side of Mt Tabor road crossing.

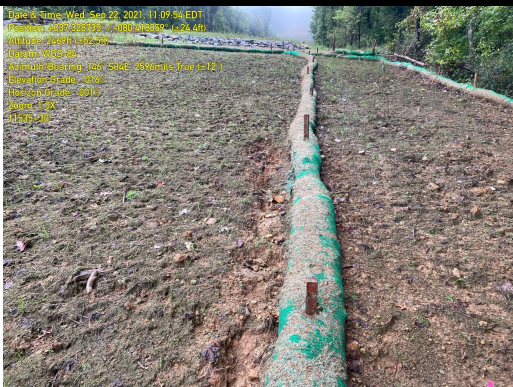
GPS Location	See photo		GPS Location	See photo	
Field Station#	11535+30		Field Station#	11536+00	
Pic 3 Desc.	Rilling needs repaired and stabilized		Pic 4 Desc.	End treatment undermined

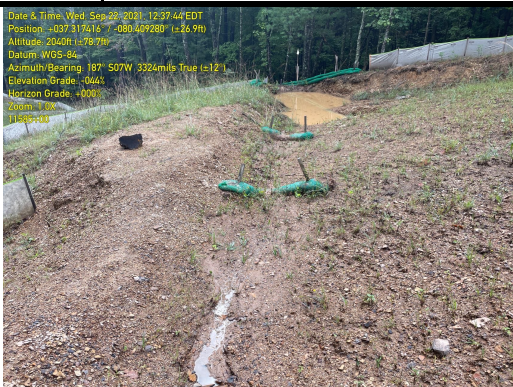
<p>Date & Time: Wed Sep 22, 2021, 12:40:40 EDT Position: -83.7191416, 35.00429289 (±16.9m) Altitude: 204ft (±37.0ft) Datum: WGS 84 Azimuth/Bearing: 187° S07W 3324mils True (±12°) Elevation Grade: -0.04° Horizon Grade: +0.00° Zoom: 1.0x 11588+00</p>			
GPS Location	See photo		GPS Location	See photo	
Field Station#	11585+00		Field Station#	11588+00	
Pic 5 Desc.	Waterbar throat and checks need cleaned out		Pic 6 Desc.	Needs stabilization

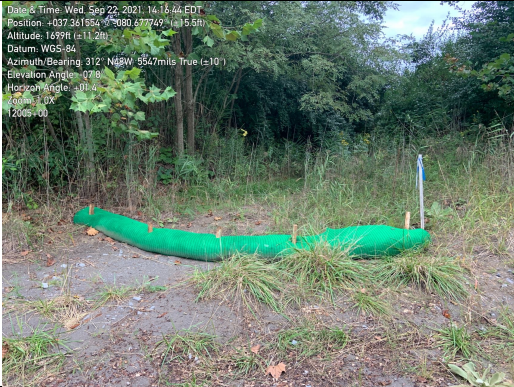
GPS Location	See photo		GPS Location	See photo	
Field Station#	12005+00		Field Station#	12005+00	
Pic 1 Desc.	18" CFS from punch list has need replaced		Pic 2 Desc.	Culvert in place and functional	
<p>Date & Time: Wed, Sep 22, 2021, 14:16:44 EDT Position: +437.34155° / +680.57774° (+15.5m) Altitude: 1699ft (+11.2m) Datum: WGS-84 Azimuth/Bearing: 352° N08W 6288mils True (+10°) Elevation Angle: -20.8° Horizon Angle: -00.0° Zoom: 1.0X 12005+00</p>

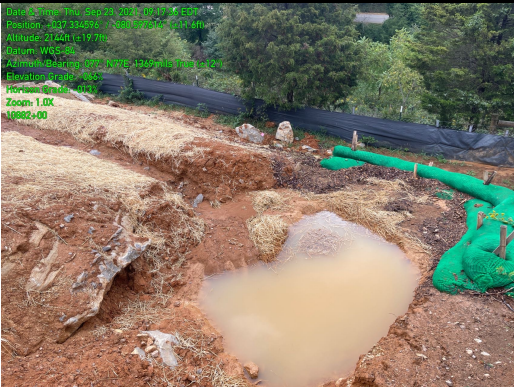
GPS Location	See Photo		GPS Location	See Photo	
Field Station#	10883+00		Field Station#	10882+00	
Pic 1 Desc.	Straw bale in the S-A32 buffer zone		Pic 2 Desc.	Sump pit requires cleaning
