Visual Site Inspection Report

| Project Name | H-600 Pipeline Spread G | AFE | 124300137 | Spread | H-600 Pipeline Spread G |
| Permit # | TBD | Inspection Type | VA SWPP | Station Begin | 11788+52 |

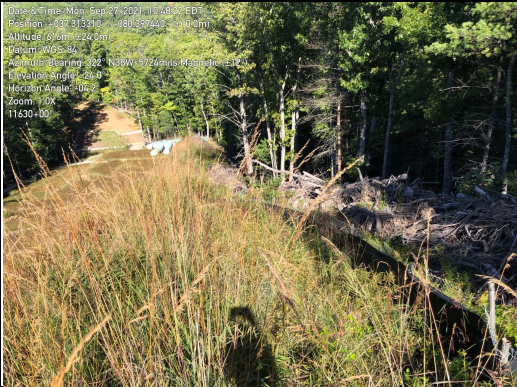
| Pic 7 Desc. | ROW currently stable. | Pic 8 Desc. | The S-HH18 crossing is stable. No impact noted to stream. | | |

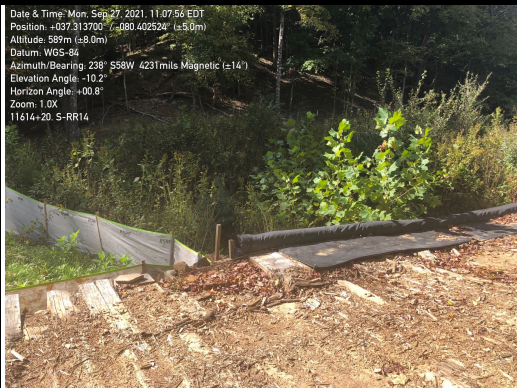
| Pic 9 Desc. | The S-RR14 crossing is stable currently. | Pic 10 Desc. | The S-006 crossing is stable. ECDs are in place. | | |

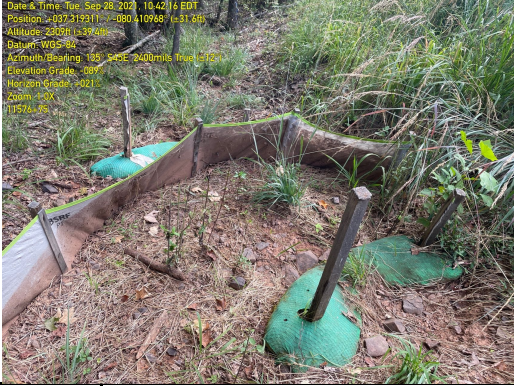
| Pic 1 Desc. | P1 silt fence needs replaced | Pic 2 Desc. | Clean water diversion berm needs a CFS check installed | | |

| <p>Completed VA SWPPP inspection from ST# 11524+16 to ST# 11600+01 (MP 218.26 to MP 219.70)</p> <p>Deficiencies found at the following station numbers:</p> <p>11576+75 Replace P1 silt fence the will no longer filter. Add additional P1 checks.</p> <p>11584+02 Replace P1 silt fence that will no longer filter.</p> <p>11589+11 Add CFS check to clean water diversion berm.</p> <p>All issues have been communicated to PPL contractor via punch list.</p> <p>Active construction site; additional deficiencies may be identified by other EIs.</p> <p>ROW is dry and in stable condition up until JNF property line ST# 11553+66.</p> <p>Final restoration has occurred between ST# 11526+50 and ST# 11548+00. Permanent waterbars with level spreaders are installed. CFS perimeter controls,end treatments and temporary waterbars are in place. Daylight drains with rock outlet protection are in place. Proper signage has been posted to keep vehicle travel off of restored ROW.</p> <p>ROW is dry and stabilized throughout JNF with significant vegetation.</p> <p>Waterbars with end treatments and perimeter controls are in place.</p> <p>50' buffers are in place at stream crossings S-PP22, S-PP21, S-PP20.</p> <p>AR-258.02 and Craig Creek road crossing RCEs are maintained in acceptable condition.</p> <p>No sensitive resources have been impacted.</p> | | | | | |

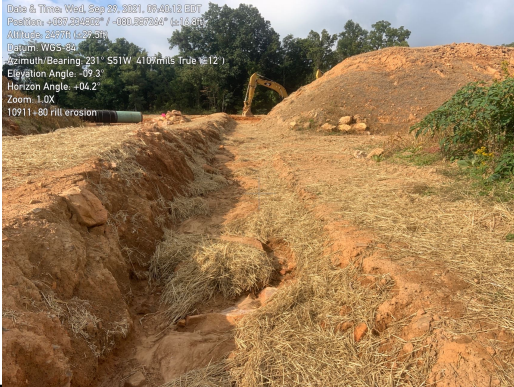
| Pic 3 Desc. | Rill erosion in throat of water bar | Pic 4 Desc. | RCE is maintained and in acceptable condition | | |

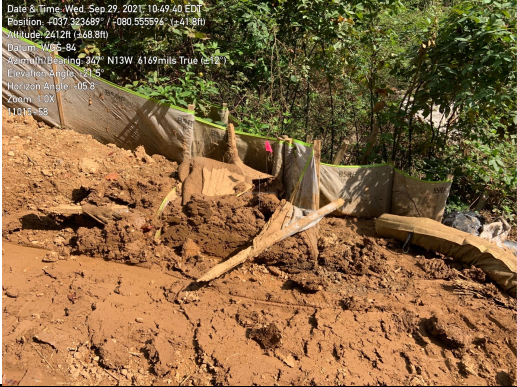
| Pic 7 Desc. | P1 silt fence has been undermined and needs maintenance | Pic 8 Desc. | Sump pit needs cleaned out | | |

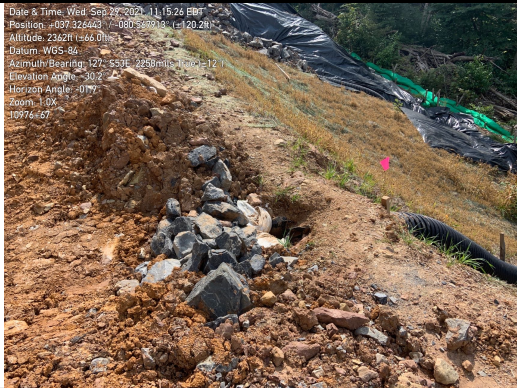
| Pic 9 Desc. | Stone inlet protection needs maintenance | Pic 10 Desc. | Subsidence along Doe creek farm road needs maintenance | | |

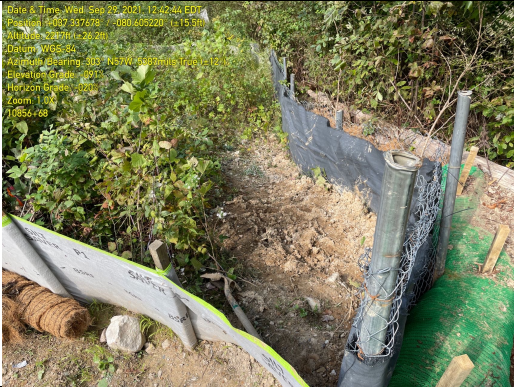
| Pic 1 Desc. | Stabilization needed | Pic 2 Desc. | Rock inlet needs cleaned out and refreshed | | |

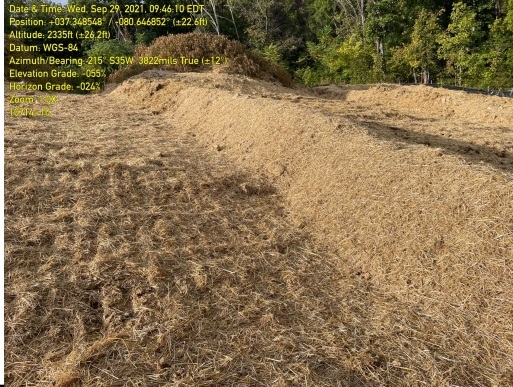
| Pic 3 Desc. | Sediment backed up slope drain pipe | Pic 4 Desc. | Low spot in waterbar needs repaired | | |
