Visual Site Inspection Report

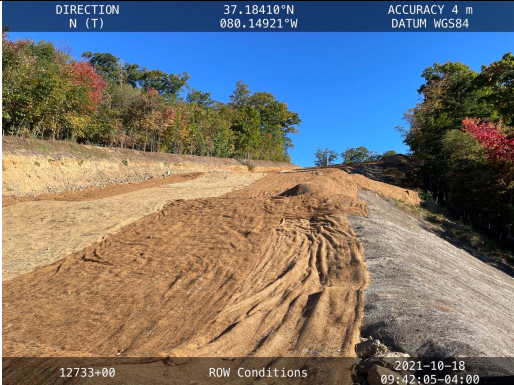
GPS Location	See photo		GPS Location	See photo	
Field Station#	12733+00		Field Station#	12735+00	
Pic 1 Desc.	Current ROW conditions. ROW is stable.		Pic 2 Desc.	Current ROW conditions. ROW is stable. Seed is has germinated.

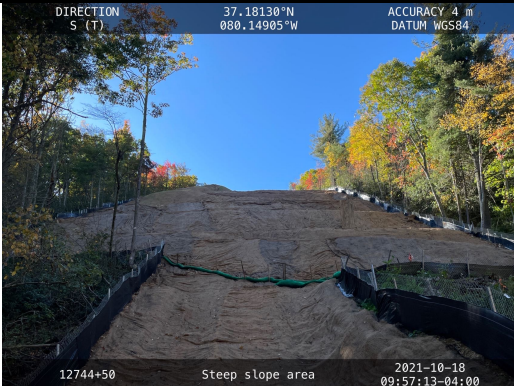
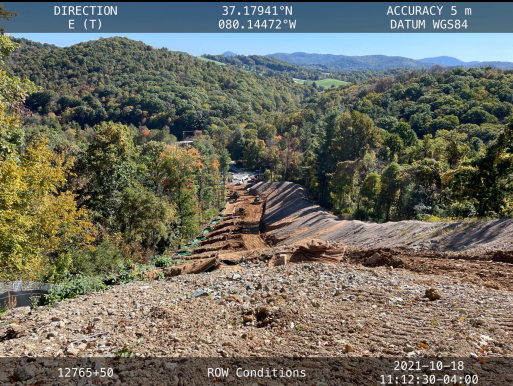
GPS Location	See photo		GPS Location	See photo	
Field Station#	12744+50		Field Station#	12765+60	
Pic 5 Desc.	Steep slope area is stable and ECDs functional.		Pic 6 Desc.	Current ROW conditions. ROW is stable. Waterbars are functional.

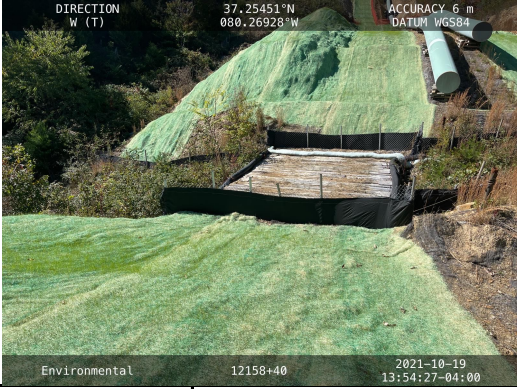
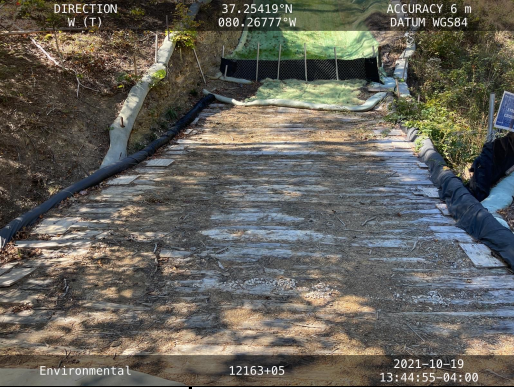
GPS Location	See photo		GPS Location	See photo	
Field Station#	12158+40		Field Station#	12163+05	
Pic 7 Desc.	Clean water crossing in acceptable condition		Pic 8 Desc.	Bridge and ECDs crossing stream S-C25 in acceptable condition

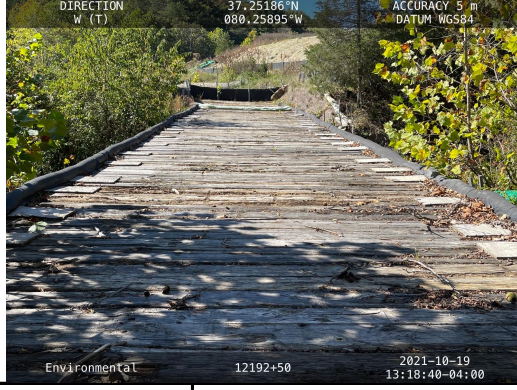
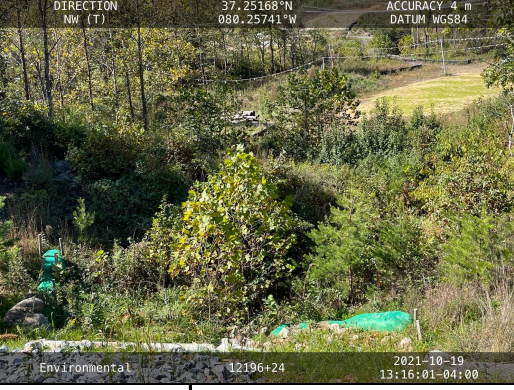
GPS Location	See photo		GPS Location	See photo	
Field Station#	12192+50		Field Station#	12196+24	
Pic 11 Desc.	Bridge and ECDs crossing stream S-C21 in acceptable condition		Pic 12 Desc.	Stream crossing S-0011 in acceptable condition

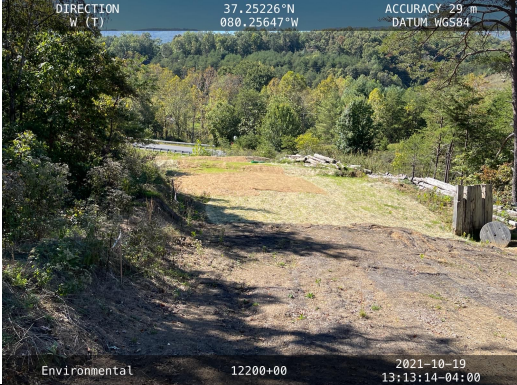
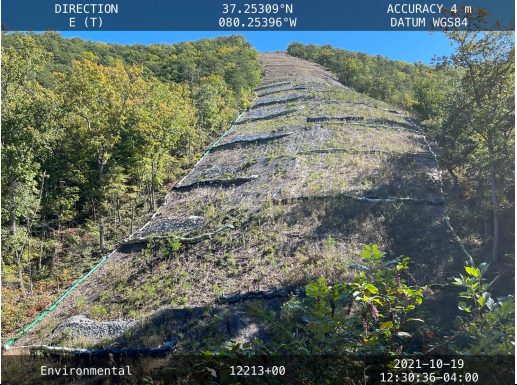
GPS Location	See photo		GPS Location	See photo	
Field Station#	12200+00		Field Station#	12213+00	
Pic 13 Desc.	Stabilized ROW in acceptable condition		Pic 14 Desc.	Stabilized ROW in acceptable condition

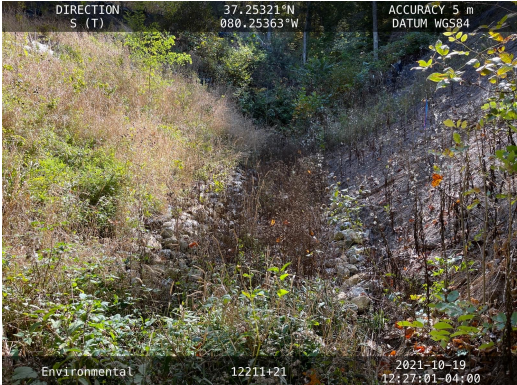
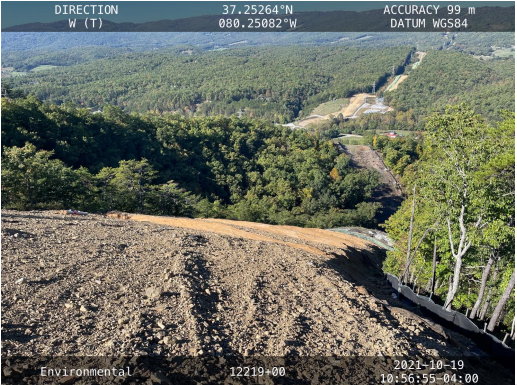
GPS Location	See photo		GPS Location	See photo	
Field Station#	12211+21		Field Station#	12219+00	
Pic 15 Desc.	Stabilized drainage feature in acceptable condition		Pic 16 Desc.	ROW conditions before stabilizing

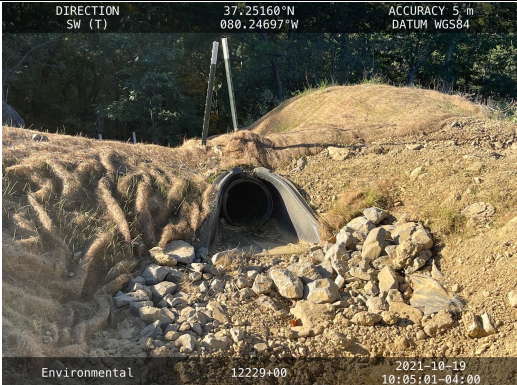
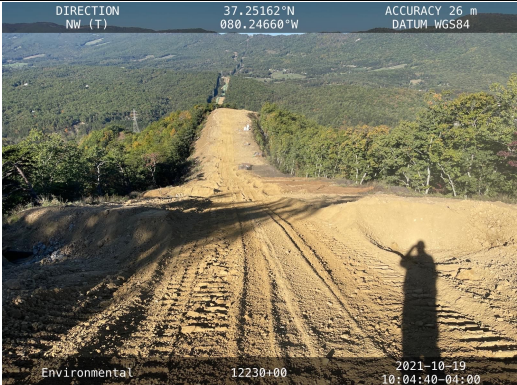
GPS Location	See photo		GPS Location	See photo	
Field Station#	12229+00		Field Station#	12230+00	
Pic 17 Desc.	Fill slope drain inlet		Pic 18 Desc.	ROW conditions during construction

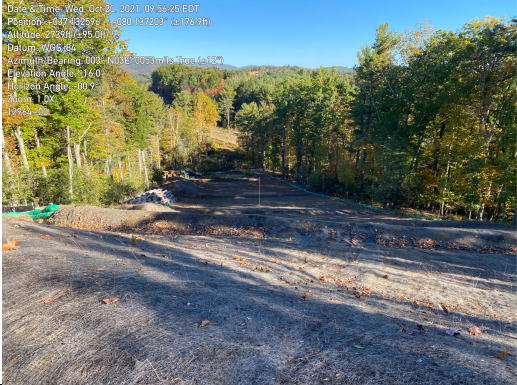
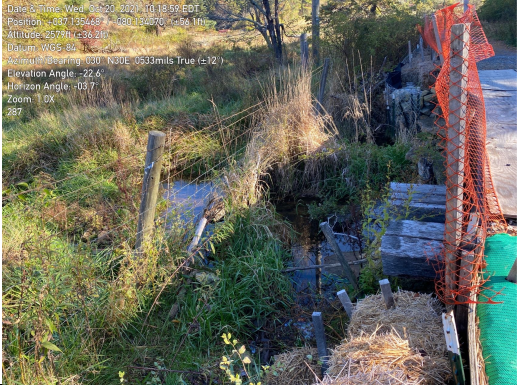
GPS Location	See photo for coordinates.		GPS Location	See photo for coordinates.	
Field Station#	12964+00		Field Station#	12957+38	
Pic 7 Desc.	ROW stable, perimeter controls in acceptable condition.		Pic 8 Desc.	MVP-RO-287, S-Z17, stream flowing clear, equipment bridge in acceptable condition.

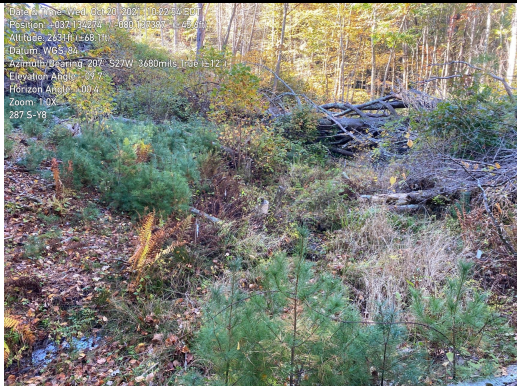
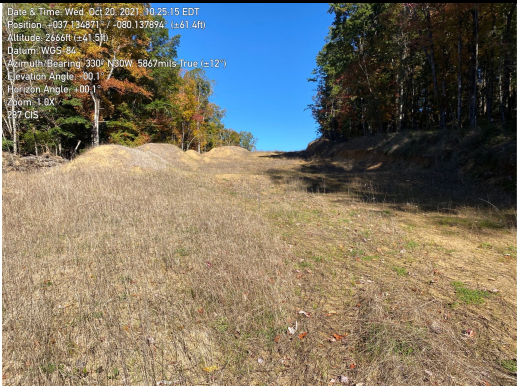
GPS Location	See photo for coordinates.		GPS Location	See photo for coordinates.	
Field Station#	12958+78		Field Station#	12955+00	
Pic 9 Desc.	S-Y7, W-Y2, S-Y8, no disturbance noted in resources.		Pic 10 Desc.	CIS of MVP-RO-287, ROW stabilized.

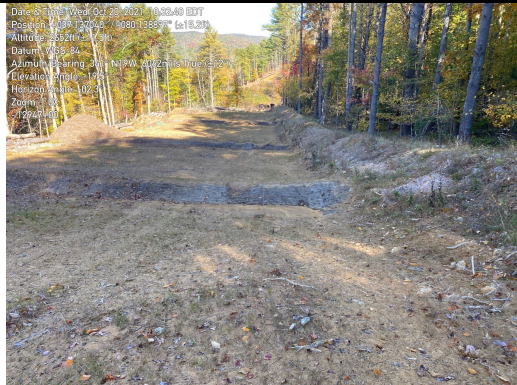
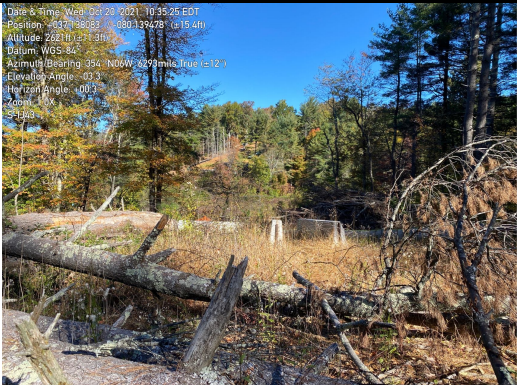
GPS Location	See photo for coordinates.		GPS Location	See photo for coordinates.	
Field Station#	12947+00		Field Station#	12942+00	
Pic 11 Desc.	ROW stabilized, waterbars in acceptable condition.		Pic 12 Desc.	GAS of S-IJ43, W-IJ36, perimeter controls in acceptable condition, no disturbance noted at stream and wetland crossing.

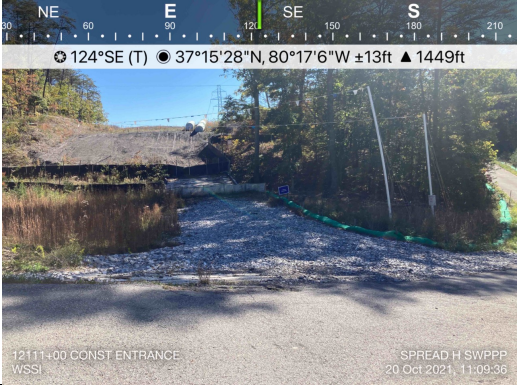
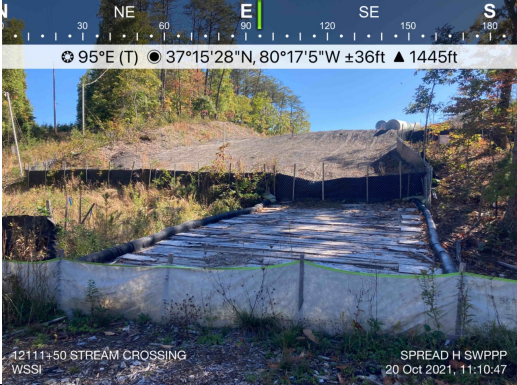
GPS Location	See Photo watermark		GPS Location	See Photo watermark	
Field Station#	12111+00		Field Station#	12111+50	
Pic 7 Desc.	Construction entrances installed at roads and in good condition. No maintenance needed.		Pic 8 Desc.	SF and SSF installed along the ROW and in good condition. No maintenance needed.

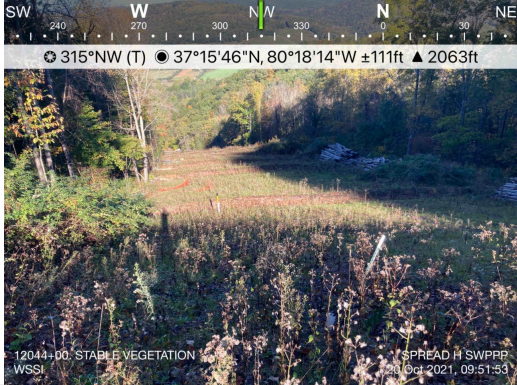
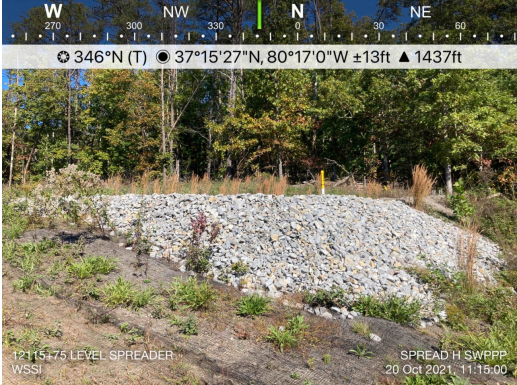
GPS Location	See Photo watermark		GPS Location	See Photo watermark	
Field Station#	12044+00		Field Station#	12115+75	
Pic 9 Desc.	Temporary vegetation established on the ROW and in good condition. No maintenance needed.		Pic 10 Desc.	Rock level spreaders installed within the ROW in good condition. No maintenance needed.

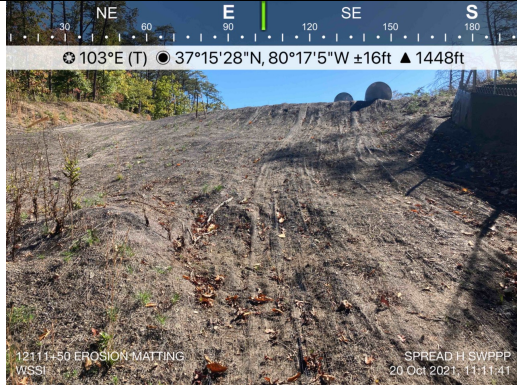
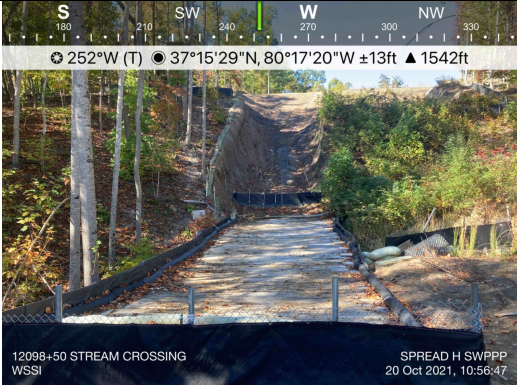
GPS Location	See Photo watermark		GPS Location	See Photo watermark	
Field Station#	12111+50		Field Station#	12098+50	
Pic 11 Desc.	Erosion control matting installed and in good condition. No maintenance needed.		Pic 12 Desc.	Buffer zones and equipment bridges at stream crossing in good condition. No maintenance needed.

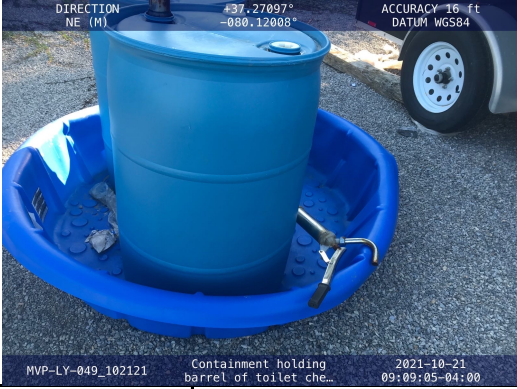
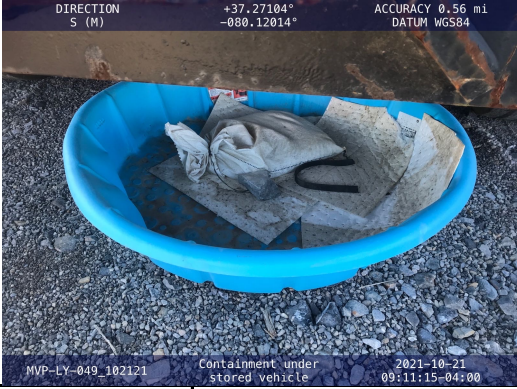
GPS Location	MVP-LY-049 See photo for gps data		GPS Location	MVP-LY-049 See photo for gps data	
Field Station#	+0		Field Station#	+0	
Pic 7 Desc.	Containment under barrel of toilet chemical. Free of fluids. Looking NE.		Pic 8 Desc.	Containment under stored vehicle. Looking S.

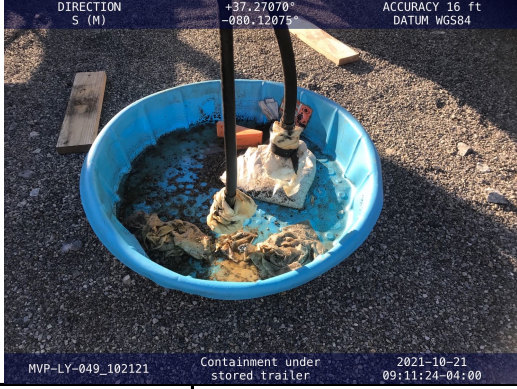
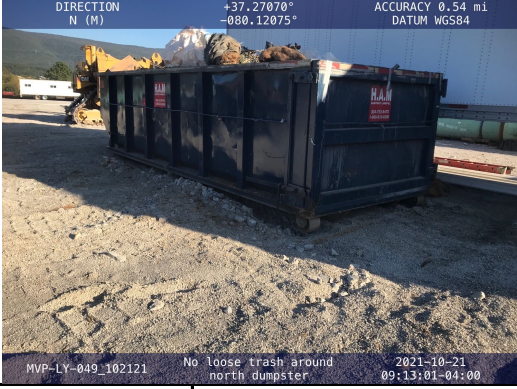
GPS Location	MVP-LY-049 See photo for gps data		GPS Location	MVP-LY-049 See photo for gps data	
Field Station#	+0		Field Station#	+0	
Pic 9 Desc.	Containment under stored trailer. Holding some fluids. Looking S.		Pic 10 Desc.	No loose trash around south dumpster or in the yard. Looking N.

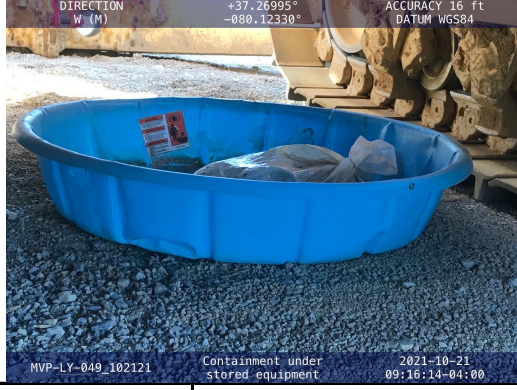
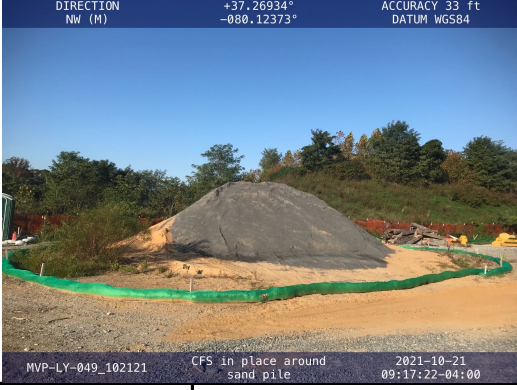
GPS Location	MVP-LY-049 See photo for gps data		GPS Location	MVP-LY-049 See photo for gps data	
Field Station#	+0		Field Station#	+0	
Pic 11 Desc.	Containment under stored equipment. Looking W.		Pic 12 Desc.	Compost filter sock in and functioning around sand pile. Looking NW.

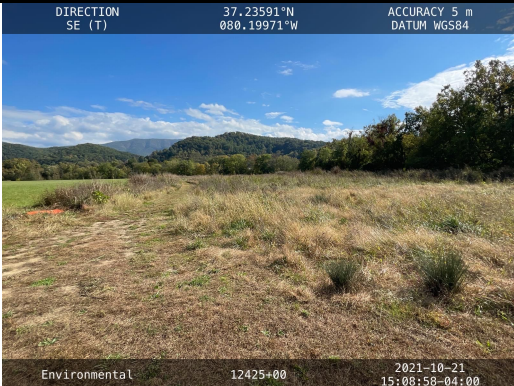
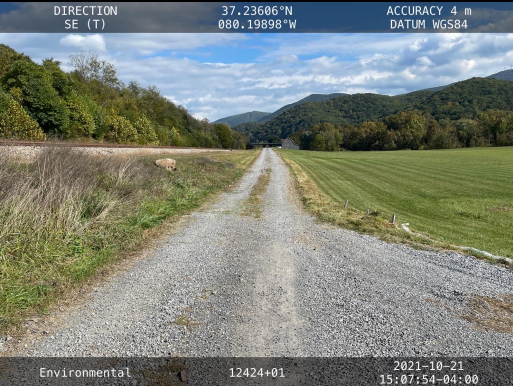
GPS Location	See photo		GPS Location	See photo	
Field Station#	12425+00		Field Station#	12424+01	
Pic 5 Desc.	Stabilized ROW conditions acceptable		Pic 6 Desc.	Access Road MVP-MN-279 in acceptable condition

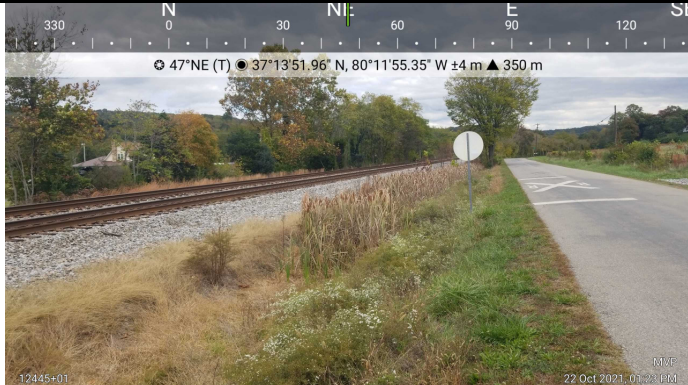
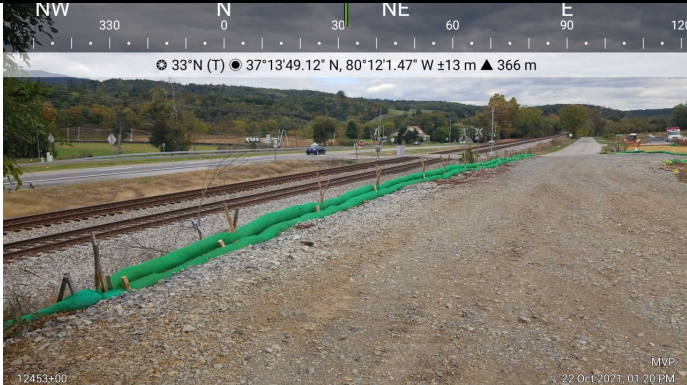
GPS Location	See Above		GPS Location	See Above	
Field Station#	12445+01		Field Station#	12453+00	
Pic 1 Desc.	Overview of Waterbody S-I1. ROW is stable. No erosion or sedimentation concerns noted.		Pic 2 Desc.	ROW Overview. ECDs are functional and ROW is stable.

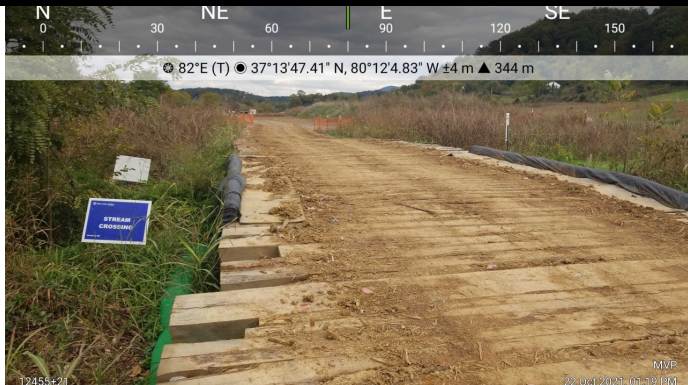
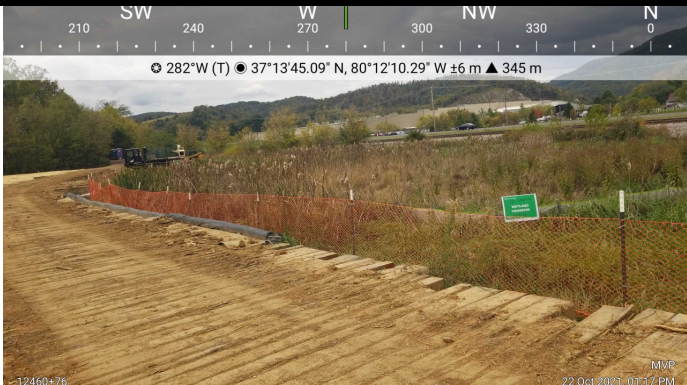
GPS Location	See Above		GPS Location	See Above	
Field Station#	12455+21		Field Station#	12460+76	
Pic 3 Desc.	Overview of Waterbody S-CD12b. ECDs are functional and ROW is stable.		Pic 4 Desc.	Overview of Wetland W-KL58. ECDs are functional and ROW is stable.

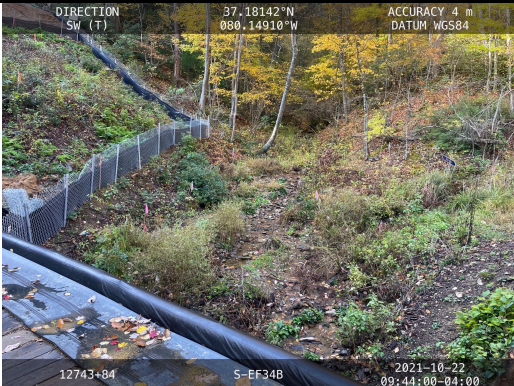
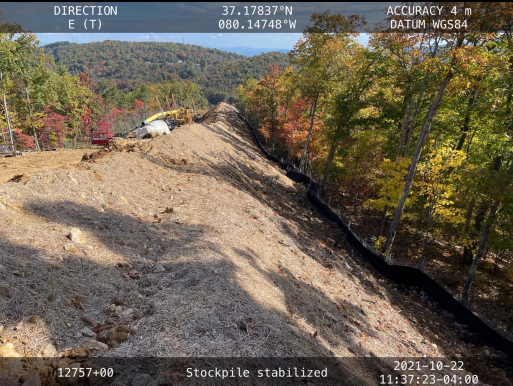
GPS Location	See photo		GPS Location	See photo	
Field Station#	12743+84		Field Station#	12757+00	
Pic 5 Desc.	Upstream of crossing at Stream S-EF34B		Pic 6 Desc.	Stockpile is stabilized
