Visual Site Inspection Report

Project Name	H-600 Pipeline Spread H	AFE	124300138	Spread	H-600 Pipeline Spread H
Contractor	Precision			Report #	30262
Inspector	Jason Nielsen			Date/Time	10/25/2021 11:49 PM
Permit #	TBD	Inspection Type	VA SWPP	Station Begin	12119+17
State	VA	Inspection Area	Partial	Station End	12284+75
County	Montgomery	Ground	Dry	Temperature (°F)	68.00
Municipality	N/A	Weather	Sunny	Rain Gauge (in)	0.00
				Rain Accumulation Time (days)	0.00

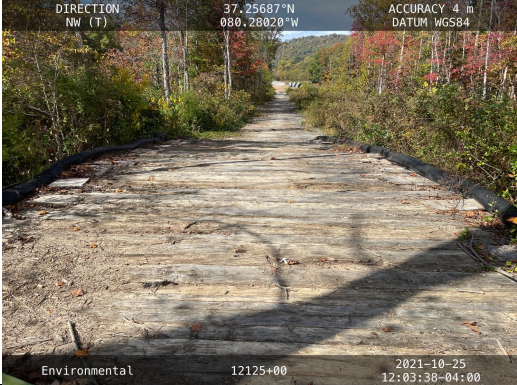
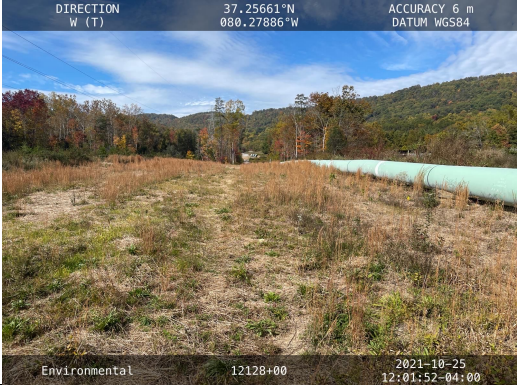
GPS Location	See photo		GPS Location	See photo	
Field Station#	12125+00		Field Station#	12128+00	
Pic 7 Desc.	Timber mat travel lane that crosses multiple streams and wetlands in acceptable condition		Pic 8 Desc.	Stabilized ROW In Acceptable condition

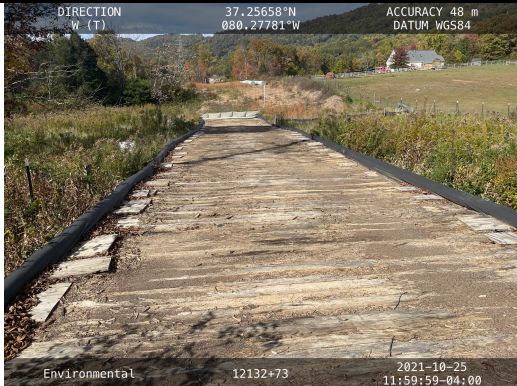
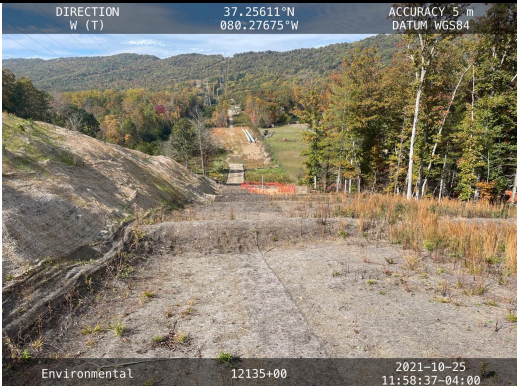
GPS Location	See photo		GPS Location	See photo	
Field Station#	12132+73		Field Station#	12135+00	
Pic 9 Desc.	Bridge and ECDs crossing stream S-C29 in acceptable condition		Pic 10 Desc.	Stabilized ROW In Acceptable condition

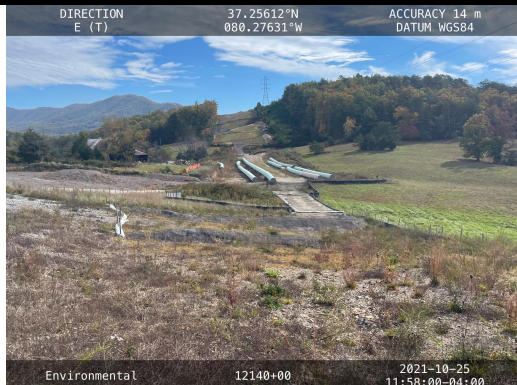
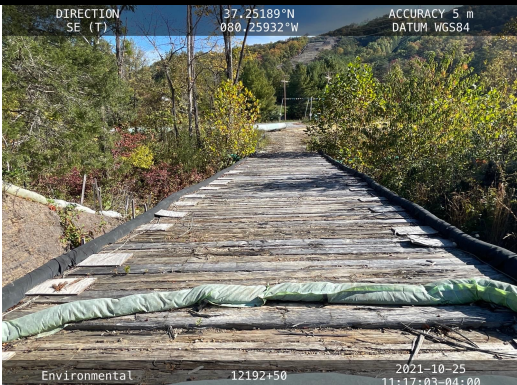
GPS Location	See photo		GPS Location	See photo	
Field Station#	12140+00		Field Station#	12192+50	
Pic 11 Desc.	Stabilized ROW In Acceptable condition		Pic 12 Desc.	Bridge and ECDs crossing stream S-C21 in acceptable condition

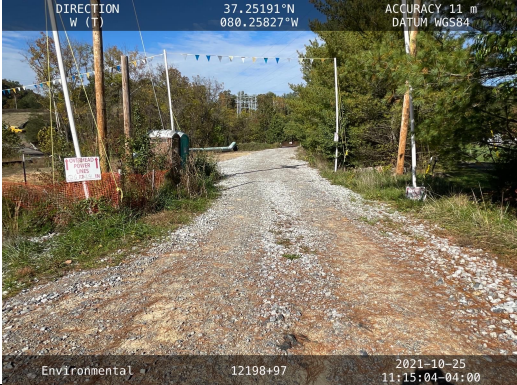
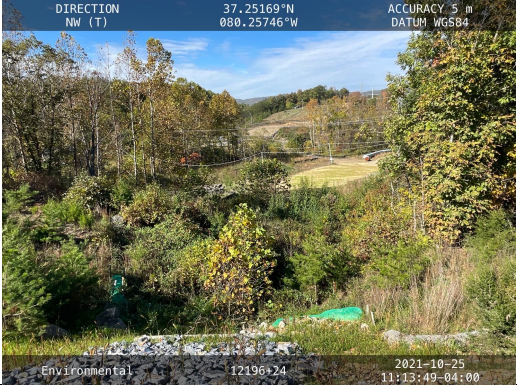
GPS Location	See photo		GPS Location	See photo	
Field Station#	12198+97		Field Station#	12196+24	
Pic 13 Desc.	Access Road MVP-MN-275 in acceptable condition		Pic 14 Desc.	Stream crossing S-OO11 In Acceptable condition

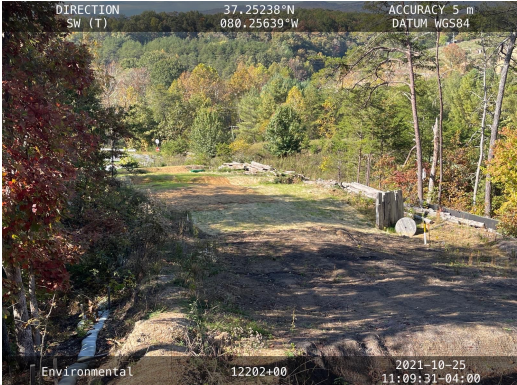
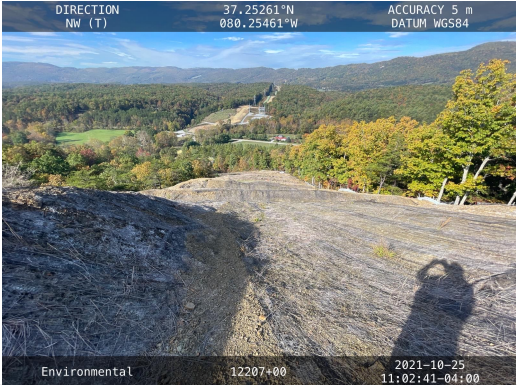
GPS Location	See photo		GPS Location	See photo	
Field Station#	12202+00		Field Station#	12207+00	
Pic 15 Desc.	Stabilized ROW In Acceptable condition		Pic 16 Desc.	Stabilized ROW In Acceptable condition

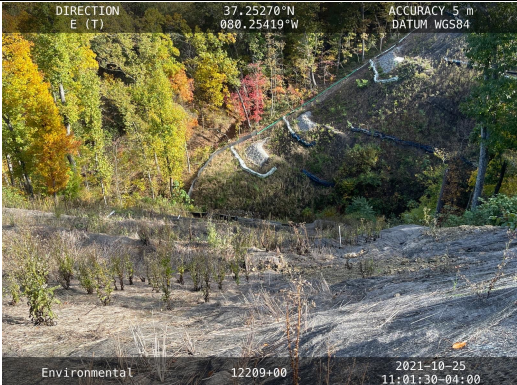
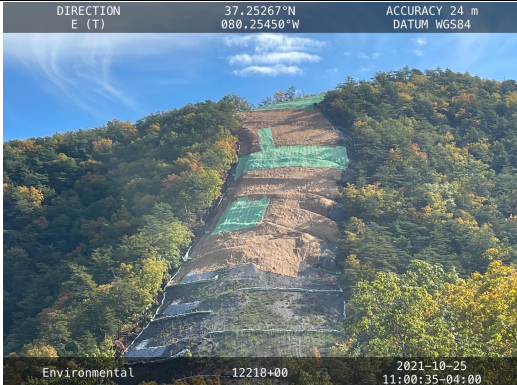
GPS Location	See photo		GPS Location	See photo	
Field Station#	12209+00		Field Station#	12218+00	
Pic 17 Desc.	Stabilized drainage feature in acceptable condition		Pic 18 Desc.	Stabilized ROW in acceptable condition

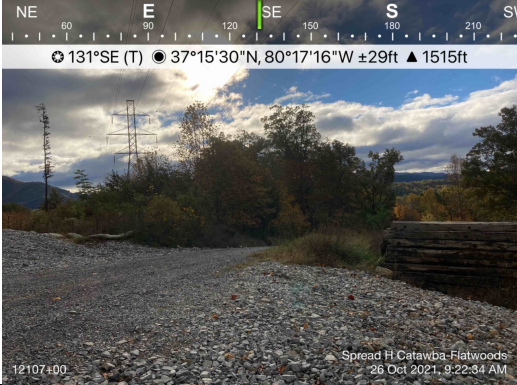
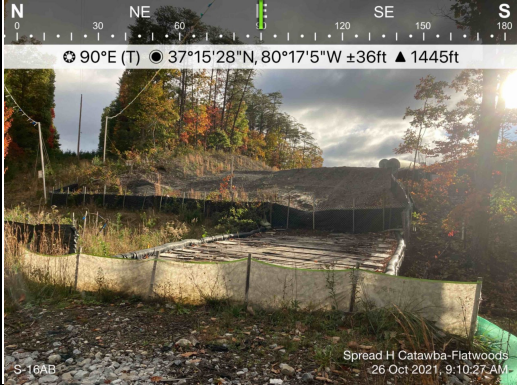
GPS Location	See photo above		GPS Location	See photo above	
Field Station#	12107+00		Field Station#	12111+50	
Pic 13 Desc.	Gravel construction entrance and access road are in good condition.		Pic 14 Desc.	Timber mat stream crossing as well as silt fence is functional and no maintenance is needed.

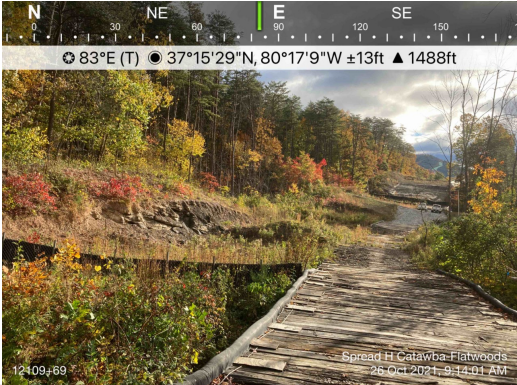
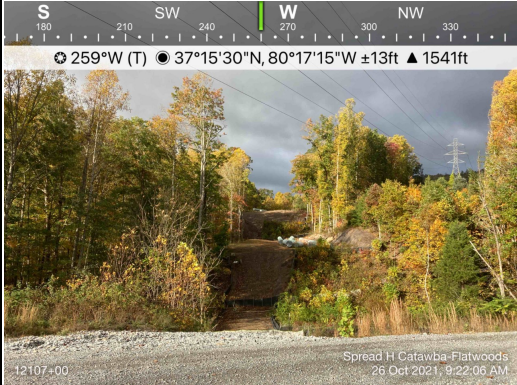
GPS Location	See photo above		GPS Location	See photo above	
Field Station#	12109+69		Field Station#	12107+00	
Pic 15 Desc.	Stream crossing and adjacent wetlands is in good condition.		Pic 16 Desc.	Access road to ROW are well maintained.

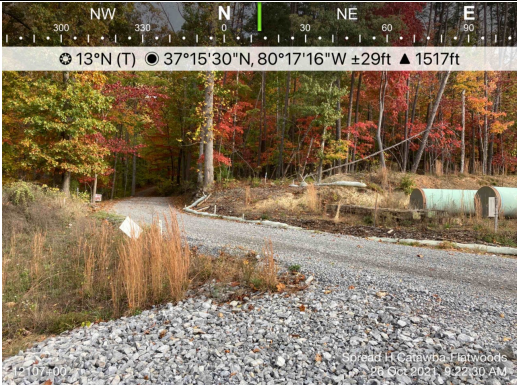
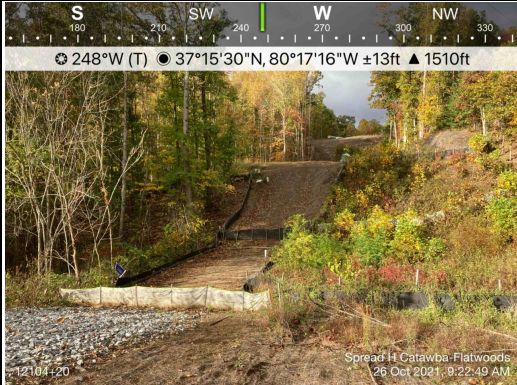
GPS Location	See photo above		GPS Location	See photo above	
Field Station#	12107+00		Field Station#	12104+20	
Pic 17 Desc.	Access road and construction entrance are in good condition.		Pic 18 Desc.	Silt fence and erosion control measures are present and need no maintenance.

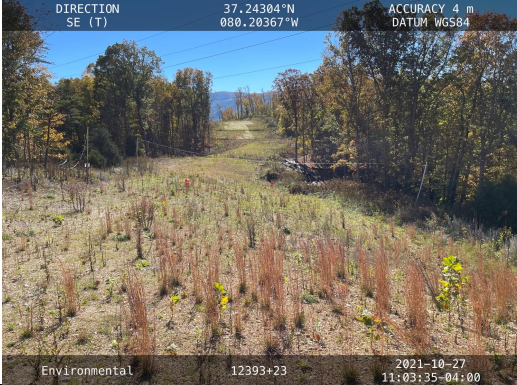
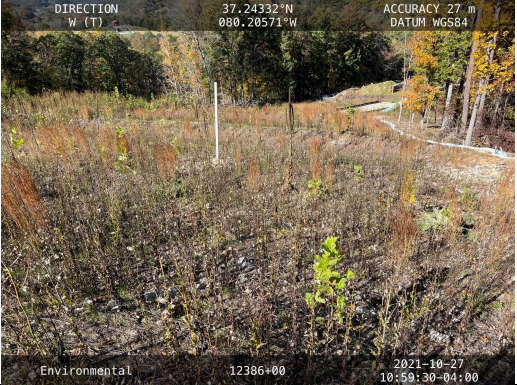
GPS Location	See photo		GPS Location	See photo	
Field Station#	12393+23		Field Station#	12386+00	
Pic 13 Desc.	Stabilized ROW in acceptable condition		Pic 14 Desc.	Stabilized ROW in acceptable condition

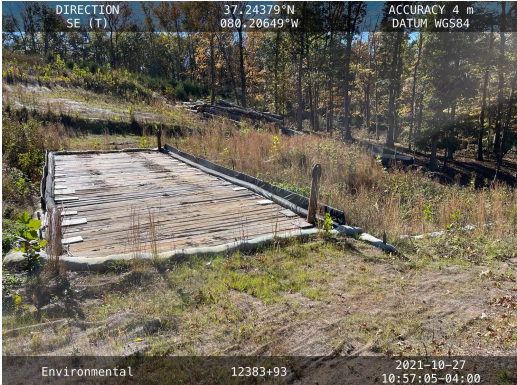
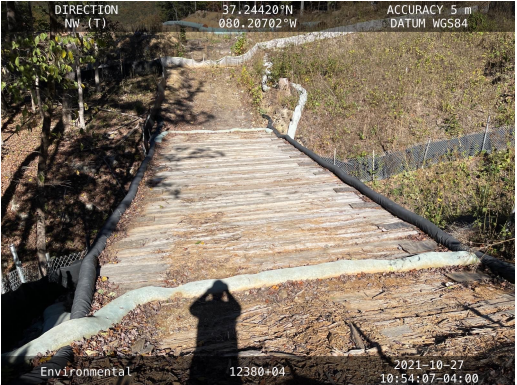
GPS Location	See photo		GPS Location	See photo	
Field Station#	12383+93		Field Station#	12380+04	
Pic 15 Desc.	Clean water crossing in acceptable condition		Pic 16 Desc.	Bridge and ECDs crossing stream S-NN19 in acceptable condition

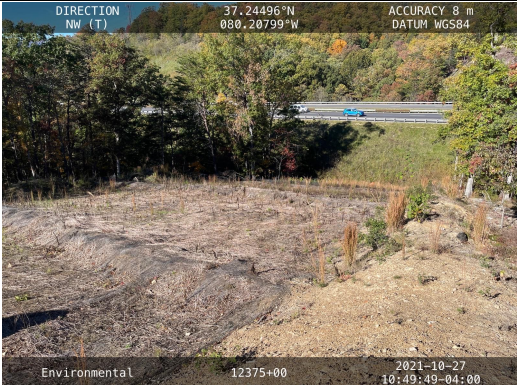
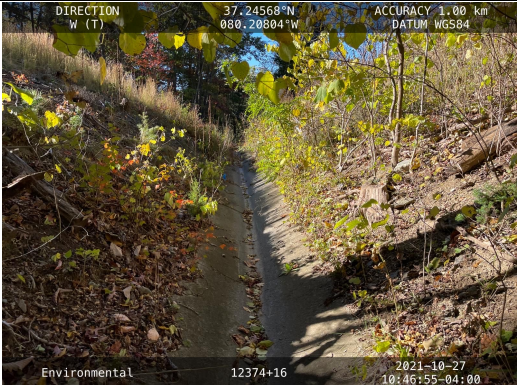
GPS Location	See photo		GPS Location	See photo	
Field Station#	12375+00		Field Station#	12374+16	
Pic 17 Desc.	Stabilized ROW in acceptable condition		Pic 18 Desc.	Stream crossing S-0016 in acceptable condition
