# Visual Site Inspection Report

<b>Project Name</b>	H-600 Pipeline Spread H	<b>AFE</b>	124300138	<b>Spread</b>	H-600 Pipeline Spread H
<b>Contractor</b>	Precision			<b>Report #</b>	29306
<b>Inspector</b>	Joe Scott			<b>Date/Time</b>	10/4/2021 6:04 PM
<b>Permit #</b>	TBD	<b>Inspection Type</b>	VA SWPP	<b>Station Begin</b>	12865+00
<b>State</b>	VA	<b>Inspection Area</b>	Partial	<b>Station End</b>	13024+00
<b>County</b>	Roanoke	<b>Ground</b>	Wet	<b>Temperature (°F)</b>	71.00
<b>Municipality</b>	N/A	<b>Weather</b>	Cloudy	<b>Rain Gauge (in)</b>	0.60
				<b>Rain Accumulation Time (days)</b>	1.00

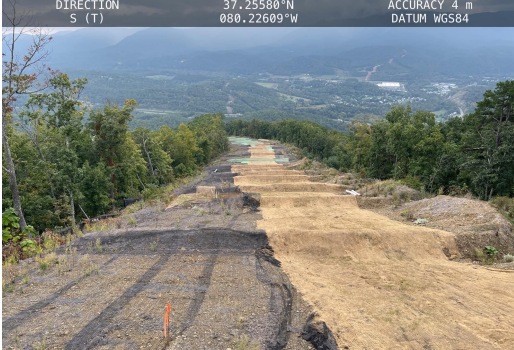
<div>Environmental</div> <div>12300+00</div> <div>2021-10-05 13:36:26-04:00</div> </div>		<div> <div>DIRECTION N (T)</div> <div>37.24416°N 080.20717°W</div> <div>ACCURACY 14 m DATUM WGS84</div>

<b>GPS Location</b>	See photo		<b>GPS Location</b>	See photo	
<b>Field Station#</b>	12300+00		<b>Field Station#</b>	12380+04	
<b>Pic 3 Desc.</b>	Stabilized ROW in acceptable condition		<b>Pic 4 Desc.</b>	Bridge and ECDs crossing stream S-NN19 in acceptable condition	
<div> <div>DIRECTION W (T)</div> <div>37.24357°N 080.20614°W</div> <div>ACCURACY 11 m DATUM WGS84</div>

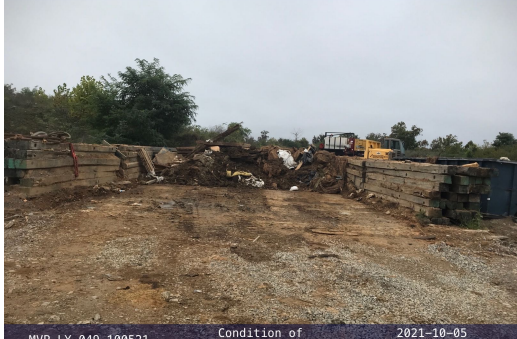
MVP-LY-049_100521 Condition of temporary trash tran... 2021-10-05 08:58:03-04:00		DIRECTION SW (M) +37.27063° -080.12361° ACCURACY 16 ft DATUM WGS84

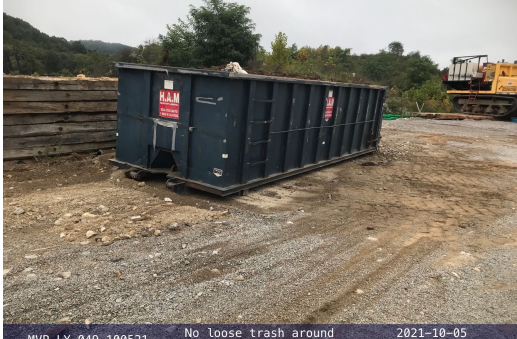
MVP-LY-049_100521 No loose trash around north dumpster 2021-10-05 08:58:13-04:00

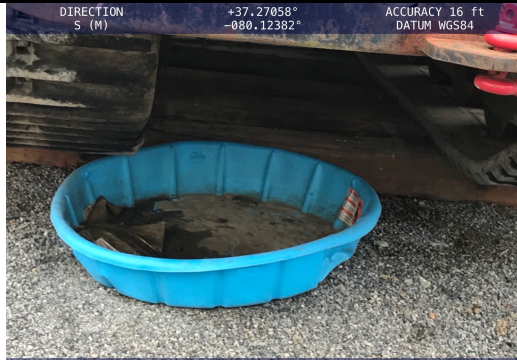
MVP-LY-049_100521 Containment under stored equipment 2021-10-05 08:58:28-04:00		DIRECTION W (M) +37.26966° -080.12407° ACCURACY 16 ft DATUM WGS84

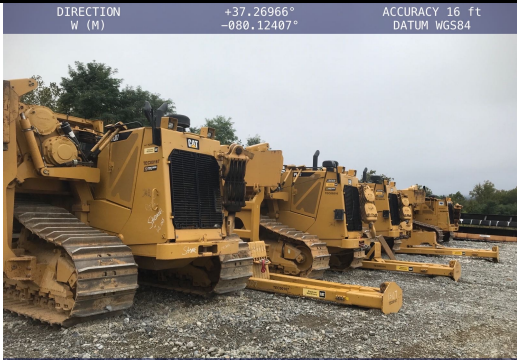
MVP-LY-049_100521 Check parked equipment for leaks 2021-10-05 09:01:33-04:00			
<b>GPS Location</b>	MVP-LY-049 See photo for gps data		<b>GPS Location</b>	MVP-LY-049 See photo for gps data	
<b>Field Station#</b>	+0		<b>Field Station#</b>	+0	
<b>Pic 11 Desc.</b>	Secondary containment under stored equipment. Holding some fluids. Looking S.		<b>Pic 12 Desc.</b>	Check parked equipment for leaks. No new leaks located. Looking NW.

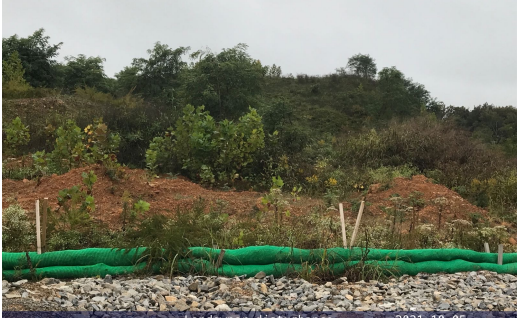
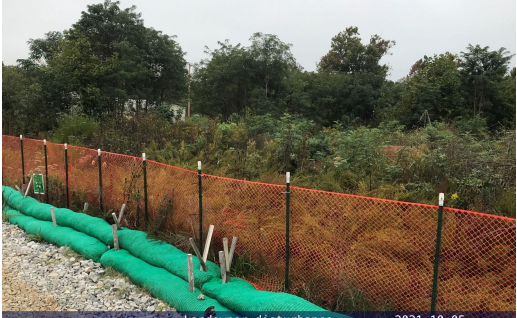
MVP-LY-049_100521 Landowner disturbance along CFS 2021-10-05 08:58:36-04:00		MVP-LY-049_100521 Landowner disturbance along feature 2021-10-05 08:59:15-04:00			
<b>GPS Location</b>	MVP-LY-049 See photo for gps data		<b>GPS Location</b>	MVP-LY-049 See photo for gps data	
<b>Field Station#</b>	+0		<b>Field Station#</b>	+0	
<b>Pic 13 Desc.</b>	Landowner soil disturbance along triple stack compost filter sock. No new damage to installed ECD's. Looking SW.		<b>Pic 14 Desc.</b>	Landowner soil disturbance along edge of feature W-CV21A. Area not stabilized. Not project related. Looking SW.	
DIRECTION S (M) +37.27046° -080.12464° ACCURACY 16 ft DATUM WGS84		DIRECTION E (M) +37.27043° -080.12471° ACCURACY 16 ft DATUM WGS84

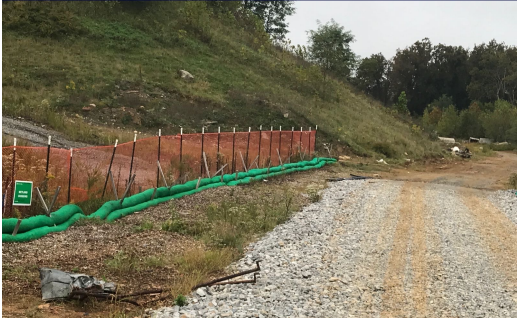
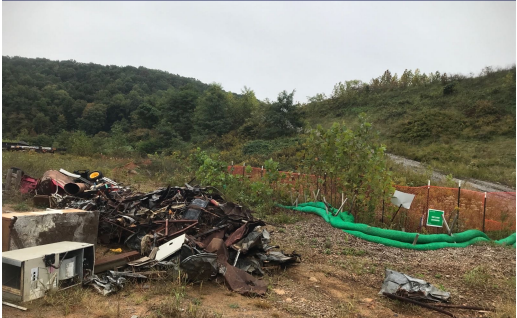
MVP-LY-049_100521 Landowner disturbance west of feature 2021-10-05 08:59:20-04:00		MVP-LY-049_100521 Landowner disturbance & debris along CFS 2021-10-05 08:59:39-04:00			
<b>GPS Location</b>	MVP-LY-049 See photo for gps data		<b>GPS Location</b>	MVP-LY-049 See photo for gps data	
<b>Field Station#</b>	+0		<b>Field Station#</b>	+0	
<b>Pic 15 Desc.</b>	Landowner soil disturbance west of feature W-CV21B. Areas not stabilized. Looking SW.		<b>Pic 16 Desc.</b>	Landowner soil disturbance and debris piled along triple stack compost filter sock and east of feature W-CV21B. Looking E.	
DIRECTION SW (M) +37.27315° -080.11979° ACCURACY 1.25 m DATUM WGS84		DIRECTION E (M) +37.26951° -080.12212° ACCURACY 98 ft DATUM WGS84

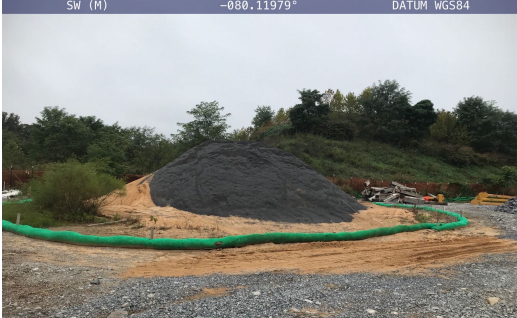
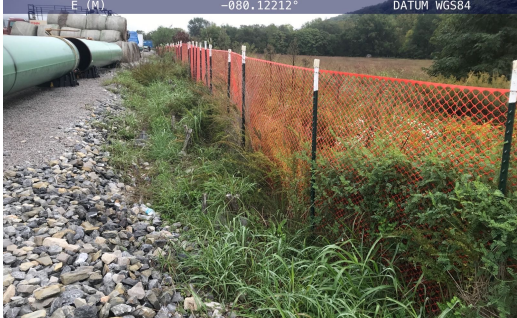
MVP-LY-049_100521 CFS in place around sand pile 2021-10-05 09:01:14-04:00		MVP-LY-049_100521 Condition of CFS & safety fence LOD 2021-10-05 09:03:49-04:00			
<b>GPS Location</b>	MVP-LY-049 See photo for gps data		<b>GPS Location</b>	MVP-LY-049 See photo for gps data

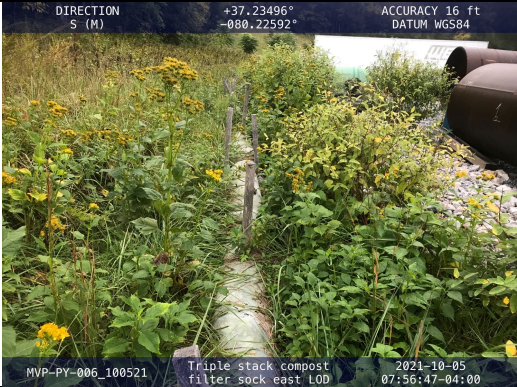
<p>DIRECTION S (M) +37.23496° -080.22592° ACCURACY 16 ft DATUM WGS84 MVP-PY-006_100521 Triple stack compost filter sock east LOD 2021-10-05 07:56:47-04:00</p>

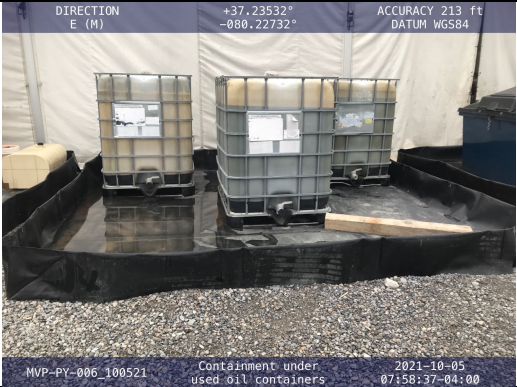
<p>DIRECTION E (M) +37.23532° -080.22732° ACCURACY 213 ft DATUM WGS84 MVP-PY-006_100521 Containment under used oil containers 2021-10-05 07:58:37-04:00</p>			
<b>GPS Location</b>	MVP-PY-006 See photo for gps data		<b>GPS Location</b>	MVP-PY-006 See photo for gps data	
<b>Field Station#</b>	+0		<b>Field Station#</b>	+0	
<b>Pic 13 Desc.</b>	Condition of triple stack compost filter sock along east LOD. Over grown with vegetation. Looking S.		<b>Pic 14 Desc.</b>	Secondary containment under used oil containers. Holding stormwater. Looking E.

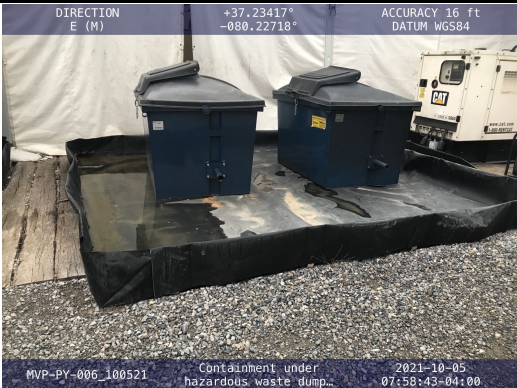
<p>DIRECTION E (M) +37.23417° -080.22718° ACCURACY 16 ft DATUM WGS84 MVP-PY-006_100521 Containment under hazardous waste dump... 2021-10-05 07:58:43-04:00</p>

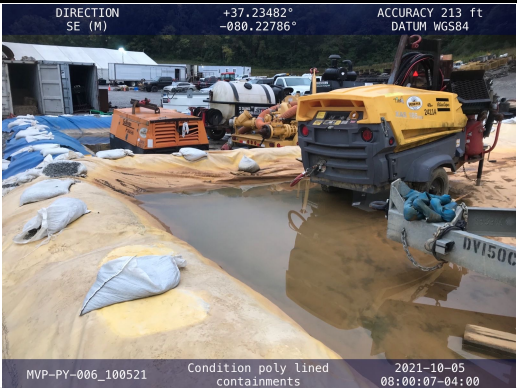
<p>DIRECTION SE (M) +37.23482° -080.22786° ACCURACY 213 ft DATUM WGS84 MVP-PY-006_100521 Condition poly lined containments 2021-10-05 08:00:07-04:00</p>

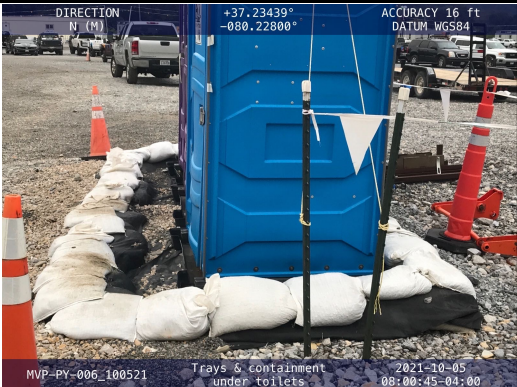
<p>DIRECTION N (M) +37.23439° -080.22800° ACCURACY 16 ft DATUM WGS84 MVP-PY-006_100521 Trays &amp; containment under toilets 2021-10-05 08:00:43-04:00</p>

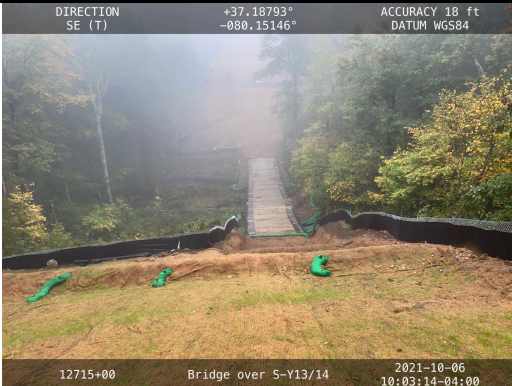
<p>DIRECTION SE (T) +37.18793° -080.15146° ACCURACY 18 ft DATUM WGS84</p> <p>12715+00 Bridge over S-Y13/14 2021-10-06 10:03:14-04:00</p>

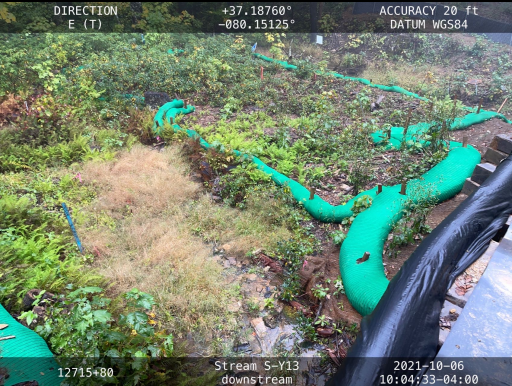
<p>DIRECTION E (T) +37.18760° -080.15125° ACCURACY 20 ft DATUM WGS84</p> <p>12715+80 Stream S-Y13 downstream 2021-10-06 10:04:33-04:00</p>			
<b>GPS Location</b>	See photo for gps location data		<b>GPS Location</b>	See photo for gps location data	
<b>Field Station#</b>	12715+00		<b>Field Station#</b>	12715+80	
<b>Pic 5 Desc.</b>	Photo shows the bridge over streams S-Y13 and S-Y14		<b>Pic 6 Desc.</b>	Photo shows the stream S-Y13 downstream from the bridge

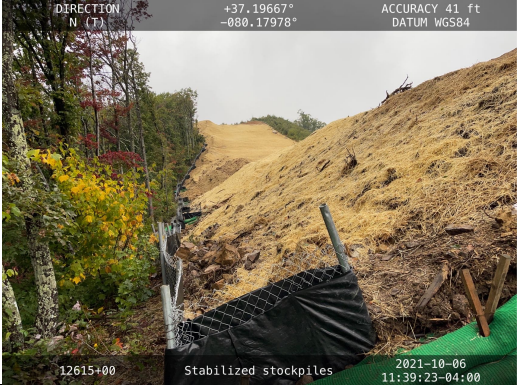
<p>DIRECTION N (T) +37.19667° -080.17978° ACCURACY 41 ft DATUM WGS84</p> <p>12615+00 Stabilized stockpiles 2021-10-06 11:39:23-04:00</p>

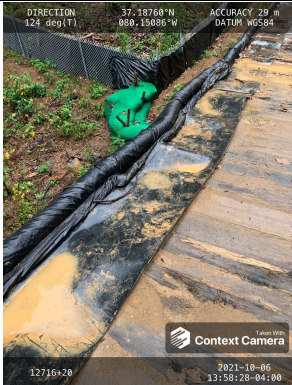
<p>DIRECTION 124 deg(T) 37.19768° N 880.15086° W ACCURACY 29 ft DATUM WGS84</p> <p>12716+20 2021-10-06 13:58:28-04:00</p>		<p>ert image here</p>	
<b>GPS Location</b>	See photo for gps location data		<b>GPS Location</b>	See photo for gps location data	
<b>Field Station#</b>	12703+50		<b>Field Station#</b>	12716+20	
<b>Pic 17 Desc.</b>	Photo shows the waterbars after the sediment was cleaned out		<b>Pic 18 Desc.</b>	Photo shows the bridge over stream S-Y14 after the geotechnical fabric was repaired

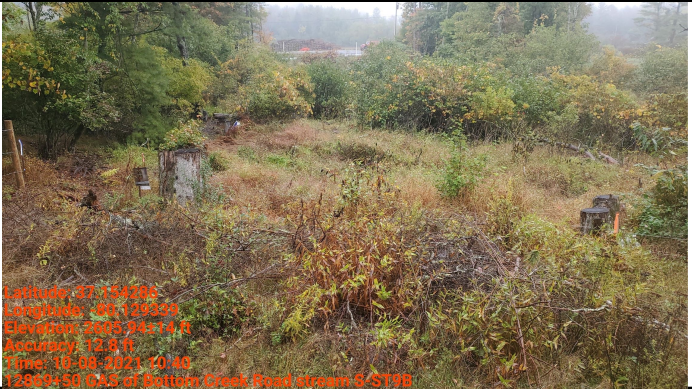
<p>Latitude: 37.150296 Longitude: -80.129324 Elevation: 2625.9±14 ft Accuracy: 13.8 ft Time: 10-08-2021 10:40 12869+50 GAS of Bottom Creek Road stream S-ST9B</p>

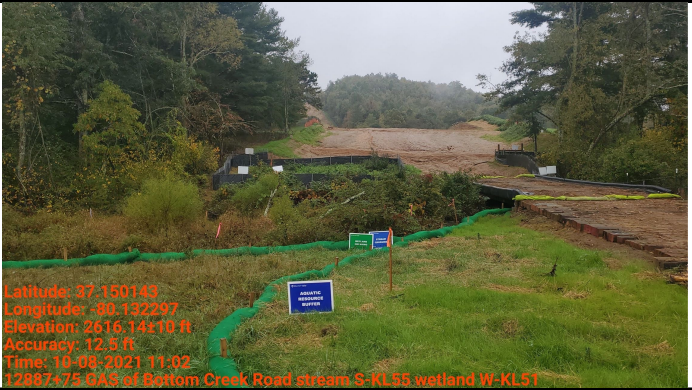
<p>Latitude: 37.150143 Longitude: -80.132297 Elevation: 2616.1±10 ft Accuracy: 12.5 ft Time: 10-08-2021 11:02 12887+75 GAS of Bottom Creek Road stream S-KL55 wetland W-KL51</p>			
<b>GPS Location</b>	See pic for GPS location.		<b>GPS Location</b>	See pic for GPS location.	
<b>Field Station#</b>	12886+75		<b>Field Station#</b>	12887+75	
<b>Pic 5 Desc.</b>	Wetland crossing W-KL49 from the CIS.		<b>Pic 6 Desc.</b>	Wetland W-KL51 and stream S-KL55 from the CIS.
