Visual Site Inspection Report

Project Name	H-600 Pipeline Spread H	AFE	124300138	Spread	H-600 Pipeline Spread H
Contractor	Precision			Report #	31181
Inspector	Tanner Cullop			Date/Time	11/15/2021 1:21 PM
Permit #	TBD	Inspection Type	VA SWPP	Station Begin	13316+21
State	VA	Inspection Area	Partial	Station End	13422+00
County	Franklin	Ground	Damp	Temperature (°F)	43.00
Municipality	N/A	Weather	Sunny	Rain Gauge (in)	0.00
				Rain Accumulation Time (days)	0.00

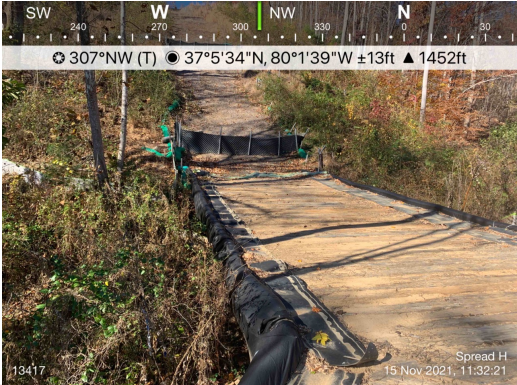
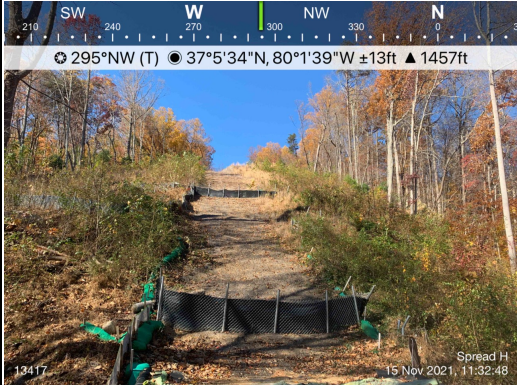
GPS Location	See photo above		GPS Location	See photo above	
Field Station#	13417+00		Field Station#	13417+50	
Pic 15 Desc.	Timber mat bridge and super silt fence is in acceptable condition crossing S-IJ1.		Pic 16 Desc.	Slope has been stabilized and controls are functioning properly.

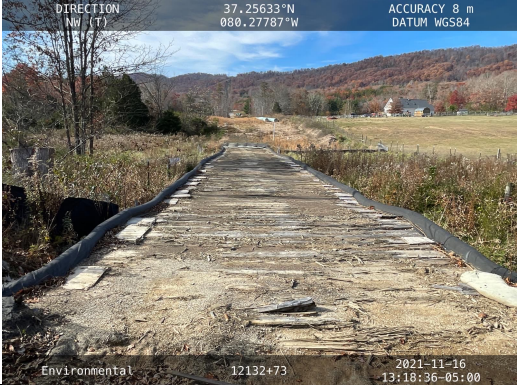
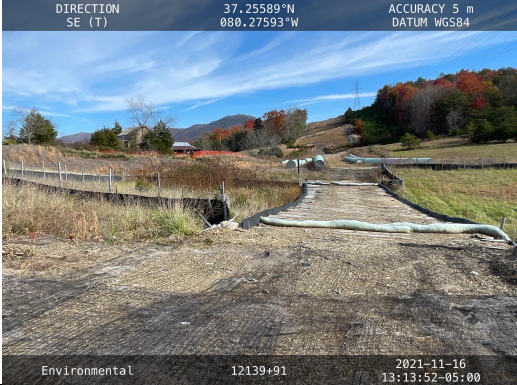
GPS Location	See photo		GPS Location	See photo	
Field Station#	12132+73		Field Station#	12139+91	
Pic 7 Desc.	Bridge and ECDs crossing stream S-C29 in acceptable condition		Pic 8 Desc.	Wetland crossing W-C6 in acceptable condition

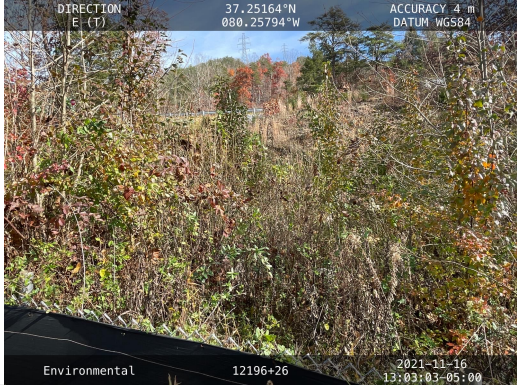
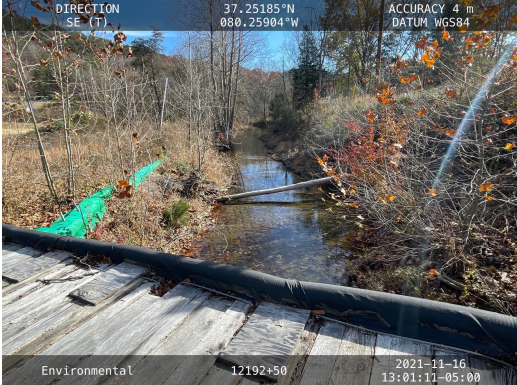
GPS Location	See photo		GPS Location	See photo	
Field Station#	12196+26		Field Station#	12192+50	
Pic 9 Desc.	Stream crossing S-0011 in acceptable condition		Pic 10 Desc.	Down stream of S-C21 in acceptable condition

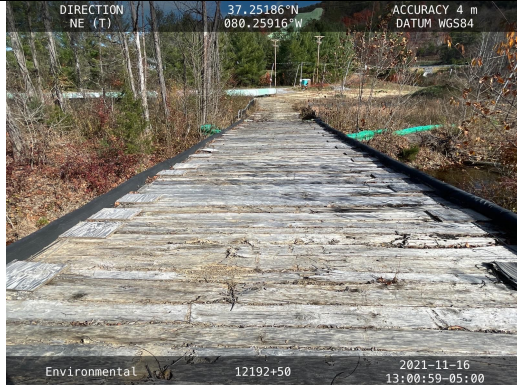
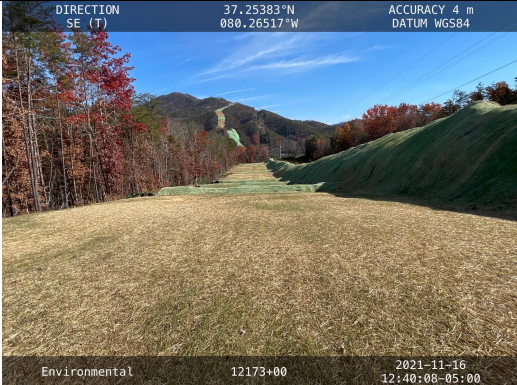
GPS Location	See photo		GPS Location	See photo	
Field Station#	12192+50		Field Station#	12173+00	
Pic 11 Desc.	Bridge and ECDs crossing stream S-C21 in acceptable condition		Pic 12 Desc.	Stabilized ROW conditions

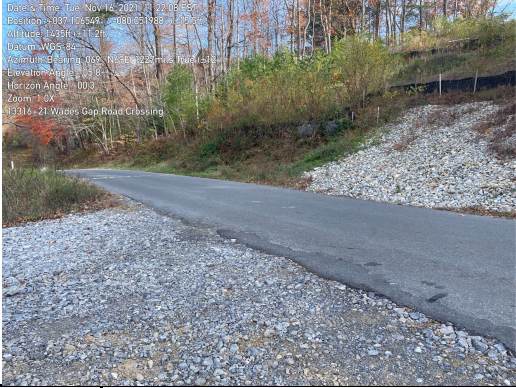
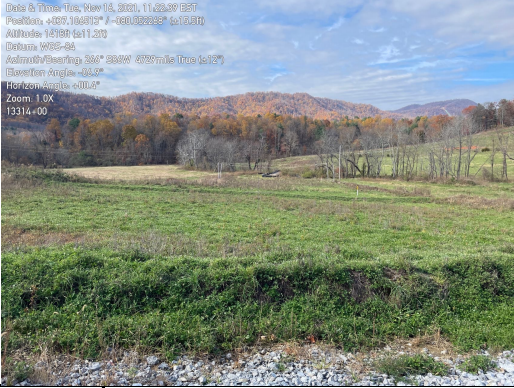
GPS Location	0	GPS Location	0		
Field Station#	13316+21	Field Station#	13314+00		
Pic 1 Desc.	Wades Gap Road Crossing in good condition		Pic 2 Desc.	ROW and ECDs In good condition with good vegetation established across ROW

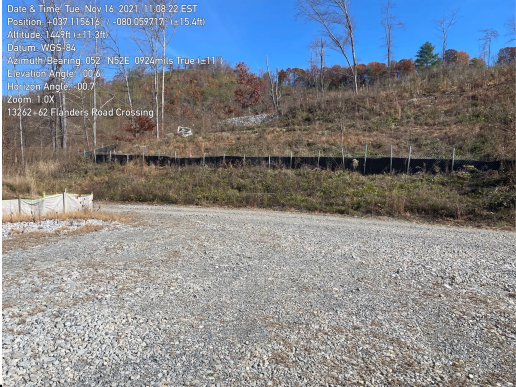
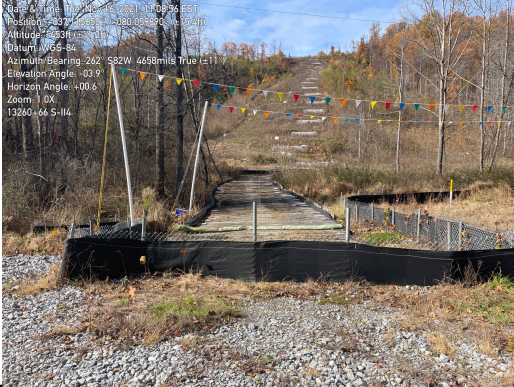
GPS Location	0	GPS Location	0		
Field Station#	13262+62	Field Station#	13260+66		
Pic 3 Desc.	Flanders Road Crossing in good condition		Pic 4 Desc.	MVP-S-II4 and Corresponding buffer zone in good condition

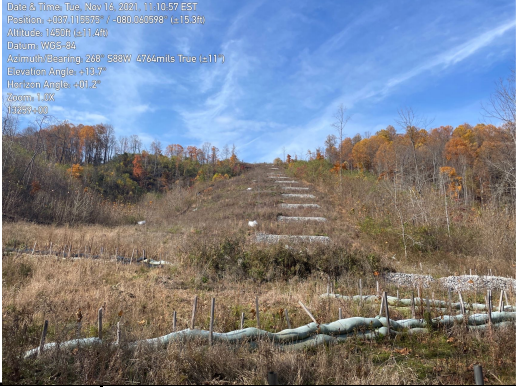
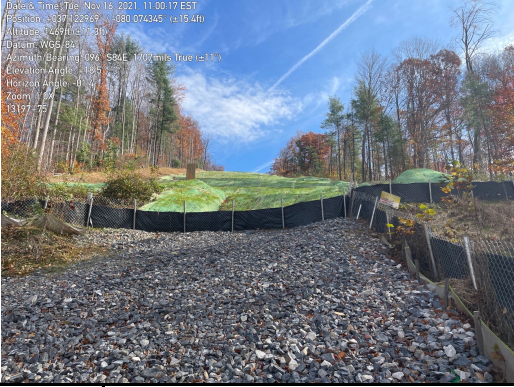
GPS Location	0	GPS Location	0		
Field Station#	13259+00	Field Station#	13197+75		
Pic 5 Desc.	ROW and ECDs In good condition with good vegetation established across ROW		Pic 6 Desc.	ROW and ECDs In good condition and stable

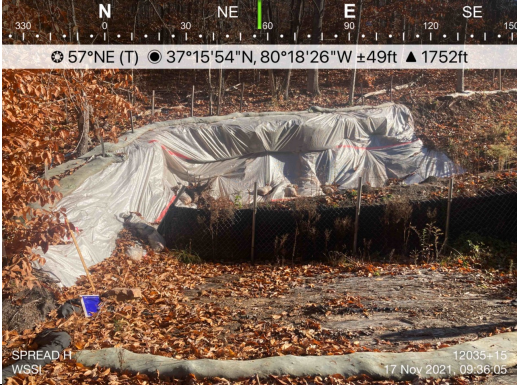
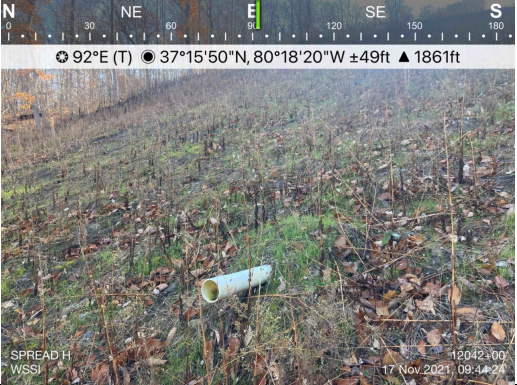
GPS Location	See photo watermark		GPS Location	See photo watermark	
Field Station#	12031+51		Field Station#	12042+00	
Pic 13 Desc.	Stream and controls at S-G39 in good condition. No maintenance needed.		Pic 14 Desc.	Trench drains installed along the ROW are in good condition. No maintenance needed.

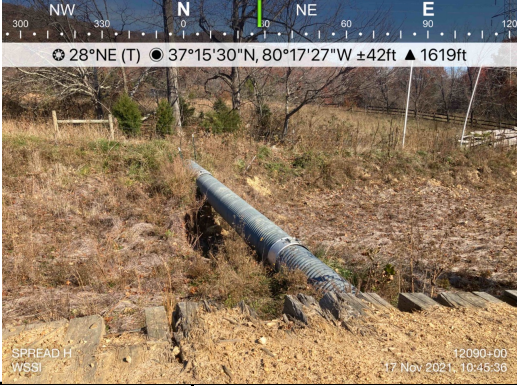
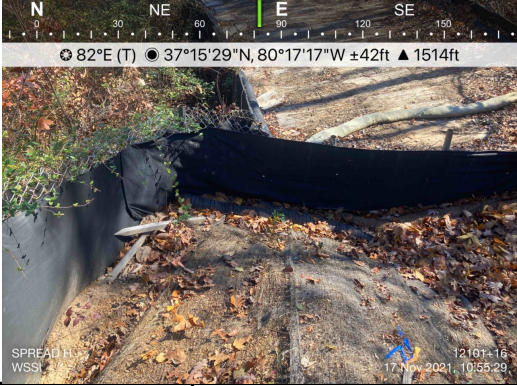
GPS Location	See photo watermark		GPS Location	See photo watermark	
Field Station#	12090+00		Field Station#	12101+16	
Pic 17 Desc.	CWD pipe installed and functioning properly. No maintenance needed.		Pic 18 Desc.	Installed SSF on ROW in good condition. No maintenance needed.

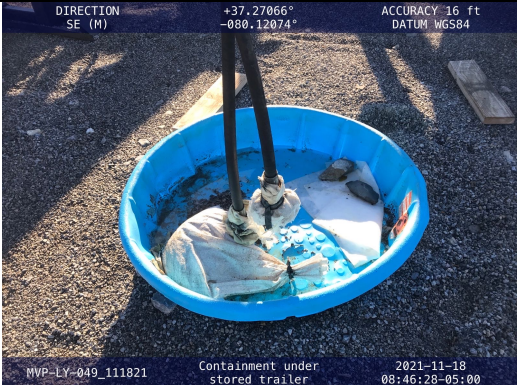
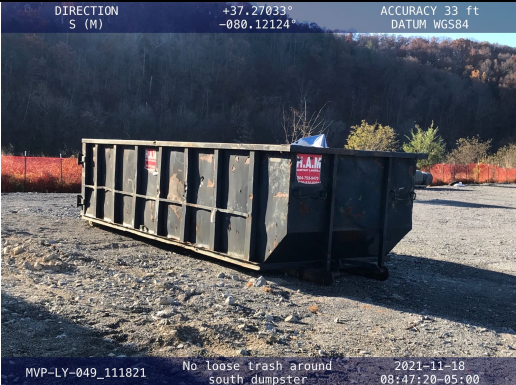
GPS Location	MVP-LY-049 See photo for gps data		GPS Location	MVP-LY-049 See photo for gps data	
Field Station#	+0		Field Station#	+0	
Pic 7 Desc.	Secondary containment under stored trailer. Holding fluids. Looking SE.		Pic 8 Desc.	No loose trash around south dumpster or in the yard. Looking S.

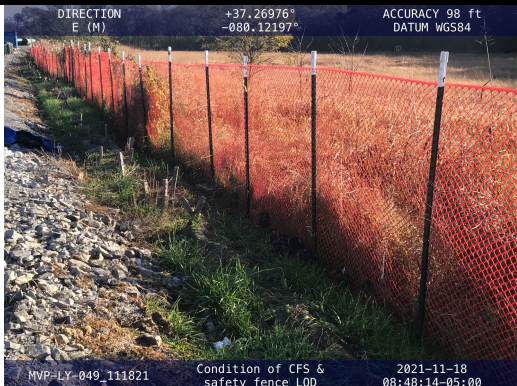
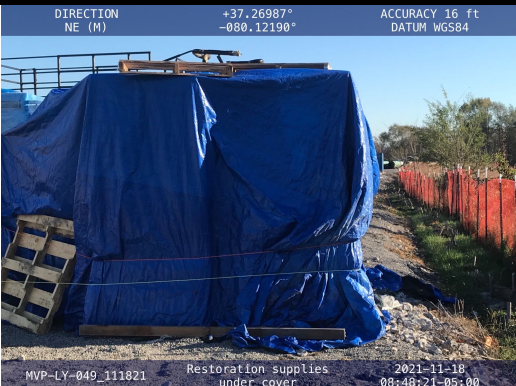
GPS Location	MVP-LY-049 See photo for gps data		GPS Location	MVP-LY-049 See photo for gps data	
Field Station#	+0		Field Station#	+0	
Pic 9 Desc.	Condition of triple stack compost filter sock and safety fence along south LOD. Over grown with vegetation. Looking E.		Pic 10 Desc.	Restoration supplies under cover. Looking NE.

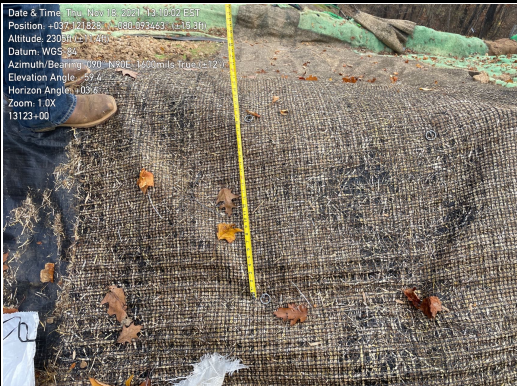
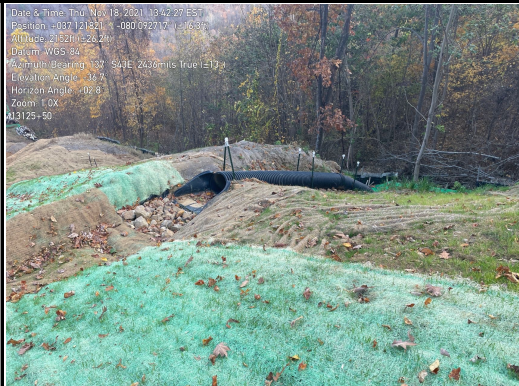
GPS Location		0		GPS Location		0					
Field Station#		13123+00		Field Station#		13125+50					
Pic 15 Desc.		Gripple pins installed at 2' spacing		Pic 16 Desc.		Slope drain pipe in good condition and functioning properly

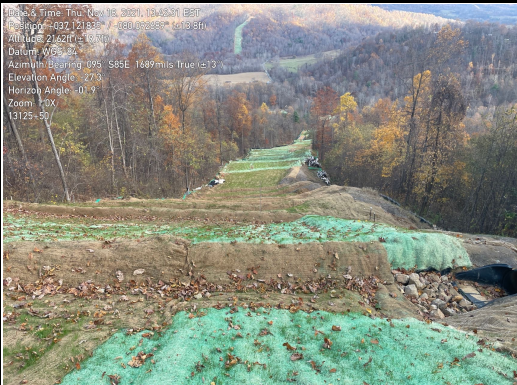
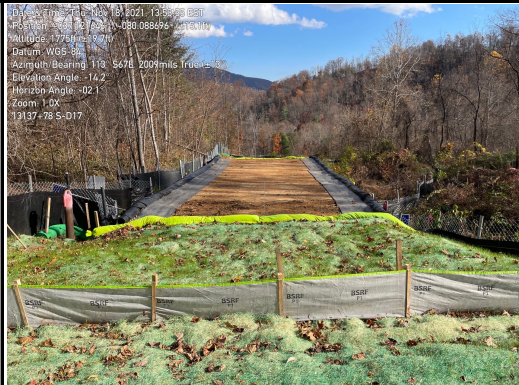
GPS Location		0		GPS Location		0					
Field Station#		13125+50		Field Station#		13137+78					
Pic 17 Desc.		ROW and ECDs in good condition and stable		Pic 18 Desc.		MVP-S-D17 and Corresponding buffer zone in good condition

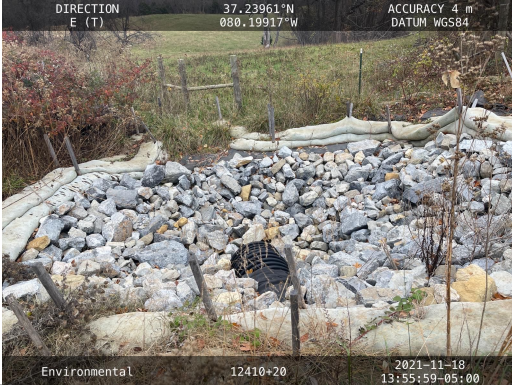
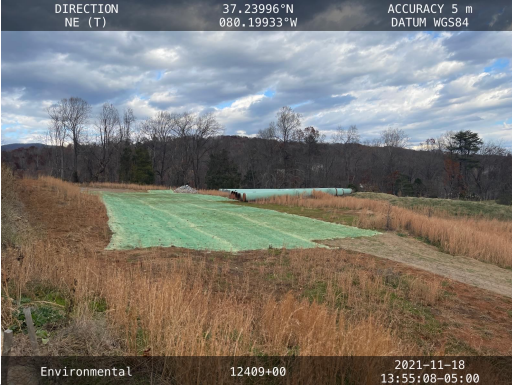
GPS Location	See photo		GPS Location	See photo	
Field Station#	12410+20		Field Station#	12409+00	
Pic 3 Desc.	Clean water crossing pipe outlet		Pic 4 Desc.	Stabilized ROW conditions

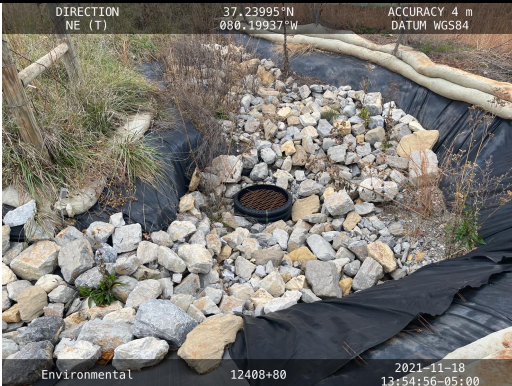
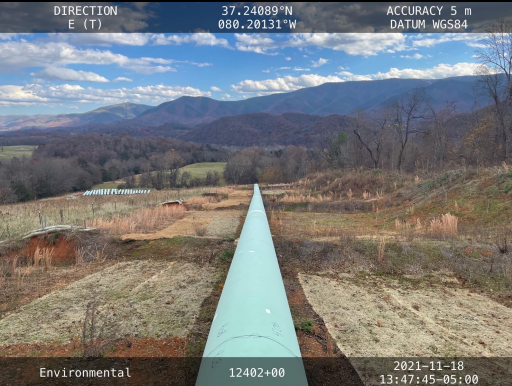
GPS Location	See photo		GPS Location	See photo	
Field Station#	12408+80		Field Station#	12402+00	
Pic 5 Desc.	Clean water crossing pipe inlet		Pic 6 Desc.	Stabilized ROW conditions

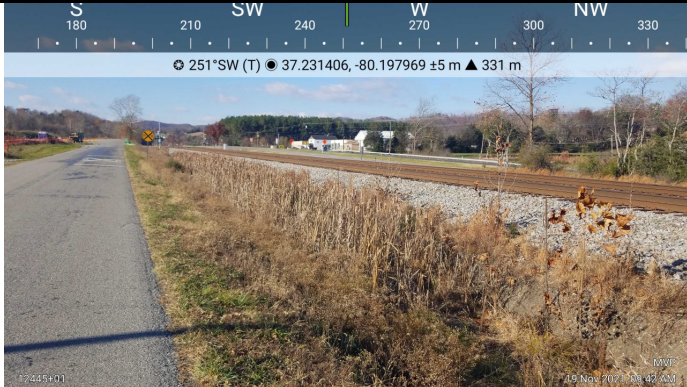
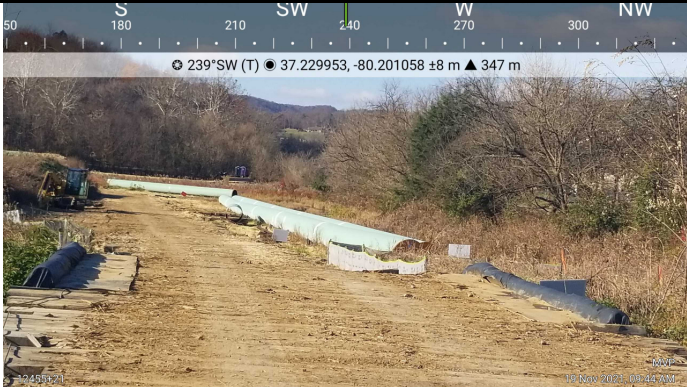
GPS Location	See Above	GPS Location	See Above		
Field Station#	12445+01	Field Station#	12455+21		
Pic 1 Desc.	Overview of Waterbody S-I1. ROW is stable. No erosion or sedimentation concerns noted.	Pic 2 Desc.	Overview of Waterbody S-CD12b. ECDs are functional and ROW is stable.

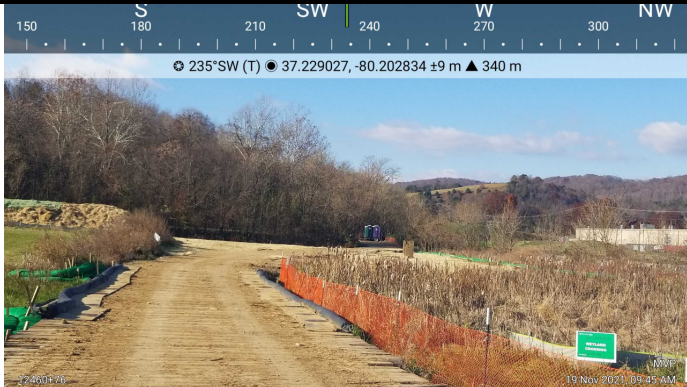
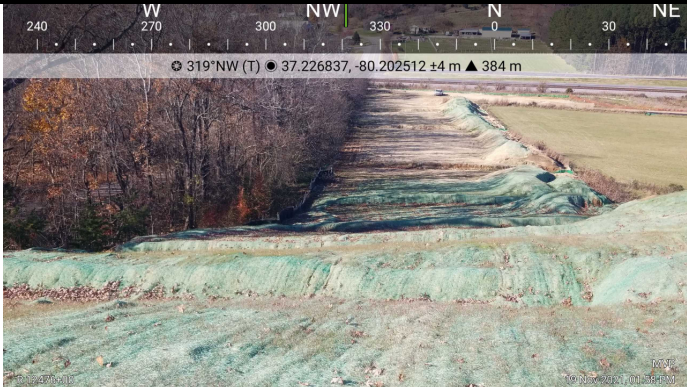
GPS Location	See Above	GPS Location	See Above		
Field Station#	12460+76	Field Station#	12476+00		
Pic 3 Desc.	Overview of Wetland W-KL58. ECDs are functional and ROW is stable.	Pic 4 Desc.	(reroute stationing) ROW Overview (temporary stabilization). ECDs are functional and ROW is stable.
