Visual Site Inspection Report

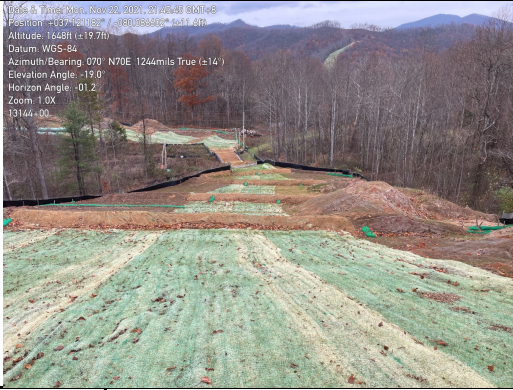
<p>Date & Time: Mon, Nov 22, 2021, 21:55:15 GMT+8 Position: +037.122419 / +080.086095 (±11.5m) Altitude: 1636ft (±11.2m) Datum: WGS-84 Azimuth/Bearing: 287° N73W 5102mils True (±14°) Elevation Angle: -02.7° Horizon Angle: -01.2° Zoom: 1.0X 13141+53 S-D14</p>		<p>GPS Location 0</p> <p>Field Station# 13141+53</p> <p>Pic 1 Desc. MVP-S-D14 and Corresponding buffer zone in good condition</p>

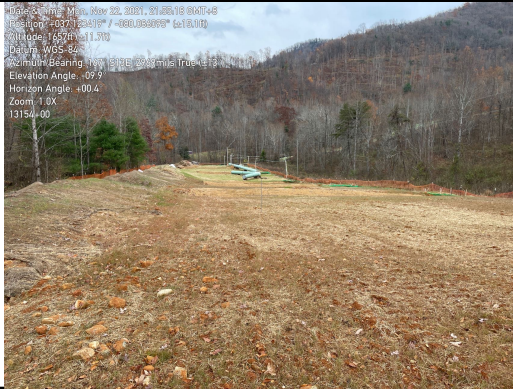
<p>Date & Time: Mon, Nov 22, 2021, 21:55:15 GMT+8 Position: +037.122419 / +080.086095 (±11.5m) Altitude: 1636ft (±11.2m) Datum: WGS-84 Azimuth/Bearing: 287° N73W 5102mils True (±14°) Elevation Angle: -02.7° Horizon Angle: -01.2° Zoom: 1.0X 13141+53 S-D14</p>		<p>GPS Location 0</p> <p>Field Station# 13146+56</p> <p>Pic 3 Desc. MVP-S-D12/13 and Corresponding buffer zone in good condition</p>

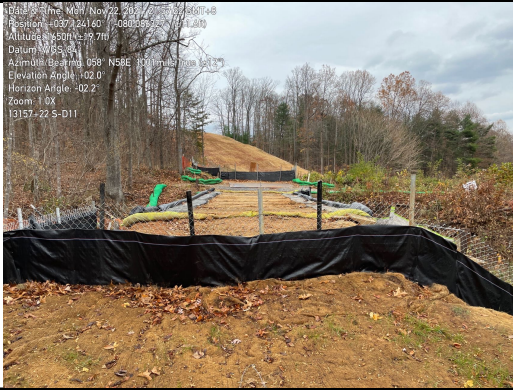
<p>Date & Time: Mon, Nov 22, 2021, 21:55:15 GMT+8 Position: +037.122419 / +080.086095 (±11.5m) Altitude: 1636ft (±11.2m) Datum: WGS-84 Azimuth/Bearing: 287° N73W 5102mils True (±14°) Elevation Angle: -02.7° Horizon Angle: -01.2° Zoom: 1.0X 13141+53 S-D14</p>		<p>GPS Location 0</p> <p>Field Station# 13154+00</p> <p>Pic 5 Desc. Slope drain pipe in good condition and functioning properly</p>

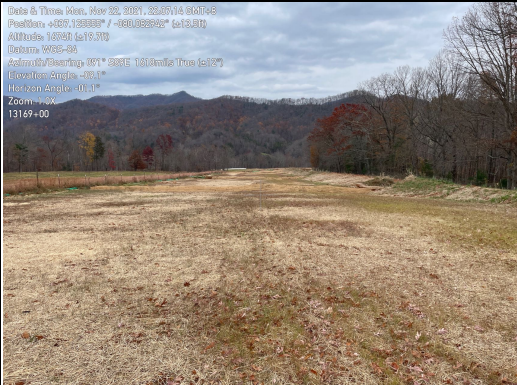
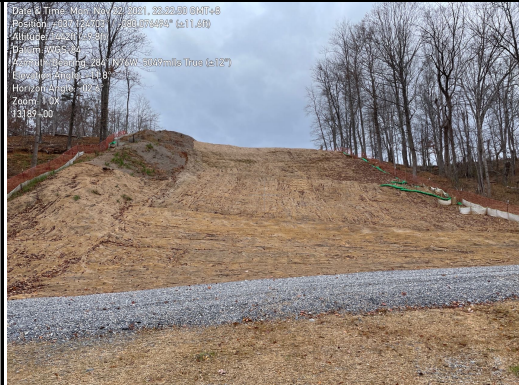
GPS Location		0		GPS Location	
Field Station#		13169+00		Field Station#	
Pic 7 Desc.		ROW and ECDs In good condition and stable		Pic 8 Desc.	
				ROW and ECDs In good condition and stable

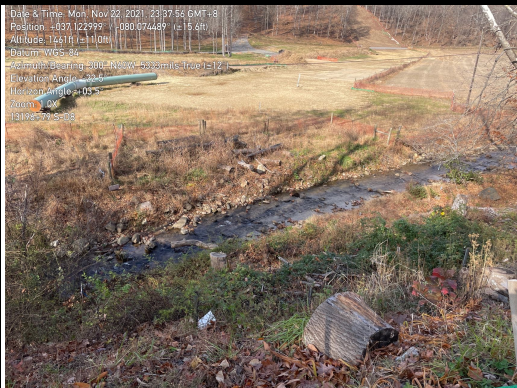
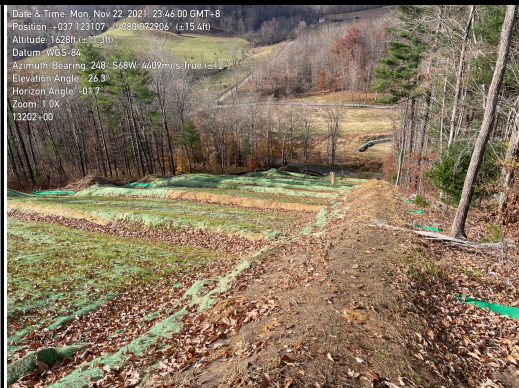
GPS Location		0		GPS Location	
Field Station#		13196+79		Field Station#	
Pic 9 Desc.		MVP-S-D8 and Corresponding buffer zone in good condition		Pic 10 Desc.	
				ROW and ECDs In good condition and stable

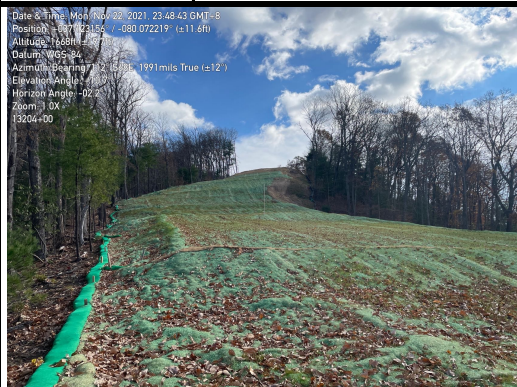
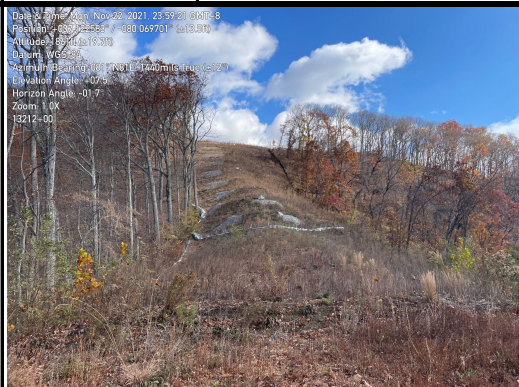
GPS Location		0		GPS Location	
Field Station#		13204+00		Field Station#	
Pic 11 Desc.		ROW and ECDs In good condition and stable		Pic 12 Desc.	
				ROW and ECDs In good condition with good vegetation established across ROW

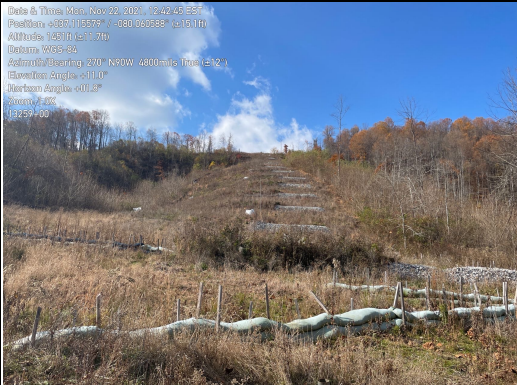
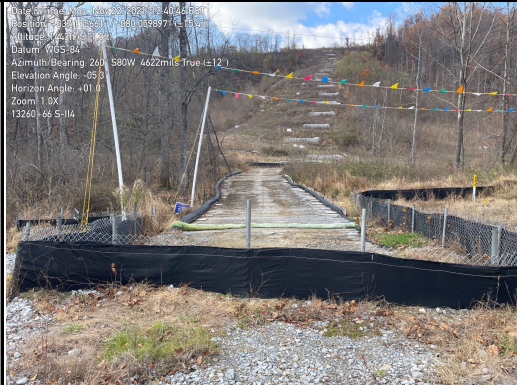
GPS Location			0			
Field Station#			13259+00			
Pic 13 Desc.			ROW and ECDs In good condition with good vegetation established across ROW			
GPS Location			0			
Field Station#			13260+66			
Pic 14 Desc.			MVP-S-D14 and Corresponding buffer zone in good condition			
<p>Date & Time: Mon, Nov 22, 2021 12:42:55 EST Position: +037 116211 / -080 060717 (s1514ft) Altitude: 1421ft (s1170ft) Datum: WGS-84 Azimuth Bearing: 050° N50E 5889mils True (s110) Elevation Angle: +01.2° Horizon Angle: +00.2° Zoom: 1.0X 13262+62 Flanders Road Crossing</p>

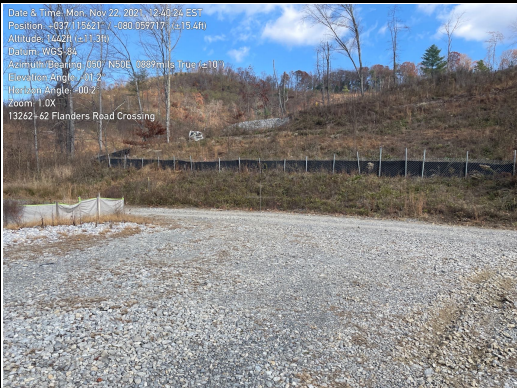
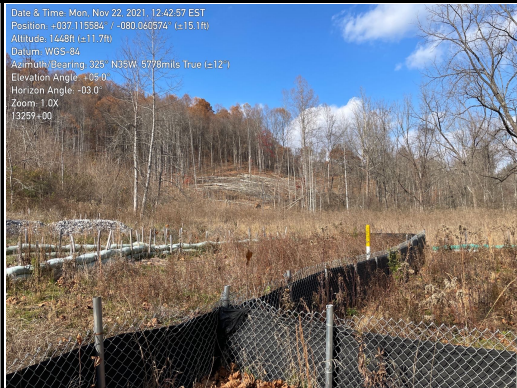
GPS Location			0			
Field Station#			13262+62			
Pic 15 Desc.			Flanders Road Crossing in good condition			
GPS Location			0			
Field Station#			13259+00			
Pic 16 Desc.			Logging operations near ROW and S-II4			
<p>Date & Time: Mon, Nov 22, 2021 12:09:38 EST Position: +037 106523 / -080 060425 (s1515ft) Altitude: 1571ft (s1190ft) Datum: WGS-84 Azimuth Bearing: 200° N20W 4800mils True (s121) Elevation Angle: +01.0° Horizon Angle: +00.0° Zoom: 1.0X 13309+09 S-GH7</p>

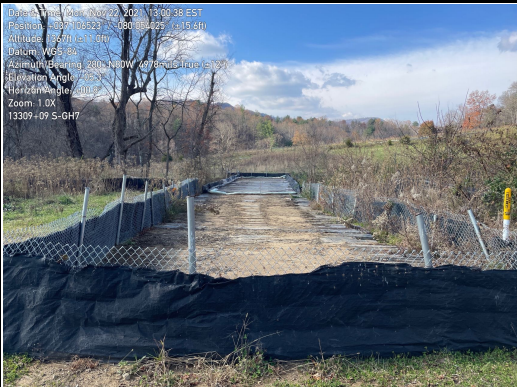
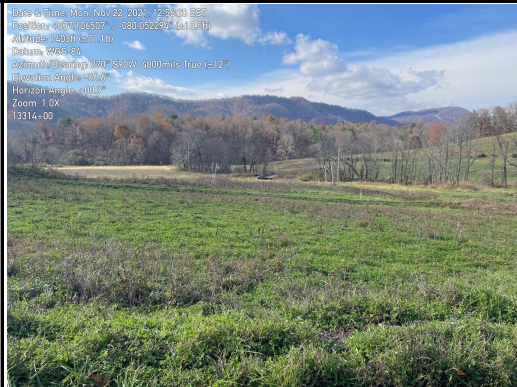
GPS Location			0			
Field Station#			13309+09			
Pic 17 Desc.			MVP-S-D14 and Corresponding buffer zone in good condition			
GPS Location			0			
Field Station#			13314+00			
Pic 18 Desc.			ROW and ECDs In good condition with good vegetation established across ROW

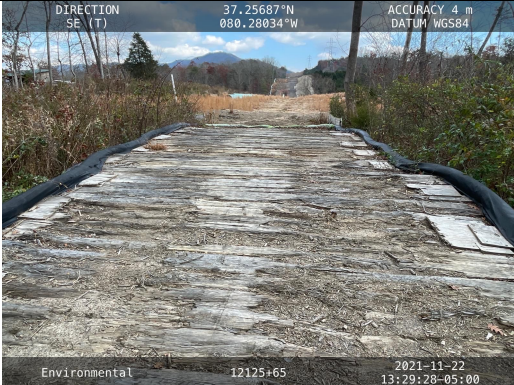
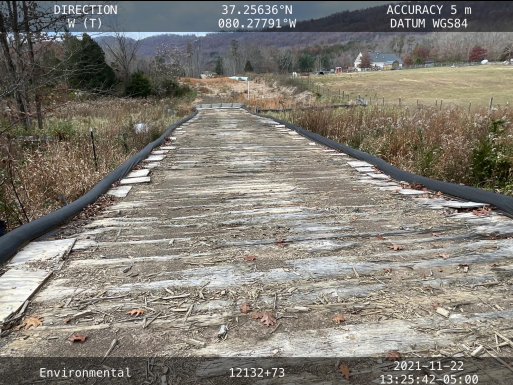
GPS Location	See photo		GPS Location	See photo	
Field Station#	12125+65		Field Station#	12132+73	
Pic 1 Desc.	Bridge and ECDs crossing stream S-MM31 in acceptable condition		Pic 2 Desc.	Bridge and ECDs crossing stream S-C29 in acceptable condition

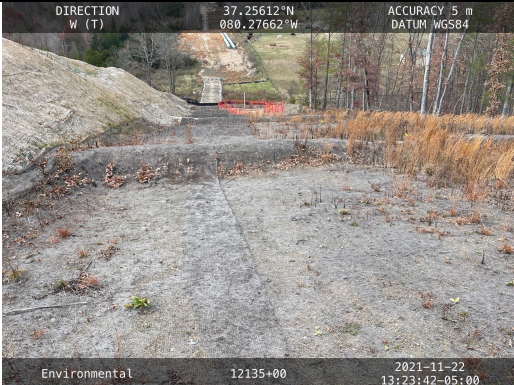
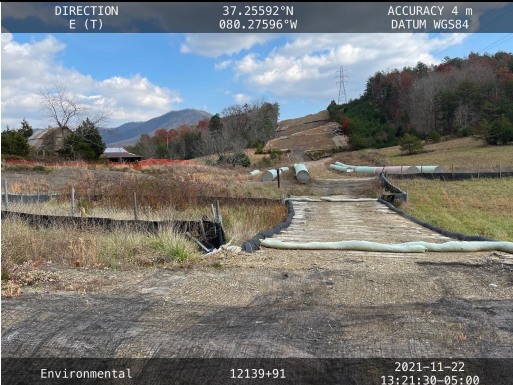
GPS Location	See photo		GPS Location	See photo	
Field Station#	12135+00		Field Station#	12139+91	
Pic 3 Desc.	Stabilized ROW conditions		Pic 4 Desc.	Wetland W-C6 in acceptable condition

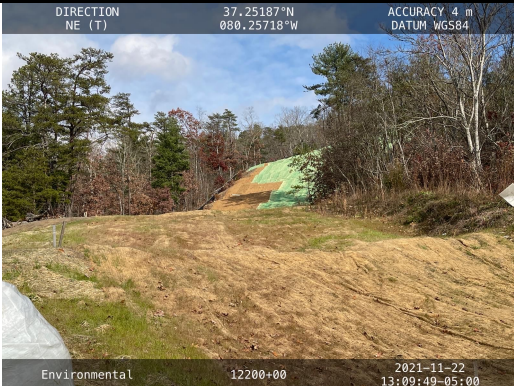
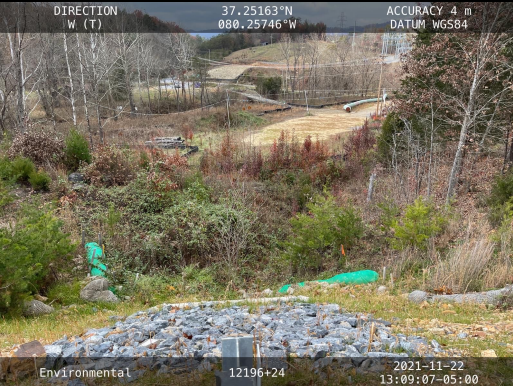
GPS Location	See photo		GPS Location	See photo	
Field Station#	12200+00		Field Station#	12196+24	
Pic 5 Desc.	Stabilized ROW conditions		Pic 6 Desc.	Down stream of S-OO11 in acceptable condition

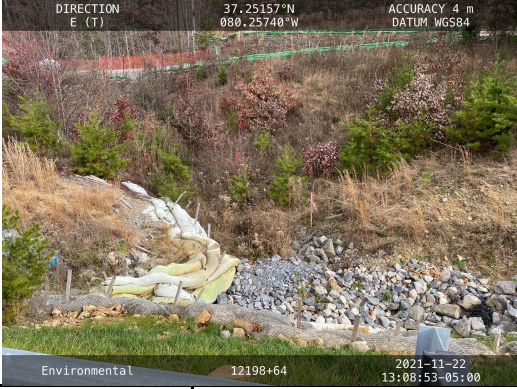
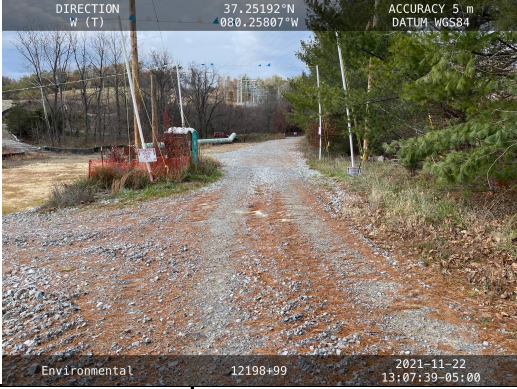
GPS Location	See photo		GPS Location	See photo	
Field Station#	12198+64		Field Station#	12198+99	
Pic 7 Desc.	Up stream of S-OO11 in acceptable condition		Pic 8 Desc.	Access Road MVP-MN-275 in acceptable condition

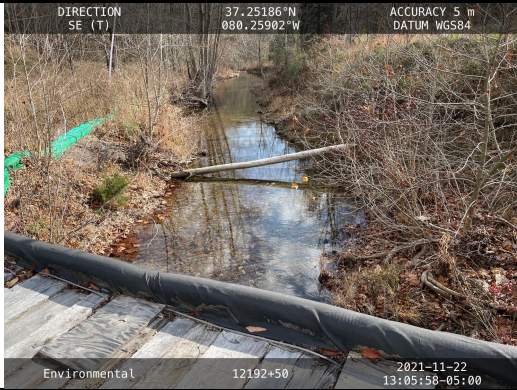
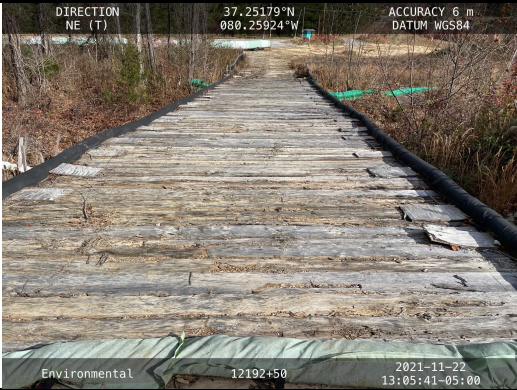
GPS Location	See photo		GPS Location	See photo	
Field Station#	12192+50		Field Station#	12192+50	
Pic 9 Desc.	Stream crossing S-C21 In Acceptable condition		Pic 10 Desc.	Bridge and ECDs crossing stream S-C21 in acceptable condition

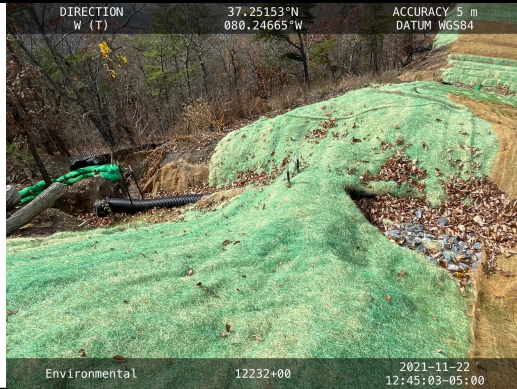
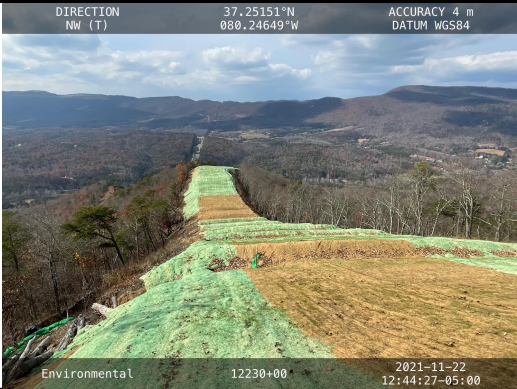
GPS Location	See photo		GPS Location	See photo	
Field Station#	12232+00		Field Station#	12230+00	
Pic 11 Desc.	Fill slope drain in acceptable condition		Pic 12 Desc.	Stabilized ROW conditions

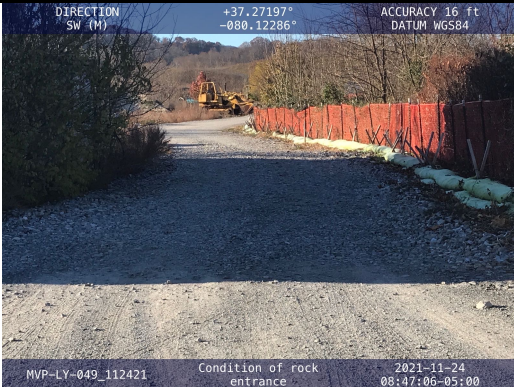
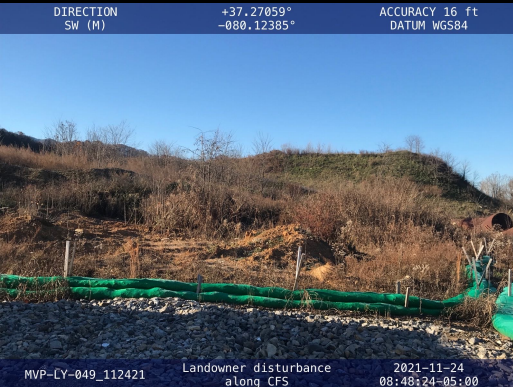
GPS Location	MVP-LY-049 See photo for gps data	GPS Location	MVP-LY-049 See photo for gps data		
Field Station#	+0	Field Station#	+0		
Pic 1 Desc.	Condition of rock entrance. No sediment or debris on stone. Looking SW.	Pic 2 Desc.	Landowner soil disturbance along triple stack compost filter sock. No new damage to installed ECD's. Looking SW.

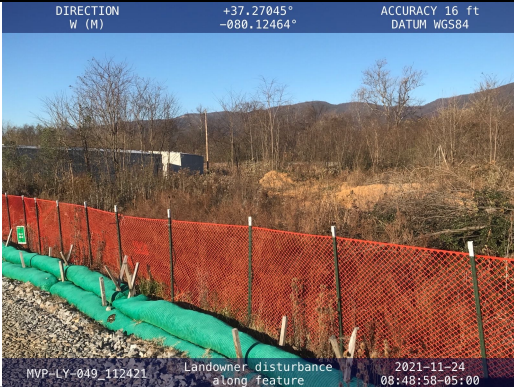
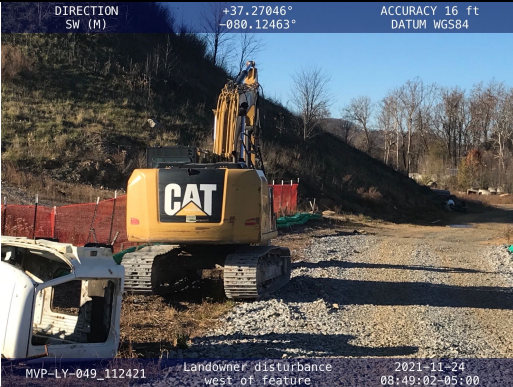
GPS Location	MVP-LY-049 See photo for gps data	GPS Location	MVP-LY-049 See photo for gps data		
Field Station#	+0	Field Station#	+0		
Pic 3 Desc.	Landowner soil disturbance along feature W-CV21A. Area not stabilized. Looking NW.	Pic 4 Desc.	Landowner soil disturbance west of feature W-CV21B. Areas not stabilized. Looking SW.

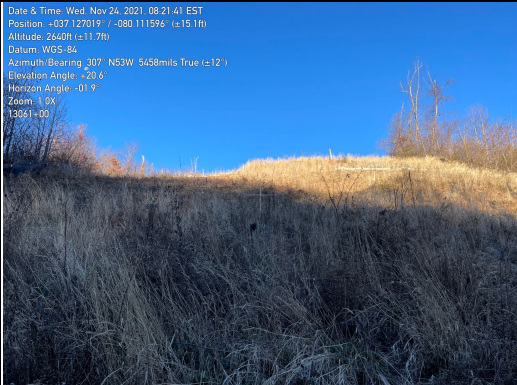
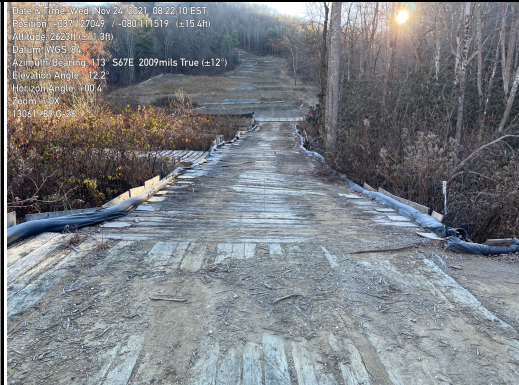
GPS Location		0		GPS Location		0	
Field Station#		13061+00		Field Station#		13061+89	
Pic 7 Desc.		ROW and ECDs In good condition with good vegetation established across ROW		Pic 8 Desc.		MVP-S-G26 and Corresponding buffer zone in good condition	
<p>Date & Time: Wed, Nov 24, 2021, 08:22:45 EST Position: +037 126929 / -080 111275 (±15.4ft) Altitude: 2425ft (±11.3ft) Datum: WGS-84 Azimuth/Bearing: 110° S70E 1956mils True (±12°) Elevation Angle: -12.2° Horizon Angle: -00.8° Zoom: 1.0X 13062+96</p>

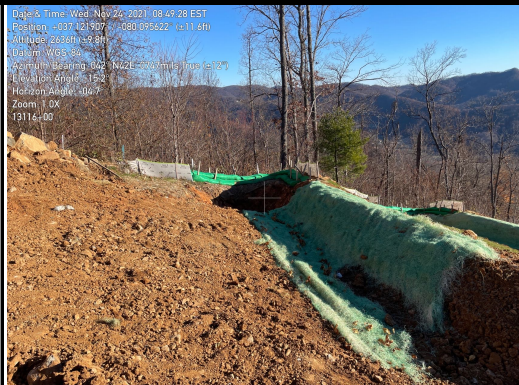
GPS Location		0		GPS Location		0	
Field Station#		13113+00		Field Station#		13116+00	
Pic 11 Desc.		ROW and ECDs In good condition with good vegetation established across ROW		Pic 12 Desc.		Sump and end treatment in good condition

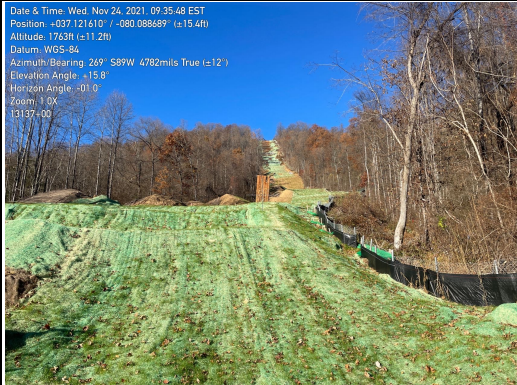
GPS Location	0	GPS Location	0		
Field Station#	13137+78	Field Station#	13137+00		
Pic 17 Desc.	MVP-S-D17 and Corresponding buffer zone in good condition		Pic 18 Desc.	ROW and ECDs In good and stable

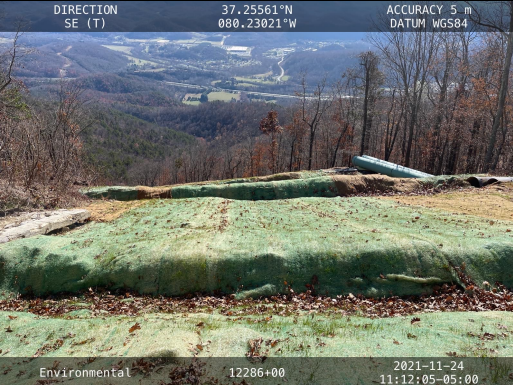
GPS Location	See photo		GPS Location	See photo	
Field Station#	12284+75		Field Station#	12286+00	
Pic 1 Desc.	ROW crossing on access road MVP-MN-276.03		Pic 2 Desc.	Stabilized ROW conditions

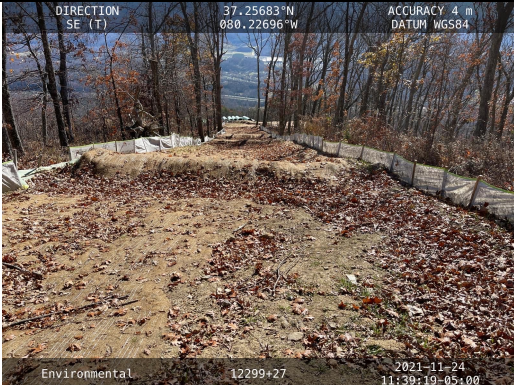
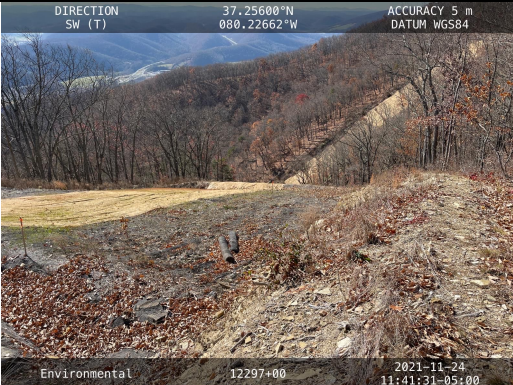
GPS Location	See photo		GPS Location	See photo	
Field Station#	12299+27		Field Station#	12297+00	
Pic 3 Desc.	Stabilized access Road		Pic 4 Desc.	Stabilized ROW conditions

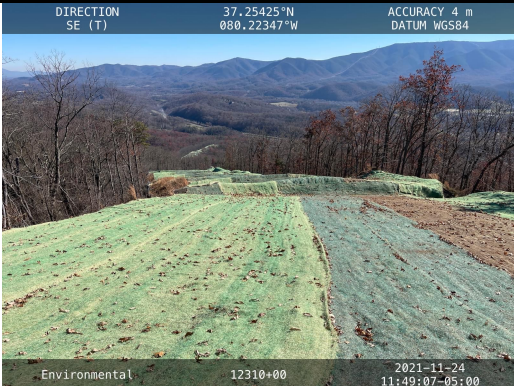
GPS Location	See photo		GPS Location	See photo	
Field Station#	12310+00		Field Station#	12300+00	
Pic 5 Desc.	Stabilized ROW conditions		Pic 6 Desc.	Stabilized ROW conditions

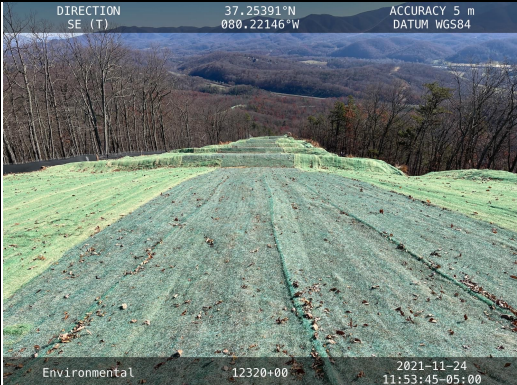
GPS Location	See photo		GPS Location	See photo	
Field Station#	1232+00		Field Station#	12331+00	
Pic 7 Desc.	Stabilized ROW conditions		Pic 8 Desc.	Fill slope drain

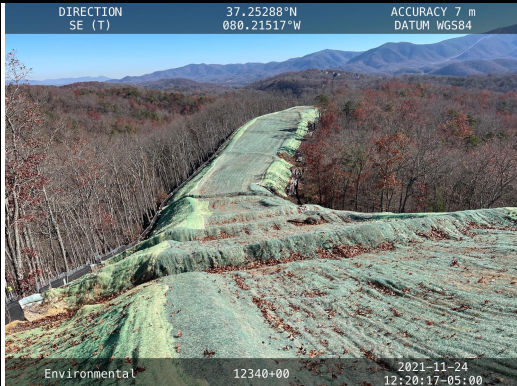
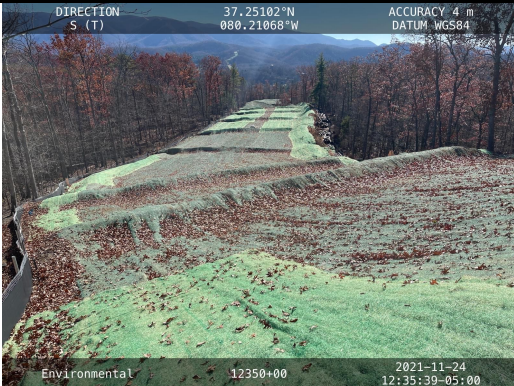
GPS Location	See photo		GPS Location	See photo	
Field Station#	1234+00		Field Station#	12350+00	
Pic 9 Desc.	Stabilized ROW conditions		Pic 10 Desc.	Stabilized ROW conditions

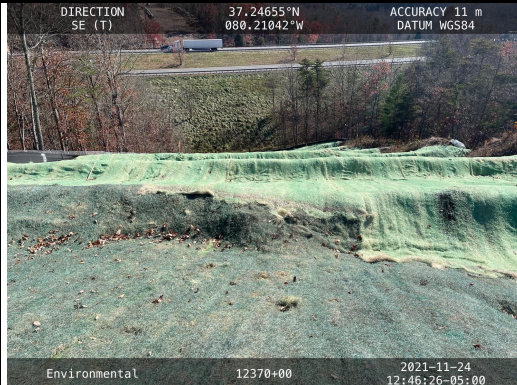
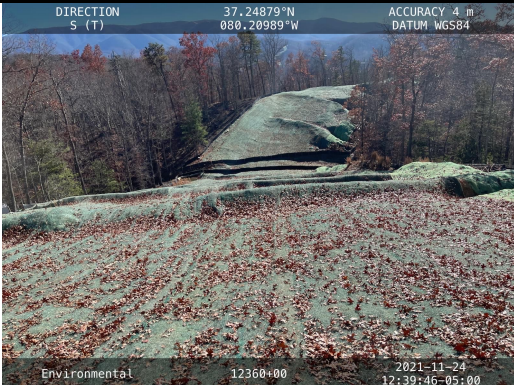
GPS Location	See photo		GPS Location	See photo	
Field Station#	12370+00		Field Station#	12360+00	
Pic 11 Desc.	Stabilized ROW conditions		Pic 12 Desc.	Stabilized ROW conditions

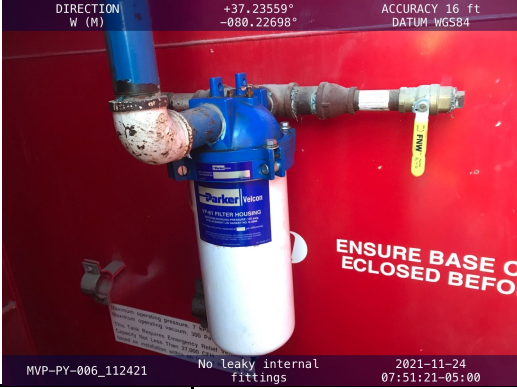
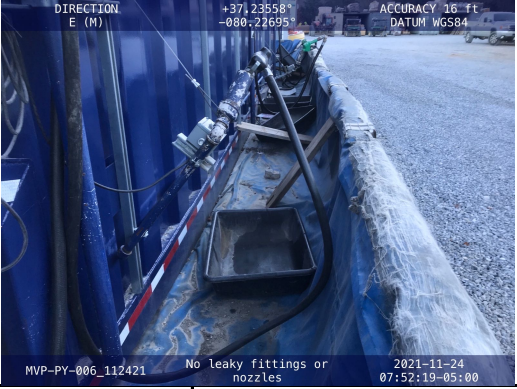
GPS Location	MVP-PY-006 See photo for gps data	GPS Location	MVP-PY-006 See photo for gps data		
Field Station#	+0	Field Station#	+0		
Pic 13 Desc.	Off Road Fuel unit no leaky internal fittings. Looking W.	Pic 14 Desc.	Blue Bulk Fuel tanks no leaky fittings or nozzles. Catch pans on site. Looking E.

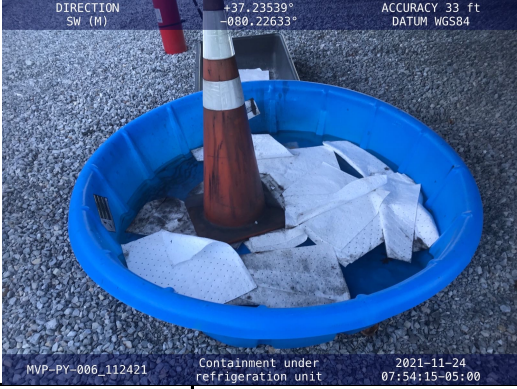
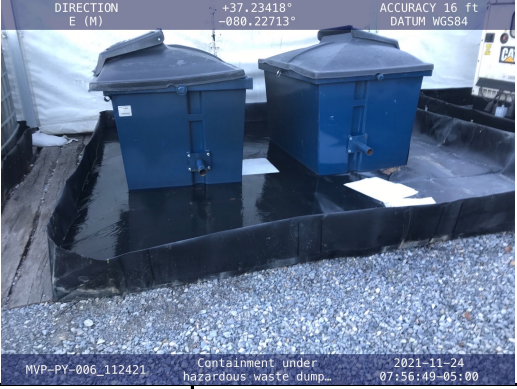
GPS Location	MVP-PY-006 See photo for gps data	GPS Location	MVP-PY-006 See photo for gps data		
Field Station#	+0	Field Station#	+0		
Pic 15 Desc.	Secondary containment under refrigeration unit. Catching fluids. Looking SW.	Pic 16 Desc.	Secondary containment under hazardous waste dumpsters holding stormwater and ice. Looking E.

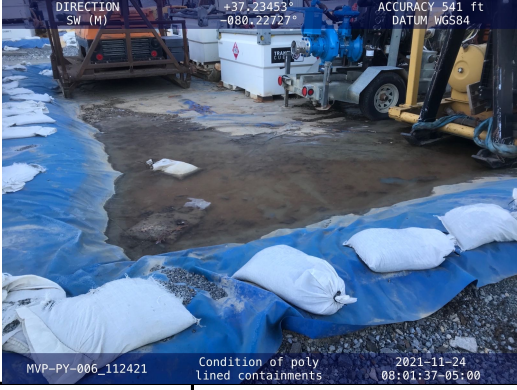
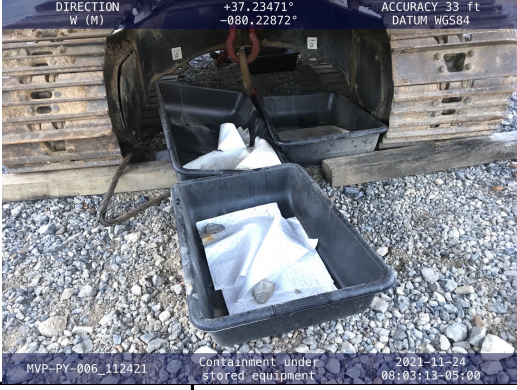
GPS Location	MVP-PY-006 See photo for gps data	GPS Location	MVP-PY-006 See photo for gps data		
Field Station#	+0	Field Station#	+0		
Pic 17 Desc.	Condition of poly lined containment holding stormwater and ice. Looking SW.	Pic 18 Desc.	Secondary containment under stored equipment. Looking SW.

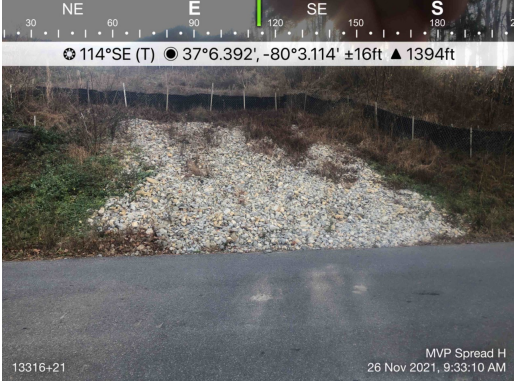
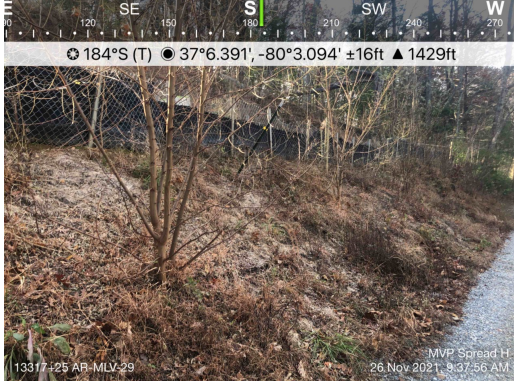
GPS Location	See Picture Watermark		GPS Location	See Picture Watermark	
Field Station#	13316+21		Field Station#	13317+25	
Pic 1 Desc.	Construction entrance is installed and in good condition. No tracking observed.		Pic 2 Desc.	SSF is installed and in good condition. No maintenance is needed.

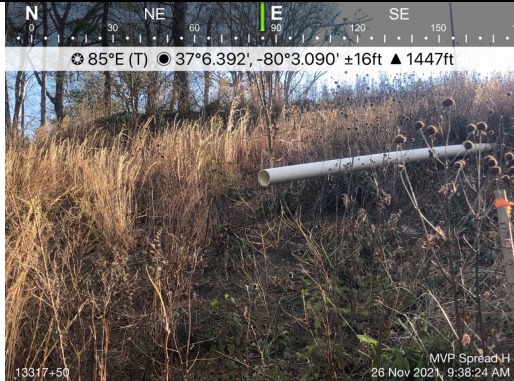
GPS Location	See Picture Watermark		GPS Location	See Picture Watermark	
Field Station#	13317+25		Field Station#	13317+50	
Pic 3 Desc.	AR-MLV-29 is in good condition and no signs of accelerated erosion were observed. No maintenance needed.		Pic 4 Desc.	Trench drain installed and in good condition. No maintenance needed.

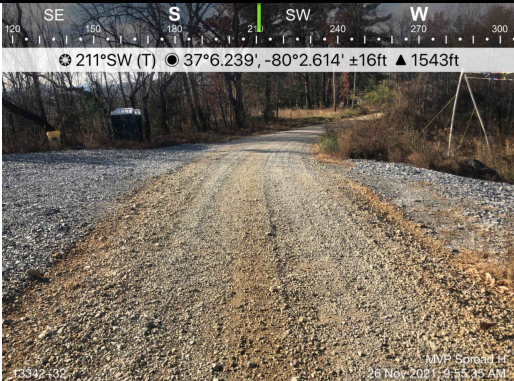
GPS Location	See Picture Watermark		GPS Location	See Picture Watermark	
Field Station#	13342+32		Field Station#	13342+35	
Pic 5 Desc.	ROW construction entrances are installed and in good condition.		Pic 6 Desc.	Portable toilets are level and within secondary containments. No maintenance needed.

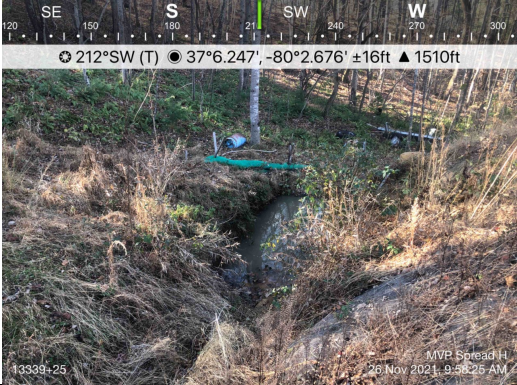
GPS Location	See Picture Watermark		GPS Location	See Picture Watermark	
Field Station#	13340+50		Field Station#	13339+25	
Pic 7 Desc.	ROW is temporarily stabilized and waterbar is in good condition. No maintenance needed.		Pic 8 Desc.	Sump pit and waterbar end treatment are in good condition, and no maintenance is needed.

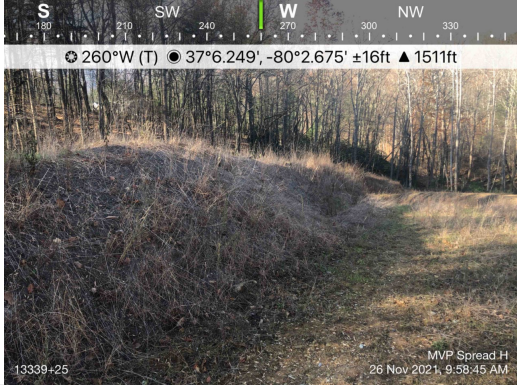
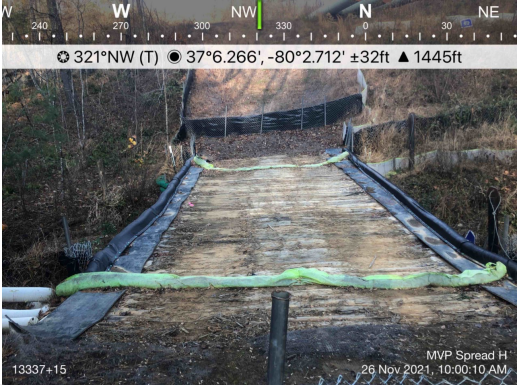
GPS Location	See Picture Watermark		GPS Location	See Picture Watermark	
Field Station#	13339+25		Field Station#	13337+15	
Pic 9 Desc.	Temporarily stabilized stockpiles in good condition.		Pic 10 Desc.	Stream crossing equipment bridge is in good condition, and free of tracked sediment.

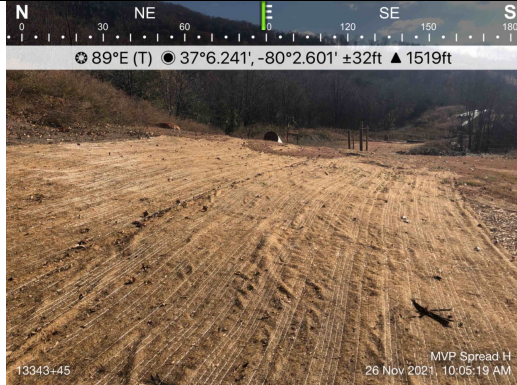
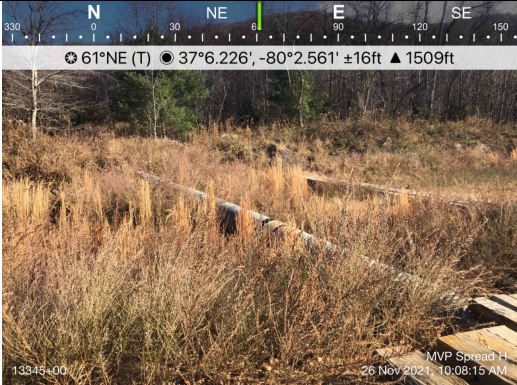
GPS Location	See Picture Watermark		GPS Location	See Picture Watermark	
Field Station#	13343+45		Field Station#	13345+00	
Pic 11 Desc.	Erosion control matting is installed and in good condition, no maintenance needed.		Pic 12 Desc.	CWD pipe is in good condition, and no maintenance is needed.

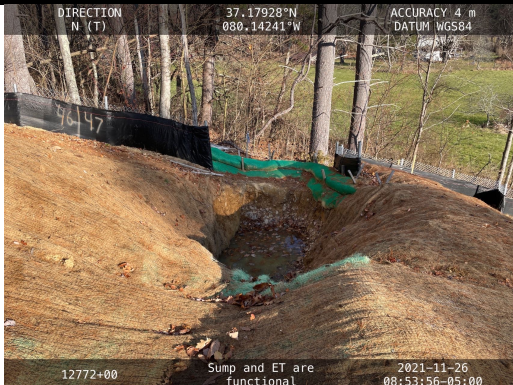
GPS Location	See photo		GPS Location	See photo	
Field Station#	12773+00		Field Station#	12772+00	
Pic 5 Desc.	ROW conditions. ROW is stable. ECDs are functional.		Pic 6 Desc.	Sump and ET are functional

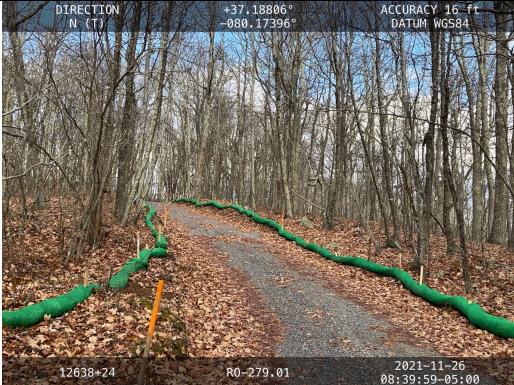
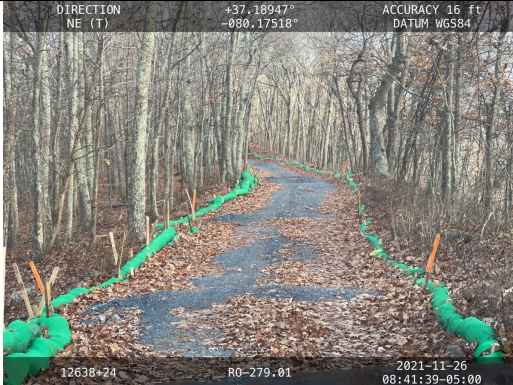
GPS Location	See photo for gps location data		GPS Location	See photo for gps location data	
Field Station#	12638+24		Field Station#	12638+24	
Pic 1 Desc.	Photo shows the condition of access road RO-279.01.		Pic 2 Desc.	Photo shows the condition of access road RO-279.01.

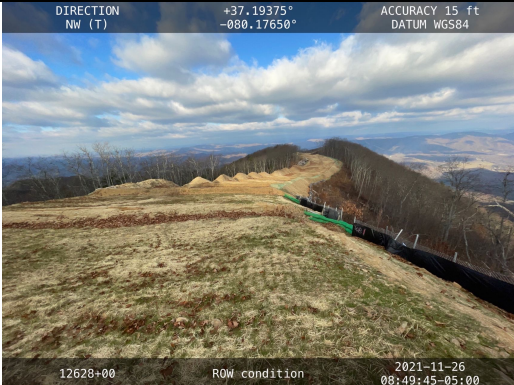
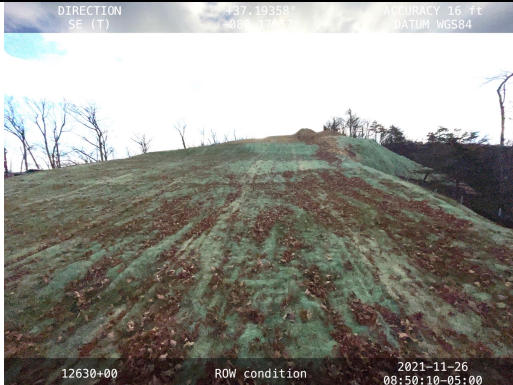
GPS Location	See photo for gps location data		GPS Location	See photo for gps location data	
Field Station#	12628+00		Field Station#	12630+00	
Pic 3 Desc.	Photo shows the ROW condition. ECDs are installed and functioning as designed.		Pic 4 Desc.	Photo shows the ROW condition. ECDs are installed and functioning as designed.

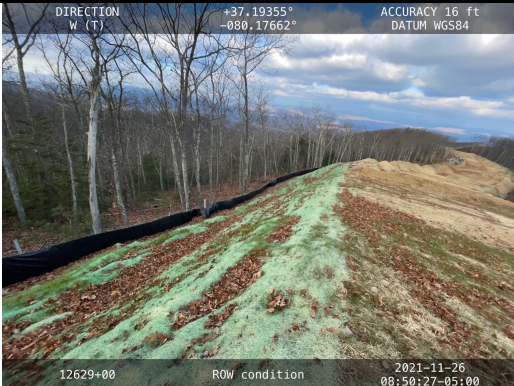
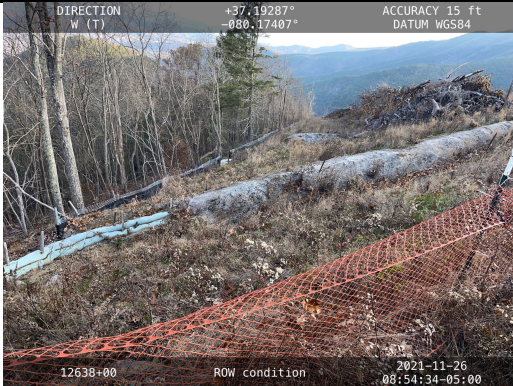
GPS Location	See photo for gps location data		GPS Location	See photo for gps location data	
Field Station#	12629+00		Field Station#	12638+00	
Pic 5 Desc.	Photo shows the ROW condition. ECDs are installed and functioning as designed.		Pic 6 Desc.	Photo shows the ROW condition. ECDs are installed and functioning as designed.
