Visual Site Inspection Report

Project Name	H-600 Pipeline Spread H	AFE	124300138	Spread	H-600 Pipeline Spread H
Contractor	Precision			Report #	31692
Inspector	Bryan Cole			Date/Time	11/29/2021 2:25 PM
Permit #	TBD	Inspection Type	VA SWPP	Station Begin	13141+65
State	VA	Inspection Area	Partial	Station End	13316+21
County	Franklin	Ground	Dry	Temperature (°F)	36.00
Municipality	N/A	Weather	Sunny	Rain Gauge (in)	0.00
				Rain Accumulation Time (days)	0.00

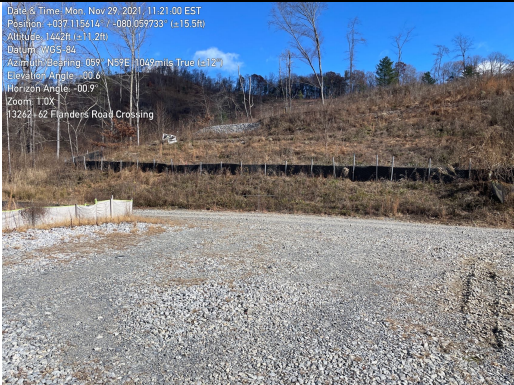
GPS Location	0	GPS Location	0		
Field Station#	13262+62	Field Station#	13260+66		
Pic 3 Desc.	Flanders Road Crossing in good condition	Pic 4 Desc.	MVP-S-II4 and Corresponding buffer zone in good condition		
<p>Date & Time: Mon, Nov 29, 2021, 11:24:03 EST Position: -037.115597, -080.060520 (+14.0ft) Altitude: 1438ft (+13.4ft) Datum: WGS-84 Azimuth/Bearing: 270° S90W 4800mils True (+12°) Elevation Angle: +11.9 Horizon Angle: +01.8 Zoom: 1.0X 13259+00</p>

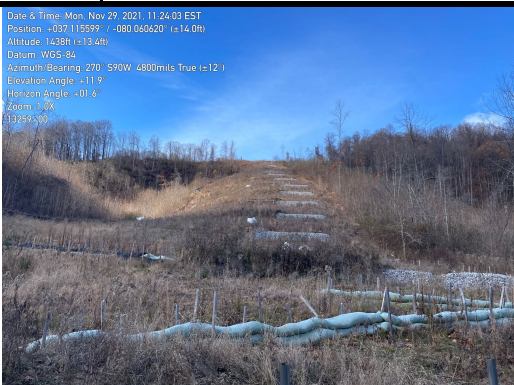
GPS Location	0	GPS Location	0		
Field Station#	13259+00	Field Station#	13197+75		
Pic 5 Desc.	ROW and ECDs In good condition with good vegetation established across ROW	Pic 6 Desc.	ROW and ECDs In good condition and stable

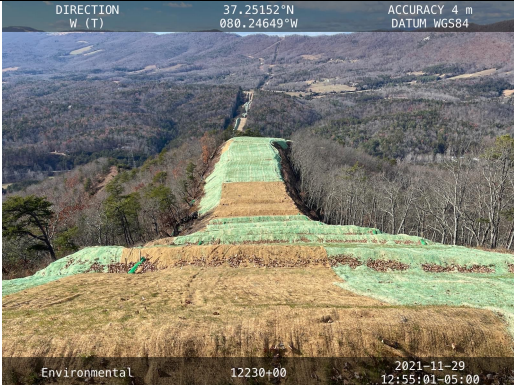
<p>DIRECTION W (T) 37.25152°N 080.24649°W ACCURACY 4 m DATUM WGS84</p> <p>Environmental 12230+00 2021-11-29 12:55:01-05:00</p>

<p>DIRECTION S (T) 37.25172°N 080.24590°W ACCURACY 4 m DATUM WGS84</p> <p>Environmental 12236+00 2021-11-29 12:54:28-05:00</p>			
GPS Location	See photo		GPS Location	see photo	
Field Station#	12230+00		Field Station#	12236+00	
Pic 1 Desc.	Stabilized ROW Conditions		Pic 2 Desc.	Stabilized ROW conditions

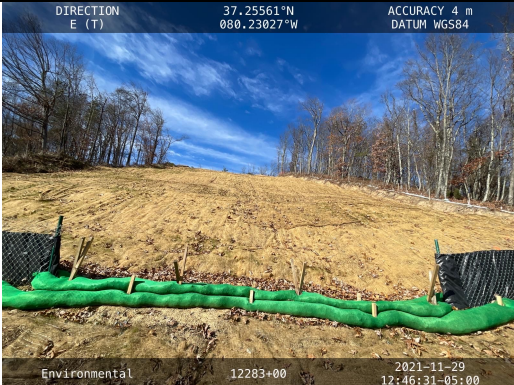
<p>DIRECTION E (T) 37.25561°N 080.23027°W ACCURACY 4 m DATUM WGS84</p> <p>Environmental 12283+00 2021-11-29 12:46:31-05:00</p>

<p>DIRECTION SE (T) 37.25165°N 080.25741°W ACCURACY 5 m DATUM WGS84</p> <p>Environmental 12196+24 2021-11-29 12:21:36-05:00</p>			
GPS Location	See photo		GPS Location	See photo	
Field Station#	12283+00		Field Station#	12196+24	
Pic 3 Desc.	Stabilized ROW conditions		Pic 4 Desc.	Stream crossing S-Oo11 in acceptable condition

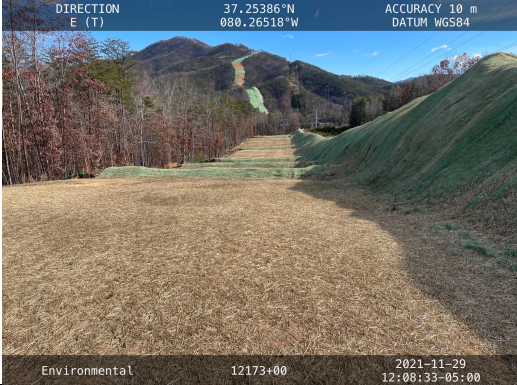
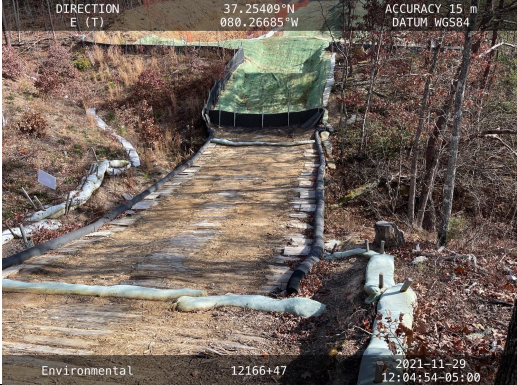
GPS Location	See photo		GPS Location	See photo	
Field Station#	12173+00		Field Station#	12166+47	
Pic 7 Desc.	Stabilized ROW conditions		Pic 8 Desc.	Bridge and ECDs crossing stream S-C24 in acceptable condition

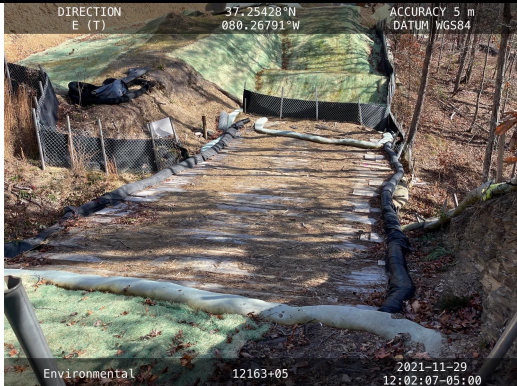
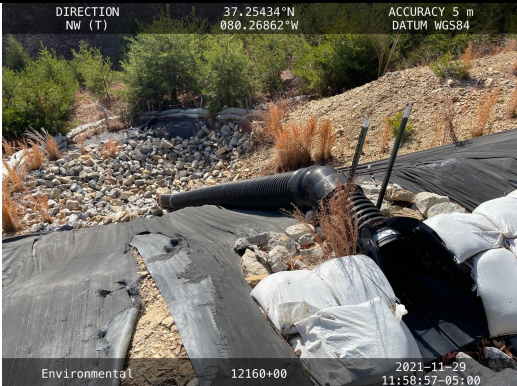
GPS Location	See photo		GPS Location	See photo	
Field Station#	12163+05		Field Station#	12160+00	
Pic 9 Desc.	Stream S-C25 in acceptable condition		Pic 10 Desc.	Fill slope drain pipe in acceptable condition

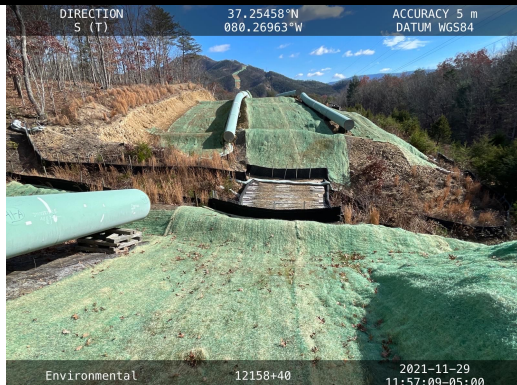
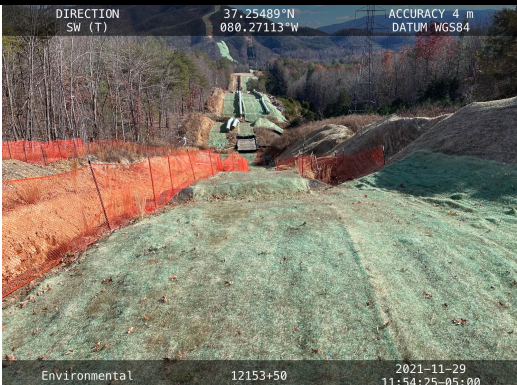
GPS Location	See photo		GPS Location	See photo	
Field Station#	12158+40		Field Station#	12153+50	
Pic 11 Desc.	Clean water crossing in acceptable condition		Pic 12 Desc.	Stabilized ROW conditions

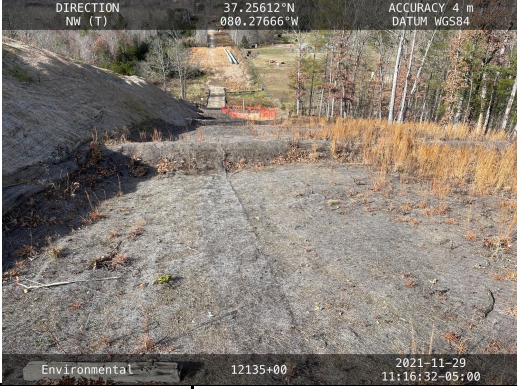
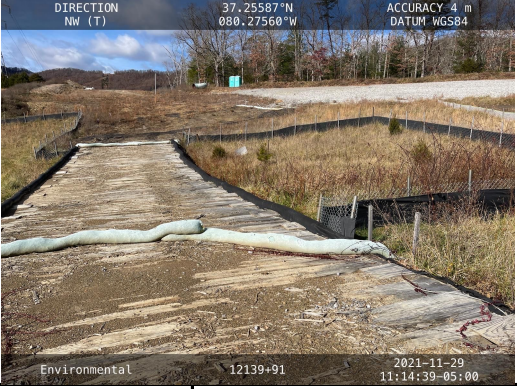
Pic 15 Desc.	Stabilized ROW Conditions		Pic 16 Desc.	Wetland W-C6 crossing in acceptable condition

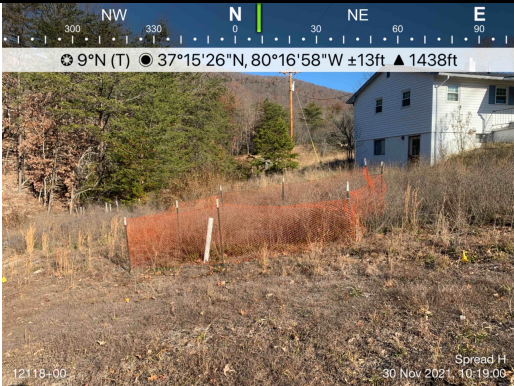
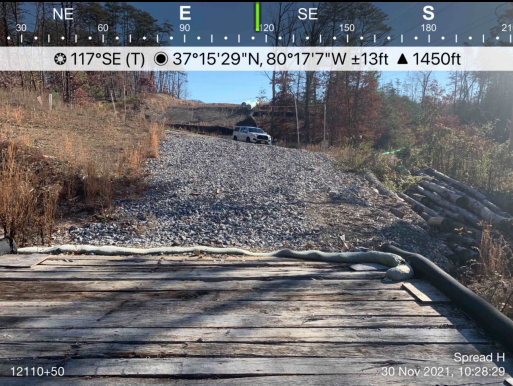
GPS Location	See photo above		GPS Location	See photo above	
Field Station#	12118+00		Field Station#	12110+50	
Pic 5 Desc.	Safety fence is in place and in good condition.		Pic 6 Desc.	Construction entrance is in good condition.

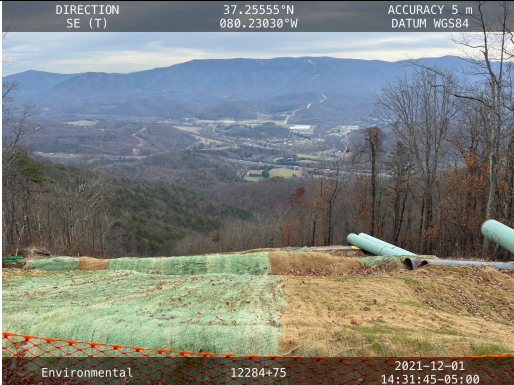
GPS Location	See photo		GPS Location	See photo	
Field Station#	12284+75		Field Station#	12284+75	
Pic 1 Desc.	Stabilized ROW conditions		Pic 2 Desc.	Access Road MVP-MN-276.03 ROW crossing in acceptable condition

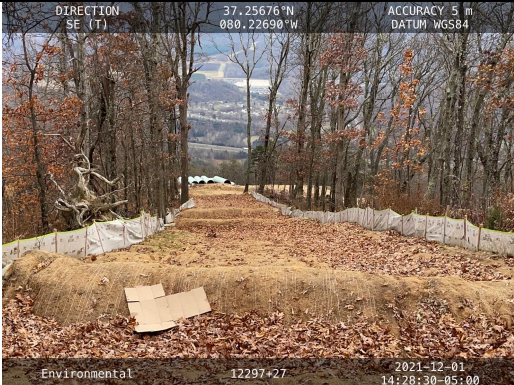
GPS Location	See photo		GPS Location	See photo	
Field Station#	12297+27		Field Station#	12424+01	
Pic 3 Desc.	Stabilized access Road in acceptable condition		Pic 4 Desc.	Access Road MVP-MN-279 In Acceptable condition

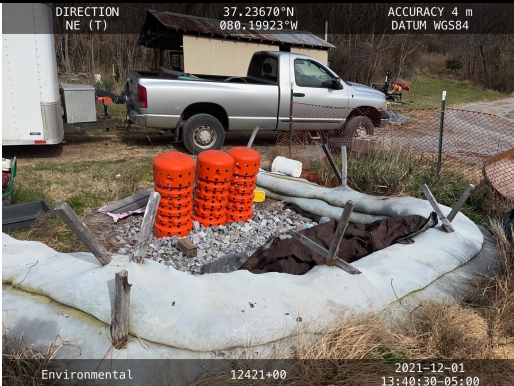
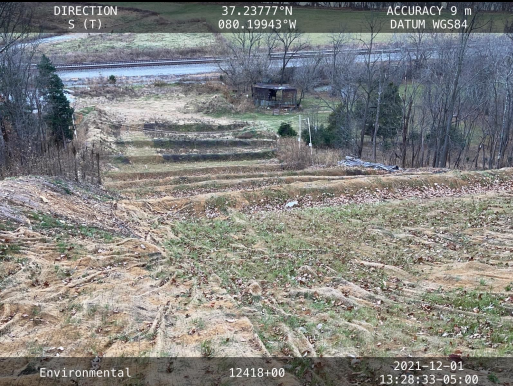
GPS Location	See photo		GPS Location	See photo	
Field Station#	12421+00		Field Station#	12418+00	
Pic 5 Desc.	Clean water crossing pipe inlet in acceptable condition		Pic 6 Desc.	Stabilized ROW conditions

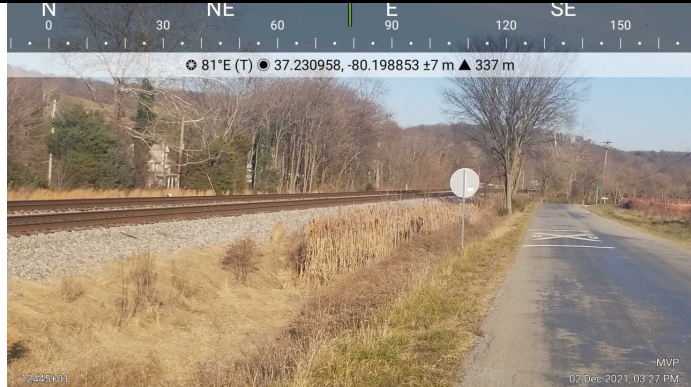
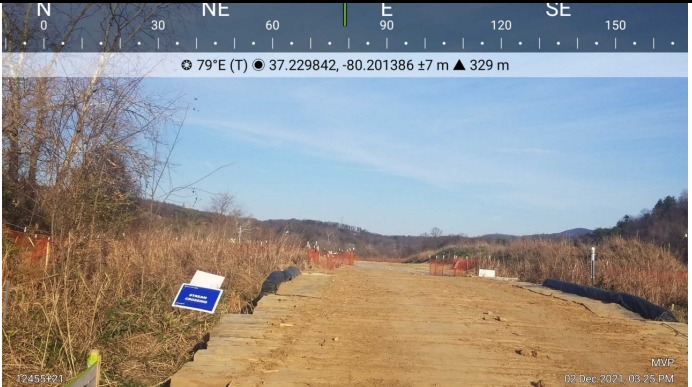
GPS Location	See Above	GPS Location	See Above		
Field Station#	12445+01	Field Station#	12455+21		
Pic 1 Desc.	Overview of Waterbody S-I1. ROW is stable. No erosion or sedimentation concerns noted.	Pic 2 Desc.	Overview of Waterbody S-CD12b. ECDs are functional and ROW is stable.

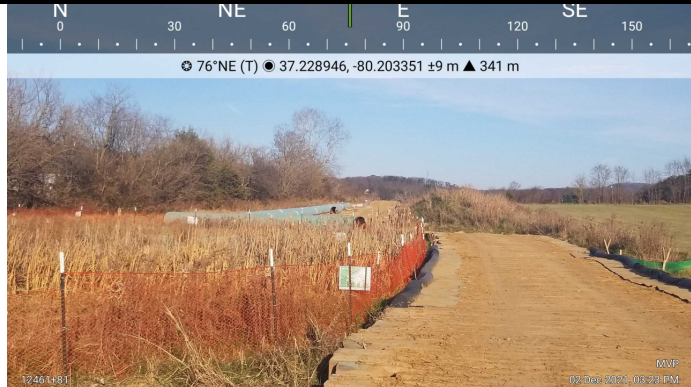
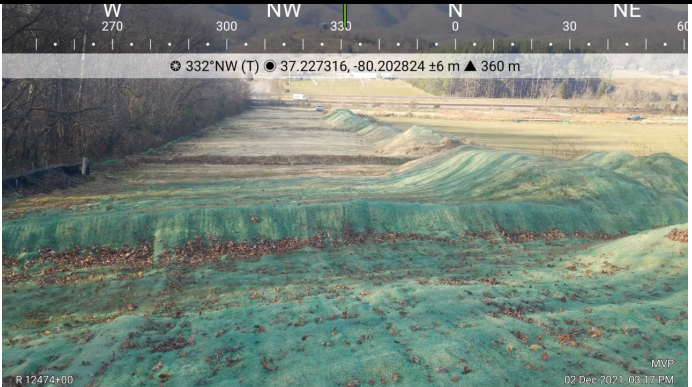
GPS Location	See Above	GPS Location	See Above		
Field Station#	12461+81	Field Station#	12474+00		
Pic 3 Desc.	Overview of Wetland W-KL58. ECDs are functional and ROW is stable.	Pic 4 Desc.	(reroute stationing) ROW Overview (temporary stabilization). ECDs are functional and ROW is stable.

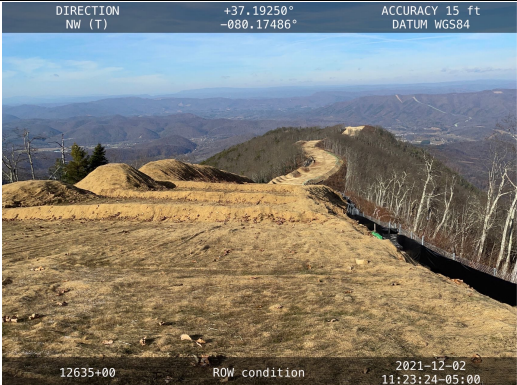
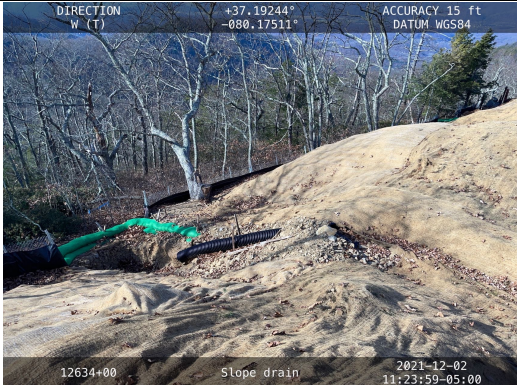
GPS Location	See photo for gps location data.		GPS Location	See photo for gps location data.	
Field Station#	12635+00		Field Station#	12634+00	
Pic 17 Desc.	Photo shows the ROW condition. ECDs are installed and functioning as designed.		Pic 18 Desc.	Photo shows the slope drain.

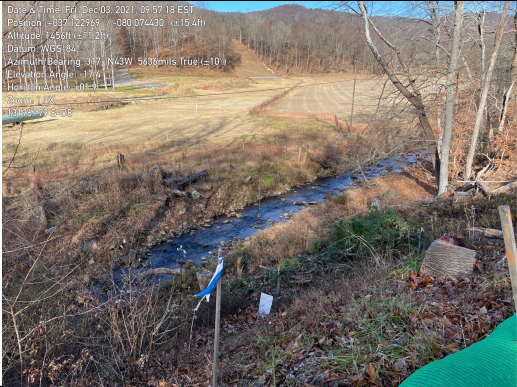
GPS Location	0	GPS Location	0		
Field Station#	13189+00	Field Station#	13196+79		
Pic 11 Desc.	ROW and ECDs In good condition and stable		Pic 12 Desc.	MVP-S-D8 and Corresponding buffer zone in good condition
