Visual Site Inspection Report

Project Name	H-600 Pipeline Spread H	AFE	124300138	Spread	H-600 Pipeline Spread H
Contractor	Precision			Report #	28695
Inspector	Jonathan Altizer			Date/Time	9/20/2021 7:38 PM
Permit #	TBD	Inspection Type	VA SWPP	Station Begin	12600+00
State	VA	Inspection Area	Partial	Station End	12865+00
County	Roanoke	Ground	Dry	Temperature (°F)	78.00
Municipality	N/A	Weather	Cloudy	Rain Gauge (in)	0.30
				Rain Accumulation Time (days)	2.00

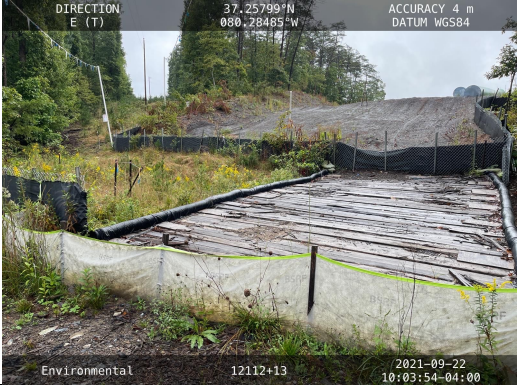
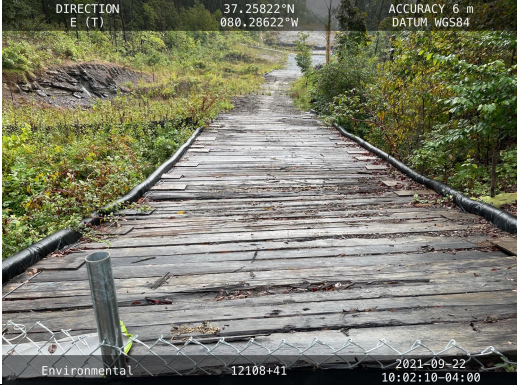
GPS Location	See photo		GPS Location	See photo	
Field Station#	12112+13		Field Station#	12108+41	
Pic 7 Desc.	Bridge and ECDs crossing stream S-F16a/b		Pic 8 Desc.	Bridge and ECDs crossing stream crossing S-F15

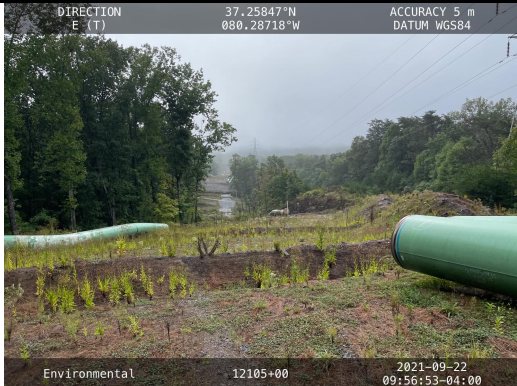
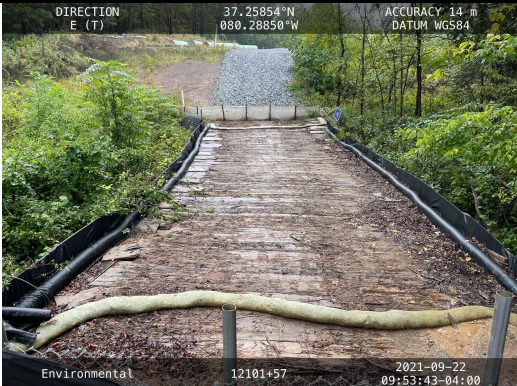
GPS Location	See photo		GPS Location	See photo	
Field Station#	12105+00		Field Station#	12101+57	
Pic 9 Desc.	Stabilized ROW conditions		Pic 10 Desc.	Bridge and ECDs crossing stream S-MM11

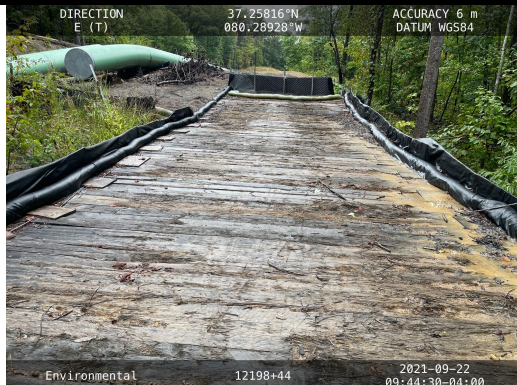
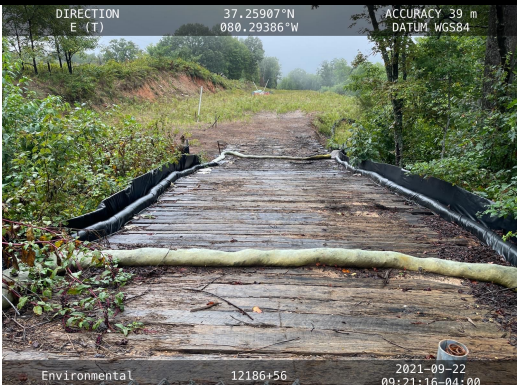
GPS Location	See photo		GPS Location	See photo	
Field Station#	12198+44		Field Station#	12186+56	
Pic 11 Desc.	Bridge and ECDs crossing stream S-MM13		Pic 12 Desc.	Bridge and ECDs crossing stream S-MM14

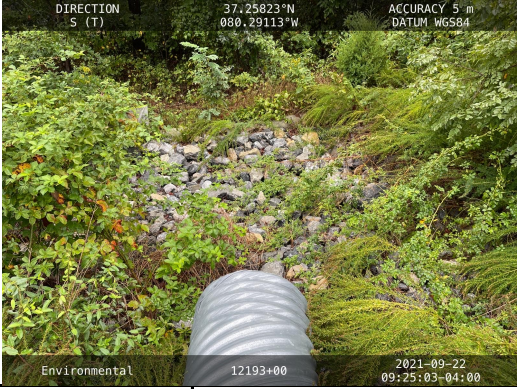
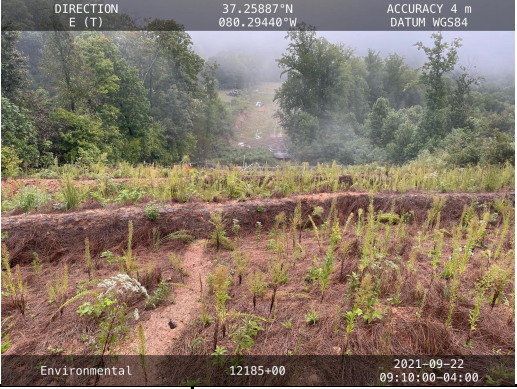
GPS Location	See photo		GPS Location	See photo	
Field Station#	12193+00		Field Station#	12185+00	
Pic 13 Desc.	Clean water crossing pipe outlet		Pic 14 Desc.	Stabilized ROW conditions

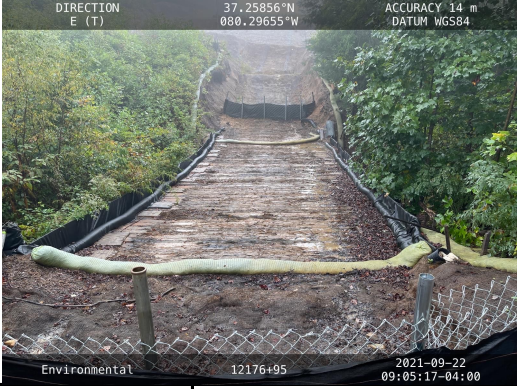
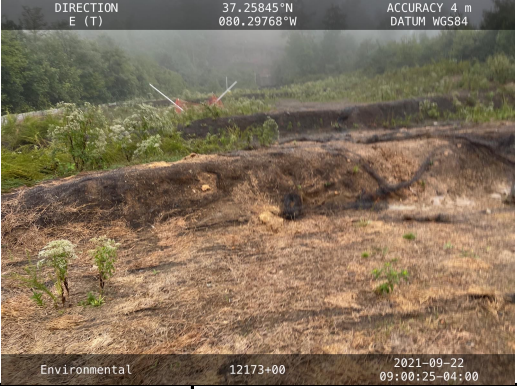
GPS Location	See photo		GPS Location	See photo	
Field Station#	12176+95		Field Station#	12173+00	
Pic 15 Desc.	Bridge and ECDs crossing stream S-MM15		Pic 16 Desc.	Stabilized ROW conditions

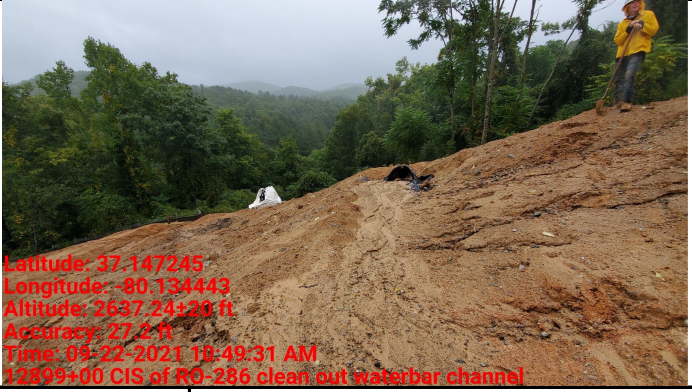
<p>Latitude: 37.147245 Longitude: -80.134443 Altitude: 2637.24±20 ft Accuracy: 27.2 ft Time: 09-22-2021 10:49:31 AM 12899+00 CIS of RO-286 clean out waterbar channel</p>			
GPS Location	See pic for GPS location.		GPS Location	See pic for GPS location.	
Field Station#	12894+00		Field Station#	12899+00	
Pic 5 Desc.	12" CFS end treatment to be upgraded to 18" CFS where overtopped. No sediment found beyond the LOD.		Pic 6 Desc.	Waterbar filled with sediment and need to be cleaned out. Environmental crew addressed the issue immediately and cleaned out channel

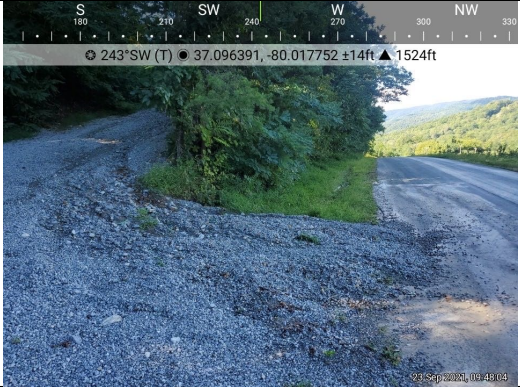
GPS Location	0	GPS Location	0		
Field Station#	0+00	Field Station#	0+00		
Pic 1 Desc.	MVP-FR-293.02 Washout on access road	Pic 2 Desc.	MVP-FR-293.02 Gravel washing onto blacktop

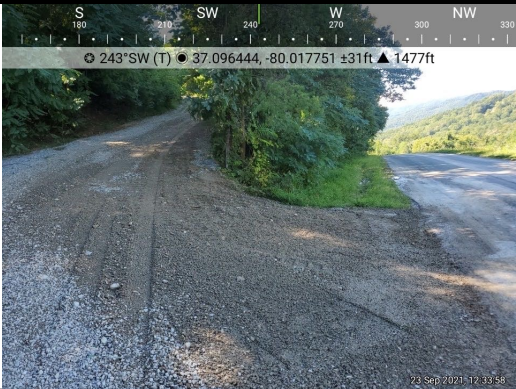
GPS Location	0	GPS Location	0		
Field Station#	0+00	Field Station#	13437+75		
Pic 3 Desc.	MVP-FR-293.02 Repairs	Pic 4 Desc.	3rd party activities processing Timber with ground disturbance

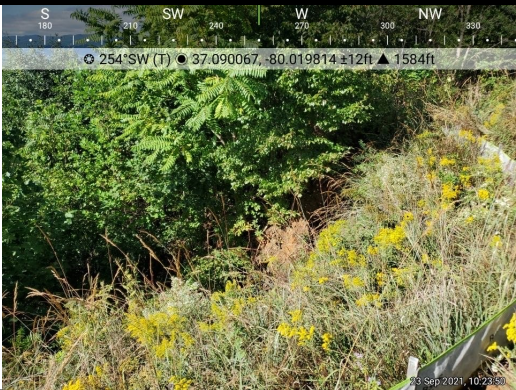
GPS Location	0	GPS Location	0		
Field Station#	13442+00	Field Station#	13496+00		
Pic 5 Desc.	Existing slip after heavy rains	Pic 6 Desc.	CIS Cahas Mtn #2 with Waterbar outlet

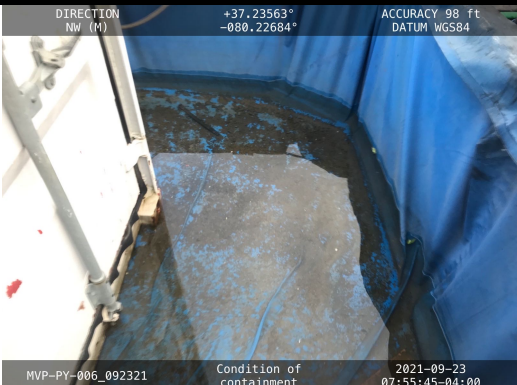
<p>DIRECTION NW (M) +37.23563° -080.22684° ACCURACY 98 ft DATUM WGS84 MVP-PY-006_092321 Condition of containment. 2021-09-23 07:55:45-04:00</p>		
GPS Location	MVP-PY-006 See photo for gps data		GPS Location	MVP-PY-006 See photo for gps data	
Field Station#	+0		Field Station#	+0	
Pic 11 Desc.	Blue Bulk Fuel tanks secondary containments in place for tankers offloading fuel. Looking W.		Pic 12 Desc.	Off Road Fuel unit containment holding stormwater. A sheen noted. Looking NW.

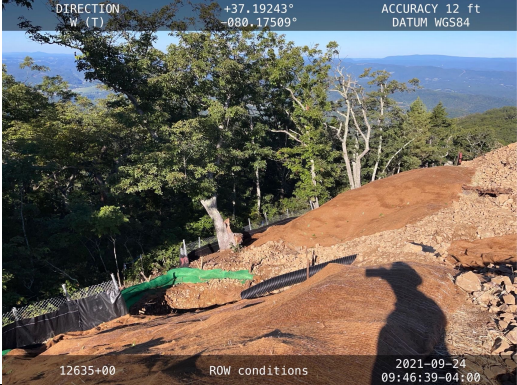
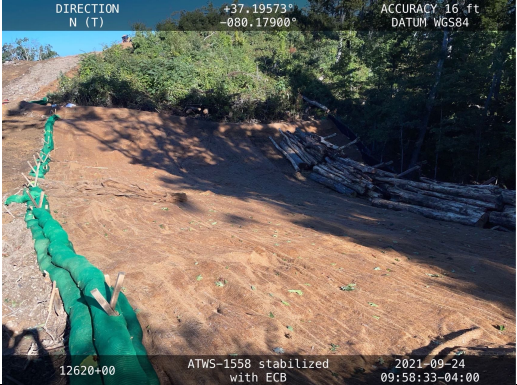
GPS Location	See photo		GPS Location	See photo	
Field Station#	12635+00		Field Station#	12620+00	
Pic 13 Desc.	Current ROW conditions. Functional slope drain		Pic 14 Desc.	ATWS has been stabilized with curlex

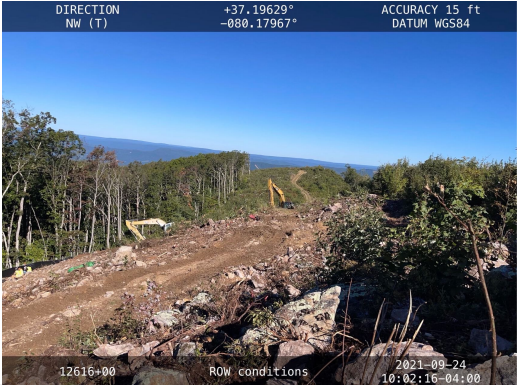
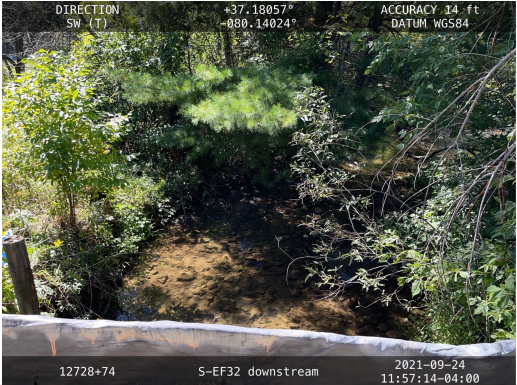
GPS Location	See photo		GPS Location	See photo	
Field Station#	12616+00		Field Station#	12728+74	
Pic 15 Desc.	Current ROW conditions. Actively clearing ROW.		Pic 16 Desc.	Downstream of crossing at Stream S-EF32
