# Visual Site Inspection Report

<b>Project Name</b>	H-600 Pipeline Spread H	<b>AFE</b>	124300138	<b>Spread</b>	H-600 Pipeline Spread H
<b>Contractor</b>	Precision			<b>Report #</b>	29017
<b>Inspector</b>	Bryan Cole			<b>Date/Time</b>	9/27/2021 5:32 PM
<b>Permit #</b>	TBD	<b>Inspection Type</b>	VA SWPP	<b>Station Begin</b>	13141+65
<b>State</b>	VA	<b>Inspection Area</b>	Partial	<b>Station End</b>	13316+21
<b>County</b>	Franklin	<b>Ground</b>	Damp	<b>Temperature (°F)</b>	70.00
<b>Municipality</b>	N/A	<b>Weather</b>	Sunny	<b>Rain Gauge (in)</b>	0.00
				<b>Rain Accumulation Time (days)</b>	0.00

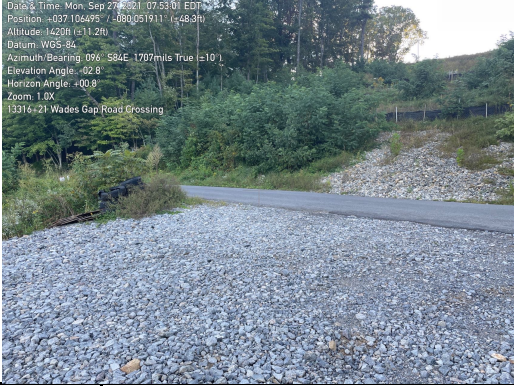
<b>GPS Location</b>	0	<b>GPS Location</b>	0		
<b>Field Station#</b>	13316+21	<b>Field Station#</b>	13314+00		
<b>Pic 1 Desc.</b>	Wades Gap Road Crossing in good condition	<b>Pic 2 Desc.</b>	ROW and ECDs in good condition with good vegetation established across ROW

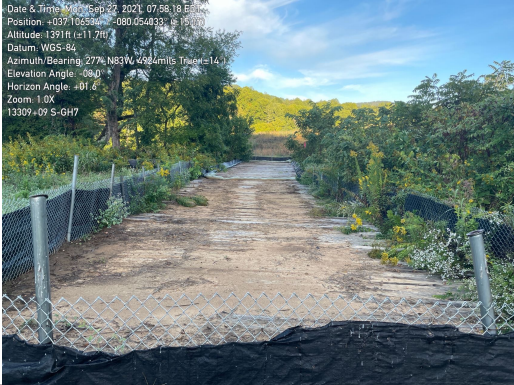
<b>GPS Location</b>	0	<b>GPS Location</b>	0		
<b>Field Station#</b>	13309+09	<b>Field Station#</b>	13362+62		
<b>Pic 3 Desc.</b>	MVP-S-GH7 and Corresponding buffer zone in good condition	<b>Pic 4 Desc.</b>	Flanders Road Crossing in good condition		
<p>Date &amp; Time: Mon, Sep 27, 2021, 08:14:40 EDT  Position: +037.118446, -080.059935 (+15.40)  Altitude: 1444ft (+11.20)  Datum: WGS-84  Azimuth/Bearing: 253.574W 4516mils True (+10.1)  Elevation Angle: -04.7  Horizon Angle: +03.9  Zoom: 1.0X  13360+66 S-II4</p>

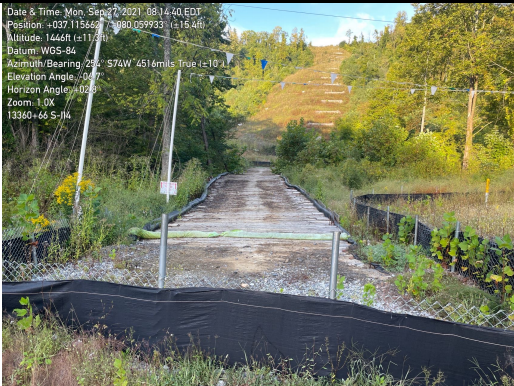
<b>GPS Location</b>	0	<b>GPS Location</b>	0		
<b>Field Station#</b>	13360+66	<b>Field Station#</b>	13359+00		
<b>Pic 5 Desc.</b>	MVP-S-II4 and Corresponding buffer zone in good condition	<b>Pic 6 Desc.</b>	ROW and ECDs in good condition with good vegetation established across ROW

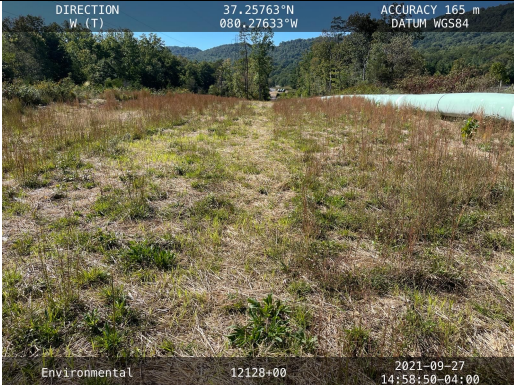
<b>GPS Location</b>	See photo		<b>GPS Location</b>	See photo	
<b>Field Station#</b>	12128+00		<b>Field Station#</b>	12132+72	
<b>Pic 1 Desc.</b>	Stabilized row conditions acceptable		<b>Pic 2 Desc.</b>	Bridge and ECDs crossing stream S-C29 in acceptable condition.

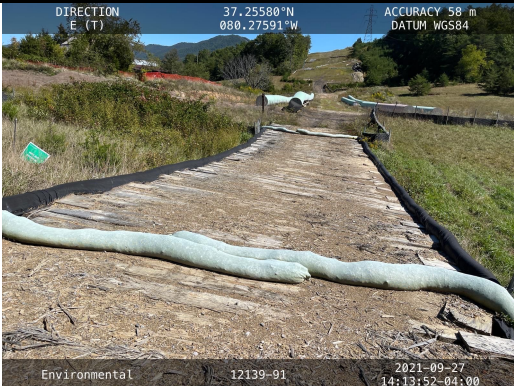
<b>GPS Location</b>	See photo		<b>GPS Location</b>	See photo	
<b>Field Station#</b>	12139+91		<b>Field Station#</b>	12150+95	
<b>Pic 5 Desc.</b>	Wetland crossing W-C6 in acceptable condition		<b>Pic 6 Desc.</b>	Stabilized drainage feature in acceptable condition

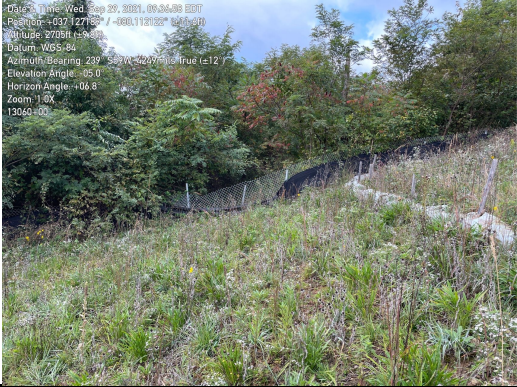
<b>GPS Location</b>	0	<b>GPS Location</b>	0		
<b>Field Station#</b>	13060+00	<b>Field Station#</b>	13061+89		
<b>Pic 7 Desc.</b>	Fence fabric needs reattached- 72hr maintenance item	<b>Pic 8 Desc.</b>	MVP-S-G26 and Corresponding buffer zone in good condition

E&S BMPs	Compliance Level	Corrective Action	Corrective Time Frame	Date Repaired
Cleanwater Diversion Berm	Acceptable			
Compost Filter Sock	Acceptable			
Equipment Bridge	Acceptable			
Erosion Control Blanket	Acceptable			
Rock Construction Entrance	Acceptable			
Silt Fence (Reinforce Filter Fence)	Acceptable			
Silt Fence (Reinforced Filter Fabric Fence)	Communication	Repair fence fabric- 72hr item		
Slope Drain Pipe	Acceptable			
Waterbar	Acceptable

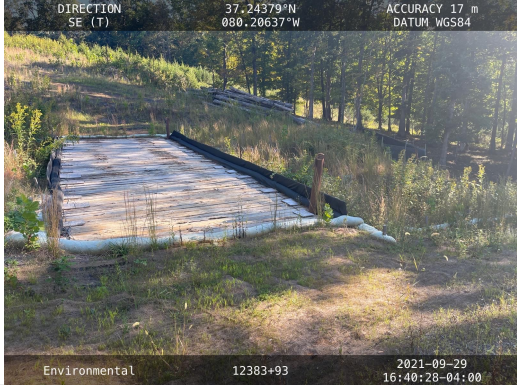
<b>GPS Location</b>	See photo		<b>GPS Location</b>	See photo	
<b>Field Station#</b>	12383+93		<b>Field Station#</b>	12380+04	
<b>Pic 9 Desc.</b>	Clean water crossing		<b>Pic 10 Desc.</b>	Down stream of stream crossing S-NN19

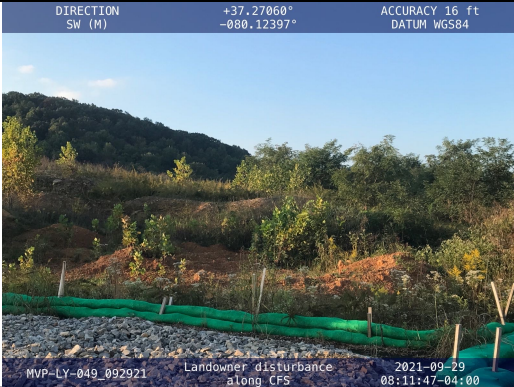
<b>GPS Location</b>	MVP-LY-049 See photo for gps data	<b>GPS Location</b>	MVP-LY-049 See photo for gps data		
<b>Field Station#</b>	+0	<b>Field Station#</b>	+0		
<b>Pic 3 Desc.</b>	Landowner soil disturbance along triple stack compost filter sock. No new damage to installed ECD's. Looking SW.	<b>Pic 4 Desc.</b>	Landowner soil disturbance along edge of feature W-CV21A. Area not stabilized. Looking NW.

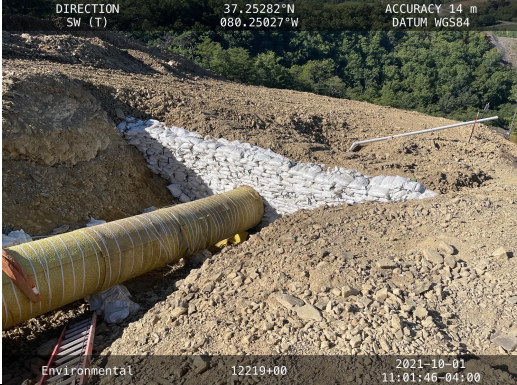
<b>GPS Location</b>	See photo		<b>GPS Location</b>	see photo	
<b>Field Station#</b>	12219+00		<b>Field Station#</b>	12219+00	
<b>Pic 13 Desc.</b>	Daylight drain trench breaker		<b>Pic 14 Desc.</b>	X-ray making an X-ray on a weld
