Visual Site Inspection Report

Project Name	H-600 Pipeline Spread I	AFE	124300139	Spread	H-600 Pipeline Spread I
Contractor	Precision			Report #	29592
Inspector	Ben Davenport			Date/Time	10/11/2021 11:04 AM
Permit #	TBD	Inspection Type	VA SWPP	Station Begin	14694+77
State	VA	Inspection Area	Partial	Station End	14802+19
County	Franklin	Ground	Damp	Temperature (°F)	74.00
Municipality	N/A	Weather	Cloudy	Rain Gauge (in)	0.10
				Rain Accumulation Time (days)	1.00

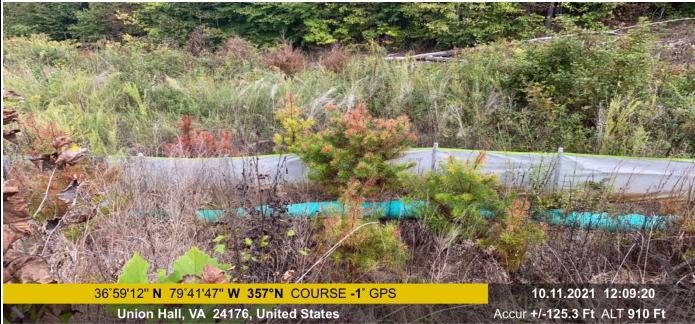
GPS Location 1			GPS Location 2		
Field Station# 14736+00			Field Station# 14739+00		
Pic 1 Desc. Perimeter CFS and P1 silt fence in good condition			Pic 2 Desc. Water bar and perimeter controls performing intended functions

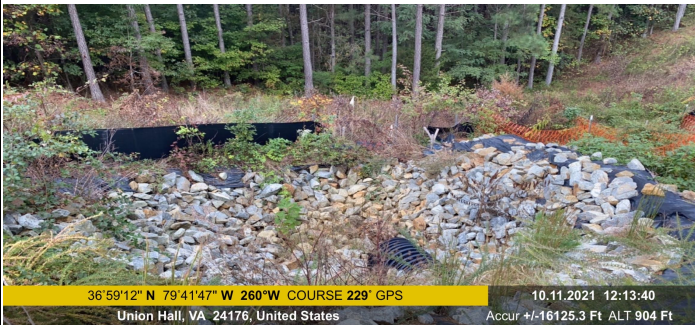
GPS Location 3			GPS Location 4		
Field Station# 14742+50			Field Station# 14760+00		
Pic 3 Desc. Plunge pool and perimeter SSF in good condition			Pic 4 Desc. Temporary diversion berm stabilized and vegetated

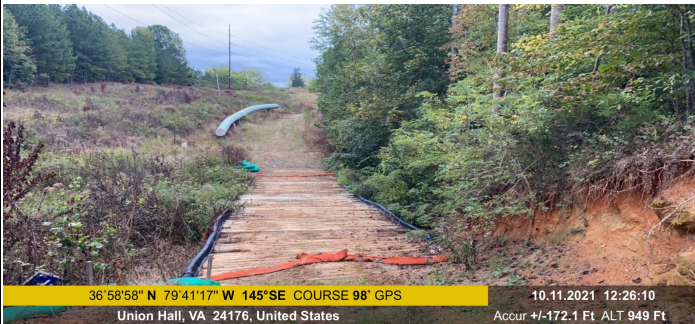
GPS Location 5			GPS Location 6		
Field Station# 14766+11			Field Station# 14770+00		
Pic 5 Desc. Equipment bridge and surrounding ECDs in place and functional at stream crossing and resource buffer			Pic 6 Desc. Slope drain tile properly filtering into sump pit; no issues observed

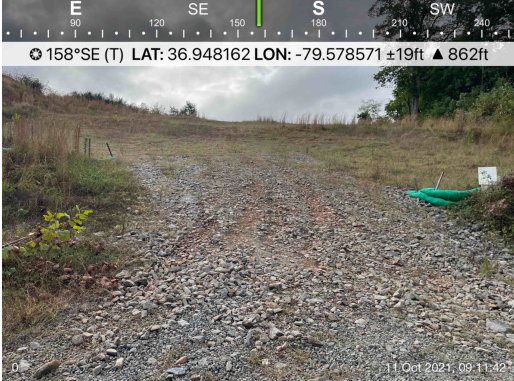
GPS Location	See photo		GPS Location	See photo	
Field Station#	15142+66		Field Station#	15150+00	
Pic 1 Desc.	RCE is in good condition at Rockcreek Rd.		Pic 2 Desc.	Perimeter CFS is in good condition throughout this section.

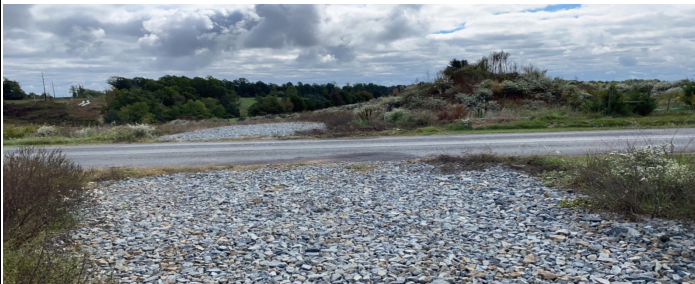
36°58'21" N 79°39'56" W 140°SE COURSE 141' GPS 1120 Listening Hill Rd, Penhook, VA 24137, United States 10.12.2021 11:00:33 Accur +/-15.4 Ft ALT 988 Ft			36°58'17" N 79°39'36" W 3°N COURSE 306' GPS 1760 Bar Ridge Rd, Penhook, VA 24137, United States 10.12.2021 15:50:46 Accur +/-21.1 Ft ALT 983 Ft		
GPS Location	1		GPS Location	2	
Field Station#	14845+68		Field Station#	14861+31	
Pic 1 Desc.	RCE at Listening Hill Rd in good condition		Pic 2 Desc.	RCE at Bar Ridge Rd in good condition

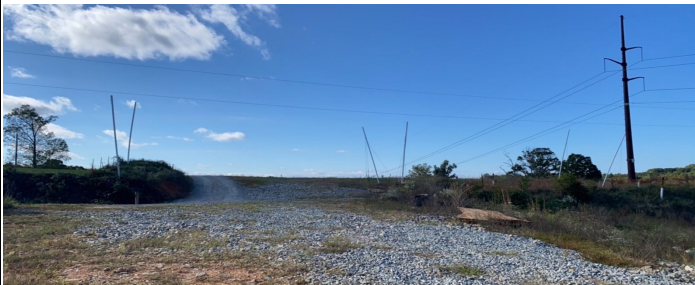
Field Station#	14928+52		Field Station#	14844+00	
Pic 3 Desc.	RCE at Ramsey Memorial Rd in good condition		Pic 4 Desc.	Perimeter CFS in place and functional

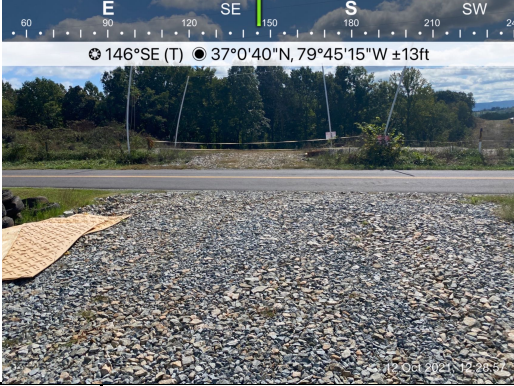
GPS Location	0	GPS Location	0		
Field Station#	14524+50	Field Station#	14531+58		
Pic 1 Desc.	Approximately 14524+50. Overview of road crossing and RCEs.	Pic 2 Desc.	Approximately 14531+58. Overview of stream crossing, equipment bridge and ECDs at stream S-G18.

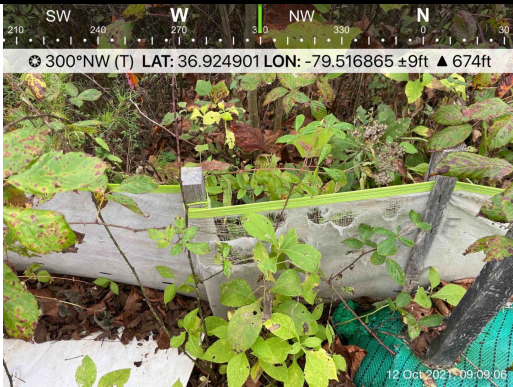
GPS Location	See photo		GPS Location	See photo	
Field Station#	15347+00		Field Station#	15347+05	
Pic 3 Desc.	P1 is degraded and needs to be replaced.		Pic 4 Desc.	P1 is damaged and needs to be replaced.

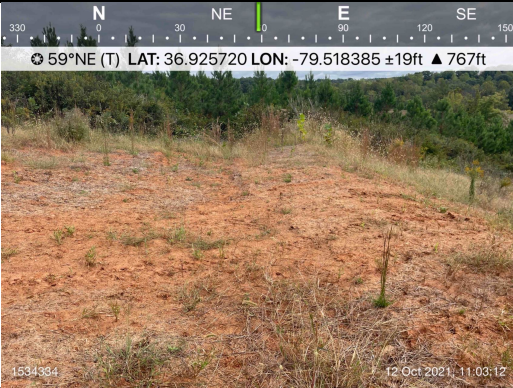
GPS Location	See photo		GPS Location	See photo	
Field Station#	15346+87		Field Station#	15343+34	
Pic 5 Desc.	Equipment bridge ECDs are in good condition and functioning.		Pic 6 Desc.	Waterbar channel needs to be reestablished and stabilized.

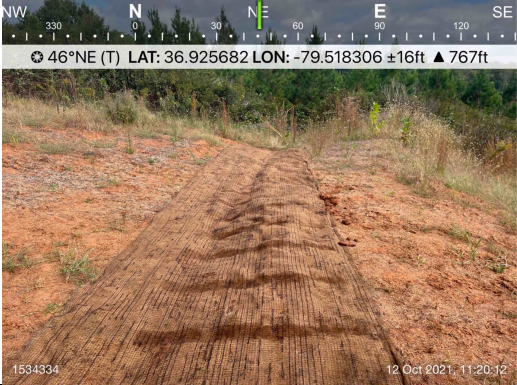
GPS Location	See photo	GPS Location	See photo		
Field Station#	15343+34	Field Station#	15338+00		
Pic 7 Desc.	Environmental crew has corrected this issue.	Pic 8 Desc.	CWD is functioning as intended.

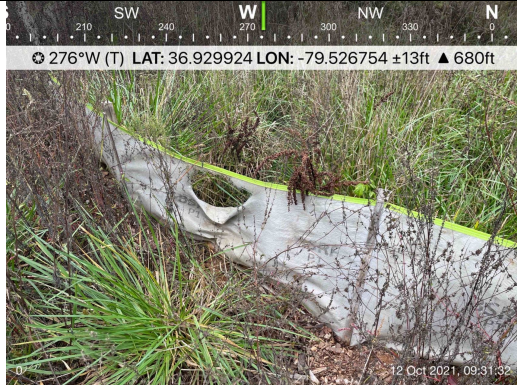
GPS Location	See photo	GPS Location	See photo		
Field Station#	15311+78	Field Station#	15310+00		
Pic 11 Desc.	P1 has been damaged at wetland buffer and needs to be replaced.	Pic 12 Desc.	Perimeter CFS is in good condition.

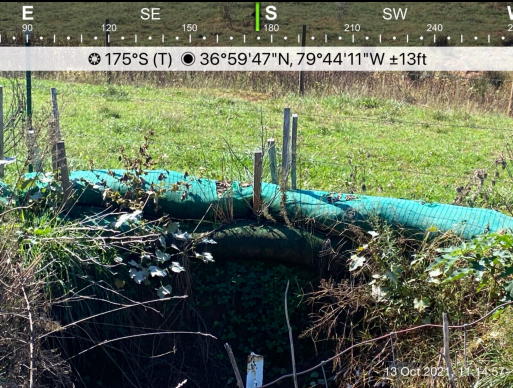
GPS Location	0	GPS Location	0		
Field Station#	14568+10	Field Station#	14606+00		
Pic 5 Desc.	Approximately 14568+10. Overview of stream crossing, equipment bridge and ECDs at stream S-E18.	Pic 6 Desc.	Approximately 14606+00. CFS at end treatment busted and torn. Routine maintenance.

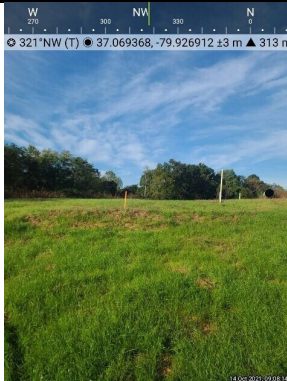
GPS Location	00000	GPS Location	00000		
Field Station#	13784+30	Field Station#	13803+15		
Pic 5 Desc.	Safety fence around sump pit requires maintenance due to being weathered. Added to the punch list for repair.		Pic 6 Desc.	Row photo showing good winter vegetation coverage. No environmental issues observed at the time of inspection.

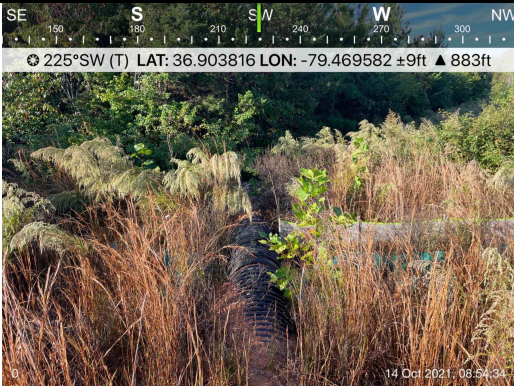
GPS Location	See photo		GPS Location	See photo	
Field Station#	15515+00		Field Station#	15527+23	
Pic 5 Desc.	CWDs are functioning as intended.		Pic 6 Desc.	P1 needs to be restaked at this location.

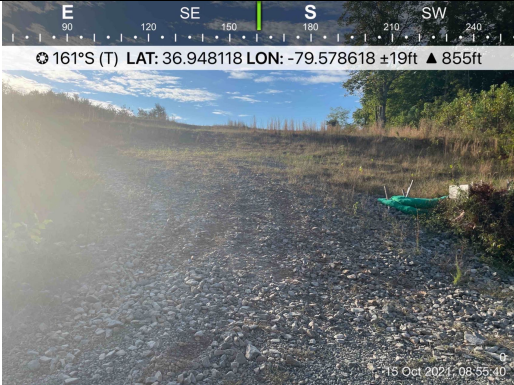
GPS Location	See photo		GPS Location	See photo	
Field Station#	15142+66		Field Station#	15150+00	
Pic 1 Desc.	RCE is in good condition at Rockcreek Rd.		Pic 2 Desc.	Perimeter CFS is in good condition throughout this section.
