Visual Site Inspection Report

Project Name	H-600 Pipeline Spread I	AFE	124300139	Spread	H-600 Pipeline Spread I
Contractor	Precision			Report #	29880
Inspector	Justin Burch			Date/Time	10/18/2021 11:47 AM
Permit #	TBD	Inspection Type	VA SWPP	Station Begin	13958+31
State	VA	Inspection Area	Full	Station End	14062+17
County	Franklin	Ground	Damp	Temperature (°F)	68.00
Municipality	N/A	Weather	Sunny	Rain Gauge (in)	0.00
				Rain Accumulation Time (days)	6.00

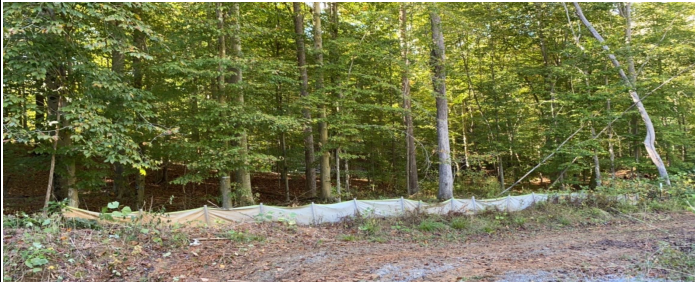
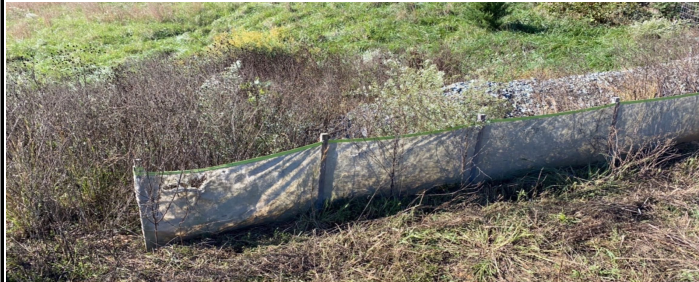
36°58'23" N 79°40'22" W 272°W COURSE -1° GPS 10.18.2021 11:14:47 Accur +/-34.8 Ft ALT 875 Ft			36°58'19" N 79°39'49" W 254°W COURSE 122° GPS 10.18.2021 10:57:03 355 Listening Hill Rd, Penhook, VA 24137, United States Accur +/-79.5 Ft ALT 970 Ft		
GPS Location	1	GPS Location	2		
Field Station#	14824+00	Field Station#	14851+00		
Pic 1 Desc.	Routine maintenance. Replace row of P1 silt fence beyond effective lifespan.		Pic 2 Desc.	Routine maintenance. Replace rows of P1 silt fence with holes/tears in fabric.

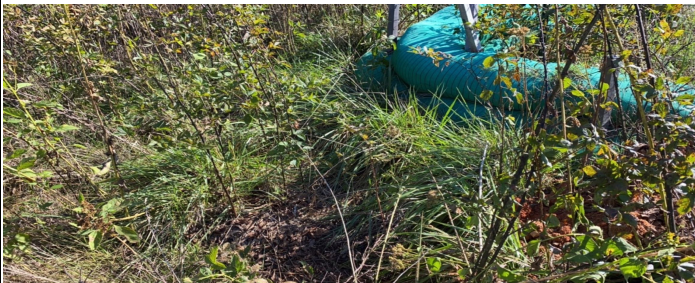
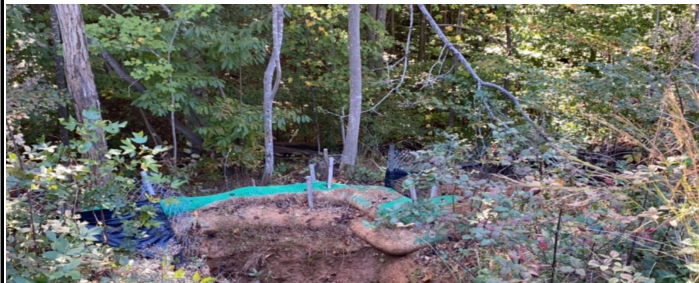
Pic 3 Desc.	Ineffective ESC measure. Perimeter CFS worn or nonexistent on low side perimeter of ROW after mowing was completed in area.		Pic 4 Desc.	Routine maintenance. CFS end treatment not properly filtering due to sediment-laden fabric.

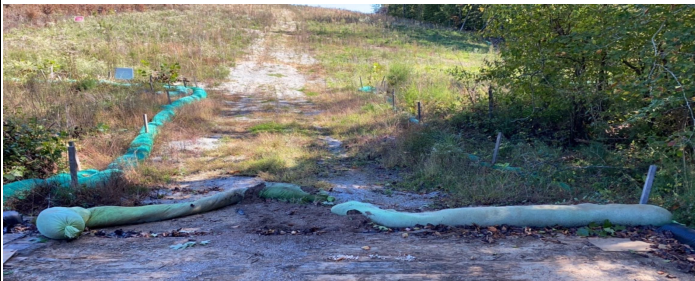
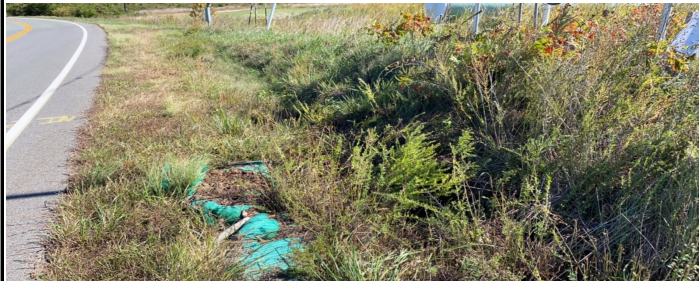
36°58'6" N 79°38'31" W 149°SE COURSE 0° GPS 10.18.2021 13:08:48 Sorry no results found Accur +/-36.5 Ft ALT 0 Ft			36°57'20" N 79°34'55" W 140°SE COURSE 355° GPS 10.18.2021 11:32:52 8850-8968 Museville Rd, Sandy Level, VA 24161, United States Accur +/-15.4 Ft ALT 917 Ft		
GPS Location	5	GPS Location	6		
Field Station#	14915+96	Field Station#	15113+00		
Pic 5 Desc.	Routine maintenance. Replace damaged bridge wattles (possible third party damage)		Pic 6 Desc.	Routine maintenance. Replace damaged perimeter CFS from third party damage (observed in drive by inspection at road crossing)

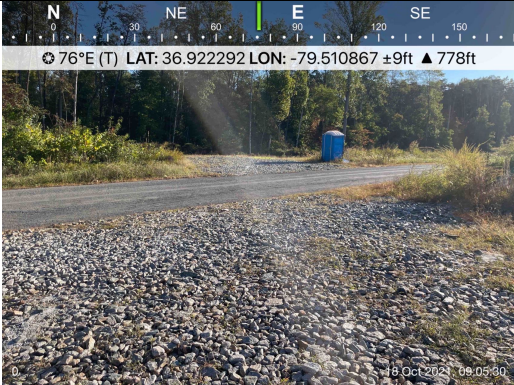
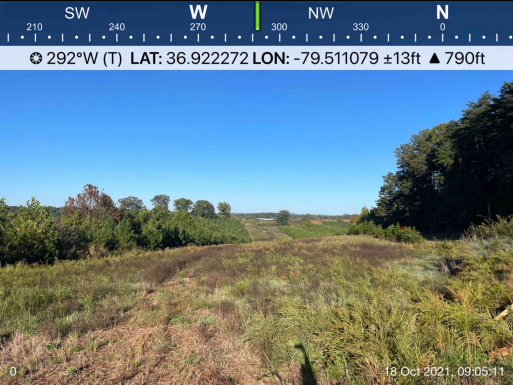
GPS Location	See photo		GPS Location	See photo	
Field Station#	15370+62		Field Station#	15370+00	
Pic 1 Desc.	RCEs are in good condition at all road crossings.		Pic 2 Desc.	Vegetation continues to fill in throughout this section.

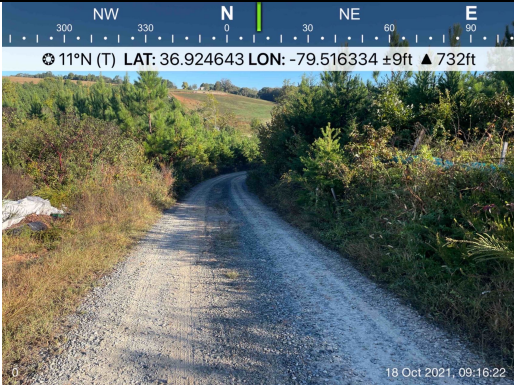
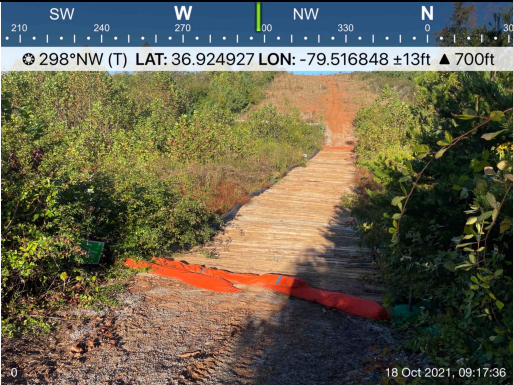
GPS Location	See photo		GPS Location	See photo	
Field Station#	15350+00		Field Station#	15346+87	
Pic 3 Desc.	MVP-PI-332 remains in good condition with controls in place.		Pic 4 Desc.	Equipment bridge ECDs are in place and functioning.

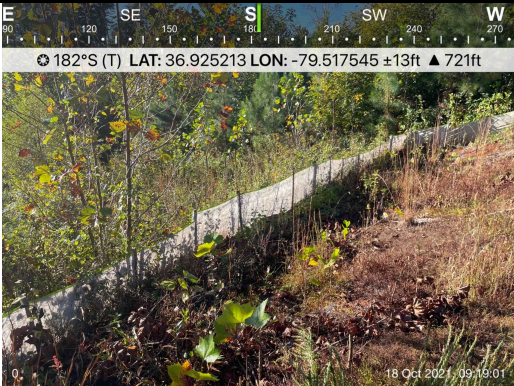
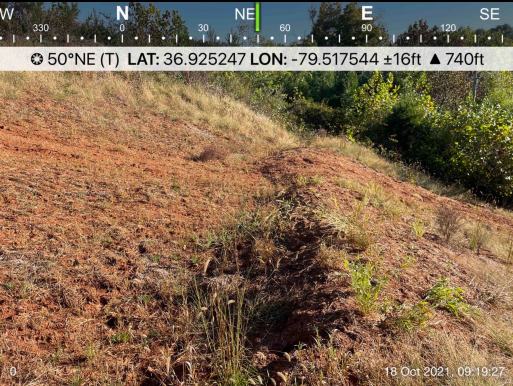
GPS Location	See photo		GPS Location	See photo	
Field Station#	15346+50		Field Station#	15346+00	
Pic 5 Desc.	P1 is in good condition at all stream and wetland buffers.		Pic 6 Desc.	Waterbars are functioning as intended.

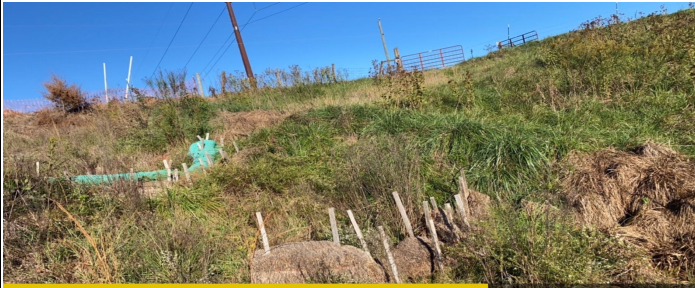
GPS Location			GPS Location		
1			2		
Field Station#			Field Station#		
14929+50			14932+25		
Pic 1 Desc.			Pic 2 Desc.		
Routine maintenance. Straw bale check dams washed out and need replaced.			Routine maintenance. Replace damaged section of CFS at resource buffer.

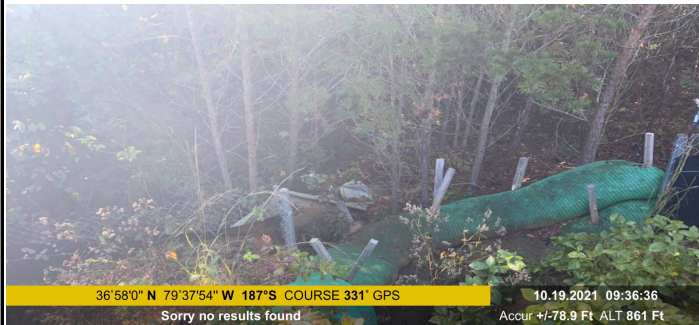
GPS Location			GPS Location		
3			4		
Field Station#			Field Station#		
14938+00			14946+24		
Pic 3 Desc.			Pic 4 Desc.		
Routine maintenance. Perimeter CFS in extra workspace beyond effective lifespan. Replace.			Routine maintenance. P1 silt fence J Hook damaged and needs replaced.

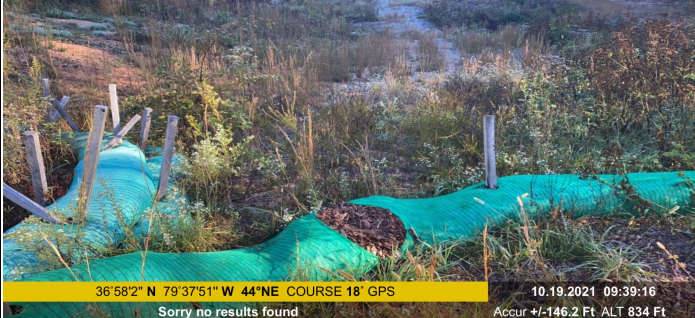
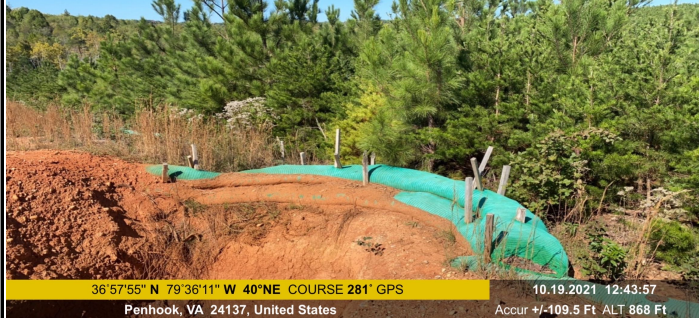
GPS Location			GPS Location		
5			6		
Field Station#			Field Station#		
14949+48			15034+00		
Pic 5 Desc.			Pic 6 Desc.		
Routine maintenance. Damage to perimeter CFS needs repaired.			Routine maintenance. CFS end treatment not properly filtering. Remove sediment.

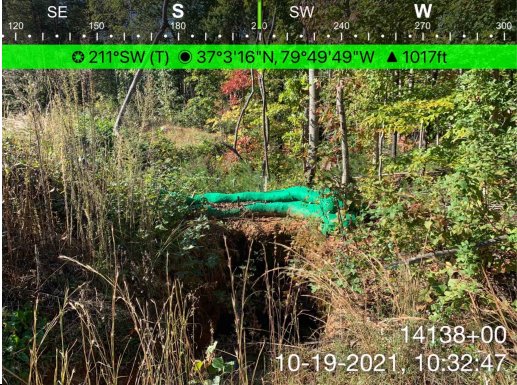
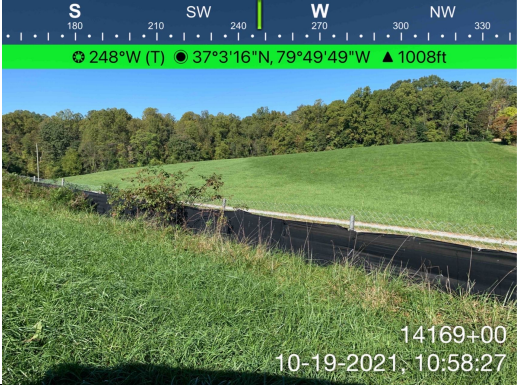
<p>14169+00 10-19-2021, 10:58:27</p>			
GPS Location	0	GPS Location	0		
Field Station#	14138+00	Field Station#	14169+00		
Pic 7 Desc.	Sump pit in acceptable condition		Pic 8 Desc.	Super silt fence in acceptable condition

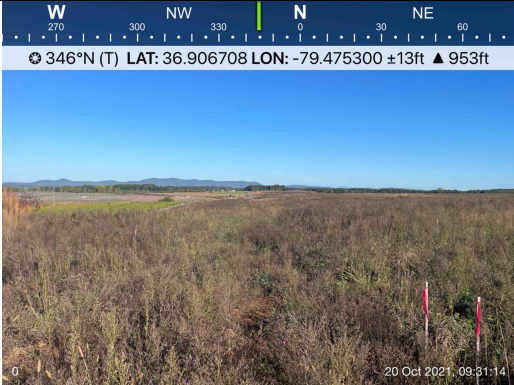
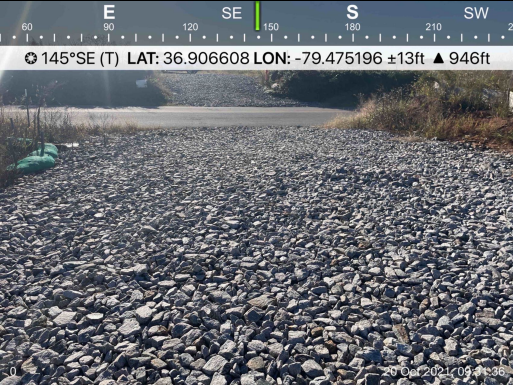
GPS Location	See photo		GPS Location	See photo	
Field Station#	15495+00		Field Station#	15496+70	
Pic 1 Desc.	Vegetation continues to fill in throughout this section.		Pic 2 Desc.	RCEs are in good condition at all road crossings.

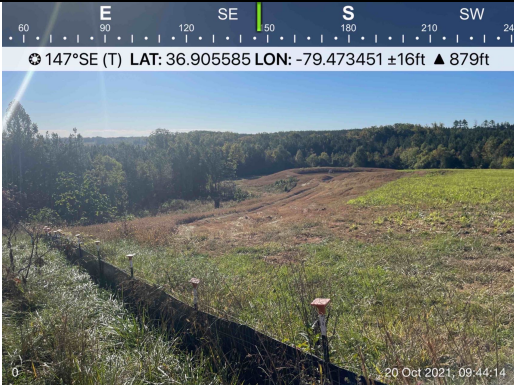
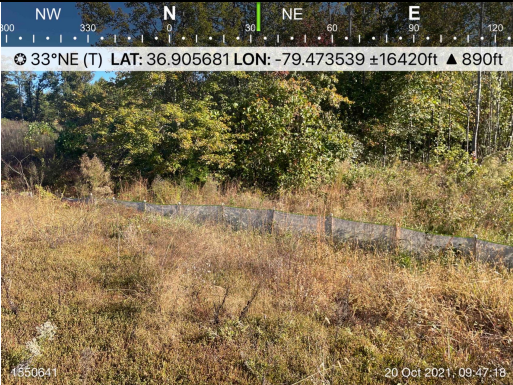
GPS Location	See photo		GPS Location	See photo	
Field Station#	15501+00		Field Station#	15506+41	
Pic 3 Desc.	No evidence of sedimentation from 3rd party disturbance.		Pic 4 Desc.	P1 is in good condition at all stream and wetland buffers.

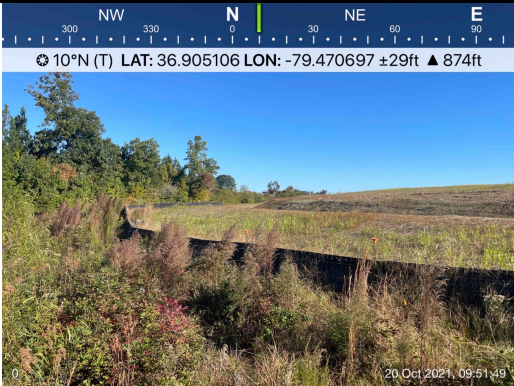
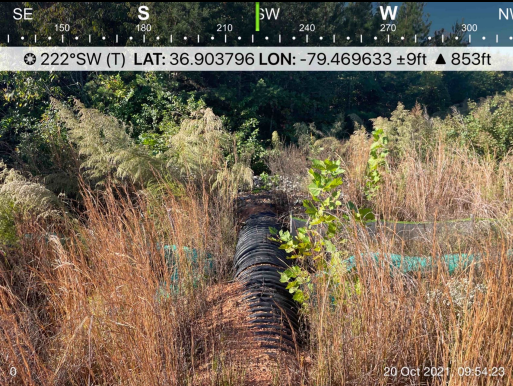
GPS Location	See photo		GPS Location	See photo	
Field Station#	15510+00		Field Station#	15515+00	
Pic 5 Desc.	3rd party ECDs appear to be in good condition.		Pic 6 Desc.	CWDs are functioning as intended.

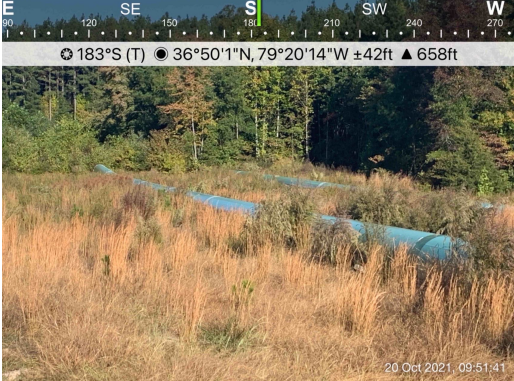
GPS Location	O	GPS Location	O		
Field Station#	22+00	Field Station#	13+93		
Pic 1 Desc.	Observing temporary stabilization	Pic 2 Desc.	Observing temporary stabilization and RCE

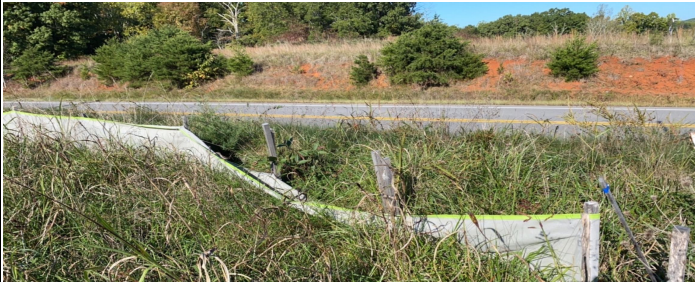
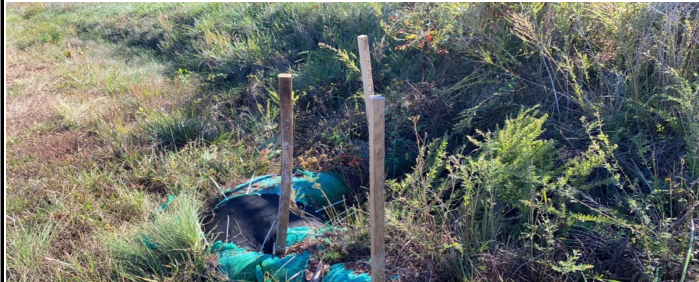
36°57'19" N 79°34'55" W 344°N COURSE 39° GPS 8776 Museville Rd, Sandy Level, VA 24161, United States 10.20.2021 10:32:19 Accur +/-248.9 Ft ALT 934 Ft			36°57'20" N 79°34'55" W 172°S COURSE 13° GPS 8776 Museville Rd, Sandy Level, VA 24161, United States 10.20.2021 10:33:24 Accur +/-26.0 Ft ALT 932 Ft		
GPS Location	1		GPS Location	2	
Field Station#	15113+25		Field Station#	15113+00	
Pic 1 Desc.	Routine maintenance. Repair damaged P1 silt fence in extra workspace.		Pic 2 Desc.	Contractor repaired damaged CFS per punch list item.

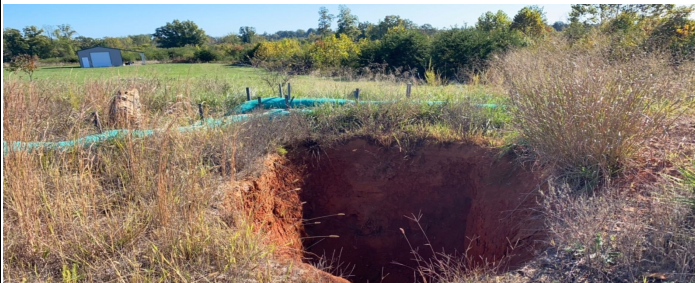
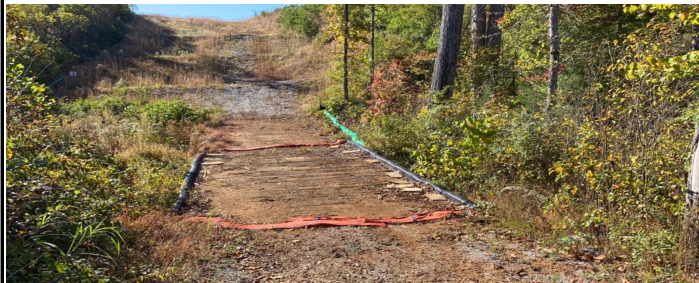
GPS Location	3		GPS Location	4	
Field Station#	15116+00		Field Station#	15126+40	
Pic 3 Desc.	Sump pit and CFS end treatment performing intended functions.		Pic 4 Desc.	Equipment bridge and surrounding ECDs in place and functional at stream crossing and resource buffer.

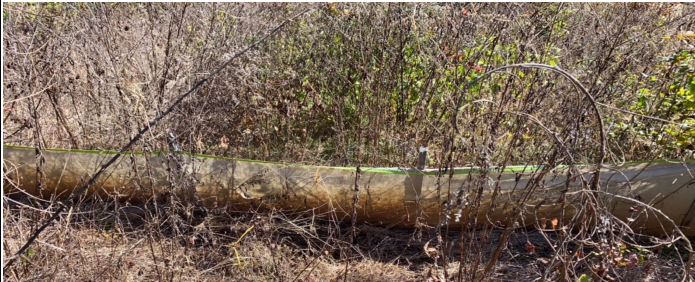
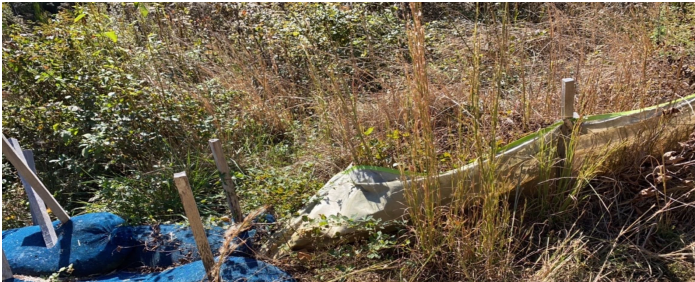
36°59'17" N 79°42'30" W 137°SE COURSE 87° GPS Sorry no results found 10.21.2021 11:45:15 Accur +/-134.6 Ft ALT 944 Ft			36°59'17" N 79°42'19" W 287°W COURSE 250° GPS Sorry no results found 10.21.2021 12:12:20 Accur +/-25.7 Ft ALT 913 Ft		
GPS Location	1		GPS Location	2	
Field Station#	14700+20		Field Station#	14709+00	
Pic 1 Desc.	Routine maintenance. Replace damaged/worn panels of P1 silt fence at resource buffer CIS S-H32.		Pic 2 Desc.	Routine maintenance. Replace broken stakes of P1 silt fence.

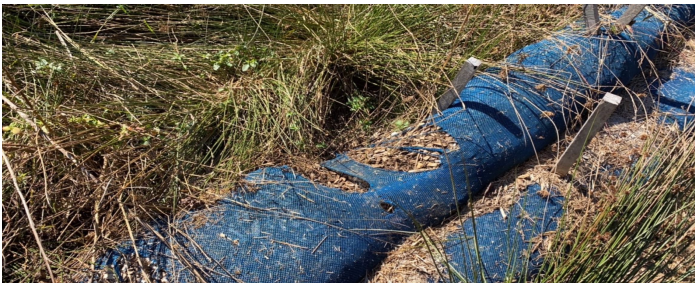
Pic 3 Desc.	Routine maintenance. Repair damaged P1 silt fence around spoil pile.		Pic 4 Desc.	Routine maintenance. Repair damaged CFS triple stack.

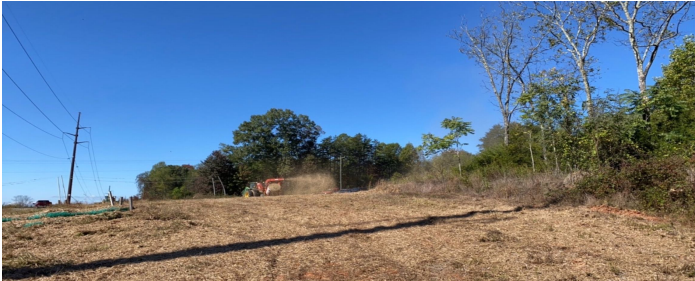
36°59'16" N 79°42'7" W 223°SW COURSE 70° GPS Sorry no results found 10.21.2021 11:57:00 Accur +/-92.3 Ft ALT 892 Ft			36°59'17" N 79°42'32" W 327°NW COURSE 264° GPS Sorry no results found 10.21.2021 12:17:06 Accur +/-74.5 Ft ALT 912 Ft		
GPS Location	5		GPS Location	6	
Field Station#	14711+50		Field Station#	14697+00	
Pic 5 Desc.	Routine maintenance. Replace row of P1 silt fence past effective lifespan.		Pic 6 Desc.	Contractor seeding and stabilizing ROW

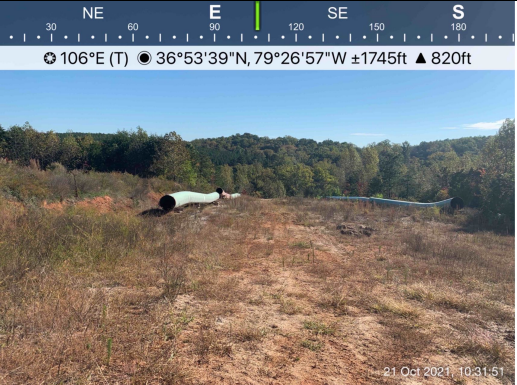
GPS Location	O	GPS Location	O		
Field Station#	15630+00	Field Station#	15590+00		
Pic 1 Desc.	Observing temporary stabilization,CWD outlet and ECD's		Pic 2 Desc.	Observing temporary stabilization and water bars

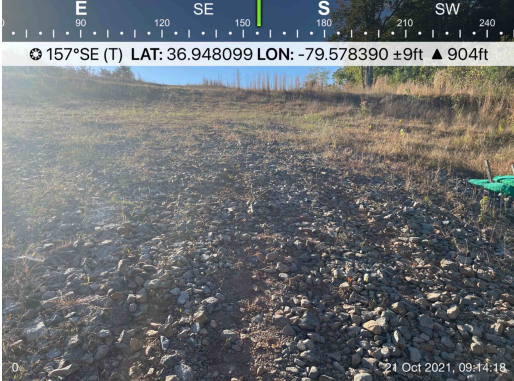
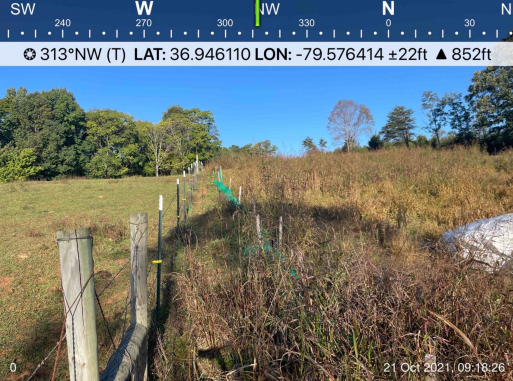
GPS Location	See photo		GPS Location	See photo	
Field Station#	15142+66		Field Station#	15150+00	
Pic 1 Desc.	RCE is in good condition at Rockcreek Rd		Pic 2 Desc.	CFS is in good condition at this location.

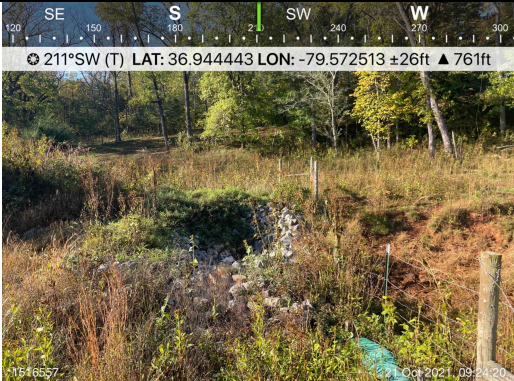
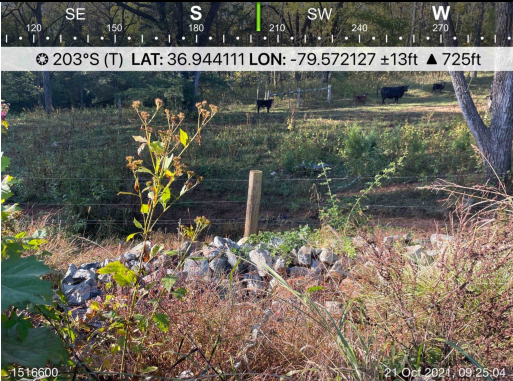
GPS Location	See photo		GPS Location	See photo	
Field Station#	15165+57		Field Station#	15166+00	
Pic 3 Desc.	Rock filter remains in good condition.		Pic 4 Desc.	Rock filter outlet remains in good condition.

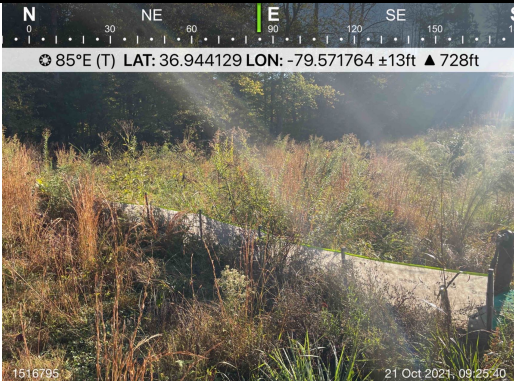
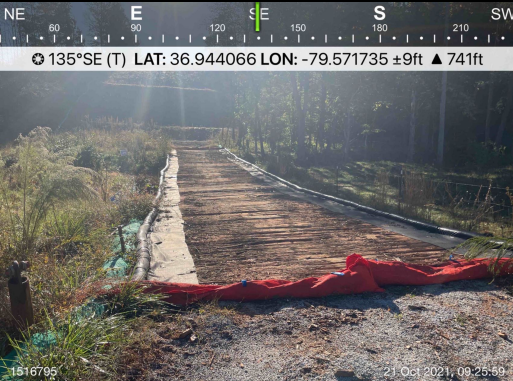
GPS Location	See photo		GPS Location	See photo	
Field Station#	15167+95		Field Station#	15167+95	
Pic 5 Desc.	P1 is in good condition at stream buffer.		Pic 6 Desc.	Equipment bridge ECDs are in place and functioning.

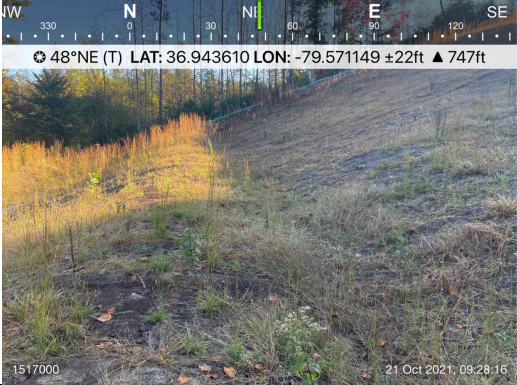
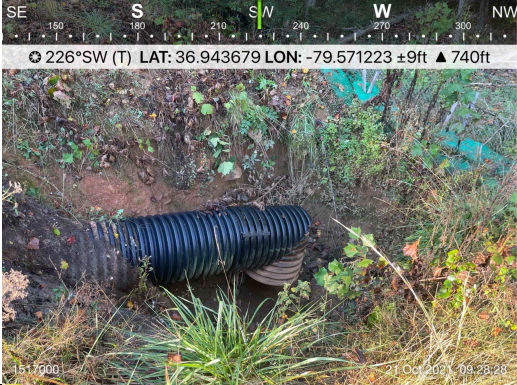
GPS Location	See photo		GPS Location	See photo	
Field Station#	15170+00		Field Station#	15170+00	
Pic 7 Desc.	Waterbars are in good condition and functioning.		Pic 8 Desc.	Slope drain is functioning as intended.

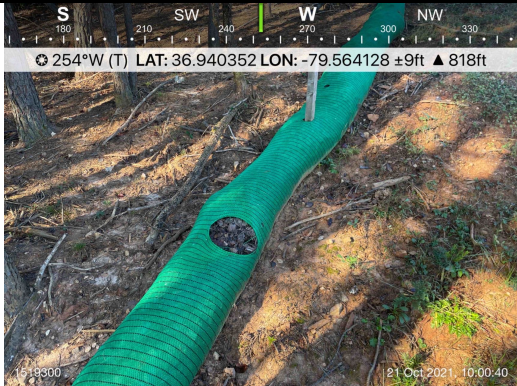
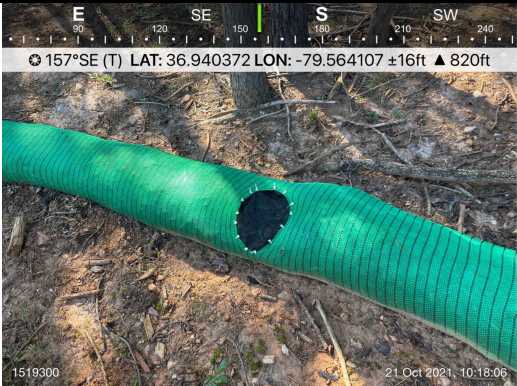
GPS Location	See photo		GPS Location	See photo	
Field Station#	15193+00		Field Station#	15193+00	
Pic 9 Desc.	CFS has been damaged by livestock and needs to be repaired.		Pic 10 Desc.	Environmental crew has corrected this issue.

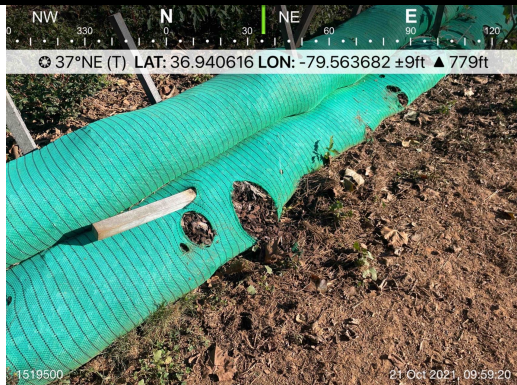
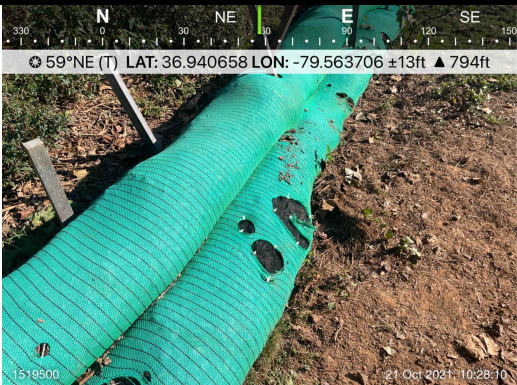
GPS Location	See photo		GPS Location	See photo	
Field Station#	15195+00		Field Station#	15195+00	
Pic 11 Desc.	CFS has been damaged by livestock and needs to be repaired.		Pic 12 Desc.	Environmental crew has corrected this issue.

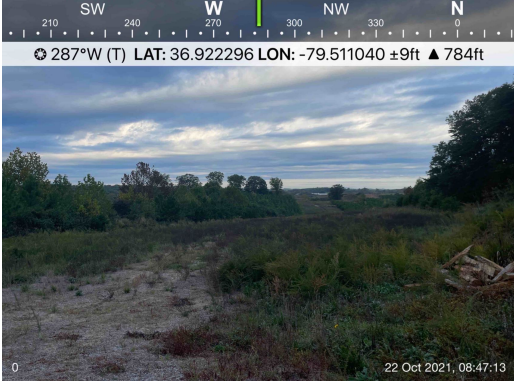
GPS Location	See photo		GPS Location	See photo	
Field Station#	15370+00		Field Station#	15350+00	
Pic 1 Desc.	Vegetation continues to fill in throughout this section.		Pic 2 Desc.	MVP-PI-332 remains in good condition with controls in place.

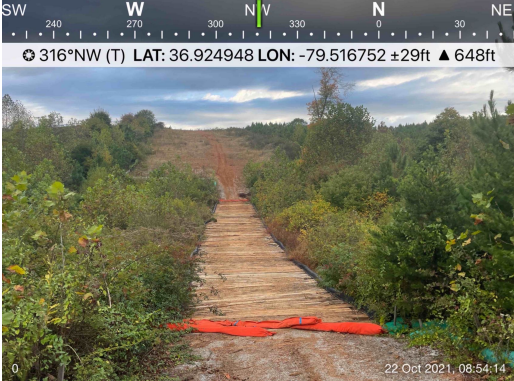
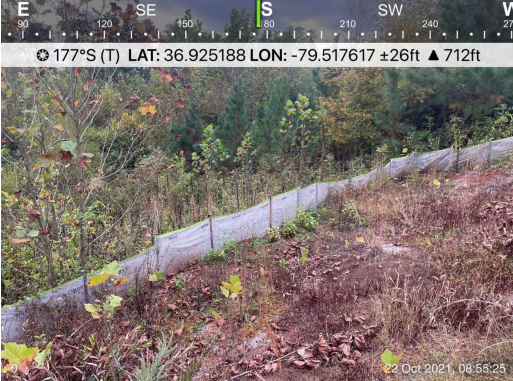
GPS Location	See photo		GPS Location	See photo	
Field Station#	15346+87		Field Station#	15346+00	
Pic 3 Desc.	Equipment bridge ECDs are in good condition and functioning.		Pic 4 Desc.	P1 is in good condition at all stream and wetland buffers.

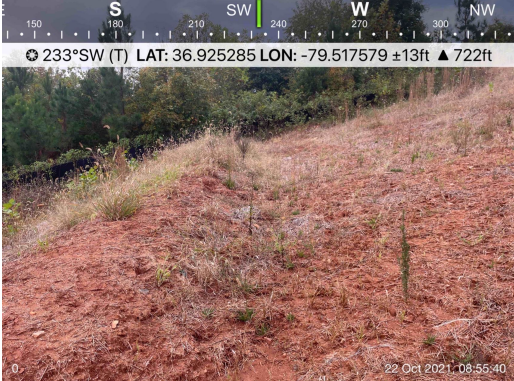
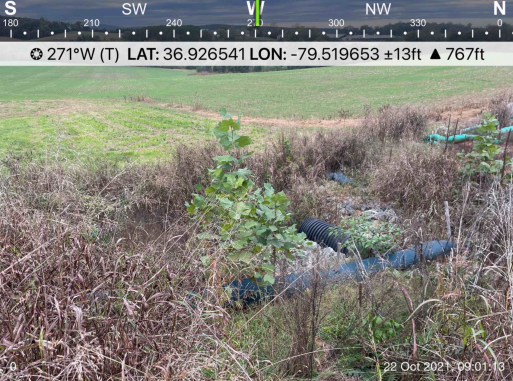
GPS Location	See photo		GPS Location	See photo	
Field Station#	15345+50		Field Station#	15338+00	
Pic 5 Desc.	Waterbars are in good condition throughout this section.		Pic 6 Desc.	CWDs are functioning as intended.

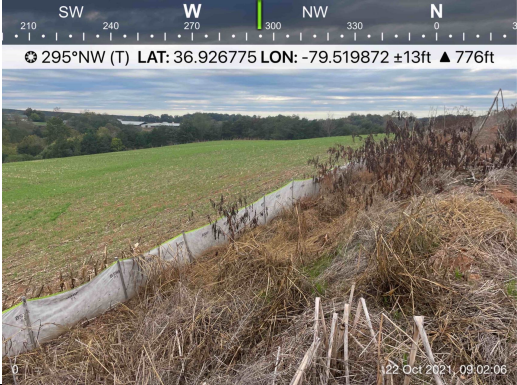
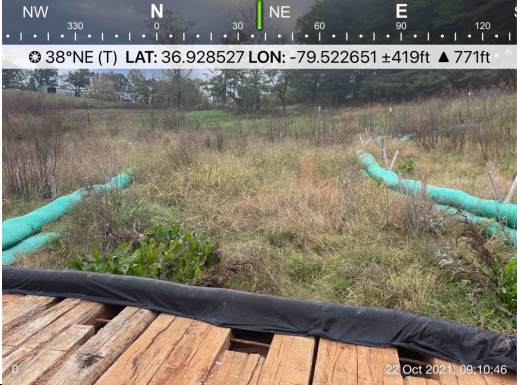
GPS Location	See photo		GPS Location	See photo	
Field Station#	15336+00		Field Station#	15330+00	
Pic 7 Desc.	Perimeter P1 is in good condition.		Pic 8 Desc.	Drainage ECDs are in good condition and functioning.

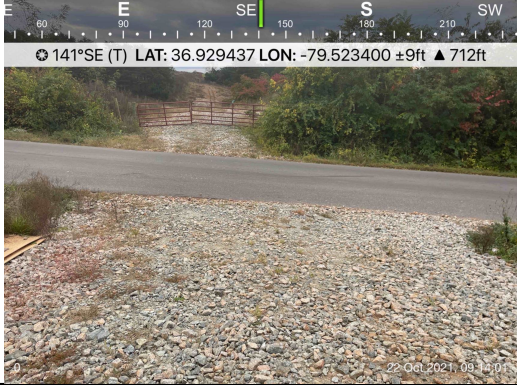
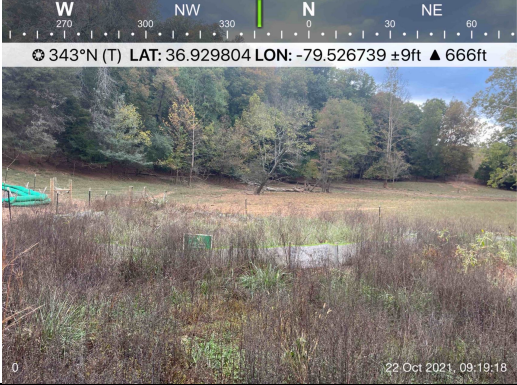
GPS Location	See photo		GPS Location	See photo	
Field Station#	15323+24		Field Station#	15311+78	
Pic 9 Desc.	RCEs are in good condition at all road crossings.		Pic 10 Desc.	P1 is in good condition at wetland buffer.

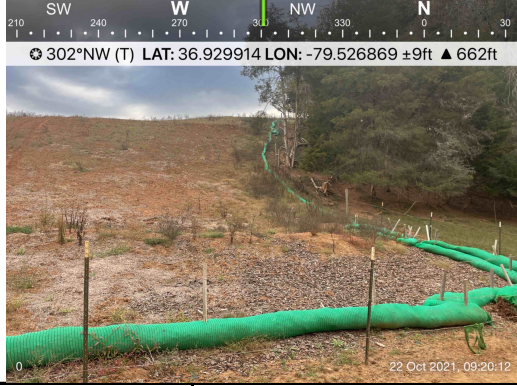
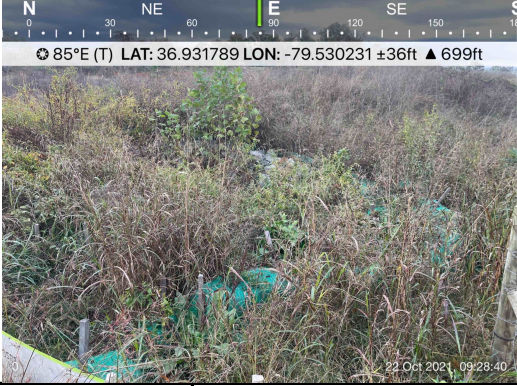
GPS Location	See photo		GPS Location	See photo	
Field Station#	15310+00		Field Station#	15299+00	
Pic 11 Desc.	Perimeter CFS is in good condition.		Pic 12 Desc.	CWD is functioning at this location.

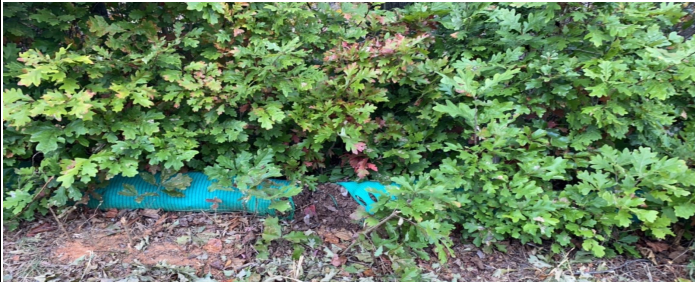
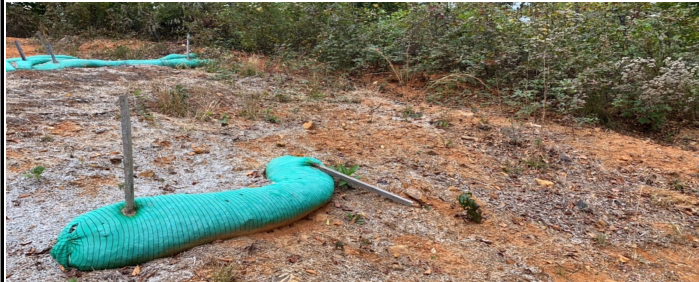
36°58'16" N 79°39'30" W 75°E COURSE -1' GPS 1760 Bar Ridge Rd, Penhook, VA 24137, United States 10.22.2021 09:01:57 Accur +/-25.5 Ft ALT 941 Ft			36°58'15" N 79°39'29" W 70°E COURSE -1' GPS 1760 Bar Ridge Rd, Penhook, VA 24137, United States 10.22.2021 09:03:52 Accur +/-130.3 Ft ALT 940 Ft		
GPS Location	1		GPS Location	2	
Field Station#	14868+00		Field Station#	14869+00	
Pic 1 Desc.	Routine maintenance. Repair damage to perimeter CFS.		Pic 2 Desc.	Routine maintenance. Replace broken stakes in CFS check on slope.

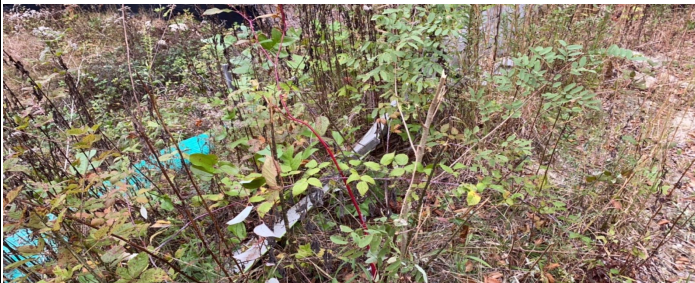
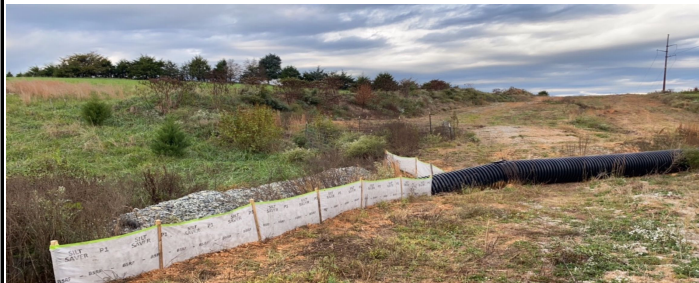
GPS Location	3		GPS Location	4	
Field Station#	14870+93		Field Station#	14851+00	
Pic 3 Desc.	Routine maintenance. Broken stakes in P1 silt fence at resource buffer.		Pic 4 Desc.	Contractor replaced P1 silt fence per punch list item.

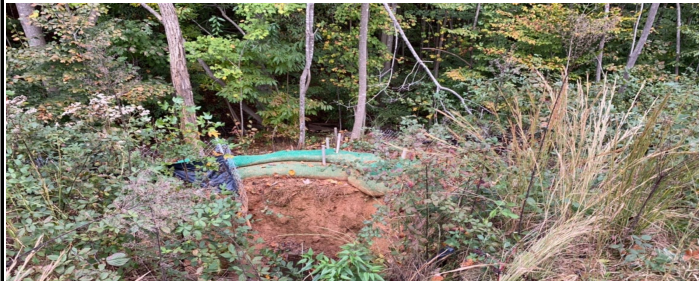
36°58'18" N 79°39'37" W 298°NW COURSE 290' GPS 1760 Bar Ridge Rd, Penhook, VA 24137, United States 10.22.2021 09:16:29 Accur +/-116.9 Ft ALT 986 Ft			36°58'13" N 79°39'20" W 192°S COURSE 62' GPS 1760 Bar Ridge Rd, Penhook, VA 24137, United States 10.22.2021 09:09:15 Accur +/-70.6 Ft ALT 875 Ft		
GPS Location	5		GPS Location	6	
Field Station#	14856+00		Field Station#	14786+00	
Pic 5 Desc.	Contractor replaced perimeter CFS per punch list item.		Pic 6 Desc.	Contractor removed sediment from end treatment per punch list item.

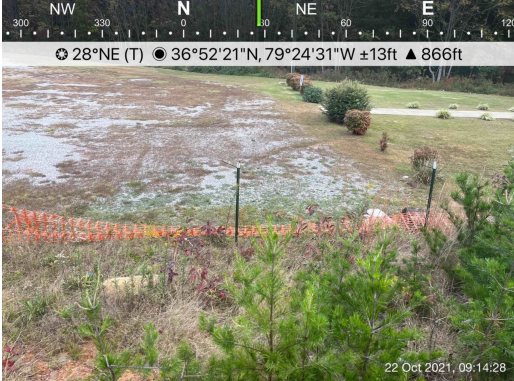
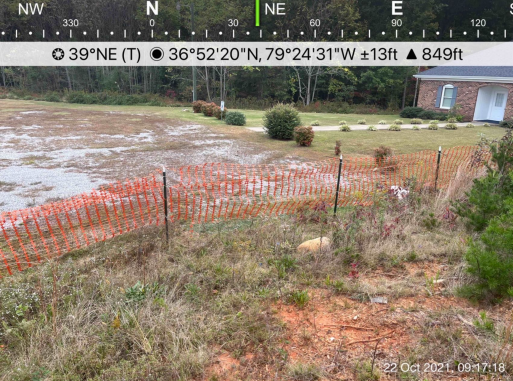
GPS Location	O	GPS Location	O		
Field Station#	15745+00	Field Station#	15745+00		
Pic 1 Desc.	Observing safety fence that required maintenance	Pic 2 Desc.	Observing safety fence that received maintenance
