Visual Site Inspection Report

Project Name	H-600 Pipeline Spread I	AFE	124300139	Spread	H-600 Pipeline Spread I
Contractor	Precision			Report #	30227
Inspector	John White			Date/Time	10/25/2021 11:28 AM
Permit #	TBD	Inspection Type	VA SWPP	Station Begin	15772+27
State	VA	Inspection Area	Full	Station End	15947+64
County	Pittsylvania	Ground	Dry	Temperature (°F)	70.00
Municipality	Chatham	Weather	Sunny	Rain Gauge (in)	0.00
				Rain Accumulation Time (days)	6.00

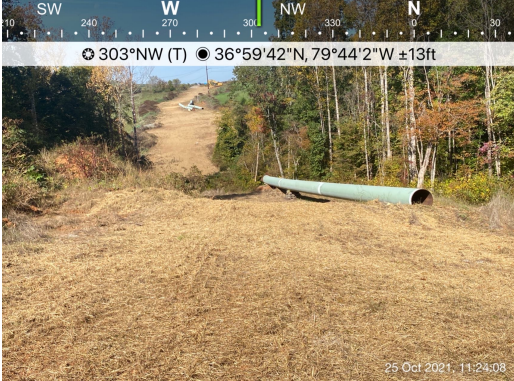
GPS Location	0	GPS Location	0		
Field Station#	14615+00	Field Station#	14611+27		
Pic 1 Desc.	Approximately 14615+00. Overview of ROW.		Pic 2 Desc.	Approximately 14611+27. Overview of stream crossing, equipment bridge and ECDs at stream S-E14.

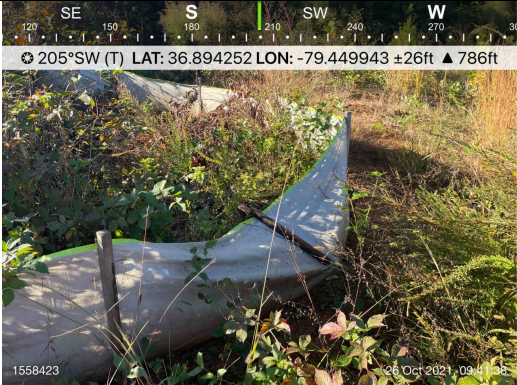
GPS Location	See photo		GPS Location	See photo	
Field Station#	15575+00		Field Station#	15584+23	
Pic 11 Desc.	Slope drain is functioning as intended.		Pic 12 Desc.	P1 needs to be restaked at road pipe outlet.

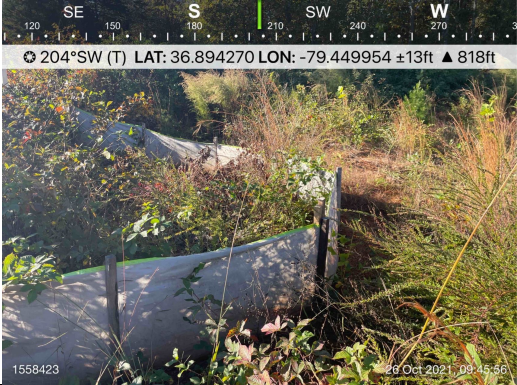
GPS Location	See photo	GPS Location			
Field Station#	15584+23	Field Station#			
Pic 13 Desc.	Environmental crew has corrected this issue.	Pic 14 Desc.			
Insert image here		Insert image here			
GPS Location		GPS Location			
Field Station#		Field Station#			
Pic 15 Desc.		Pic 16 Desc.			
Insert image here		Insert image here			
GPS Location		GPS Location			
Field Station#		Field Station#			
Pic 17 Desc.		Pic 18 Desc.

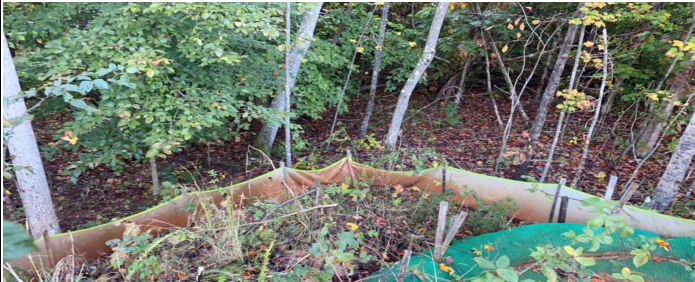
36°57'44" N 79°35'27" W 316°NW COURSE 28° GPS Penhook, VA 24137, United States 10.26.2021 08:36:33 Accur +/-98.3 Ft ALT 908 Ft			36°57'44" N 79°35'26" W 134°SE COURSE 5° GPS Penhook, VA 24137, United States 10.26.2021 08:37:06 Accur +/-63.6 Ft ALT 873 Ft		
GPS Location	1		GPS Location	2	
Field Station#	15072+00		Field Station#	15072+60	
Pic 1 Desc.	Routine maintenance. Replace row of P1 silt fence past effective lifespan.		Pic 2 Desc.	Routine maintenance. Repair damage to safety fence.

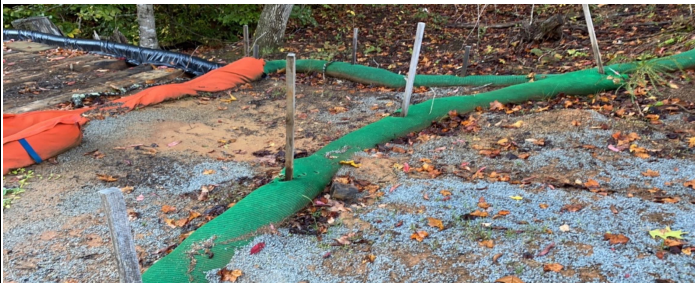
Pic 3 Desc.	Routine maintenance. CFS check and bridge wattles more than half full of sediment.		Pic 4 Desc.	Routine maintenance. Tree fallen on perimeter SSF.

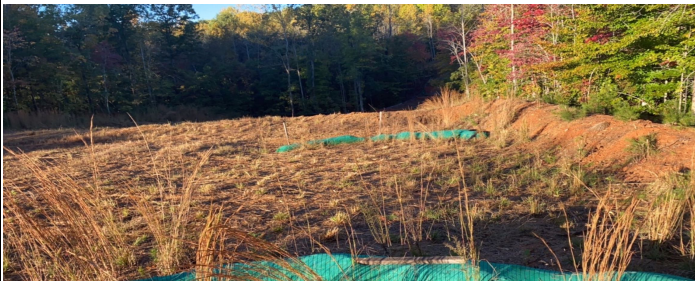
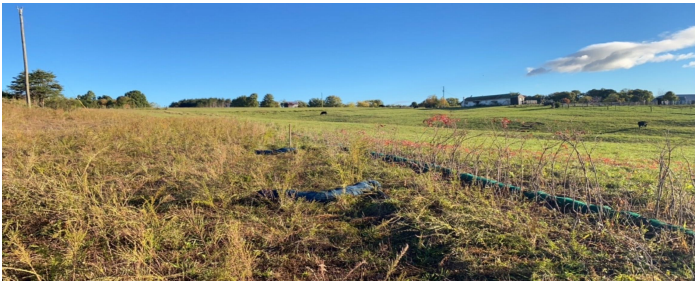
36°57'45" N 79°35'22" W 224°SW COURSE 9° GPS Sandy Level, VA 24161, United States 10.26.2021 08:40:24 Accur +/-29.7 Ft ALT 884 Ft			36°57'44" N 79°35'21" W 81°E COURSE 113° GPS Sandy Level, VA 24161, United States 10.26.2021 08:43:52 Accur +/-169.6 Ft ALT 886 Ft		
GPS Location	5		GPS Location	6	
Field Station#	15076+00		Field Station#	15081+60	
Pic 5 Desc.	Routine maintenance. Broken or missing stakes in CFS check dams need replaced.		Pic 6 Desc.	Routine maintenance. Broken or missing stakes in CFS check dams need replaced.

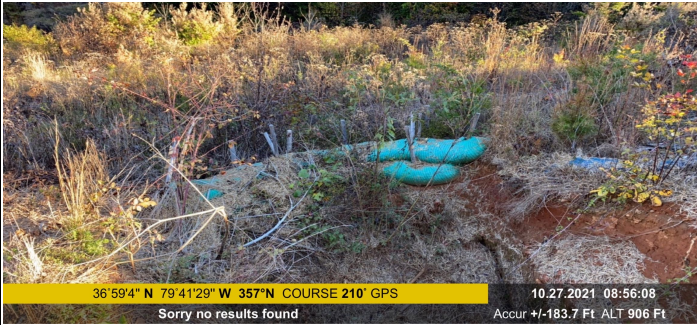
Pic 3 Desc.	Routine maintenance. CFS end treatment not properly filtering. Remove debris/sediment.		Pic 4 Desc.	Routine maintenance. CFS check dams missing stakes.

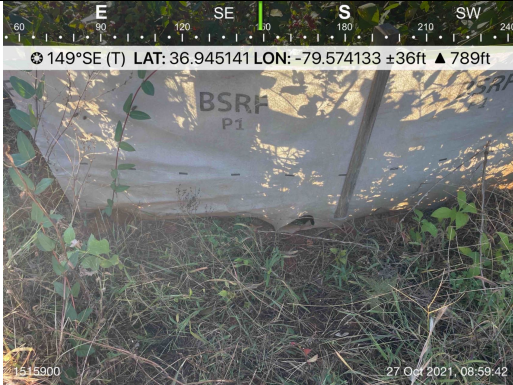
GPS Location	See photo		GPS Location	See photo	
Field Station#	15142+66		Field Station#	15159+00	
Pic 1 Desc.	RCE is in good condition at Rockcreek Rd.		Pic 2 Desc.	P1 has been damaged by livestock and needs to be replaced.

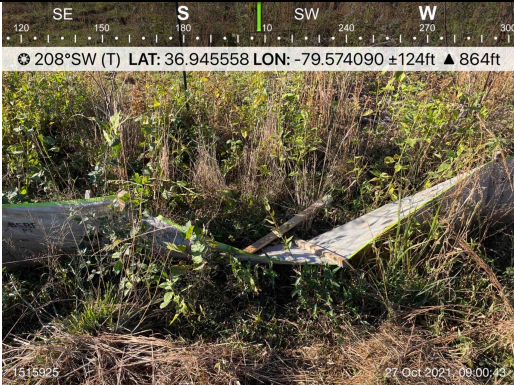
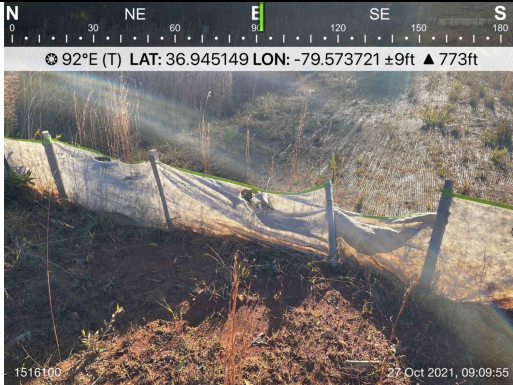
GPS Location	See photo		GPS Location	See photo	
Field Station#	15159+25		Field Station#	15161+00	
Pic 3 Desc.	P1 has been damaged by livestock and needs to be replaced.		Pic 4 Desc.	P1 has been damaged by livestock and needs to be replaced.

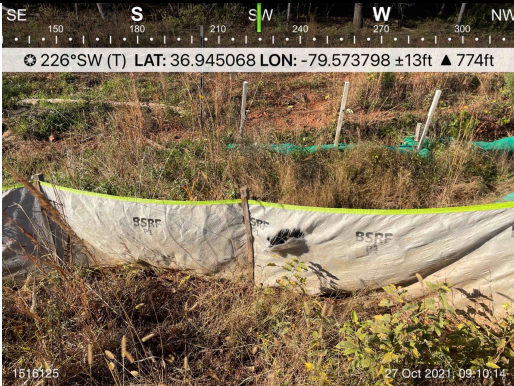
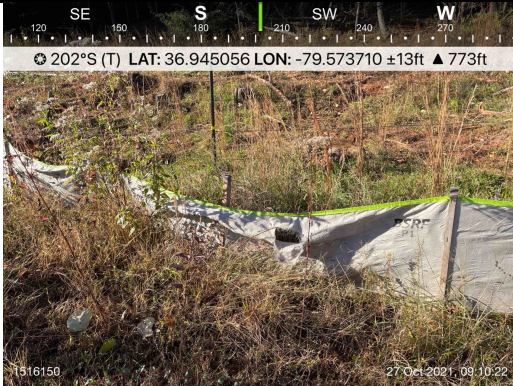
GPS Location	See photo		GPS Location	See photo	
Field Station#	15161+25		Field Station#	15161+50	
Pic 5 Desc.	P1 has been damaged by livestock and needs to be replaced.		Pic 6 Desc.	P1 has been damaged by livestock and needs to be replaced.

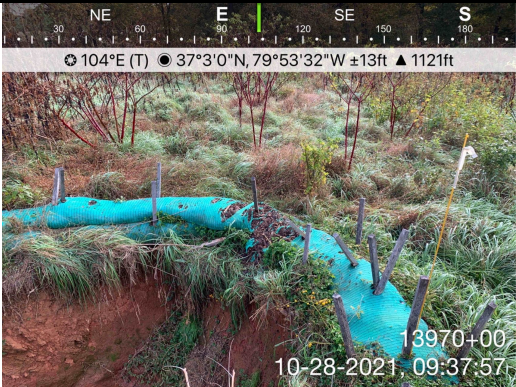
GPS Location	0		GPS Location	0	
Field Station#	13970+00		Field Station#	13994+00	
Pic 1 Desc.	CFS on waterbar end treatment damaged by wildlife		Pic 2 Desc.	P1 silt fence damaged by wildlife

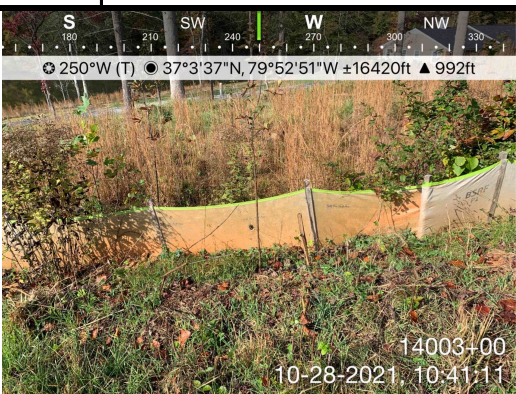
GPS Location	0		GPS Location	0	
Field Station#	14003+00		Field Station#	14044+50	
Pic 3 Desc.	P1 silt fence with a hole in it		Pic 4 Desc.	P1 silt fence damaged by fallen tree branch (multiple panels)

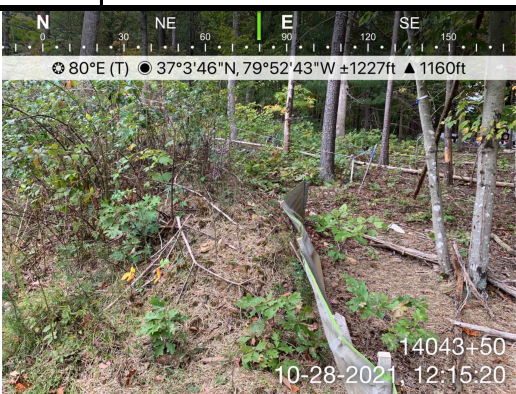
GPS Location	0		GPS Location	0	
Field Station#	14043+50		Field Station#	14044+50	
Pic 5 Desc.	P1 silt fence with multiple broken stakes from 14043+00 to 14043+50		Pic 6 Desc.	P1 silt fence with a hole in it

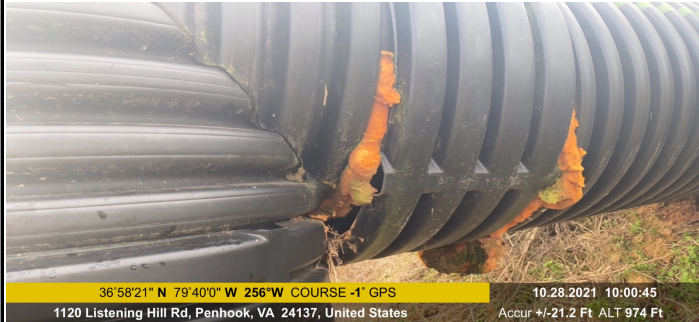
36°58'22" N 79°40'7" W 292°W COURSE 178° GPS 1103 Listening Hill Rd, Penhook, VA 24137, United States 10/28/2021 10:03:53 Accur +/-38.9 Ft ALT 968 Ft			36°58'21" N 79°40'0" W 256°W COURSE -1° GPS 1120 Listening Hill Rd, Penhook, VA 24137, United States 10/28/2021 10:00:45 Accur +/-21.2 Ft ALT 974 Ft		
GPS Location	1	GPS Location	2		
Field Station#	14836+00	Field Station#	14842+00		
Pic 1 Desc.	Routine maintenance. Space between main CWD pipe and coupler leading to water not diverting properly off ROW.		Pic 2 Desc.	Routine maintenance. Space between main CWD pipe and coupler leading to water not diverting properly off ROW.

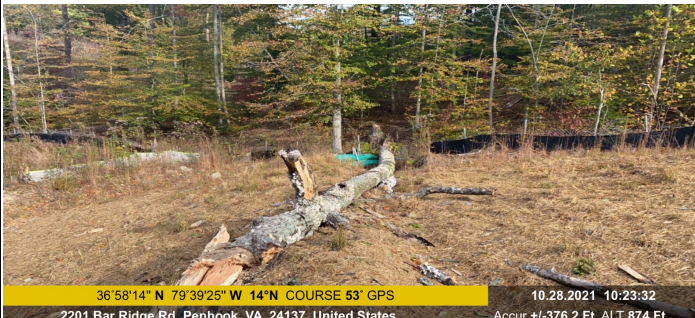
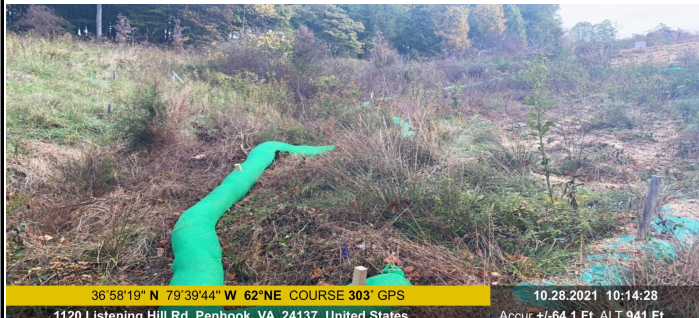
GPS Location	3	GPS Location	4		
Field Station#	14871+00	Field Station#	14856+00		
Pic 3 Desc.	Routine maintenance. Fallen tree down on CFS end treatment and in throat of water bar.		Pic 4 Desc.	Contractor replaced CFS in resource buffer per punch list item

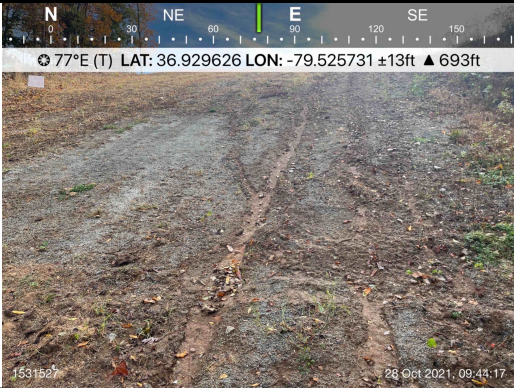
GPS Location	See photo		GPS Location	See photo	
Field Station#	15315+27		Field Station#	15336+00	
Pic 5 Desc.	Rill erosion on this slope needs to be regraded and stabilized.		Pic 6 Desc.	Perimeter P1 remains in good condition.
