Visual Site Inspection Report

Project Name H-600 Pipeline Spread I		AFE 124300139	Spread H-600 Pipeline Spread I
Contractor Precision		Report # 29313	
Inspector Ben Farmer		Date/Time 10/4/2021 12:39 PM	
Permit # TBD	Inspection Type VA SWPP	Station Begin 15480+67	
State VA	Inspection Area Partial	Station End 15584+23	
County Pittsylvania	Ground Damp	Temperature (°F) 72.00	
Municipality Chatham	Weather Cloudy	Rain Gauge (in) 0.00	
			Rain Accumulation Time (days) 0.00

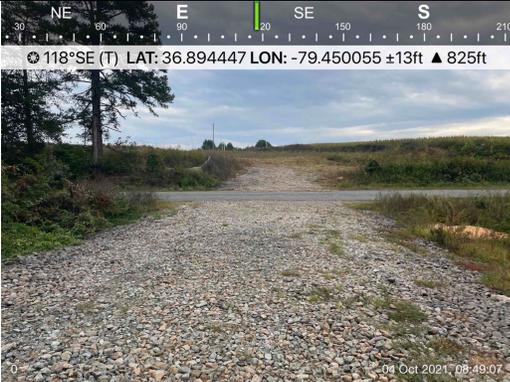
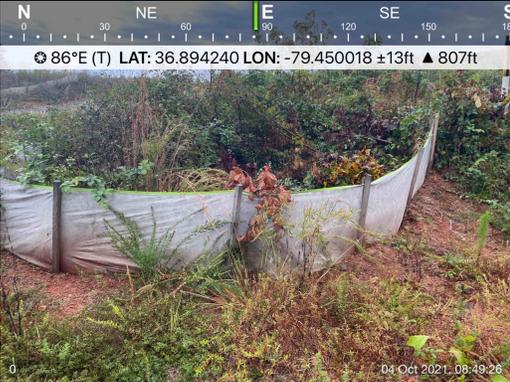
GPS Location	See photo	GPS Location	See photo
Field Station#	15584+23	Field Station#	15584+00
Pic 1 Desc.	RCEs are in good condition at all road crossings.	Pic 2 Desc.	P1 is in good condition at road pipe outlet.

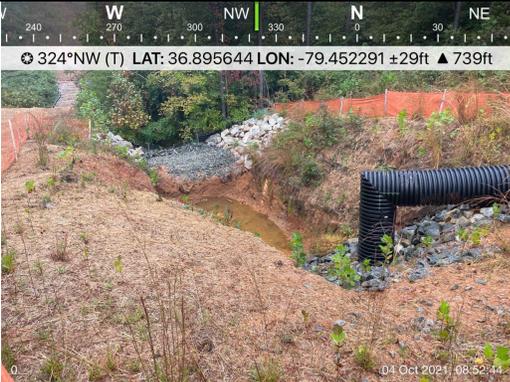
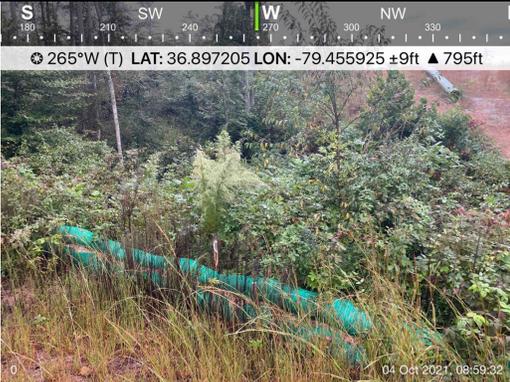
GPS Location	See photo	GPS Location	See photo
Field Station#	15574+87	Field Station#	15563+00
Pic 3 Desc.	Slope drain is in good condition and functioning.	Pic 4 Desc.	Stream buffers remain in good condition with controls in place.

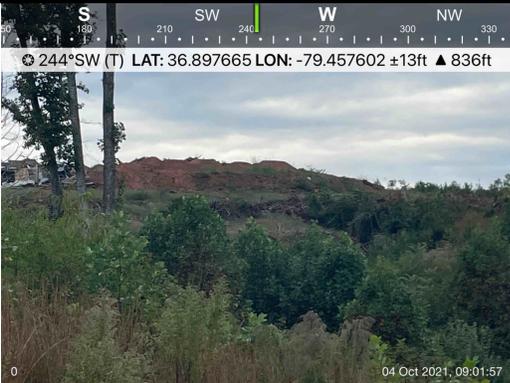
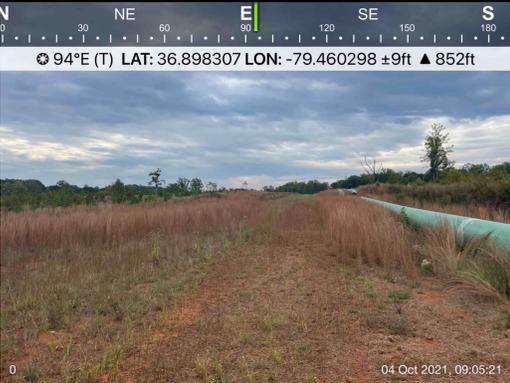
GPS Location	See photo	GPS Location	See photo
Field Station#	15556+00	Field Station#	15550+00
Pic 5 Desc.	No evidence of sedimentation from 3rd party disturbance.	Pic 6 Desc.	Vegetation continues to fill in throughout this section.

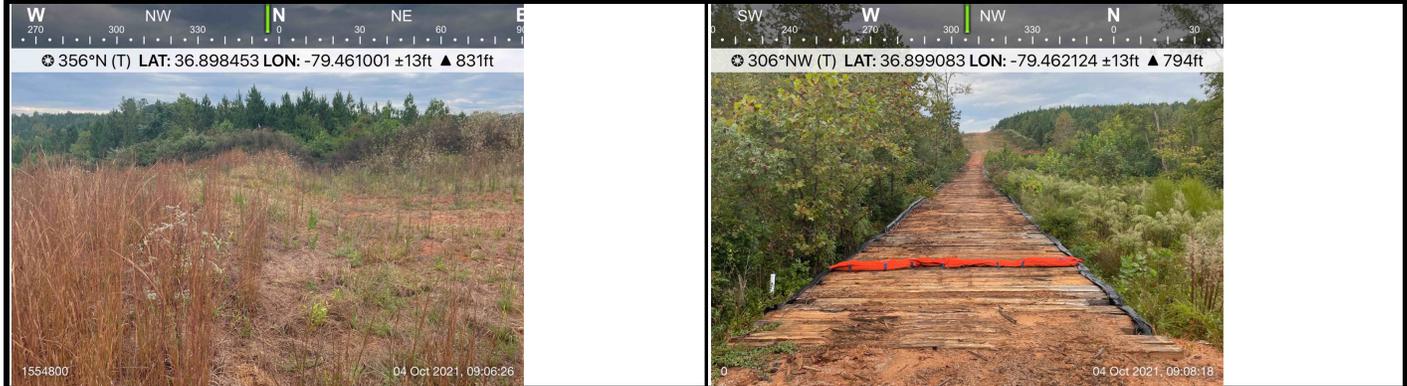
GPS Location	See photo	GPS Location	See photo
Field Station#	15548+00	Field Station#	15543+00
Pic 7 Desc.	Waterbars are functioning as intended.	Pic 8 Desc.	Equipment bridge ECDs are in good condition and functioning.

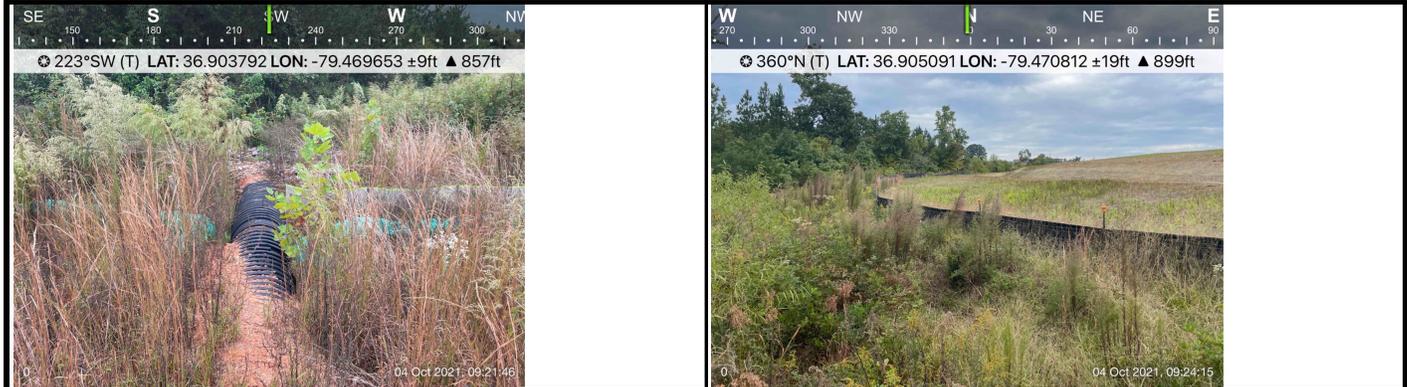
GPS Location	See photo	GPS Location	See photo
Field Station#	15515+00	Field Station#	15510+00
Pic 9 Desc.	CWDs are functioning as intended.	Pic 10 Desc.	3rd party ECDs appear to be in good condition.

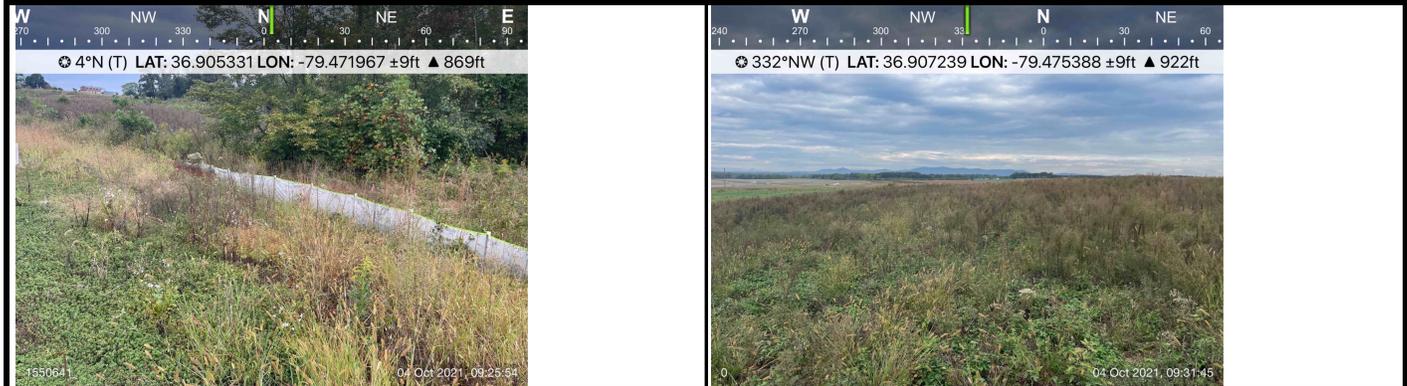
GPS Location	See photo	GPS Location	See photo
Field Station#	15506+00	Field Station#	15481+00
Pic 11 Desc.	P1 is in good condition condition at all stream and wetland buffers.	Pic 12 Desc.	Vegetation continues to fill in throughout this section.

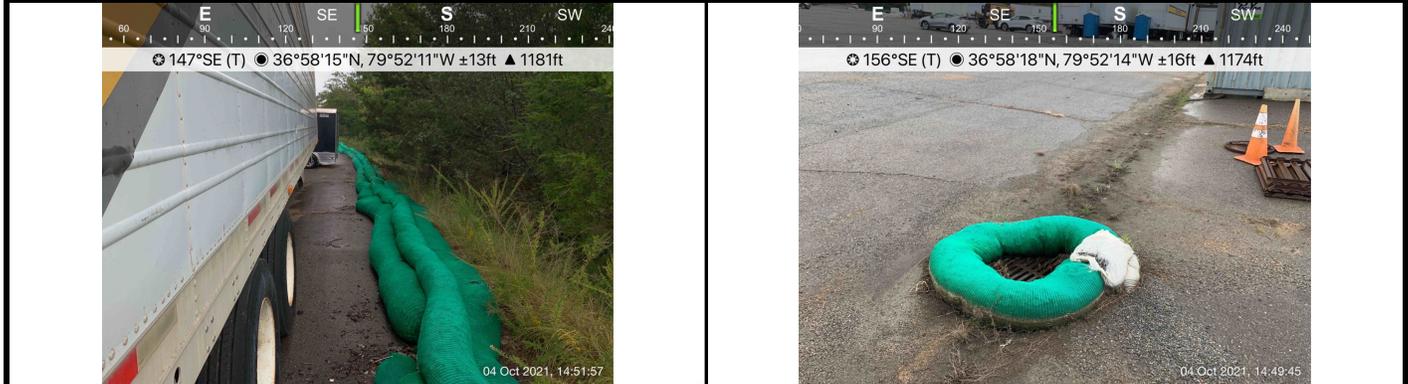
GPS Location	See picture	GPS Location	See picture
Field Station#	0000+00	Field Station#	0000+00
Pic 1 Desc.	Perimeter ECD's on south end of LY-046 in good condition	Pic 2 Desc.	Inlet protection for catch basin on north end of LY-046 in good condition.

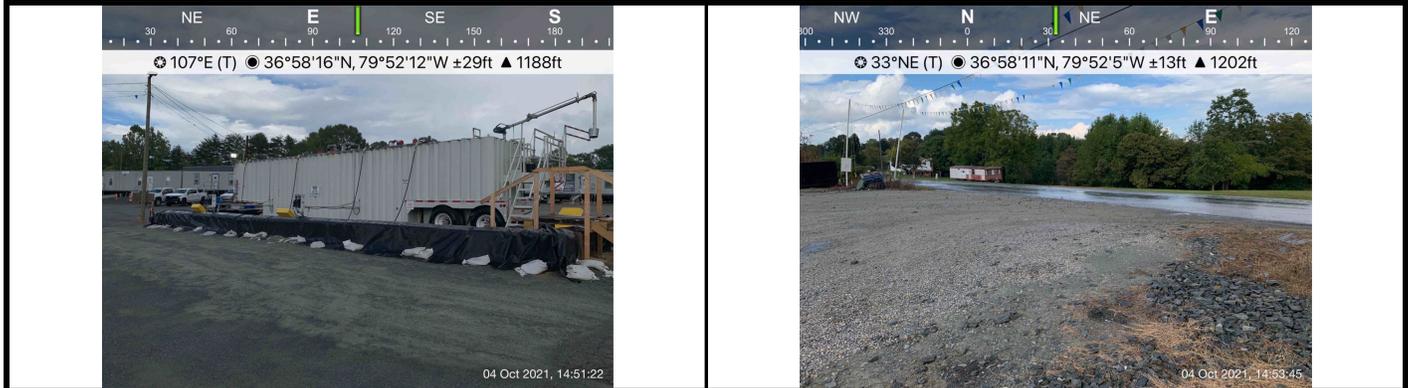
GPS Location	See picture	GPS Location	See picture
Field Station#	00000+00	Field Station#	00000+00
Pic 3 Desc.	Secondary containment structure for fuel cell at LY-046 in good condition.	Pic 4 Desc.	RCE at LY-045 in good condition.

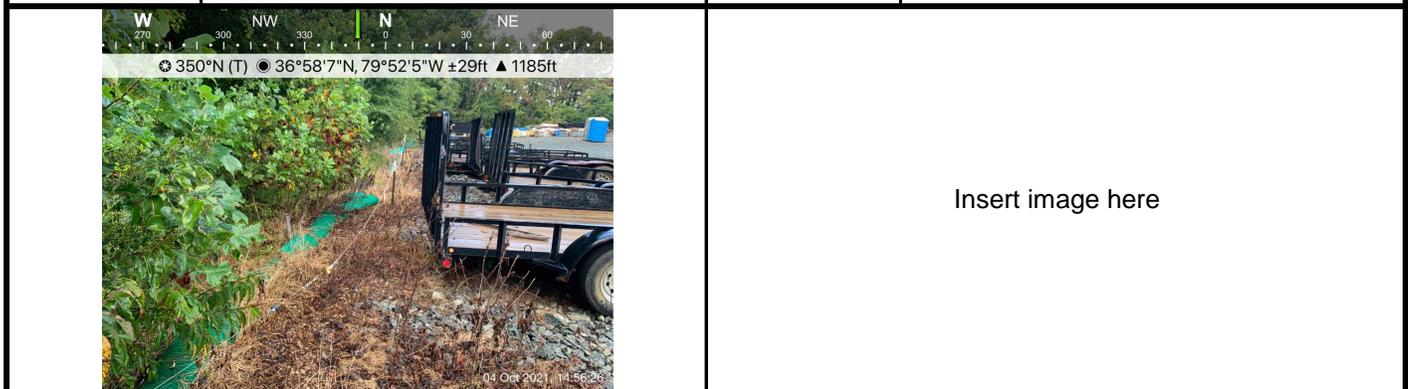
GPS Location	See picture	GPS Location	
Field Station#	0000+00	Field Station#	
Pic 5 Desc.	Perimeter ECD's on west side of LY-045 near employee parking area in good condition.	Pic 6 Desc.

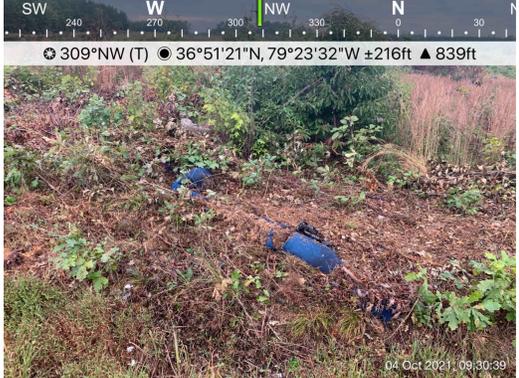
<p>GPS: 309°NW (T) ● 36°51'21"N, 79°23'32"W ±216ft ▲ 839ft 04 Oct 2021 09:30:39</p>		
GPS Location	O		GPS Location	O	
Field Station#	16008+00		Field Station#	15826+00	
Pic 1 Desc.	Observing temporary stabilization, sump and end treatment		Pic 2 Desc.	Observing CFS that requires maintenance (3rd party damage)

Performed SWPPP Inspection on this section. There were issues identified and added to the punch list. The Contractor is working on repairing the identified issues. Other than that there were no issues to report at the time of inspection.

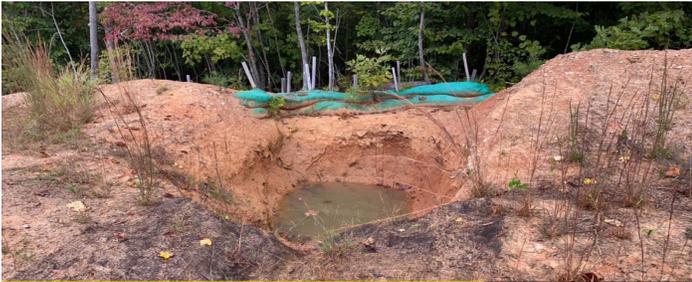
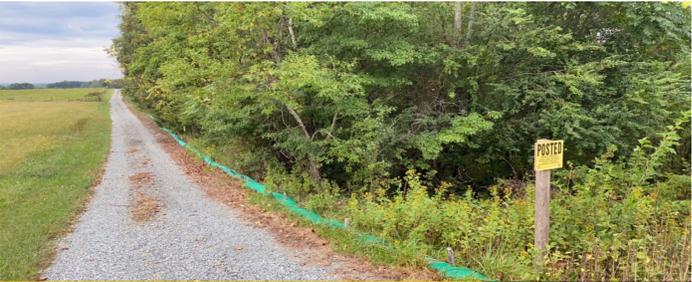
<small>10.04.2021 09:36:39 Accur +/-27.7 Ft ALT 940 Ft</small>					
GPS Location	3	GPS Location	4		
Field Station#	15075+00	Field Station#	15080+64		
Pic 3 Desc.	Sump pit and CFS end treatment performing intended functions.		Pic 4 Desc.	RCE and perimeter CFS in good condition.

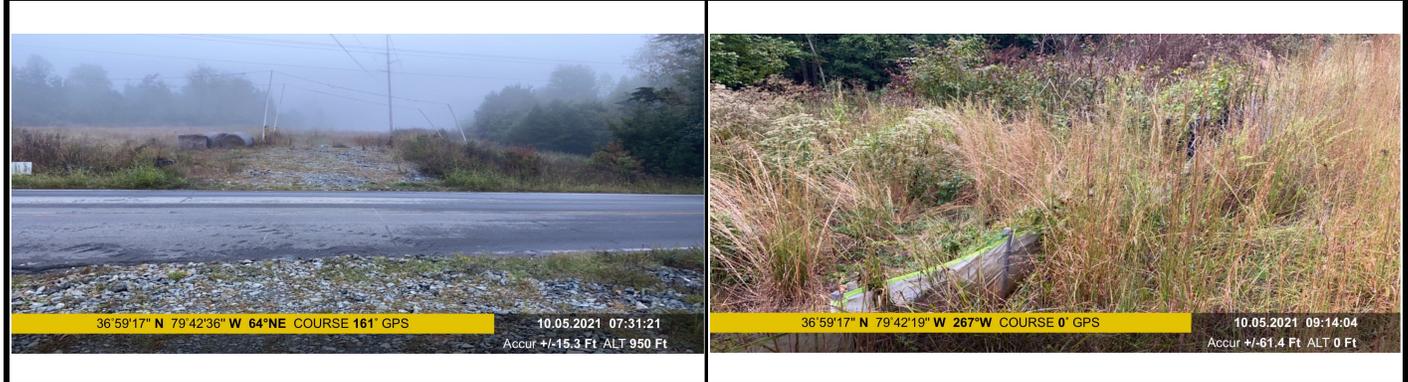
GPS Location	1	GPS Location	2
Field Station#	14694+77	Field Station#	14708+00
Pic 1 Desc.	RCE at Jacks Creek Rd in good condition	Pic 2 Desc.	P1 silt fence in place and functional along ROW

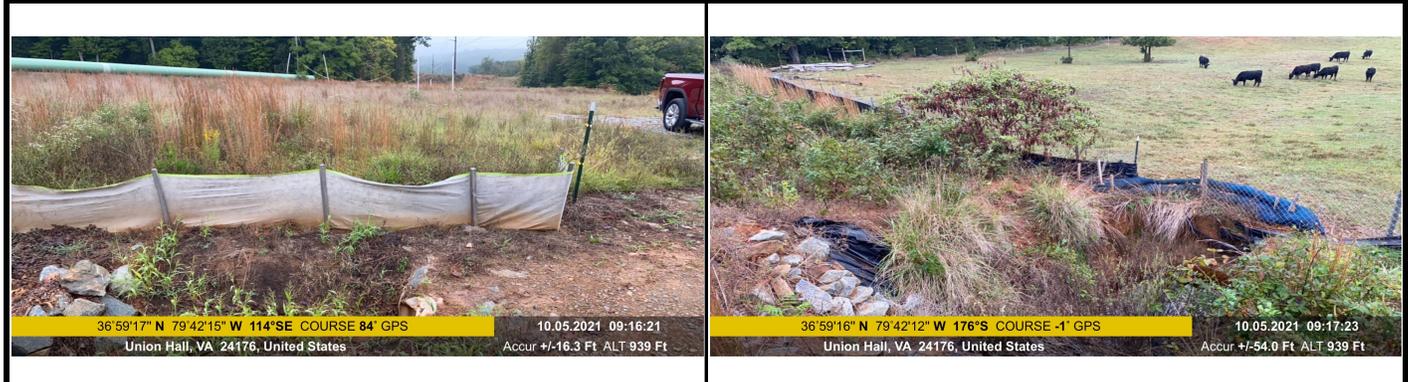
GPS Location	3	GPS Location	4
Field Station#	14712+20	Field Station#	14715+00
Pic 3 Desc.	Perimeter P1 silt fence and ditch culvert in good condition	Pic 4 Desc.	Sump pit and perimeter controls performing intended functions

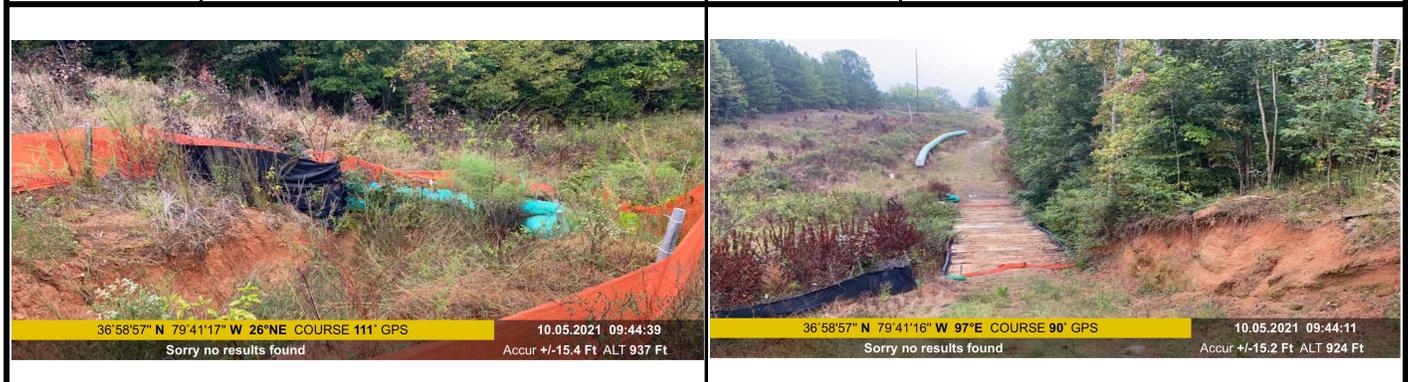
GPS Location	5	GPS Location	6
Field Station#	14763+00	Field Station#	14766+11
Pic 5 Desc.	Sump pit and perimeter controls performing intended functions	Pic 6 Desc.	Equipment bridge and surrounding ECDs in place and functional at stream crossing and resource buffer

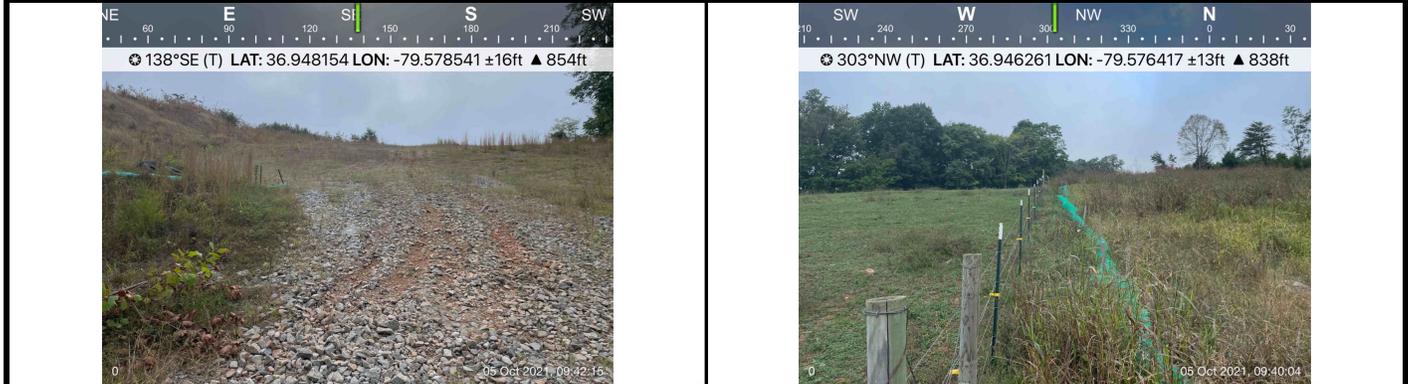
GPS Location	See photo	GPS Location	See photo
Field Station#	15142+66	Field Station#	15152+84
Pic 1 Desc.	RCE is in good condition at Rockcreek Rd.	Pic 2 Desc.	Perimeter CFS is in good condition throughout this section.

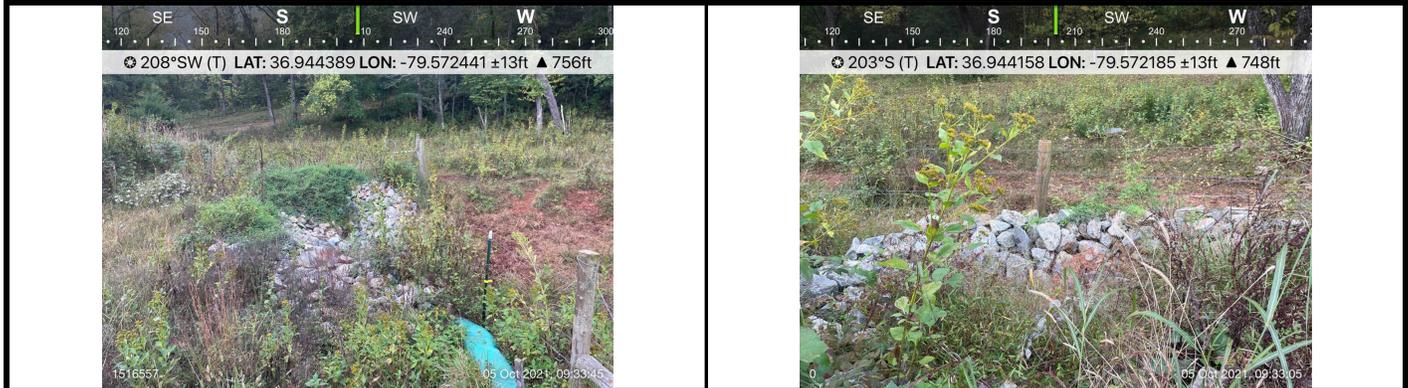
GPS Location	See photo	GPS Location	See photo
Field Station#	15165+57	Field Station#	15166+00
Pic 3 Desc.	Rock inlet remains in good condition.	Pic 4 Desc.	Rock outlet remains in good condition.

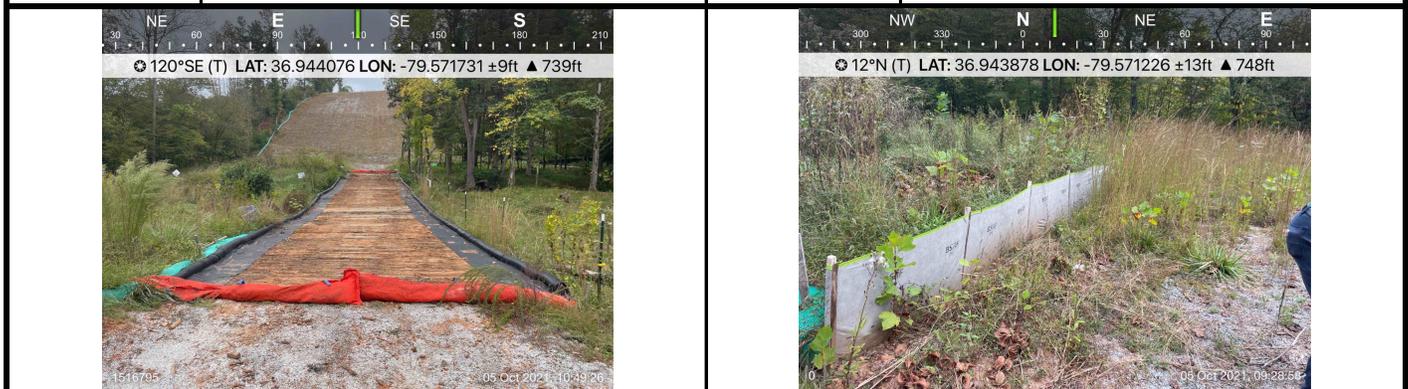
GPS Location	See photo	GPS Location	See photo
Field Station#	15167+95	Field Station#	15169+00
Pic 5 Desc.	Equipment bridge ECDs are functioning as intended.	Pic 6 Desc.	P1 is in good condition at stream and wetland buffers.

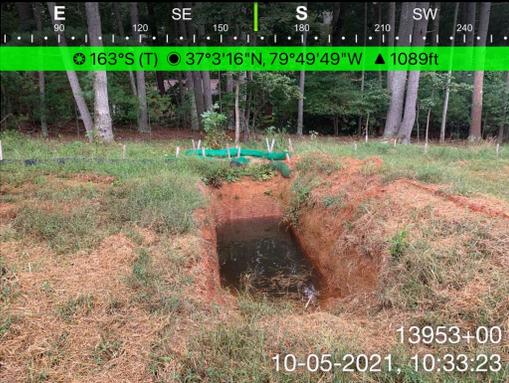
<p>13953+00 10-05-2021, 10:33:23</p>			
GPS Location 0		GPS Location 0			
Field Station# 13953+00		Field Station# 13953+00			
Pic 5 Desc. Waterbar in acceptable condition		Pic 6 Desc. Waterbar end treatment in acceptable condition

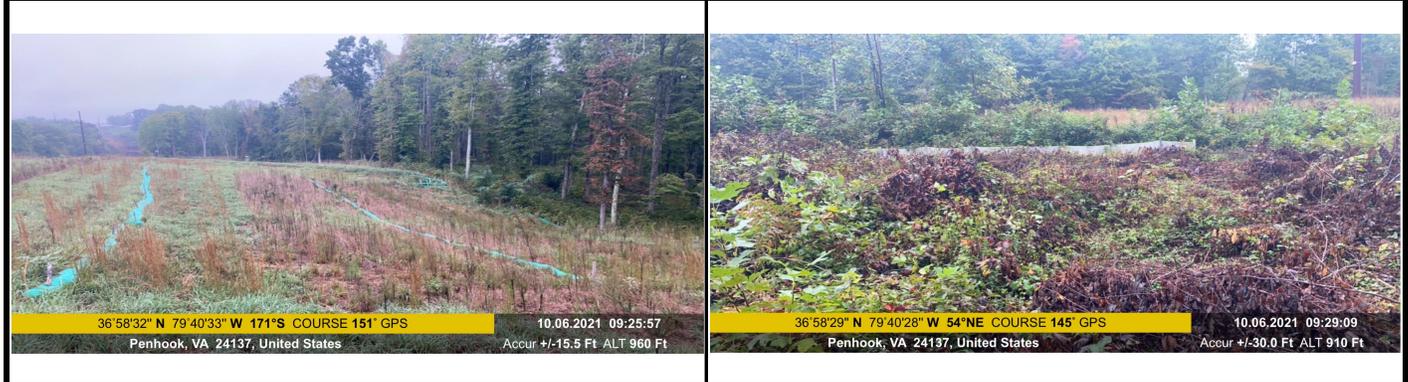
GPS Location	1	GPS Location	2
Field Station#	14814+00	Field Station#	14816+07
Pic 1 Desc.	CFS in good condition in final cleanup area	Pic 2 Desc.	Picture of ECDs in place and functional in resource buffer

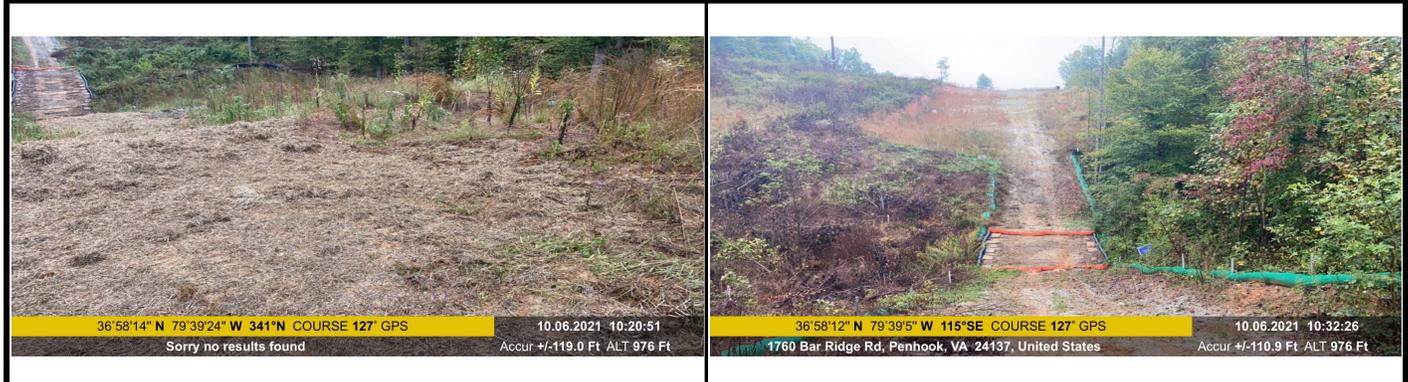
GPS Location	3	GPS Location	4
Field Station#	14872+00	Field Station#	14881+54
Pic 3 Desc.	Contractor performed environmental maintenance in area and stabilized ROW	Pic 4 Desc.	Equipment bridge and surrounding ECDs in place and functional at stream crossing and resource buffer

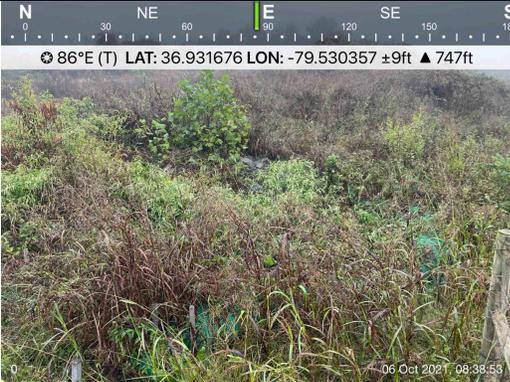
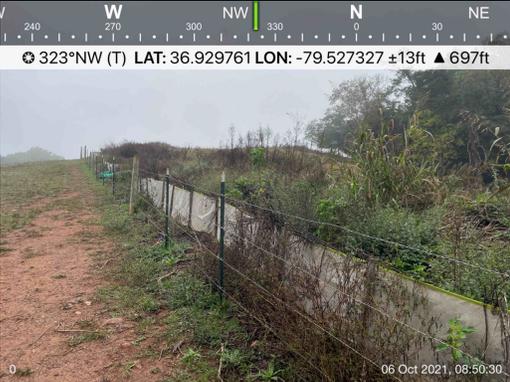
GPS Location	See photo	GPS Location	See photo
Field Station#	15299+00	Field Station#	15310+00
Pic 1 Desc.	CWD is functioning as intended.	Pic 2 Desc.	Perimeter P1 is in good condition at this location.

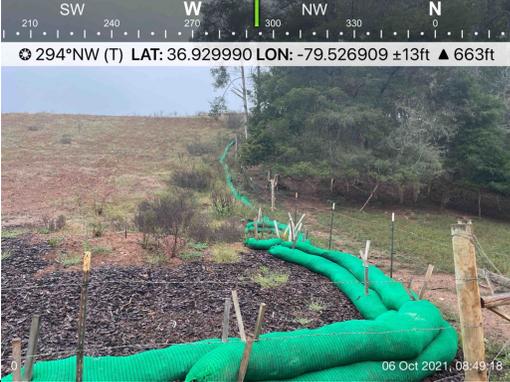
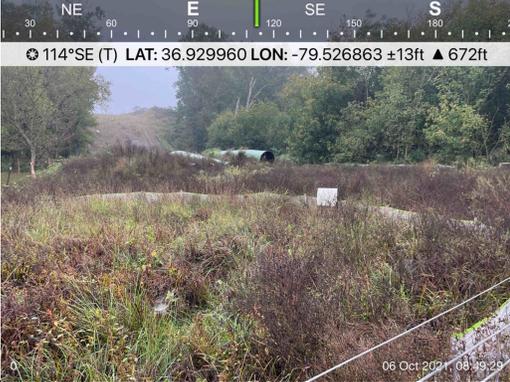
GPS Location	See photo	GPS Location	See photo
Field Station#	15310+00	Field Station#	15311+78
Pic 3 Desc.	Perimeter CFS is in good condition throughout this section.	Pic 4 Desc.	Wetland buffer remains in good condition.

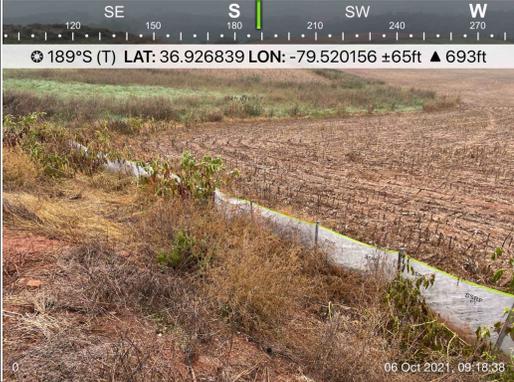
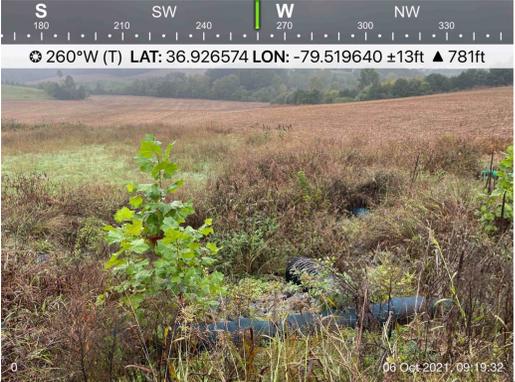
GPS Location	See photo	GPS Location	See photo
Field Station#	15337+00	Field Station#	15338+00
Pic 7 Desc.	Perimeter P1 is in good condition at this location.	Pic 8 Desc.	CWD remains in good condition and functioning.

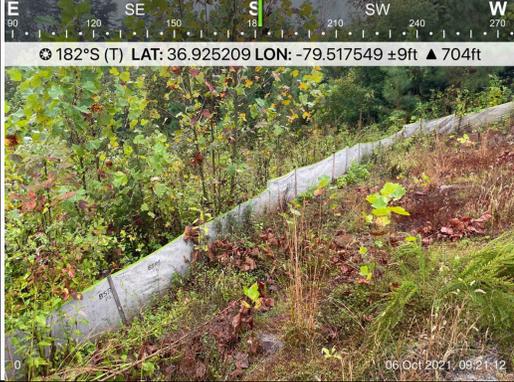
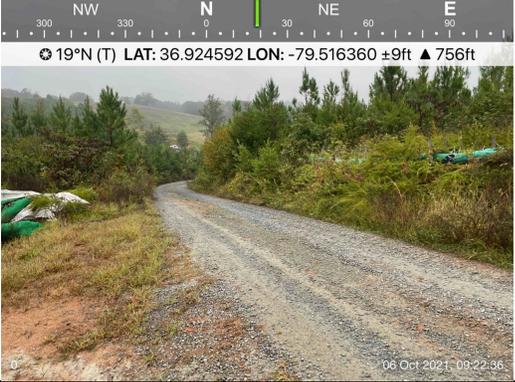
GPS Location	See photo	GPS Location	See photo
Field Station#	15346+00	Field Station#	15350+00
Pic 9 Desc.	P1 is in good condition at all stream and wetland buffers.	Pic 10 Desc.	MVP-PI-332 remains in good condition condition with controls in place.

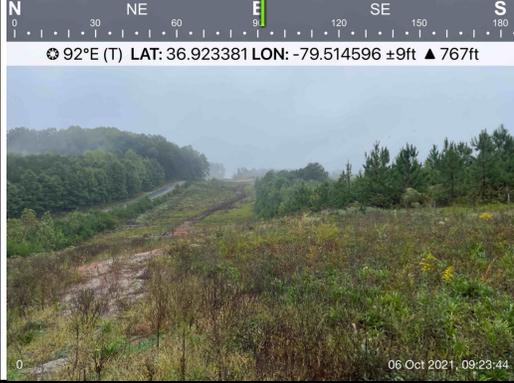
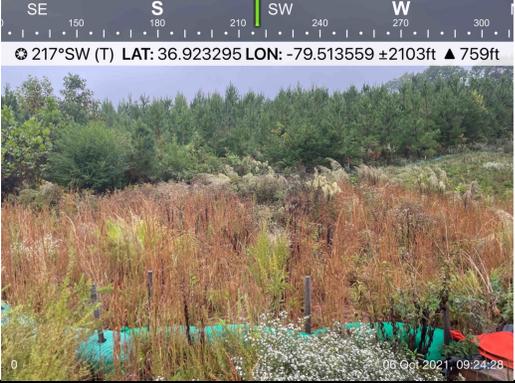
GPS Location	See photo	GPS Location	See photo
Field Station#	15357+00	Field Station#	15365+00
Pic 11 Desc.	Vegetation continues to fill in throughout this section.	Pic 12 Desc.	Drainage ECDs are in good condition and functioning.

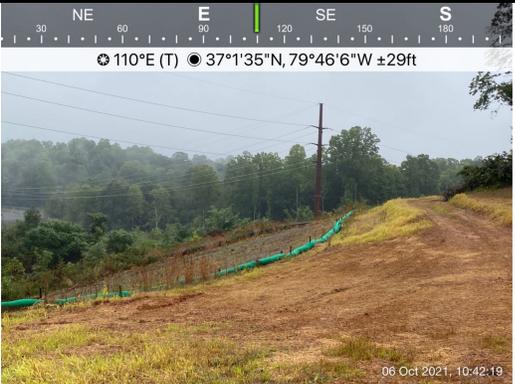
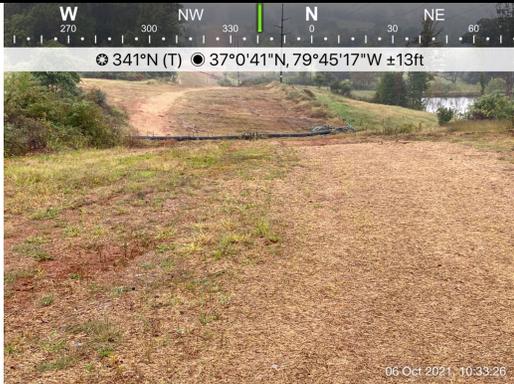
GPS Location	0	GPS Location	0		
Field Station#	14456+00	Field Station#	14520+00		
Pic 1 Desc.	Approximately 14456+00. Overview of ROW.		Pic 2 Desc.	Approximately 14520+00. Overview of ROW.

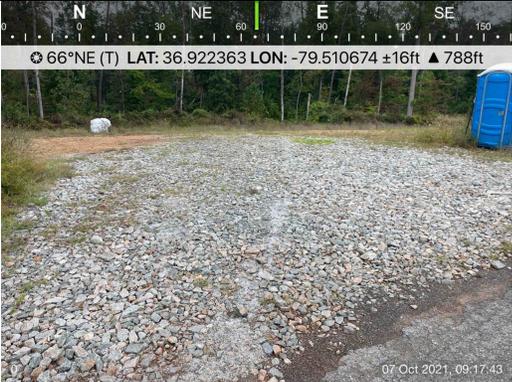
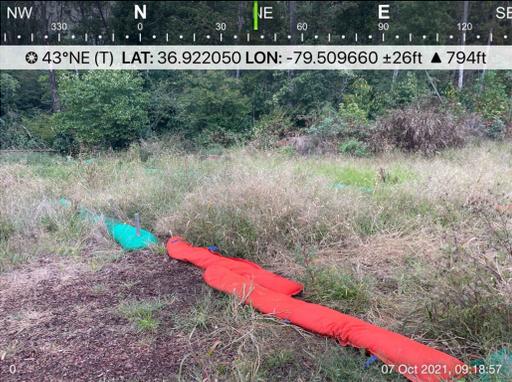
GPS Location	See photo	GPS Location	See photo
Field Station#	15370+62	Field Station#	15375+00
Pic 1 Desc.	RCEs are in good condition at all road crossings.	Pic 2 Desc.	Drainage ECDs are in place and functioning.

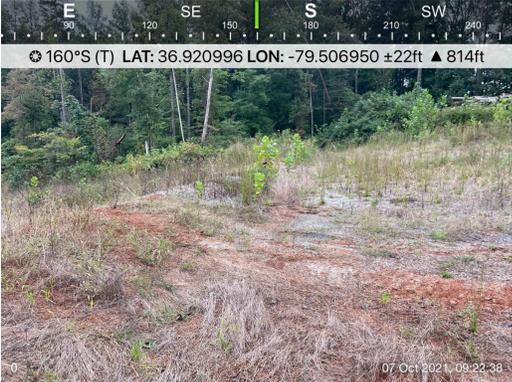
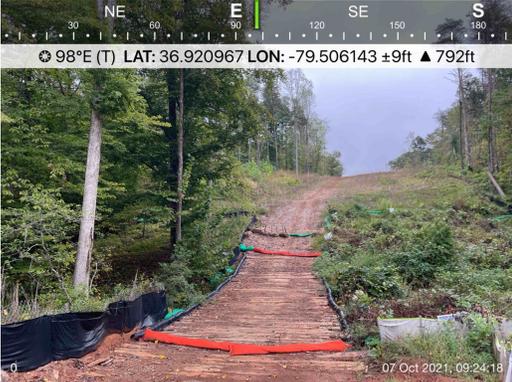
GPS Location	See photo	GPS Location	See photo
Field Station#	15380+00	Field Station#	15384+74
Pic 3 Desc.	Waterbars are in good condition throughout this section.	Pic 4 Desc.	Equipment bridge ECDs are in place and functioning.

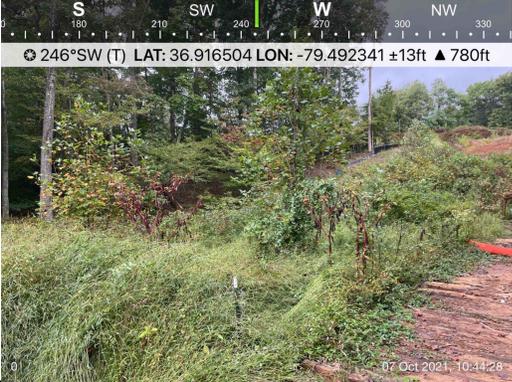
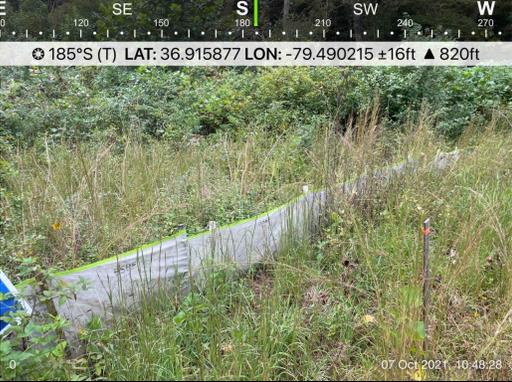
GPS Location	See photo	GPS Location	See photo
Field Station#	15427+43	Field Station#	15435+09
Pic 5 Desc.	Stream buffers remain in good condition.	Pic 6 Desc.	P1 is in good condition at all stream and wetland buffers.

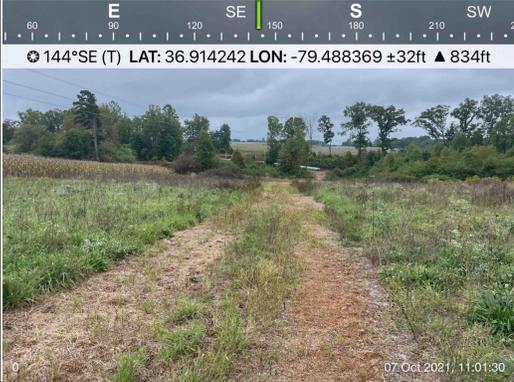
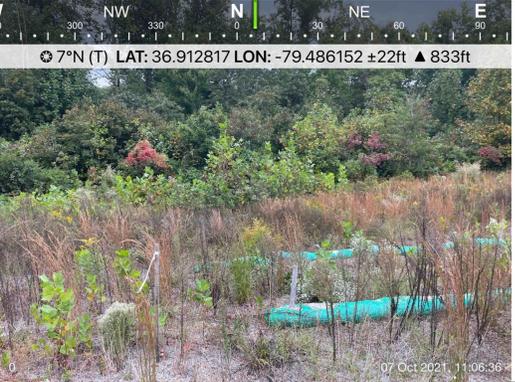
GPS Location	See photo	GPS Location	See photo
Field Station#	15443+00	Field Station#	15453+00
Pic 7 Desc.	Vegetation continues to fill in throughout this section.	Pic 8 Desc.	CWD is in good condition.

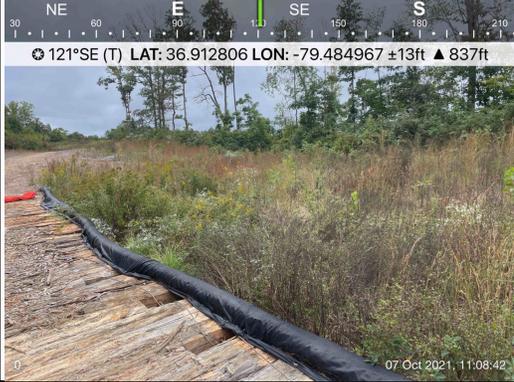
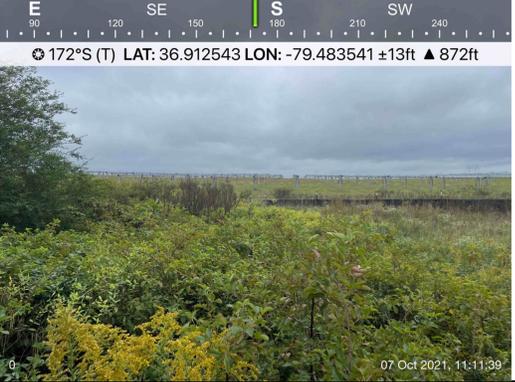
GPS Location	See photo	GPS Location	See photo
Field Station#	15457+00	Field Station#	15460+81
Pic 9 Desc.	No evidence of sedimentation from 3rd party disturbance within drainage.	Pic 10 Desc.	No evidence of sedimentation from 3rd party disturbance into CWD inlet.

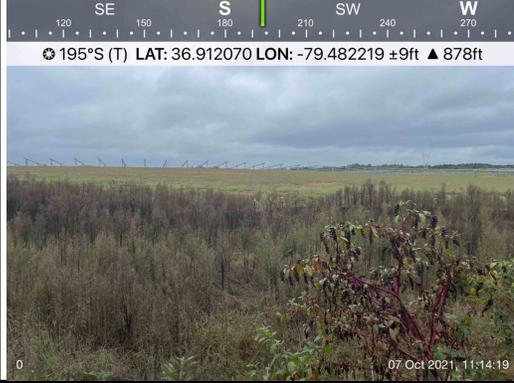
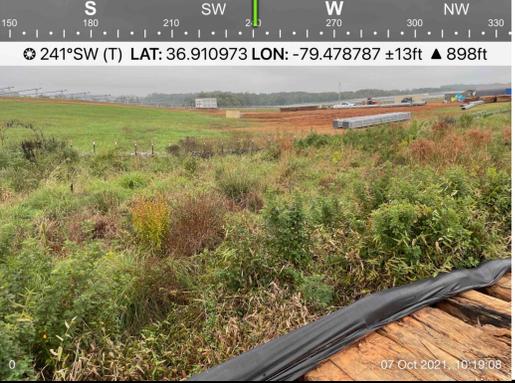
GPS Location	See photo	GPS Location	See photo
Field Station#	15465+00	Field Station#	15475+00
Pic 11 Desc.	No evidence of sedimentation from 3rd party disturbance.	Pic 12 Desc.	3rd party rock outlet appears to be in good condition.

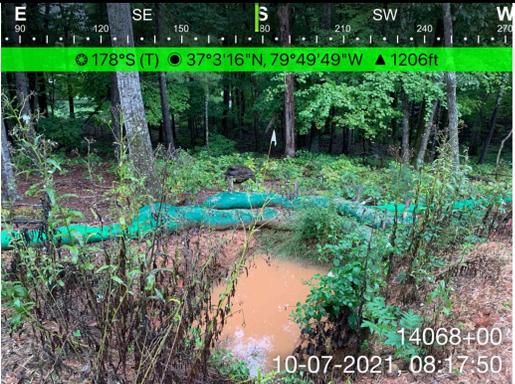
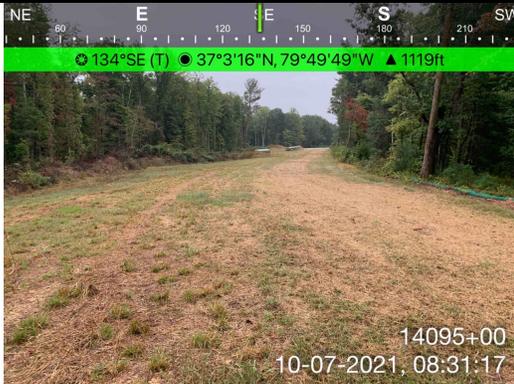
GPS Location	0		GPS Location	0	
Field Station#	14068+00		Field Station#	14095+00	
Pic 1 Desc.	Waterbar end treatment in acceptable condition		Pic 2 Desc.	Temporary vegetative stabilization in acceptable condition

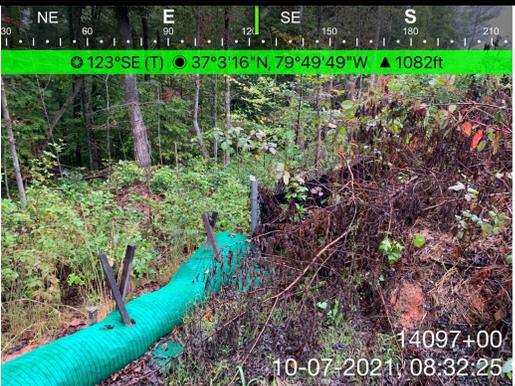
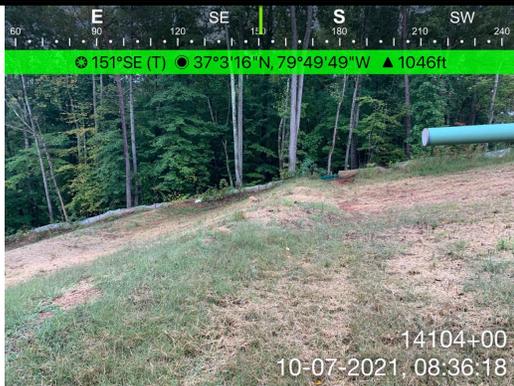
GPS Location	0		GPS Location	0	
Field Station#	14097+00		Field Station#	14104+00	
Pic 3 Desc.	CFS and perimeter super silt fence in acceptable conditions		Pic 4 Desc.	Waterbar in acceptable condition

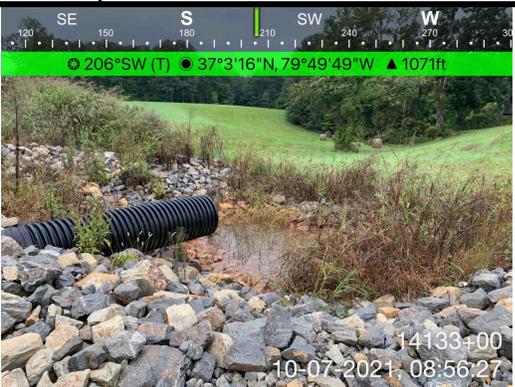
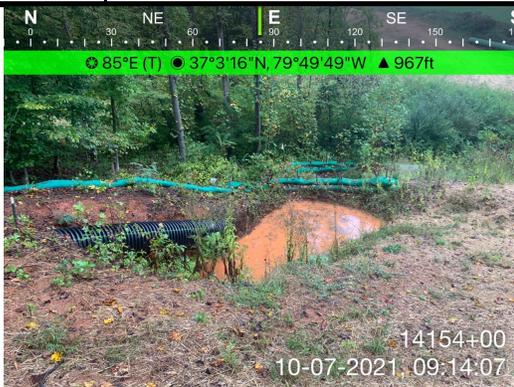
GPS Location	0		GPS Location	0	
Field Station#	14133+00		Field Station#	14154+00	
Pic 5 Desc.	Clean water diversion pipe and plunge pool in acceptable conditions		Pic 6 Desc.	Slope drain pipe and sump pit in acceptable conditions

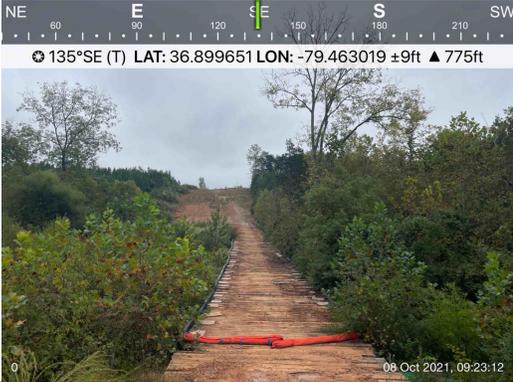
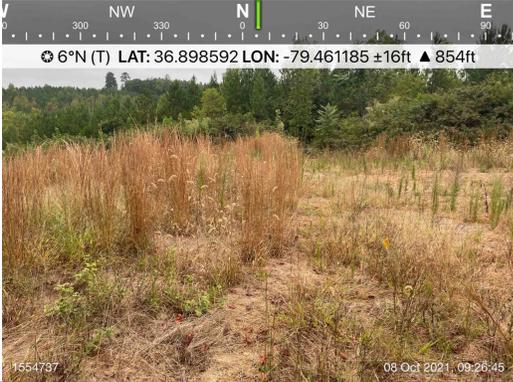
GPS Location	See photo	GPS Location	See photo
Field Station#	15540+00	Field Station#	15547+37
Pic 7 Desc.	Equipment bridge ECDs are in good condition.	Pic 8 Desc.	Waterbars are in good condition and functioning.

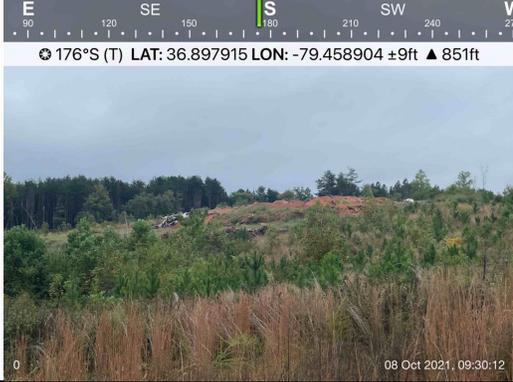
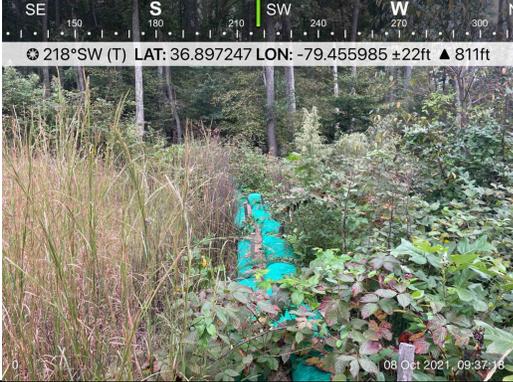
GPS Location	See photo	GPS Location	See photo
Field Station#	15556+83	Field Station#	15562+68
Pic 9 Desc.	No evidence of sedimentation from 3rd party disturbance.	Pic 10 Desc.	CFS is in good condition throughout this area.

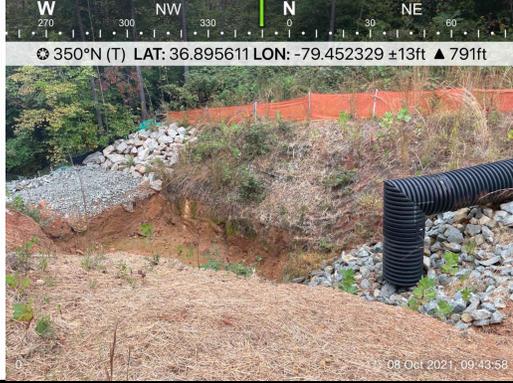
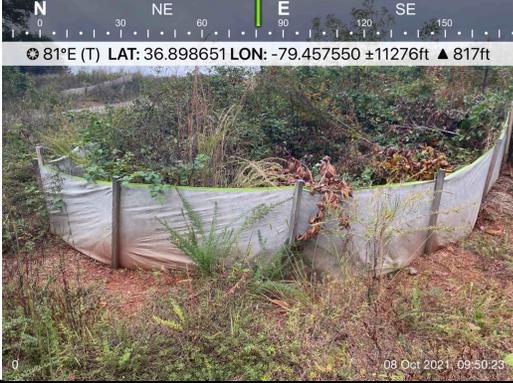
GPS Location	See photo	GPS Location	See photo
Field Station#	15575+09	Field Station#	15584+23
Pic 11 Desc.	Slope drain is functioning as intended.	Pic 12 Desc.	P1 is in good condition at road pipe outlet.

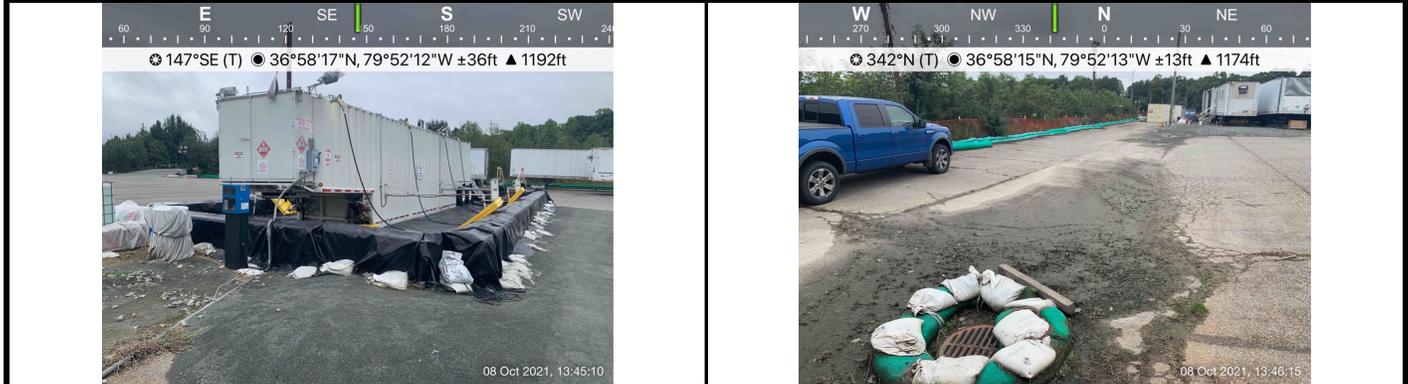
GPS Location	See picture	GPS Location	See picture
Field Station#	0000+00	Field Station#	0000+00
Pic 1 Desc.	Secondary containment structure for fuel cell at LY-046 in good condition.	Pic 2 Desc.	Inlet protection for catch basin and perimeter ECD's on southwest corner of LY-045 in good condition.

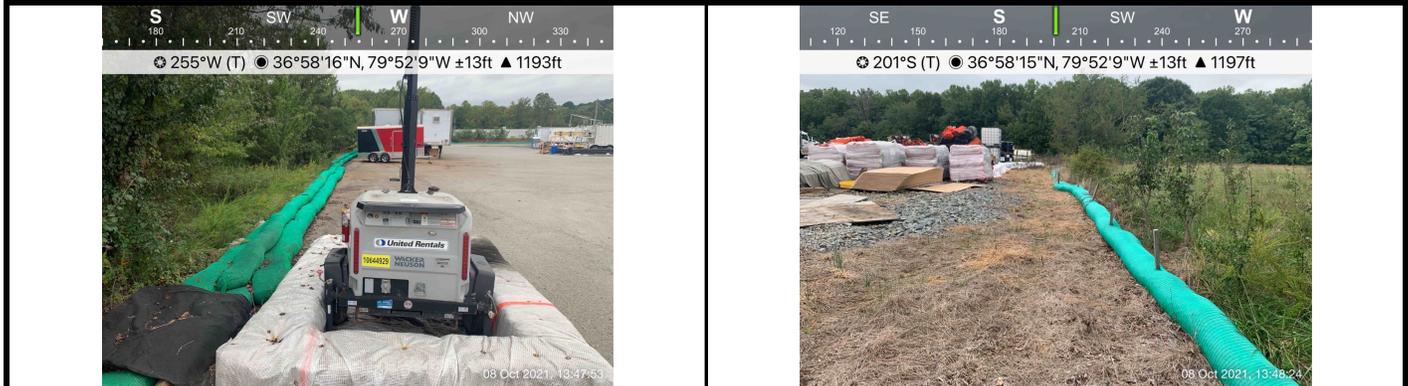
GPS Location	See picture	GPS Location	See picture
Field Station#	0000+00	Field Station#	0000+00
Pic 3 Desc.	Secondary containment structure for light plant and perimeter ECD's on south end of LY-046 in good condition.	Pic 4 Desc.	Perimeter ECD's on north end of LY-045 in good condition

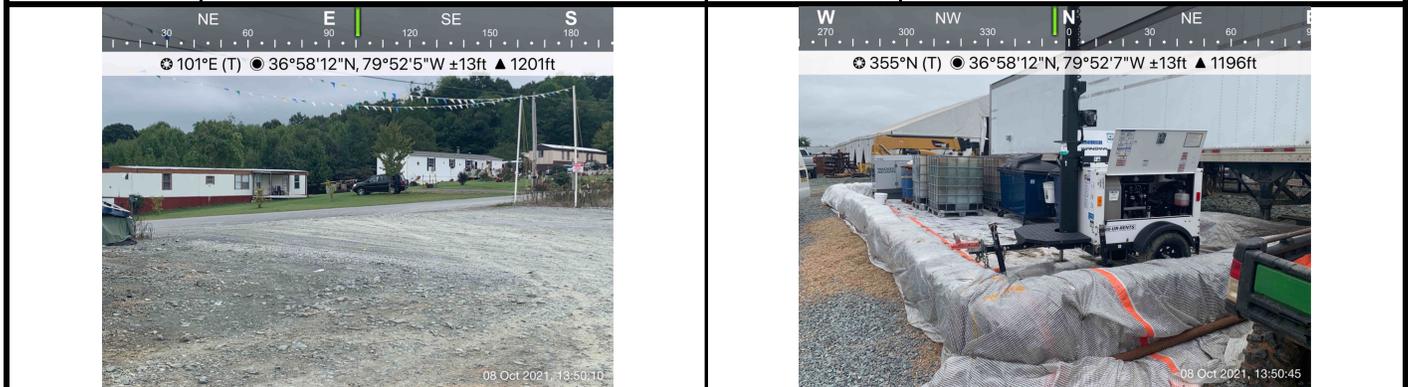
GPS Location	See picture	GPS Location	See picture
Field Station#	00000+00	Field Station#	0000+00
Pic 5 Desc.	RCE at LY-045 in good condition.	Pic 6 Desc.	Secondary containment structure behind trailer at LY-045 in good condition.

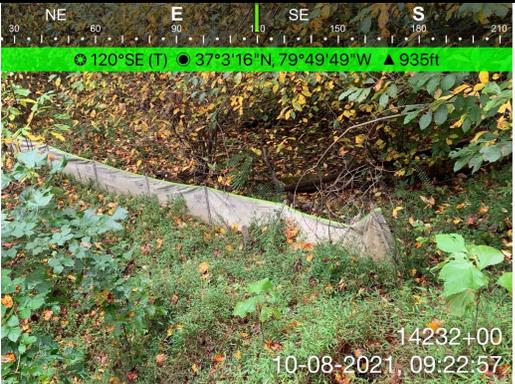
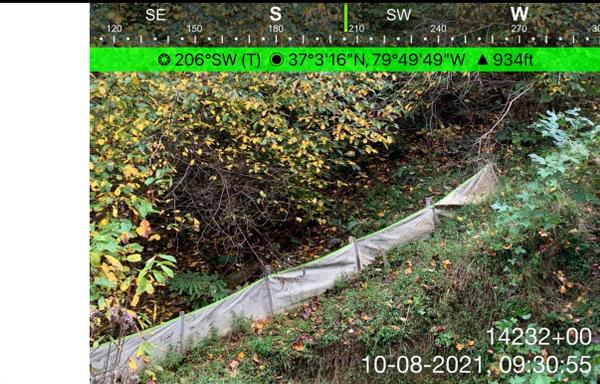
GPS Location	0	GPS Location	0		
Field Station#	14232+00	Field Station#	14232+00		
Pic 1 Desc.	P1 silt fence with broken stakes, contractor repaired immediately		Pic 2 Desc.	P1 silt fence after maintenance

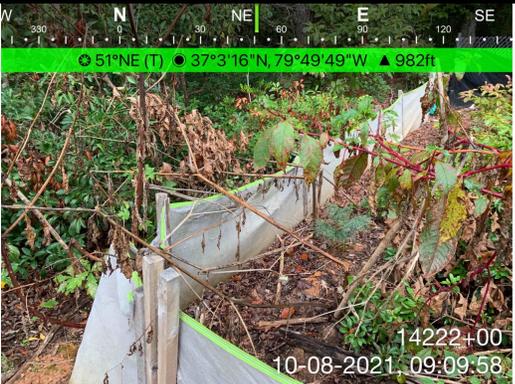
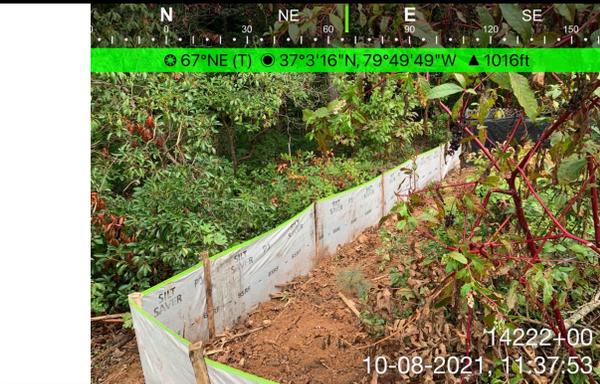
GPS Location	0	GPS Location	0		
Field Station#	14222+00	Field Station#	14222+00		
Pic 3 Desc.	P1 silt fence is deteriorated, contractor replaced it immediately		Pic 4 Desc.	P1 silt fence after replacement

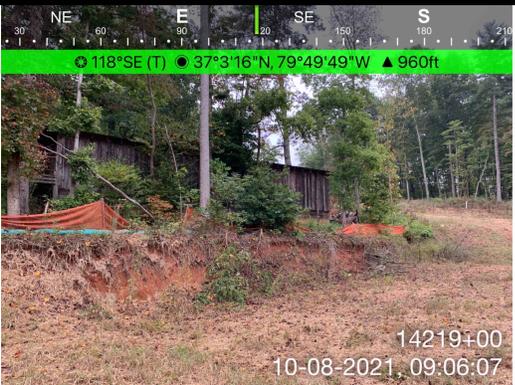
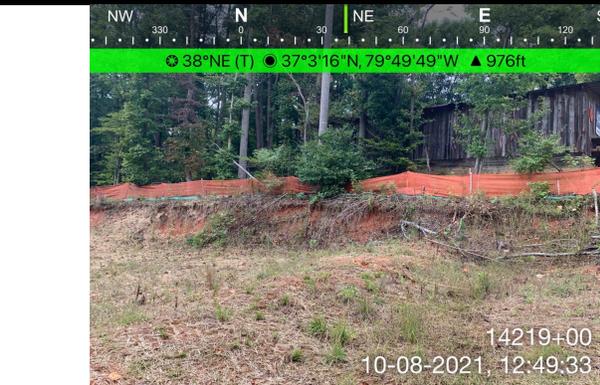
GPS Location	0	GPS Location	0		
Field Station#	14219+00	Field Station#	14219+00		
Pic 5 Desc.	Safety fence is down from 14218+00 to 14220+00, contractor repaired immediately		Pic 6 Desc.	Safety fence after maintenance
