# Visual Site Inspection Report

<b>Project Name</b>	H-600 Pipeline Spread I	<b>AFE</b>	124300139	<b>Spread</b>	H-600 Pipeline Spread I
<b>Contractor</b>	Precision			<b>Report #</b>	30564
<b>Inspector</b>	Logan Box			<b>Date/Time</b>	11/1/2021 2:59 PM
<b>Permit #</b>	TBD	<b>Inspection Type</b>	VA SWPP	<b>Station Begin</b>	13748+30
<b>State</b>	VA	<b>Inspection Area</b>	Partial	<b>Station End</b>	13853+45
<b>County</b>	Franklin	<b>Ground</b>	Damp	<b>Temperature (°F)</b>	65.00
<b>Municipality</b>	N/A	<b>Weather</b>	Cloudy	<b>Rain Gauge (in)</b>	0.00
				<b>Rain Accumulation Time (days)</b>	0.00

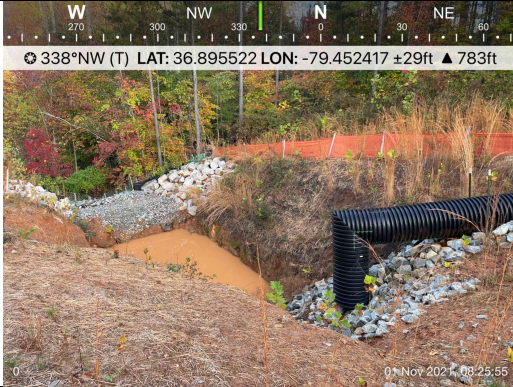
<b>GPS Location</b>	See photo		<b>GPS Location</b>	See photo	
<b>Field Station#</b>	15584+00		<b>Field Station#</b>	15574+87	
<b>Pic 1 Desc.</b>	P1 is in good condition around road pipe outlet.		<b>Pic 2 Desc.</b>	Slope drain is in good condition and functioning as intended.

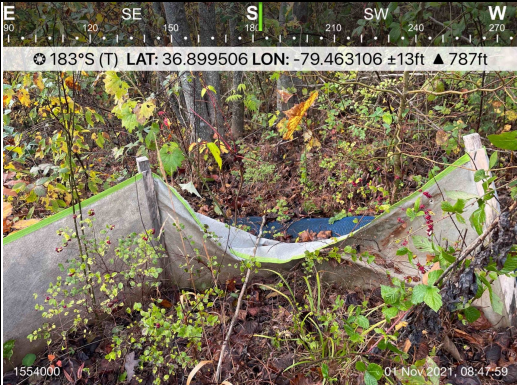
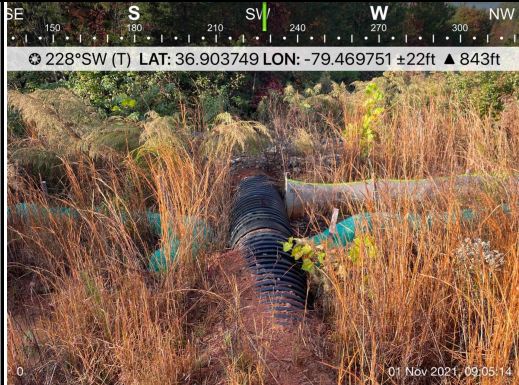
GPS Location	See photo		GPS Location	See photo	
Field Station#	15540+00		Field Station#	15515+00	
Pic 7 Desc.	P1 needs to be replaced at this buffer.		Pic 8 Desc.	CWDs are functioning as intended.

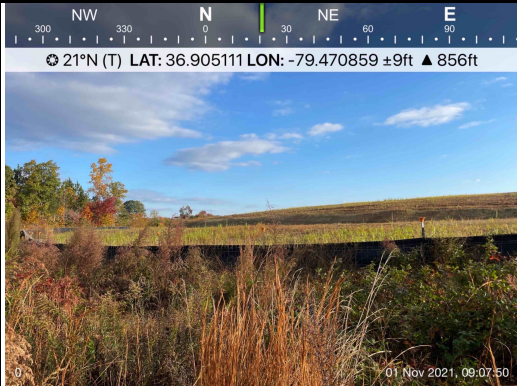
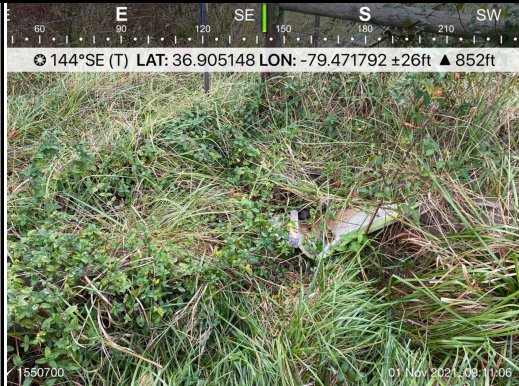
GPS Location	See photo		GPS Location	See photo	
Field Station#	15510+00		Field Station#	15507+00	
Pic 9 Desc.	3rd party ECDs appear to be in good condition.		Pic 10 Desc.	P1 needs to be restaked.

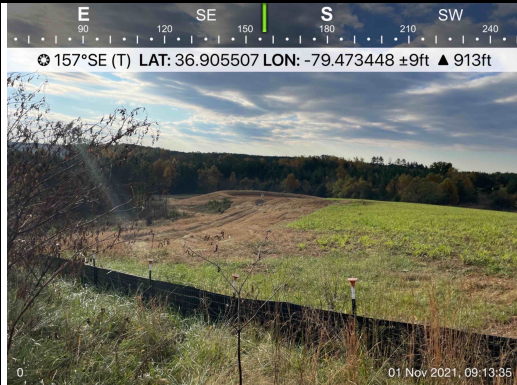
Insert image here			
GPS Location	See photo		GPS Location		
Field Station#	15501+00		Field Station#		
Pic 11 Desc.	No evidence of sedimentation from 3rd party disturbance.		Pic 12 Desc.

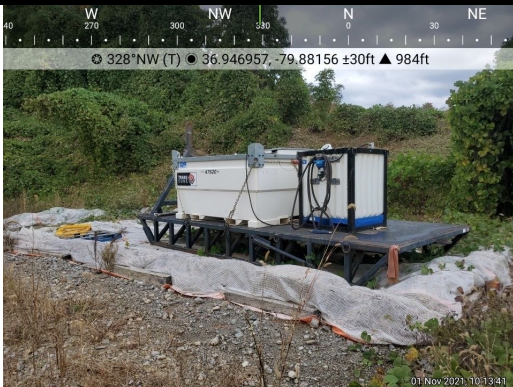
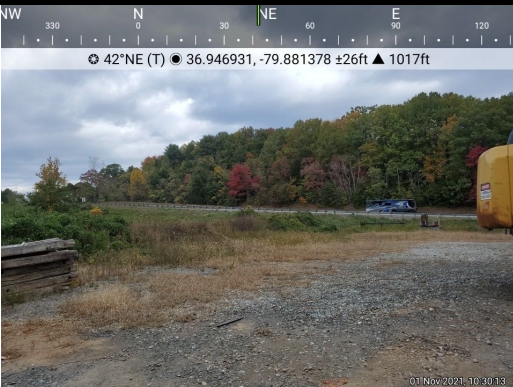
GPS Location	0	GPS Location	0		
Field Station#	0+00	Field Station#	0+00		
Pic 1 Desc.	LY-032 Secondary containment	Pic 2 Desc.	LY-032 Temporary vegetation

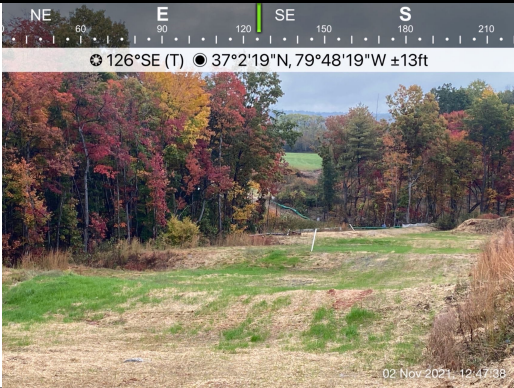
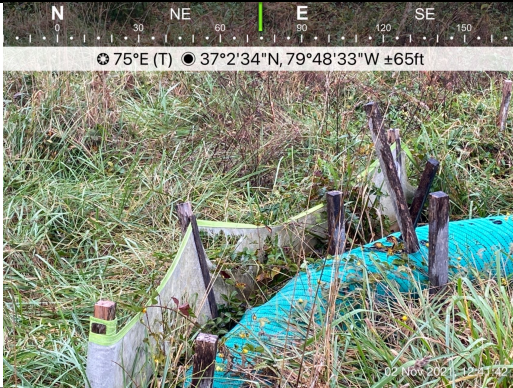
<b>GPS Location</b>	0	<b>GPS Location</b>	0		
<b>Field Station#</b>	14337+00	<b>Field Station#</b>	14314+25		
<b>Pic 5 Desc.</b>	Approximately 14337+00. Overview of ROW.	<b>Pic 6 Desc.</b>	Approximately 14314+25. P-1 weathered and torn. Replace fence.

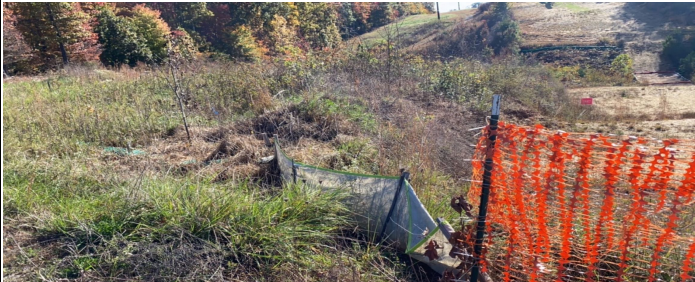
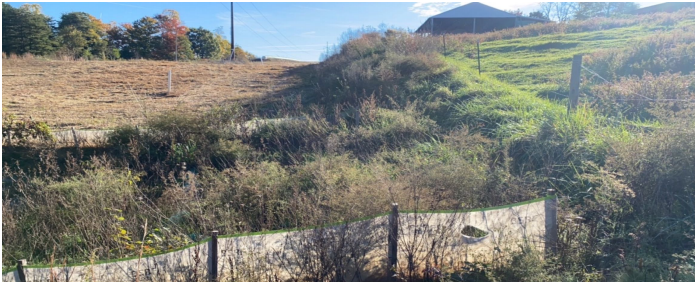
36°58'36" N 79°40'41" W 197°S COURSE 285° GPS Penhook, VA 24137, United States 11.03.2021 10:51:41 Accur +/-38.7 Ft ALT 955 Ft			36°58'23" N 79°40'11" W 112°E COURSE 31° GPS Penhook, VA 24137, United States 11.03.2021 09:55:39 Accur +/-45.0 Ft ALT 867 Ft		
GPS Location	1	GPS Location	2		
Field Station#	14802+25	Field Station#	14832+61		
Pic 1 Desc.	Routine maintenance. Replace damaged P1 silt fence.		Pic 2 Desc.	Routine maintenance. Replace damaged panels of P1 silt fence in resource buffer.

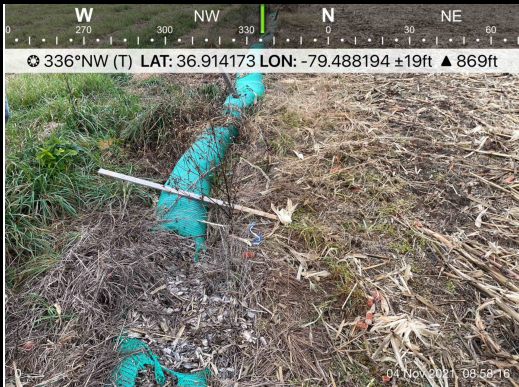
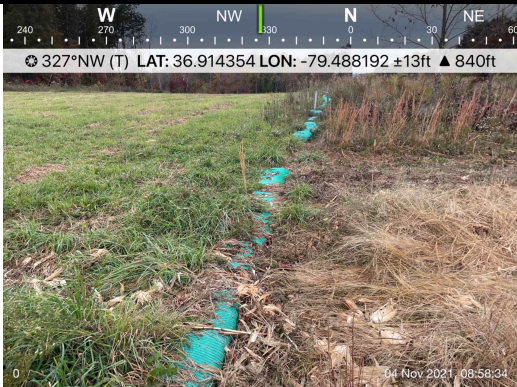
GPS Location	See photo		GPS Location	See photo	
Field Station#	15440+00		Field Station#	15440+00	
Pic 7 Desc.	CFS is degraded/damaged and needs to be replaced 15440+00-15447+00		Pic 8 Desc.	CFS is degraded/damaged and needs to be replaced 15440+00-15447+00

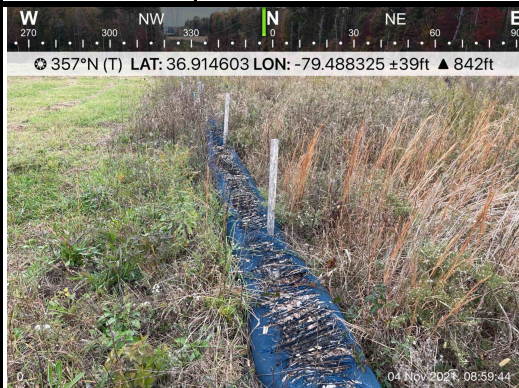
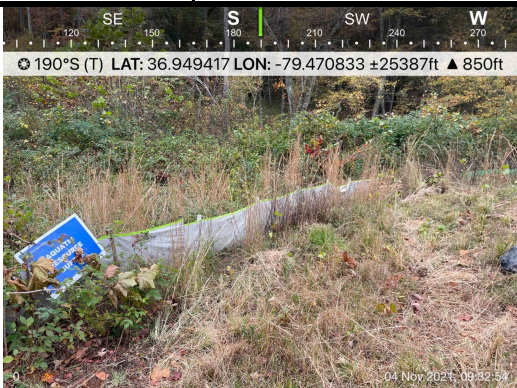
GPS Location	See photo		GPS Location	See photo	
Field Station#	15440+00		Field Station#	15435+10	
Pic 9 Desc.	CFS is degraded/damaged and needs to be replaced 15440+00-15447+00		Pic 10 Desc.	P1 is in good condition at all stream and wetland buffers.

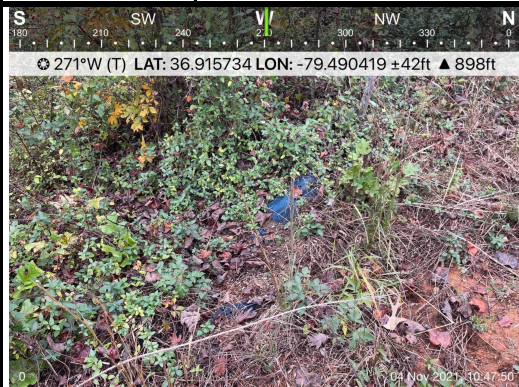
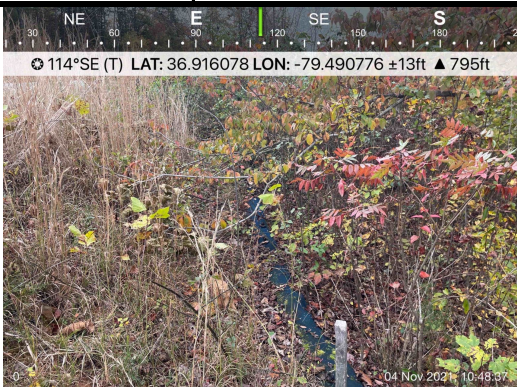
GPS Location	See photo		GPS Location	See photo	
Field Station#	154330+00		Field Station#	15430+00	
Pic 11 Desc.	CFS is degraded/damaged and needs to be replaced 15430+00-15435+00		Pic 12 Desc.	CFS is degraded/damaged and needs to be replaced 15430+00-15435+00

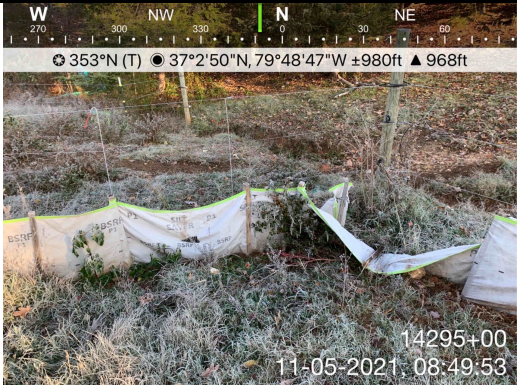
GPS Location		0		GPS Location	
Field Station#		14295+00		14294+00	
Pic 1 Desc.		P1 silt fence damaged by livestock		Pic 2 Desc.

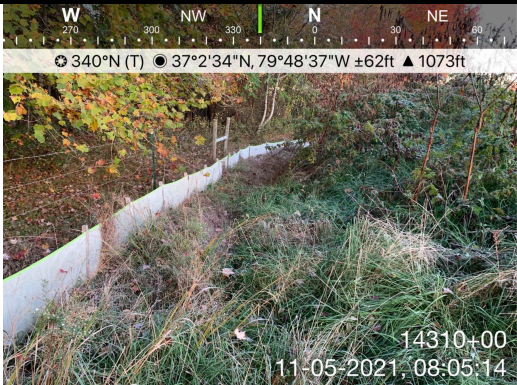
GPS Location		0		GPS Location	
Field Station#		14310+00		14279+00	
Pic 3 Desc.		P1 silt fence in acceptable condition		Pic 4 Desc.

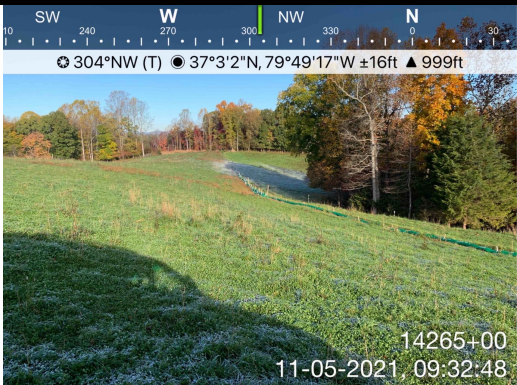
GPS Location		0		GPS Location	
Field Station#		14265+00		14231+00	
Pic 5 Desc.		Permanent vegetative stabilization in acceptable condition		Pic 6 Desc.
