Visual Site Inspection Report

Project Name	H-600 Pipeline Spread I	AFE	124300139	Spread	H-600 Pipeline Spread I
Contractor	Precision			Report #	31178
Inspector	Ben Farmer			Date/Time	11/15/2021 1:09 PM
Permit #	TBD	Inspection Type	VA SWPP	Station Begin	15260+00
State	VA	Inspection Area	Partial	Station End	15370+62
County	Pittsylvania	Ground	Dry	Temperature (°F)	39.00
Municipality	Chatham	Weather	Sunny	Rain Gauge (in)	0.00
				Rain Accumulation Time (days)	0.00

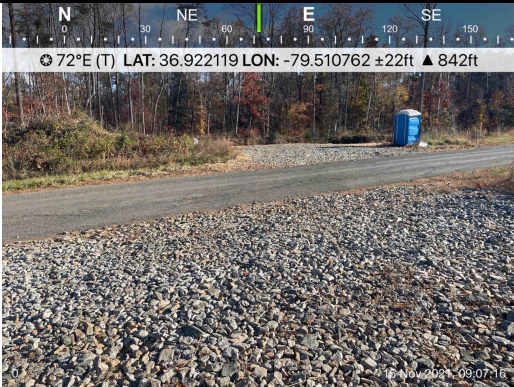
GPS Location	See photo		GPS Location	See photo	
Field Station#	15370+62		Field Station#	15370+00	
Pic 1 Desc.	RCEs are in good condition at all road crossings.		Pic 2 Desc.	Area remains stabilized.

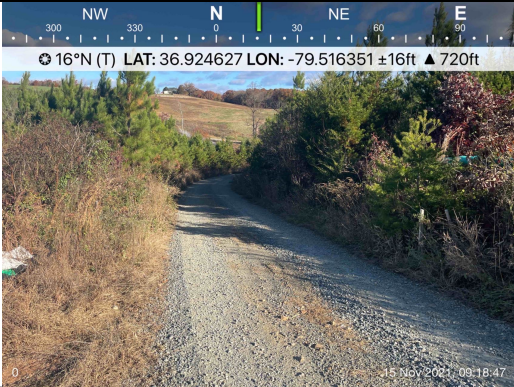
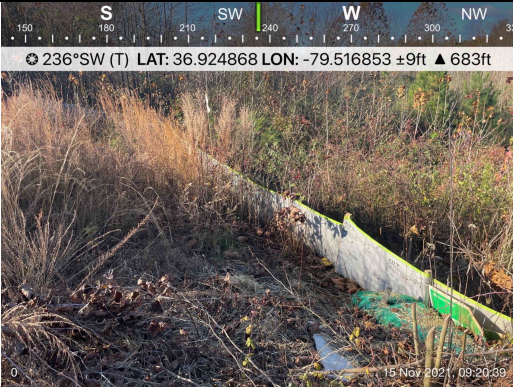
GPS Location	See photo		GPS Location	See photo	
Field Station#	15350+00		Field Station#	15348+00	
Pic 3 Desc.	MVP-PI-332 remains in good condition with controls in place.		Pic 4 Desc.	P1 is in good condition at this stream buffer.

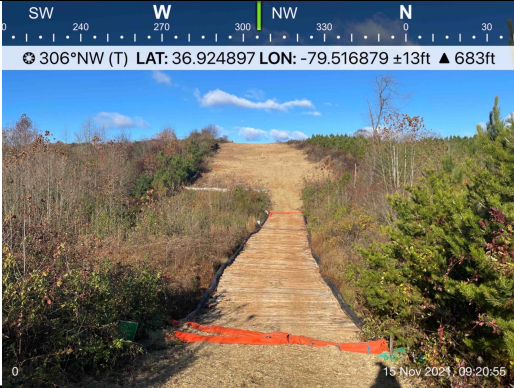
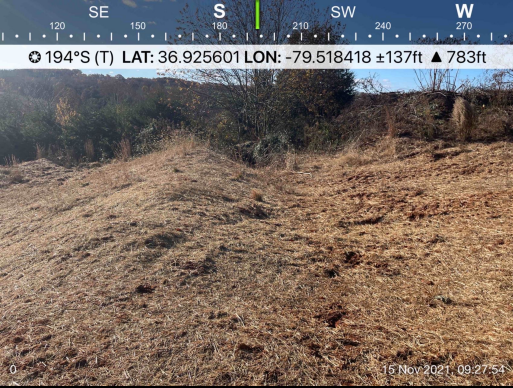
GPS Location	See photo		GPS Location	See photo	
Field Station#	15348+00		Field Station#	15343+00	
Pic 5 Desc.	Equipment bridge ECDs are in place and functioning.		Pic 6 Desc.	Waterbars are functioning as intended.

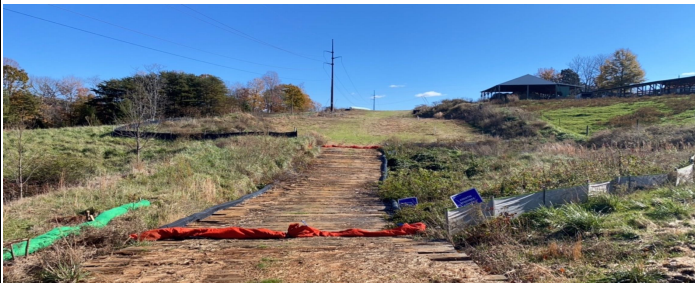
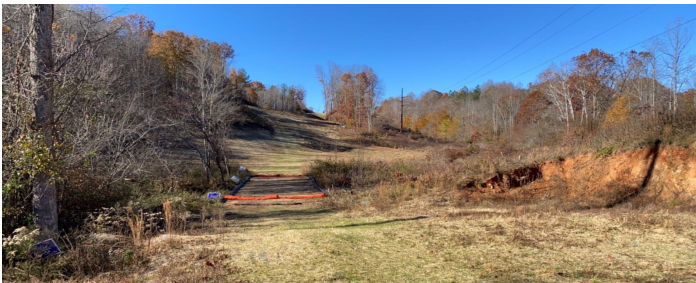
Pic 3 Desc.	Equipment bridge and surrounding ECDs in place and functional at stream crossing and resource buffer		Pic 4 Desc.	Equipment bridge and surrounding ECDs in place and functional at stream crossing and resource buffer

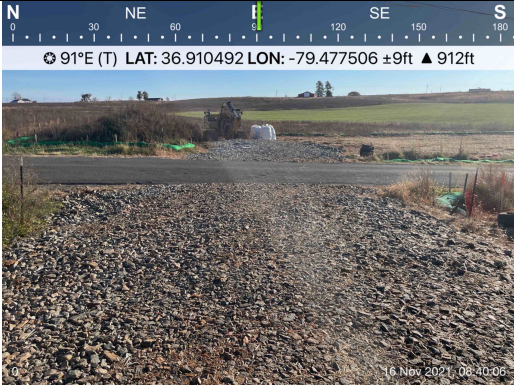
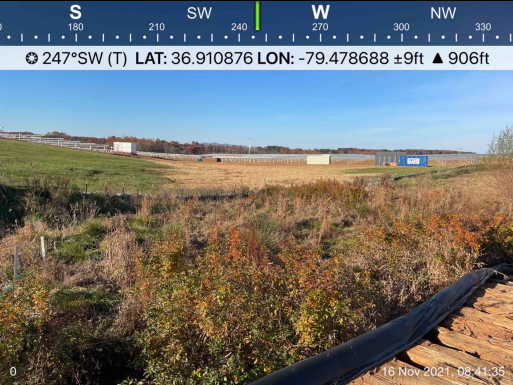
GPS Location	See photo		GPS Location	See photo	
Field Station#	15480+67		Field Station#	15475+00	
Pic 1 Desc.	RCEs are in good condition at all road crossings.		Pic 2 Desc.	3rd party rock outlet appears to be in good condition along this drainage.

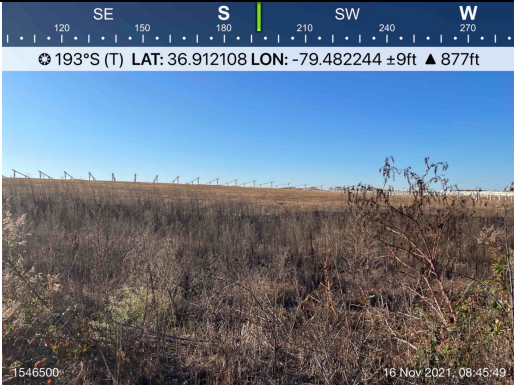
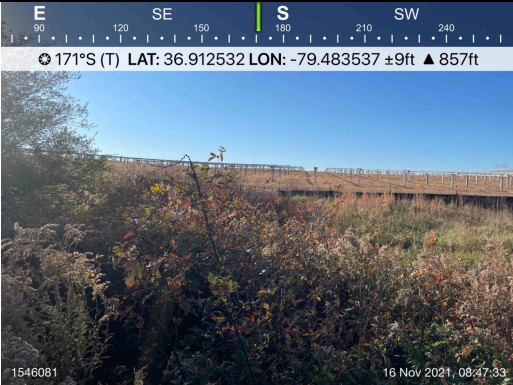
GPS Location	See photo		GPS Location	See photo	
Field Station#	15465+00		Field Station#	15460+81	
Pic 3 Desc.	No evidence of sedimentation from 3rd party disturbance.		Pic 4 Desc.	No evidence of sedimentation from 3rd party disturbance into CWD inlet.

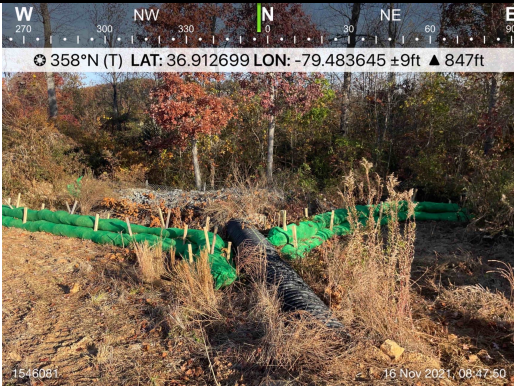
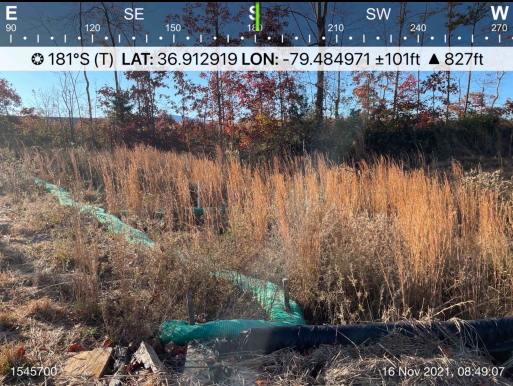
GPS Location	See photo		GPS Location	See photo	
Field Station#	15460+81		Field Station#	15457+00	
Pic 5 Desc.	CWD remains in good condition.		Pic 6 Desc.	No evidence of sedimentation within drainage feature.

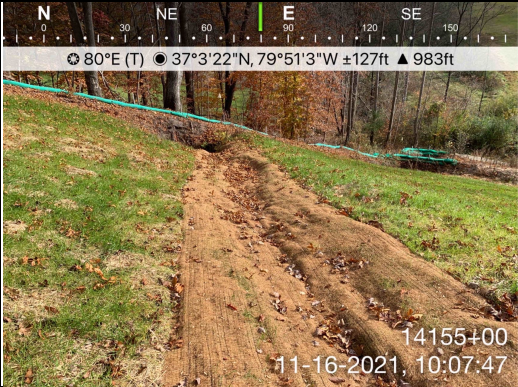
<p>GPS photo showing erosion control blanket in acceptable condition. GPS data: 80°E (T), 37°3'22"N, 79°51'3"W ±127ft, 983ft. Station: 14155+00. Date/Time: 11-16-2021, 10:07:47.</p>

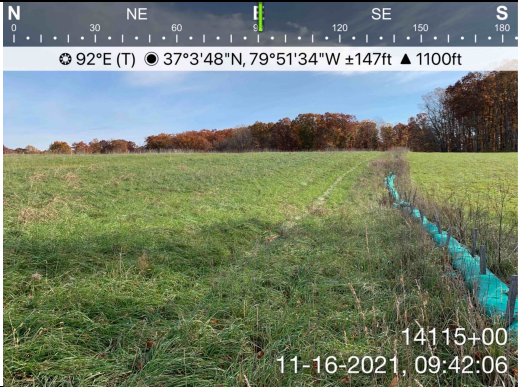
<p>GPS photo showing permanent vegetative stabilization and perimeter CFS in acceptable conditions. GPS data: 92°E (T), 37°3'48"N, 79°51'34"W ±147ft, 1100ft. Station: 14115+00. Date/Time: 11-16-2021, 09:42:06.</p>			
GPS Location	0	GPS Location	0		
Field Station#	14155+00	Field Station#	14115+00		
Pic 7 Desc.	Erosion control blanket in acceptable condition	Pic 8 Desc.	Permanent vegetative stabilization and perimeter CFS in acceptable conditions		
Insert image here		Insert image here			
GPS Location		GPS Location			
Field Station#		Field Station#			
Pic 9 Desc.		Pic 10 Desc.			
Insert image here		Insert image here			
GPS Location		GPS Location

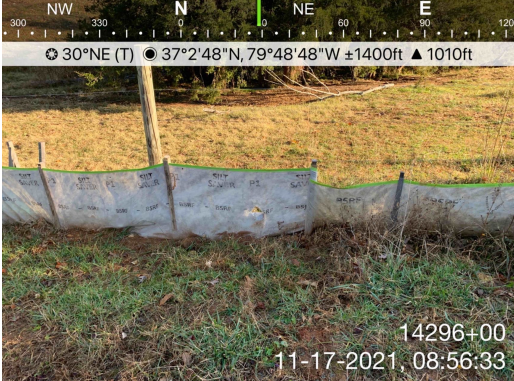
GPS Location	0	GPS Location	0		
Field Station#	14296+00	Field Station#	14294+50		
Pic 1 Desc.	P1 silt fence (multiple panels) damaged by livestock from 14295+00 to 14296+00	Pic 2 Desc.	Geotech fabric detached from equipment bridge

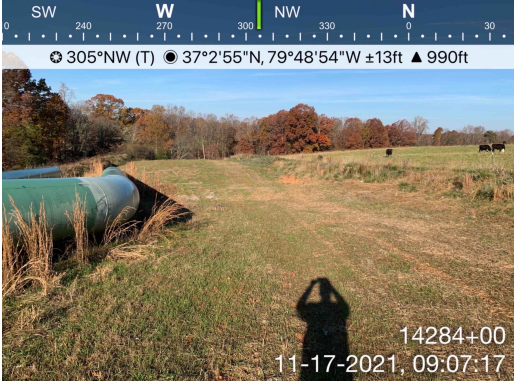
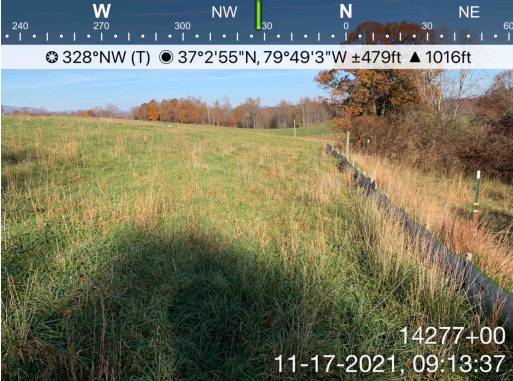
GPS Location	0	GPS Location	0		
Field Station#	14284+00	Field Station#	14277+00		
Pic 3 Desc.	Temporary vegetative stabilization in acceptable condition	Pic 4 Desc.	Permanent vegetative stabilization and perimeter P1 silt fence in acceptable conditions

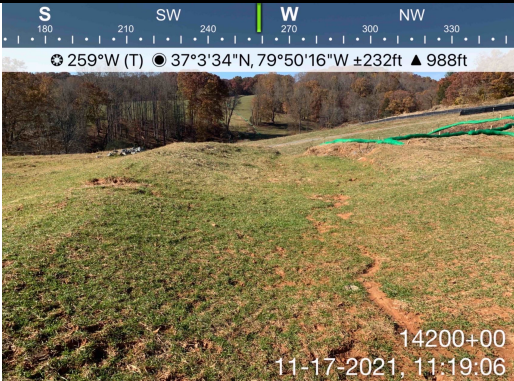
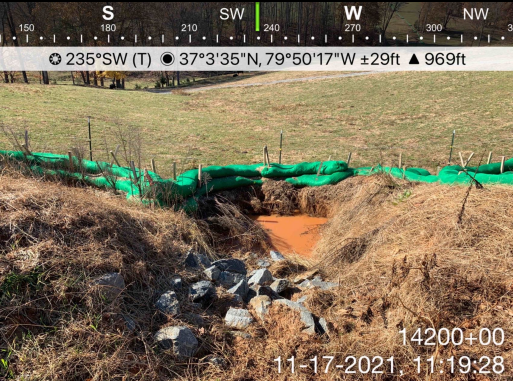
GPS Location	0	GPS Location	0		
Field Station#	14200+00	Field Station#	14200+00		
Pic 5 Desc.	Waterbar in acceptable condition	Pic 6 Desc.	Waterbar end treatment in acceptable condition

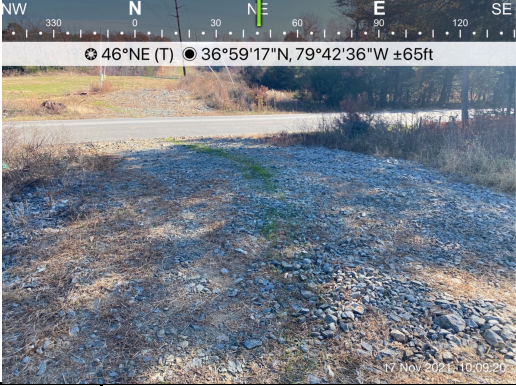
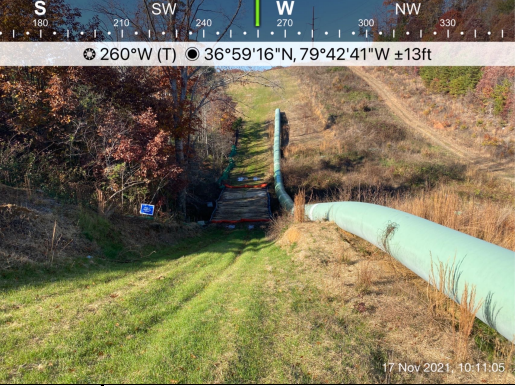
GPS Location	0	GPS Location	0		
Field Station#	14694+50	Field Station#	14689+36		
Pic 1 Desc.	Approximately 14694+50. Overview of road crossing and RCE.		Pic 2 Desc.	Approximately 14689+36. Overview of stream crossing, equipment bridge and ECDs at stream S-H34.

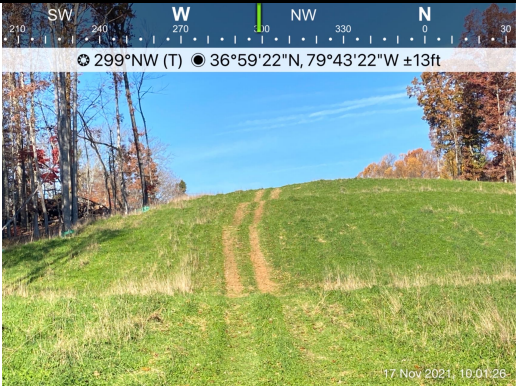
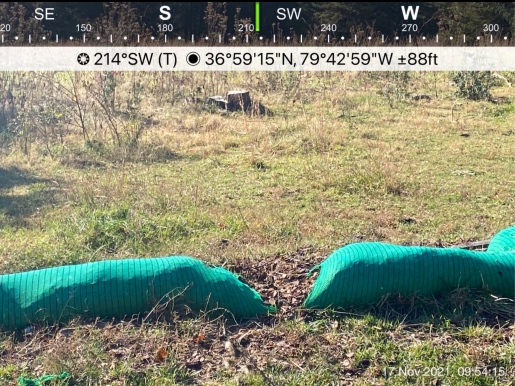
GPS Location	0	GPS Location	0		
Field Station#	14653+00	Field Station#	14676+00		
Pic 5 Desc.	Approximately 14653+00. Overview of ROW. Third party has been traveling with agricultural equipment on the ROW.		Pic 6 Desc.	Approximately 14676+00. CFS requires maintenance. Damaged by livestock.

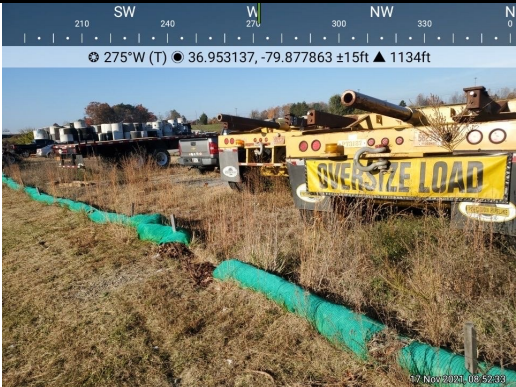
GPS Location	0		GPS Location	0	
Field Station#	0+00		Field Station#	0+00	
Pic 1 Desc.	ANC-006 East perimeter CFS needing repairs		Pic 2 Desc.	LY-032 Secondary containment

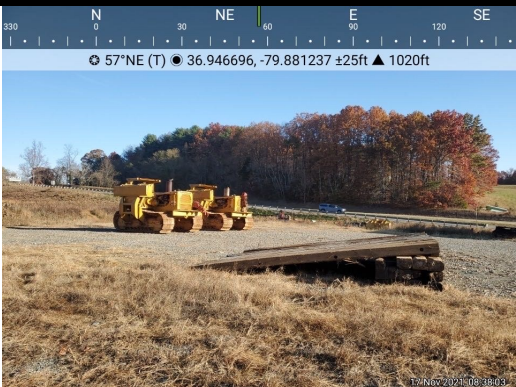
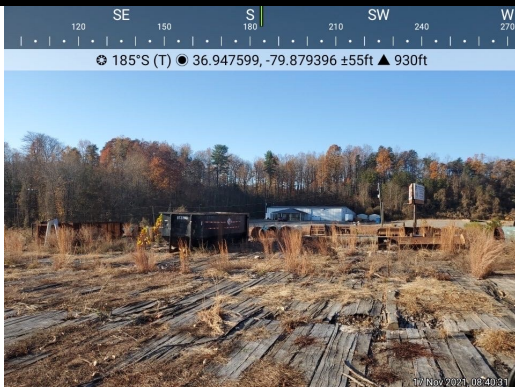
GPS Location	0		GPS Location	0	
Field Station#	0+00		Field Station#	0+00	
Pic 3 Desc.	LY-032 Equipment staging		Pic 4 Desc.	LY-033 Timber mat staging area

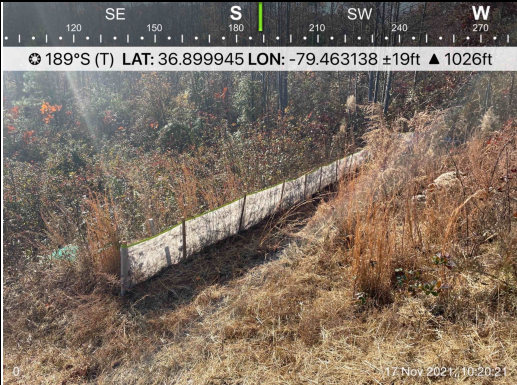
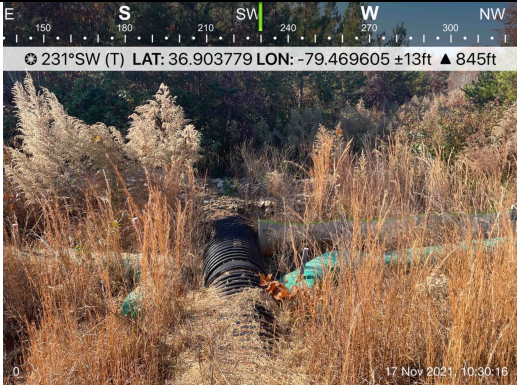
GPS Location	See photo		GPS Location	See photo	
Field Station#	15540+00		Field Station#	15515+00	
Pic 7 Desc.	P1 is in good condition at all stream and wetland buffers.		Pic 8 Desc.	CWDs are functioning as intended.

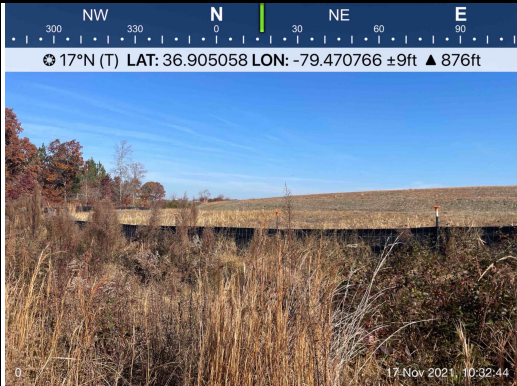
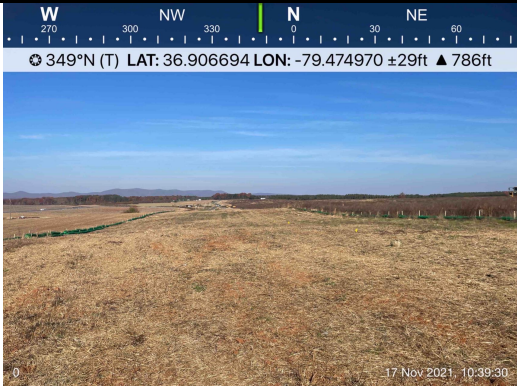
GPS Location	See photo		GPS Location	See photo	
Field Station#	15510+00		Field Station#	15495+00	
Pic 9 Desc.	3rd party ECDs appear to be in good condition.		Pic 10 Desc.	Area has been temporarily stabilized.

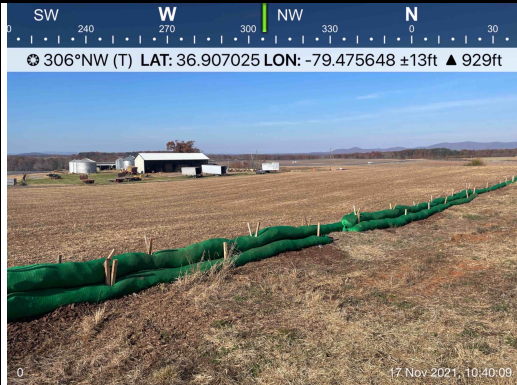
<div>Insert image here</div>			
GPS Location	See photo		GPS Location		
Field Station#	15492+00		Field Station#		
Pic 11 Desc.	Perimeter CFS is in good condition throughout this section.		Pic 12 Desc.

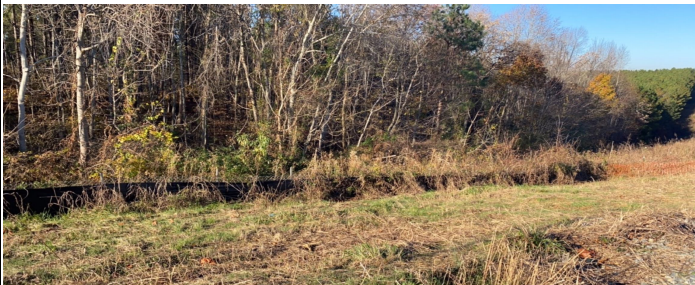
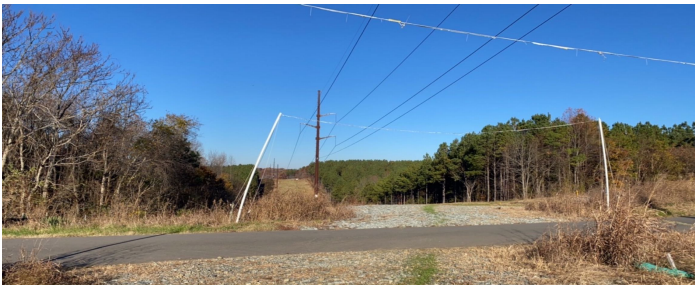
GPS Location	3	GPS Location	4		
Field Station#	14756+00	Field Station#	14758+16		
Pic 3 Desc.	Perimeter SSF in place and functional		Pic 4 Desc.	RCE at Indian Cave Rd in good condition

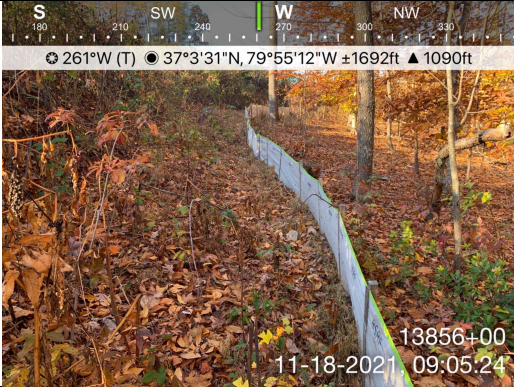
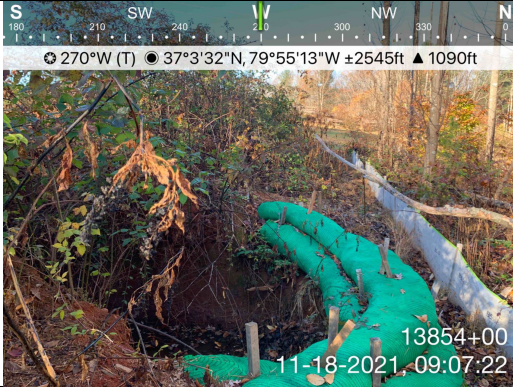
GPS Location	0	GPS Location	0		
Field Station#	13856+00	Field Station#	13854+00		
Pic 1 Desc.	P1 silt fence in acceptable condition	Pic 2 Desc.	Waterbar end treatment and P1 silt fence in acceptable conditions

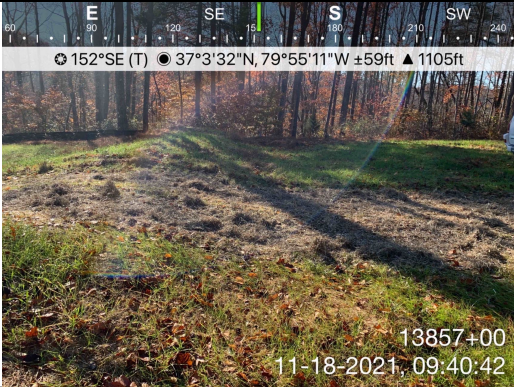
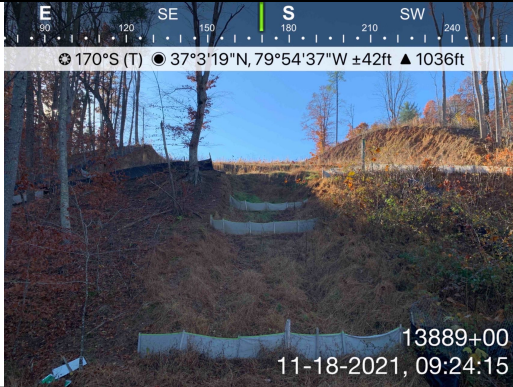
GPS Location	0	GPS Location	0		
Field Station#	13857+00	Field Station#	13889+00		
Pic 3 Desc.	Waterbar in acceptable condition	Pic 4 Desc.	Temporary vegetative stabilization and P1 silt fence in acceptable conditions

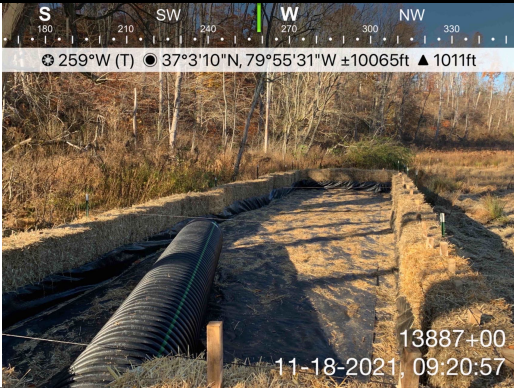
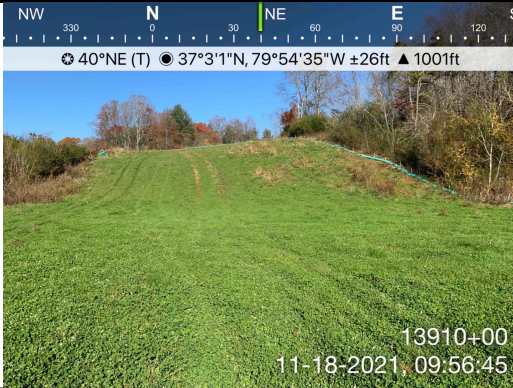
GPS Location	0	GPS Location	0		
Field Station#	13887+00	Field Station#	13910+00		
Pic 5 Desc.	Above-ground sump pit in acceptable condition	Pic 6 Desc.	Permanent vegetative stabilization in acceptable condition

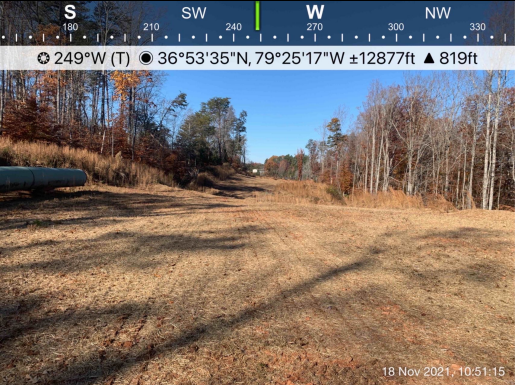
GPS Location	O	GPS Location	O		
Field Station#	15644+00	Field Station#	15632+00		
Pic 1 Desc.	Observing temporary stabilization, sump and end treatment	Pic 2 Desc.	Observing temporary stabilization

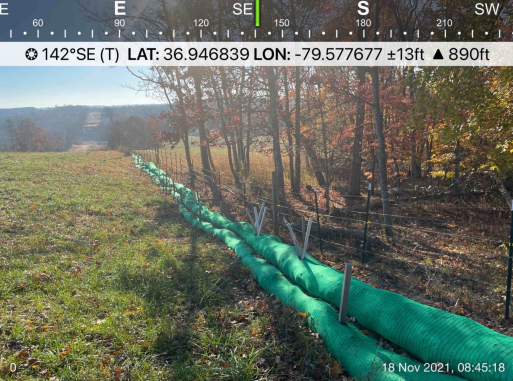
GPS Location	See photo		GPS Location	See photo	
Field Station#	15142+66		Field Station#	15150+00	
Pic 1 Desc.	RCE is in good condition at Rockcreek Rd.		Pic 2 Desc.	Perimeter CFS is in good condition throughout this section.

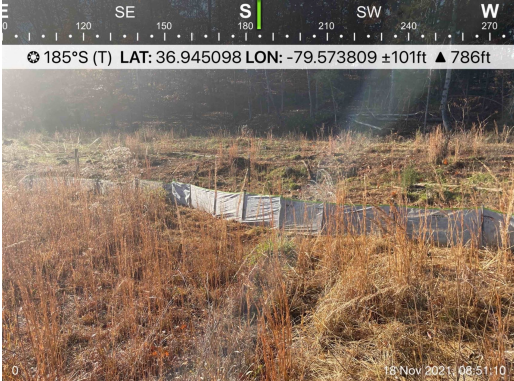
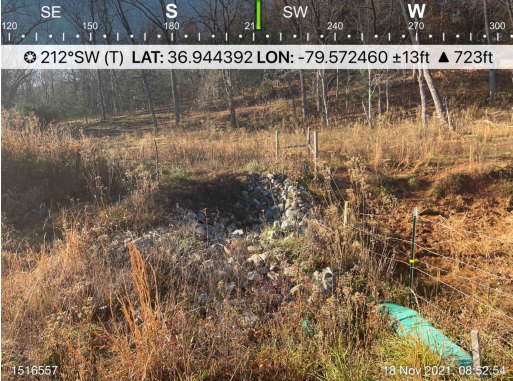
GPS Location	See photo		GPS Location	See photo	
Field Station#	15160+00		Field Station#	15165+57	
Pic 3 Desc.	Perimeter P1 remains in good condition.		Pic 4 Desc.	Rock inlet remains in good condition.

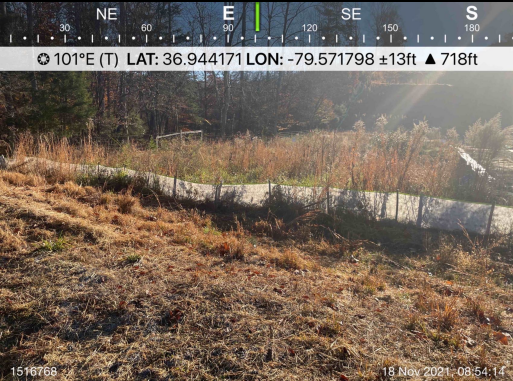
GPS Location	See photo		GPS Location	See photo	
Field Station#	15166+00		Field Station#	15167+68	
Pic 5 Desc.	Rock outlet remains in good condition.		Pic 6 Desc.	P1 is in good condition at stream buffer.

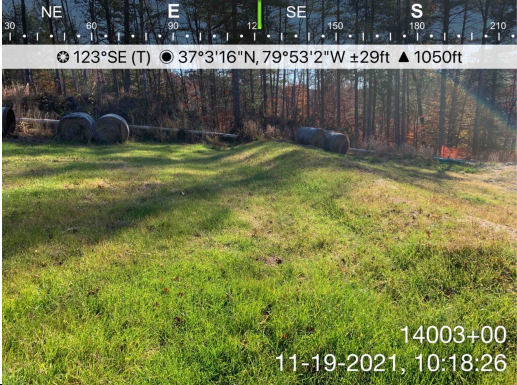
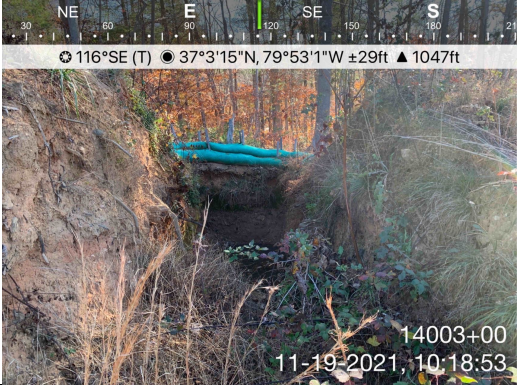
GPS Location	0	GPS Location	0		
Field Station#	14003+00	Field Station#	14003+00		
Pic 7 Desc.	Waterbar in acceptable condition		Pic 8 Desc.	Waterbar end treatment in acceptable condition

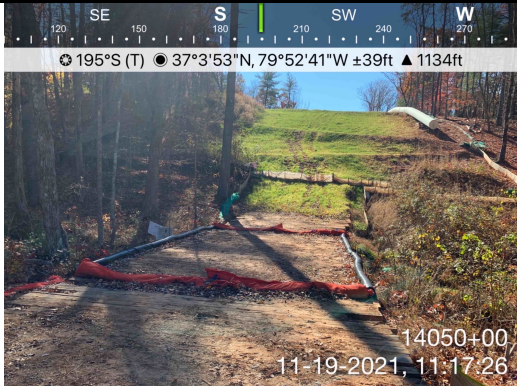
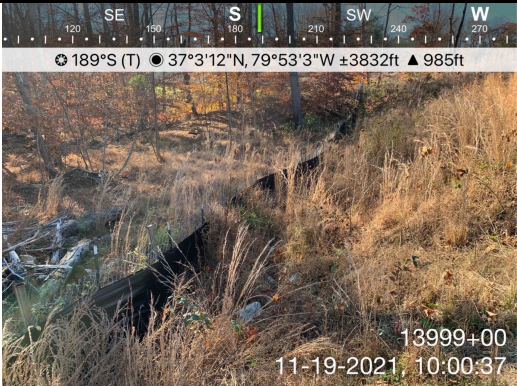
GPS Location	0	GPS Location	0		
Field Station#	14050+00	Field Station#	13999+00		
Pic 9 Desc.	Equipment bridge and temporary vegetative stabilization in acceptable conditions		Pic 10 Desc.	Super silt fence in acceptable condition

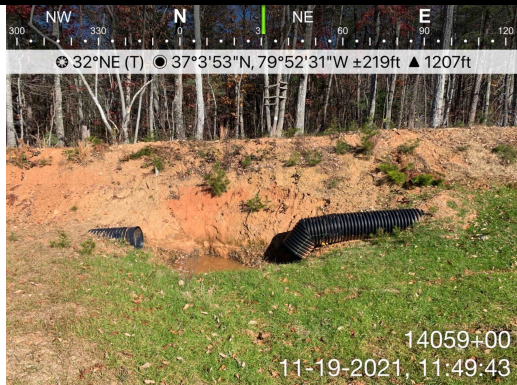
<div style="text-align: center; height: 150px;">Insert image here</div>			
GPS Location	0	GPS Location			
Field Station#	14059+00	Field Station#			
Pic 11 Desc.	Slope drain pipe in acceptable condition		Pic 12 Desc.

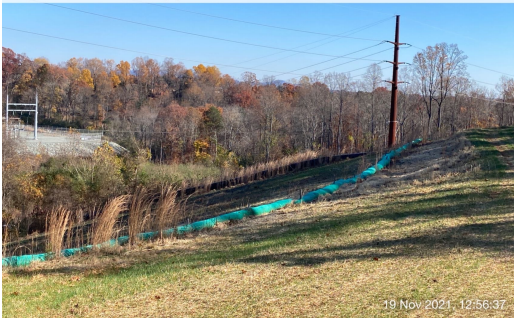
GPS Location	0	GPS Location	0		
Field Station#	14456+00	Field Station#	14460+00		
Pic 1 Desc.	Approximately 14456+00. Overview of ROW.		Pic 2 Desc.	Approximately 14460+00. Overview of ROW.

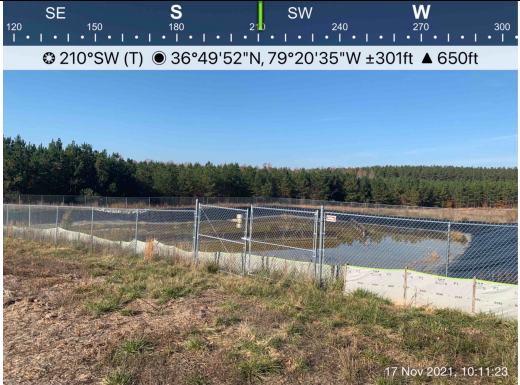
GPS Location	O	GPS Location	O		
Field Station#	00+00	Field Station#	00+00		
Pic 1 Desc.	Observing temporary stabilization and ECD's	Pic 2 Desc.	Observing temporary stabilization, storm water pond and ECD's
