Visual Site Inspection Report

Project Name	H-600 Pipeline Spread I	AFE	124300139	Spread	H-600 Pipeline Spread I
Contractor	Precision			Report #	31695
Inspector	Ben Farmer			Date/Time	11/29/2021 1:52 PM
Permit #	TBD	Inspection Type	VA SWPP	Station Begin	15370+62
State	VA	Inspection Area	Partial	Station End	15480+67
County	Pittsylvania	Ground	Dry	Temperature (°F)	38.00
Municipality	Chatham	Weather	Sunny	Rain Gauge (in)	0.00
				Rain Accumulation Time (days)	0.00

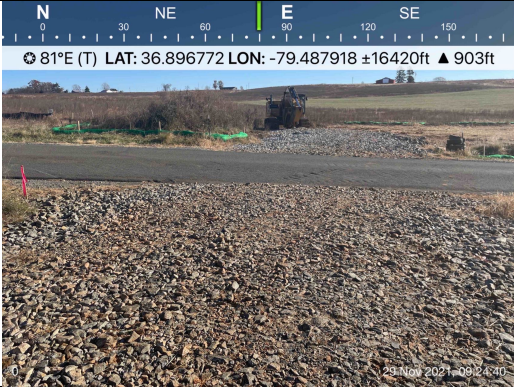
GPS Location	See photo		GPS Location	See photo	
Field Station#	15480+67		Field Station#	15475+00	
Pic 1 Desc.	RCEs are in good condition at all road crossings.		Pic 2 Desc.	3rd party rock outlet appears to be in good condition along this drainage.

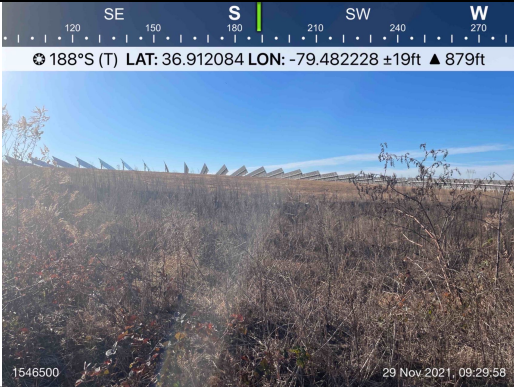
GPS Location	See photo		GPS Location	See photo	
Field Station#	15465+00		Field Station#	15460+81	
Pic 3 Desc.	No evidence of sedimentation from 3rd party disturbance.		Pic 4 Desc.	No evidence of sedimentation from 3rd party disturbance into CWD inlet.

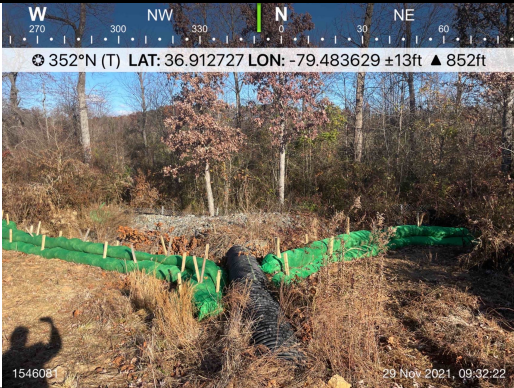
GPS Location	See photo		GPS Location	See photo	
Field Station#	15460+81		Field Station#	15457+00	
Pic 5 Desc.	CWD remains in good condition		Pic 6 Desc.	No evidence of sedimentation within drainage feature.

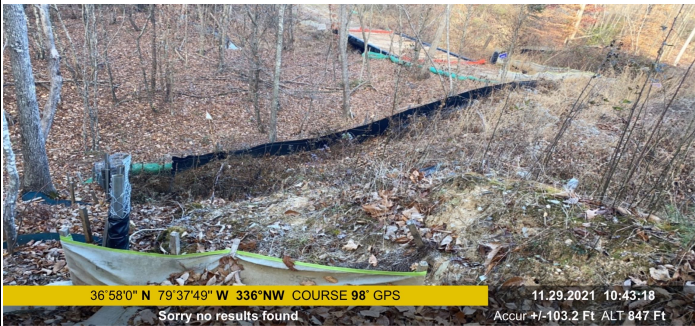
GPS Location	1	GPS Location	2		
Field Station#	14951+50	Field Station#	14953+00		
Pic 1 Desc.	Routine maintenance. Replace damaged row of P1 silt fence.		Pic 2 Desc.	Routine maintenance. Replace damaged CFS check dams in drainage area.

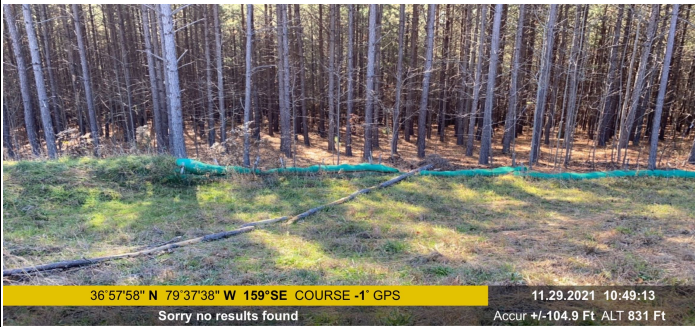
GPS Location	3	GPS Location	4		
Field Station#	14965+00	Field Station#	14937+00		
Pic 3 Desc.	Routine maintenance. Fallen tree down on perimeter CFS requires maintenance.		Pic 4 Desc.	CWD pipe in good condition across ROW.

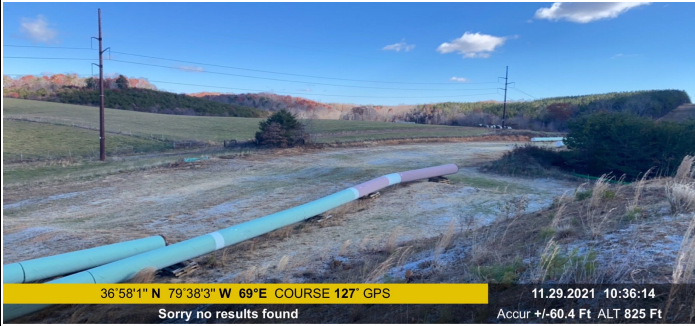
GPS Location	5	GPS Location	6		
Field Station#	14943+00	Field Station#	14983+00		
Pic 5 Desc.	ROW stabilized and vegetated in temporary area.		Pic 6 Desc.	Plunge pool performing intended function.

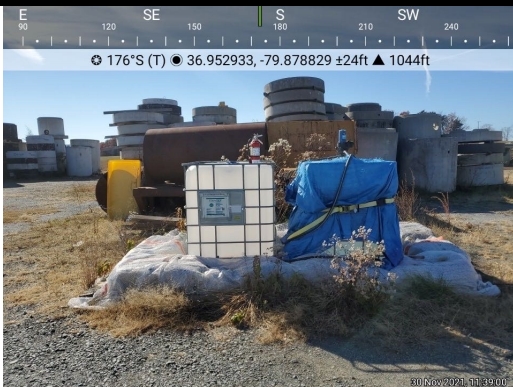
GPS Location	0		GPS Location	0	
Field Station#	0+00		Field Station#	0+00	
Pic 3 Desc.	ANC-006 Secondary containment		Pic 4 Desc.	ANC-006 Stormwater drain inlet protection

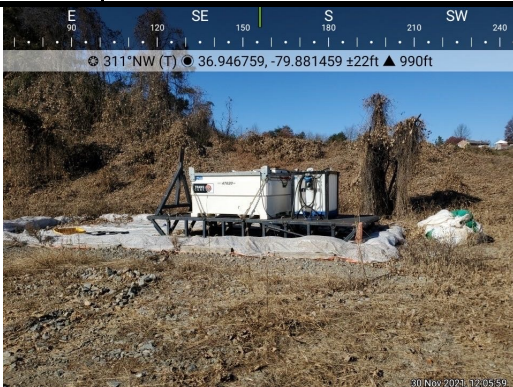
GPS Location	0		GPS Location	0	
Field Station#	0+00		Field Station#	0+00	
Pic 5 Desc.	LY-032 Secondary containment		Pic 6 Desc.	LY-032 Secondary containment and waste management

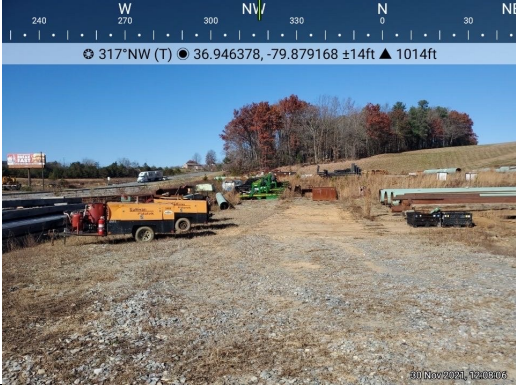
GPS Location	0	GPS Location	0		
Field Station#	0+00	Field Station#	0+00		
Pic 7 Desc.	LY-033 Staging area	Pic 8 Desc.	LY-033 Stormwater drain inlet protection		
Insert image here		Insert image here			
GPS Location		GPS Location			
Field Station#		Field Station#			
Pic 9 Desc.		Pic 10 Desc.			
Insert image here		Insert image here			
GPS Location		GPS Location			
Field Station#		Field Station#			
Pic 11 Desc.		Pic 12 Desc.

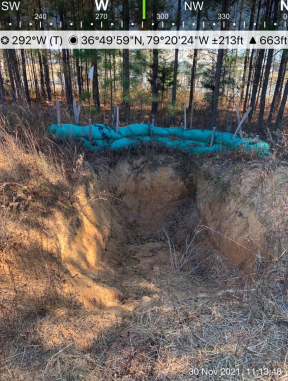
GPS Location	O	GPS Location	O		
Field Station#	6+00	Field Station#	8+00		
Pic 1 Desc.	Observing temporary stabilization, sump and end treatment		Pic 2 Desc.	Observing temporary stabilization and water bars

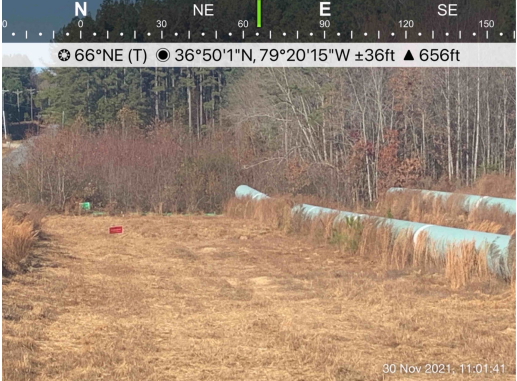
GPS Location	O	GPS Location	O		
Field Station#	21+00	Field Station#	14+00		
Pic 3 Desc.	Observing temporary stabilization, signage and buffer		Pic 4 Desc.	Observing temporary stabilization, signage and buffer	
Insert image here			Insert image here		
GPS Location		GPS Location			
Field Station#		Field Station#			
Pic 5 Desc.			Pic 6 Desc.

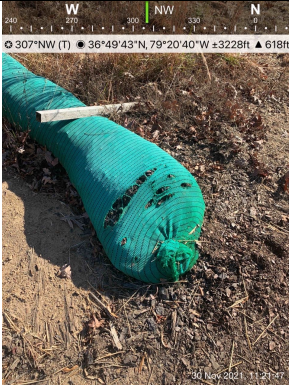
GPS Location	O	GPS Location	O		
Field Station#	13+50	Field Station#	13+45		
Pic 1 Desc.	Observing CFS that requires maintenance		Pic 2 Desc.	Observing temporary stabilization, sump and end treatment

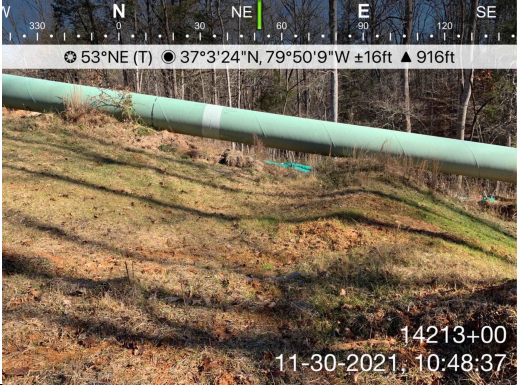
GPS Location	0	GPS Location	0		
Field Station#	14213+00	Field Station#	14213+00		
Pic 7 Desc.	Waterbar in acceptable condition	Pic 8 Desc.	Waterbar end treatment in acceptable condition

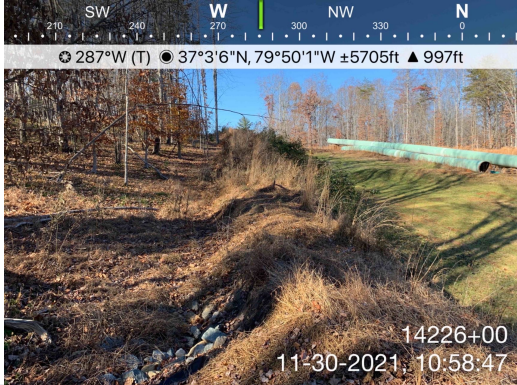
GPS Location	0	GPS Location	0		
Field Station#	14226+00	Field Station#	14224+00		
Pic 9 Desc.	Clean water diversion berm in acceptable condition	Pic 10 Desc.	P1 silt fence in acceptable condition

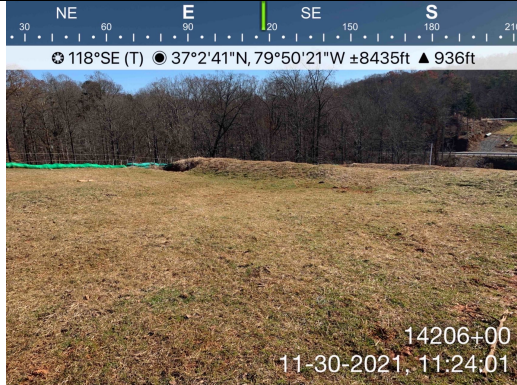
GPS Location	0	GPS Location	0		
Field Station#	14206+00	Field Station#	14199+00		
Pic 11 Desc.	Temporary vegetative stabilization in acceptable condition	Pic 12 Desc.	Clean water diversion plunge pool in acceptable

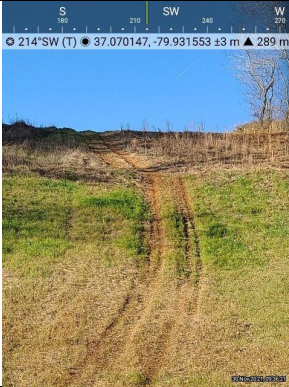
GPS Location	0000	GPS Location	0000		
Field Station#	13786+90	Field Station#	13770+00		
Pic 1 Desc.	Travel lane on hill side from 3rd party activities, the EI will continue to monitor the area.		Pic 2 Desc.	Observed recently replaced P1, no environmental issues observed at the time of inspection.

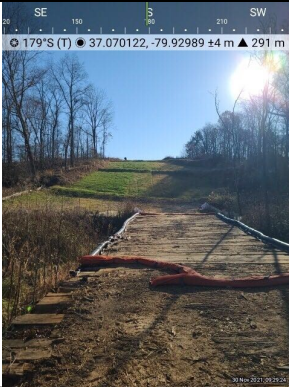
GPS Location	0000	GPS Location	0000		
Field Station#	13794+57	Field Station#	13770+69		
Pic 3 Desc.	Observed equipment bridge at stream crossing and ECDs, no environmental issues observed at the time of inspection I		Pic 4 Desc.	Monitored equipment bridge and ECDs at stream crossing, no environmental issues observed at the time of inspection I

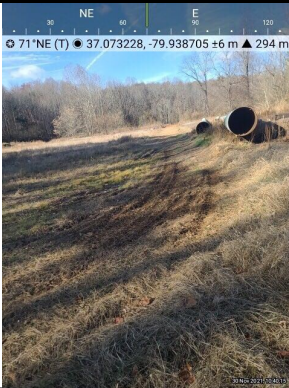
GPS Location	0000	GPS Location	0000		
Field Station#	13757+30	Field Station#	13791+22		
Pic 5 Desc.	Travel lane from 3rd party activities, the EI will continue to monitor the area.		Pic 6 Desc.	P1 requires maintenance due to being weathered and stakes broken, documented and added to the punch list for repair.

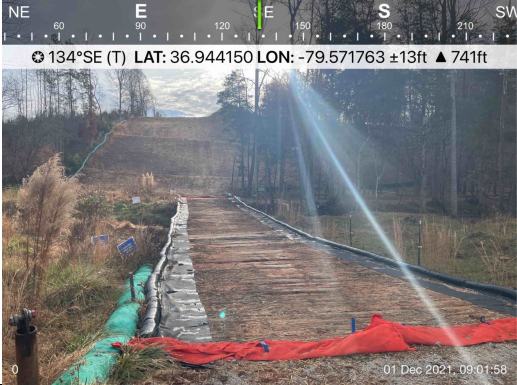
GPS Location	See photo		GPS Location	See photo	
Field Station#	15167+95		Field Station#	15168+00	
Pic 7 Desc.	Equipment bridge ECDs are in place and functioning.		Pic 8 Desc.	Resource buffer remains in good condition.

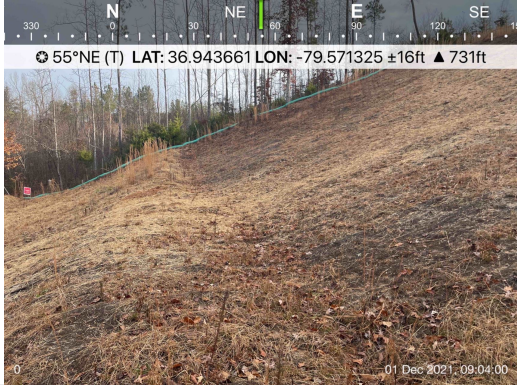
GPS Location	See photo		GPS Location	See photo	
Field Station#	15169+00		Field Station#	15170+00	
Pic 9 Desc.	Waterbars are in good condition and functioning.		Pic 10 Desc.	Slope drain is functioning as intended.

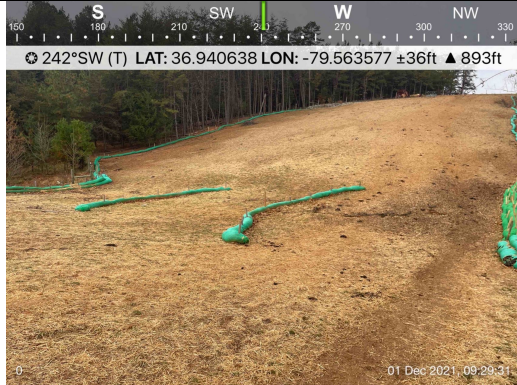
GPS Location	See photo		GPS Location	See photo	
Field Station#	15195+00		Field Station#	15230+00	
Pic 11 Desc.	Drainage ECDs are in place and functioning.		Pic 12 Desc.	Vegetation continues to fill in throughout this section.

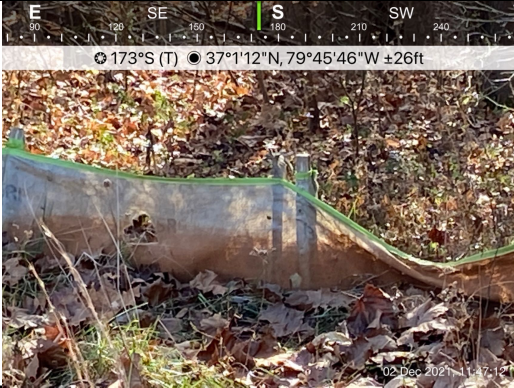
GPS Location	0	GPS Location	0		
Field Station#	14484+60	Field Station#	14460+00		
Pic 5 Desc.	Approximately 14484+60. P-1 requires maintenance. Damaged by livestock.		Pic 6 Desc.	Approximately 14460+00. CWD piping requires maintenance.

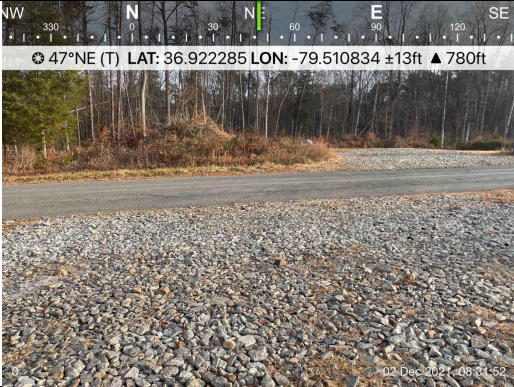
GPS Location	See photo	GPS Location	See photo		
Field Station#	15370+62	Field Station#	15370+00		
Pic 1 Desc.	RCEs are in good condition at all road crossings.	Pic 2 Desc.	Vegetation continues to fill in throughout this section.

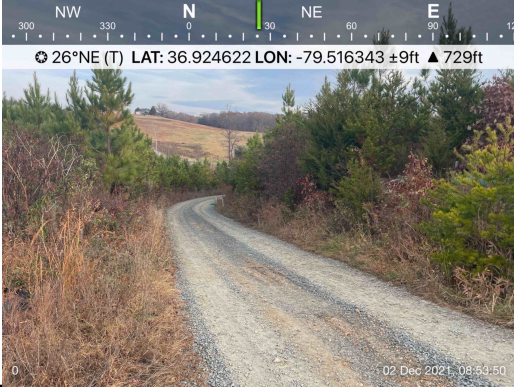
GPS Location	See photo	GPS Location	See photo		
Field Station#	15350+00	Field Station#	15348+21		
Pic 3 Desc.	MVP-PI-332 remains in good condition with controls in place.	Pic 4 Desc.	Equipment bridge ECDs are in place and functioning.

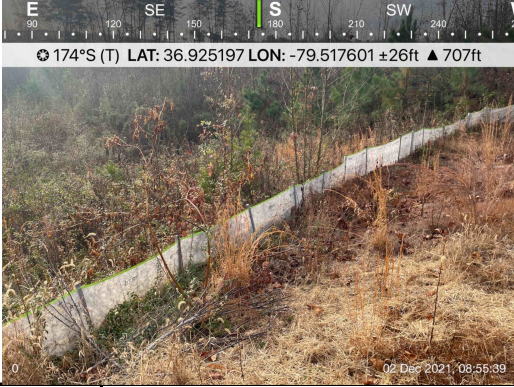
GPS Location	See photo	GPS Location	See photo		
Field Station#	15346+00	Field Station#	15346+50		
Pic 5 Desc.	P1 is in good condition at all stream and wetland buffers.	Pic 6 Desc.	Waterbars are in good condition.

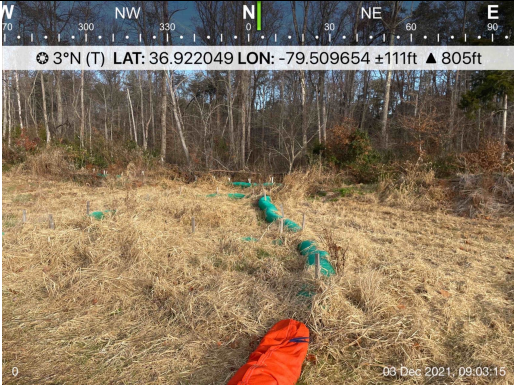
GPS Location	See photo		GPS Location	See photo	
Field Station#	15375+00		Field Station#	15380+00	
Pic 1 Desc.	Drainage ECDs are in good condition and functioning.		Pic 2 Desc.	Waterbars are in good condition.

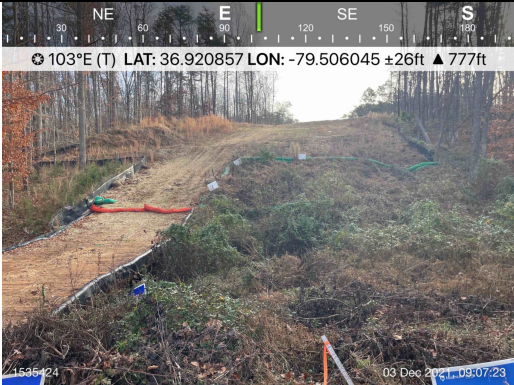
GPS Location	See photo		GPS Location	See photo	
Field Station#	15354+24		Field Station#	15354+24	
Pic 3 Desc.	Resource buffers remain in good condition.		Pic 4 Desc.	Equipment bridge ECDs are in place and functioning.

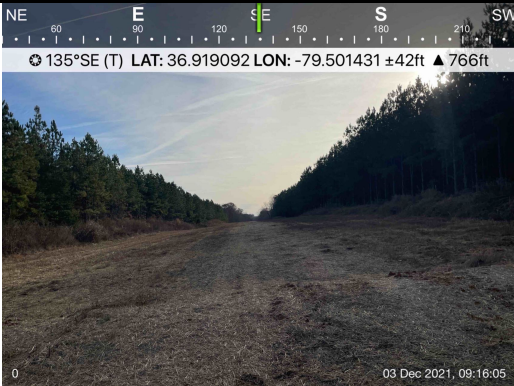
GPS Location	See photo		GPS Location	See photo	
Field Station#	15400+00		Field Station#	15443+00	
Pic 5 Desc.	Vegetation continues to fill in throughout this section.		Pic 6 Desc.	Perimeter CFS has been damaged by 3rd party and needs to be replaced with waddles.

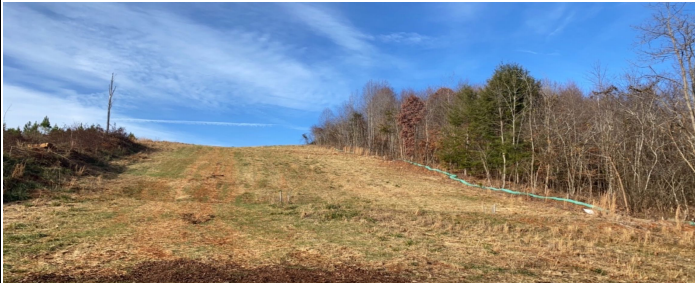
36°57'55" N 79°36'20" W 227°SW COURSE 271° GPS Penhook, VA 24137, United States 12.03.2021 09:28:38 Accur +/-132.8 Ft ALT 803 Ft			36°57'55" N 79°35'55" W 294°W COURSE 303° GPS Penhook, VA 24137, United States 12.03.2021 09:19:13 Accur +/-101.8 Ft ALT 845 Ft		
GPS Location	5		GPS Location	6	
Field Station#	15021+00		Field Station#	15045+50	
Pic 5 Desc.	ROW stabilized and vegetated in temporary area.		Pic 6 Desc.	Appropriate signage intact and visible in resource buffer and at stream crossing.
