Visual Site Inspection Report

Project Name	H-600 Pipeline Spread I	AFE	124300139	Spread	H-600 Pipeline Spread I
Contractor	Precision			Report #	30896
Inspector	Justin Burch			Date/Time	11/8/2021 11:46 AM
Permit #	TBD	Inspection Type	VA SWPP	Station Begin	13853+45
State	VA	Inspection Area	Full	Station End	13958+31
County	Franklin	Ground	Damp	Temperature (°F)	69.00
Municipality	N/A	Weather	Sunny	Rain Gauge (in)	0.10
				Rain Accumulation Time (days)	6.00

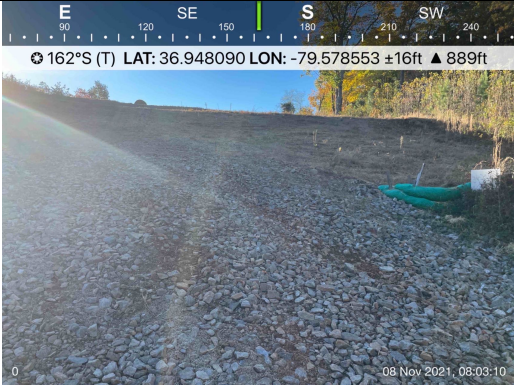
GPS Location	See photo		GPS Location	See photo	
Field Station#	15142+66		Field Station#	15147+00	
Pic 1 Desc.	RCE is in good condition at Rockcreek Rd.		Pic 2 Desc.	Perimeter CFS is in good condition throughout this section.

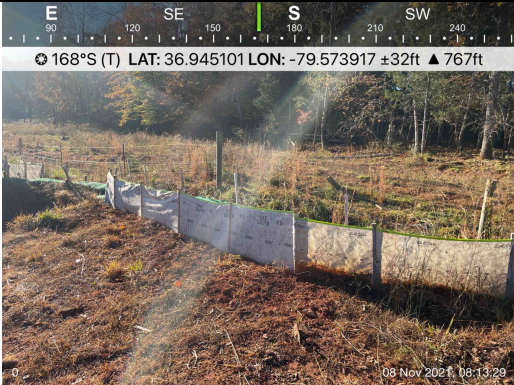
GPS Location	See photo		GPS Location	See photo	
Field Station#	15160+00		Field Station#	15165+57	
Pic 3 Desc.	Perimeter P1 remains in good condition.		Pic 4 Desc.	Rock filter inlet remains in good condition.

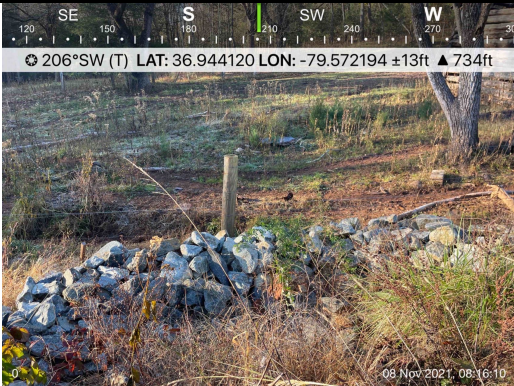
GPS Location	See photo		GPS Location	See photo	
Field Station#	15160+00		Field Station#	15167+68	
Pic 5 Desc.	Rock filter outlet remains in good condition.		Pic 6 Desc.	P1 is in good condition at stream buffer.

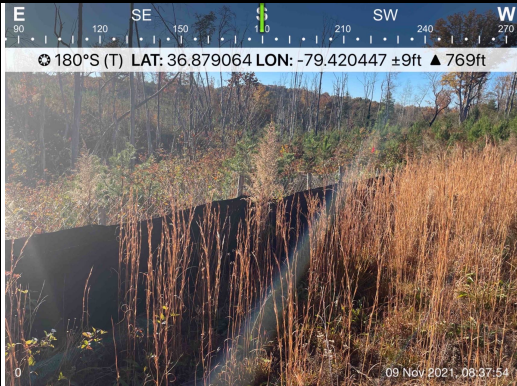
GPS Location	See photo		GPS Location	See photo	
Field Station#	15699+50		Field Station#	15694+00	
Pic 9 Desc.	SSF is in good condition.		Pic 10 Desc.	Waterbar channel needs to be regraded and stabilized.

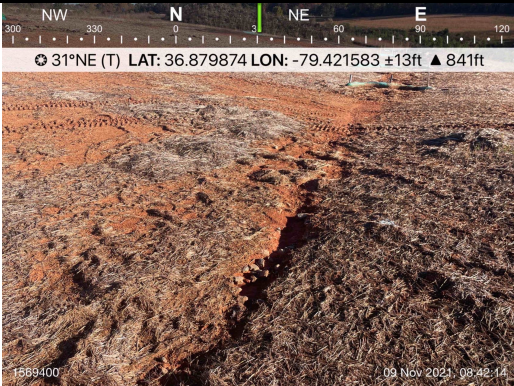
4. E&S BMPs (List BMPs and note if installed and maintained as per the plan. If corrective action is needed, a picture is required.)					
E&S BMPs	Compliance Level	Corrective Action	Corrective Time Frame	Date Repaired	
Cleanwater Diversion Pipe	Acceptable				
Compost Filter Sock	Acceptable				
Equipment Bridge	Acceptable				
Rock Construction Entrance	Acceptable				
Sensitive Resource Buffer	Acceptable				
Silt Fence (Filter Fabric Fence)	Acceptable				
Silt Fence (Reinforced Filter Fabric Fence)	Acceptable				
Vegetative Stabilization (Temporary)	Communication	Waterbar channel is eroded. Area n			
Waterbar	Acceptable

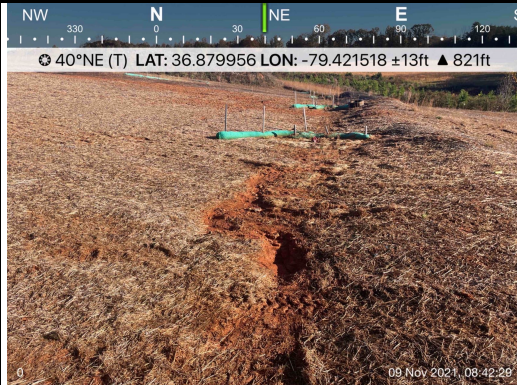
Insert image here			
GPS Location	See photo		GPS Location		
Field Station#	15694+00		Field Station#		
Pic 11 Desc.	Waterbar channel needs to be regraded and stabilized.		Pic 12 Desc.

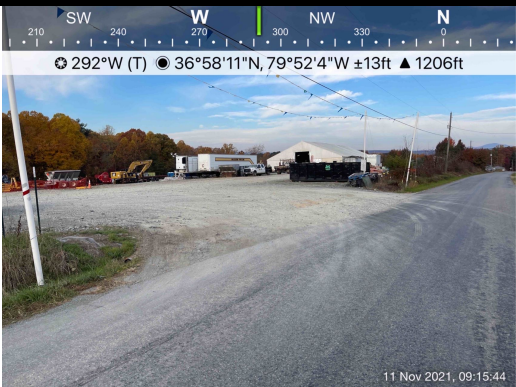
GPS Location	See pic		GPS Location	See pic	
Field Station#	0000+00		Field Station#	0000+00	
Pic 3 Desc.	RCE at LY-045 in good condition.		Pic 4 Desc.	Secondary containment structure liner at wash station deteriorated needs replaced.

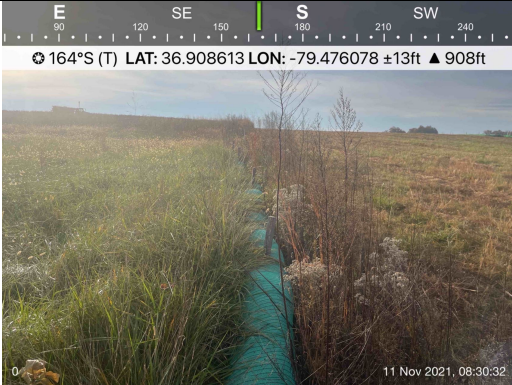
GPS Location	See photo	GPS Location	See photo		
Field Station#	154800+00	Field Station#	15480+00		
Pic 1 Desc.	Perimeter CFS is degraded/damaged and needs to be replaced.	Pic 2 Desc.	Perimeter CFS is degraded/damaged and needs to be replaced.

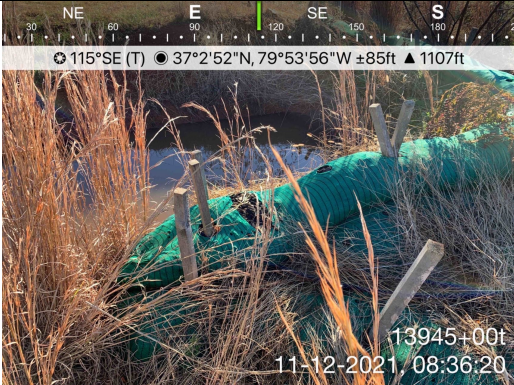
GPS Location	0	GPS Location	0		
Field Station#	13945+00	Field Station#	13945+00		
Pic 1 Desc.	CFS has a hole in it, contractor repaired immediately		Pic 2 Desc.	CFS after hole was repaired

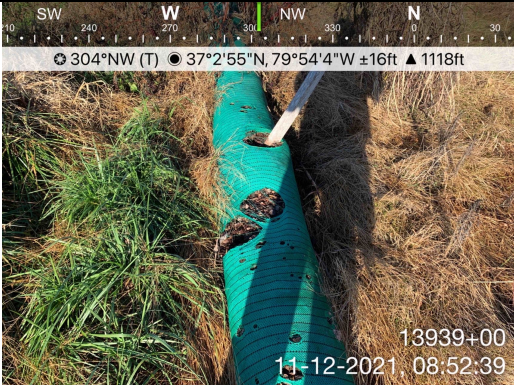
GPS Location	0	GPS Location	0		
Field Station#	13939+00	Field Station#	13939+00		
Pic 3 Desc.	Perimeter CFS with multiple holes in it from 13939+00 to 13943+00, contractor repaired immediately		Pic 4 Desc.	Perimeter CFS after holes were repaired from 13939+00 to 13943+00

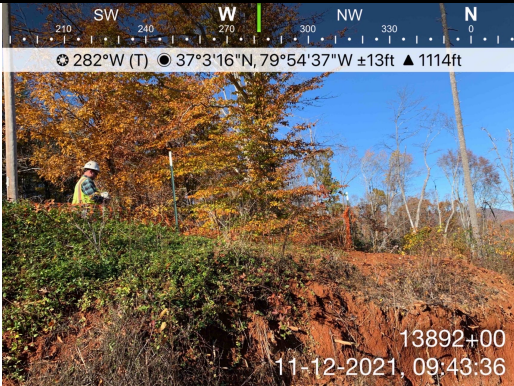
GPS Location	0	GPS Location	0		
Field Station#	13892+00	Field Station#	13892+00		
Pic 5 Desc.	Safety fence requiring maintenance, contractor maintained immediately		Pic 6 Desc.	Safety fence after maintenance

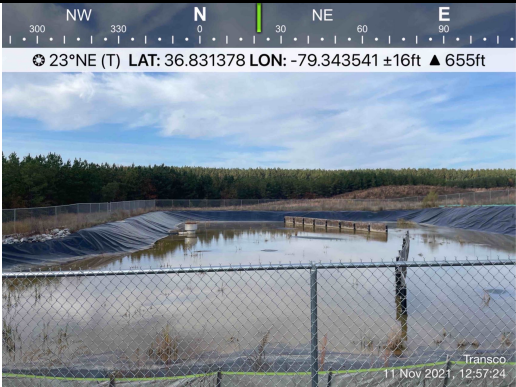
GPS Location	See photo		GPS Location	See photo	
Field Station#	00+00		Field Station#	00+00	
Pic 1 Desc.	Sediment basin is in good condition and functioning.		Pic 2 Desc.	Sediment basin outlet is in good condition and functioning.
