Visual Site Inspection Report

Project Name	H-600 Pipeline Spread I	AFE	124300139	Spread	H-600 Pipeline Spread I
Contractor	Precision			Report #	28659
Inspector	Ben Davenport			Date/Time	9/20/2021 8:20 AM
Permit #	TBD	Inspection Type	VA SWPP	Station Begin	14802+19
State	VA	Inspection Area	Partial	Station End	14928+52
County	Franklin	Ground	Damp	Temperature (°F)	75.00
Municipality	N/A	Weather	Cloudy	Rain Gauge (in)	0.00
				Rain Accumulation Time (days)	0.00

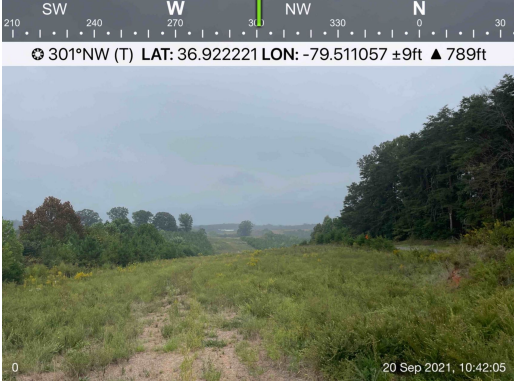
GPS Location	See photo		GPS Location	See photo	
Field Station#	15370+00		Field Station#	15350+00	
Pic 1 Desc.	Vegetation continues to fill in throughout this section.		Pic 2 Desc.	MVP-PI-332 remains in good condition with controls in place.

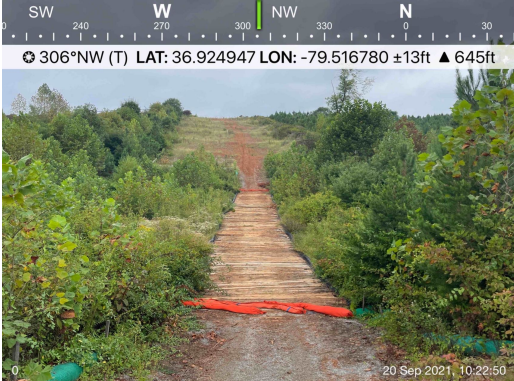
GPS Location	See photo		GPS Location	See photo	
Field Station#	15346+80		Field Station#	15345+00	
Pic 3 Desc.	Equipment bridge ECDs are in good condition and functioning.		Pic 4 Desc.	Waterbars are in good condition throughout this section.

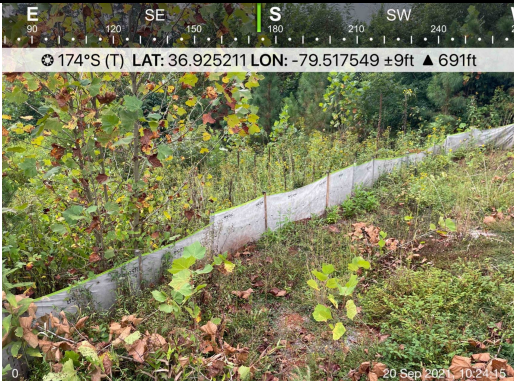
GPS Location	See photo		GPS Location	See photo	
Field Station#	15346+00		Field Station#	15338+00	
Pic 5 Desc.	P1 is in good condition at all stream and wetland crossings.		Pic 6 Desc.	CWD is functioning as intended.

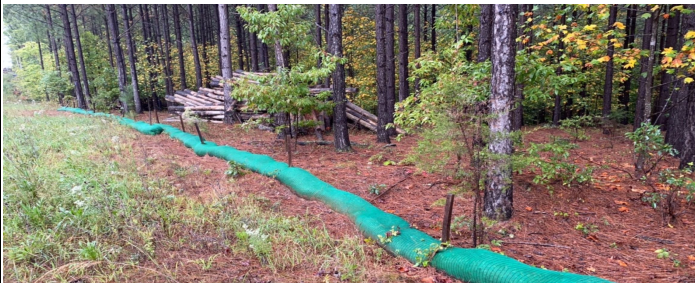
Pic 3 Desc.	Perimeter CFS in good condition		Pic 4 Desc.	Plunge pool performing intended function

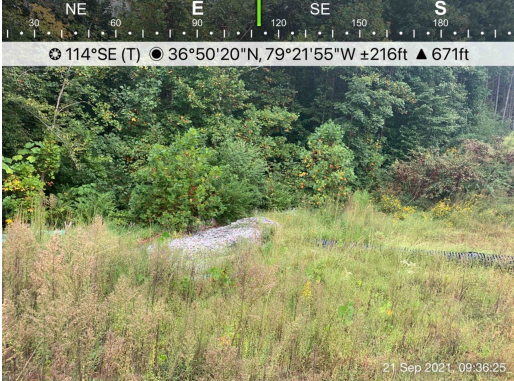
GPS Location	O	GPS Location	O		
Field Station#	15934+00	Field Station#	15860+00		
Pic 1 Desc.	Observing temporary stabilization,CWD outlet and ECD's	Pic 2 Desc.	Observing temporary stabilization,CWD outlet and ECD's

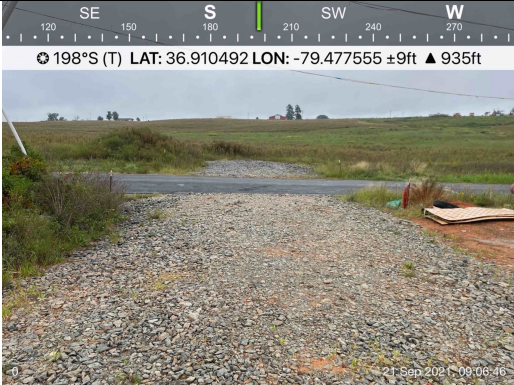
GPS Location	See photo		GPS Location	See photo	
Field Station#	15480+67		Field Station#	15475+00	
Pic 1 Desc.	RCEs are in good condition at all road crossings.		Pic 2 Desc.	3rd party rock outlet appears to be in good condition along this drainage.

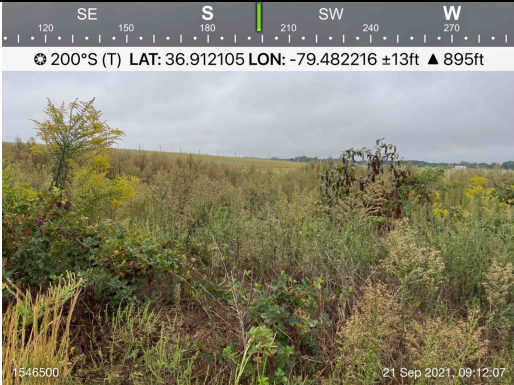
GPS Location	See photo		GPS Location	See photo	
Field Station#	15465+00		Field Station#	15460+81	
Pic 3 Desc.	No evidence of sedimentation from 3rd party disturbance		Pic 4 Desc.	No evidence of sedimentation into CWD inlet.

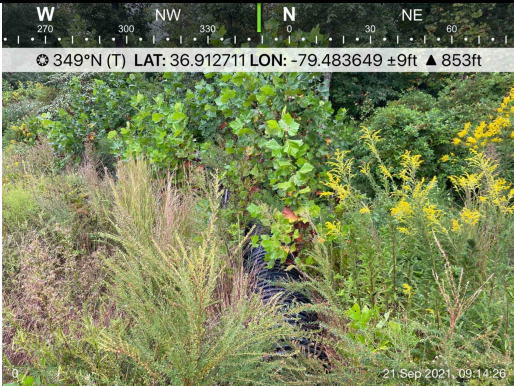
GPS Location	See photo		GPS Location	See photo	
Field Station#	15460+81		Field Station#	15457+00	
Pic 5 Desc.	CWD remains in good condition.		Pic 6 Desc.	No evidence of sedimentation within drainage.

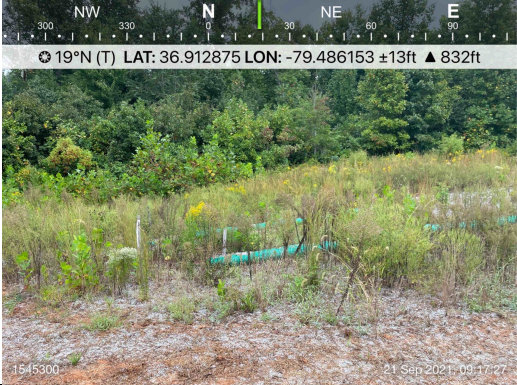
GPS Location	See photo		GPS Location	See photo	
Field Station#	15453+00		Field Station#	15440+00	
Pic 7 Desc.	CWD remains in good condition.		Pic 8 Desc.	Vegetation continues to fill in throughout this section.

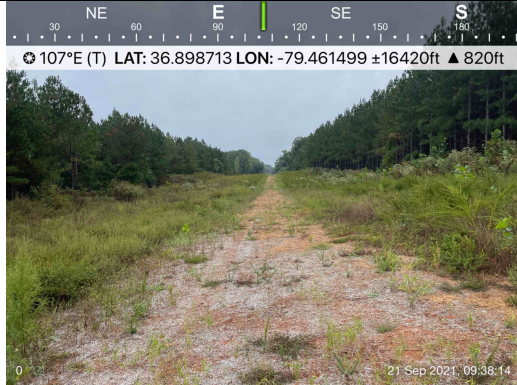
GPS Location	See photo		GPS Location	See photo	
Field Station#	15400+00		Field Station#	15385+00	
Pic 11 Desc.	Vegetation continues to fill in throughout this section.		Pic 12 Desc.	CFS is in good condition throughout this section.

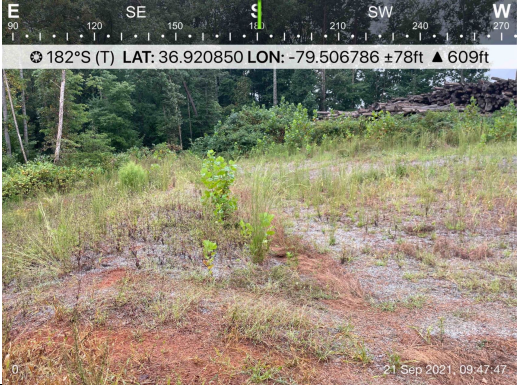
GPS Location	See photo	GPS Location	See photo		
Field Station#	15380+00	Field Station#	15375+00		
Pic 13 Desc.	Waterbars are functioning as intended.	Pic 14 Desc.	Drainage ECDs are in place and functioning.		
Insert image here		Insert image here			
GPS Location		GPS Location			
Field Station#		Field Station#			
Pic 15 Desc.		Pic 16 Desc.			
Insert image here		Insert image here			
GPS Location		GPS Location			
Field Station#		Field Station#			
Pic 17 Desc.		Pic 18 Desc.

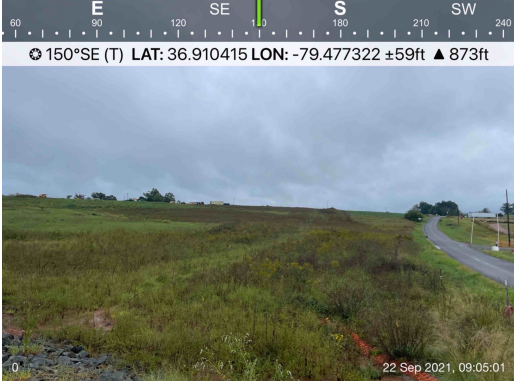
GPS Location	See photo		GPS Location	See photo	
Field Station#	15481+00		Field Station#	15496+70	
Pic 1 Desc.	Vegetation continues to fill in throughout this section.		Pic 2 Desc.	RCEs are in good condition at all road crossings.

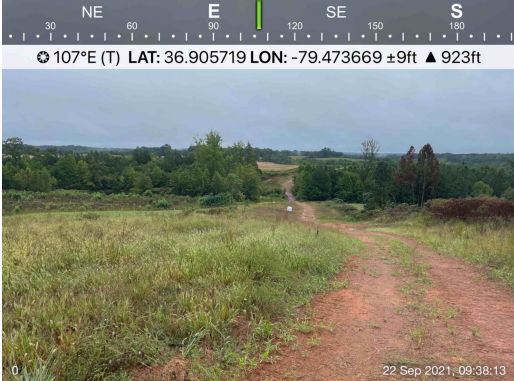
GPS Location	See photo		GPS Location	See photo	
Field Station#	15505+00		Field Station#	15505+00	
Pic 3 Desc.	Vegetation continues to fill in throughout this area.		Pic 4 Desc.	No evidence of sedimentation from 3rd party disturbance.

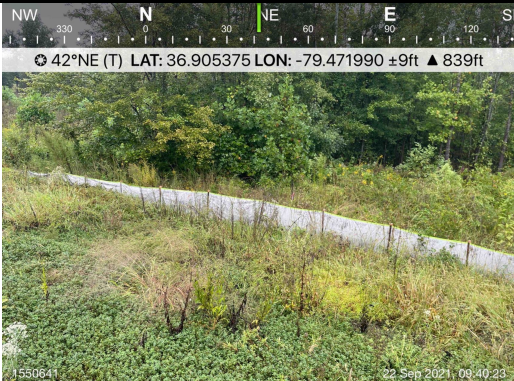
GPS Location	See photo		GPS Location	See photo	
Field Station#	15506+41		Field Station#	15510+00	
Pic 5 Desc.	P1 is in good condition at all stream and wetland buffers.		Pic 6 Desc.	3rd party ECDs appear to be in good condition.

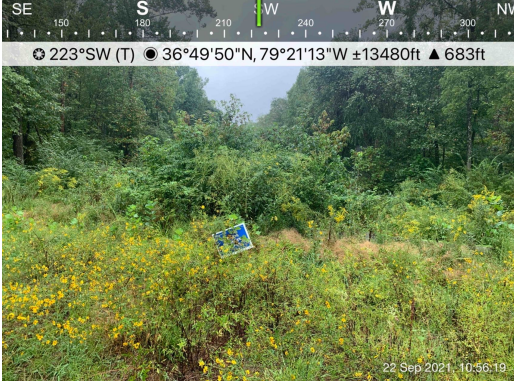
GPS Location	O	GPS Location	O		
Field Station#	16004+00	Field Station#	16010+00		
Pic 1 Desc.	Observing temporary stabilization, signage and buffer	Pic 2 Desc.	Observing temporary stabilization, CWD outlet and ECD's

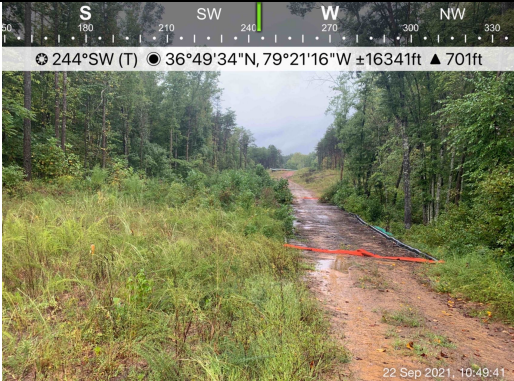
GPS Location	O	GPS Location	O		
Field Station#	16016+36	Field Station#	15970+00		
Pic 3 Desc.	Observing temporary stabilization, buffer, equipment crossing and ECD's	Pic 4 Desc.	Observing fence gap that requires maintenance (damaged by livestock)

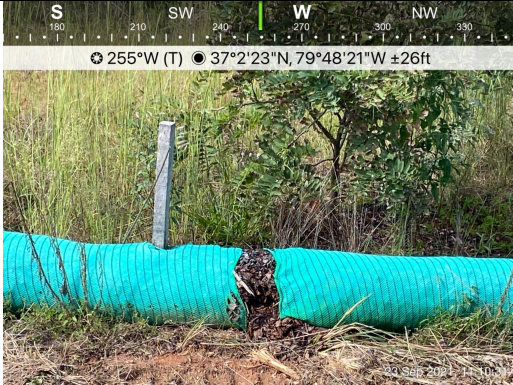
GPS Location	0	GPS Location	0		
Field Station#	14320+00	Field Station#	14330+00		
Pic 1 Desc.	Approximately 14320+00. Overview of ROW.	Pic 2 Desc.	Approximately 14330+00. CFS requires maintenance.

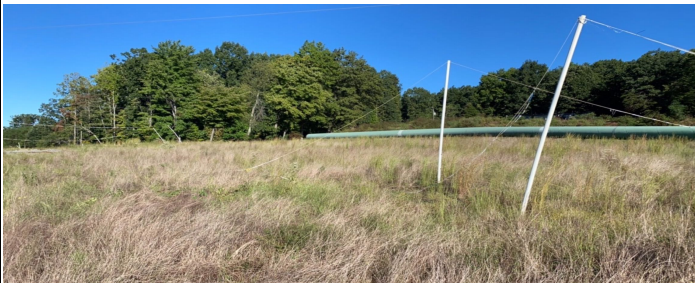
GPS Location	3	GPS Location	4		
Field Station#	14713+00	Field Station#	14717+00		
Pic 3 Desc.	ROW stabilized and vegetated in extra workspace.		Pic 4 Desc.	Erosion control devices in place and functional.

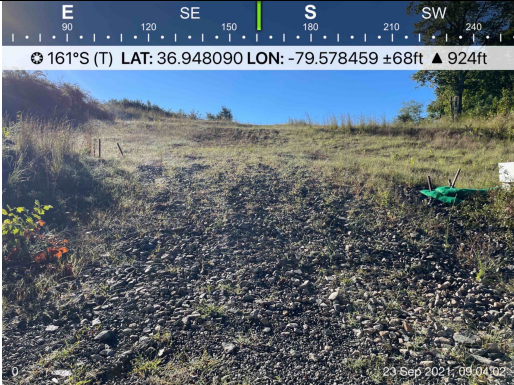
GPS Location	See photo		GPS Location	See photo	
Field Station#	15142+66		Field Station#	15150+00	
Pic 1 Desc.	RCE is in good condition at Rockcreek Rd.		Pic 2 Desc.	Perimeter CFS is in good condition throughout this section.

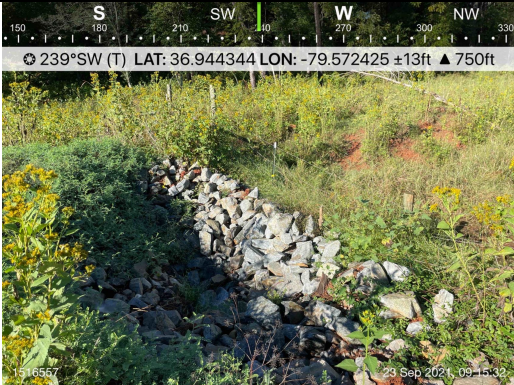
GPS Location	See photo		GPS Location	See photo	
Field Station#	15165+57		Field Station#	15166+00	
Pic 3 Desc.	Rock filter remains in good condition.		Pic 4 Desc.	Rock outlet remains in good condition.

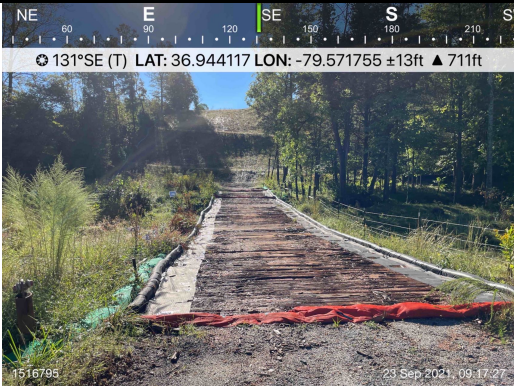
GPS Location	See photo		GPS Location	See photo	
Field Station#	15167+95		Field Station#	15169+55	
Pic 5 Desc.	Equipment bridge ECDs are in place and functioning.		Pic 6 Desc.	P1 is in good condition at stream buffer.

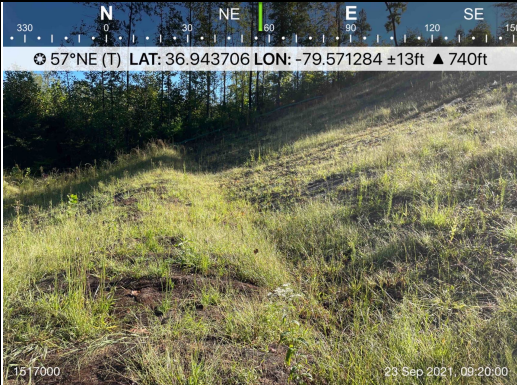
GPS Location	See photo		GPS Location	See photo	
Field Station#	15170+00		Field Station#	15170+00	
Pic 7 Desc.	Waterbars are functioning as intended.		Pic 8 Desc.	Slope drain is in good condition and functioning.

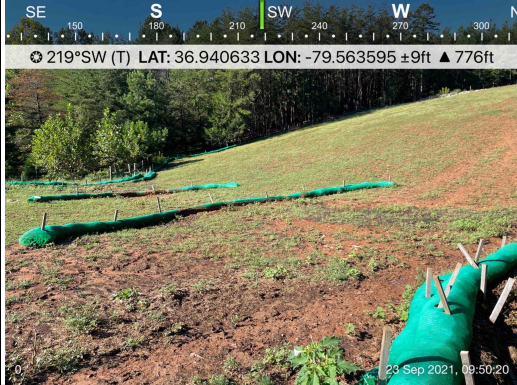
GPS Location	See photo		GPS Location	See photo	
Field Station#	15195+00		Field Station#	15209+00	
Pic 9 Desc.	Drainage ECDs are in good condition.		Pic 10 Desc.	Vegetation continues to fill in throughout this section.

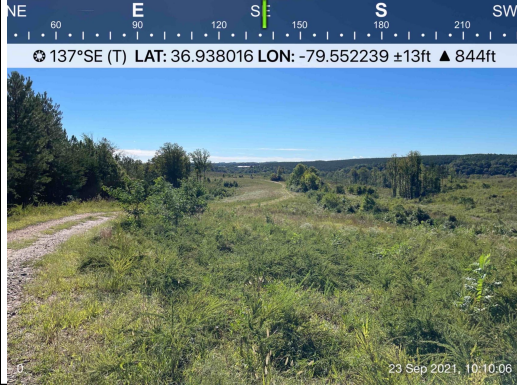
Insert image here			
GPS Location	See photo		GPS Location		
Field Station#	15230+00		Field Station#		
Pic 11 Desc.	Vegetation continues to fill in throughout this section.		Pic 12 Desc.

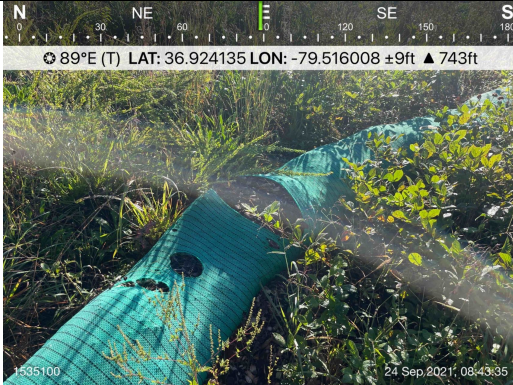
GPS Location	See photo		GPS Location	See photo	
Field Station#	15370+00		Field Station#	15351+00	
Pic 1 Desc.	Vegetation continues to fill in throughout this section.		Pic 2 Desc.	CFS has been damaged and needs to be repaired.

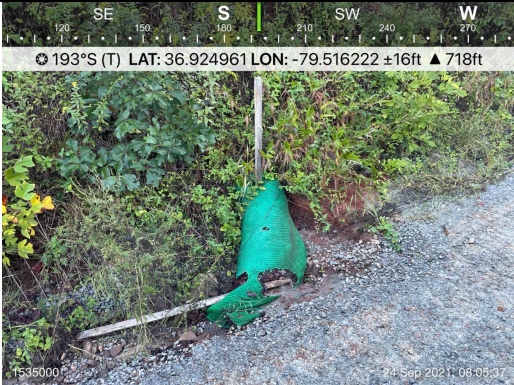
GPS Location	See photo		GPS Location	See photo	
Field Station#	15350+00		Field Station#	15346+50	
Pic 3 Desc.	CFS check dam has been damaged along MVP-PI-332 and needs to be replaced.		Pic 4 Desc.	Equipment bridge ECDs are in place and functioning.

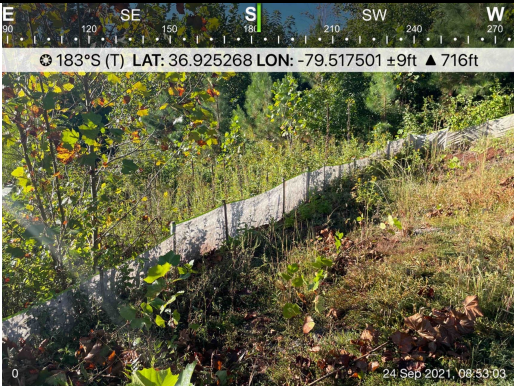
GPS Location	See photo		GPS Location	See photo	
Field Station#	15346+00		Field Station#	15383+00	
Pic 5 Desc.	P1 is in good condition at all stream and wetland buffers		Pic 6 Desc.	CWD is functioning as intended.

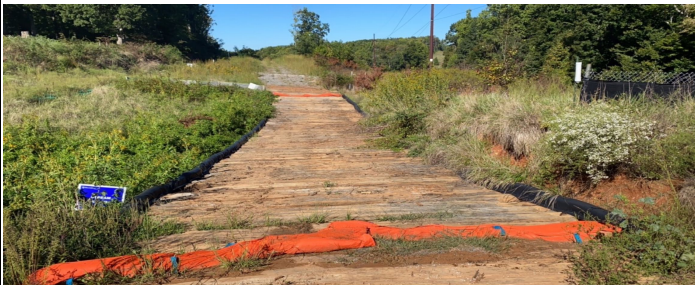
GPS Location	3	GPS Location	4		
Field Station#	14832+61	Field Station#	14851+50		
Pic 3 Desc.	Equipment bridge and surrounding ECDs in place and functional at stream crossing and resource buffer		Pic 4 Desc.	Perimeter P1 silt fence in good condition
