Visual Site Inspection Report

Project Name	H-600 Pipeline Spread I	AFE	124300139	Spread	H-600 Pipeline Spread I
Contractor	Precision			Report #	29015
Inspector	Ben Farmer			Date/Time	9/27/2021 2:31 PM
Permit #	TBD	Inspection Type	VA SWPP	Station Begin	15370+62
State	VA	Inspection Area	Partial	Station End	15480+67
County	Pittsylvania	Ground	Dry	Temperature (°F)	60.00
Municipality	Chatham	Weather	Sunny	Rain Gauge (in)	0.00
				Rain Accumulation Time (days)	0.00

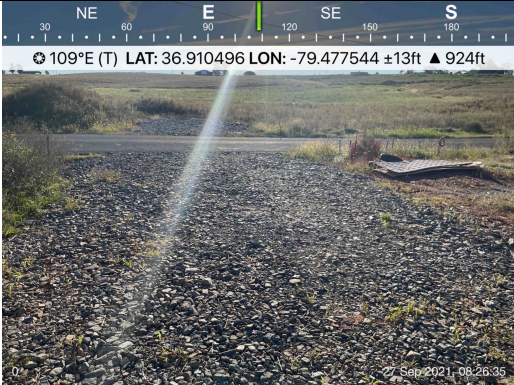
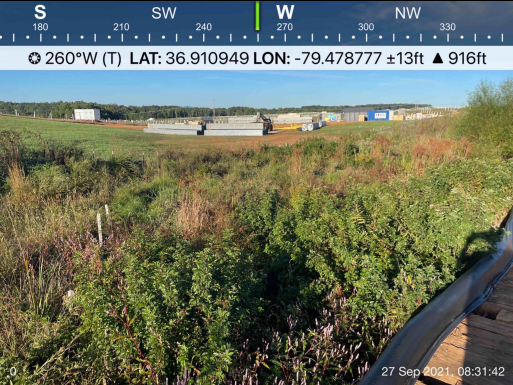
GPS Location	See photo		GPS Location	See photo	
Field Station#	15480+67		Field Station#	15475+00	
Pic 1 Desc.	RCEs are in good condition at all road crossings.		Pic 2 Desc.	3rd party rock outlet is in good condition along this drainage feature

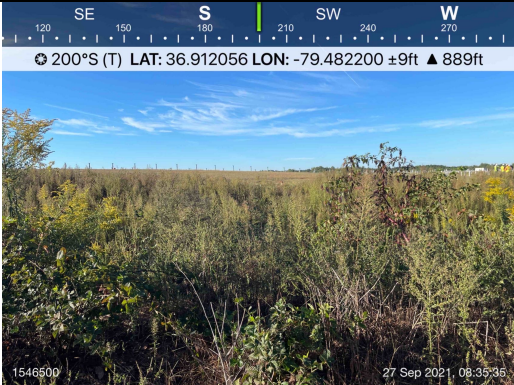
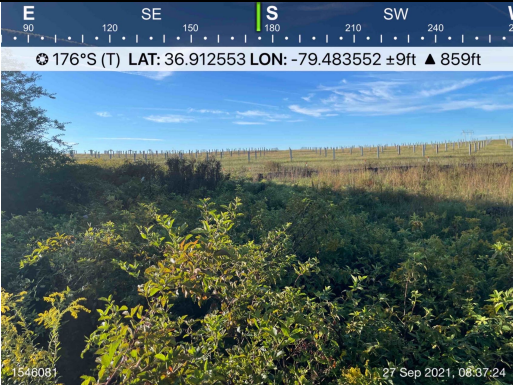
GPS Location	See photo		GPS Location	See photo	
Field Station#	15465+00		Field Station#	15460+81	
Pic 3 Desc.	No evidence of sedimentation from 3rd party disturbance.		Pic 4 Desc.	No evidence of sedimentation from 3rd party disturbance into CWD inlet.

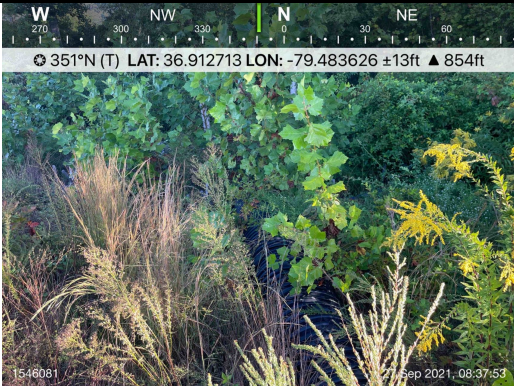
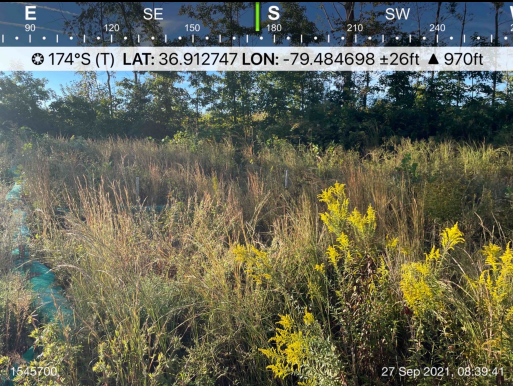
GPS Location	See photo		GPS Location	See photo	
Field Station#	15460+81		Field Station#	15457+00	
Pic 5 Desc.	CWD remains in good condition.		Pic 6 Desc.	No evidence of sedimentation within drainage from 3rd party disturbance.

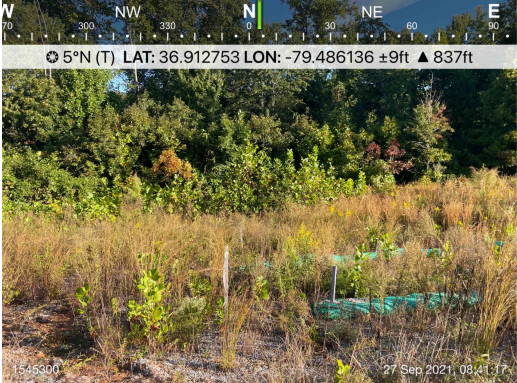
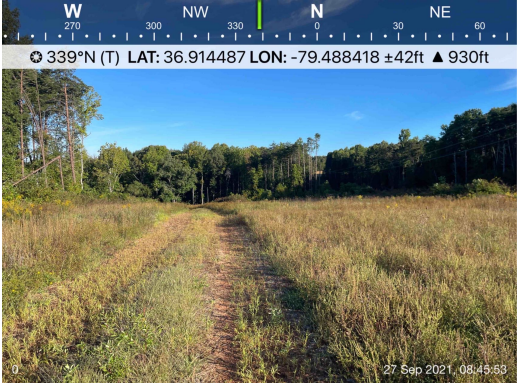
GPS Location	See photo		GPS Location	See photo	
Field Station#	15453+00		Field Station#	15440+00	
Pic 7 Desc.	CWD remains in good condition.		Pic 8 Desc.	Vegetation continues to fill in throughout this section.

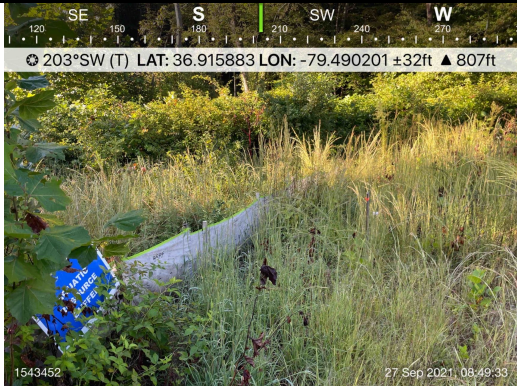
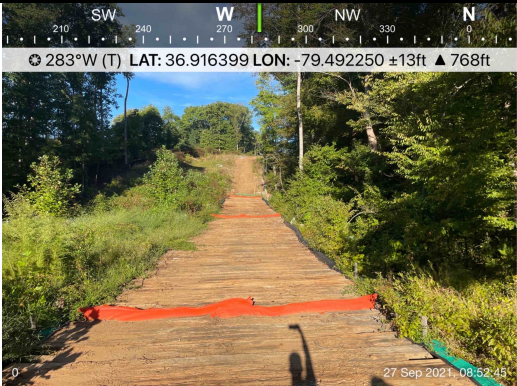
GPS Location	See photo		GPS Location	See photo	
Field Station#	15434+52		Field Station#	15426+70	
Pic 9 Desc.	P1 is in good condition at all stream and wetland buffers.		Pic 10 Desc.	Equipment bridge ECDs are functioning as intended.

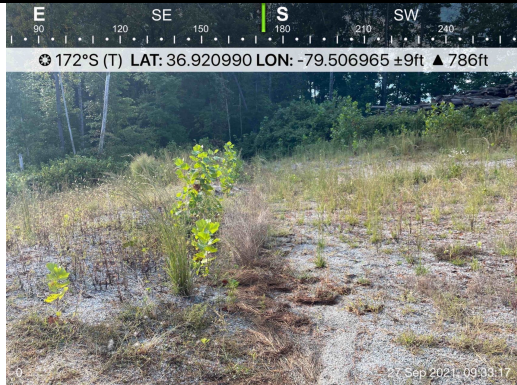
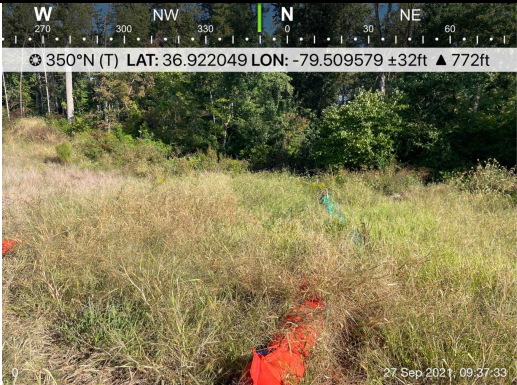
GPS Location	See photo		GPS Location	See photo	
Field Station#	15380+00		Field Station#	15375+00	
Pic 11 Desc.	Waterbars are functioning as intended.		Pic 12 Desc.	Drainage feature ECDs are in place and functioning.

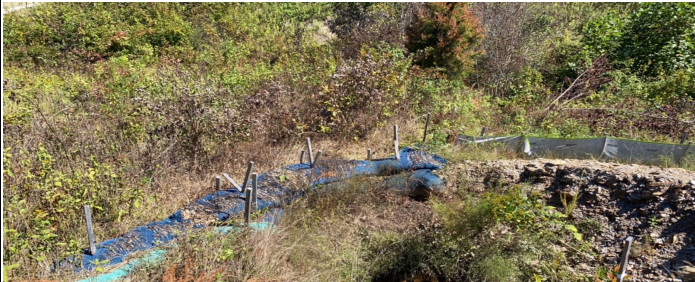
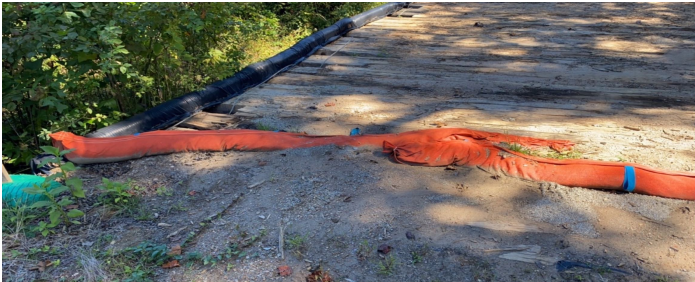
36°58'4" N 79°38'13" W 126°SE COURSE 86° GPS 2082 Ramsey Memorial Rd, Penhook, VA 24137, United States 09.27.2021 12:53:42 Accur +/-130.2 Ft ALT 864 Ft			36°58'3" N 79°38'12" W 108°E COURSE 86° GPS 2082 Ramsey Memorial Rd, Penhook, VA 24137, United States 09.27.2021 12:54:32 Accur +/-343.9 Ft ALT 864 Ft		
GPS Location	1		GPS Location	2	
Field Station#	14931+75		Field Station#	14932+89	
Pic 1 Desc.	Routine maintenance. CFS end treatment beyond effective lifespan.		Pic 2 Desc.	Routine maintenance. Sediment accumulation on bridge wattles at stream crossing. Repair and stabilize.

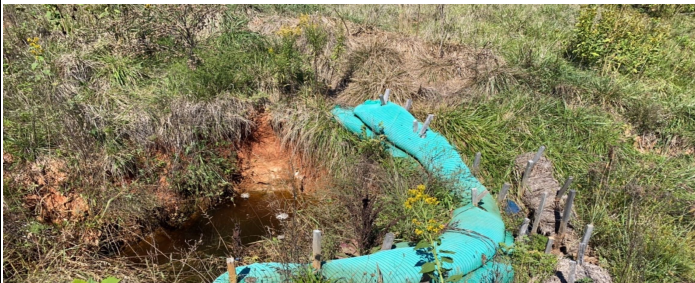
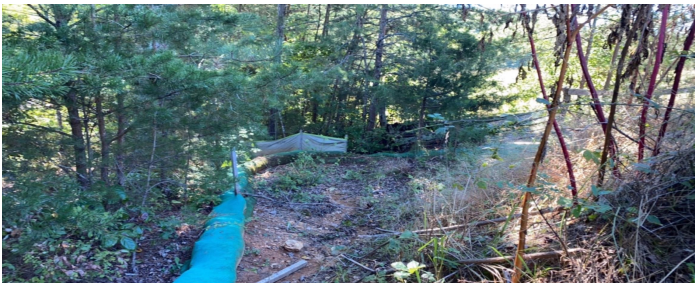
GPS Location	3		GPS Location	4	
Field Station#	14929+00		Field Station#	14941+19	
Pic 3 Desc.	Sump pit and CFS end treatment in place and functional		Pic 4 Desc.	Perimeter CFS and P1 silt fence in good condition

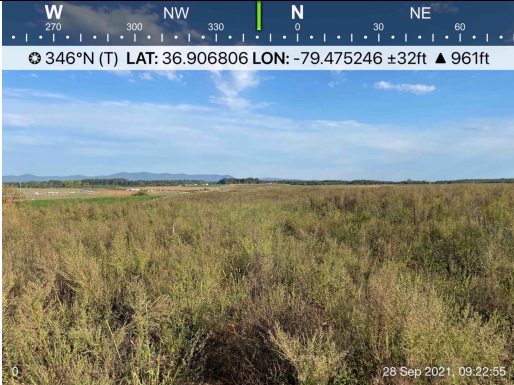
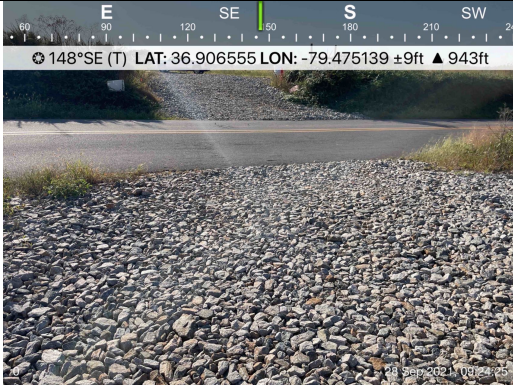
GPS Location	See photo		GPS Location	See photo	
Field Station#	15495+00		Field Station#	15496+70	
Pic 1 Desc.	Vegetation continues to fill in throughout this section.		Pic 2 Desc.	RCEs are in good condition at all road crossings.

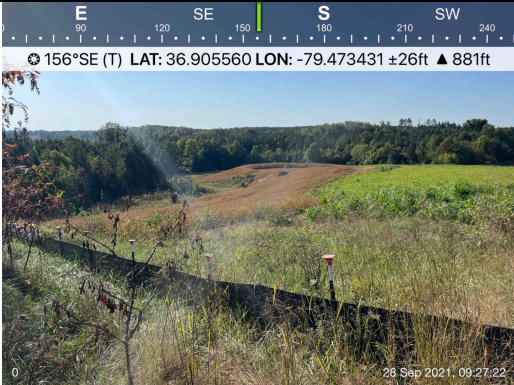
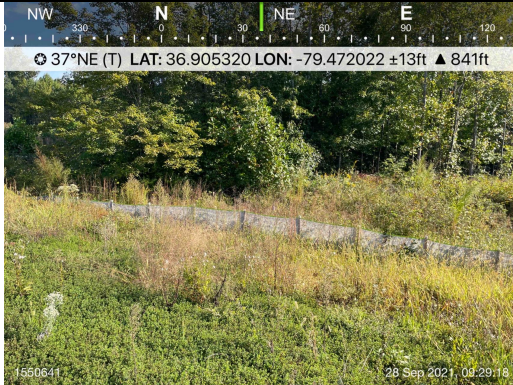
GPS Location	See photo		GPS Location	See photo	
Field Station#	15505+00		Field Station#	15506+41	
Pic 3 Desc.	3rd party ECDs appear to be in good condition.		Pic 4 Desc.	P1 is in good condition at all stream and wetland buffers.

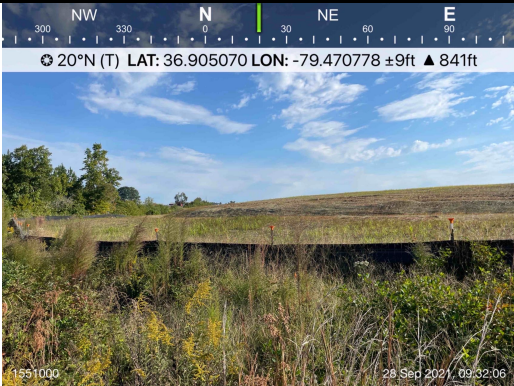
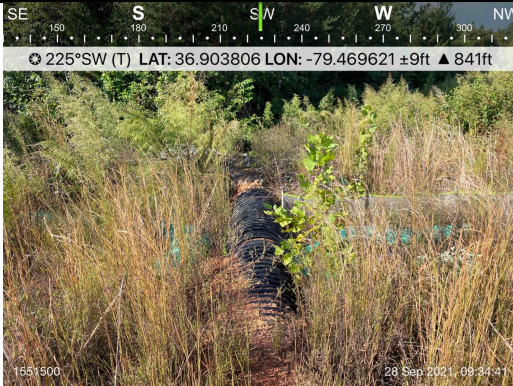
GPS Location	See photo		GPS Location	See photo	
Field Station#	15510+00		Field Station#	15515+00	
Pic 5 Desc.	3rd party ECDs appear to be in good condition.		Pic 6 Desc.	CWDs are in good condition and functioning.

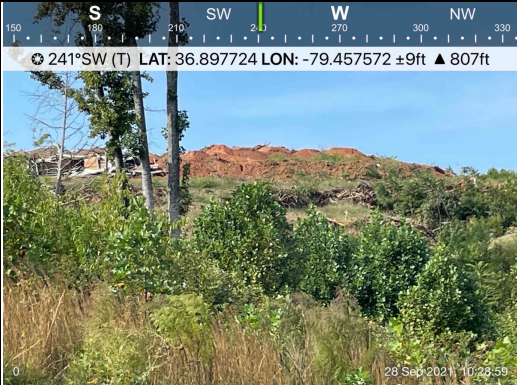
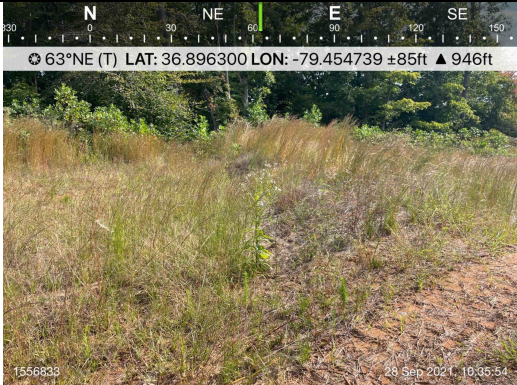
GPS Location	See photo		GPS Location	See photo	
Field Station#	15556+00		Field Station#	15568+33	
Pic 7 Desc.	No evidence of sedimentation from 3rd party disturbance.		Pic 8 Desc.	Waterbars are functioning as intended.

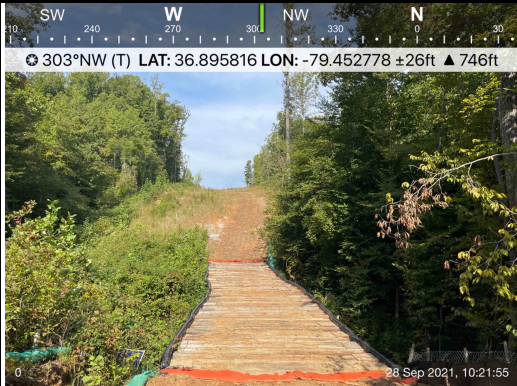
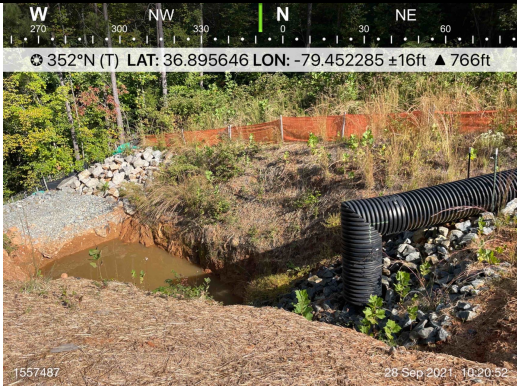
GPS Location	See photo		GPS Location	See photo	
Field Station#	15573+54		Field Station#	15574+87	
Pic 9 Desc.	Equipment bridge ECDs are in place and functioning.		Pic 10 Desc.	Slope drain is in good condition and functioning.

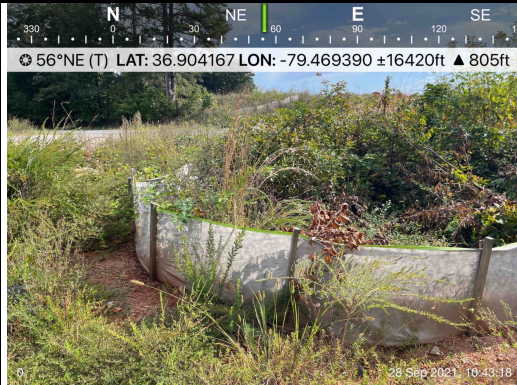
Insert image here			
GPS Location	See photo		GPS Location		
Field Station#	15584+23		Field Station#		
Pic 11 Desc.	P1 is in good condition at road pipe outlet.		Pic 12 Desc.

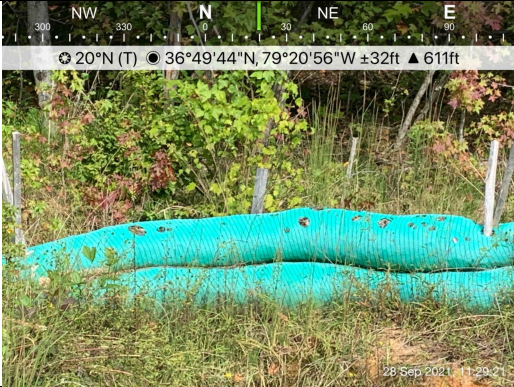
GPS Location	O	GPS Location	O		
Field Station#	16006+00	Field Station#	16004+50		
Pic 1 Desc.	CFS requires maintenance	Pic 2 Desc.	Observing temporary stabilization, signage and buffer

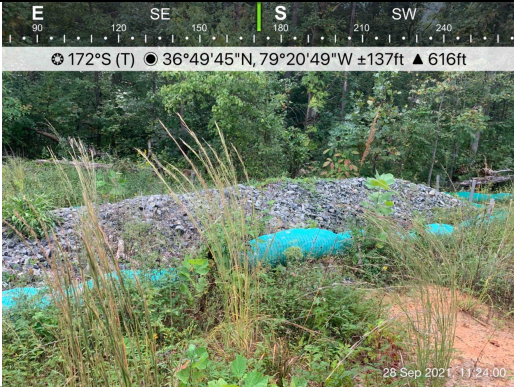
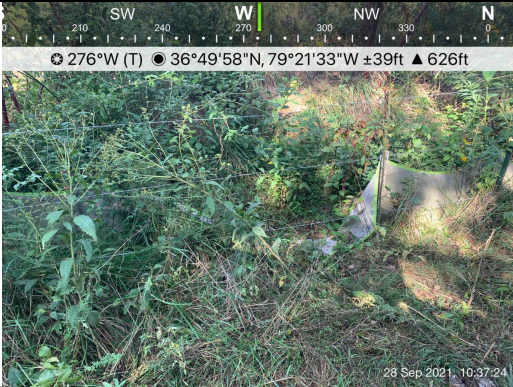
GPS Location	O	GPS Location	O		
Field Station#	16010+00	Field Station#	15964+53		
Pic 3 Desc.	Observing temporary stabilization,CWD outlet and ECD's	Pic 4 Desc.	Observing P1 that requires maintenance (damaged by livestock)

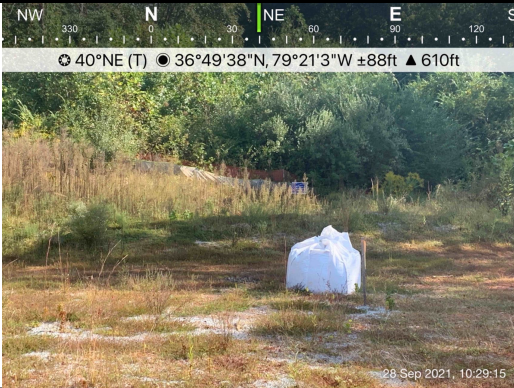
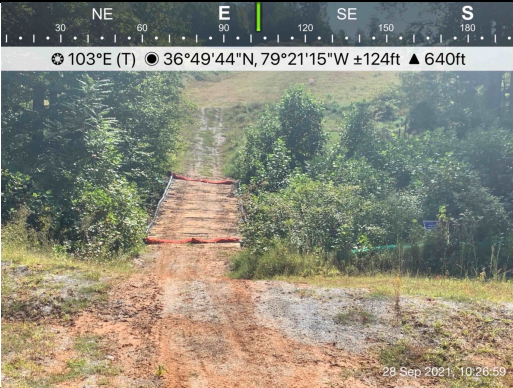
GPS Location	O	GPS Location	O		
Field Station#	15999+80	Field Station#	15987+31		
Pic 5 Desc.	Observing temporary stabilization, signage and buffer	Pic 6 Desc.	Observing temporary stabilization,water bar, signage, buffer, equipment crossing and ECD's

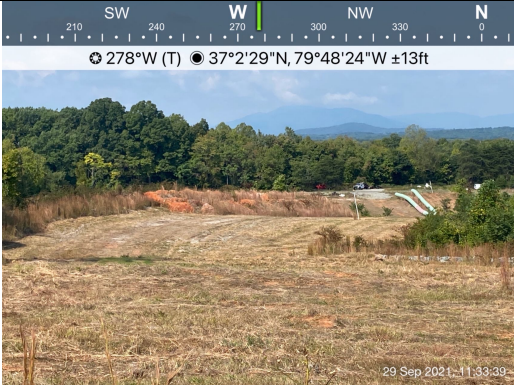
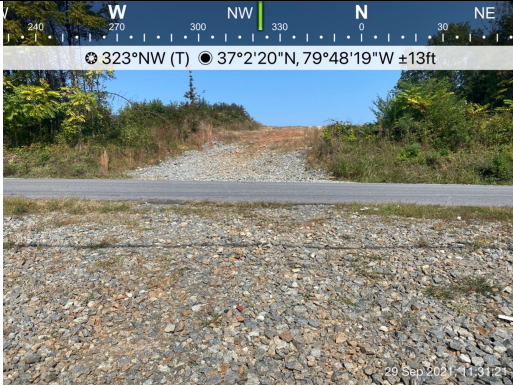
GPS Location	0	GPS Location	0		
Field Station#	14320+00	Field Station#	14333+00		
Pic 1 Desc.	Approximately 14320+00. Overview of ROW.	Pic 2 Desc.	Approximately 14333+00. Overview of road crossing and RCEs.

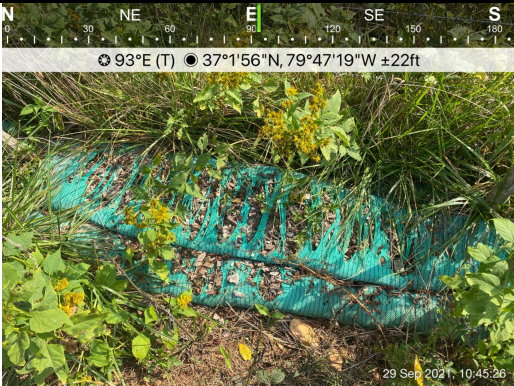
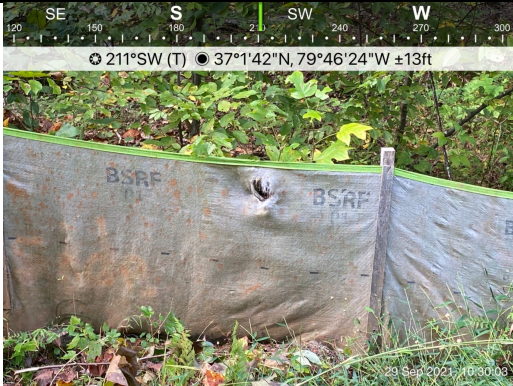
GPS Location	0	GPS Location	0		
Field Station#	14389+50	Field Station#	14437+50		
Pic 5 Desc.	Approximately 14389+50. CFS weathered and torn. Replace CFS.	Pic 6 Desc.	Approximately 14437+50. P-1 requires maintenance. Replace damaged panels.

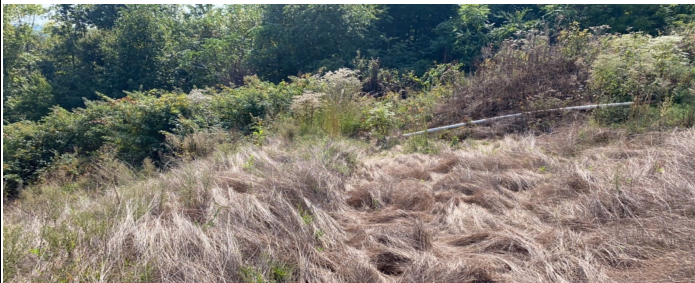
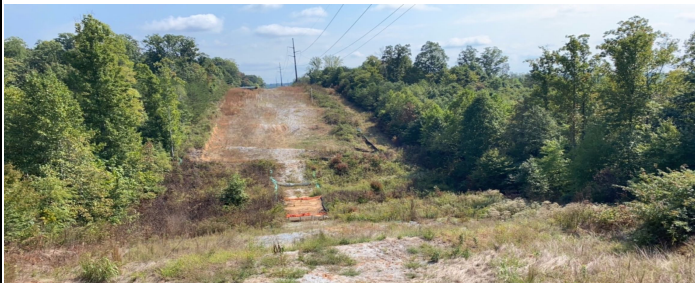
Pic 3 Desc.	Water bar in temporary area in place and functional		Pic 4 Desc.	Equipment bridge and surrounding ECDs in place and functional at stream crossing and resource buffer; ROW stabilized and vegetated in temporary area

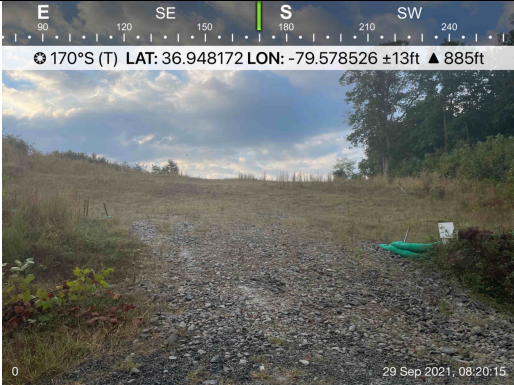
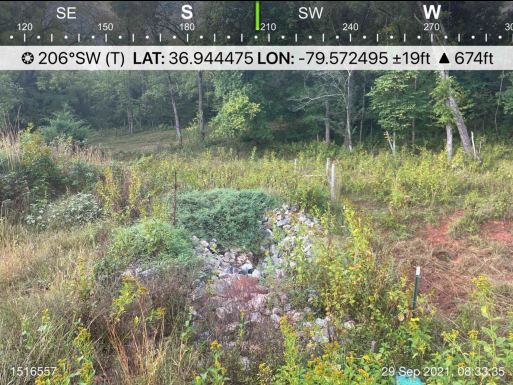
GPS Location	See photo		GPS Location	See photo	
Field Station#	15142+66		Field Station#	15165+57	
Pic 1 Desc.	RCEs are in good condition at all road crossings.		Pic 2 Desc.	Rock filter remains in good condition.

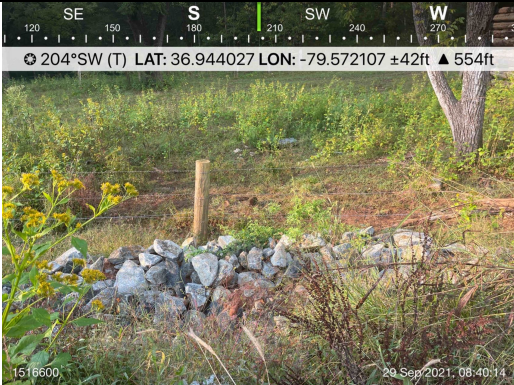
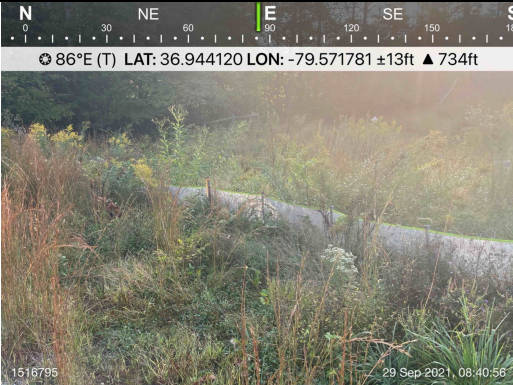
GPS Location	See photo		GPS Location	See photo	
Field Station#	15166+00		Field Station#	15167+95	
Pic 3 Desc.	Rock outlet remains in good condition.		Pic 4 Desc.	P1 is in good condition at all stream and wetland buffers.

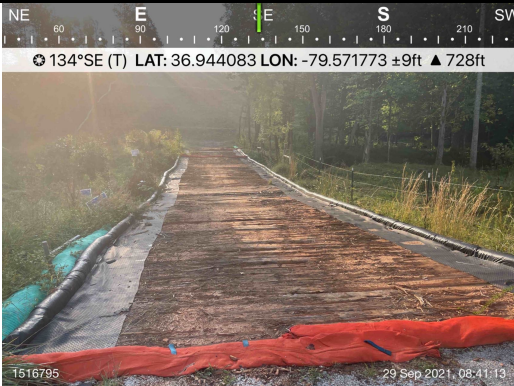
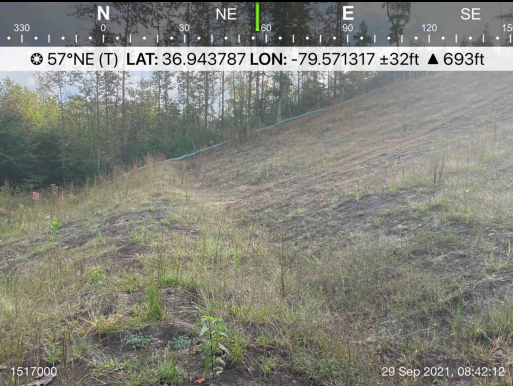
GPS Location	See photo		GPS Location	See photo	
Field Station#	15167+95		Field Station#	15170+00	
Pic 5 Desc.	Equipment bridge ECDs are in good condition and functioning.		Pic 6 Desc.	Waterbars are in good condition throughout this section.

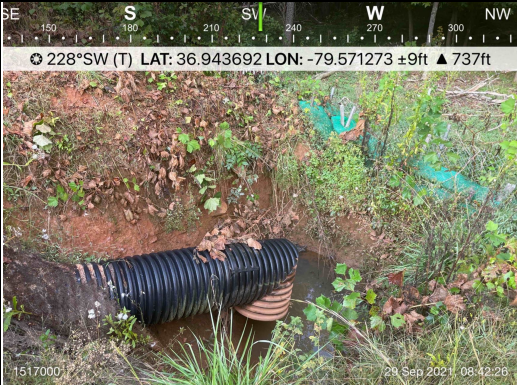
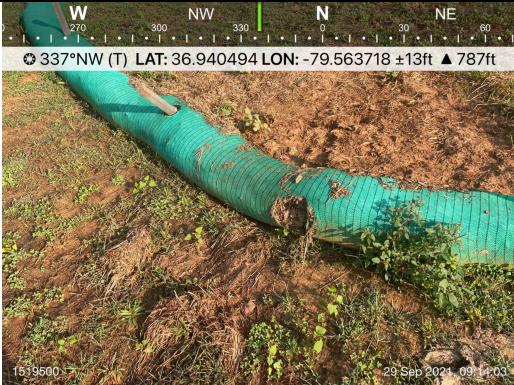
GPS Location	See photo		GPS Location	See photo	
Field Station#	15170+00		Field Station#	15195+00	
Pic 7 Desc.	Slope drain is functioning as intended.		Pic 8 Desc.	CFS has been damaged by livestock and needs to be repaired.

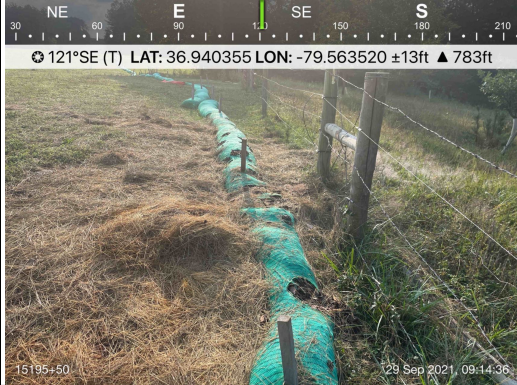
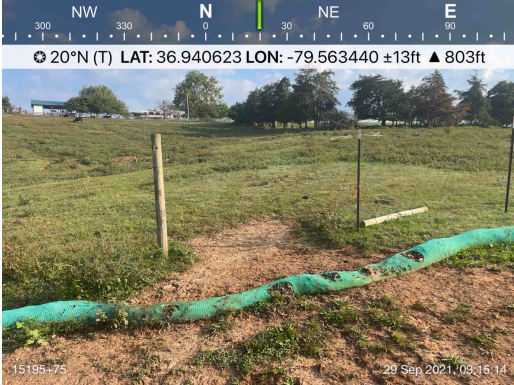
GPS Location	See photo		GPS Location	See photo	
Field Station#	15195+50		Field Station#	15195+75	
Pic 9 Desc.	CFS has been damaged by livestock and needs to be replaced.		Pic 10 Desc.	CFS needs to be replaced with waddles for land owner access.

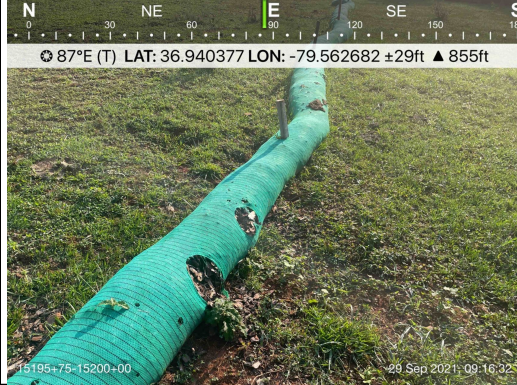
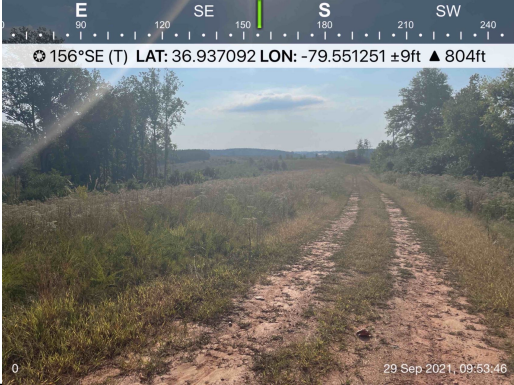
GPS Location	See photo		GPS Location	See photo	
Field Station#	15195+75		Field Station#	151233+00	
Pic 11 Desc.	CFS has been damaged by livestock and needs to be repaired.		Pic 12 Desc.	Vegetation continues to fill in throughout this section.

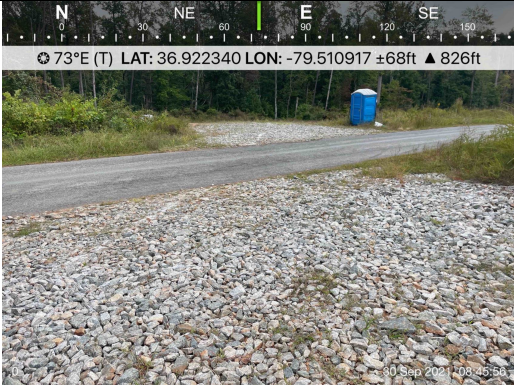
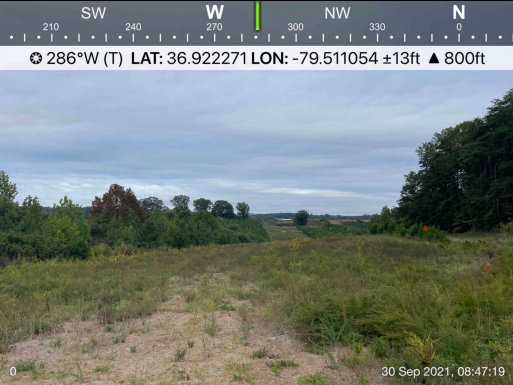
GPS Location	See photo		GPS Location	See photo	
Field Station#	15370+62		Field Station#	15370+00	
Pic 1 Desc.	RCEs are in good condition at all road crossings.		Pic 2 Desc.	Vegetation continues to fill in throughout this section.

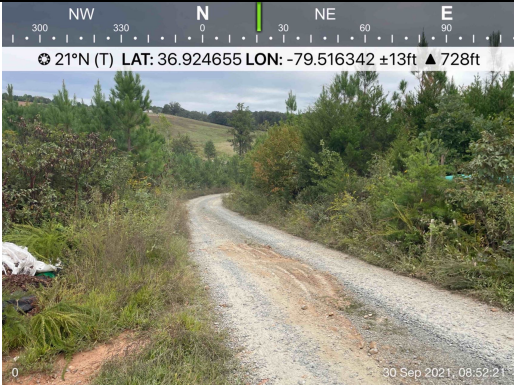
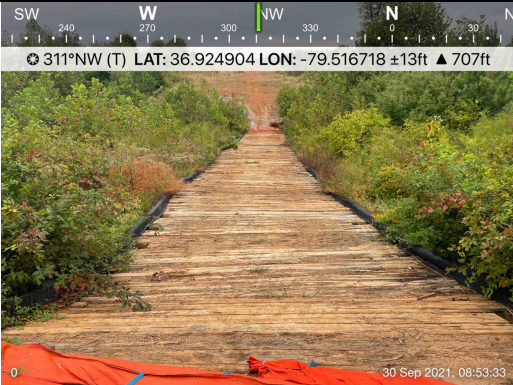
GPS Location	See photo		GPS Location	See photo	
Field Station#	15350+00		Field Station#	15346+70	
Pic 3 Desc.	MVP-PI-332 remains in good condition with controls in place.		Pic 4 Desc.	Equipment bridge ECDs are in place and functioning.

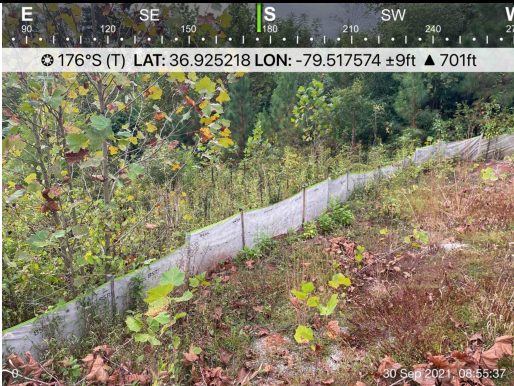
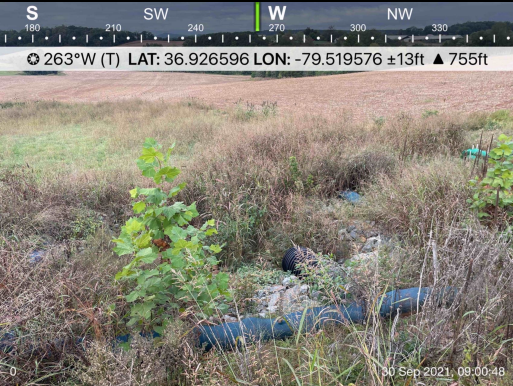
GPS Location	See photo		GPS Location	See photo	
Field Station#	15346+00		Field Station#	15338+00	
Pic 5 Desc.	P1 is in good condition at all stream and wetland buffers.		Pic 6 Desc.	CWD is functioning as intended.

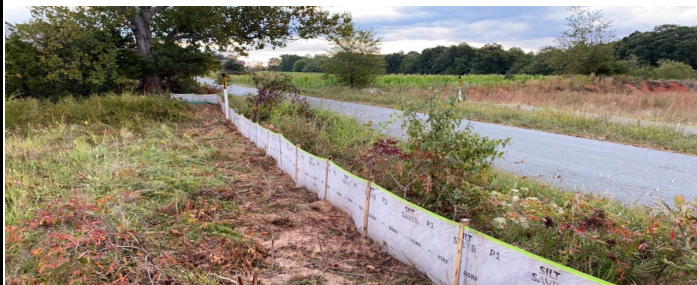
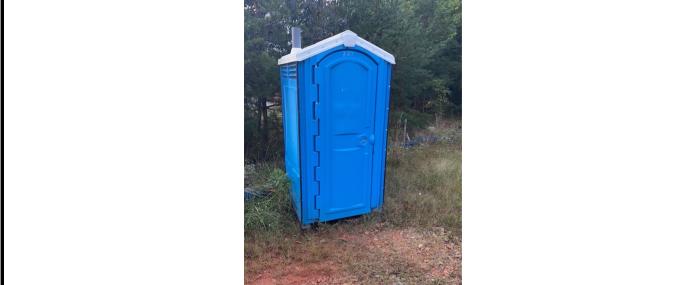
Field Station#	15063+85		Field Station#	14981+55	
Pic 3 Desc.	Contractor replaced damaged P1 silt fence per punch list item		Pic 4 Desc.	Portajon properly contained in secondary containment at road crossing

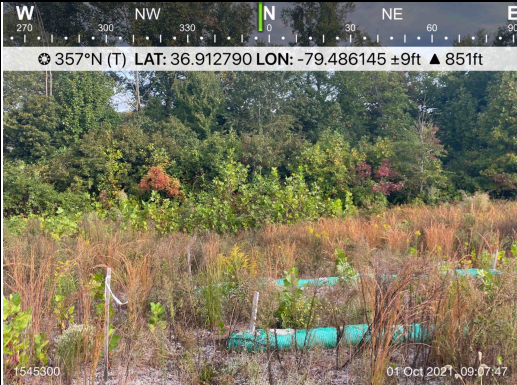
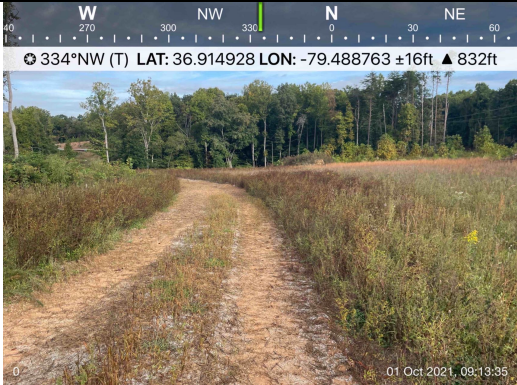
GPS Location	See photo		GPS Location	See photo	
Field Station#	15453+00		Field Station#	15440+00	
Pic 7 Desc.	CWD remains in good condition.		Pic 8 Desc.	Vegetation continues to fill in throughout this section.

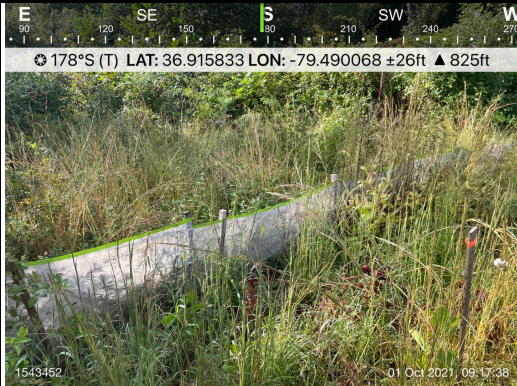
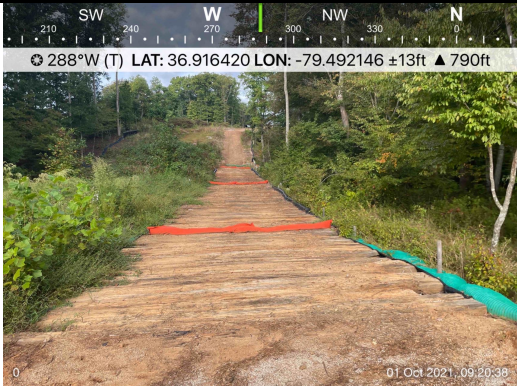
GPS Location	See photo		GPS Location	See photo	
Field Station#	15434+52		Field Station#	15426+70	
Pic 9 Desc.	P1 is in good condition at all stream and wetland crossings.		Pic 10 Desc.	Equipment bridge ECDs are in place and functioning.

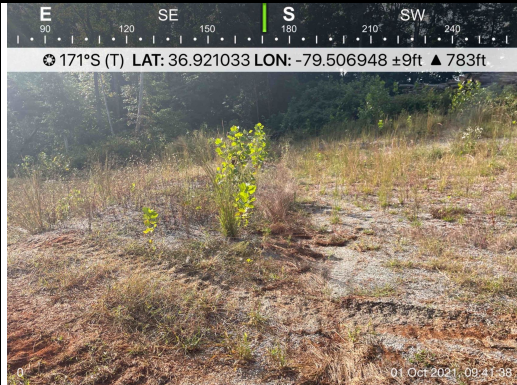
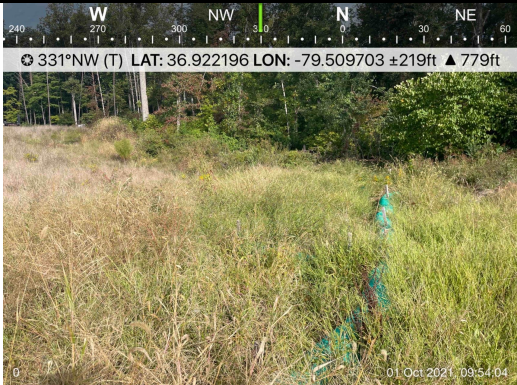
GPS Location	See photo		GPS Location	See photo	
Field Station#	15380+00		Field Station#	15375+00	
Pic 11 Desc.	Waterbars are in good condition throughout this section		Pic 12 Desc.	Drainage feature ECDs are in good condition and functioning.
