Visual Site Inspection Report

Project Name	H-600 Pipeline Spread G	AFE	124300137	Spread	H-600 Pipeline Spread G
Contractor	Precision			Report #	33100
Inspector	David Schoolcraft			Date/Time	1/10/2022 2:26 PM
Permit #	TBD	Inspection Type	VA SWPP	Station Begin	11023+80
State	VA	Inspection Area	Full	Station End	11098+47
County	Giles	Ground	Wet	Temperature (°F)	30.00
Municipality	N/A	Weather	Sunny	Rain Gauge (in)	0.40
				Rain Accumulation Time (days)	1.00

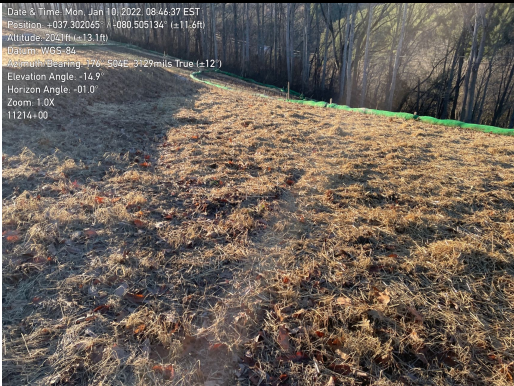
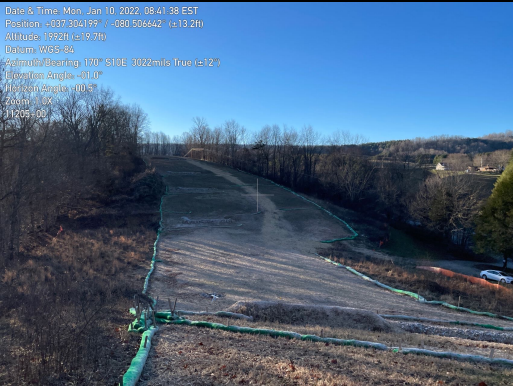
GPS Location	See photo		GPS Location	See photo	
Field Station#	11214+00		Field Station#	11205+00	
Pic 5 Desc.	Stabilization functional		Pic 6 Desc.	Stabilization functional

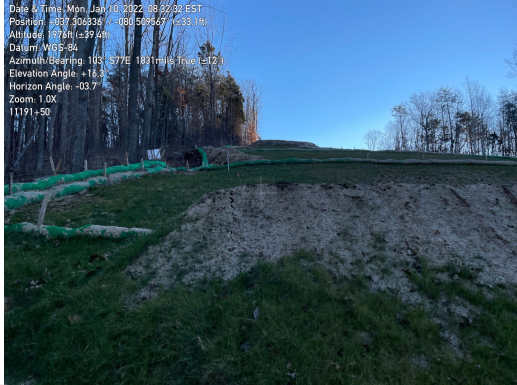
GPS Location	See photo		GPS Location	See photo	
Field Station#	11191+50		Field Station#	11191+00	
Pic 9 Desc.	Water bars in place		Pic 10 Desc.	Clean water drainage feature functional

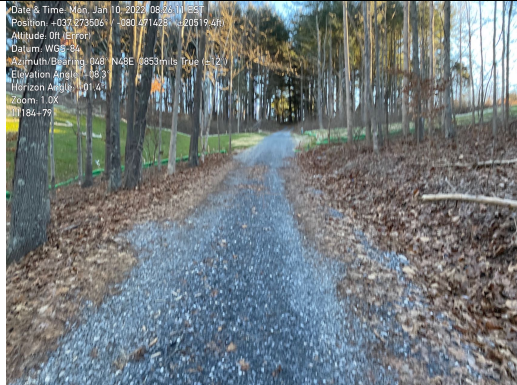
Insert image here	
GPS Location	See photo		GPS Location		
Field Station#	11184+79		Field Station#		
Pic 11 Desc.	AR 249.02 functional		Pic 12 Desc.

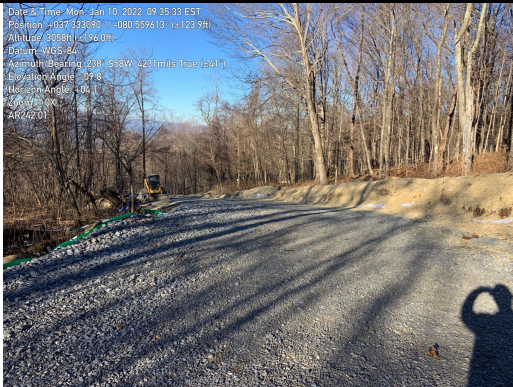
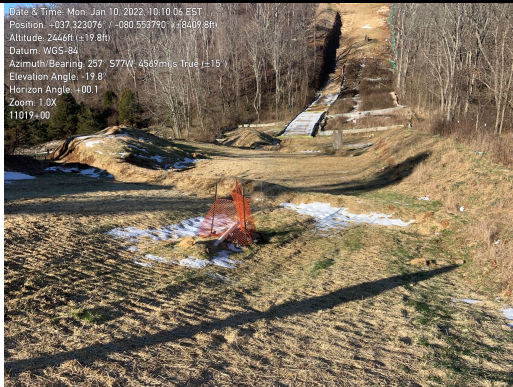
GPS Location				See photo				GPS Location				See photo			
Field Station#				10971+00				Field Station#				11019+00			
Pic 1 Desc.				AR242.01 rock surface is in acceptable condition				Pic 2 Desc.				Daylight drain with outlet protection and water bars are in place

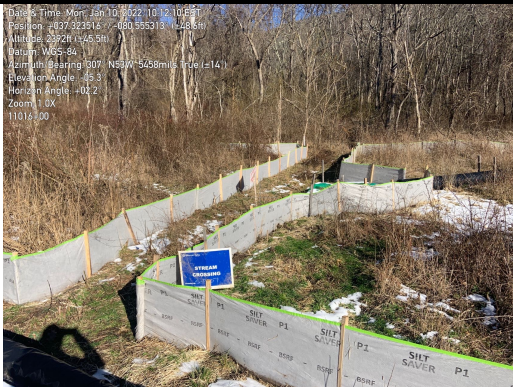
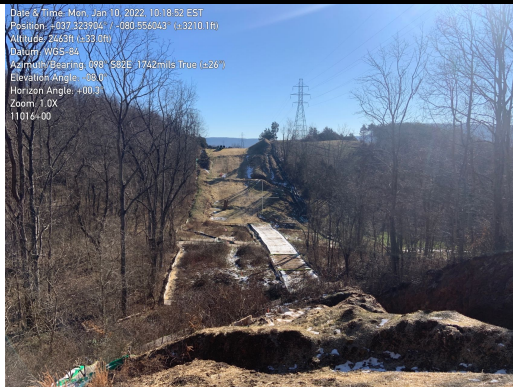
GPS Location				See photo				GPS Location				See photo			
Field Station#				11016+00				Field Station#				11016+00			
Pic 3 Desc.				Perimeter controls are in acceptable condition at stream crossing				Pic 4 Desc.				Buffer zones are in acceptable condition as well as perimeter controls.

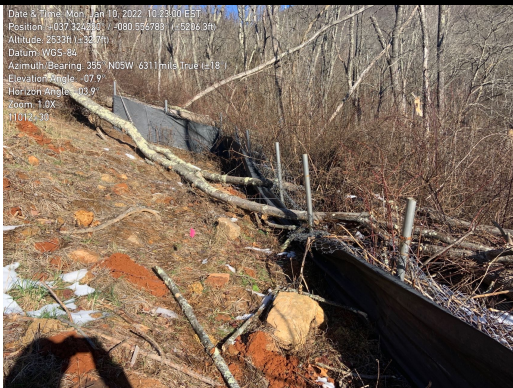
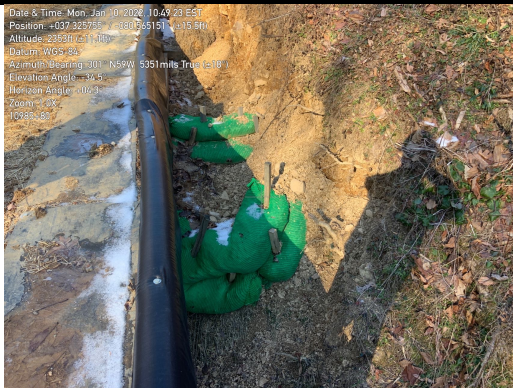
GPS Location				See photo				GPS Location				See photo			
Field Station#				11012+30				Field Station#				10985+80			
Pic 5 Desc.				SSF added to the punch list for maintenance due to a downed tree				Pic 6 Desc.				CFS checks near equipment bridge added to the punch list for maintenance remove sediment

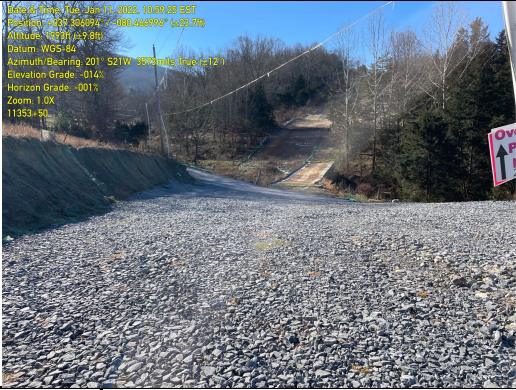
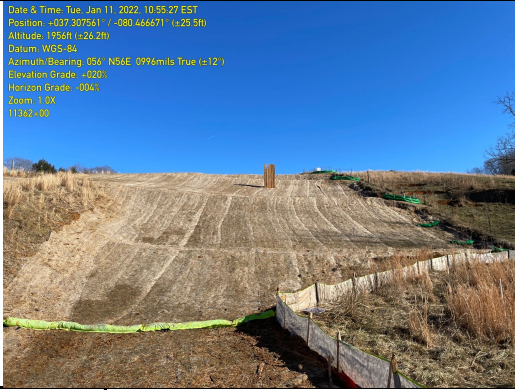
GPS Location	See photo	GPS Location	See photo		
Field Station#	11353+50	Field Station#	11362+00		
Pic 1 Desc.	RCE in place	Pic 2 Desc.	Erosion control blanket in place		
<p>Date & Time: Tue, Jan 11, 2022, 10:45:40 EST Position: +037.308077 / -080.466172 (+23.0ft) Altitude: 2000ft (+26.2ft) Datum: WGS-84 Azimuth/Bearing: 172° S07E 3076mils True (+12°) Elevation Grade: -023% Horizon Grade: -015% Zoom: 1.0X 11363+00</p>

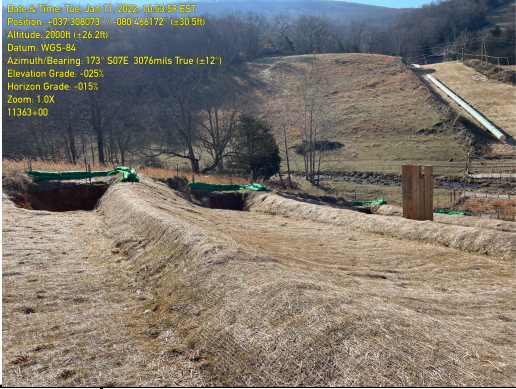
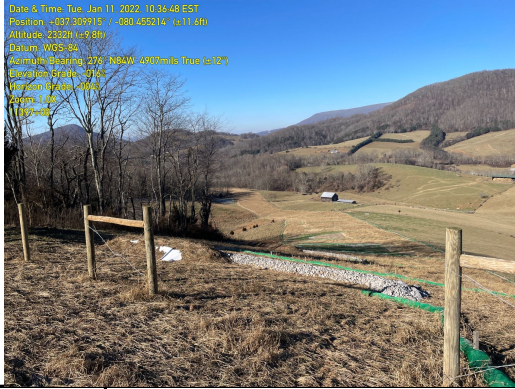
GPS Location	See photo	GPS Location	See phot		
Field Station#	11363+00	Field Station#	11397+00		
Pic 3 Desc.	End treatments in place	Pic 4 Desc.	Level spreader in place		
<p>Date & Time: Tue, Jan 11, 2022, 10:31:13 EST Position: +037.314291 / -080.458314 (+25.0ft) Altitude: 2260ft (+26.2ft) Datum: WGS-84 Azimuth/Bearing: 038° N35E 0622mils True (+12°) Elevation Grade: -017% Horizon Grade: -000% Zoom: 1.2X 11412+00</p>

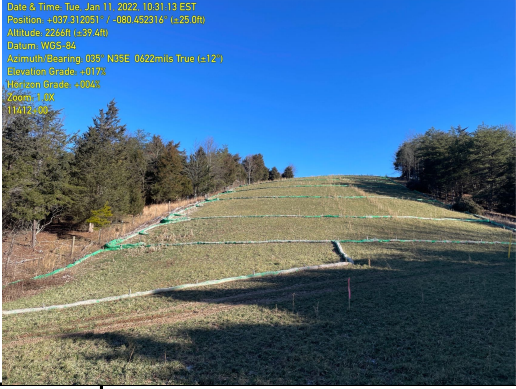
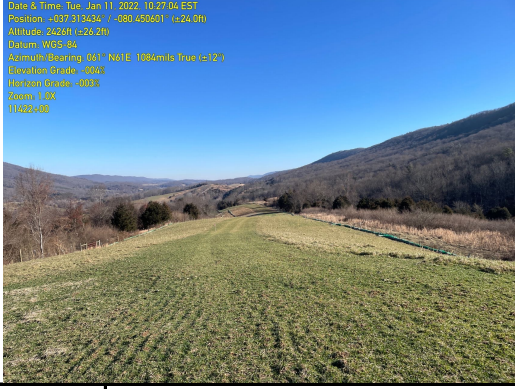
GPS Location	See photo	GPS Location	See photo		
Field Station#	11412+00	Field Station#	11422+00		
Pic 5 Desc.	Temporary CFS waterbars in place	Pic 6 Desc.	Good vegetation on ROW

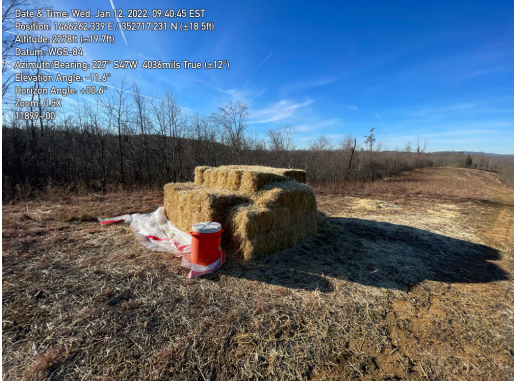
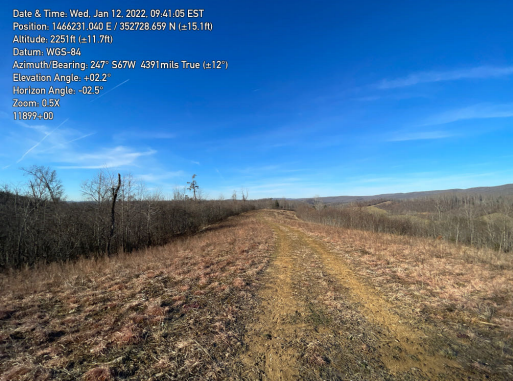
GPS Location	1	GPS Location	2		
Field Station#	11899+00	Field Station#	11899+00		
Pic 1 Desc.	Staged materials.	Pic 2 Desc.	Section of RoW showing conditions and controls.

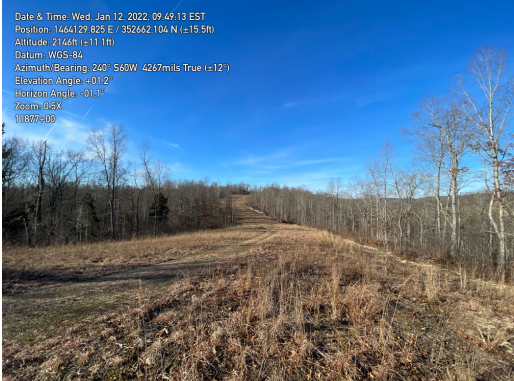
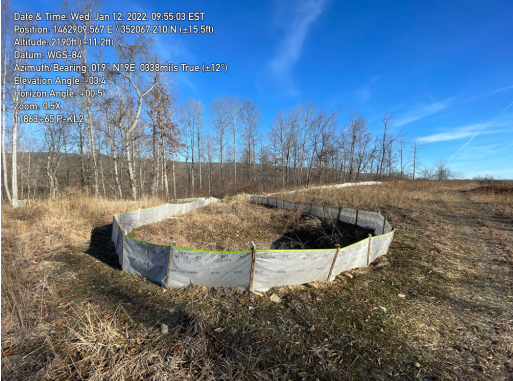
GPS Location	3	GPS Location	4		
Field Station#	11877+00	Field Station#	11863+65		
Pic 3 Desc.	Section of RoW showing conditions and controls.	Pic 4 Desc.	P-KL2 and controls.

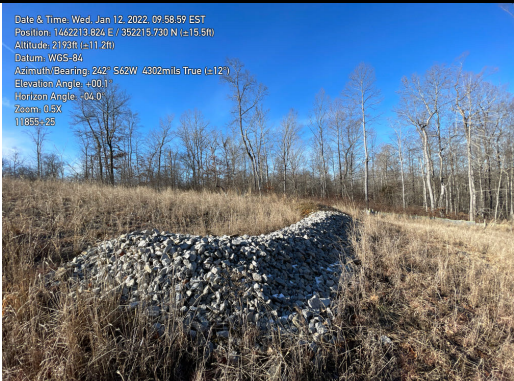
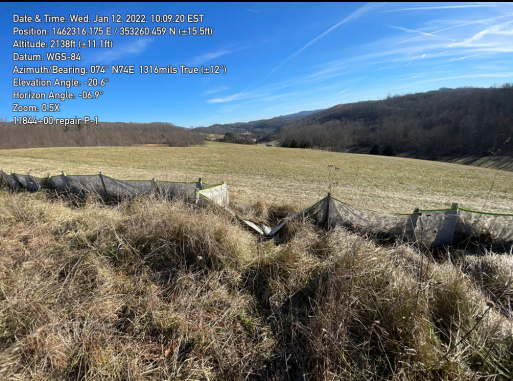
GPS Location	5	GPS Location	6		
Field Station#	11855+25	Field Station#	11844+00		
Pic 5 Desc.	Representational photo of permanent waterbar and level spreader.	Pic 6 Desc.	Representational photo of damaged P-1.

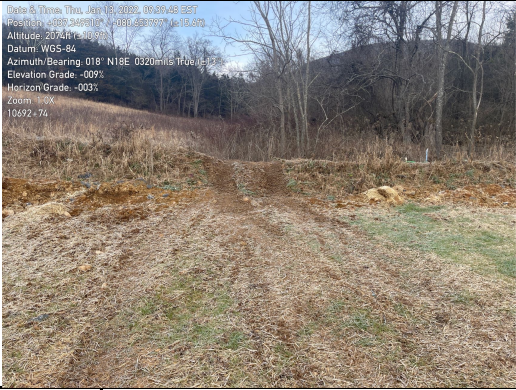
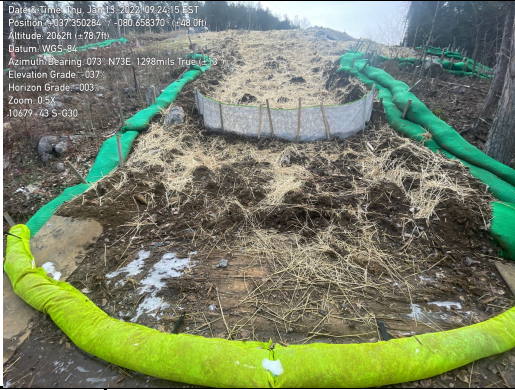
GPS Location	See photo	GPS Location	See photo		
Field Station#	10692+74	Field Station#	10679+43		
Pic 1 Desc.	Needs re-stabilization to area	Pic 2 Desc.	Needs re-stabilization

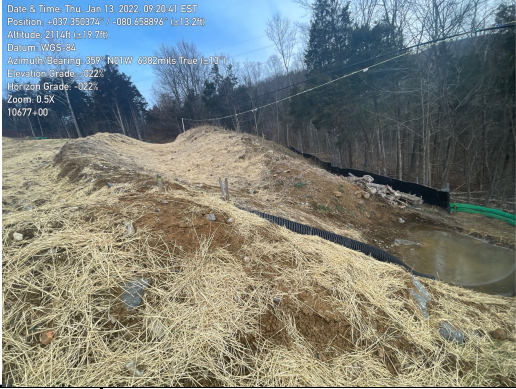
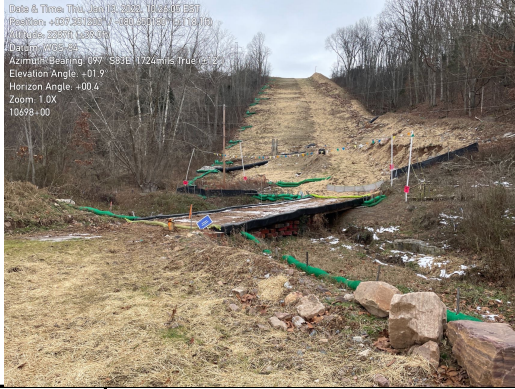
GPS Location	See photo	GPS Location	See photo		
Field Station#	10677+00	Field Station#	10698+00		
Pic 3 Desc.	Needs re-stabilization	Pic 4 Desc.	Equipment bridge functional

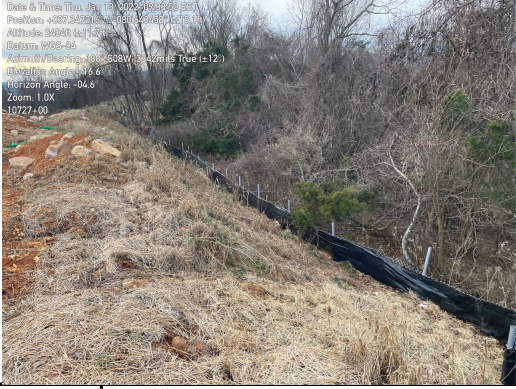
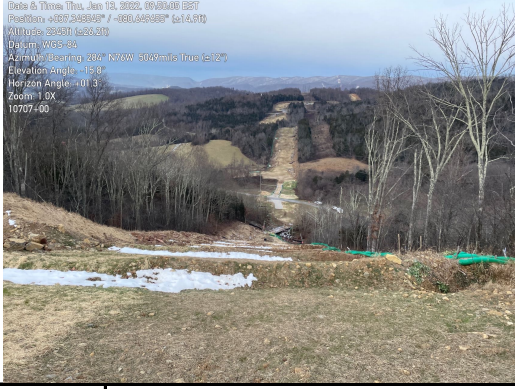
GPS Location	See photo	GPS Location	See photo		
Field Station#	10727+00	Field Station#	10707+00		
Pic 5 Desc.	SSF functional	Pic 6 Desc.	Water bars in place

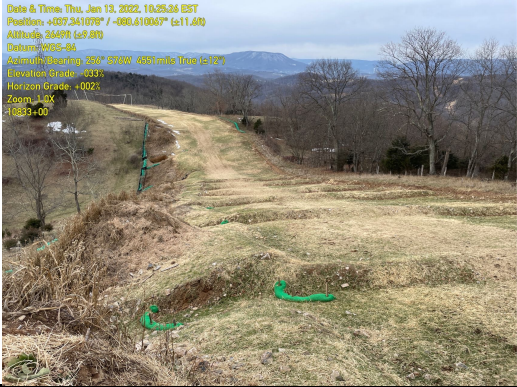
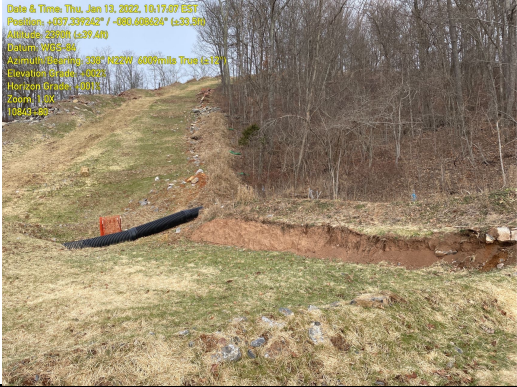
GPS Location	See photo	GPS Location	See photo		
Field Station#	10833+00	Field Station#	10843+80		
Pic 7 Desc.	Waterbars in place	Pic 8 Desc.	Cleanwater diversion berm in place		
<p>Date & Time: Thu, Jan 13, 2022, 10:40:20 EST Position: +037.338642° / -080.407711° (s=16.44) Altitude: 3384ft (s=9.60) Datum: WGS 84 Azimuth/Bearing: 129° 55'55" 2222mile True (s=12°) Elevation Grade: +03% Horizon Grade: +05% Zoom: 1.0X 10848+00</p>

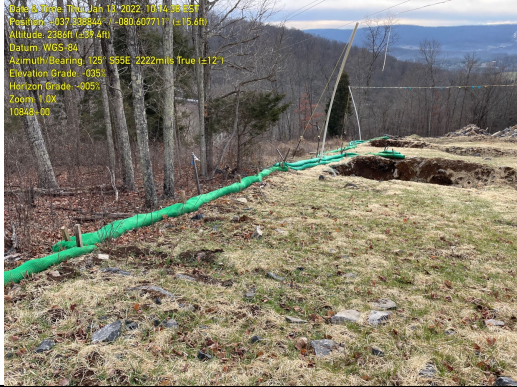
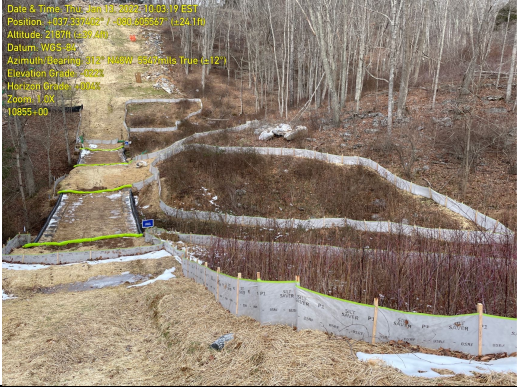
GPS Location	See photo	GPS Location	See photo		
Field Station#	10848+00	Field Station#	10855+00		
Pic 9 Desc.	CFS perimeter control in place	Pic 10 Desc.	Stream buffer in place		
<p>Date & Time: Thu, Jan 13, 2022, 10:45:32 EST Position: +037.357355° / -080.414704° (s=13.10) Altitude: 3271ft (s=11.70) Datum: WGS 84 Azimuth/Bearing: 211° 53'10" 1495ft mile True (s=12°) Elevation Grade: +50% Horizon Grade: +00% Zoom: 1.0X 10858+00</p>
