Visual Site Inspection Report

Project Name	H-600 Pipeline Spread G	AFE	124300137	Spread	H-600 Pipeline Spread G
Contractor	Precision			Report #	33354
Inspector	Daniel Fortune			Date/Time	1/18/2022 8:34 PM
Permit #	TBD	Inspection Type	VA SWPP	Station Begin	11524+16
State	VA	Inspection Area	Partial	Station End	11600+01
County	Montgomery	Ground	Frozen	Temperature (°F)	23.00
Municipality	N/A	Weather	Below Freezing Temp	Rain Gauge (in)	0.00
				Rain Accumulation Time (days)	0.00

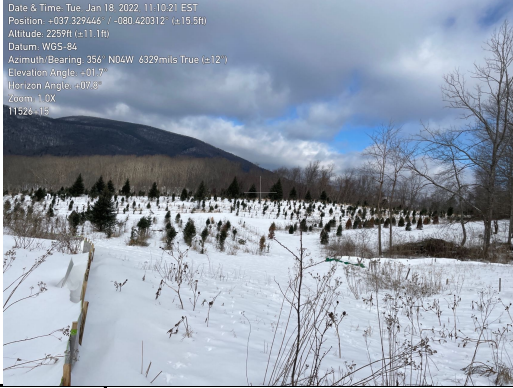
<p>Date & Time: Tue, Jan 18, 2022, 11:10:21 EST Position: +037.329804 / -080.420312 (Error) Altitude: 2259ft (Error) Datum: WGS-84 Azimuth/Bearing: 356° N04W 6329mils True (±12°) Elevation Angle: +01.9° Horizon Angle: +00.3° Zoom: 1.0X 11526+15</p>			
GPS Location	See Photo	GPS Location	See Photo		
Field Station#	11526+00	Field Station#	11526+15		
Pic 1 Desc.	Distant view of frozen final restoration area.	Pic 2 Desc.	Drainage feature condition.

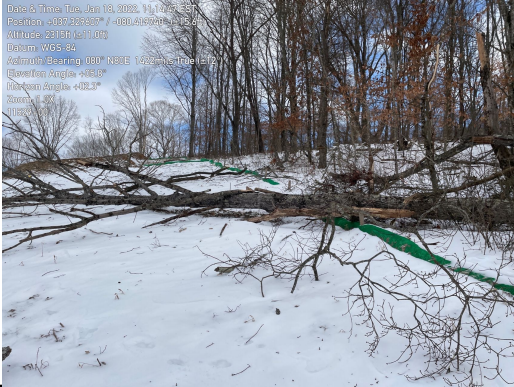
GPS Location	See Photo	GPS Location	See Photo		
Field Station#	11529+00	Field Station#	11531+00		
Pic 3 Desc.	Downed tree over perimeter CFS. No Damage to the sock at this time.	Pic 4 Desc.	Final restoration area. View of permanent level spreader condition.

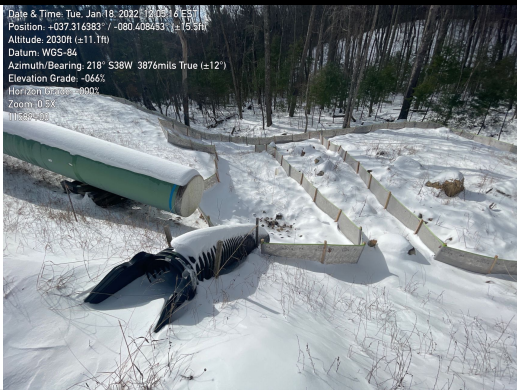
GPS Location		See Photo		GPS Location	
Field Station#		11589+00		Field Station#	
Pic 9 Desc.		Snow covered stone inlet condition.		Pic 10 Desc.	
<p>Date & Time: Tue, Jan 18, 2022, 12:08:18 EST Position: +037.317308° / -080.409365° (±15.5ft) Altitude: 2087ft (±11.1ft) Datum: WGS-84 Azimuth/Bearing: 322° N33W 5073mils True (±12°) Elevation Grade: -028% Horizon Grade: -001% Zoom: 4.0X 11581+50</p>

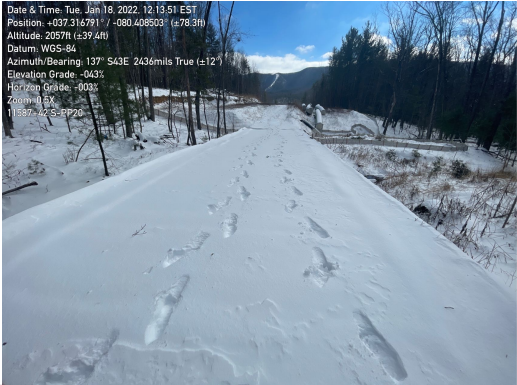
GPS Location	See Photo	GPS Location	See Photo		
Field Station#	11587+42	Field Station#	11587+42		
Pic 15 Desc.	Equipment bridge condition S-PP20	Pic 16 Desc.	View looking down stream S-PP20		
Insert image here		Insert image here			
GPS Location		GPS Location			
Field Station#		Field Station#			
Pic 17 Desc.		Pic 18 Desc.

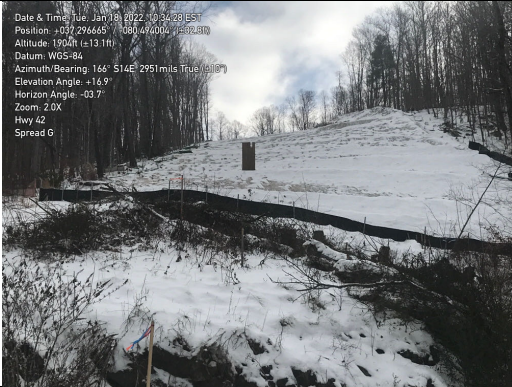
GPS Location	See photo		GPS Location	see photo	
Field Station#	11254+99		Field Station#	11353+00	
Pic 1 Desc.	Rte 42, erosion blanket under snow.		Pic 2 Desc.	S-NN 11

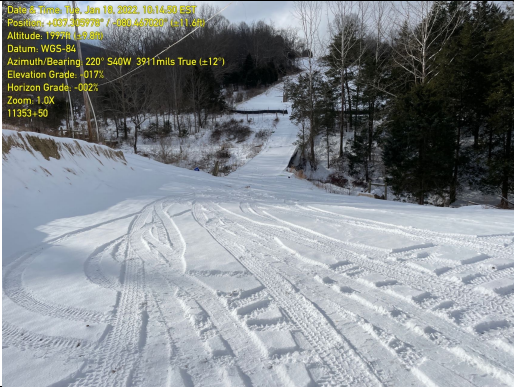
GPS Location	See photo	GPS Location	See photo		
Field Station#	11353+50	Field Station#	11363+00		
Pic 1 Desc.	RCE in place	Pic 2 Desc.	End treatments in place

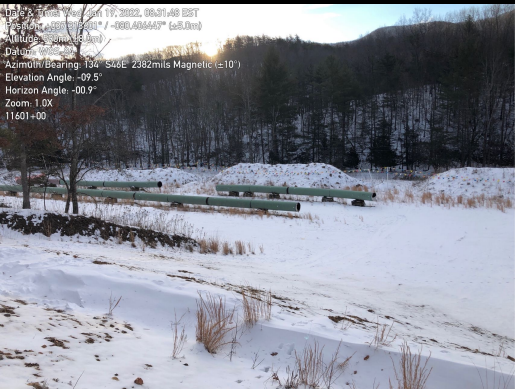
GPS Location	On photo	GPS Location			
Field Station#	11601+00	Field Station#			
Pic 13 Desc.	The ROW is currently stable. RCEs are in acceptable condition.	Pic 14 Desc.			
Insert image here		Insert image here			
GPS Location		GPS Location			
Field Station#		Field Station#			
Pic 15 Desc.		Pic 16 Desc.			
Insert image here		Insert image here			
GPS Location		GPS Location			
Field Station#		Field Station#			
Pic 17 Desc.		Pic 18 Desc.

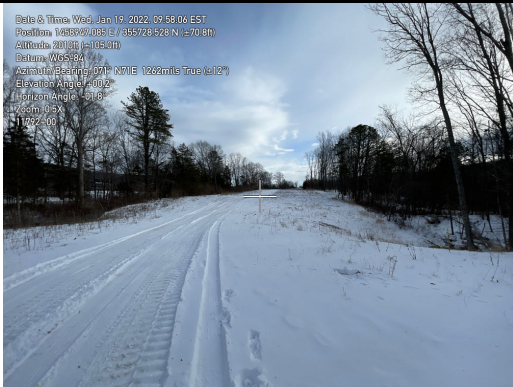
GPS Location				1				GPS Location				2			
Field Station#				11792+00				Field Station#				11813+00			
Pic 1 Desc.				Section of RoW showing conditions and controls.				Pic 2 Desc.				Section of RoW showing conditions and controls.

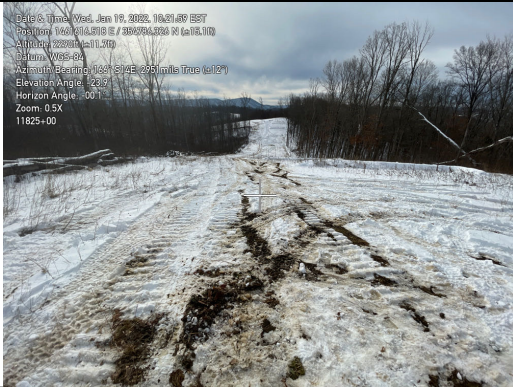
GPS Location				3				GPS Location				4			
Field Station#				11825+00				Field Station#				11839+00			
Pic 3 Desc.				Representational photo of damage from unauthorized travel.				Pic 4 Desc.				Representational photo of waterbar and level spreader.

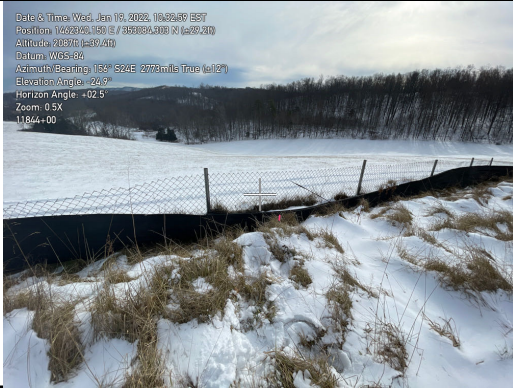
GPS Location				5				GPS Location				6			
Field Station#				11844+00				Field Station#				11863+65			
Pic 5 Desc.				Downed SSF.				Pic 6 Desc.				P-KL2 and controls.
