Visual Site Inspection Report

Project Name H-600 Pipeline Spread G		AFE 124300137	Spread H-600 Pipeline Spread G
Contractor Precision		Report # 33551	
Inspector Jared Saunders		Date/Time 1/24/2022 1:22 PM	
Permit # TBD	Inspection Type VA SWPP	Station Begin	11353+67
State VA	Inspection Area Partial	Station End	11471+56
County Giles	Ground Frozen	Temperature (°F)	40.00
Municipality N/A	Weather Below Freezing Temp	Rain Gauge (in)	0.00
			Rain Accumulation Time (days) 1.00

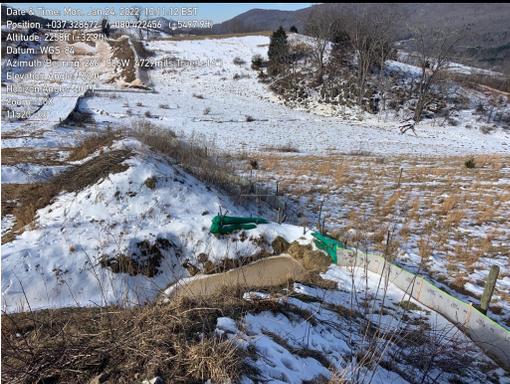
GPS Location	see photo	GPS Location	see photo		
Field Station#	11520+00	Field Station#	11518+32		
Pic 1 Desc.	Section of Row showing conditions and controls	Pic 2 Desc.	S-PP4

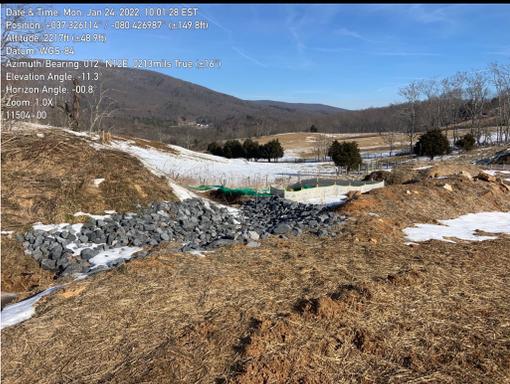
GPS Location	See photo	GPS Location	see photo		
Field Station#	11507+78	Field Station#	11504+00		
Pic 3 Desc.	S-PP3	Pic 4 Desc.	Rock lined channel is in acceptable condition

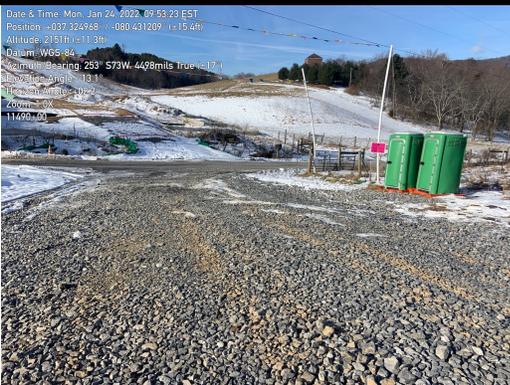
GPS Location	See photo	GPS Location	see photo		
Field Station#	11490+00	Field Station#	11487+25		
Pic 5 Desc.	RCE is maintained and in acceptable condition	Pic 6 Desc.	Plunge pool is in place

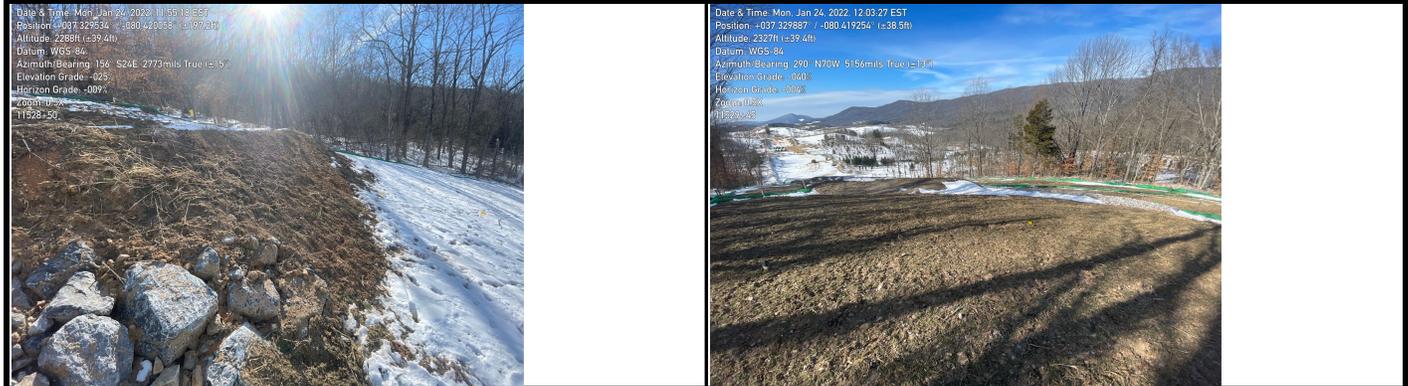
GPS Location	See Photo	GPS Location	See Photo
Field Station#	11528+50	Field Station#	11529+45
Pic 13 Desc.	Permanent water bar condition Final Restoration Area	Pic 14 Desc.	Final Restoration Area

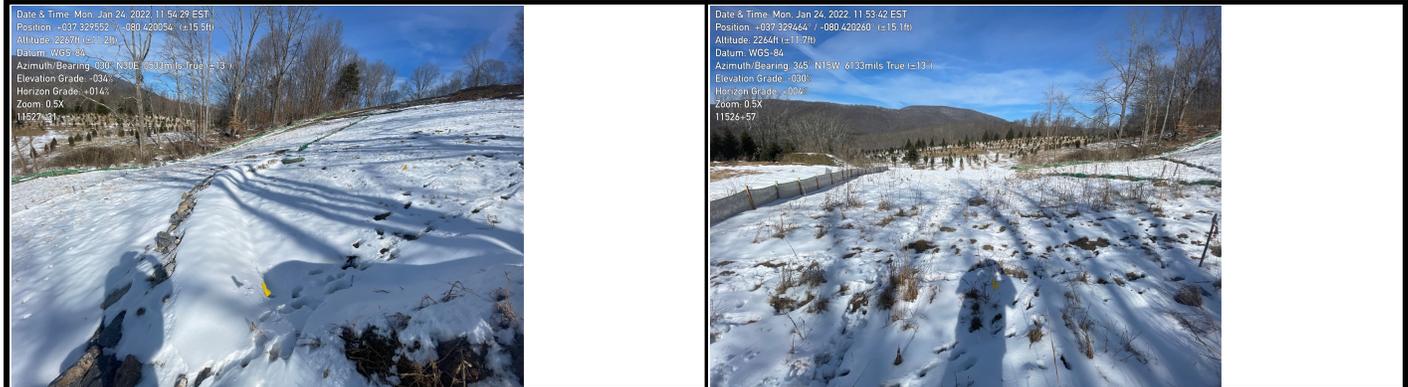
GPS Location	See Photo	GPS Location	See Photo
Field Station#	11527+31	Field Station#	11526+57
Pic 15 Desc.	Rock level spreader Final Restoration Area	Pic 16 Desc.	Drainage Feature Final Restoration Area

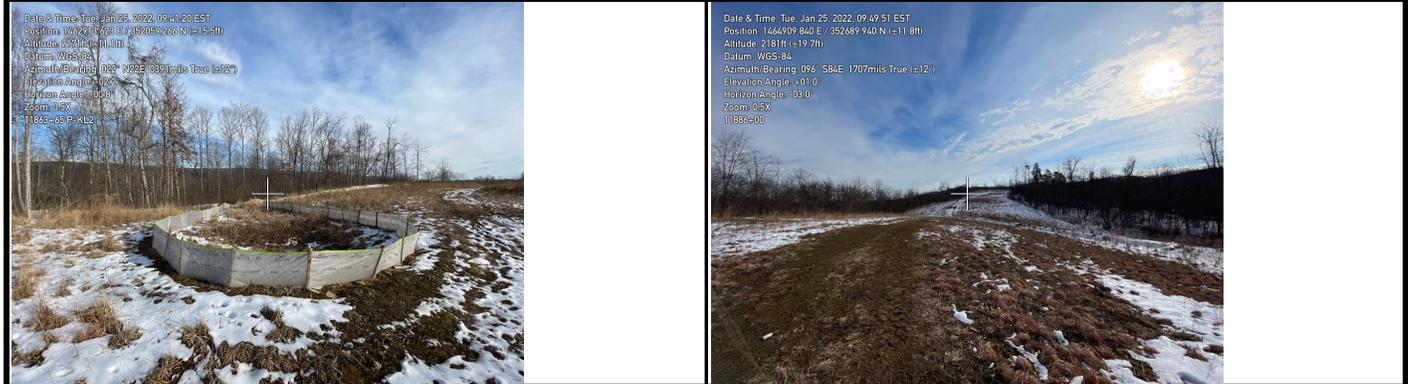
GPS Location 7	GPS Location 8
Field Station# 11863+65	Field Station# 11886+00
Pic 7 Desc. P-KL2 and controls.	Pic 8 Desc. Section of RoW showing conditions and controls.

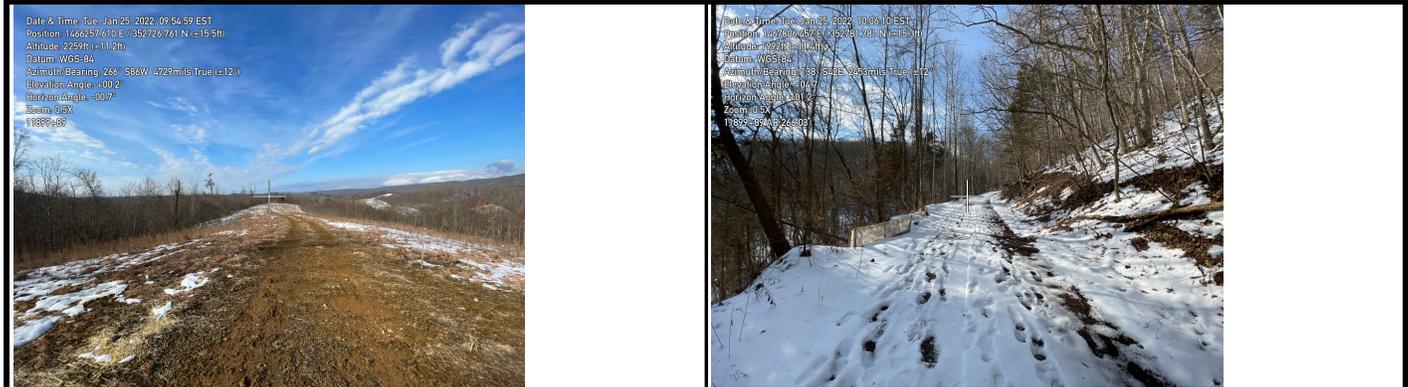
GPS Location 9	GPS Location 10
Field Station# 11899+89	Field Station# 11899+89
Pic 9 Desc. Section of RoW showing conditions and controls.	Pic 10 Desc. AR 266.03 conditions and controls.

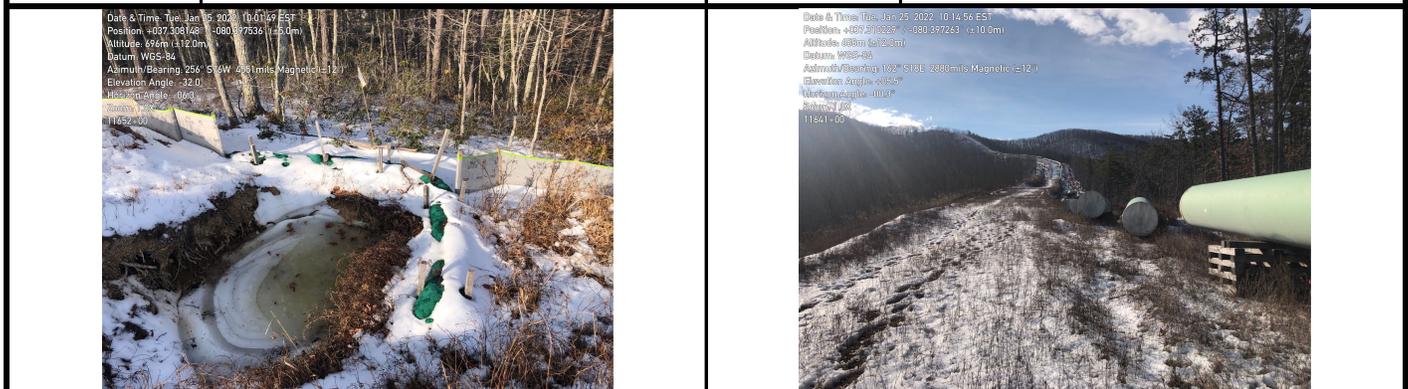
GPS Location	On photo	GPS Location	On photo
Field Station#	11652+00	Field Station#	11641+00
Pic 5 Desc.	Perimeter ECDs are in place. No issues caused by runoff.	Pic 6 Desc.	Slope breakers functional. ROW stable.

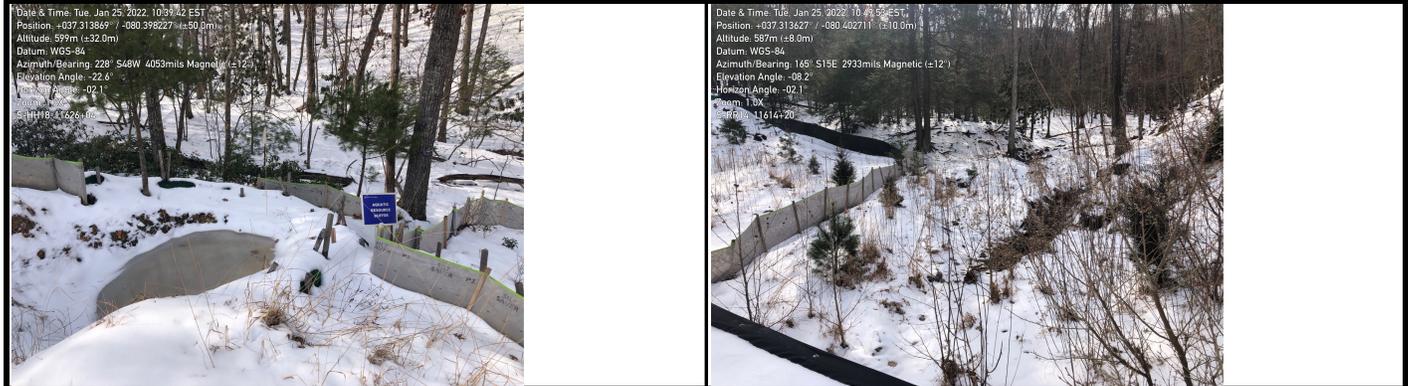
GPS Location	On photo	GPS Location	On photo
Field Station#	11626+04	Field Station#	11614+20
Pic 7 Desc.	ECDs at the S-HH18 crossing are in good condition.	Pic 8 Desc.	The S-RR14 crossing is currently stable.

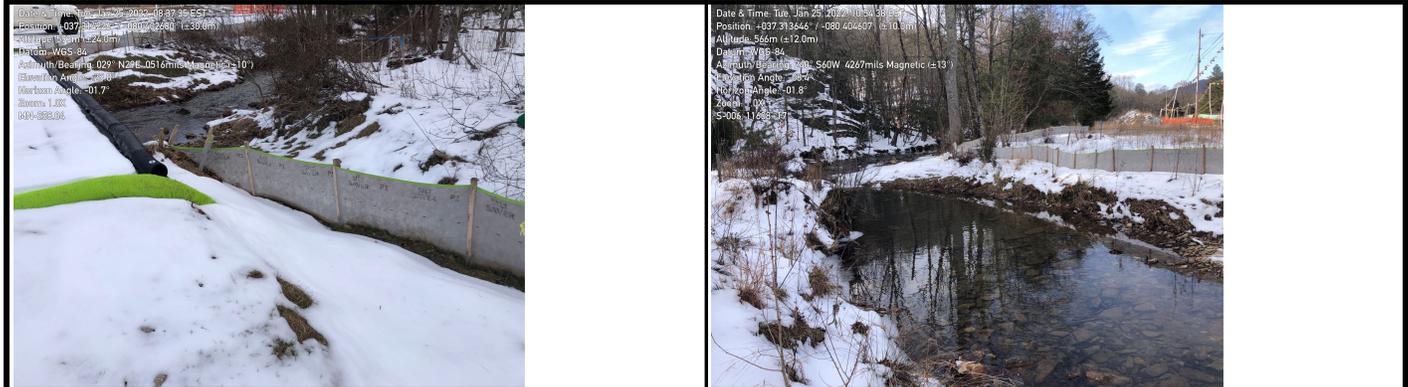
GPS Location	On photo	GPS Location	On photo
Field Station#	11613+69	Field Station#	11608+17
Pic 9 Desc.	The S-RR13 equipment bridge and ECDs are in good condition on access road MN-258.04.	Pic 10 Desc.	The S-006 crossing is currently stable.

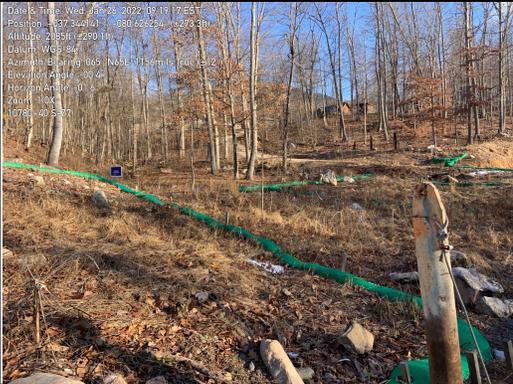
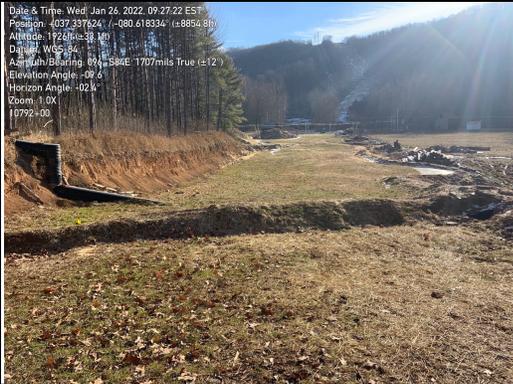
GPS Location	See photo	GPS Location	See photo
Field Station#	10780+40	Field Station#	10792+00
Pic 7 Desc.	S-Z7 showing conditions and controls	Pic 8 Desc.	Section of Row showing conditions and controls

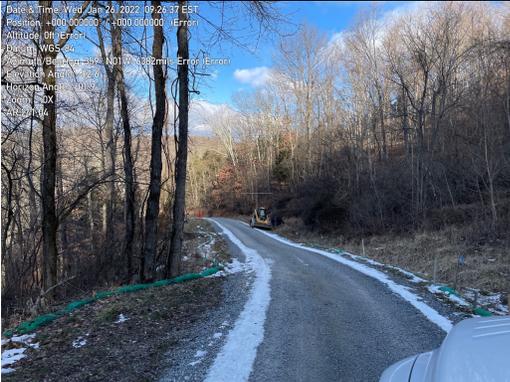
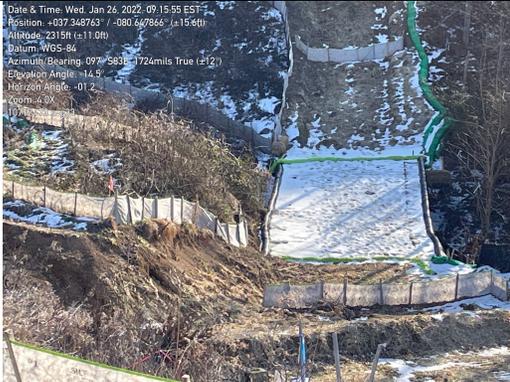
GPS Location See photo		GPS Location See photo			
Field Station# 10708+22		Field Station# 10712+73			
Pic 1 Desc. Skid steer dressing up AR 241.04		Pic 2 Desc. Equipment bridge functional

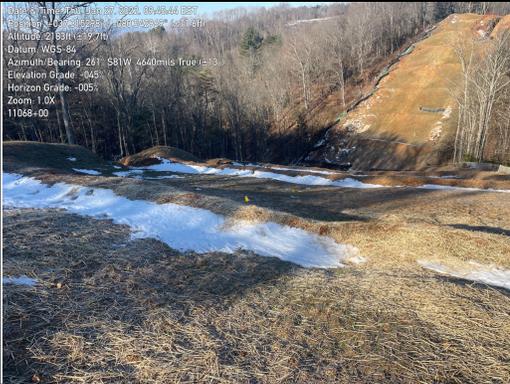
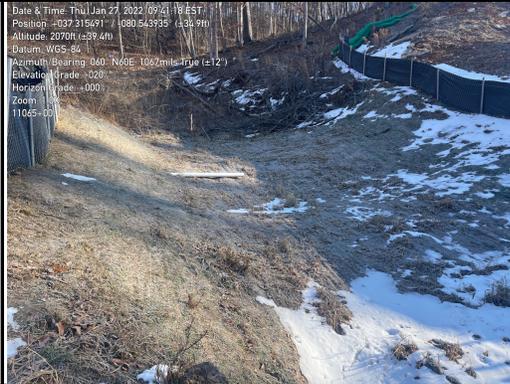
GPS Location	SEE PHOTO	GPS Location	SEE PHOTO
Field Station#	11068+00	Field Station#	11065+00
Pic 7 Desc.	Temporary stabilized row and water bar conditions.	Pic 8 Desc.	Drainage feature conditions. Limited growth where the CC4 ECB is installed.

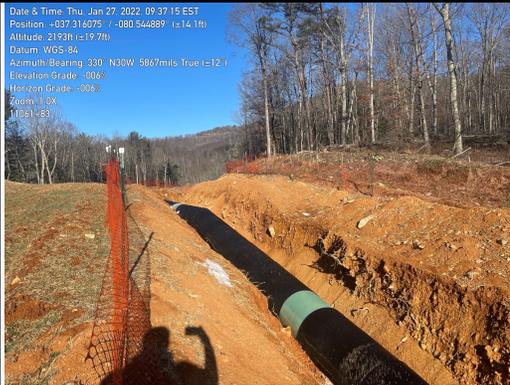
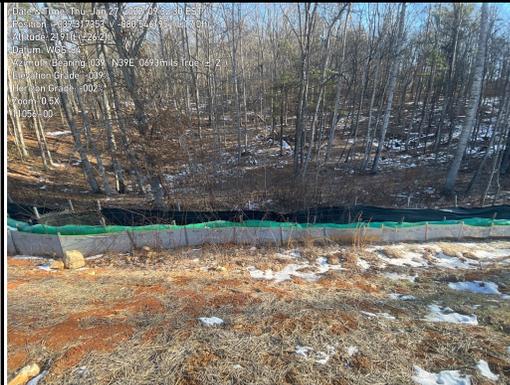
GPS Location	SEE PHOTO	GPS Location	SEE PHOTO
Field Station#	11061+83	Field Station#	11056+00
Pic 9 Desc.	Open ditch line for future valve site.	Pic 10 Desc.	Perimeter P1, triple stacked 18", and super silt fence protecting sensitive resource area located outside LOD.

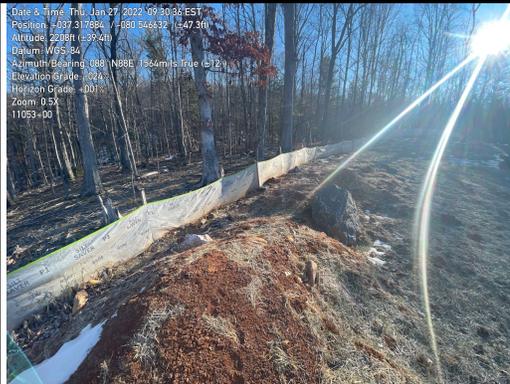
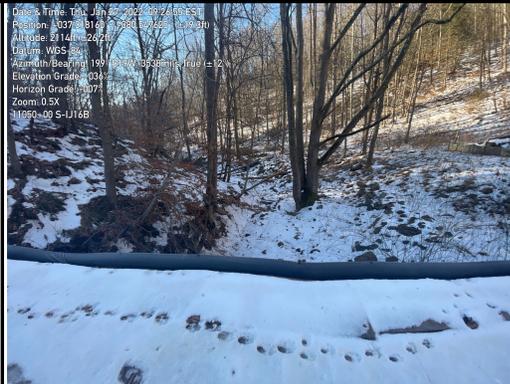
GPS Location	SEE PHOTO	GPS Location	SEE PHOTO
Field Station#	11053+00	Field Station#	11050+00
Pic 11 Desc.	Perimeter P1 silt fencing conditions.	Pic 12 Desc.	View looking down stream
