Visual Site Inspection Report

Project Name	H-600 Pipeline Spread G	AFE	124300137	Spread	H-600 Pipeline Spread G
Contractor	Precision			Report #	32841
Inspector	Joe Sweeden			Date/Time	1/3/2022 12:14 PM
Permit #	TBD	Inspection Type	VA SWPP	Station Begin	10859+46
State	VA	Inspection Area	Partial	Station End	10929+80
County	Giles	Ground	Frozen	Temperature (°F)	28.00
Municipality	N/A	Weather	Snow/Sleet	Rain Gauge (in)	1.75
				Rain Accumulation Time (days)	1.00

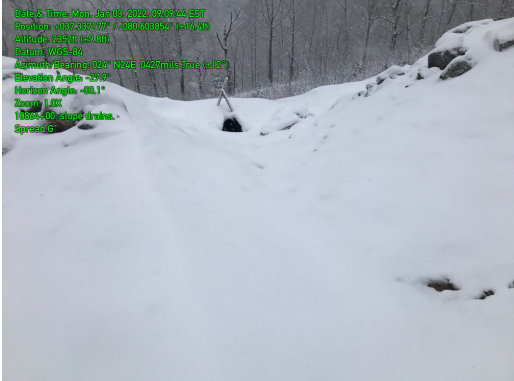
GPS Location	See photo		GPS Location	see photo	
Field Station#	10864+00		Field Station#	10929+00	
Pic 1 Desc.	Slope drains		Pic 2 Desc.	S-Y 2

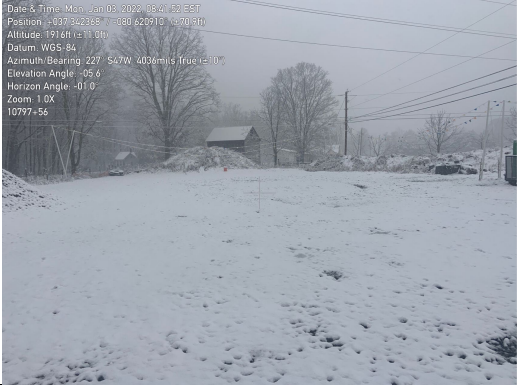
Insert image here	
GPS Location	See photo	GPS Location			
Field Station#	10797+56	Field Station#			
Pic 7 Desc.	RCE is maintained and in acceptable condition	Pic 8 Desc.			
Insert image here		Insert image here			
GPS Location		GPS Location			
Field Station#		Field Station#			
Pic 9 Desc.		Pic 10 Desc.			
Insert image here		Insert image here			
GPS Location		GPS Location			
Field Station#		Field Station#			
Pic 11 Desc.		Pic 12 Desc.

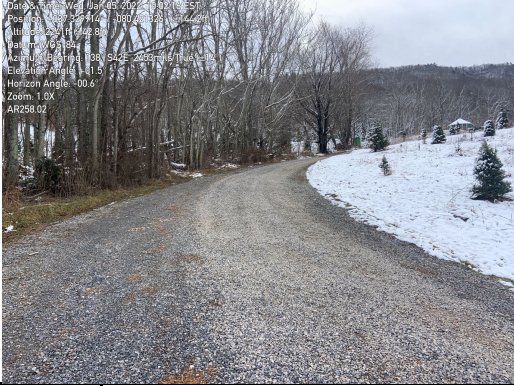
GPS Location	See photo	GPS Location	see photo		
Field Station#	11524+16	Field Station#	11514+46		
Pic 1 Desc.	AR258.02 is in acceptable condition	Pic 2 Desc.	Aquatic resource signage and and buffer zones are in acceptable condition

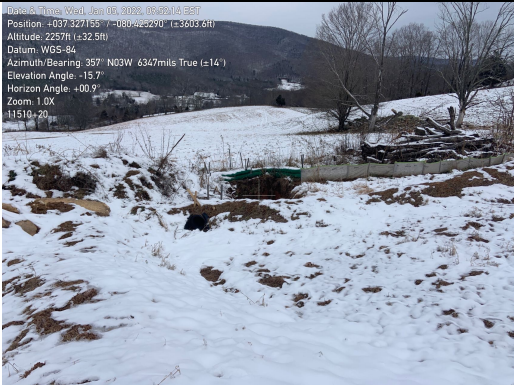
GPS Location	See photo	GPS Location	see photo		
Field Station#	11510+00	Field Station#	11507+00		
Pic 3 Desc.	Stone inlet protection is in acceptable condition	Pic 4 Desc.	Equipment bridge is maintained in acceptable condition

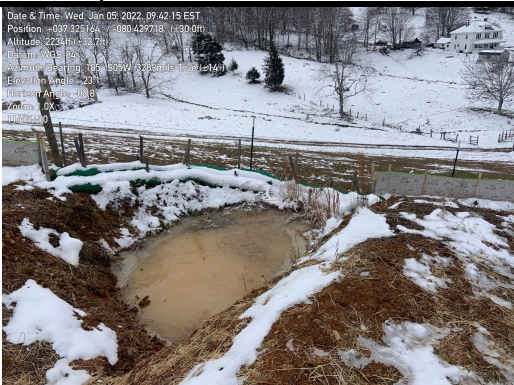
GPS Location	see photo	GPS Location	See photo		
Field Station#	11495+00	Field Station#	11490+02		
Pic 5 Desc.	Sump pit and perimeter controls are in acceptable condition	Pic 6 Desc.	Rock surface of RCE is in acceptable condition

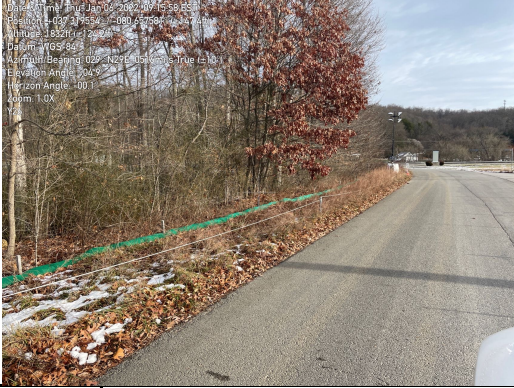
GPS Location	See photo		GPS Location	See photo	
Field Station#	12005+00		Field Station#	12005+00	
Pic 1 Desc.	CFS perimeter controls functional		Pic 2 Desc.	CFS perimeter controls & safety fence in place

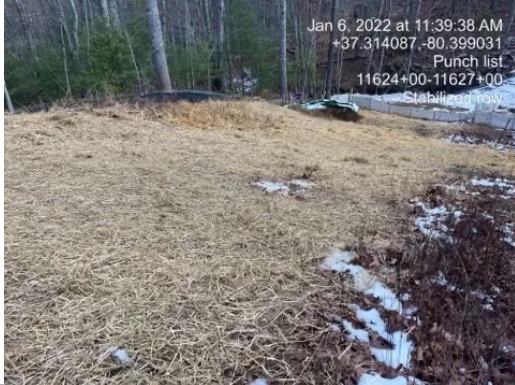
<p>Jan 6, 2022 at 11:39:38 AM +37.314087° -80.399031° Punch list 11624+00-11627+00 Stabilized row</p>

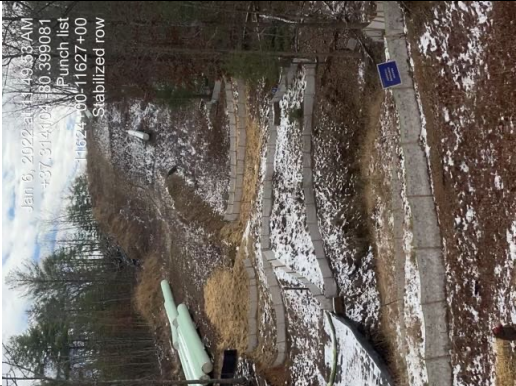
<p>Jan 6, 2022 at 11:40:33 AM +37.314103° -80.399081° Punch list 11624+00-11627+00 Stabilized row</p>

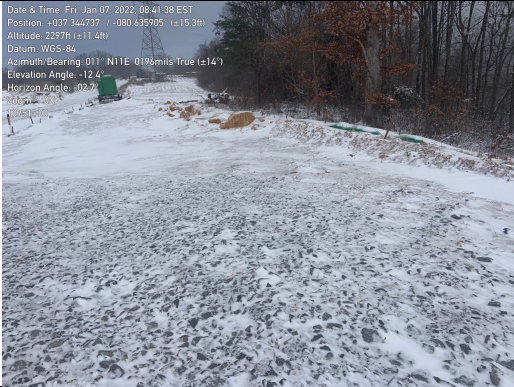
GPS Location	See photo	GPS Location	See photo		
Field Station#	10751+00	Field Station#	10753+50		
Pic 1 Desc.	RCE is maintained and in acceptable condition		Pic 2 Desc.	Sump pit and water bars are in acceptable condition

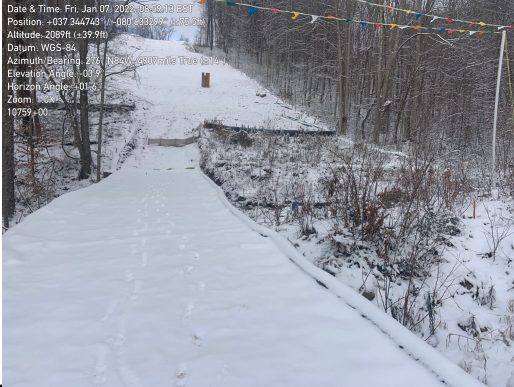
GPS Location	See photo	GPS Location	See photo		
Field Station#	10759+00	Field Station#	10759+40		
Pic 3 Desc.	Equipment bridge is maintained in acceptable condition		Pic 4 Desc.	CFS perimeter controls at temporary work space are in acceptable condition

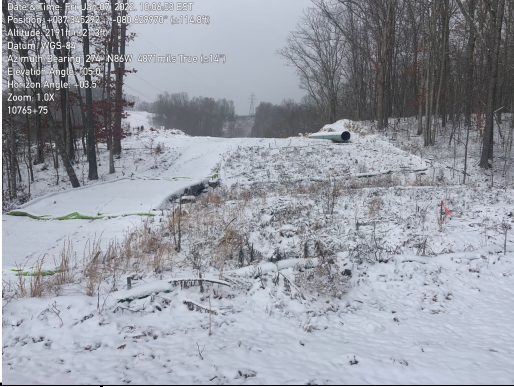
GPS Location	See photo	GPS Location	See photo		
Field Station#	10765+75	Field Station#	10771+67		
Pic 5 Desc.	Sensitive resource buffer and equipment bridge are in acceptable condition		Pic 6 Desc.	Clean water diversion pipe and level spreader are in acceptable condition
