Visual Site Inspection Report

Project Name	H-600 Pipeline Spread G	AFE	124300137	Spread	H-600 Pipeline Spread G
Contractor	Precision			Report #	33771
Inspector	Eric Hanlon			Date/Time	1/31/2022 8:18 AM
Permit #	TBD	Inspection Type	VA SWPP	Station Begin	12005+00
State	VA	Inspection Area	Full	Station End	12005+00
County	Giles	Ground	Frozen	Temperature (°F)	27.00
Municipality	N/A	Weather	Sunny	Rain Gauge (in)	0.00
				Rain Accumulation Time (days)	1.00

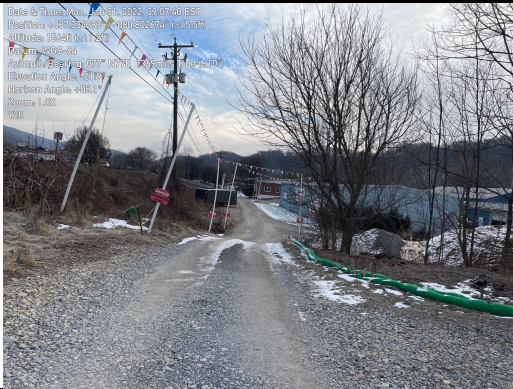
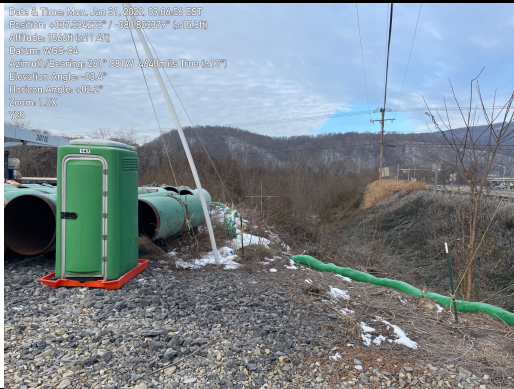
GPS Location				See photo				GPS Location				See photo			
Field Station#				12005+00				Field Station#				12005+00			
Pic 1 Desc.				AR in good condition				Pic 2 Desc.				CFS perimeter controls functional

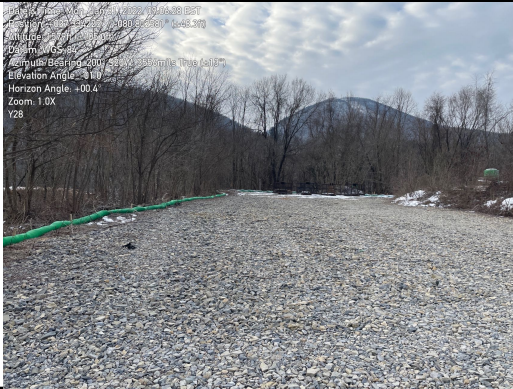
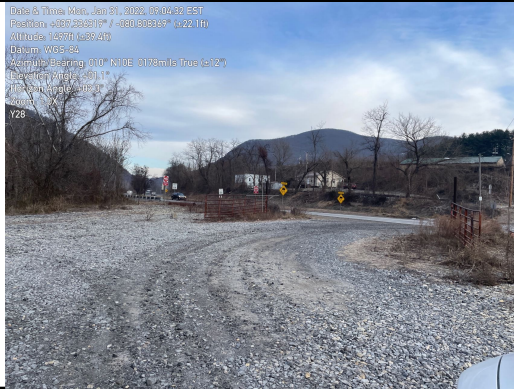
GPS Location				See photo				GPS Location				See photo			
Field Station#				12005+00				Field Station#				12005+00			
Pic 3 Desc.				Housekeeping in good order no trash or debris in Y28				Pic 4 Desc.				RCE functional

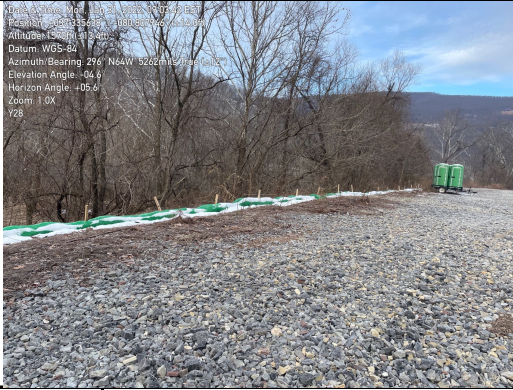
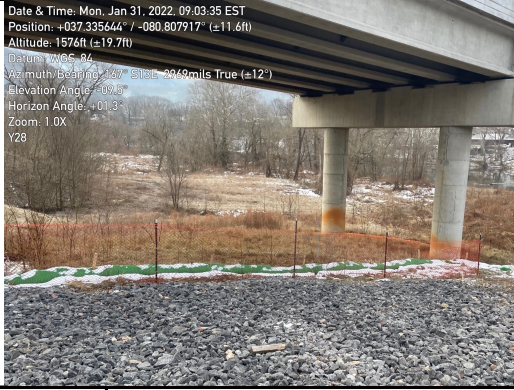
GPS Location				See photo				GPS Location				See photo			
Field Station#				12005+00				Field Station#				12005+00			
Pic 5 Desc.				CFS perimeter controls functional				Pic 6 Desc.				Safety fence & CFS in good condition

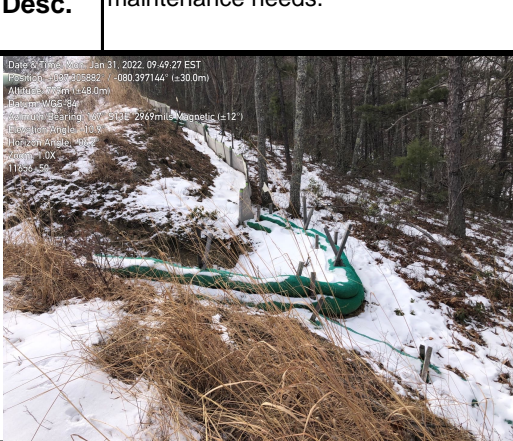
<p>Date & Time: Mon, Jan 31, 2022, 09:49:27 EST Position: +437.31144° / -080.39714° (+30.0m) Altitude: 577m (+24.0m) Datum: WGS-84 Azimuth/Bearing: 022° S 86E 1336mils Magnetic (+14.1°) Elevation Angle: -24.0° Horizon Angle: -06.1° Zoom: 1.0X 11636+50</p>		  <p>Date & Time: Mon, Jan 31, 2022, 10:04:23 EST Position: +437.31251° / -080.39735° (+30.0m) Altitude: 577m (+24.0m) Datum: WGS-84 Azimuth/Bearing: 022° S 86E 1336mils Magnetic (+14.1°) Elevation Angle: -24.0° Horizon Angle: -06.1° Zoom: 1.0X 11634+50</p>			
GPS Location	On photo		GPS Location	On photo	
Field Station#	11656+50		Field Station#	11634+50	
Pic 5 Desc.	End treatment functional.		Pic 6 Desc.	Communication for ECD maintenance need identified. One of three locations where fabric to be reattached to chainlink SSF.

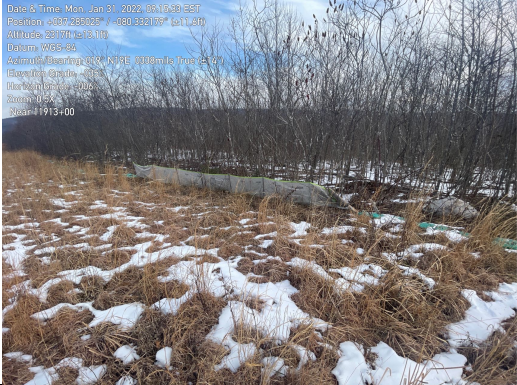
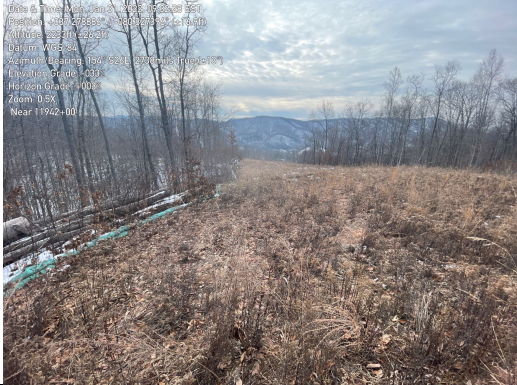
GPS Location		See Photo		GPS Location	
Field Station#		11913+00		Field Station#	
Pic 7 Desc.		View of P1 silt fence requiring maintenance.		Pic 8 Desc.	
				Final Restoration Area. View of permanent grasses and perimeter CFS.	
<p> <small> Date & Time: Mon, Jan 31, 2022 10:53:55 Position: +38°28393" / -98°03310" (±11.30) Altitude: 1537M (±15.10) Datum: WGS-84 Geoid Heighting: 100° NAD 83 Geoid: 100M Horizontal Grade: 0.00 Zoom: 0.5X Near: 11943+00 </small> </p>

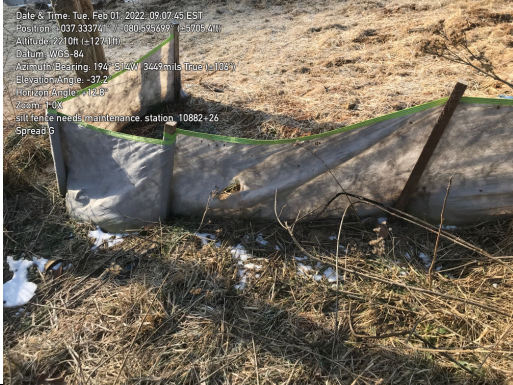
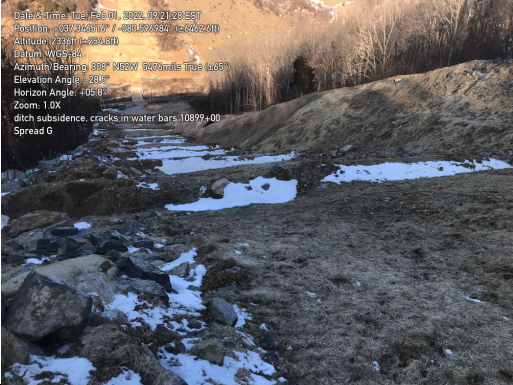
GPS Location		See photo				GPS Location		see photo			
Field Station#		10882+26				Field Station#		10899+00			
Pic 1 Desc.		P 1 needs maintenance PL				Pic 2 Desc.		Ditch subsidence, with cracks in water bars.

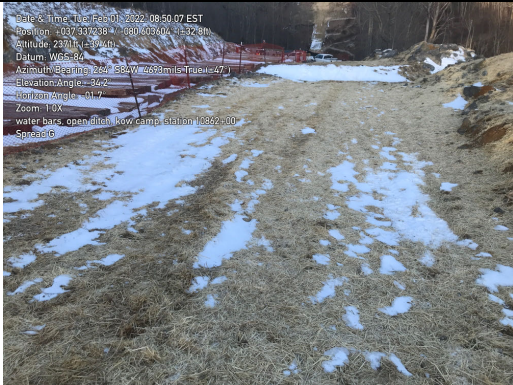
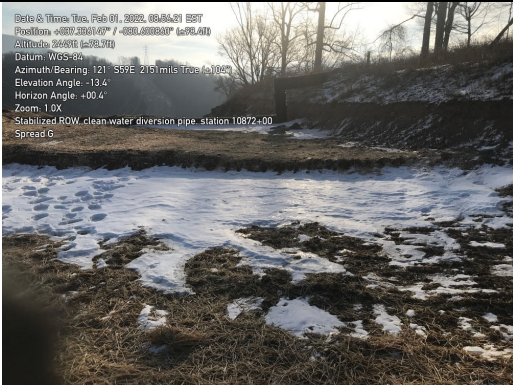
GPS Location		see photo				GPS Location		see photo			
Field Station#		10862+00				Field Station#		10872+00			
Pic 3 Desc.		Water bars, open ditch, Kow camp				Pic 4 Desc.		Stabilized ROW, clean water diversion pipe

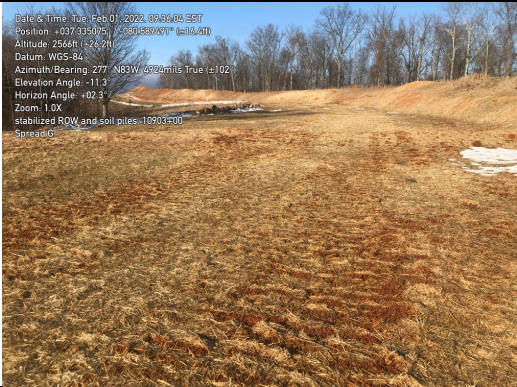
GPS Location	See photo	GPS Location	see photo		
Field Station#	10884+00	Field Station#	10903+00		
Pic 7 Desc.	Kow camp RCE	Pic 8 Desc.	Stabilized ROW and soil piles

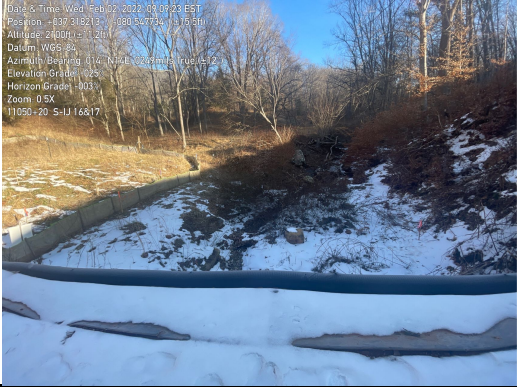
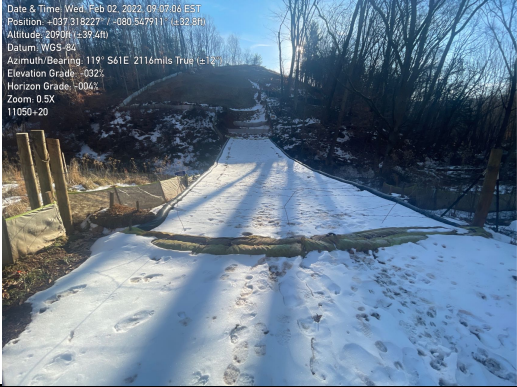
GPS Location	See Photo	GPS Location	See Photo		
Field Station#	11050+20	Field Station#	11050+20		
Pic 7 Desc.	View looking downstream	Pic 8 Desc.	S-IJ16&17 equipment bridge condition

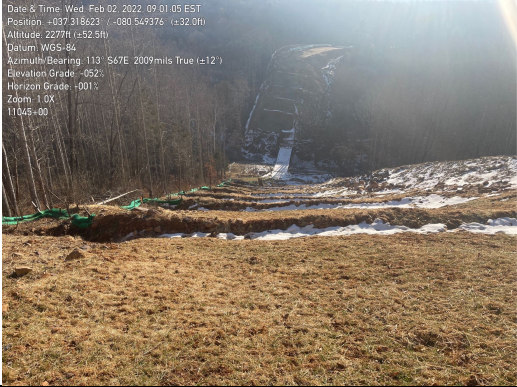
GPS Location	See Photo	GPS Location	See Photo		
Field Station#	11046+92	Field Station#	11045+00		
Pic 9 Desc.	Daylight drain out let to a water bar.	Pic 10 Desc.	Current temporary water bar conditions.

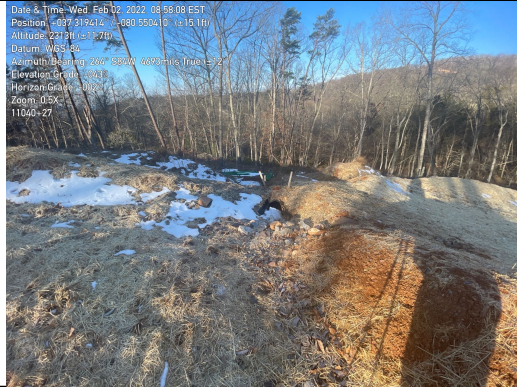
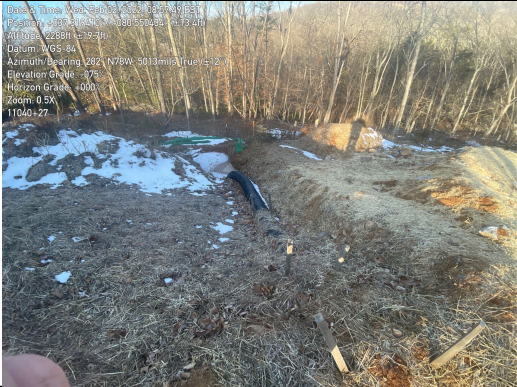
GPS Location	See Photo	GPS Location	See Photo		
Field Station#	11040+27	Field Station#	11040+27		
Pic 11 Desc.	Stone inlet protection condition	Pic 12 Desc.	temporary slope drain pipe condition.

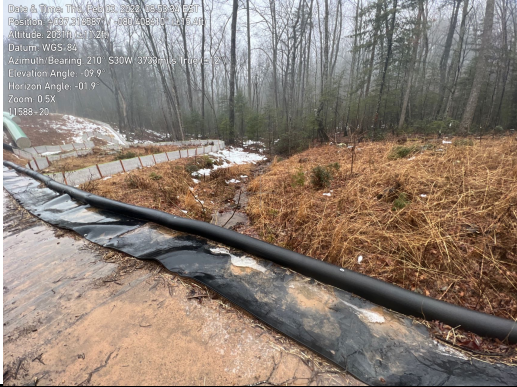
<p>Photo 8: Buffer and stream Position: 35.951125, -83.000000 (s14.00) Altitude: 205.00 (s14.00) Datum: WGS-84 Azimuth Bearing: 210.530W 37.00 (s14.00) Elevation Angle: -01.9 Horizon Angle: -01.9 Zoom: 0.5X 11588+20</p>			
GPS Location	See Photo	GPS Location	See Photo		
Field Station#	11585+00	Field Station#	11588+20		
Pic 7 Desc.	Equipment Bridge	Pic 8 Desc.	Buffer and stream		
Insert image here		Insert image here			
GPS Location		GPS Location			
Field Station#		Field Station#			
Pic 9 Desc.		Pic 10 Desc.			
Insert image here		Insert image here			
GPS Location		GPS Location			
Field Station#		Field Station#

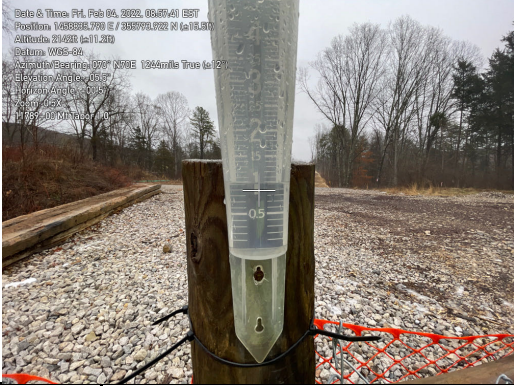
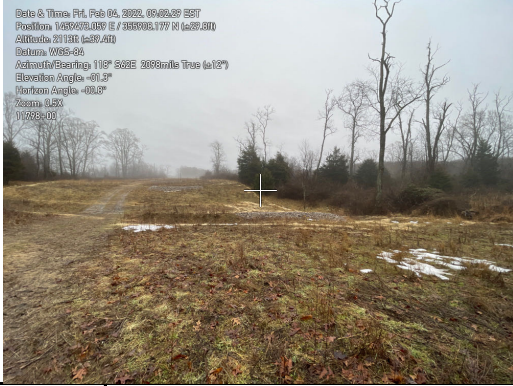
GPS Location	1	GPS Location	2		
Field Station#	11789+00	Field Station#	11798+00		
Pic 1 Desc.	Rain gauge indicating 1.0" of accumulation.		Pic 2 Desc.	Section of restored RoW showing conditions and controls.

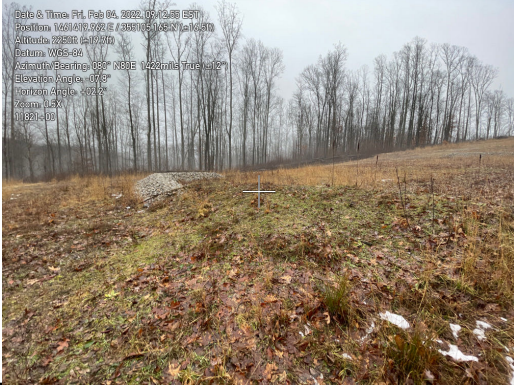
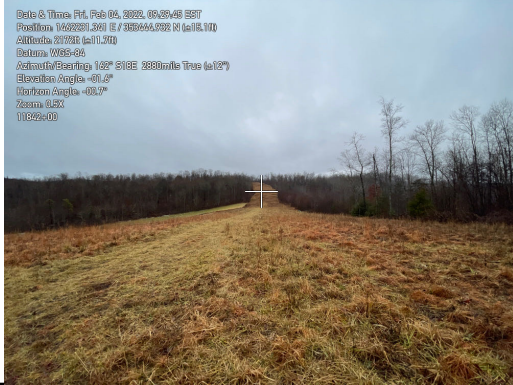
GPS Location	3	GPS Location	4		
Field Station#	11821+00	Field Station#	11842+00		
Pic 3 Desc.	Representational photo of permanent waterbar and level spreader.		Pic 4 Desc.	Section of restored RoW showing conditions and controls.

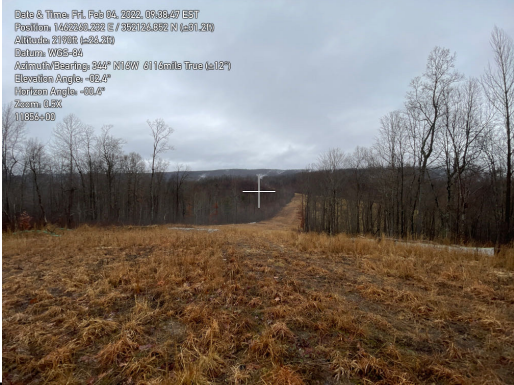
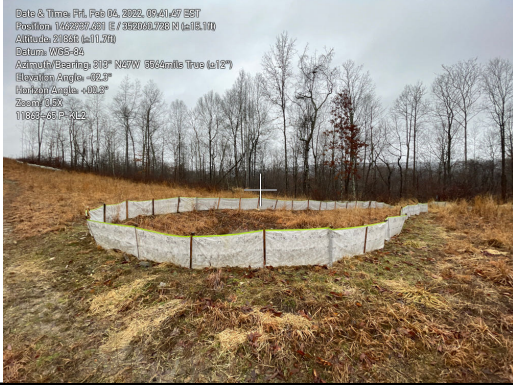
GPS Location	5	GPS Location	6		
Field Station#	11856+00	Field Station#	11863+65		
Pic 5 Desc.	Section of restored RoW showing conditions and controls.		Pic 6 Desc.	P-KL2.

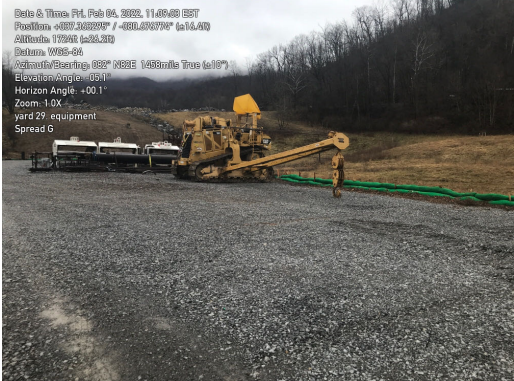
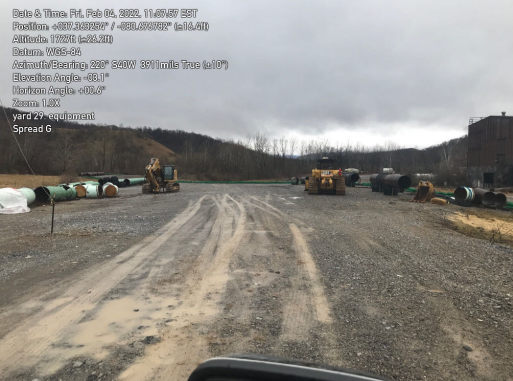
GPS Location	See photo		GPS Location	See photo	
Field Station#	12005+00		Field Station#	12005+00	
Pic 1 Desc.	Equipment yard 29		Pic 2 Desc.	Equipment yard 29

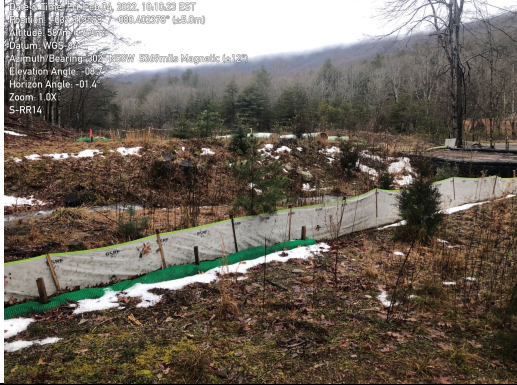
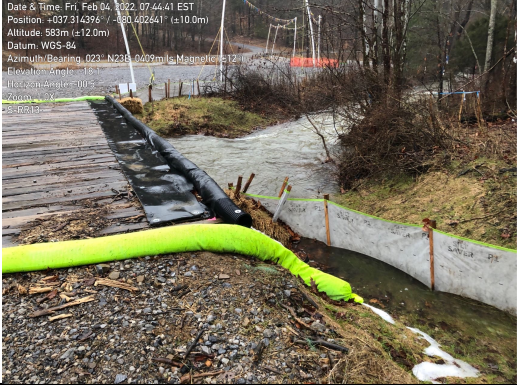
GPS Location	On photo	GPS Location	On photo		
Field Station#	11614+20	Field Station#	11613+69		
Pic 9 Desc.	The S-RR14 crossing is stable.	Pic 10 Desc.	Access road MN-258.04 and S-RR13 are in good condition.

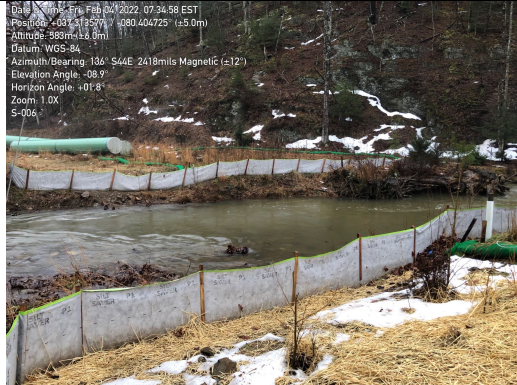
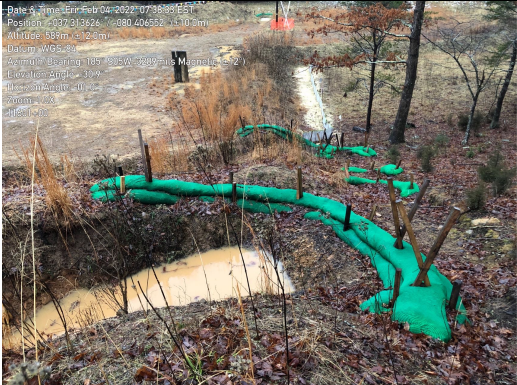
GPS Location	On photo	GPS Location	On photo		
Field Station#	11608+17	Field Station#	11601+00		
Pic 11 Desc.	S-006 crossing is stable.	Pic 12 Desc.	Perimeter ECDs in place, effective.

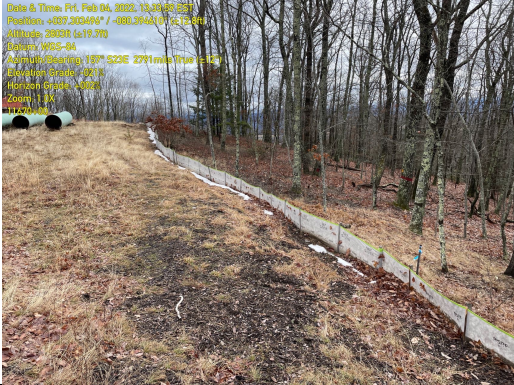
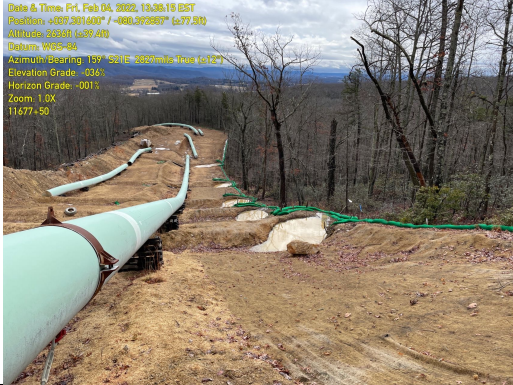
GPS Location	See photo	GPS Location	See photo		
Field Station#	11670+00	Field Station#	11677+50		
Pic 1 Desc.	P1 silt fence perimeter control in place	Pic 2 Desc.	CFS triple stack end treatments in place

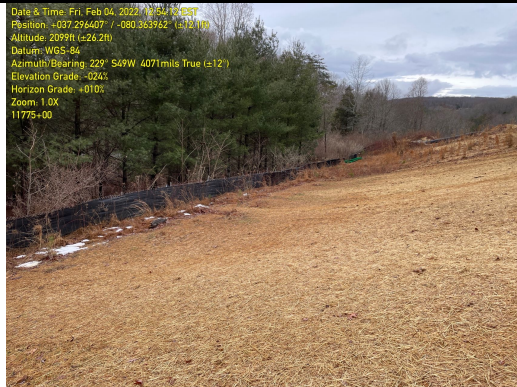
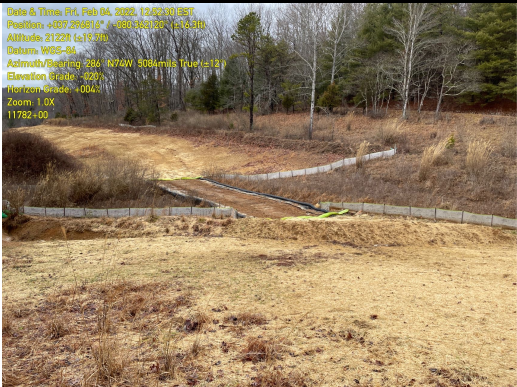
GPS Location	See photo	GPS Location	See photo		
Field Station#	11775+00	Field Station#	11782+00		
Pic 11 Desc.	Supersilt fence perimeter control in place	Pic 12 Desc.	Cleanwater drainage feature in place
